**Archaeological Evaluation Report  
Land at 184 South Coast Road  
Peacehaven, East Sussex**

**ASE Project No: 6519  
Site Code: SCR 14**

**ASE Report No: 2014106  
OASIS ID: archaeol6-176028**

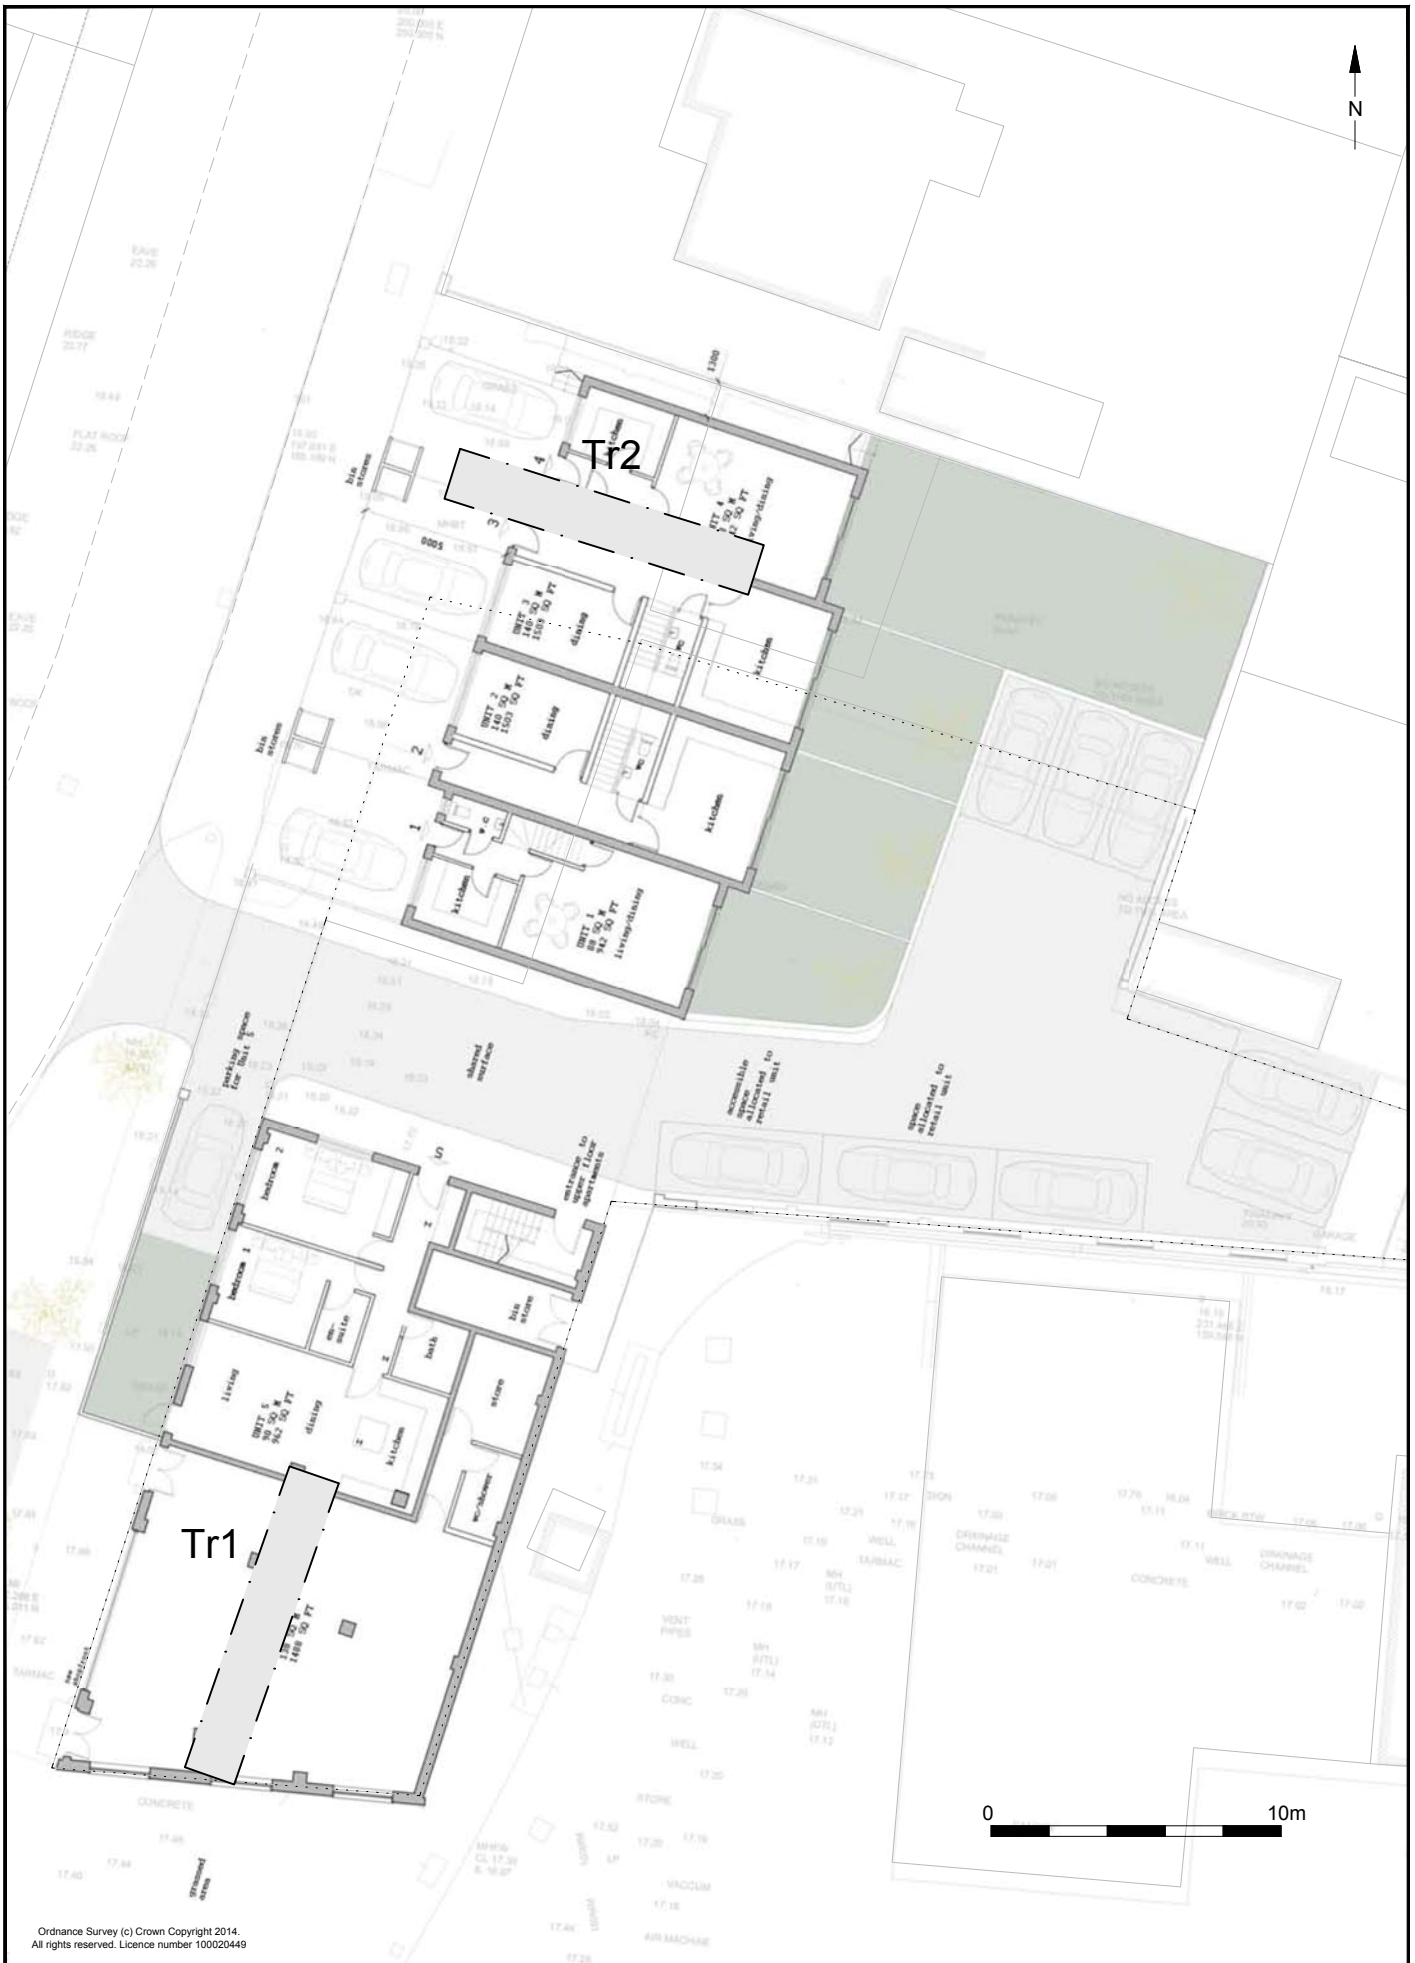
© Archaeology South-East		184 South Coast Road, Peacehaven	Fig. 2
Project Ref: 6519	April 2014	Site plan	
Report Ref: 2014106	Drawn by: RHC

- 3.1.1 Two trial trenches each 11m in length and 1.8m in width were mechanically excavated at the site (Figure 2). They were positioned to allow maximum coverage but allow site access and not endanger other contractors at the site. The location of the trenches differs slightly from those illustrated within the WSI (ASE 2014) due to on-site constraints.

- 4.1.1 Recent demolition had left the site somewhat uneven with a notably higher area left in the northern part of the site, with a slight slope downhill towards South Coast Road.
- 4.1.2 The archaeological evaluation was undertaken on 27<sup>th</sup> March 2014. Diffuse sunlight provided ideal conditions for the identification and recording of any potential archaeological features.
- 4.1.3 No archaeological features were recognised and no artefacts were recovered from the overburden.
