Historic Building Recording

Hospital Buildings at Mascalls Park, Mascalls Lane Warley, Brentwood Essex

Report No: 2014112

April 2014

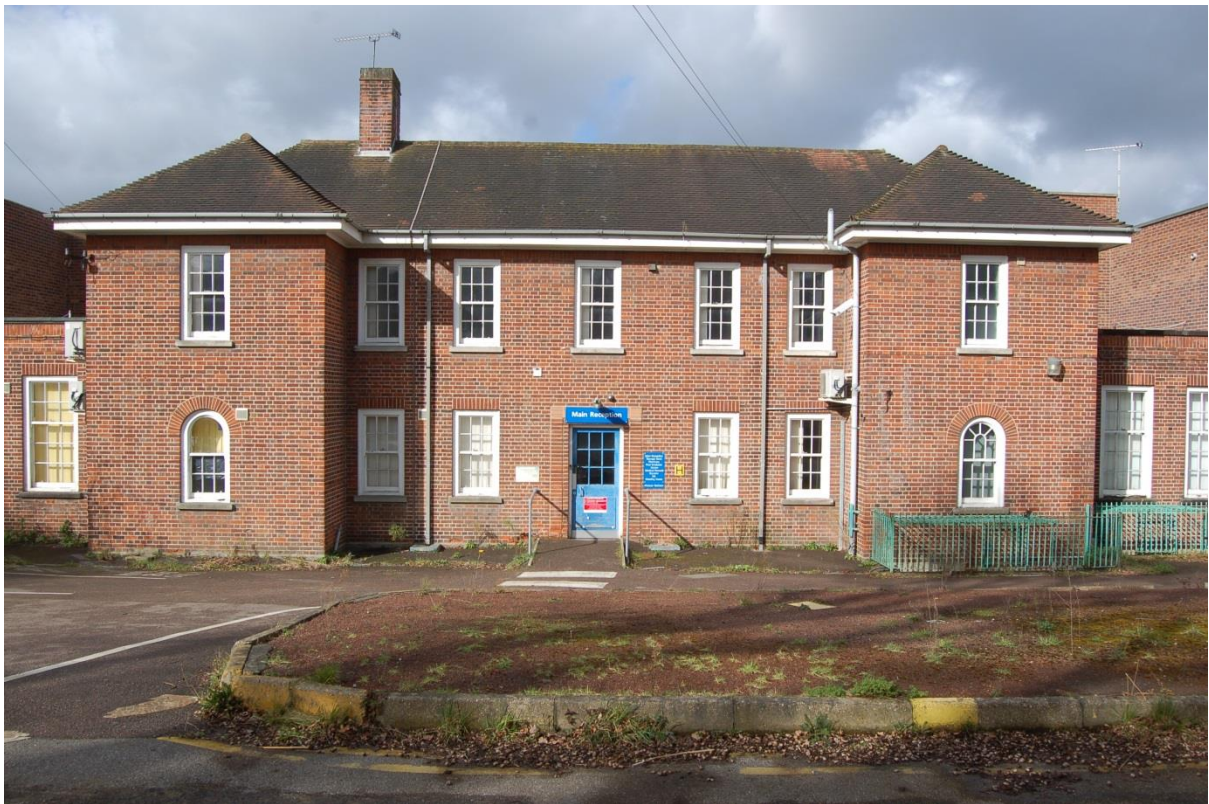
Plate 2: Building 1, Main Block

presenting a symmetrical façade. The roof has hipped ends and a chimney towards the south-west end. It would appear from Plate 2 that there was also originally a chimney on the opposite end that has been removed.

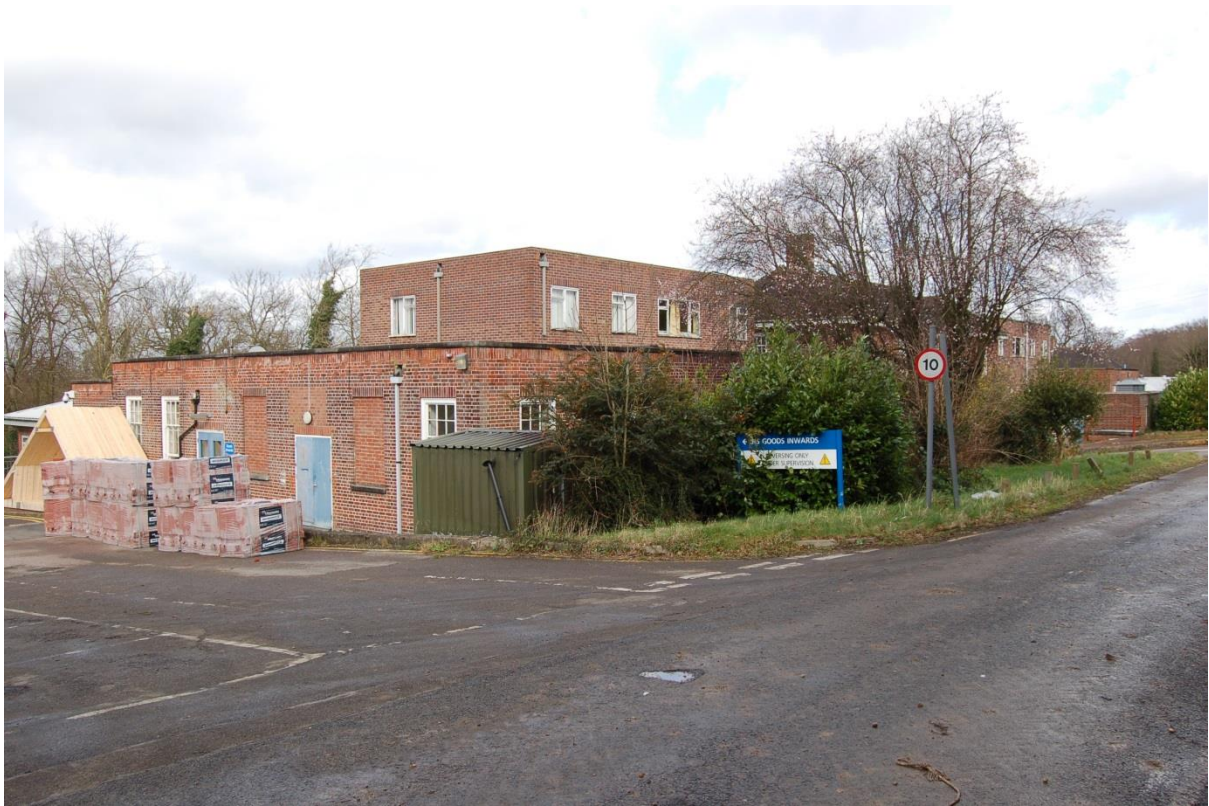
Plate 4: Building 1, viewed to north

5.4.4.4 The south-west elevation (Plate 4) was partly obscured by building materials during the survey. There are two double doorways here. The semi-glazed ones to the left led from the former linking corridor into the main corridor of Building 1 that extends the full length of the building. To its left are a pair of 6/6 sash windows, and after this the elevation is plain. The doors to the right are plain and lead into the ancillary area. Between them is a blocked window. Some rebuilding work has occurred around the frame and above the door head and it is possible the door replaced an earlier window here. Another blocked window is located to the right of the door, next to an existing 6/6 pane window.

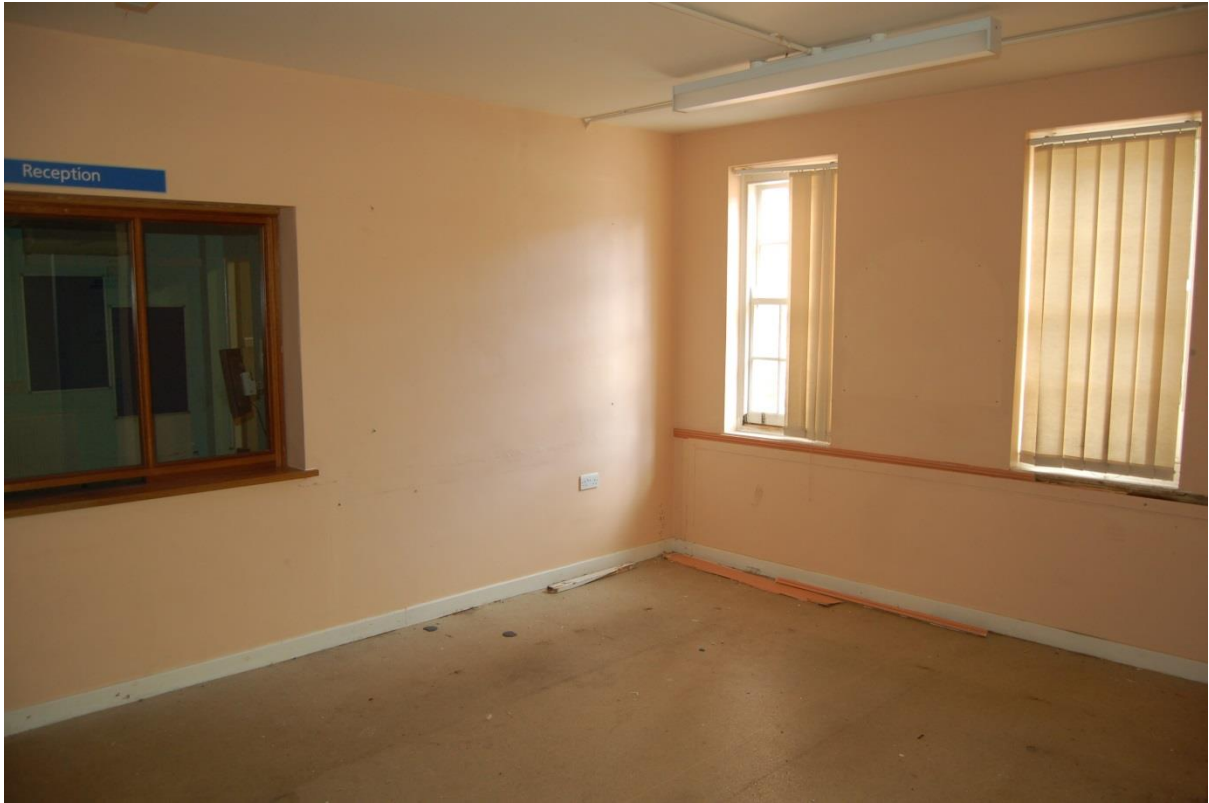
Plate 11: Room 2, with built-in radiator left

5.4.5.2 The main entrance is on the south-east side that leads into the entrance lobby, Room 1 (Plate 9). From here a wide semi-glazed door leads into the waiting area Room 2. The door was original enclosed by a semi-glazed partition which matched the waiting room door, but most of this has been replaced with hardboard. Now only a single long panel on the right side of the door remains and the two wooden base panels, flush with the wooden door panel. In the original layout, the lobby connected to a short corridor that passed Room 26 and another room, now part of the waiting area, Room 2, but this was changed when the modern waiting room was created to accompany the reception area, Room 7 (Fig. 5). This corridor was overlooked from Room 26 by a glazed screen (since blocked) and it is possible there was a second screen on the former room opposite, which is now part of Room 2. Room 2 is plainly decorated with openings onto the corridor in two places where walls or partitions have been removed. It has a cream-coloured terrazzo floor, which continues into the reception area (Plate 10). An original built-in radiator is fitted to the external wall, one of several found during the survey that comprise long iron panels, flush with the wall, that were heated by internal pipework or

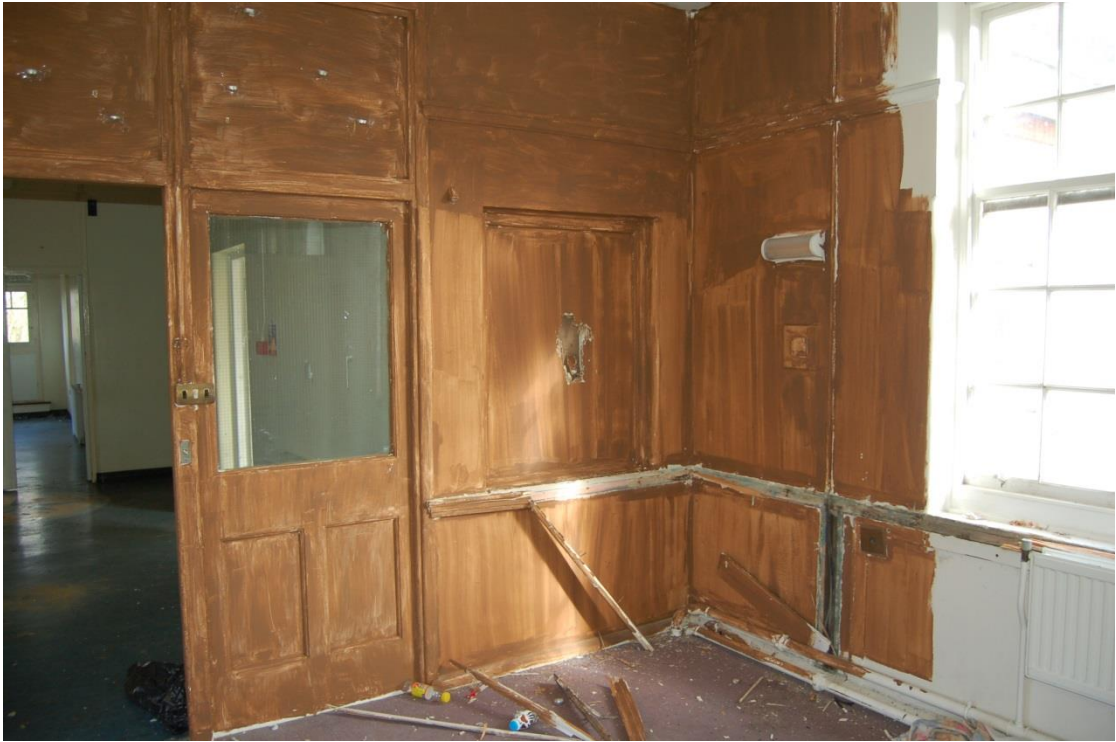
Plate 63, northeast corner of dormitory, including in-filled viewing window

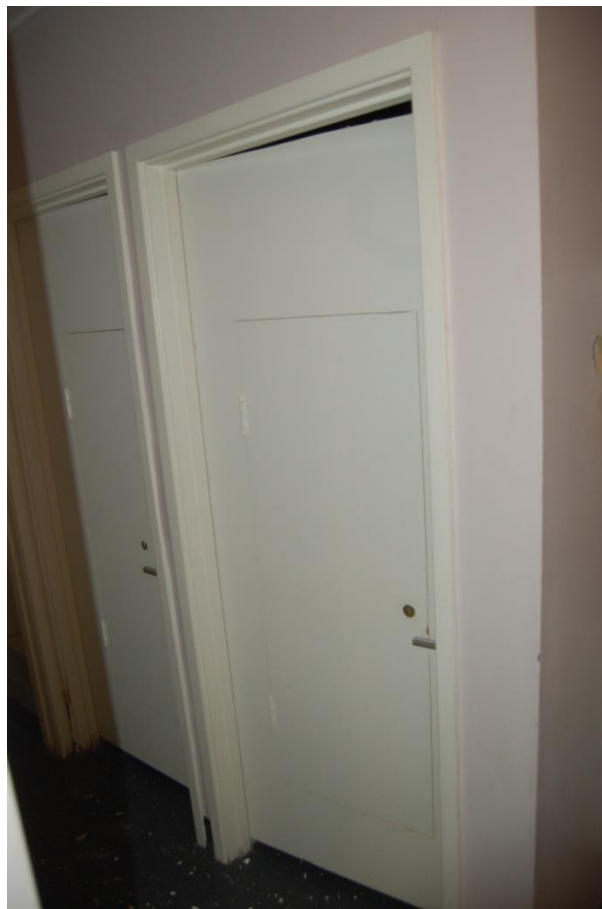
Plate 64: Room 26, modern door

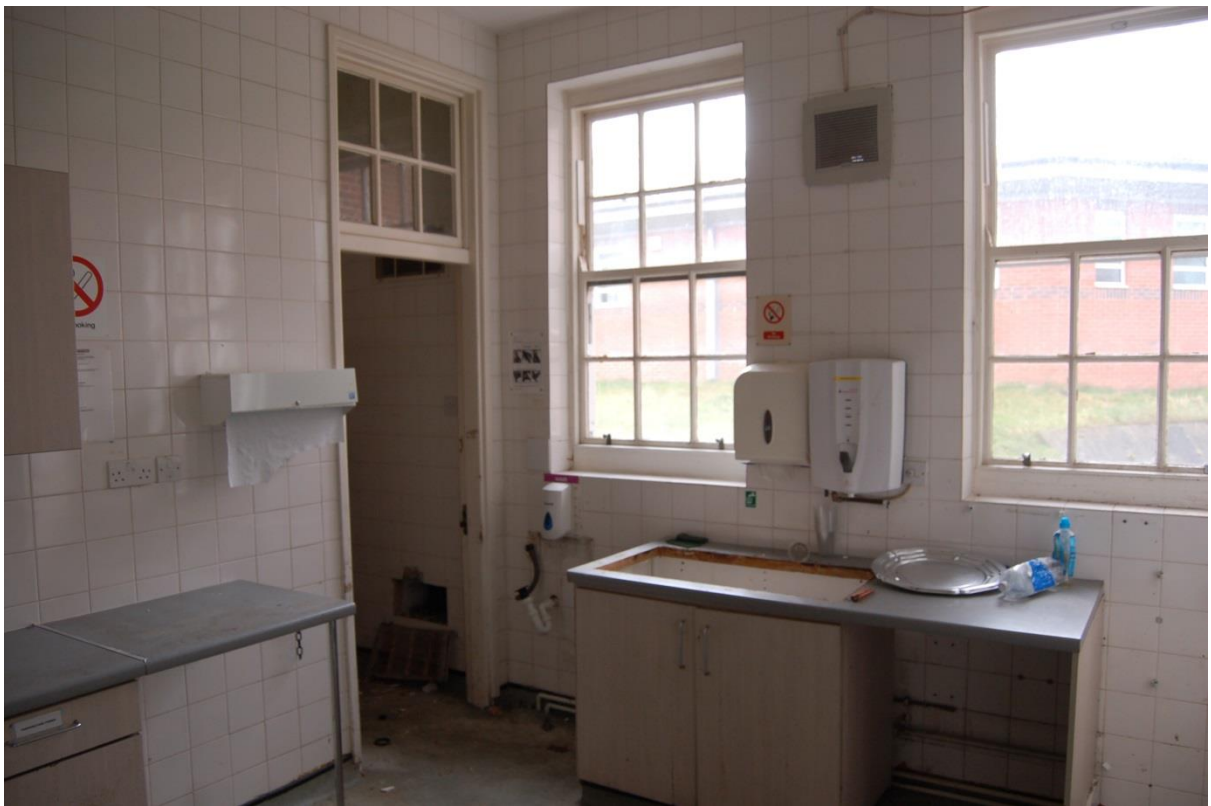
Plate 75: Room 5

sash windows (Fig. 9 and Plate 75) and a vinyl floor. It is likely that the Building 2 end wing conformed to this pattern originally. The room function is unknown.

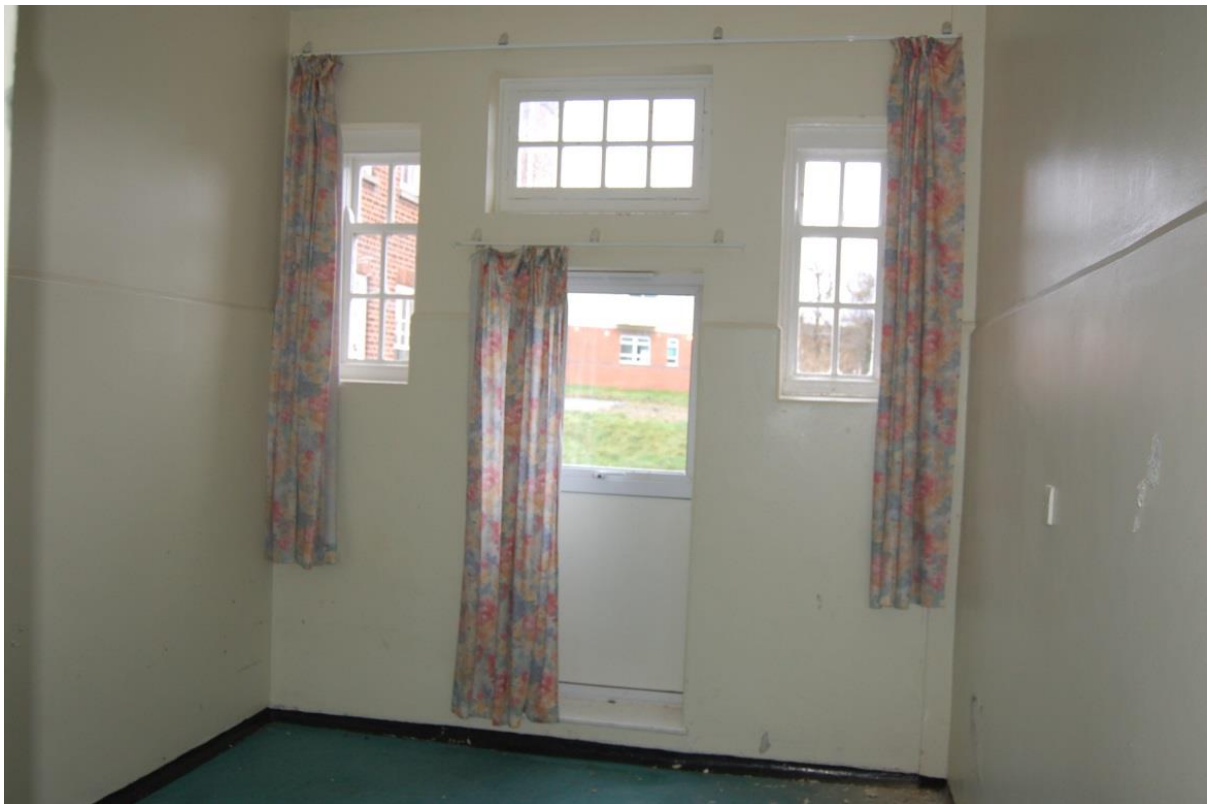
Plate 77: Lobby 18, viewed to southwest

- 5.6.5.7 Corridor 4 becomes Lobby/Corridor 18 at the central cross-wing between the staff block and male dormitory block (Fig. 9), separated by a fire door. The same decorative themes are represented here, with plain walls and green flooring with compass motif (Plate 77).

- 5.6.5.10 Room 34, the original ground floor male dormitory, comprises five bays defined by boxed ceiling beams. Entry from the lobby area is by a semi-glazed two-panel door framed by fixed semi-glazed screens either side (Plate 77). Three former glazed lights above are now boarded. Within the room are six bed bays, constructed from plasterboard stud walls with high six-pane glazed light panels, facing onto a central passage; the same format as Building 2. Cream marbled vinyl flooring covers the area and the bottom edges of the walls are defined by bullnose skirting. Beyond the south end of the room is the stair/ablutions block comprising Rooms 35-37. Rooms 35 form the refurbished modern patient shower and toilet area, which resulted in the blocking of former windows on the west side (Fig. 9). Room 36 is the stair and stair lobby, the same as those either end of the building, and Room 37 is the stair cupboard, entered by an original four-panel door. It was last used as the Property Room. The original internal layout and function of this area in unknown.

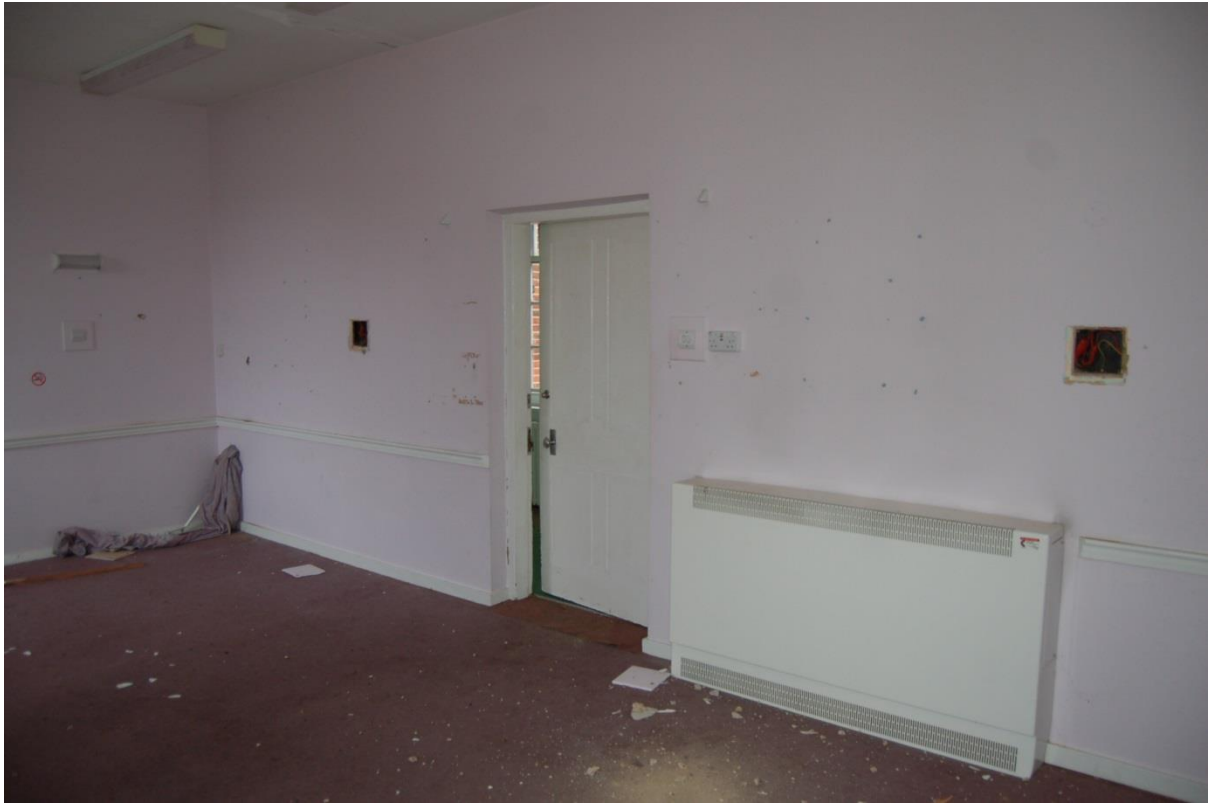
Plate 80: Room 7

- 5.6.5.16 Room 7, the dining room/dayroom (Plate 80), has the same features as the room below but the lacks the retractable screen seen in its equivalent in Ash Ward, though it is likely to have had one originally.

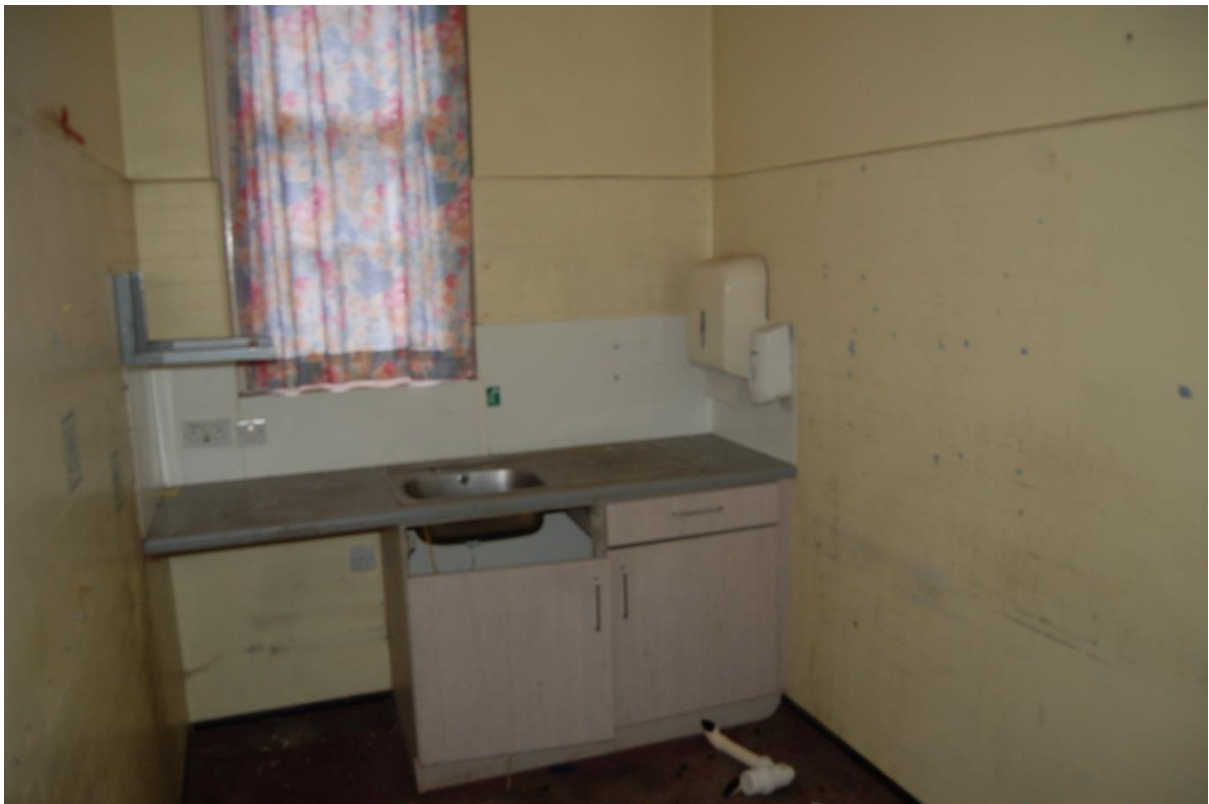
Plate 81: Room 12

Rooms 12 and 13 were originally one ward in the 1930s hospital. The rooms have vinyl floors, bullnose skirting and moulded dados (a later feature) and both modern and flat built-in radiators. Their entrance doors are the same as present at Stair G3 and Lobby 1, but in four-panelled form (Plate 81) which appear to be more common in this part of the building.

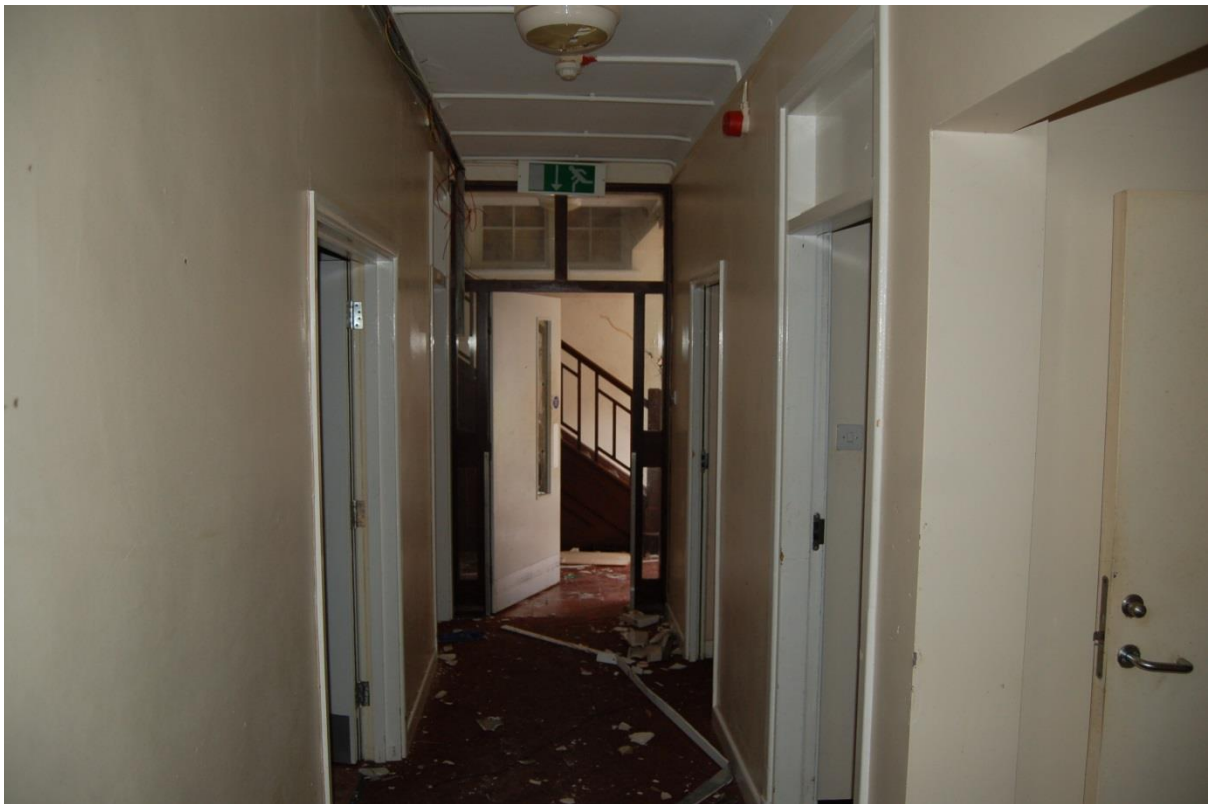
Plate 92: Corridor 4, viewed to east

Some doors have fanlights, which have been replaced by boards (Plate 92). This is essentially a staff area. On the north side of the corridor is Room 5, a small store room that has the same practical flooring as the entrance lobby. Next to it is the kitchen, Room 6, which has a modern white-tiled working area, modern sink and cabinets and covered vinyl flooring. The former range stood in the south-west corner (Plate 93). In the north-east corner is the pantry, behind Store Room 5. Only partial access was possible, but it was seen to have a red tile floor common to practical areas, white-tiled walls and lit externally by a small window. On the south side of Corridor 4 are Room 7, the function of which is unknown, Room 8 the laundry room and Room 9, the toilet and lobby. All of these are plain with no features of note and it is likely that the division between rooms 8 and 9 was added.

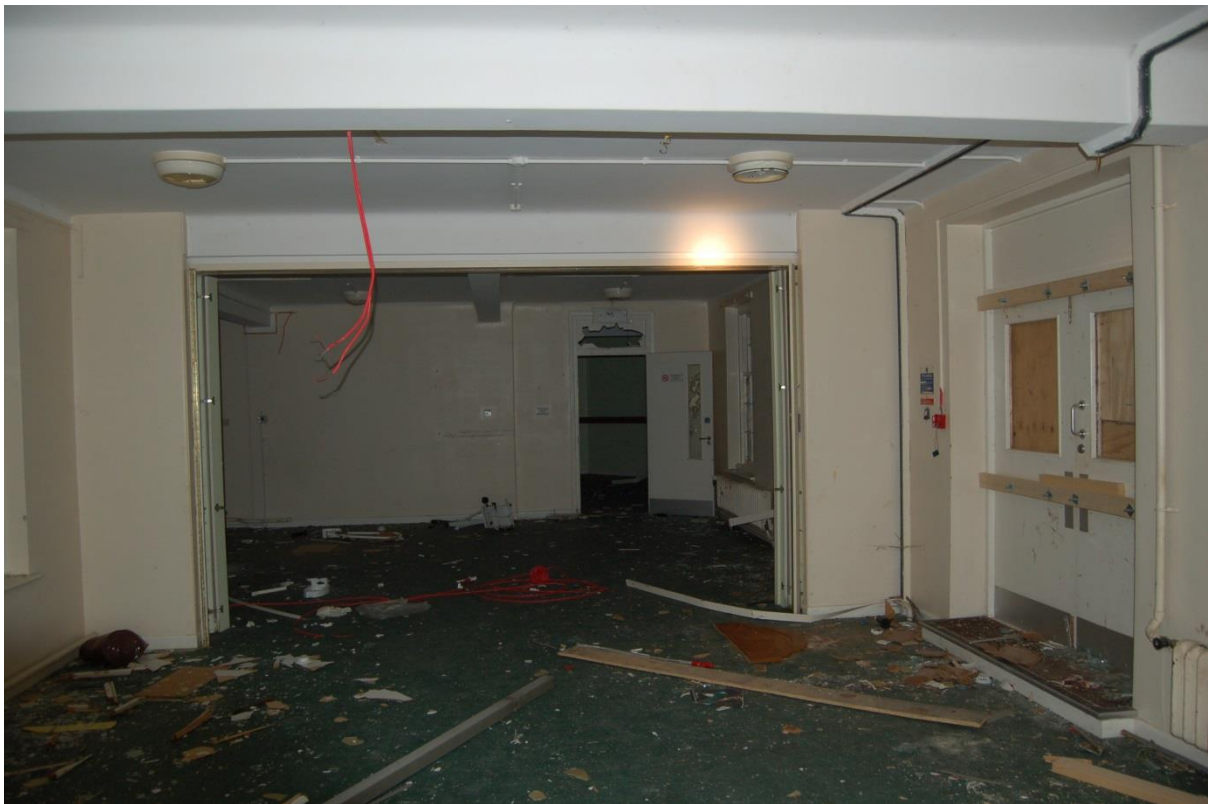
Plate 94: Room 10

5.7.5.3 At the west end of Corridor 4 are three dayrooms/dining rooms, 10, 11 and 12, which are basically the same, with modern vinyl floors and plain walls and plenty of windows facing the south to aid convalescence. Room 10 has a modern fire-door on the north side. It is possible that the wall between Rooms 10 and 11 was removed and replaced with a modern retractable screen when this new exit was inserted (Plate 94). Room 10 also had a fireplace in the north-east corner (Fig. 10). Larger and projecting Room 11 has the replaced doorway on its south wall, with square glazing with original fanlight and windows, low cast iron radiators (Plate 95) and a former fireplace on the west wall. Room 12 is carpeted and had a fireplace in the north-west corner.

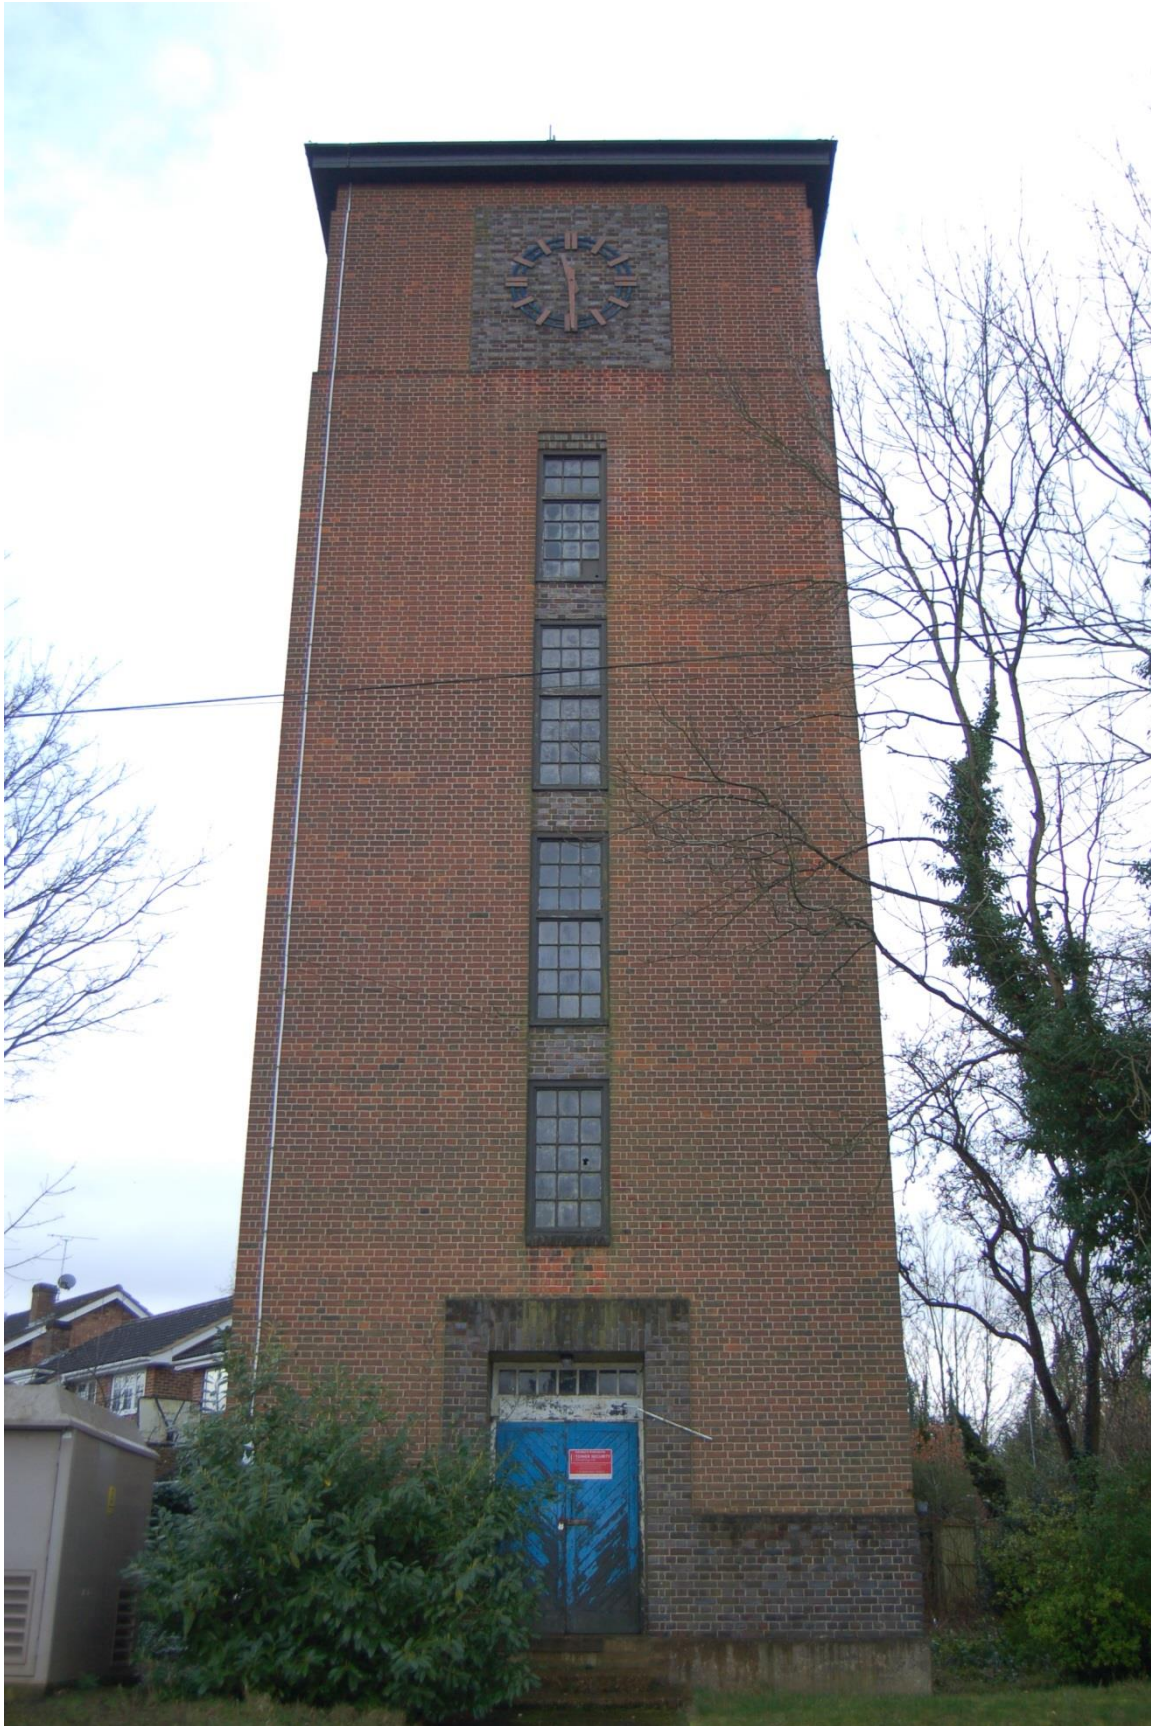
Plate 99: Building 5, northwest elevation

The building appears to be in good condition with no obvious alterations to the external fabric. The main elevation is on the north-west side (Plate 99) where a short series of concrete steps leads up to the central diagonally-battened double entrance doors which stand beneath a narrow 7-pane fanlight. The door is recessed into a thick slightly-projecting vitrified brick surround that steps down to

the brick plinth of the same material that wraps itself around the building. Above the doorway are a series of four tall multi-pane windows arranged vertically, broken by vitrified brick panels. The windows have black-painted wooden frames. The bottom one is fixed and has a bullnose brick sill. The ascending three have no sills and are top-opening in form. None have heads apart from the top one, which marks the end of the fenestration with two rows of stepped headers.

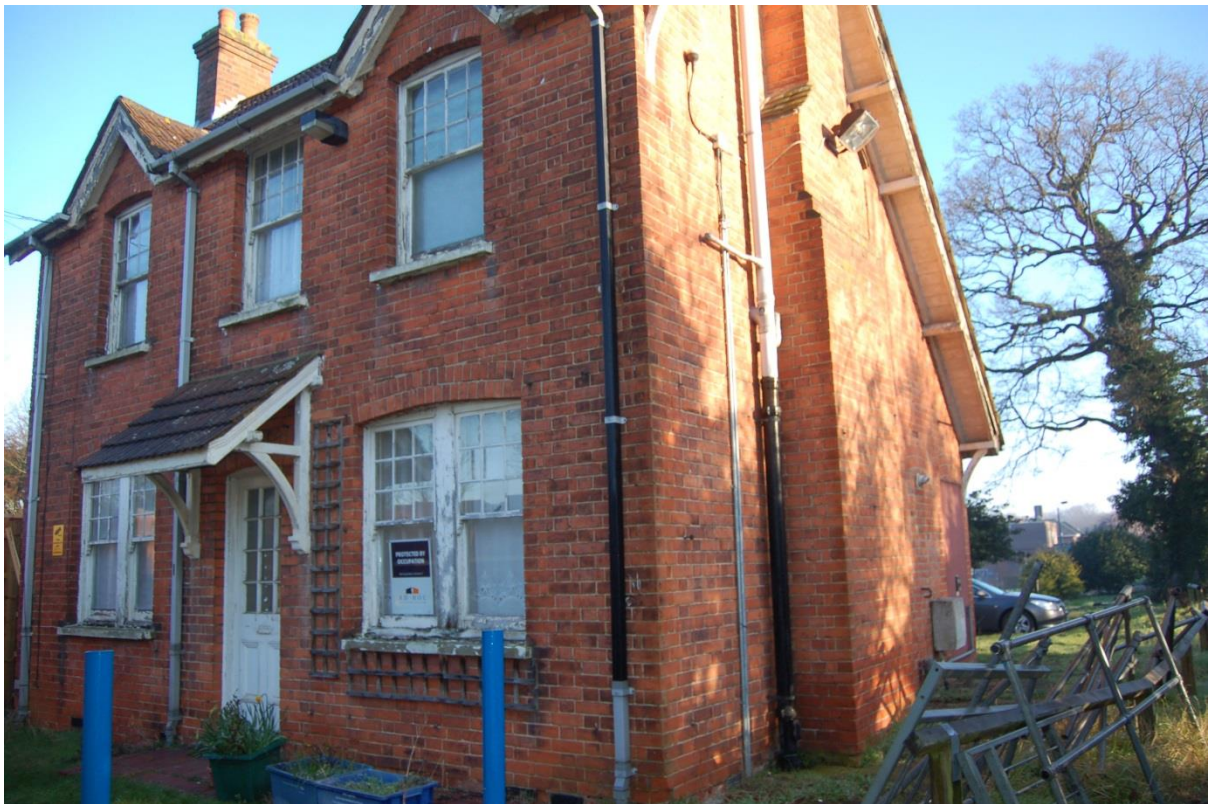
Plate 105: Building 6, viewed to north

5.9.4.1 The main façade is symmetrical (Plate 105). At the centre of the ground floor is a semi-glazed probably 1930s front door, which is in-keeping with the character of the building, accessed by a 6-inch quarry tile path and concrete step. A tiled pent-roofed canopy is situated above the door, supported on carved wooden brackets, which are an architectural feature of the building. Double sash windows flank the entrance, with single bottom panes and multiple 9-paned top ones.

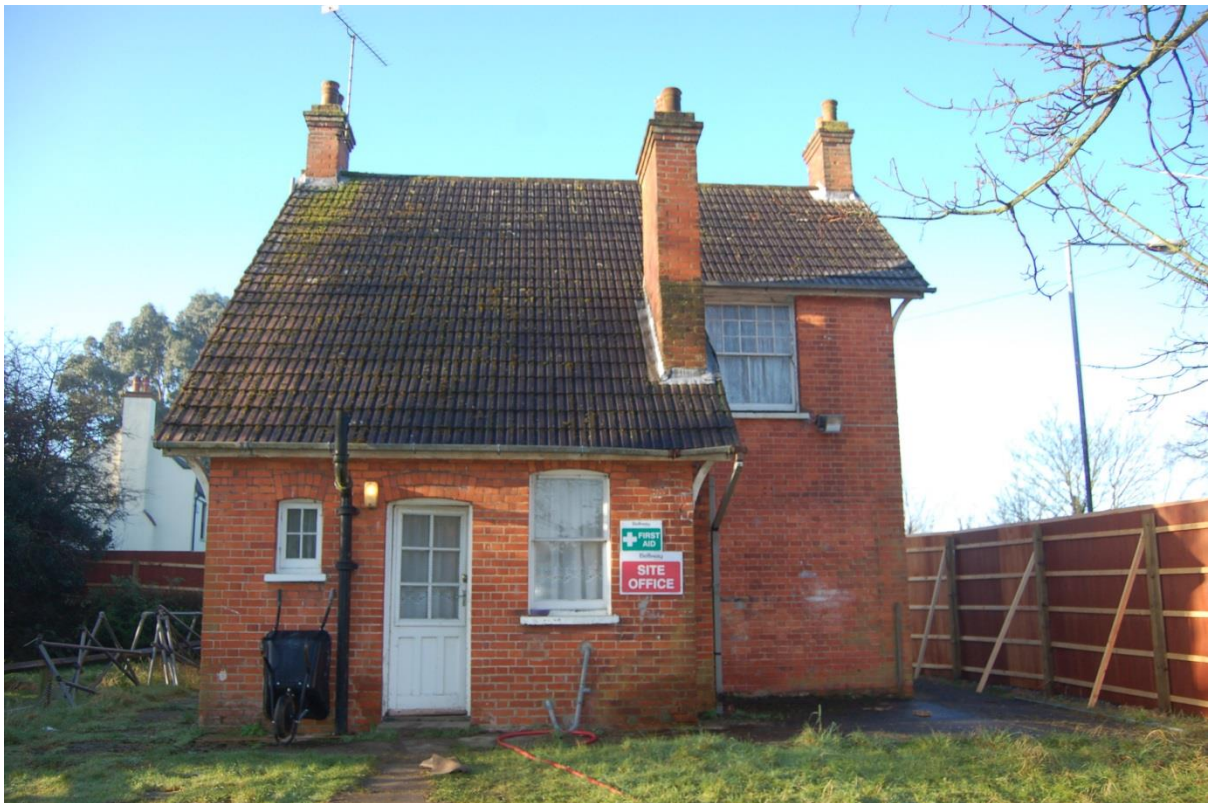
Plate 107: Building 6, northeast elevation

5.9.4.4 On the ground floor of the northeast elevation (Plates 107 & 108), the kitchen/ancillary area underneath the cat-slide roof is entered by a central semi-glazed back door, which, like its counterpart at the front, was probably replaced in

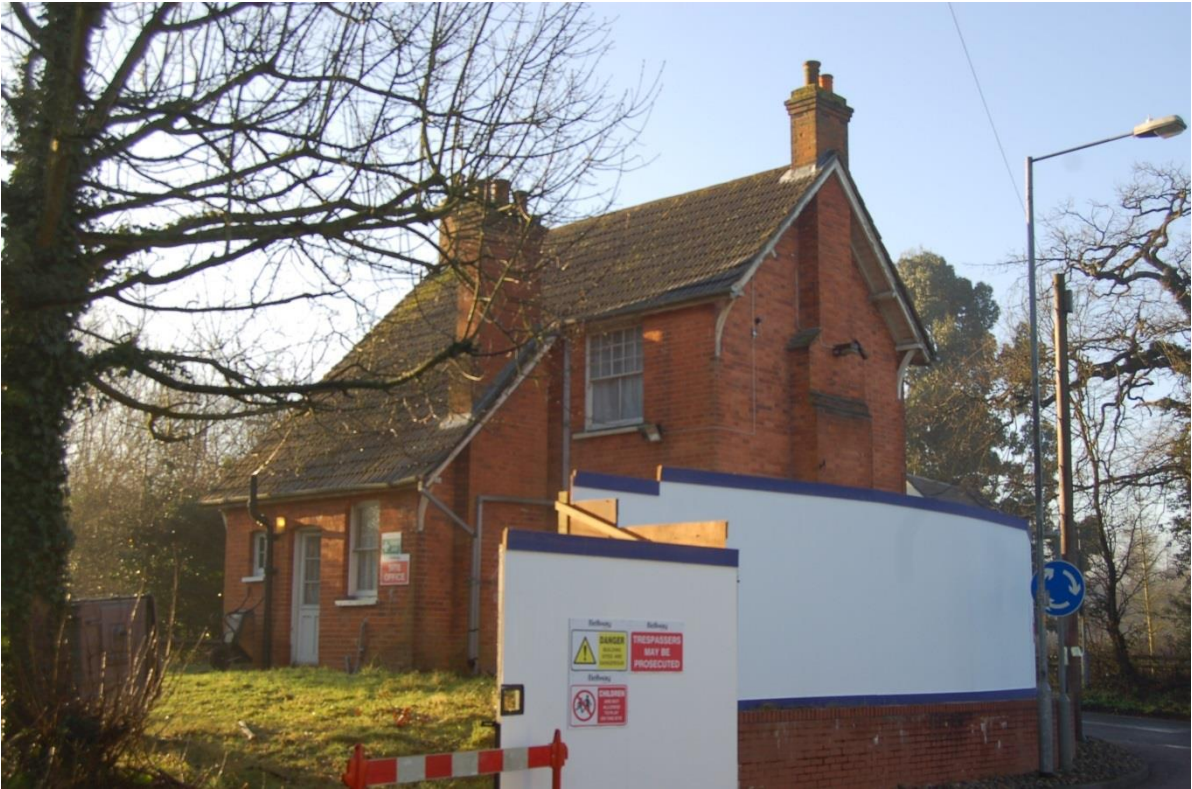
Plate 108: Building 6, viewed to south

the 1930s. To the left of it is a small four-pane casement window lighting the toilet and to the right of it is a plain sash window. A tall rectangular chimney rises from the base of the roof - presumably serving the former range and other fires, considering it has three chimney pots (Plate 108).

- 5.9.4.6 The second side elevation contains two projecting chimneys serving the ancillary area and the main part of the house (Plate 108). The first of these is plain, but the second shares the same decorative detail as the one of the opposite elevation. The chimneys pierce the over-sailing roof over the gable, which is supported on curved decorative brackets on this side as well.

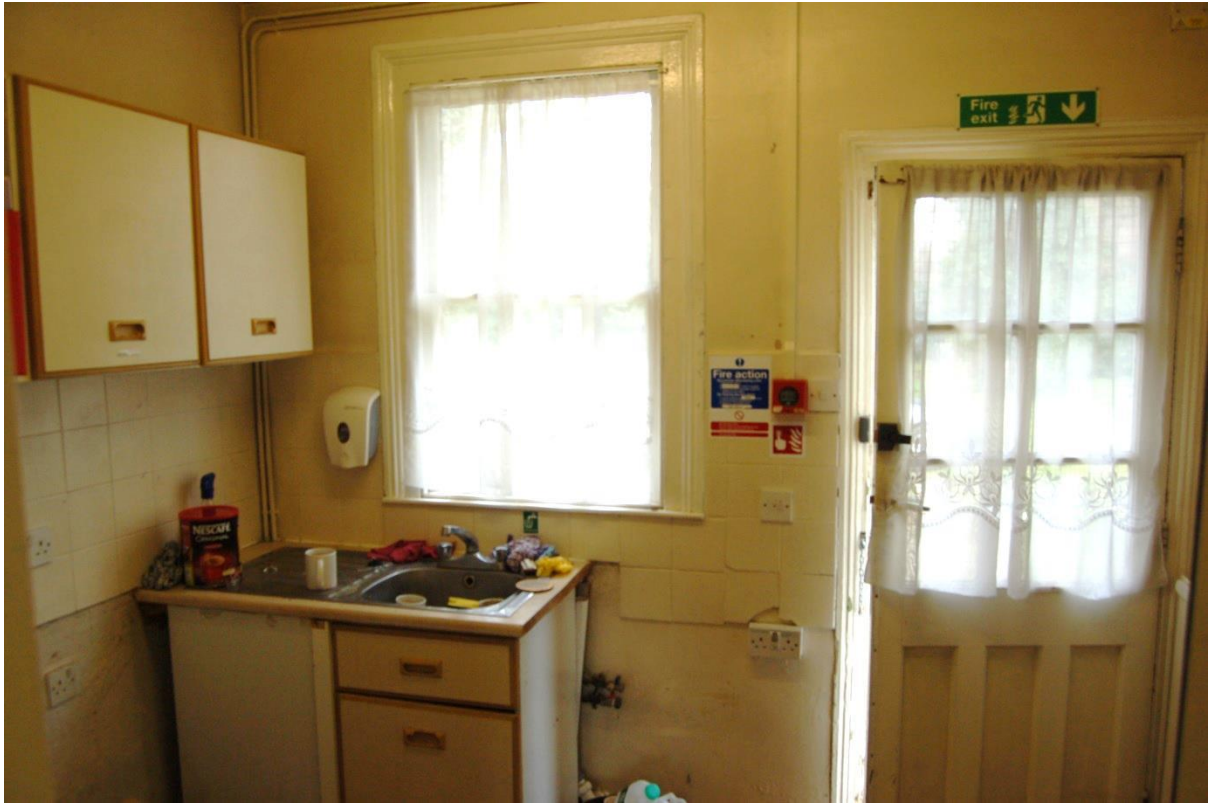
Plate 110: Room 5

dividing wall is boarded. Room 5 is the kitchen area, which has the same vinyl flooring edged with a 4-inch top-chamfered skirting. The tiled wall and sink/kitchen cabinets are modern and there are no historic fittings surviving (Plate 110). Next to the kitchen are two small rooms that were formerly accessed externally as well. Room 6 is a washroom and boiler room and Room 7 is the toilet. All fixtures and fittings are modern apart from some wooden racks in Room 7.

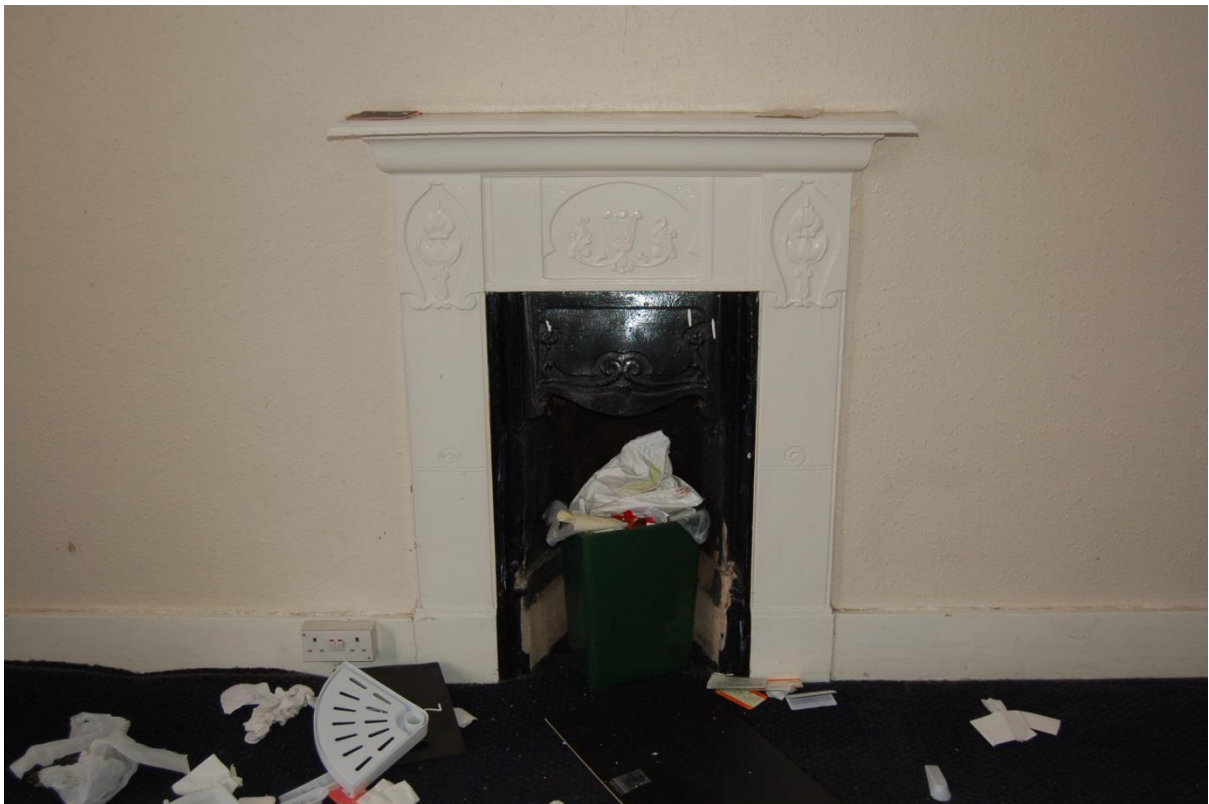
Plate 113: Room 2, fireplace

The internal layout of the cottage is clearly domestic, with living room, dining room and kitchen on the ground floor and two bedrooms and a bathroom on the first, connected by a central stair from the hall. Interiors are plainly-decorated with woodchip wallpaper and the floors are either carpeted or have vinyl flooring. All room doors have been replaced with modern fire-doors and modern radiators are fitted throughout. The main rooms at the front have 6-inch torus-moulded skirting boards and picture rails. Lesser rooms have plain 5-inch skirting. Some original historic features survive, mainly cupboards and a fireplace.
