Historic Building Record
Outbuildings to the Rear of the George Hotel
North Street
Bishop's Stortford
Hertfordshire

Commissioned by Grovebury Homes Ltd

Report No: 2014141

NGR TL 48700 21403
Planning Refs: 3/10/2067/FP and 3/10/2133/FP

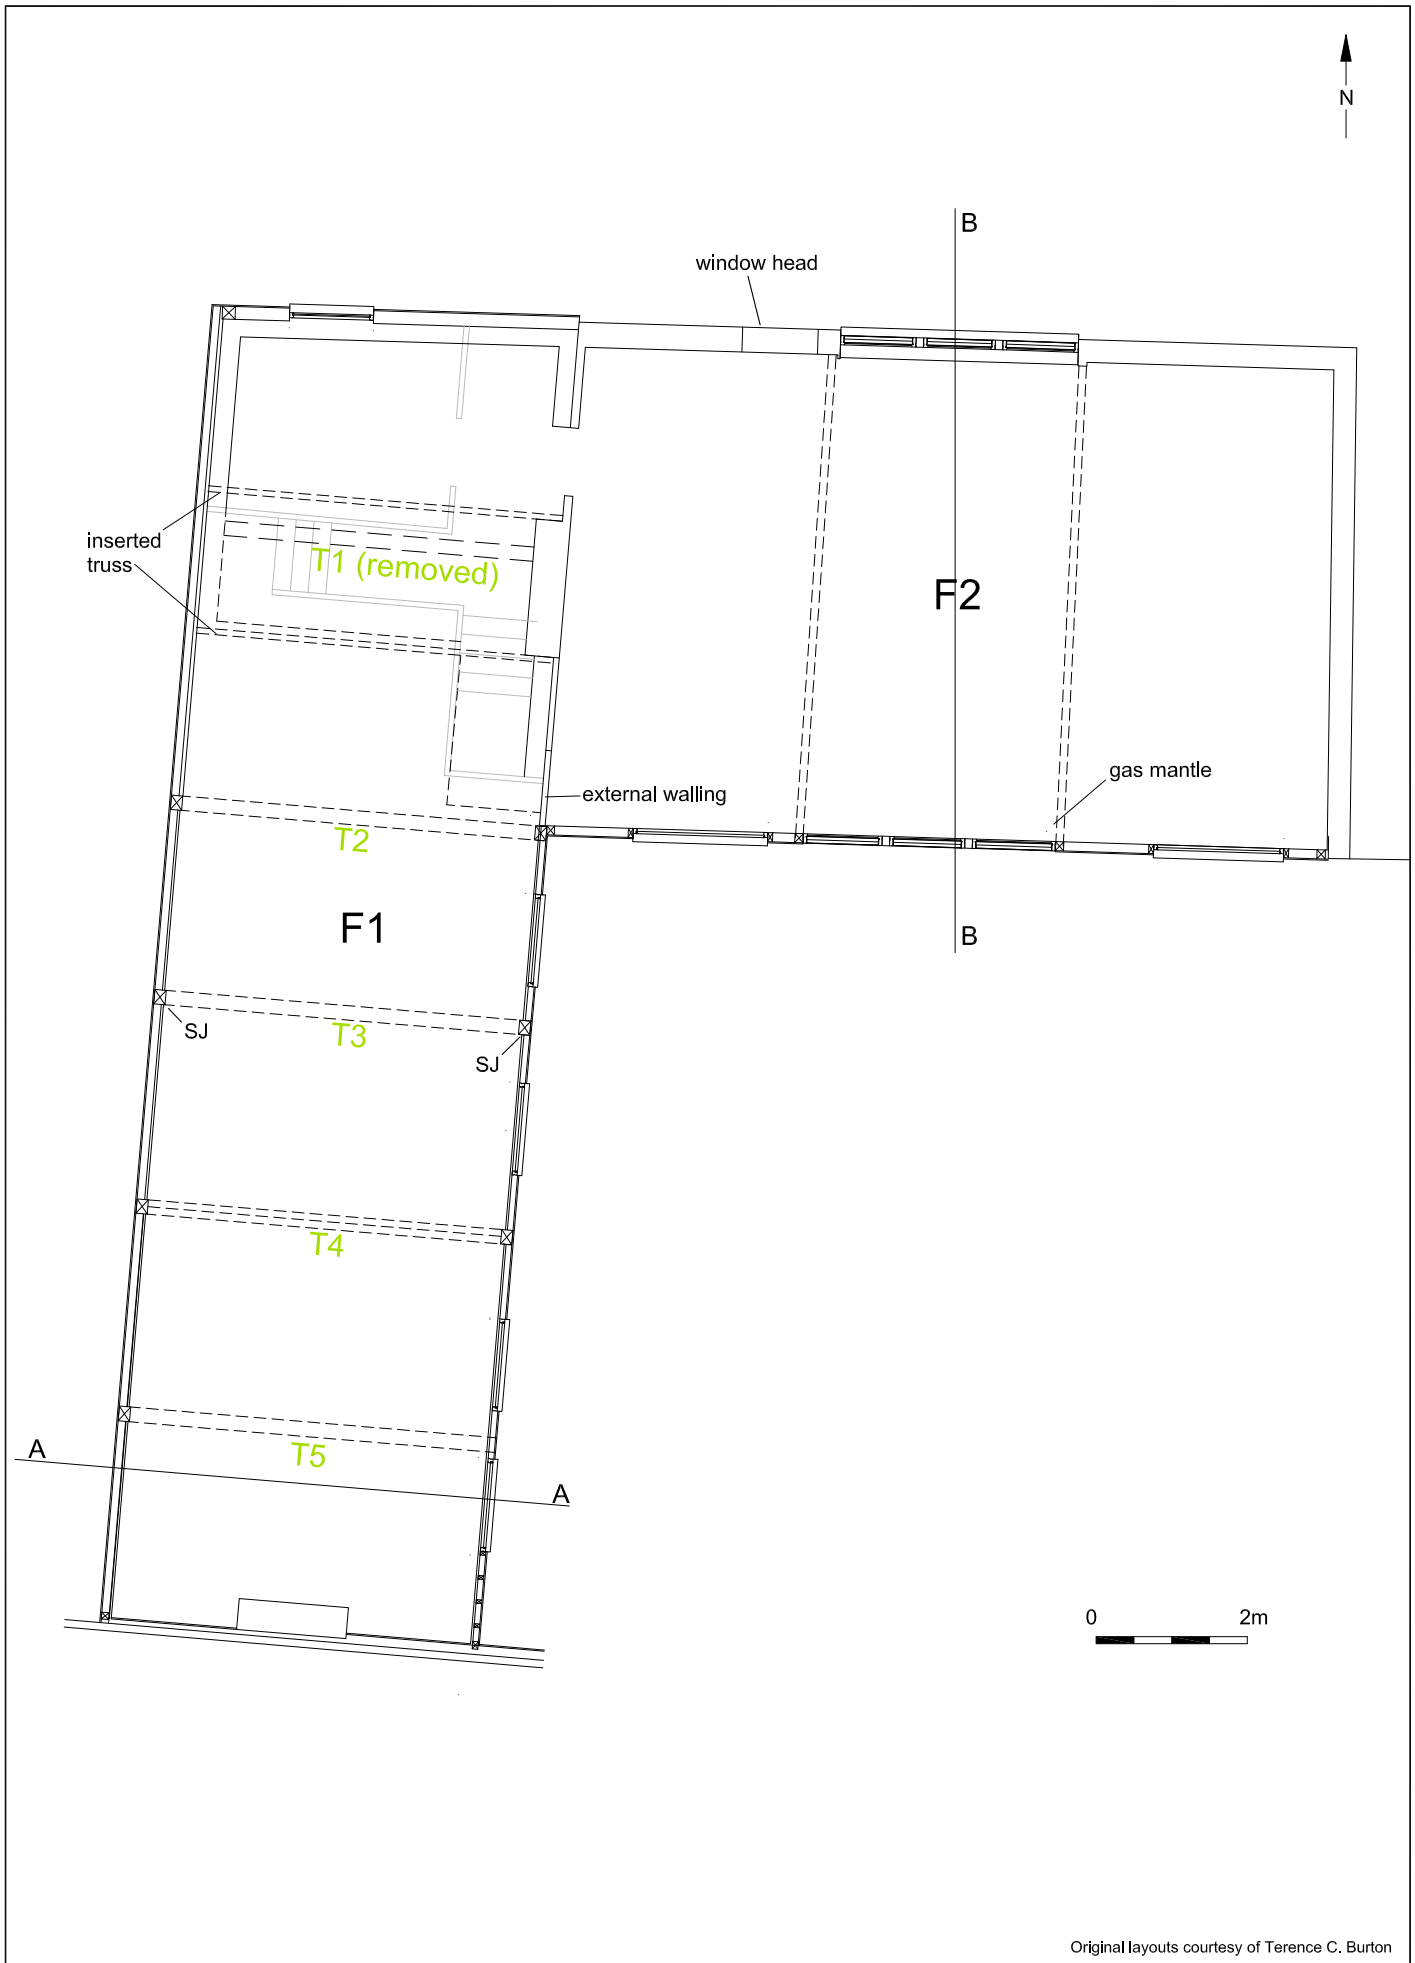
© Archaeology South-East		George Hotel, North Street, Bishop's Stortford	Fig. 5
Project Ref: 8078	May 2014	Existing first floor plan	
Report Ref: 2014141	Drawn by: APL

- 6.4.8 The interior of the room measures 5m by 18.5m and the floor is laid with 5.5-inch pine floorboards. There are six bays that represent the original internal layout of the first floor (labelled T1-5 in Fig. 5, T1 is missing) each 2.4m-wide and represented by trusses and tie beams. There is evidence in the roof space for two partition walls that partly formed three upstairs chambers, each occupying two bays in the original layout.

was found on the back (north) wall (Fig. 5), suggesting the building was once single-storey, or perhaps there were stairs along the wall here at some stage. The south wall at the front is built from machine-sawn primary-braced timbers, clearly later in date to those of the west range. The west wall (Plate 20), adjoining the older part of the outbuilding range, is mainly brick-built either side of an inserted chimney breast, which is contemporary, but also incorporates areas of existing timber-framing from Building 1. In particular, there is an area of external cladding at the southern end in the form of feather-boarding, suggesting the earlier north range was c.1m shorter than it is today (Fig. 5), making it originally similar in width to the west range. The brick element is mainly built in stretcher bond, but is partly built on eight courses of earlier, broadly English-bonded, brickwork that presumably represents the plinth of a former dividing wall to the south of the chimney and at the north end of doorway. Later Fletton brickwork has been used to block the former fireplace at the base of the chimney and around the doorway, which was originally much larger (by 0.5m either side) and presumably more formal in its appearance.

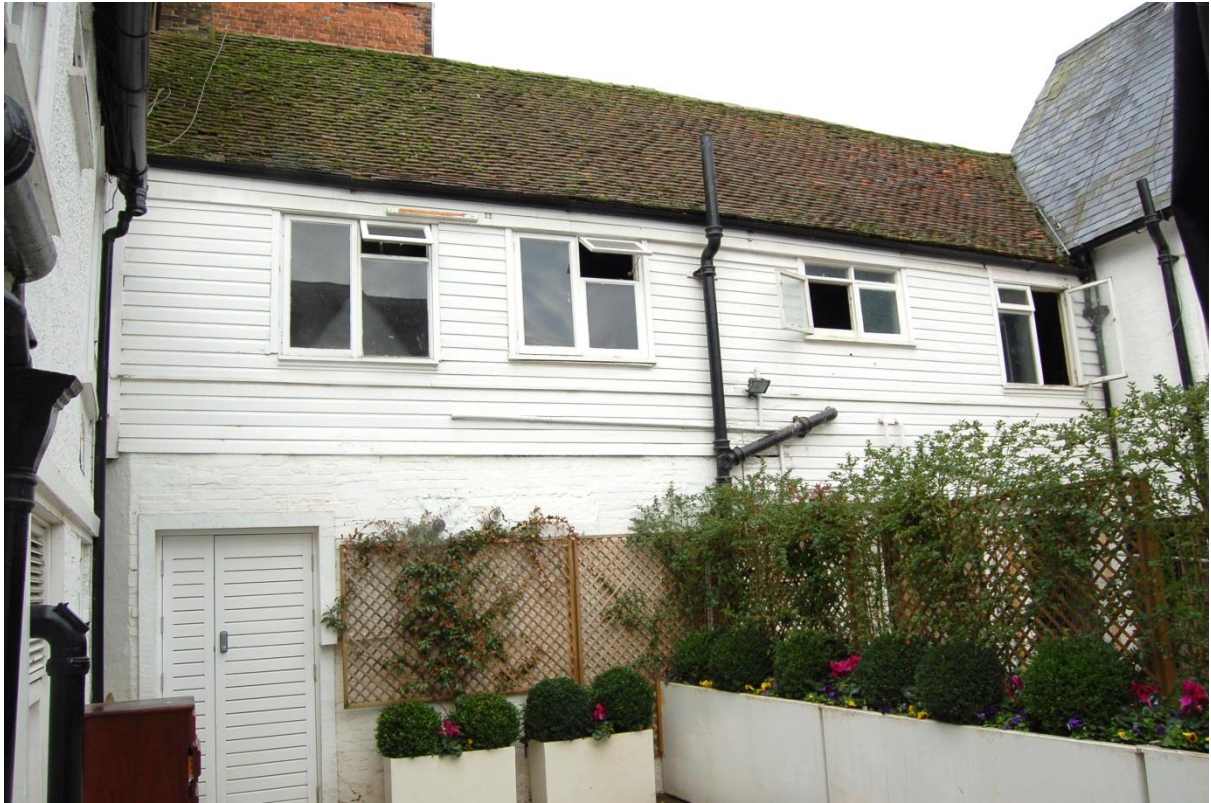
Plate 1 East elevation of Building 1 (west side)

6.2.2 The east elevation is half-boarded, with the ground floor constructed from brick and the first floor over a timber frame clad in modern shiplap timbers. The southern half (Plate 1) is fully occupied by the hotel and built using bricks with dimensions roughly of 225mm x 110mm x 70mm, suggesting an 18th or early 19th century date. Because the wall is crudely built with no discernable bond and covered in layers of thick paint, its character is difficult to determine, but the flat brick head to a blocked window or doorway partly seen behind the patio terracing, suggests a Georgian or Regency date. A modern service doorway has been inserted at the extreme southern end.

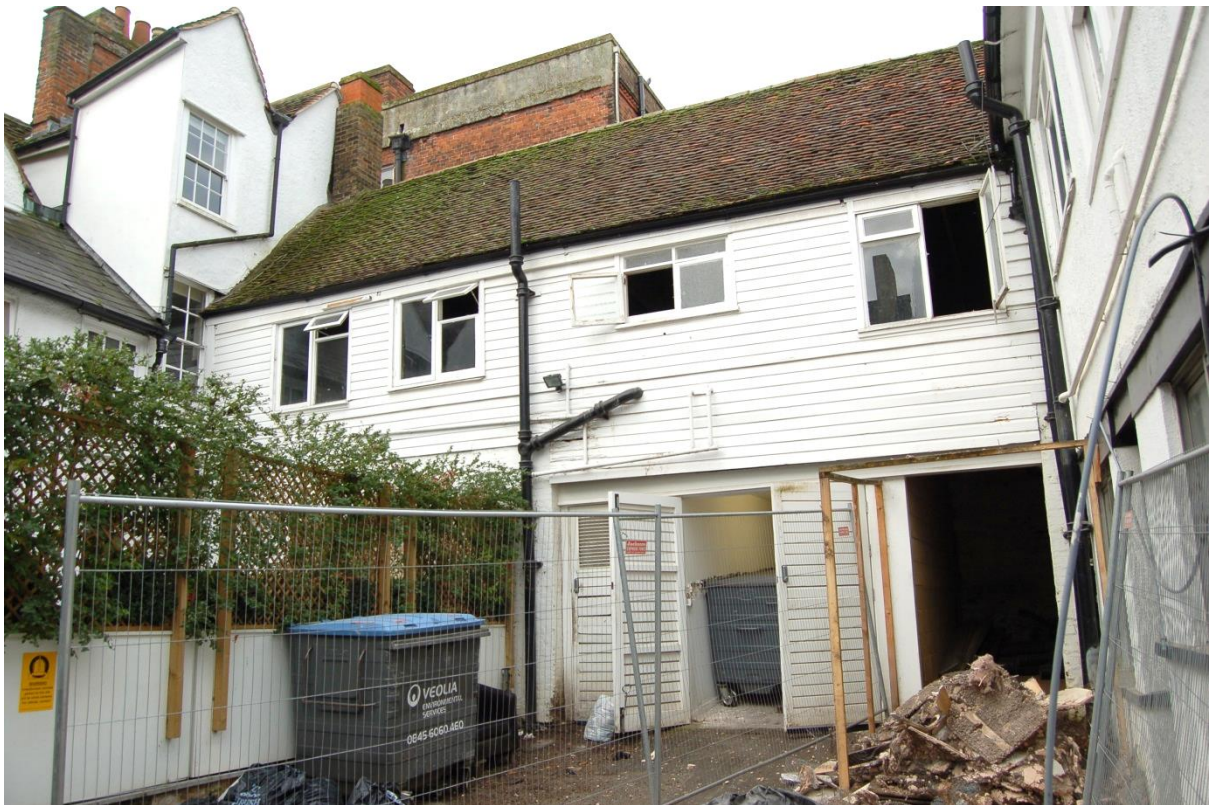
Plate 2 East elevation of Building 1 (east side)

6.2.3 The northern end of the ground floor (Plate 2) contains three modern doorways, two of which are in the ownership of the hotel and were not subject to the survey. The third open doorway, located at the north end, provides access to Room 1. The lack of any historic building fabric around the doorways suggests this end was built open-sided, though the degree of modernisation to the interiors makes this hard to verify.

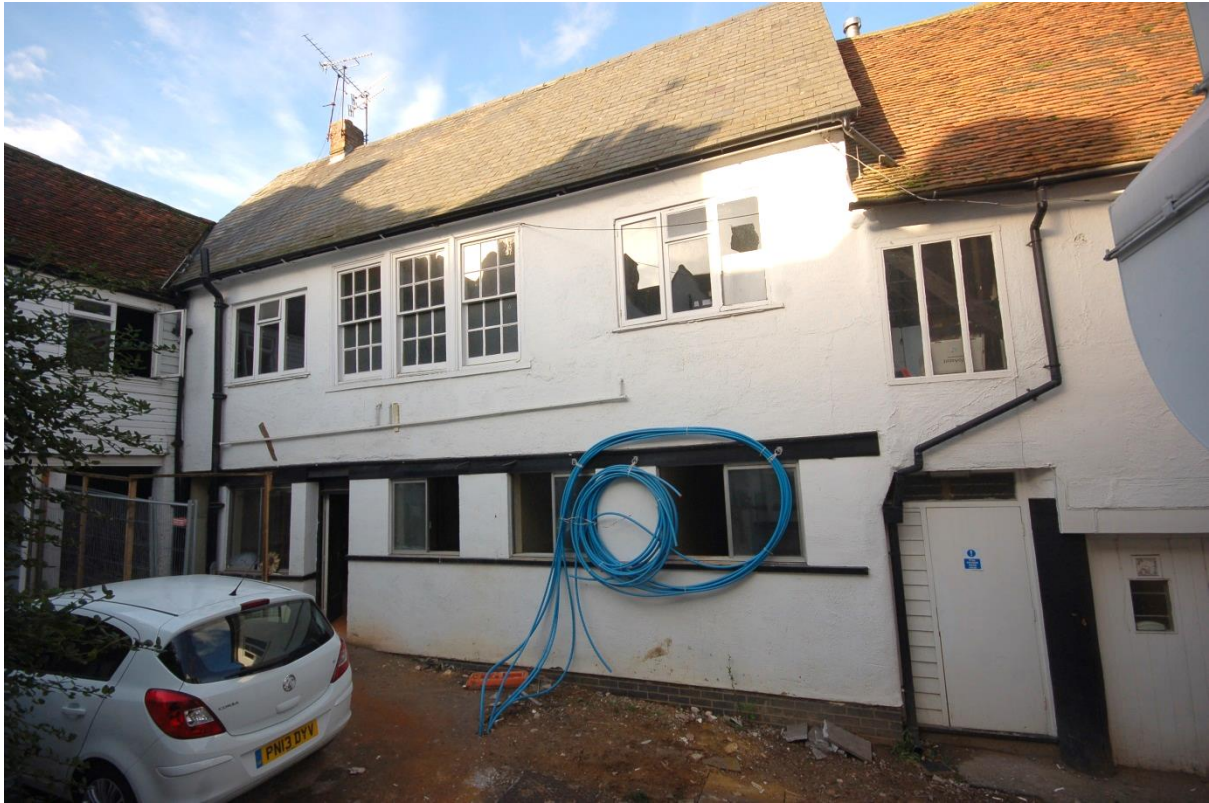
Plate 3 South elevation of Building 2

6.3.1 The south elevation (Plate 3) was the only Building 2 elevation viewed during the survey. The ground floor has been heavily modernised and the first floor and roof were rebuilt when the hall was created. Cement render covers the walls. On the ground floor and to the west are two semi-glazed modern doorways, one to Stairs G2 in the corner, which provides entry into the first floor apartments of both sides and a second close to it, which leads into Apartments A4-7, according to a sign on the door. The fabric of at least part of the front wall is built in modern Fletton bricks but the extent of this and nature of any remaining earlier wall fabric is unknown. The

- 6.3.2 A range of three multi-pane Victorian sash windows occupy the centre of the upper floor (the hall), flanked by inserted modern casement windows (Plate 3), contemporary with those on the west range. A plain chimney stands on the west end. The west and east sides are attached to existing structures.

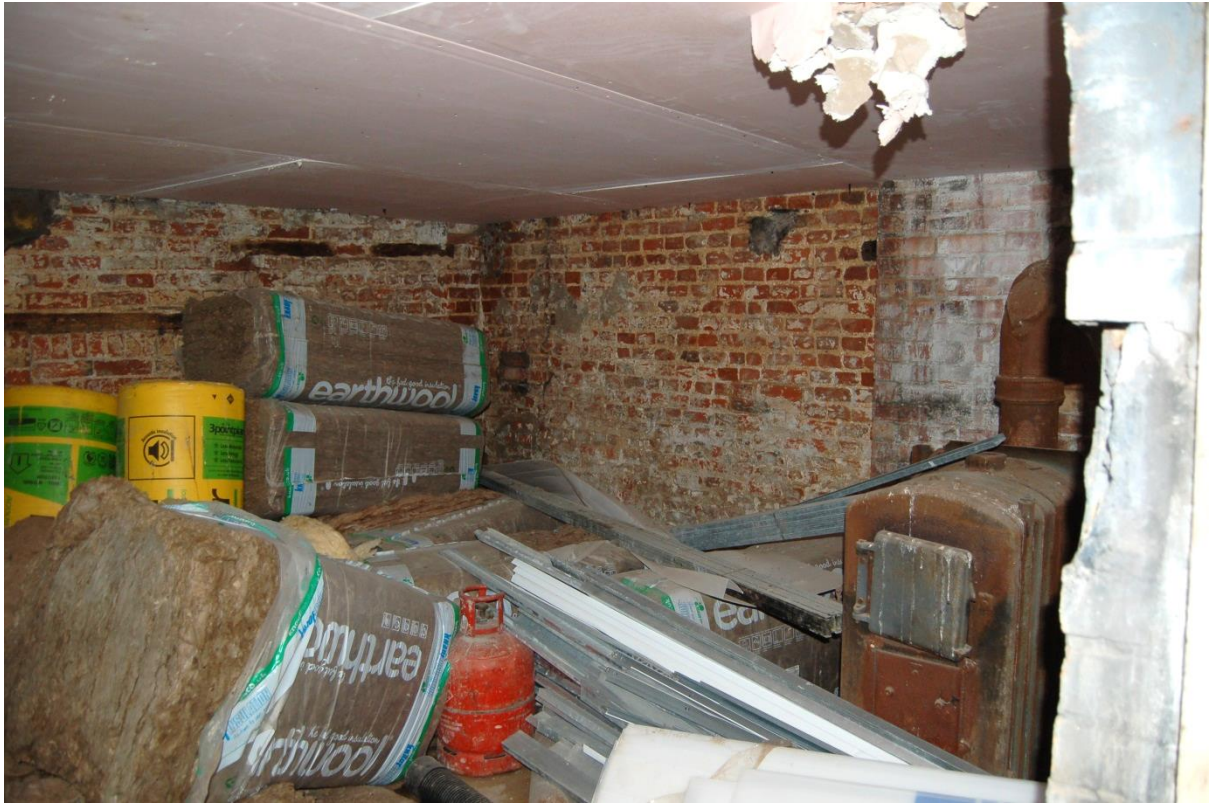
Plate 5 Room G2 viewed to north-west

- 6.4.5 Room G2 (Plate 5) has the same character as Room G1 to which it would have formed one large stabling area. Some interesting features recorded on the west wall were a second tethering ring and a door pintel to a former external doorway on this side) and a large rebuilt area or blocked doorway on the north wall. An old cast iron boiler stands in the south-east corner that used the late Victorian chimney in the north range as a flue (Plate 5, right). No evidence of earlier stairs or ladder entry points were observed in the survey.

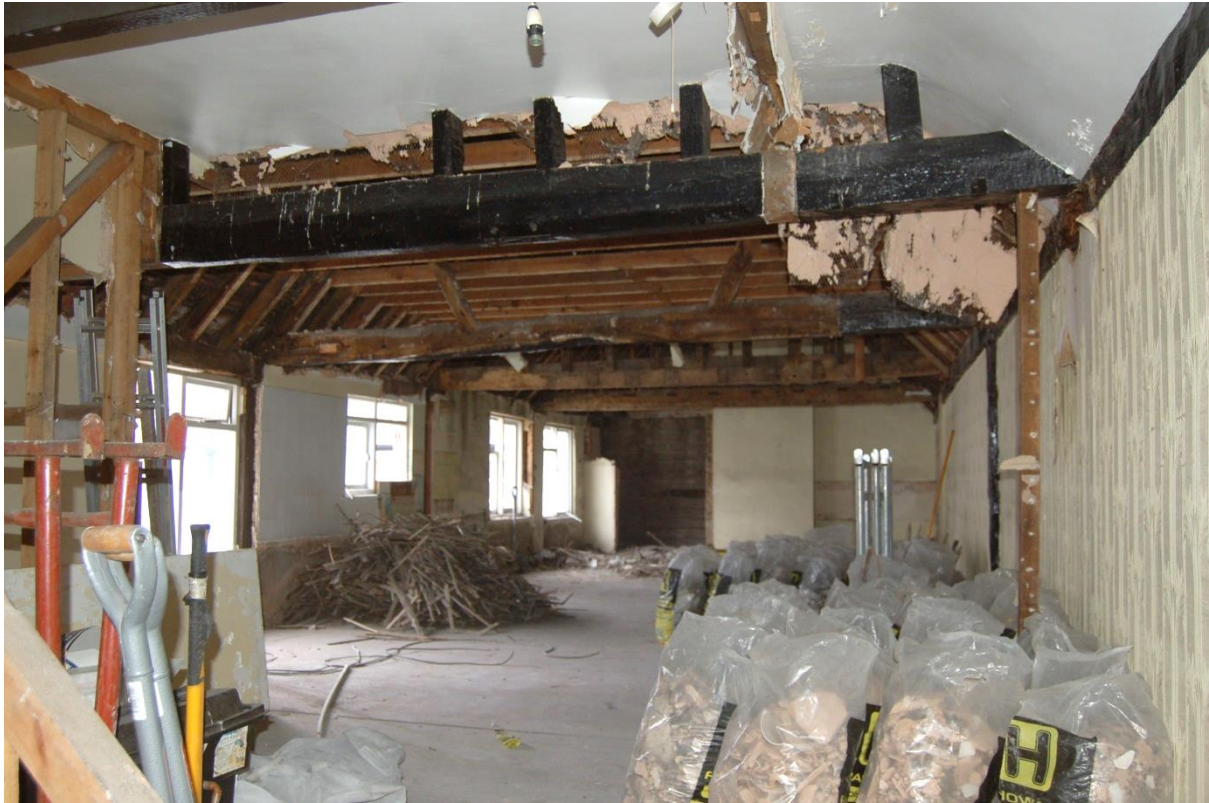
Plate 7 Room F1 viewed to south before stripping-out

- 6.4.7 Prior to the soft strip, the first floor contained a corridor, four rooms and a bathroom, connected from Stairs 3 by a second, short flight of stairs. The floor on all but the northern end is raised by 0.75m, which is 0.25m above the level of the brickwork. This means that only the bottoms of the studs and sill plates at the northern end could be viewed during the survey. Plates 7 and 8 show the first floor shortly after the room partitions were removed and again after the timber-framing on the walls was exposed.

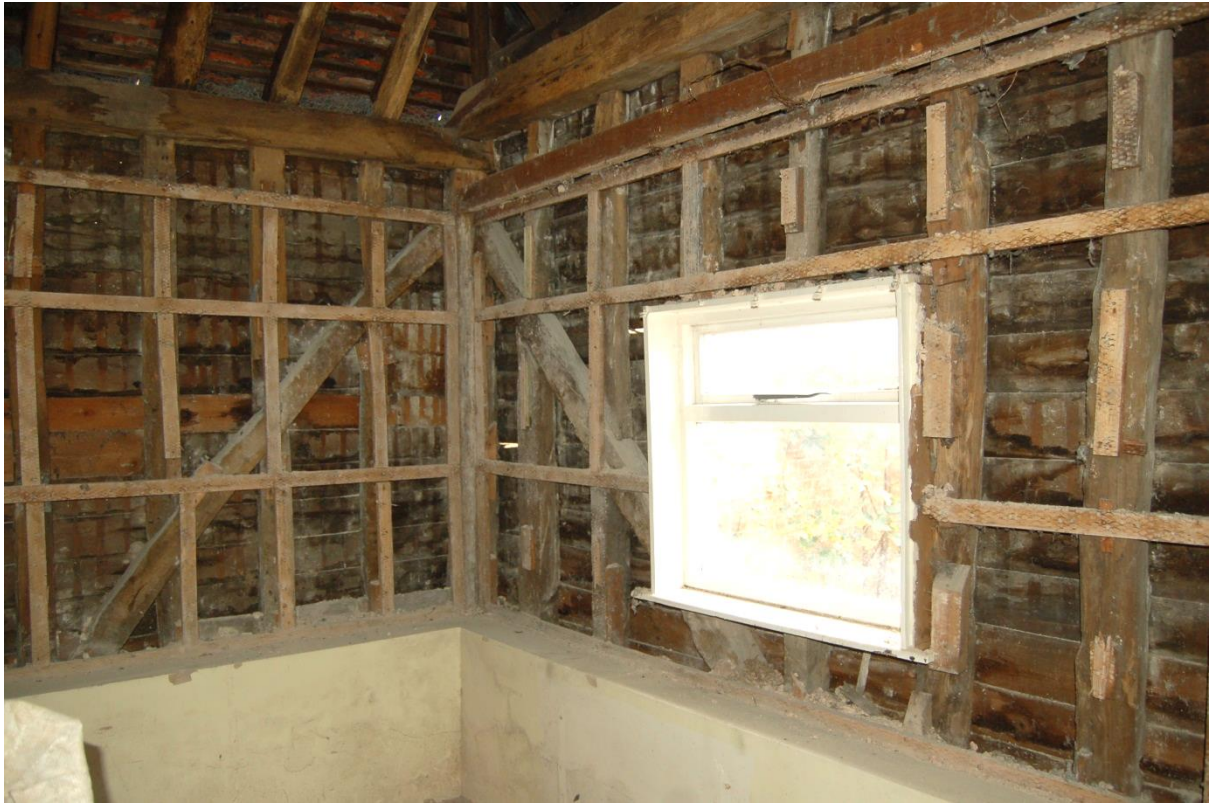
Plate 9 North-west corner of Room F1

Both studs and braces are well-pegged to top and bottom and the corners are primary-braced (Plate 9). There are signs of lime-wash on the timbers.

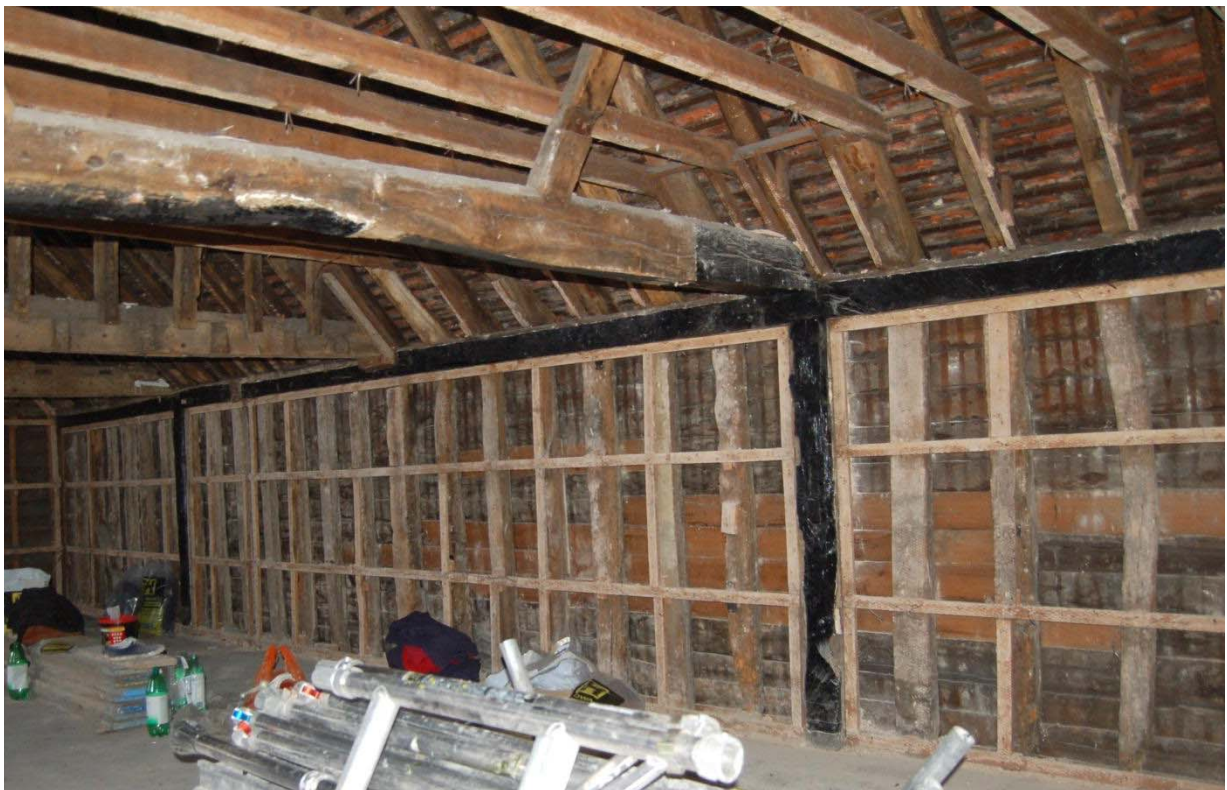
Plate 10 West wall of Room F1

6.4.11 The best-preserved studwork survives along the west wall (Plate 10) and the north end, where the end of the roof was changed from a gabled to a hipped end when Building 2 was changed (Plate 9). The east wall was rebuilt in the late 19th century, or perhaps later when the modern windows were inserted, and therefore contains a majority of machine-sawn timbers.

6.4.13 The roof frame has a nailed collar purlin form (Fig. 6) with additional collars added to some of the intermediate bays. In addition, Truss 3 has queen struts (Plate 10). It is cruder in form than the wall-framing, using narrower, more waney, timbers, more indicative of an 18th century date. Widely-spaced (90mm) nail holes on the rafter soffits suggests the roof was once internally boarded but at another time was clearly lath and plastered.

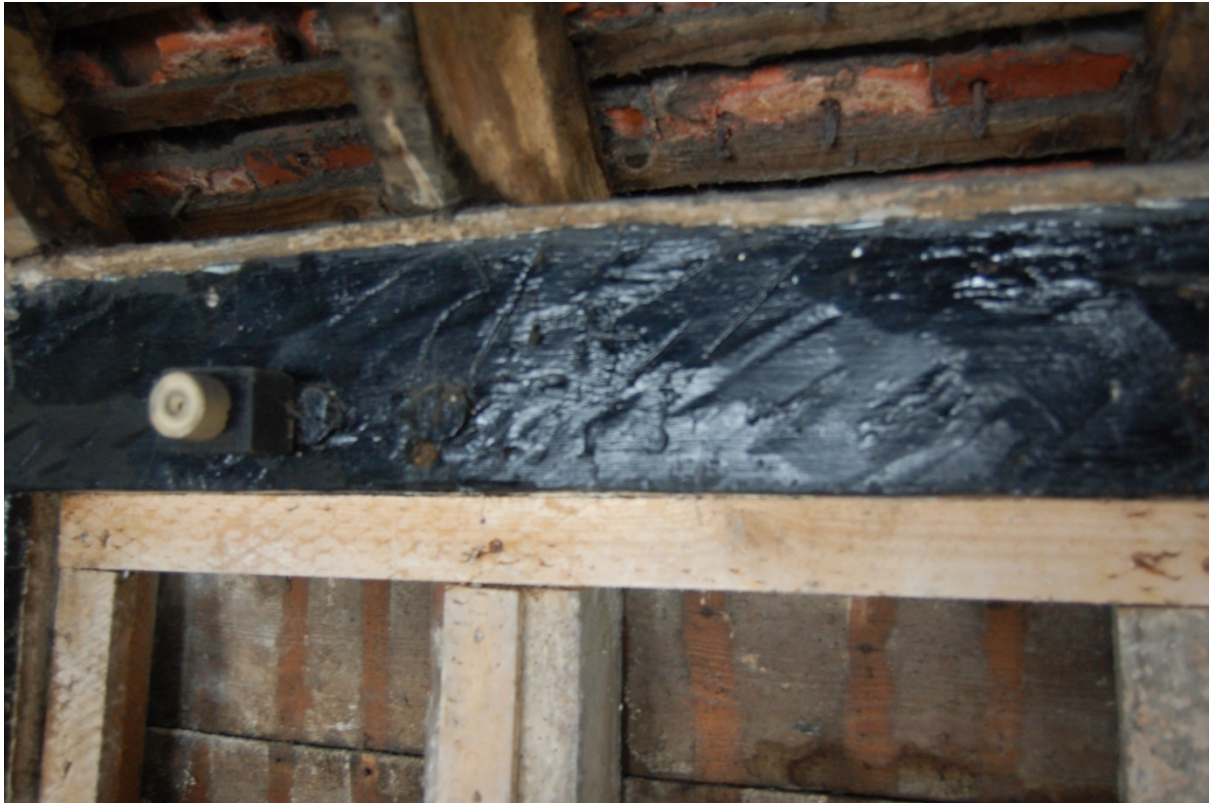
Plate 11 Baltic timber marks

6.4.12 Some of the main timbers are reused from earlier buildings, but a lot of the studwork is original. The wall plates have Baltic timber marks. Baltic oak was imported to eastern ports on the coast of Britain during the late 17th century to make up for the dwindling domestic supply and has conspicuous markings distinct from carpenter's marks (Plate 11). Along the western wall plate in bay 6 are a row of 1-inch peg-holes arranged singularly and in pairs which are difficult to identify but may be former coat pegs (suggesting a communal use for the end room) rather than harness racks for the horses (Plate 12).

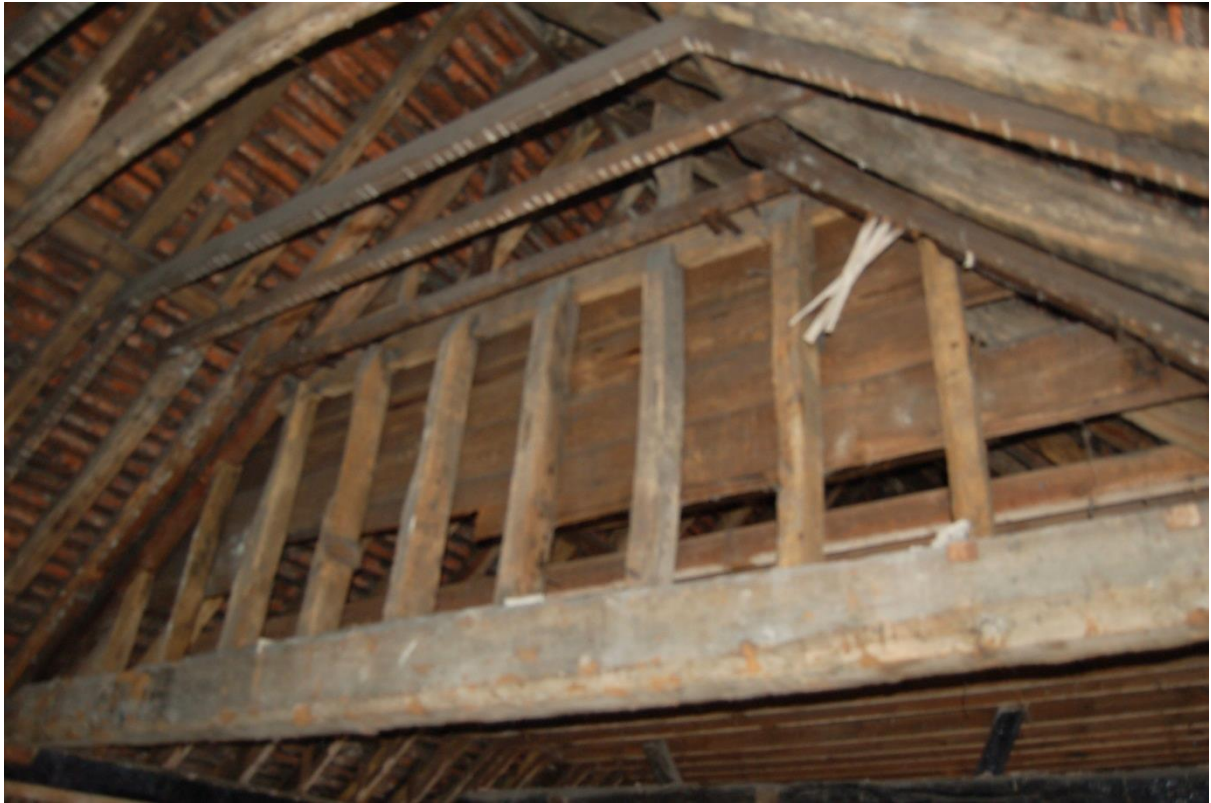
Plate 13 Remains of partition walling in Room F1 (T4), viewed to north

6.4.14 Some evidence of early room partitions was found in the roof space, defining three first floor chambers, which may be later additions since the quality of the studwork is quite crude compared with the wall studding. Both trusses 2 and 4 retain studs that are crudely lapped and nailed to the timbers rather than being tenoned and pegged. Only Truss 4 (T4) is still clad in feather-boarding (Plate 13). Any partitioning below has been removed and left no evidence.

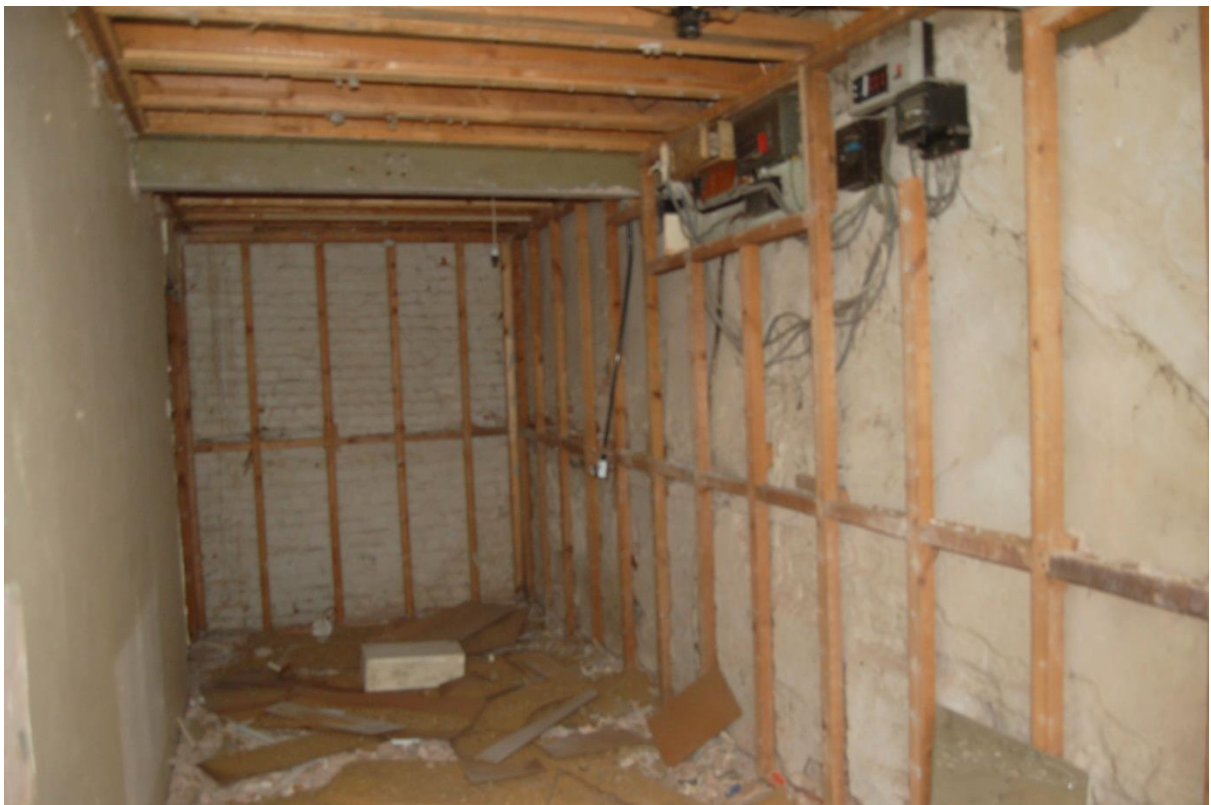
Plate 14 Remains of former stair in Room G5

6.5.1 Like the top floor of the west range, the ground floor of the north range was converted for hotel accommodation in the early 1950s. This was accomplished by dividing the area into four rooms (called A4-A7) and a toilet and shower room, linked by an L-shaped corridor (Fig. 4). The rooms were divided by existing historic brick walls, similar in form to those on the south side of Building 1, and later Fletton brick walls. The original plastered brick walls were lined-out for plaster-boarding, which was removed before the second visit took place (Plate 14). All rooms had tiled floors, carpets and sinks.

- 6.5.3 The only historic features to remain on the ground floor were evidence for a former stair on the east wall and large main floor joists to the upper floor. The stair was represented by a steep diagonal scar in the plaster, which ascended from the front of the building (Plate 14, right), which was interpreted as a former wooden handrail connecting to a since-blocked doorway. The steepness of the scar suggests this was not associated with the reputed horse ramp. Two thick floor joists span the full extent of the largest of the two rooms that in the early phase of the building would either have been propped up with posts or dividing walls. The 190mm by 200mm-wide beams were only visible on the eastern side of the building where the modern ceiling had been removed to expose an earlier plastered ceiling (Plate 15). Unfortunately the nature of the floor joist joinery could not be determined because the sides were obscured by later ceiling joists, but the socket angle suggests it is either more likely to be a soffit tenon joint with diminished haunch, which was common in Hertfordshire either side of 1600 (Gibson 1994) or the more common variation that dates from the 16th century onwards. At the eastern end, it is interesting to note that the beams finish to allow for the stair and the space is now bridged with narrow later joists (Fig. 4).

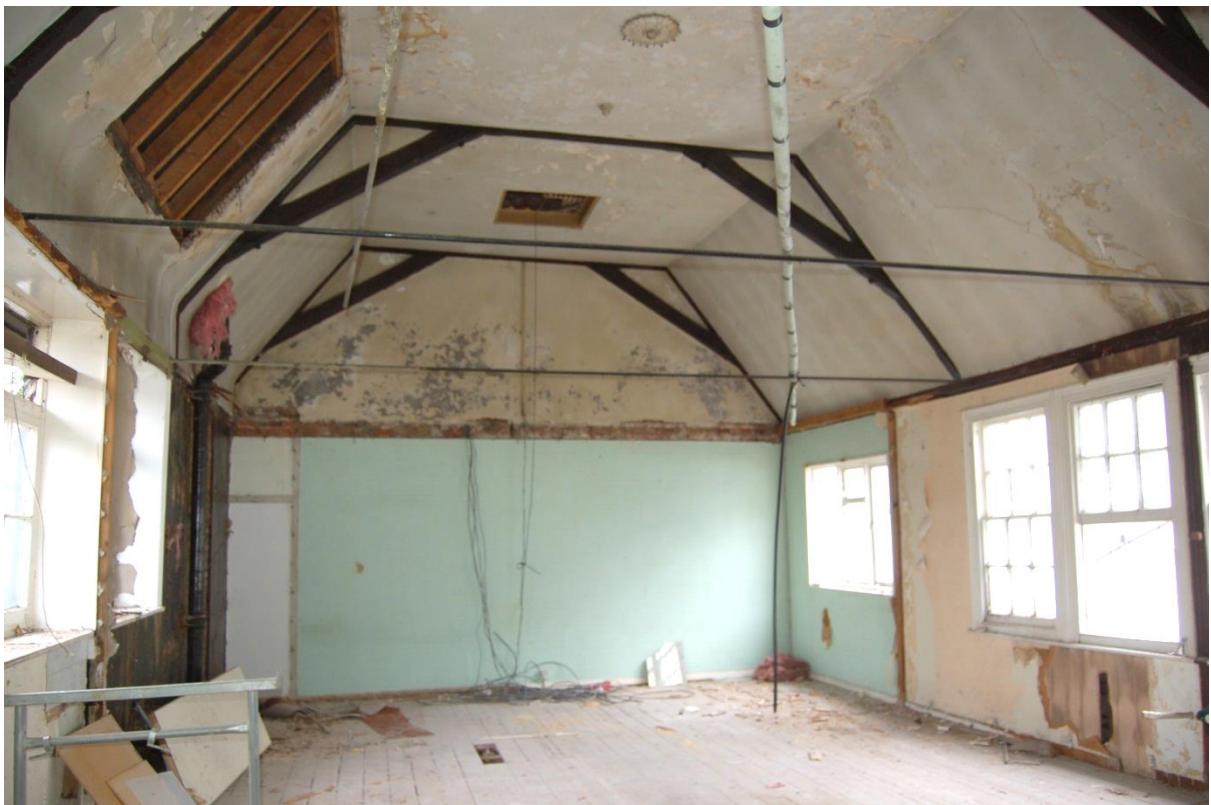
Plate 16 Room F2 viewed to east

- 6.5.5 The first floor hall is built into the eaves and correspondingly has a very high ceiling. It is divided into three 3.5m bays by bolted machine-sawn trusses fitted with diagonal bracing, the upper parts of which were not seen at the early stage (Fig. 6 and Plate 16). The floor comprises 6-inch pine floorboards and the walls have match-boarding of the same width as the floor and in line with the boards (Plate 17), showing good attention to detail. Some of the walls have been boarded-over. The long walls are well-fenestrated with multi-pane tripartite windows, those on the main elevation being of vertical sliding sashes and therefore of higher quality to those on the back, which are fixed in the main part with tilting panes at the top (Plate 17). The only entrance is in the west side, which was reached by the stairs below.

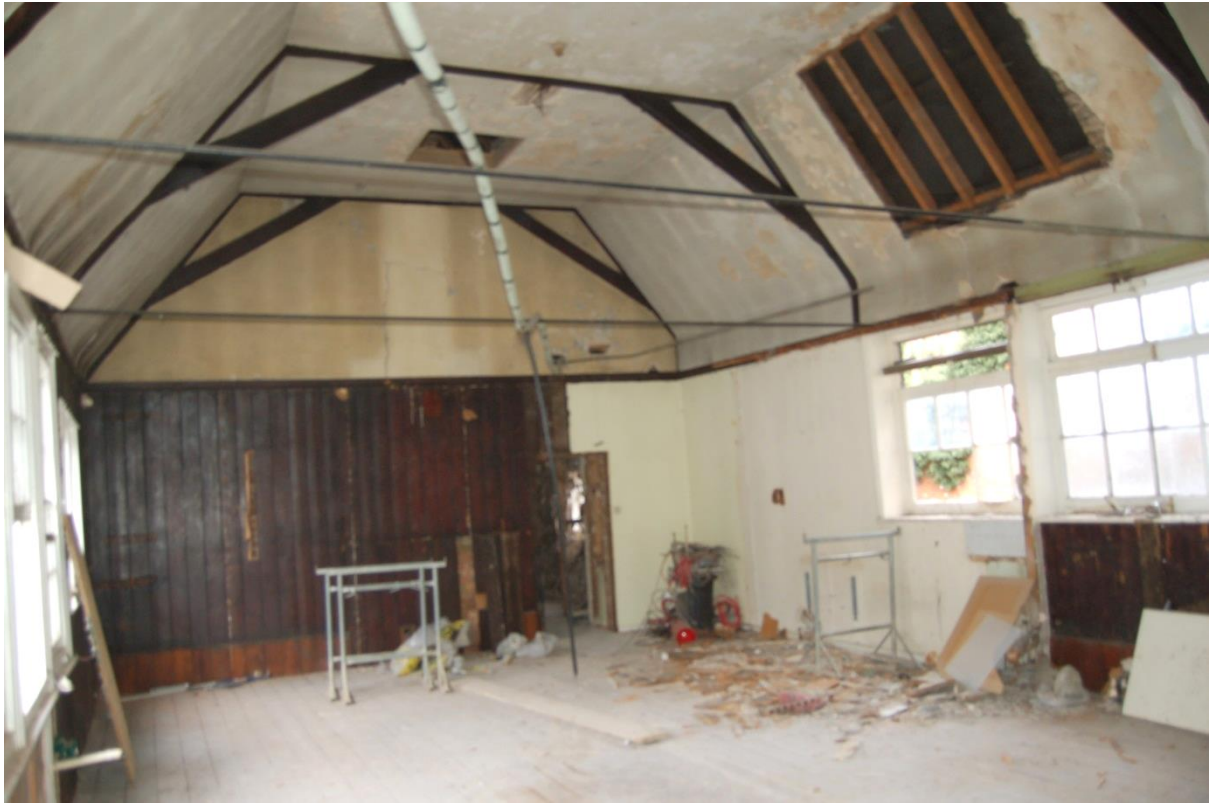
Plate 17 Room F2 viewed to north-west

- 6.5.6 The lath and plaster ceiling survives and within the roof line in the central bay on the north side is an in-filled north-facing window (Plate 17). In the main part of the ceiling are decorated iron roof vents and on the two end bays (Plate 18) and a ceiling rose in the centre perhaps for a gas-lit candelabra (Plate 19). A gas light mantle indicates that there were lights along the front wall as well (Fig. 5).

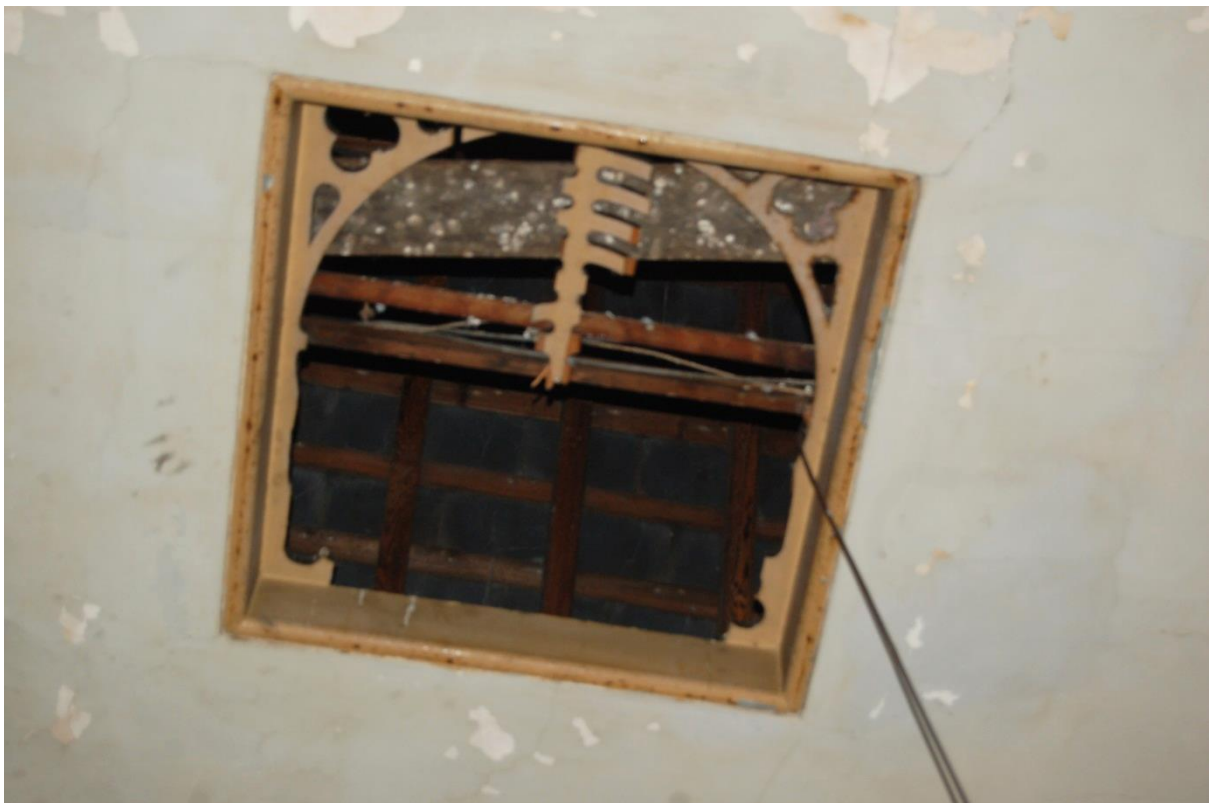
Plate 18 Cast iron ceiling vent

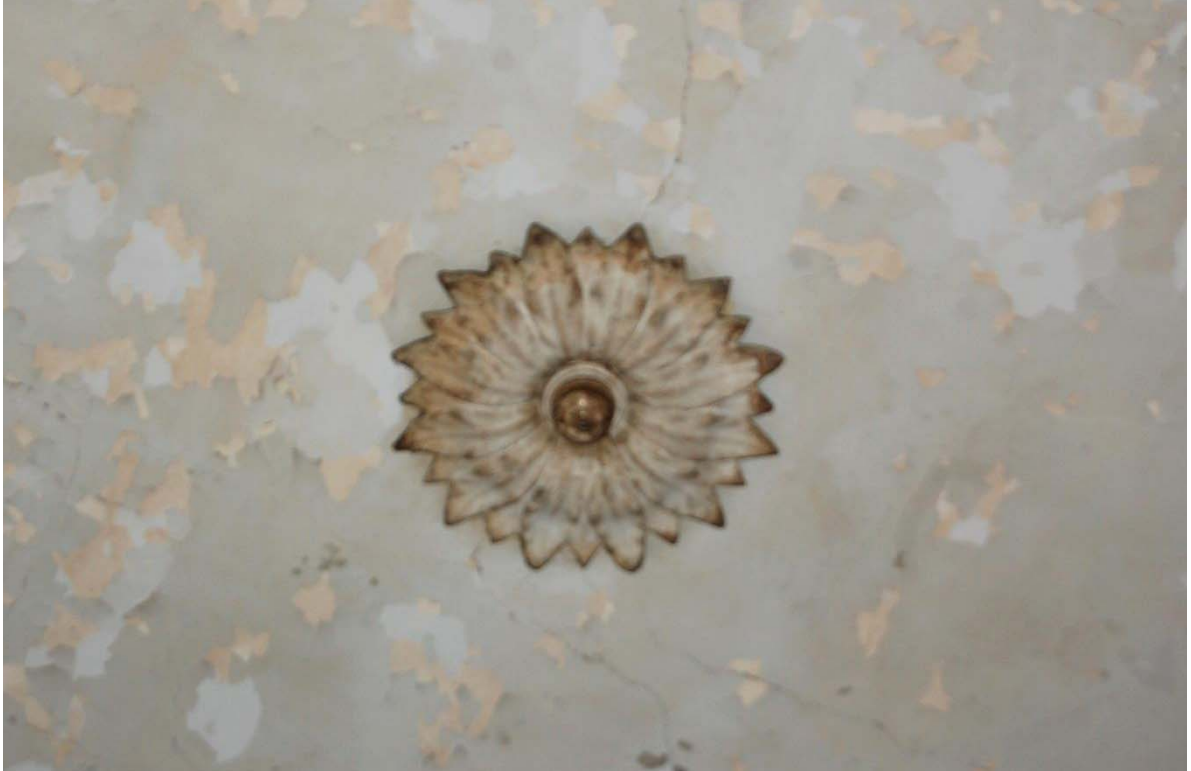
Plate 19 Ceiling rose

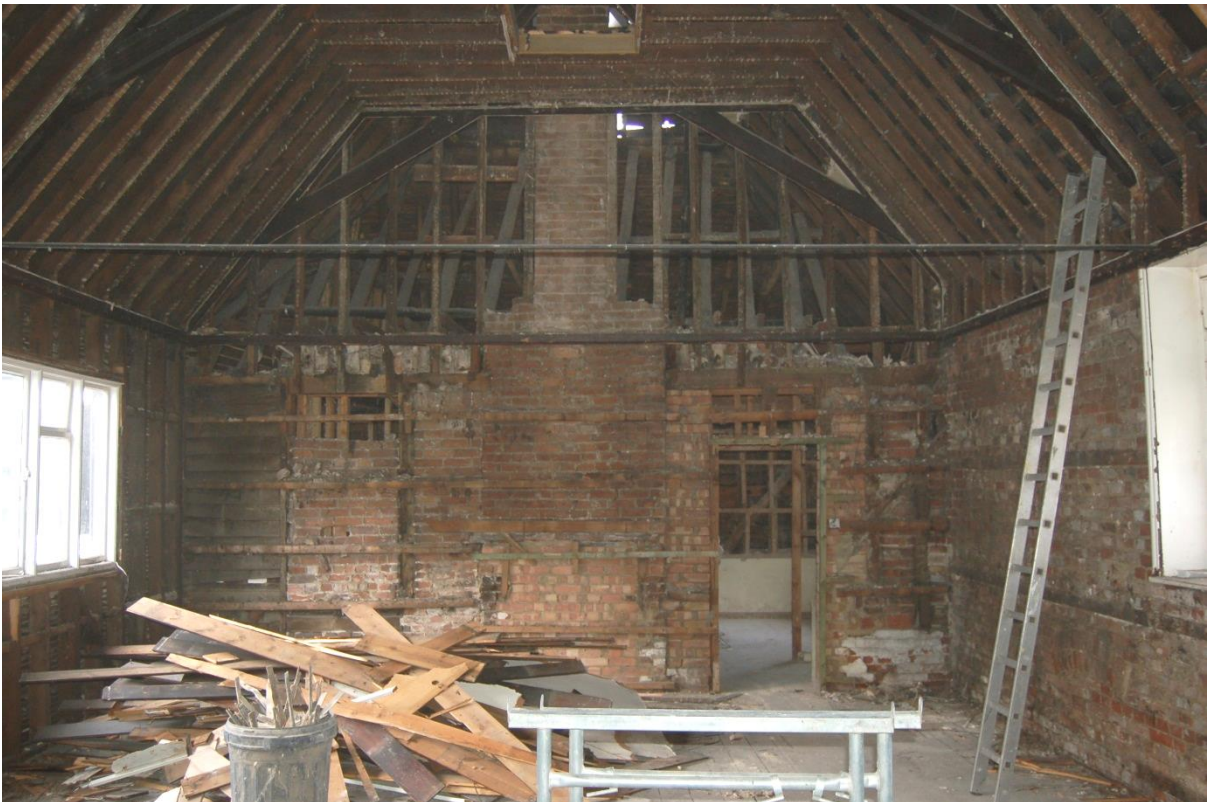
Plate 20 West wall of Room F2 after stripping-out
