**Archaeological Watching Brief and
Historic Building Recording Report
The George Hotel, High Street
Rye, East Sussex**

**ASE Project No: 4127
Site Code: GHR09**

**ASE Report No: 2014144
OASIS id: archaeol6-179114**

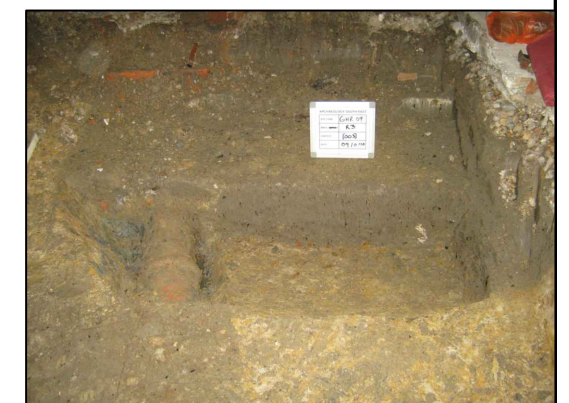
003 looking south-east

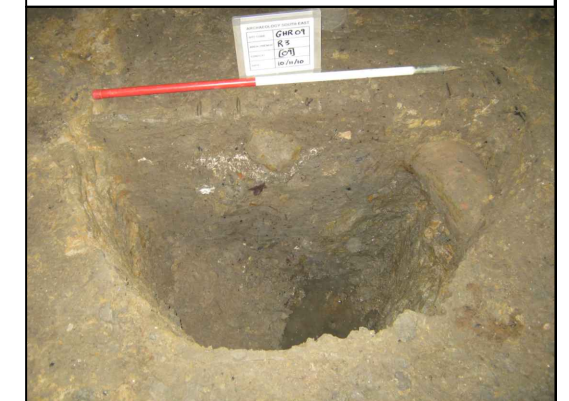
009 looking south-east

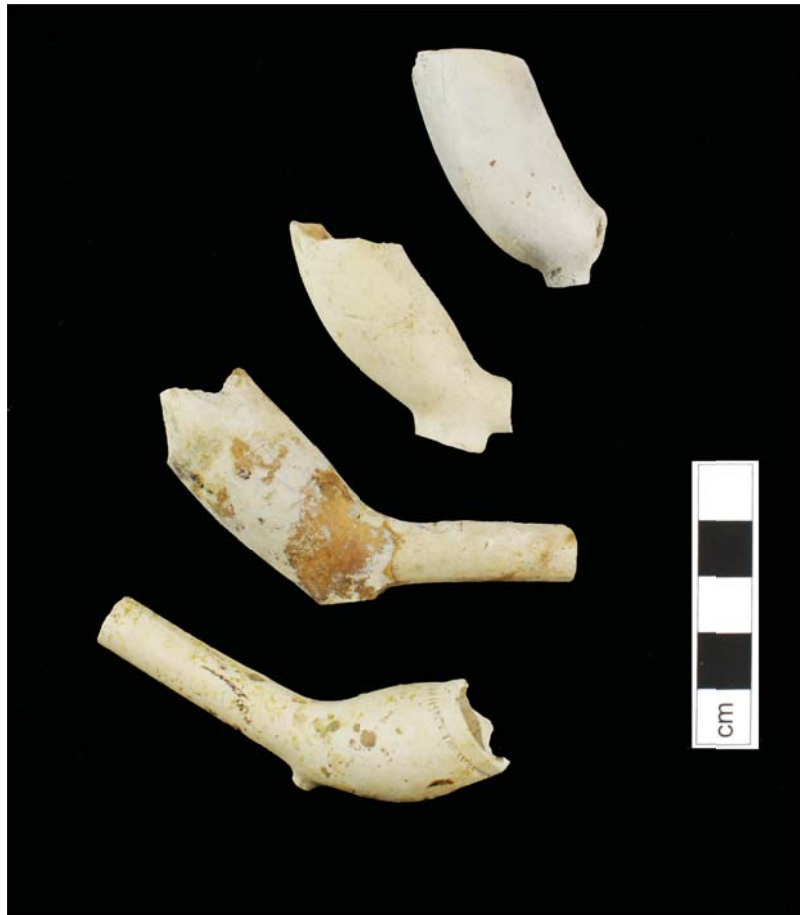
© Archaeology South-East		The George Hotel, Rye	Fig. 10
Project Ref: 4127	May 2014	Photograph of selected clay tobacco pipes and post-medieval glass	
Report Ref: 2014144	Drawn by: FEG

6.4.3 A total of six bowl fragments were found, most of which are near complete. The earliest two are both types AO15 (dated c 1660-80) and were found in [12] and [23]. Three of the long bowls dating to c. 1680-1710 were found in [23], including a type AO20 and 21. Finally, the same context also contained an OS12 (c 1730-80). The latter contained maker's marks moulded in relief on the heel sides and consisting of a rosette followed either by H or by I (*?H or *?I). The maker cannot be identified.

6.5.1 A small assemblage of eight glass fragments weighing 54g was found across four individually numbered contexts, (selected fragments photographed in Figure 10). The earliest pieces comprise colourless window glass ([23] and [63]), both pieces of which date to the 17th- to 18th-century. The fragment from [63] retains a straight cut edge. A shaft and globe bottle body fragment from [23] is of mid 17th- to mid 18th-century date. Later material includes a wine bottle fragments as well as a colourless cylindrical bottle fragment, both from [23] and both dating to c 1750-1850. The remaining three pieces all date to the mid 19th to early 20th century and include an undiagnostic piece, probably from a cylindrical bottle, with etched decoration from [4], an opaque white lid fragment with plain knob from [23] and a green glass wine bottle fragment from [48].
