**New Pumping Station  
Gilden Way  
Harlow  
Essex  
Archaeological Monitoring**

**Project No: 8113  
Site Code: HAGWS 13**

**Report No: 2014171**

**May 2014**

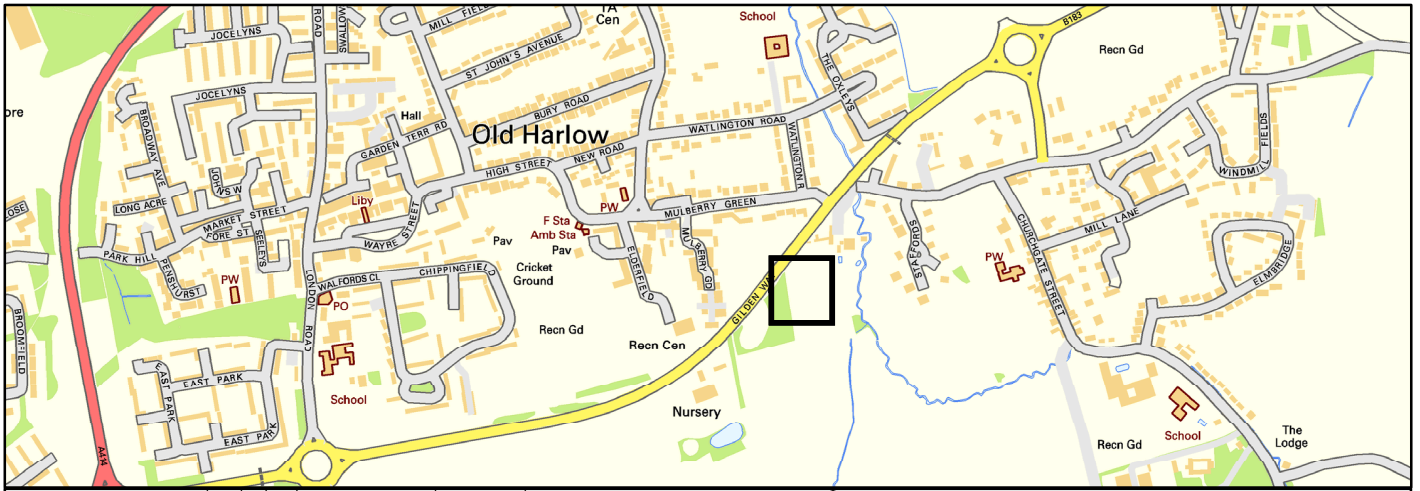
© Archaeology South-East		Gilden Way, Harlow		Fig. 1
Project Ref: 8113	May 2014	Site location and area of archaeological investigations		
Report Ref: 2014171	Drawn by: APL

- 4.1.1 The results are detailed below following the process of excavation beginning with the access road and finishing with the main strip. A 0.30m-0.40m thick layer of dark brown sandy clay ploughsoil [07] and a thin light brown subsoil layer [01] were stripped to reveal the two features that were cut into a yellowish-orange sandy clay natural soil, which was consistent across the site. All features are located on Figure 1 and described below.

1.1.2 The site occupies an area of 1500sqm located immediately to the south of Gilden Way, southeast of the historic core of Old Harlow and west of the former Churchgate Street village (Fig. 1; NGR: TL 47956 11413).

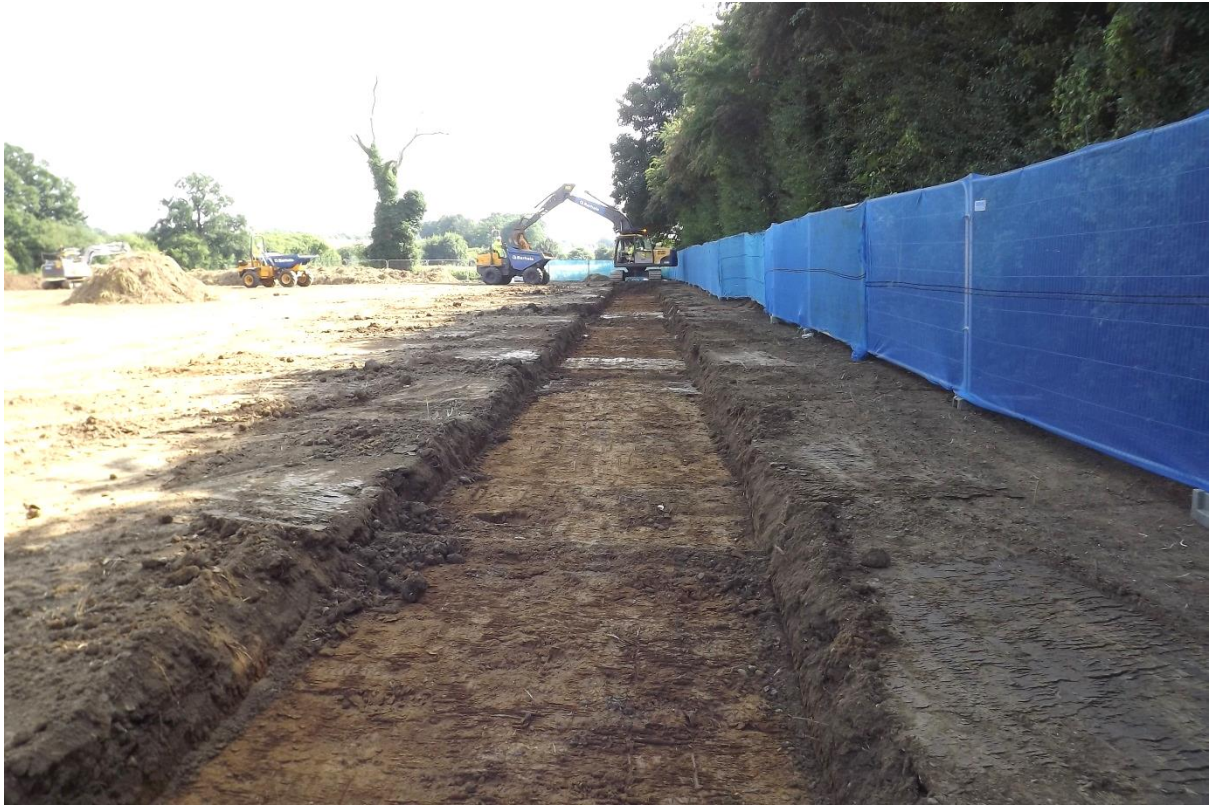
Figure 2: Excavation of access road, viewed to south

- 3.1.1 At the start of the work the area for the new access road was excavated along the southern edge of the site (Fig. 2). This was followed by stripping at the north end for a car park and the southwest corner for the site compound. The main area was then stripped, leaving a temporary access road in the middle that was reduced after the access road had been built (Fig. 4).

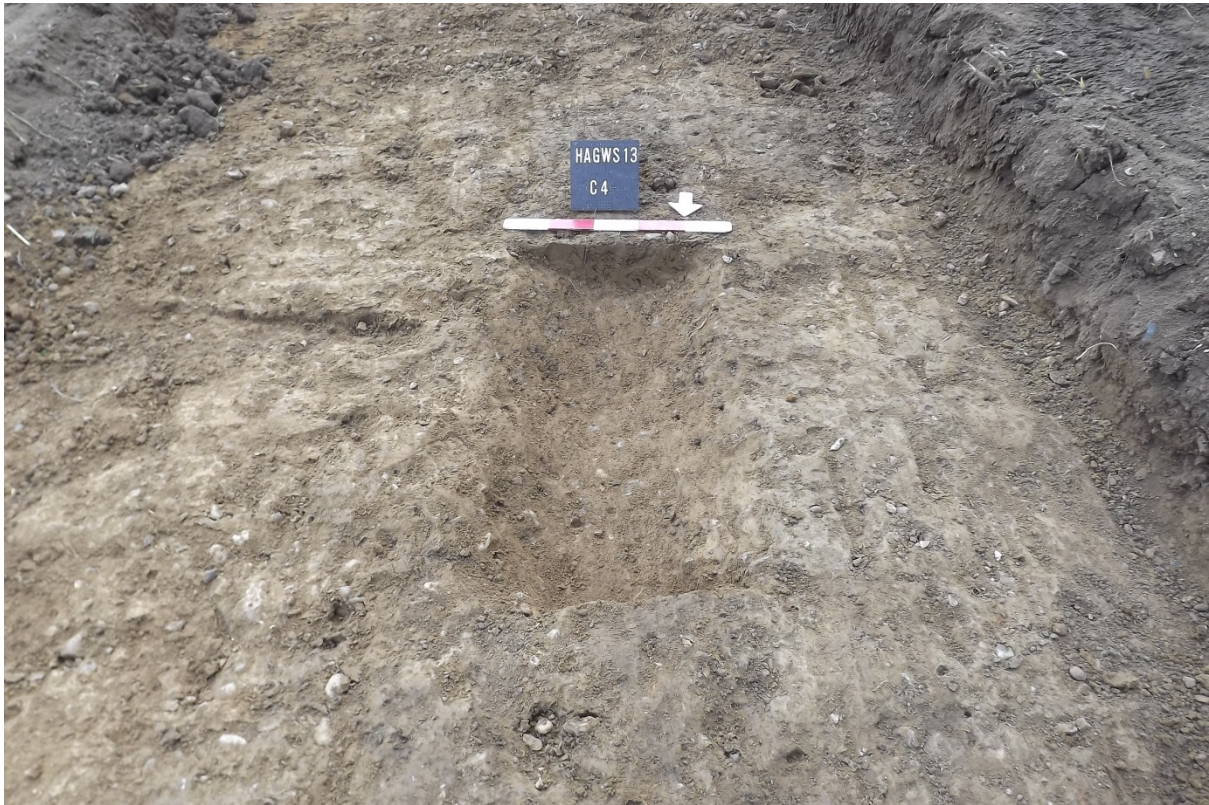
Figure 3: Feature [04] viewed to south

4.2.1 An undated linear feature was excavated along the route of the access road and interpreted as shallow gully or plough scar [03]. The feature was orientated NNE to SSW and over 9.5m long, 0.43m wide and 0.11m deep (Fig. 3). It had a single dark brown sandy clay fill (context [04]) and a concave base and may represent the remains of the former western field boundary. No cultural debris was recorded in the fill and no finds were collected.

5.1.3 Two features were excavated during the topsoil strip. The more significant of these is a possible gully that extends for over 9m along the line of the new access road on the western side of the site. In excavation it was interpreted as a possible plough scar, but its reasonable depth and profile suggests it may be the base of a former field boundary ditch that runs parallel to the existing boundary. Unfortunately no dating evidence was recovered. A small oval pit was found on the western side of the site. This too was undatable and the irregular nature of the cut suggests it is either prehistoric in date or a geological feature.

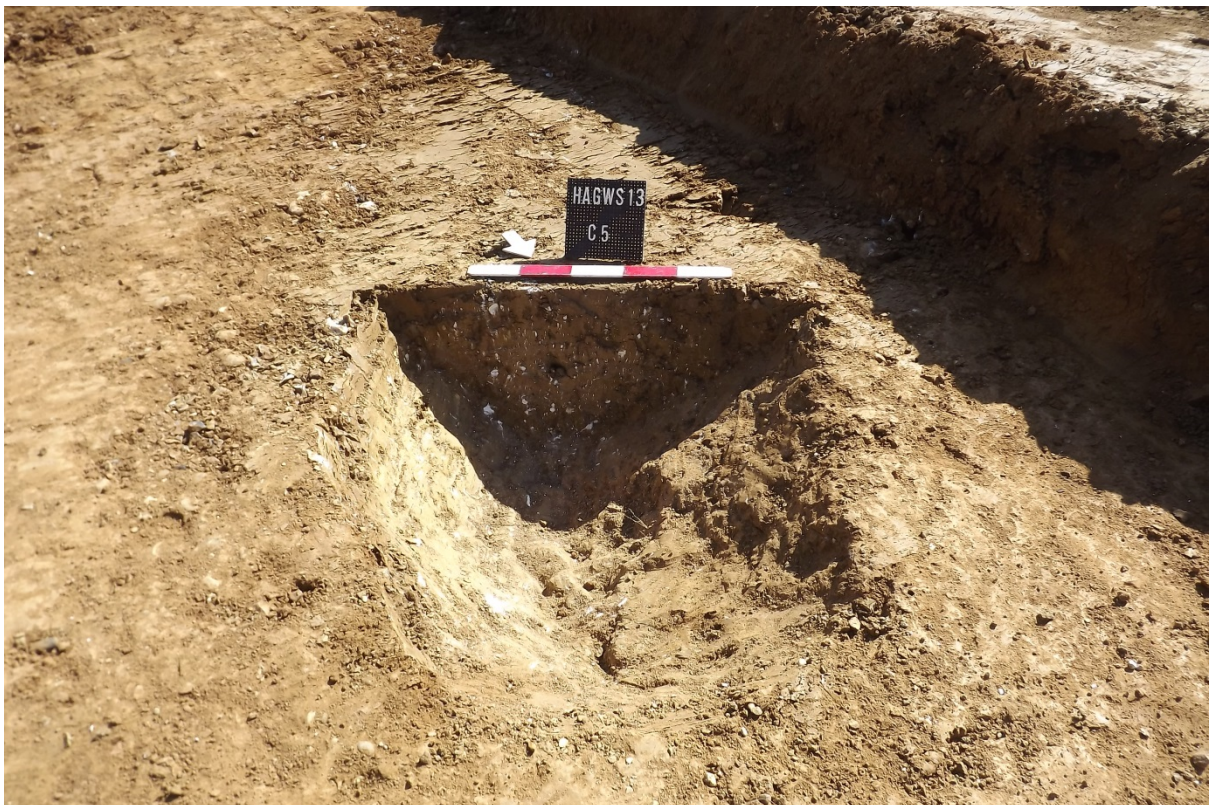
Figure 5: Feature [05] viewed to south

4.3.1 A short oval-shaped feature was excavated towards the eastern edge of the main area and was interpreted as either an elongated pit or else a small geological feature. The cut (context [05]) was orientated in a similar way to feature [03] and measured 2.1m by 0.82m (Fig. 5). It was 0.32m deep and had a single dark brown sandy clay fill (context [06]) and a concave base. Again, there were no finds or other cultural material in the fill.
