**Archaeological Watching Brief Report
Tortington Priory Barn, Arundel
West Sussex**

**ASE Project No: 6644
Site Code: TPF14**

**ASE Report No: 2014167
OASIS id: archaeol6-179490**

Archaeology South-East was commissioned by Dr Catherine Watts to undertake an archaeological watching brief at Tortington Priory Barn, Priory Lane, Arundel, West Sussex during repairs to an existing water main. No archaeological remains were encountered during the ground works and only previously disturbed deposits (by the existing pipeline) were excavated.

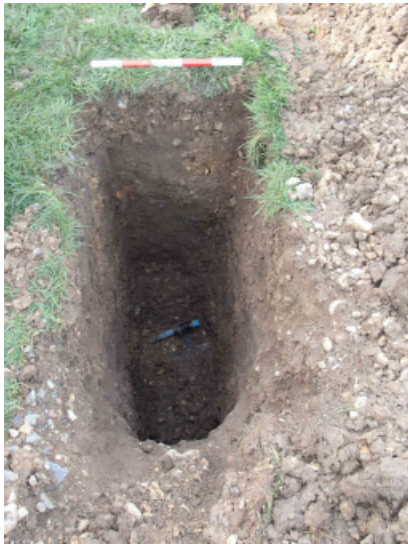
Test pit 1

4.1.1 A 1.2m by 0.7m test pit was excavated through the backfill of an existing pipe trench. Undisturbed stratigraphy was noted of the exposed sections. The natural (1/003), a dark brown silty clay, was overlain by a thin subsoil (1/002), a dark greyish brown silty clay, which was overlain in turn by a dark brown silty clay topsoil (1/001).

4.1.2 No archaeological finds, features or deposits were identified.

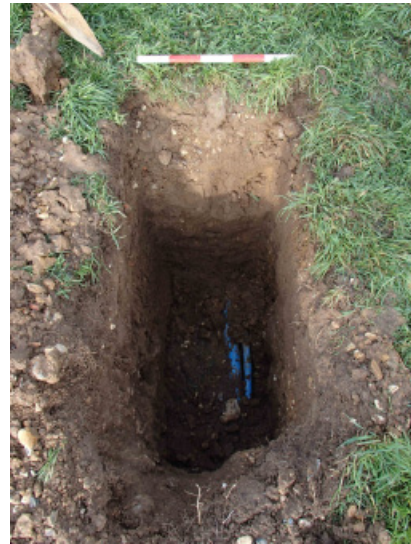
Test pit 2

4.2.1 A 1.2m by 0.6m test pit was excavated through the backfill of an existing pipe trench. Undisturbed stratigraphy was noted of the exposed sections. The natural (2/003), a dark brown silty clay, was overlain by made ground (2/002), which was overlain in turn by a dark brown silty clay topsoil (2/001).

4.2.2 No archaeological finds, features or deposits were identified.

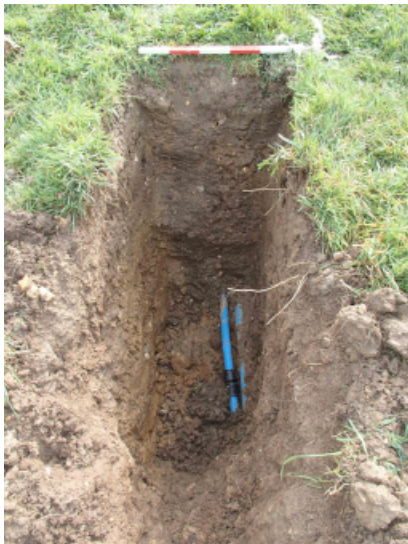
Test pit 3

4.3.1 A 1.4m by 0.7m test pit was excavated through the backfill of an existing pipe trench. Undisturbed stratigraphy was noted of the exposed sections. The natural (3/003), a dark brown silty clay, was overlain by made ground (3/002), which was overlain in turn by a dark brown silty clay topsoil (3/001).

4.3.2 No archaeological finds, features or deposits were identified.

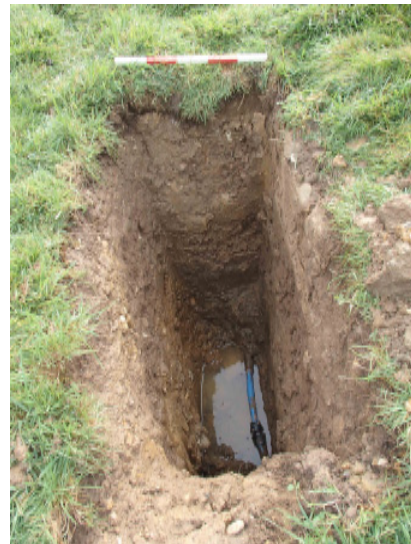
Test pit 4

4.4.1 A 1.2m by 0.6m test pit was excavated through the backfill of an existing pipe trench. Undisturbed stratigraphy was noted of the exposed sections. The natural (4/003), a dark brown silty clay, was overlain by made ground (4/002), which was overlain in turn by a dark brown silty clay topsoil (4/001).

4.4.2 No archaeological finds, features or deposits were identified.

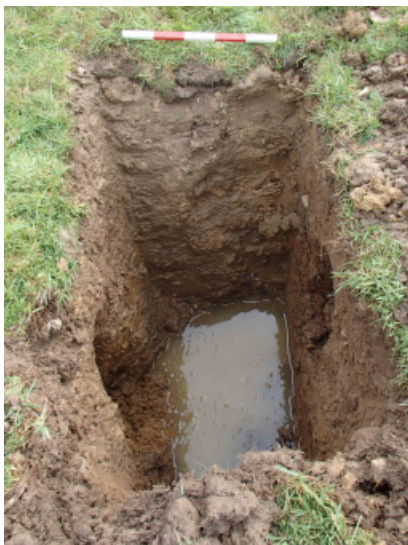
Test pit 5

4.5.1 A 1.3m by 0.7m test pit was excavated through the backfill of an existing pipe trench. Undisturbed stratigraphy was noted of the exposed sections. The natural (5/003), a dark brown silty clay, was overlain by made ground (5/002), which was overlain in turn by a dark brown silty clay topsoil (5/001).

4.5.2 No archaeological finds, features or deposits were identified.

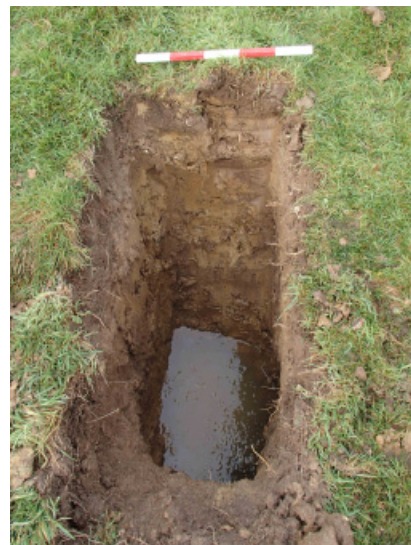
Test pit 6

4.6.1 A 1.2m by 0.6m test pit was excavated through the backfill of an existing pipe trench. Undisturbed stratigraphy was noted of the exposed sections. A possible natural (6/003), was not observed due to water inundation, was overlain by made ground (6/002), which was overlain in turn by a dark brown silty clay topsoil (6/001).

4.6.2 No archaeological finds, features or deposits were identified.

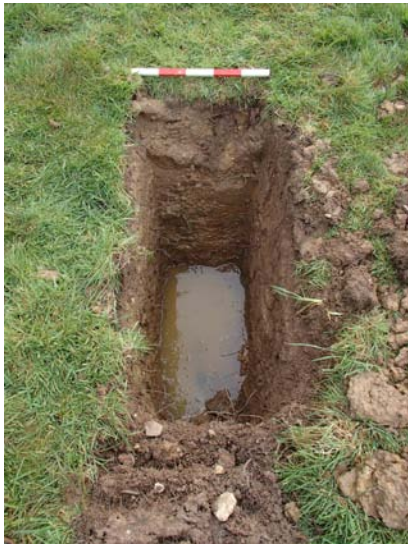
Test pit 7

4.7.1 A 1.3m by 0.6m test pit was excavated through the backfill of an existing pipe trench. Undisturbed stratigraphy was noted of the exposed sections. The natural (7/003), a dark brown silty clay, was overlain by made ground (7/002), which was overlain in turn by a dark brown silty clay topsoil (7/001).

4.7.2 No archaeological finds, features or deposits were identified.

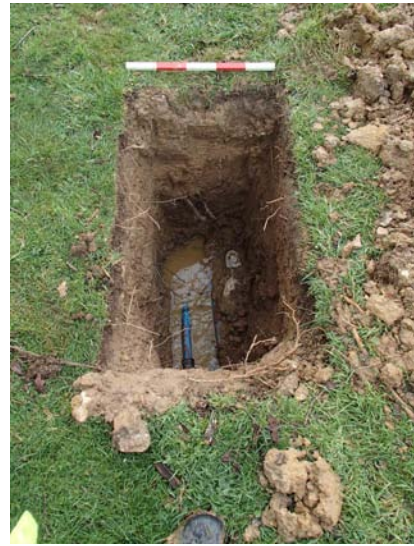
Test pit 8

4.8.1 A 1.0m by 0.6m test pit was excavated through the backfill of an existing pipe trench. Undisturbed stratigraphy was noted of the exposed sections. The natural (8/003), a dark brown silty clay, was overlain by made ground (8/002), which was overlain in turn by a dark brown silty clay topsoil (8/001).

4.8.2 No archaeological finds, features or deposits were identified.

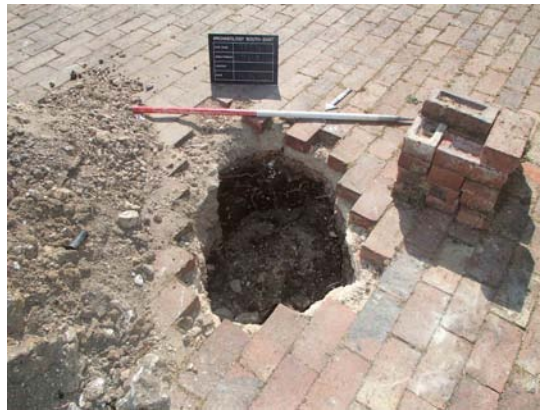
Test pit 9

4.9.1 A 0.7m by 0.5m test pit was excavated through the backfill of an existing pipe trench. Undisturbed stratigraphy was noted of the exposed sections. The natural (9/004), a mid greyish brown silty clay, was overlain by made ground (9/003), which was overlain in turn by paving (9/001) and its corresponding type 1 sub base (9/002).

4.9.2 No archaeological finds, features or deposits were identified.
