**Archaeological Evaluation Report  
The Martlets , Sea Road, East Preston  
West Sussex**

**ASE Project No: 6765  
Site Code: BN16 1JP**

**ASE Report No: 2014183  
OASIS id: archaeol6-180409**

**June 2014**

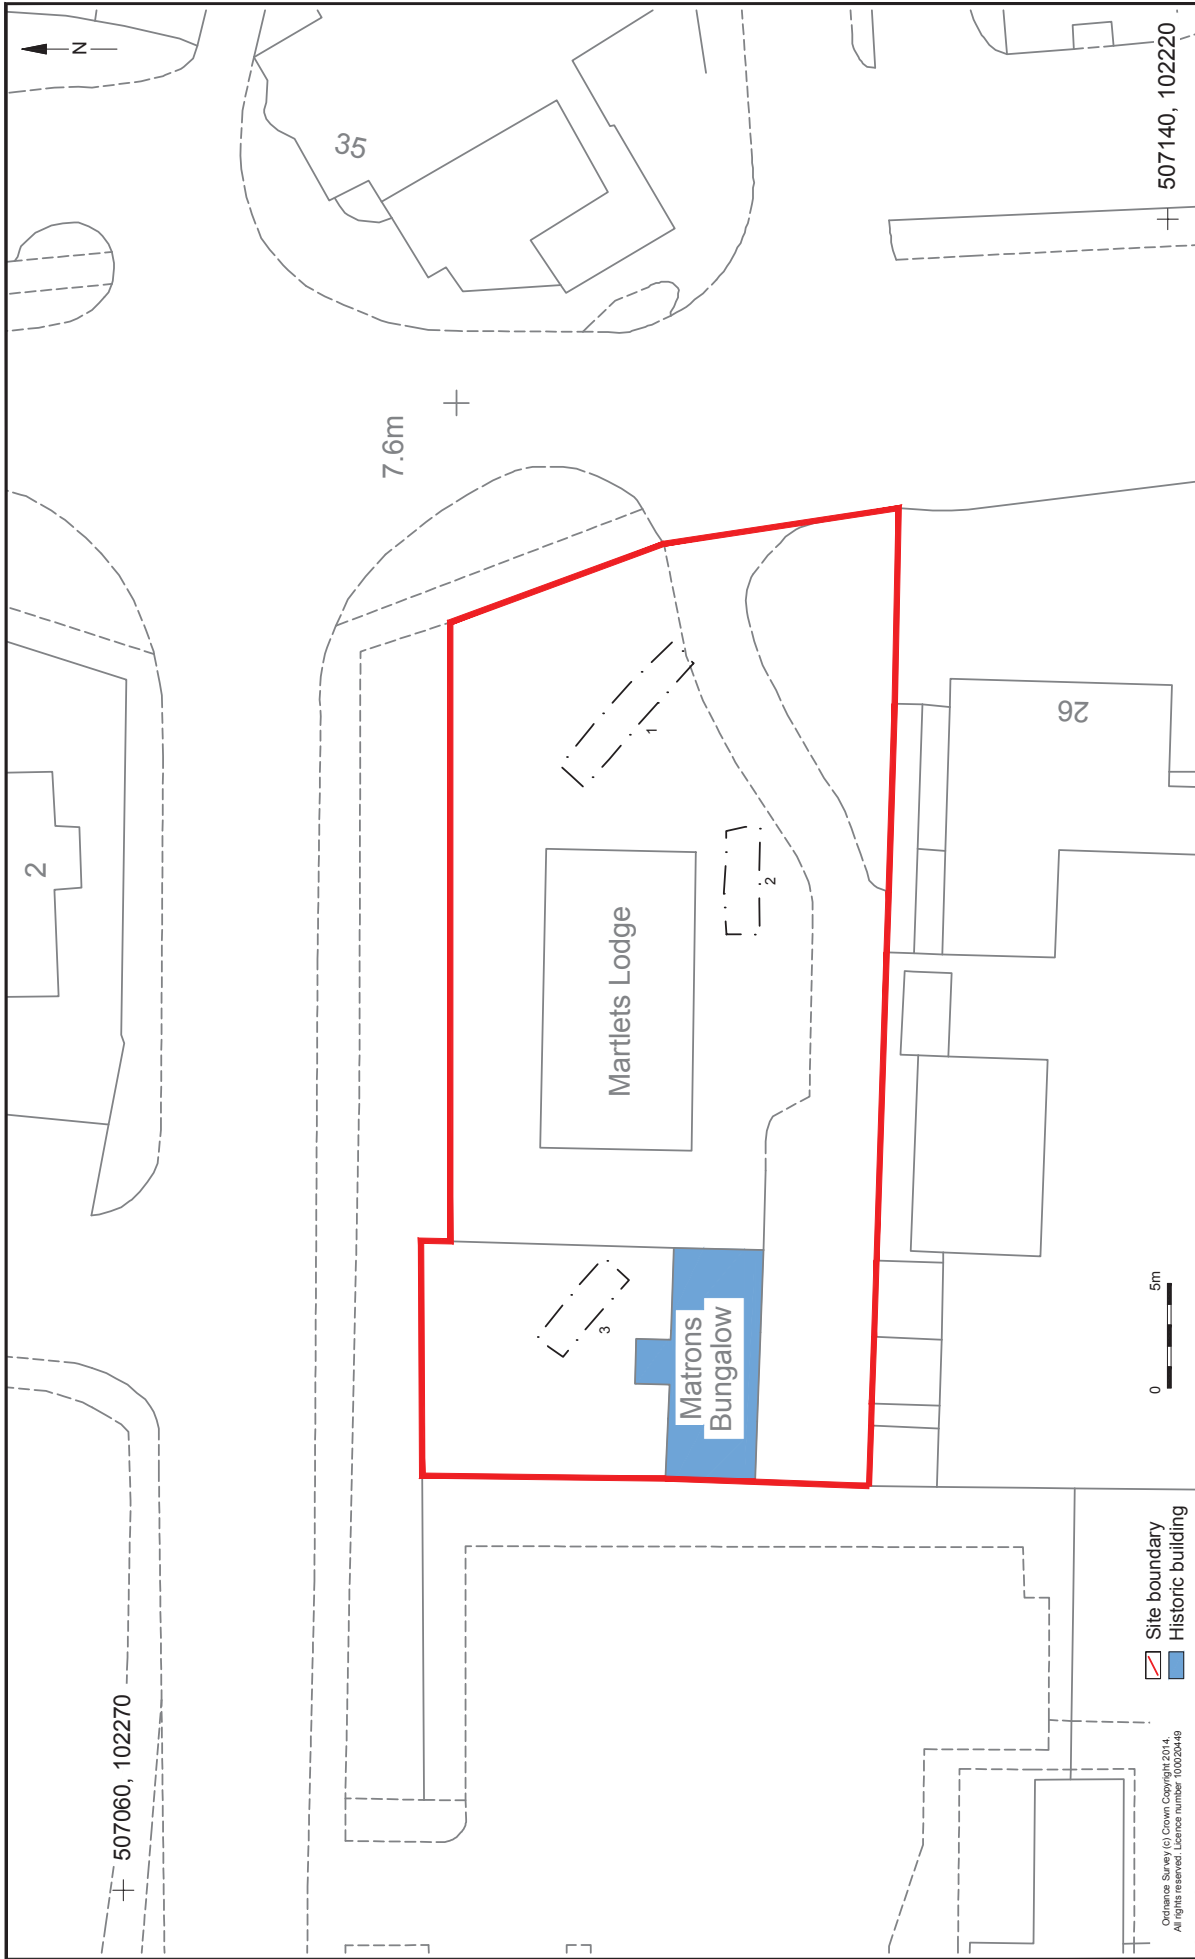
Fig. 2

- 3.1.1 The archaeological evaluation comprised the machine excavation under archaeological supervision of 3 archaeological trial trenches in a predetermined pattern within the footprint of the proposed buildings, as set out in the WSI (ASE 2014). Two trenches measured 5m by 1.50m and one measured 7.5m by 1.50m. The trench locations were surveyed after excavation using a Digital Global Positioning System (DGPS) in order to accurately determine their location. (Figure 2)

© Archaeology South-East		The Martlets, East Preston	
Project Ref: 6765	June 2014	Evaluation trench location	
Report Ref: 2014183	Drawn by: RHC

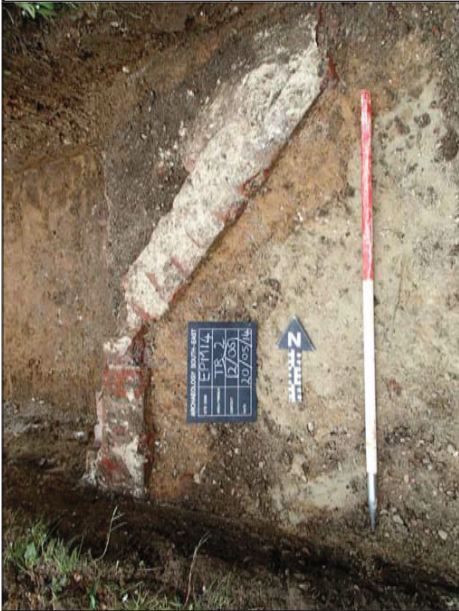
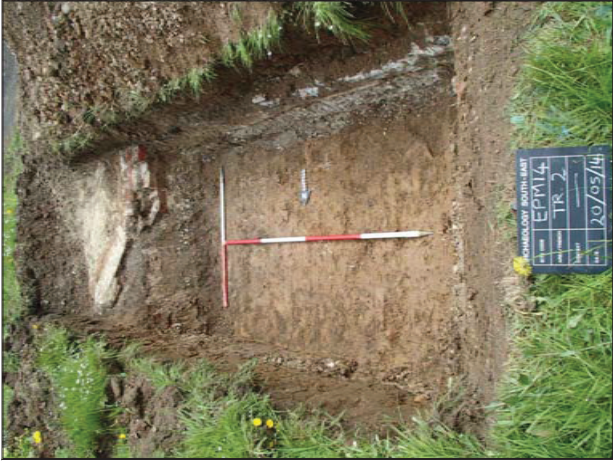
Fig. 3

4.1.3 In the east end of Trench 2 the geology was immediately overlain by a concrete foundation [2/10] measuring a thickness of 0.26m and extending beyond the northern and southern limits of the Trench. It was also identified in the north facing section of Trench 2, extending across 3m of the trench. Although a cut number [2/05] was assigned to this feature, excavation in section revealed the concrete to be immediately overlying the clay, rather than truncating it.

4.1.4 The concrete foundation [2/10] was immediately overlain by a wall [2/06] oriented northeast-southwest and north-south, with a 45° angle in the middle. Both ends of the wall extended beyond the limit of the excavation. The northeast-southwest part of the wall measured a length of >1.30 by a width of 0.45m. The north-south part of the wall measured a length of >0.58m by a width of 0.65m. The wall comprised 3 courses of shallow frogged red bricks bonded by yellowish white sandy mortar. The wall probably relates to the foundations for the large bay window embrasure visible on the left hand side of the front door in the photo of 'Lorne Villa' (c. 1909) at the back of this report. 'Lorne Villa' is shown in the location of Trench 2 on the 1870 OS map of East Preston (not illustrated in this report). The 1930s OS map also shows Lorne Villa but it is missing from the 1960s map, suggesting that it was demolished at some point between 1930 and 1960.

Wall [2/006] looking west

Trench 2 looking east

Trench 2 plan and photographs

5.3.1 A single wall [2/06] was identified in Trench 2, oriented northeast-southwest and north-south, with a 45° angle in the middle. The wall comprised 3 courses of shallow frogged red bricks bonded by yellowish white sandy mortar. The wall probably relates to the left-hand side bay window of 'Lorne Villa,' (see photograph at the rear of this report) demolished sometime before the 1960s.

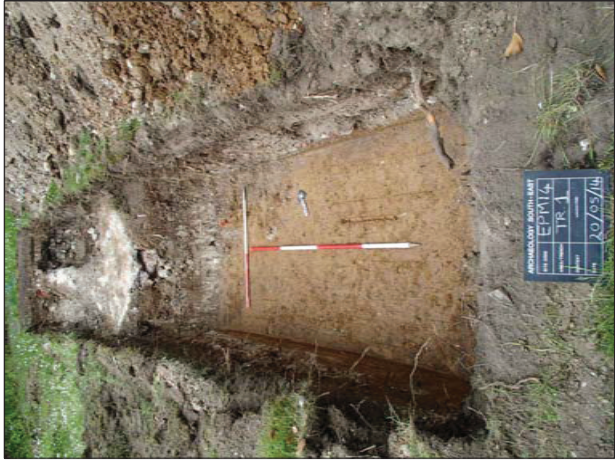
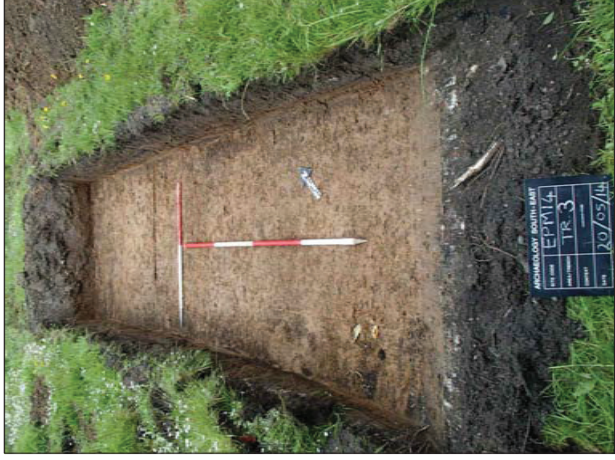
Fig. 4

- 4.2.1 The geology was encountered at 6.84m AOD in Trench 1 and 7.69m AOD in Trench 3. No archaeological finds or features were encountered within these trenches.
- 4.2.3 In Trench 1 the natural was immediately overlain by a layer of chalky silt [1/03] measuring a thickness of 0.26m. This was overlain by another layer of made ground [1/02] comprised of sandy clay.
- 4.2.4 In Trench 3 the natural was overlain by a single layer of made ground [3/02] which measured a thickness of 0.31m and comprised silty clay containing frequent CBM, concrete and brick inclusions.
- 4.2.5 Both trenches were sealed by a layer of topsoil measuring a thickness of 0.17m.

Trench 1 looking north-west

Trench 3 looking north-west

Trench 1 and 3 photographs

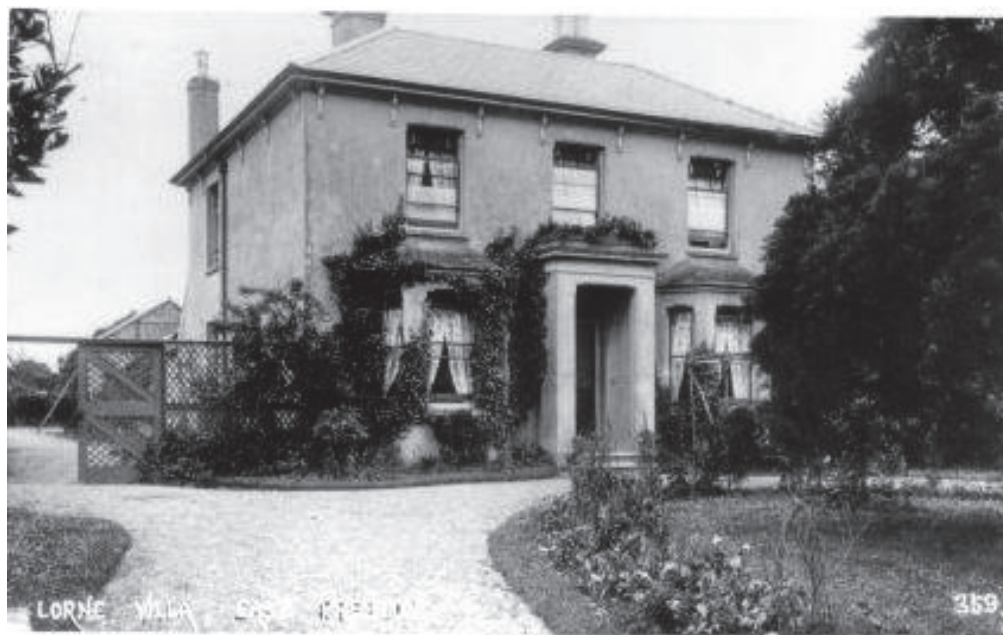
Photograph showing Lorne Villa, East Preston. View from the south east in c1909. Datemark 1911 Angmering Station. (with acknowledgement to RW Standing)
