## **Archaeological Evaluation**

### **Phase 2 – The Whitworth Centre**

#### **Harold Hill**

**ASE Project No: 8032**

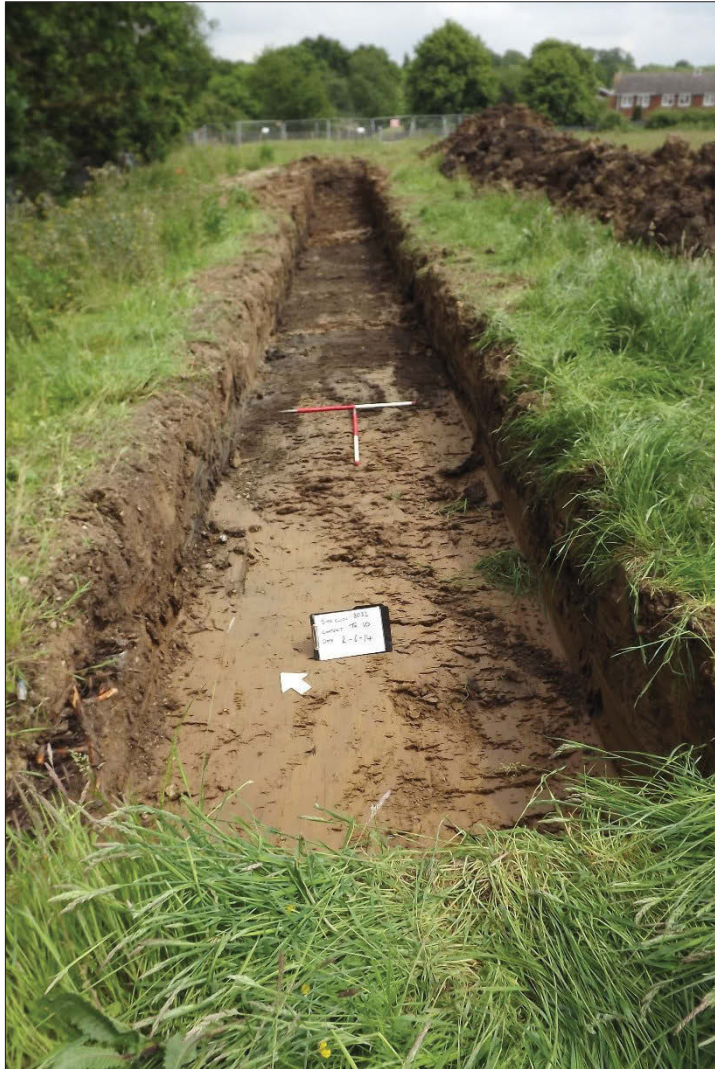
Figure 2: Trench 10

- 4.2.1 Trench 10 was located in the northwest corner of the site beyond the area that is indicated by the British Geological Survey (BGS) as landfill.
- 4.2.2 The deposit sequence consisted of a thin (0.06 – 0.1m thick) layer of dark brown soft sandy silt topsoil [10/01], overlying a 0.8-0.9m thick layer of modern made ground [10/02]. Natural geology, comprising mid-brown

compact clay [10/03], was sealed beneath [10/02].

- 4.2.3 Modern truncation was noted in the central part of the trench but no archaeological features or finds were present.

- 6.1.2 Trenches 10 and 11 appear to show that the northern extents of the quarrying / landfill area are greater than as plotted by the BGS. This is

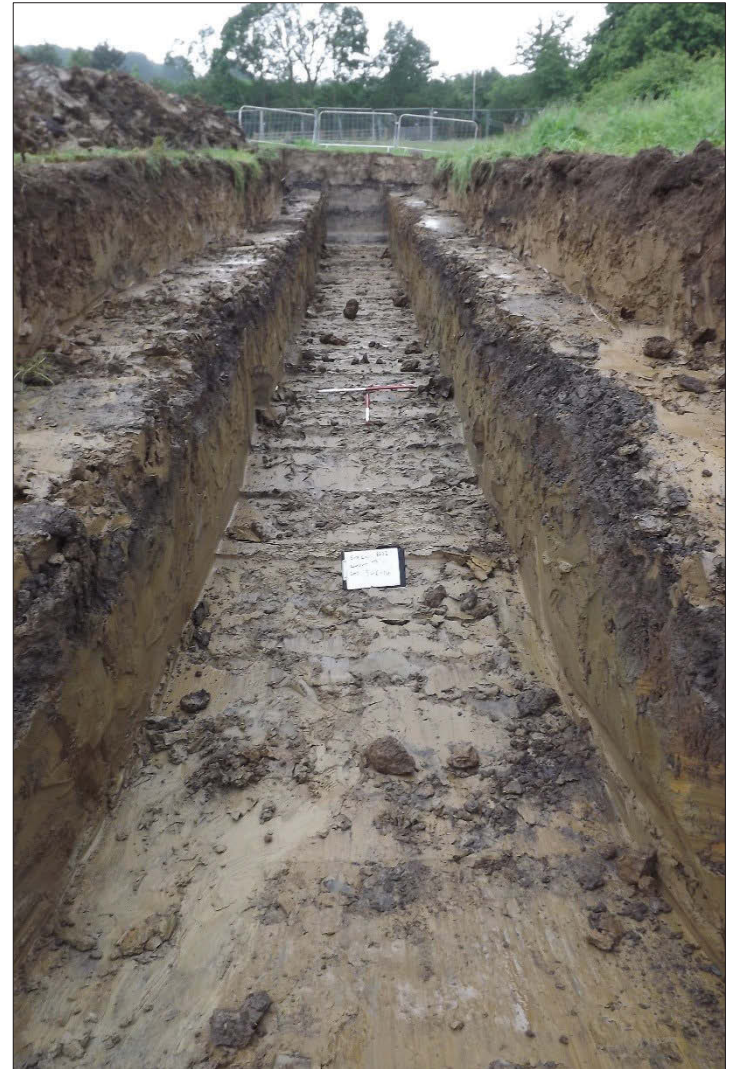
Figure 3: Trench 11

- 4.3.1 Trench 11 was positioned along the northeast boundary of the site again outside the BGS plotted extent of landfill, near geotechnical test-pit TP107.

- 4.3.2 The revealed deposit sequence comprised a 0.15-0.2m thick layer of dark brown loose sandy silt topsoil [11/01] overlying a thick (1.95-2.7m) deposit of modern made ground [11/02] which in turn was underlain by natural geology consisting of mid-brown compact clay [11/03].

- 4.3.3 No archaeological features or finds were identified below the made ground.

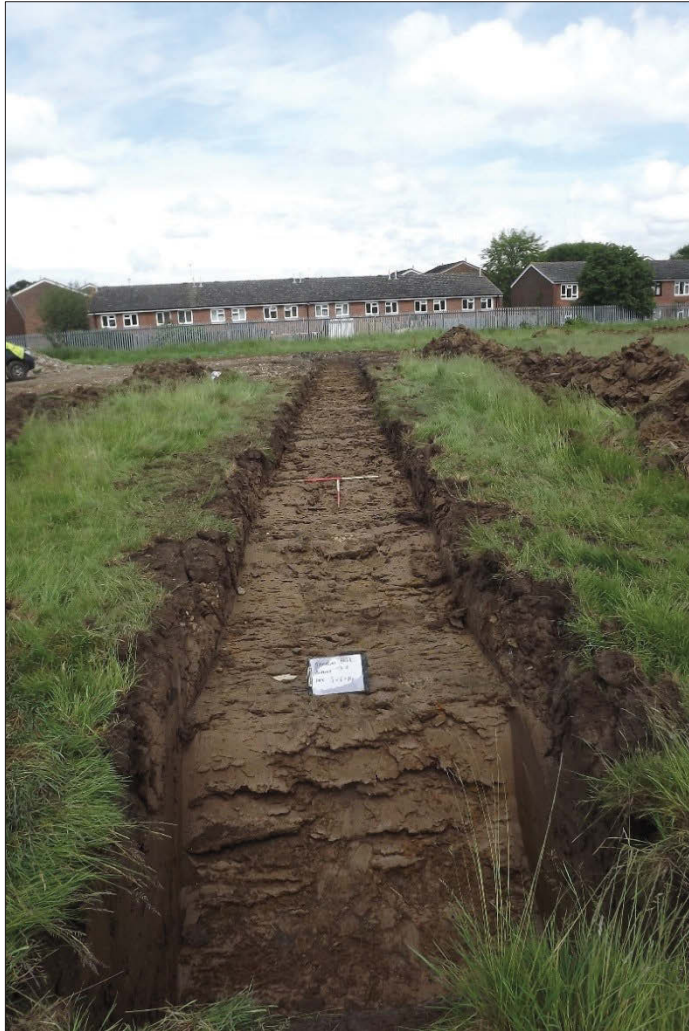
Figure 4: Trench 12

- 4.4.1 Trenches 12 to 17 were located across the southeast part of the overall site, which was indicated by the BGS to be partially covered by the landfill. All but trench 15 and parts of trenches 12 and 14 were positioned outside the plotted landfill extent.

- 4.4.2 All of these trenches demonstrated the same stratigraphic sequence that consisted of a 0.13-0.47m thick layer of dark brown soft sandy slit topsoil which lay directly on top natural geology comprising mid-brown compact clay. Three sondages located at the southwest end of trench 12, northeast end of trench 14 and southwest end of trench 16 were dug down to 0.7-1m below the trench base. None of these sondages revealed any additional deposits and confirmed the natural clay to be a thick and uniform deposit.

- 4.4.3 Land drains were noted in all of these trenches and also a modern truncation was revealed in the centre of trench 14. No archaeological features, finds or deposits were identified within any of the trenches.

- 6.1.3 The southeast part of the site, and particularly the south of Plot 2, seems to have been subject to ground reduction / levelling works, as the topsoil lies directly on homogenous natural clay that was devoid of any archaeological deposits or finds. This is likely to have been the product of the creation of the school playing fields.
- 6.1.4 No evidence has been identified for there ever having been archaeological remains present within this eastern part of The Whitworth Centre site. Indeed, not even residual artefacts in later infill and overburden deposits were found. If ever present, such remains must have been completely removed by past quarrying and landscaping of the site.
