Archaeological Evaluation
at

Car park associated with Chaucer House
Grimshaw Way and Western Road
Romford
London Borough of Havering

ASE Project No: 8117 Site Code: CUH14

ASE Report No: 2014227

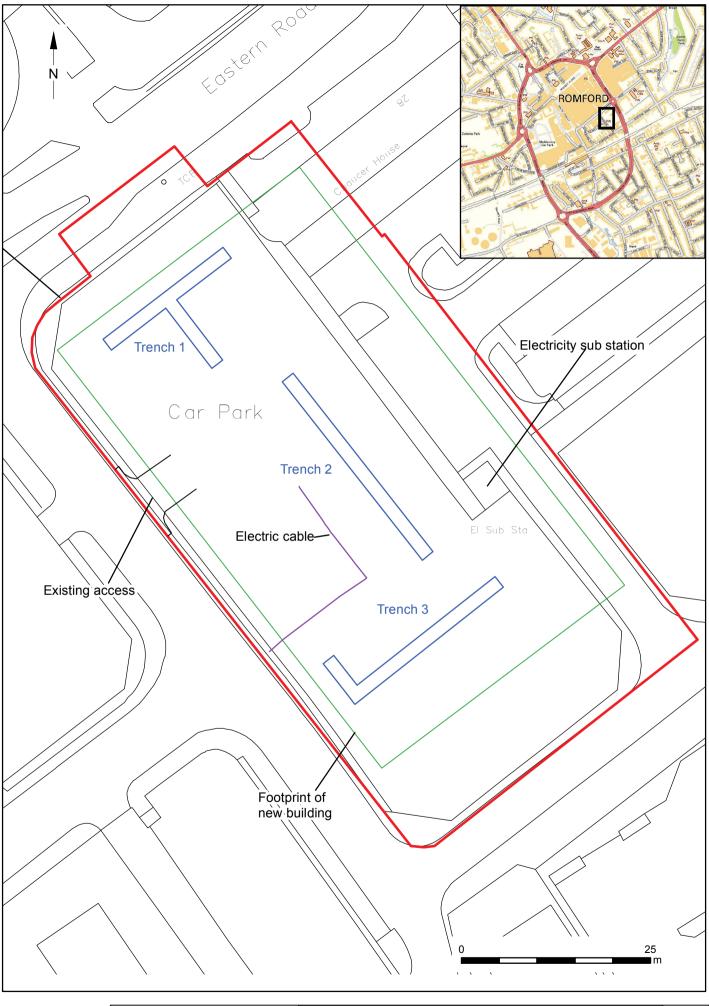
© Archaeology South-East	Chaucer House, Romford	Fig. 1
Project Ref: 8117 Jun 2014	Location of archaeological evaluation trenches	ı ıg. ı
Report Ref: WSI Drawn by: A	Location of archaeological evaluation trenches

- 4.1.1 Trench locations and other pertinent information, alluded to in the results text below, are shown on Figure 1.
- 4.1.2 Deposit thicknesses and heights in metres AOD for every trench can be found in the table in Appendix 1.

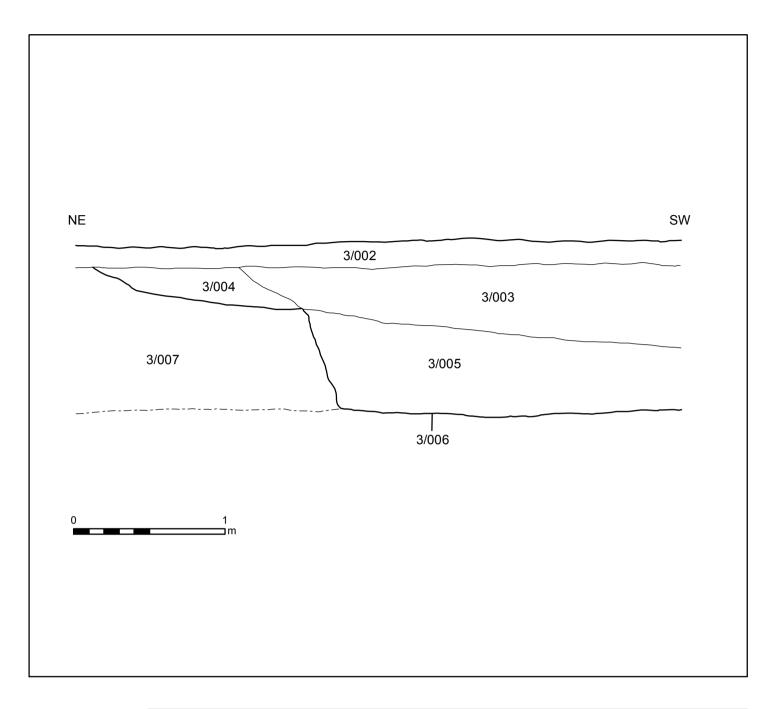
© Archaeology South-East		Chaucer House, Romford	
Project Ref: 8117	Jun 2014	Section 1. Trench 3	Fig. 3
Report Ref: 2014227	Drawn by: APL/LM	Section 1, Hendi 3

- 4.4.3 Over 11m long by at least 1.8m wide, cut [3/006] was identified in the southwest half of trench 3. It survived underneath the hard core and contained three deposits. The latest, comprising 0.35m of grevish black sandy silt with rubble [3/003], sealed a 0.55m thick layer of mid grey compact clay with very high organic content (tree roots), which in turn partially overlay a 0.24m thick deposit [3/004] of dark brown sandy clay. No artefacts were retrieved from this feature which, due to the obvious presence of an extensive root system, is likely to mark the position of a tree or large shrub removed prior to the formation of the car park (Fig. 3 & 7).

- 6.2 The large feature identified in trench 3 was probably formed by pulling out/cutting down a tree or large shrub and backfilling the resulting depression. This is likely to correspond with the area of trees shown on the 1870 map to the rear of the plot, which may have been either ornamental in nature or a small group of fruit trees.

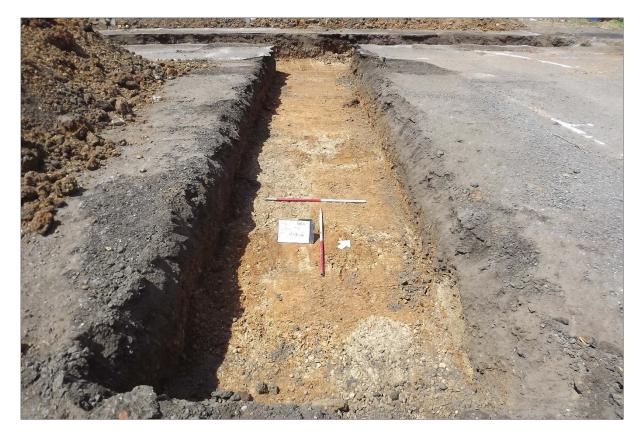
Figure 4: Trench 1

- T-shaped trench 1 was located at the northwest end of the site which, according to the first edition Ordnance Survey map, was formerly occupied by a building.
- 4.2.2 The deposit sequence consisted of a 0.06m thick layer of tarmac [1/001], overlying a 0.1-0.2m thick layer of hard core [1/002] that in turn was underlain

by 0.3-0.4m of modern made ground [1/003]. Underneath was a 0.1-0.25m layer of subsoil [1/005] which sealed natural geology, comprising brownish orange compact clay and gravel [1/006]. A slightly different sequence of deposits was recorded at the southwest end of the trench, where a 0.75m thick demolition layer [1/004] was noted underlying the hard core and sealing natural geology.

Remains of a modern demolished wall were clearly visible in the northeast arm of the trench, while the southwest end was truncated by drainage pipes and layer [1/004] mentioned above. No archaeological features or artefacts were discovered in this trench.

- 6.1 The remains of a wall and the demolition layer identified in trench 1 were presumably associated with the building, St Mary's Convent School, depicted on the 1870 Ordnance Survey map, which is known to have been demolished in the 1960s/ 70s.

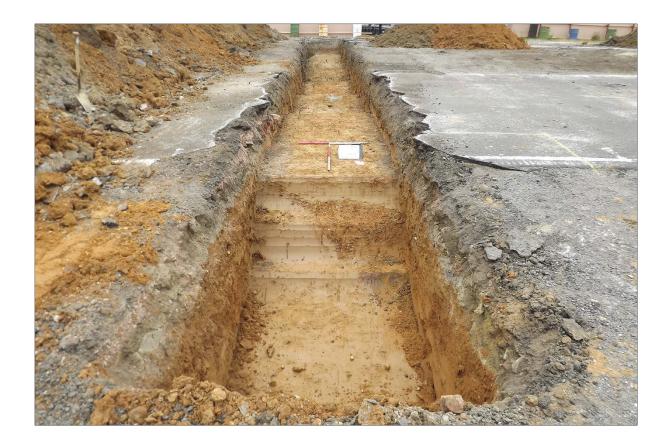
Figure 6: Trench 3

- This L-shaped trench was located at the southeast end of the site, which is 4.4.1 the lowest part of the development area.
- 4.4.2 The deposit sequence revealed in the trench comprised a 0.06m thick layer of tarmac [3/001] overlying a 0.2-0.45m thick layer of hard core [3/002], which lay directly on top of natural deposits [3/007] that consisted of brownish orange sandy clay and gravel.

- Two sondages located at the northeast and northwest end of the trench were excavated down to 1.08 m below the base of the trench (15.25 mAOD) and 0.74m below the trench base (15.29 mAOD) respectively. They showed that the natural clay and gravel was underlain by a clean yellowish orange fine sand.
