An Archaeological Evaluation at the Waste Transfer Station Cordons Farm Braintree Essex CM77 8DL

ASE Project No: E8091 Site Code: CRCF 13

ASE Report No: 2013338 OASIS id: 166742

December 2013

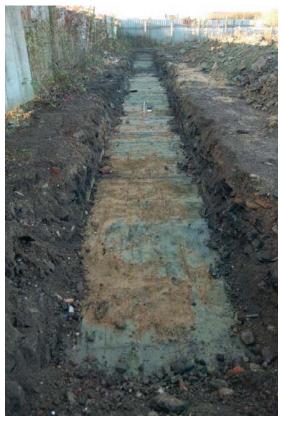
- 4.1.1 Trench 1 was a 35m-long trench excavated on the south-west side of the gravel area, west of the waste area entrance route. It targeted the area of the proposed weighbridge and the north-west end of the new waste transfer building. An extra 5m was added either end of the trench to partly make up for the loss of Trench 2.
- 4.1.2 A thick layer of modern overburden was removed across the entire trench, comprising gravel, rubble, plastic and modern debris mixed with a dark brown grey silty material, likely to represent former topsoil (context [01]). Below this lay the natural orange brown clay at c.64.85m OD, the upper part of which was predominantly stained a blue-grey colour from contamination (Figure 2). Maximum trench depth was 1.00m.

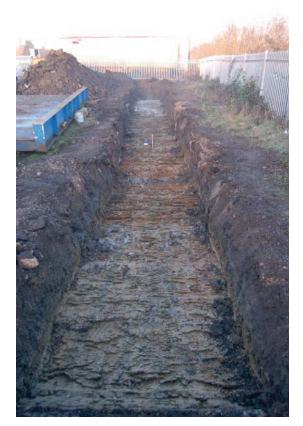
- 4.3.1 Trench 3 was excavated on the north-west side of the gravel area along the line of the south-eastern boundary fence, within the footprint of the proposed new waste transfer building. The trench was moved 19.5m to the north-east from its original position because the original trench straddled the existing fence between the two areas (CgMs 2013; Figures 1 & 2).
- 4.3.2 The same deposits were encountered within Trench 3 as Trench 1, though here the modern overburden (context [01]) was shallower, between 0.35m and 0.50m. The stained upper part of the natural clay [02] appeared at c.66.28m OD, slightly higher than in Trench 1, since the ground level is slightly higher, by 1.00m. Approximately 0.25m of contaminated geology was removed, exposing a largely similar natural deposit to that observed in Trench 1, but more gravelly and browner in the central part of the trench (Fig. 3).
