**Archaeological Watching Brief Report
Church of the Transfiguration
Church Hill, Pyecombe
West Sussex**

**Planning Reference 11/02225/FUL
Mid Sussex District Council**

**Project No: 5427
Site Code: CTP 12
Report No: 2014287
OASIS ID: archaeol6-188028**

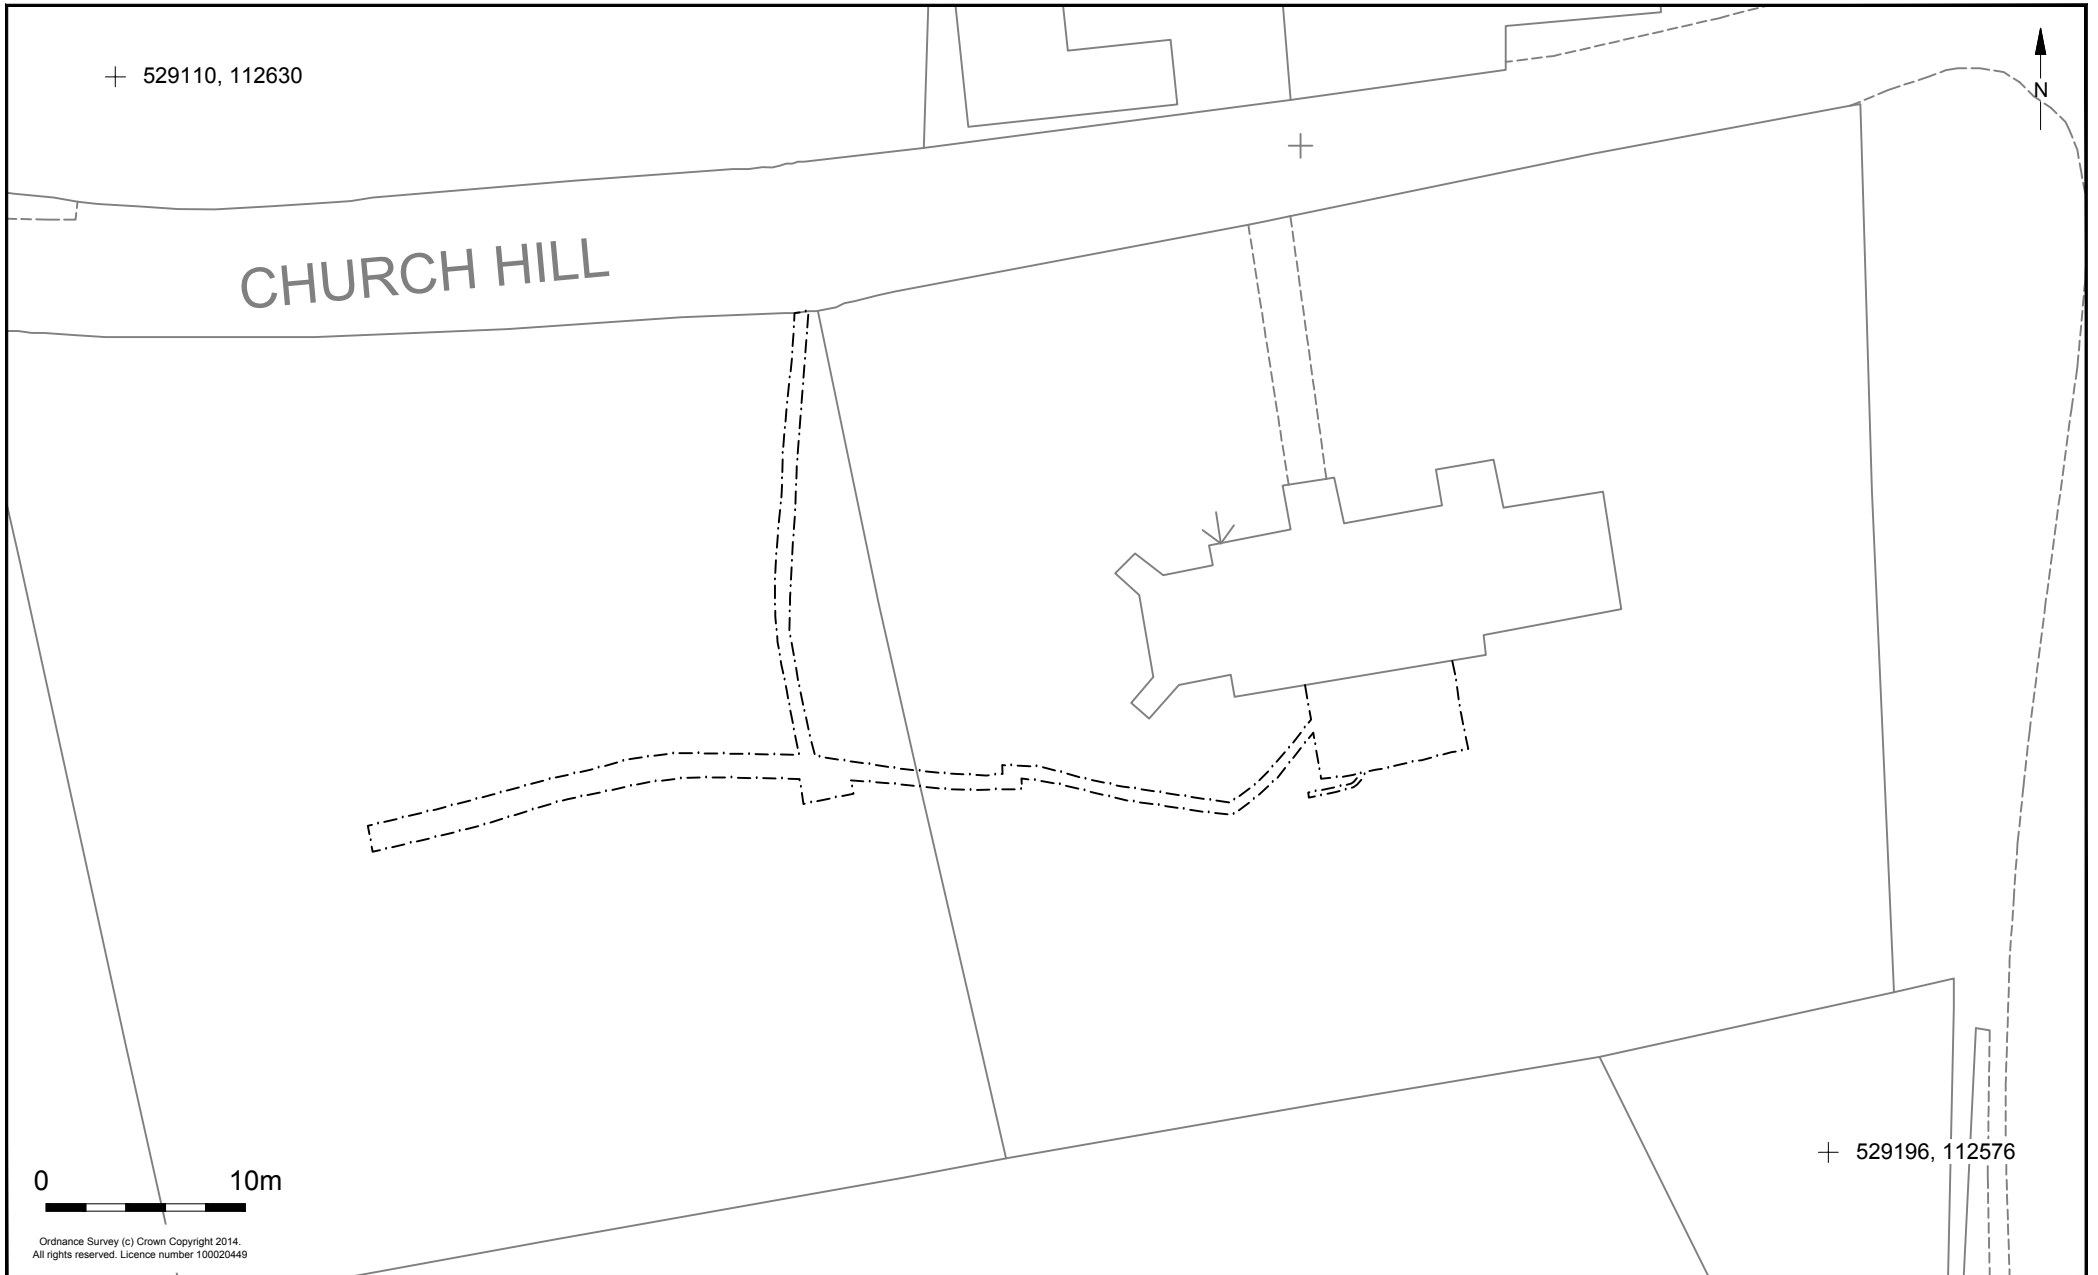
© Archaeology South-East		Church of the Transfiguraion, Pyecombe	Fig. 2
Project Ref: 5427	August 2014	Location of monitored works	
Report Ref: 2014287	Drawn by: RHC

3.1.1 The groundwork comprised ground reduction in the area of the new extension to the south side of the church, the excavation of associated foundation trenches and the excavation of new service trenches across the cemetery.

4.4 The Service Trenches and Septic Tank Excavations
