**Faircharm Creative Quarter, Lewisham, SE8 3DX
Historic Buildings Record**

**Project No: 6611
Site Code: FCQ14
Report No: 2014286**

August 2014

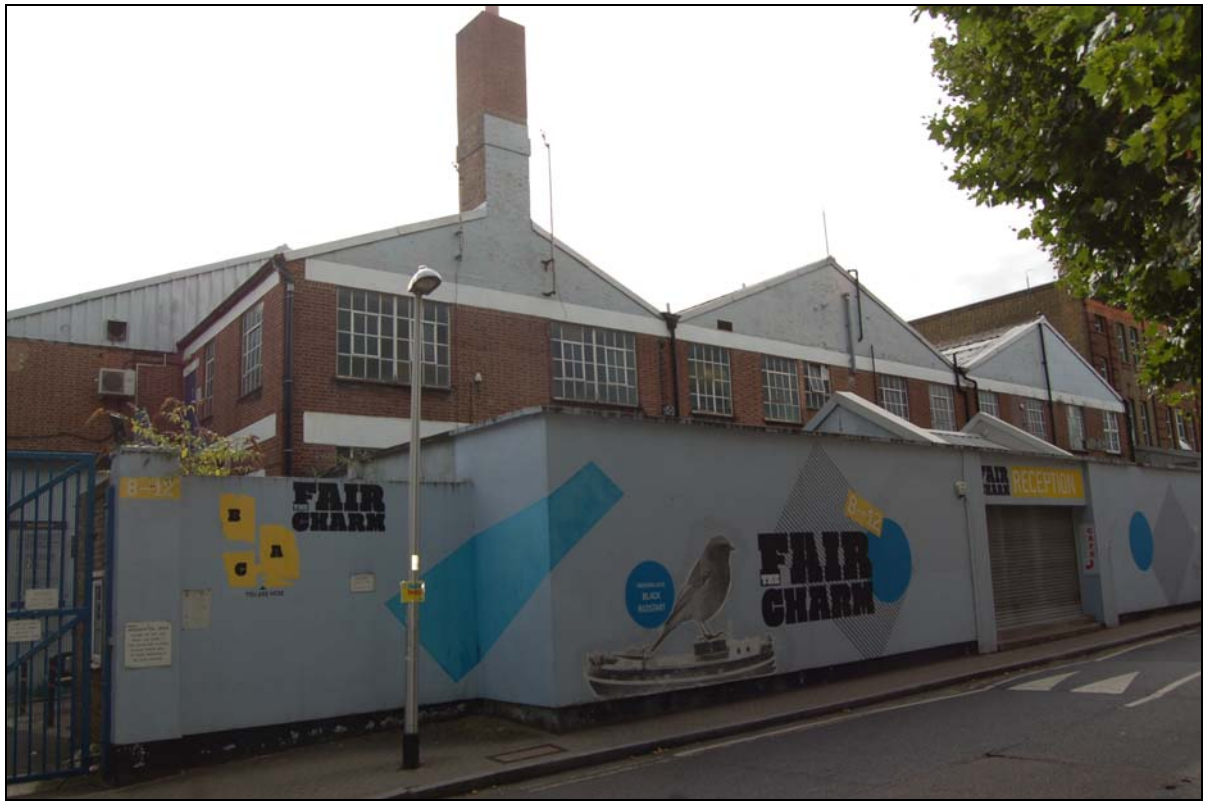
6.2.2.1 The west elevation of the main building, fronting Creekside, is obscured at ground floor level by the rendered façade of the more recent single storey street frontage (Plate 1, Figure 10). Above this the elevation is of textured red brick in Flemish bond, rising to three gable ends, the northernmost of which holds a gable end chimney stack. Fenestration is of metal factory style casements with separate tile sills and a continuous broad concrete head spanning the entire elevation over a course of bricks laid on edge. The gable ends above the window head are painted grey. To the north a bridge links building A with building C. At first floor level to the east of the elevation is a sign reading 'Zenith', a remnant of the time when the

Plate 1. Building A, Creekside elevation (FCQ14-0004)

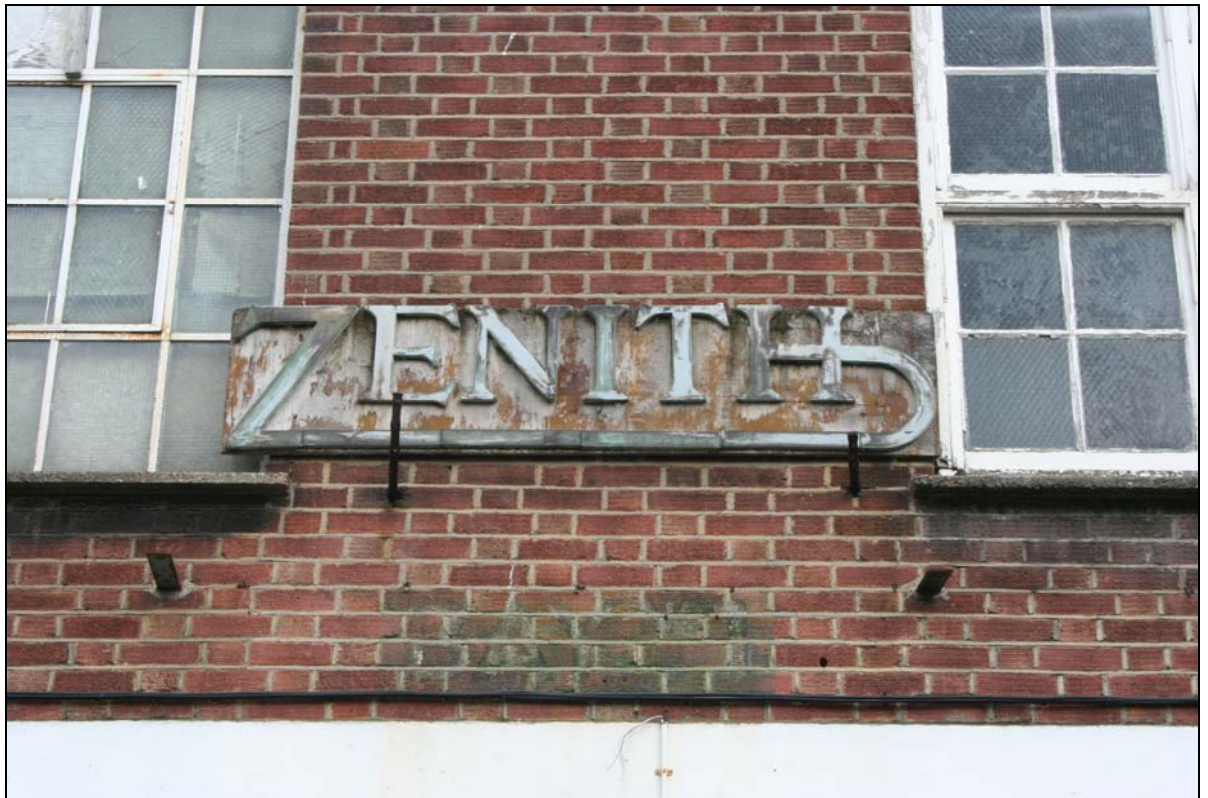
building was part of the Lewisham based Zenith Carburettors company (Plate 2).

Plate 2. Building A, 'Zenith' sign on west facing elevation

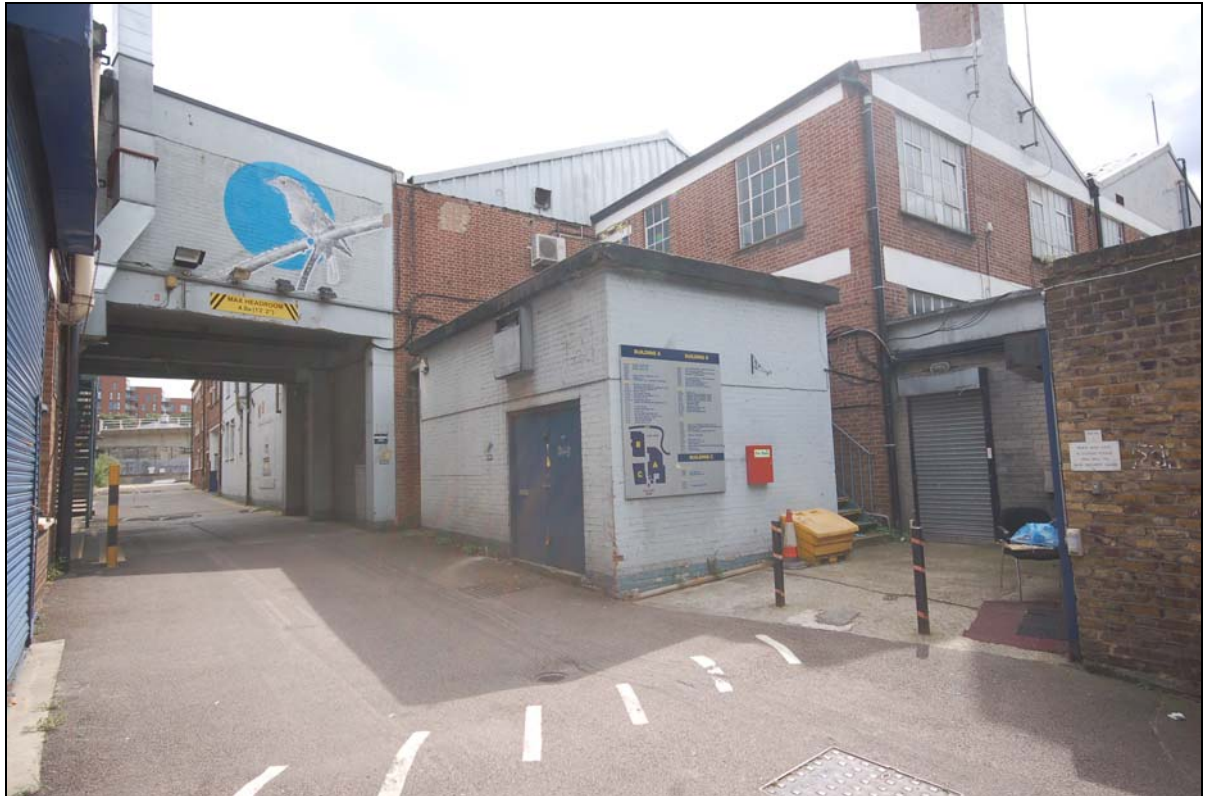
- 6.2.2.2 The north elevation consists of five bays spanning the earlier and later parts of the building, and as such is of varied construction. The earlier part, at the western end and recessed behind a small single storey structure, forms the return of the west elevation and is of similar construction, again in Flemish bond and with a continuous concrete head above the metal factory style windows. Here queen closers have been employed to either side of the window openings, which again have tile sills (Plate 3, Figure 11).

Plate 3. Building A, oblique view of north and west facing elevations (FCQ14-0012)

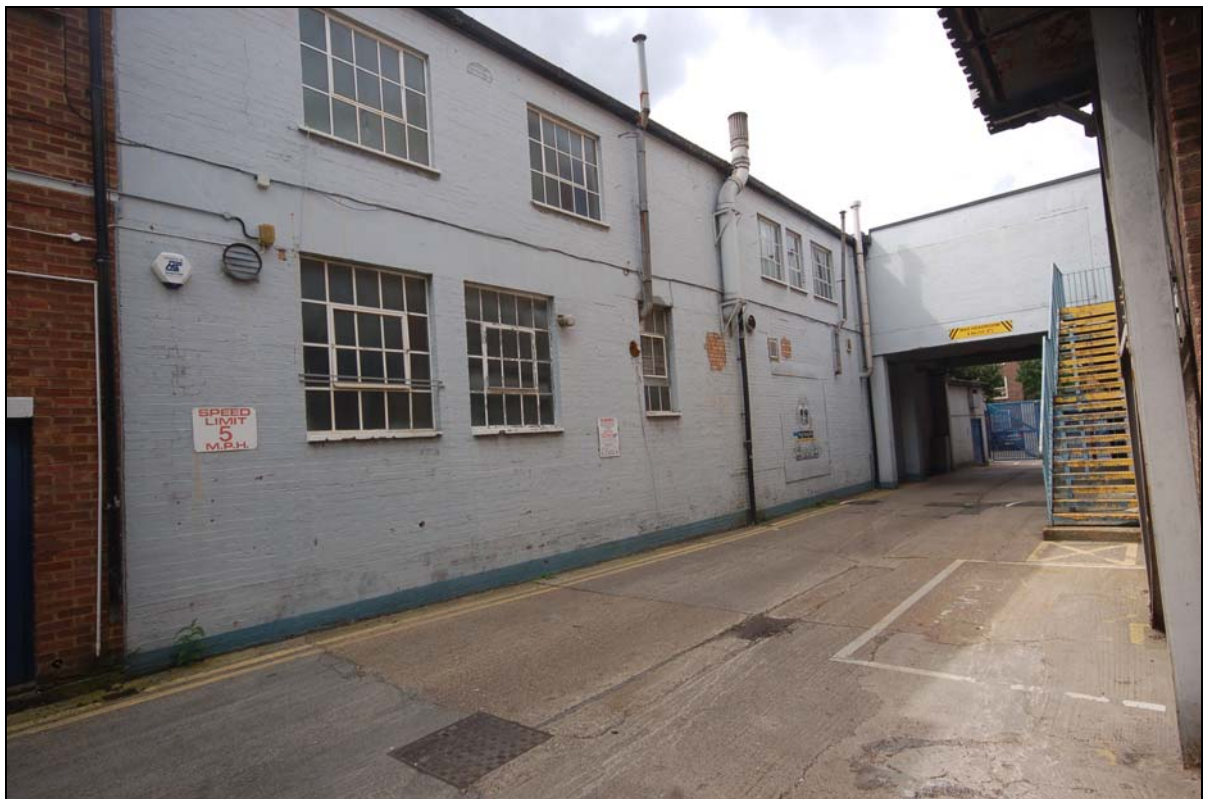
- 6.2.2.4 The subsequent bay (Plate 4) is of blue-grey painted brickwork in English bond. The ground floor holds a pair of 5x4 factory style window units and a single 4x3 unit to the east, while the western end contains a now blocked large opening with thick concrete sill and lintel. The upper floor holds two 5x3 window units at the east while at the west, above the blocked ground floor opening, are three windows of different sizes. All the windows have concrete sills and heads.

Plate 4. Building A, north facing elevation (FCQ14-0011)

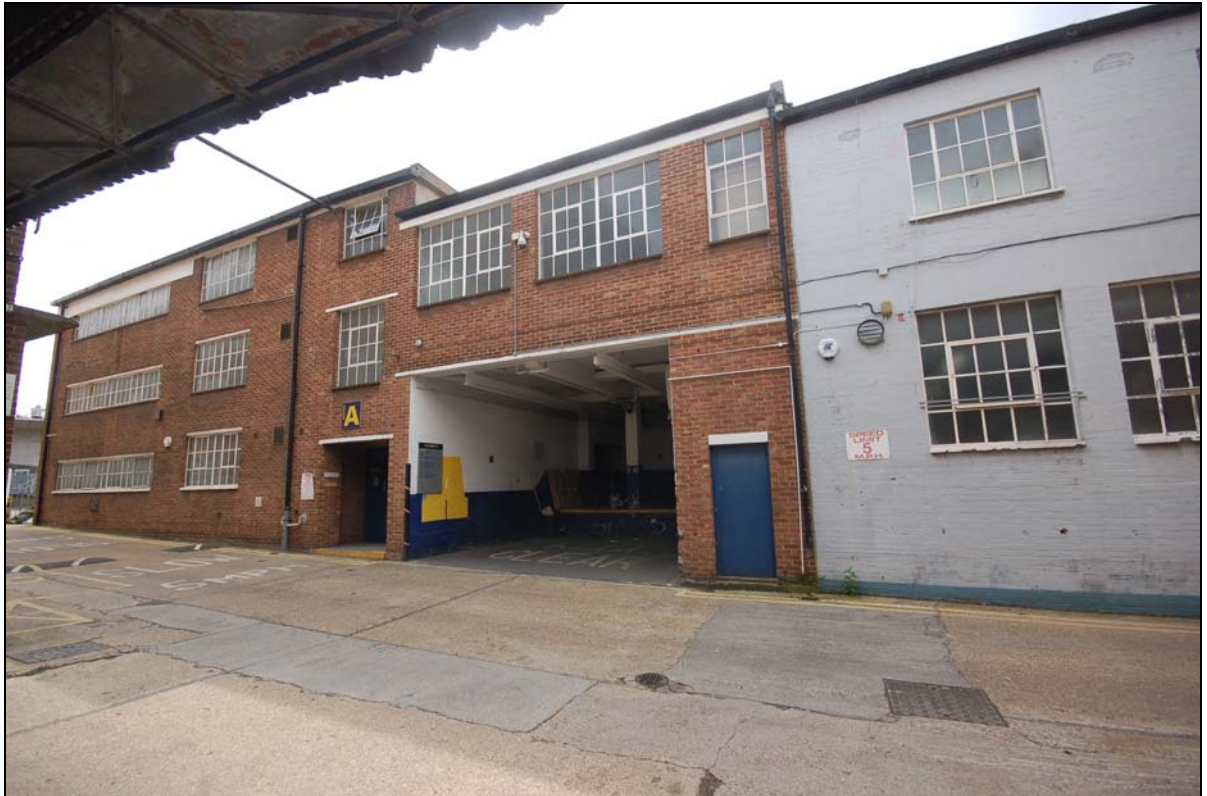
- 6.2.2.5 The final two bays are both constructed of textured red brick in stretcher bond (Plate 5). The penultimate bay is of two storeys, the lower level holding a single door and an open loading bay with raised platform to the rear, the roof of which is supported by concrete posts and steel joist spanning the full bay width. The first floor contains three window openings, two 8x4 units and a single 3x4 unit, all of which have individual tile sills and a continuous concrete header, again spanning the full bay. The final bay is of three storeys with a recessed double door with concrete lintel above to the west. The remainder holds a series of metal framed factory style windows, those to the east being long and narrow 20x2 units followed by 8x4 units in the centre. Above the recessed door are two windows, the first floor being a unit of 5x4, and above that a unit of 5x3. All the windows have individual sills and heads, the lower floor sills being of concrete while those of the upper floor are of tile. The heads are all of concrete.

Plate 5. Building A, north facing elevation (FCQ14-0010)

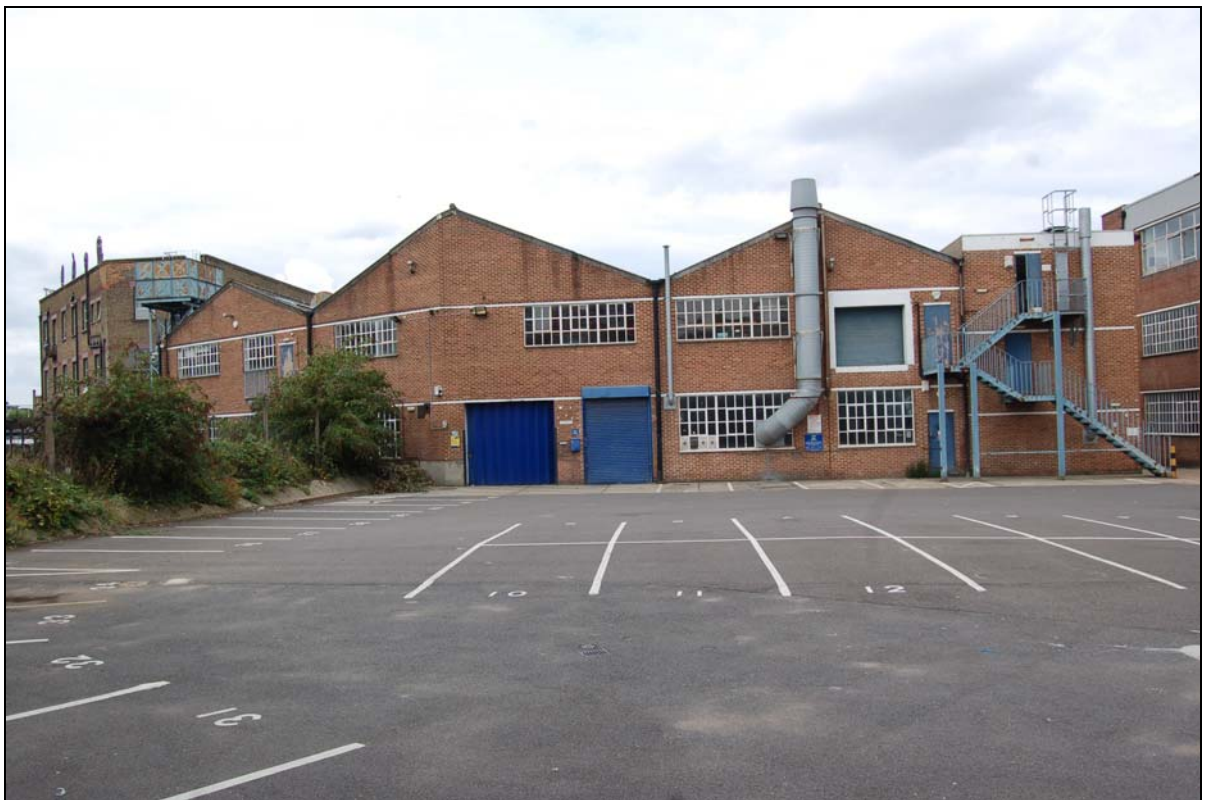
- 6.2.2.6 The east elevation spans four bays, three of two storeys with gabled ends while the northernmost bay is of three storeys and flat roofed (Plate 6). All are constructed of textured red brick in stretcher bond. The southern bay and half of that to the north are angled to accommodate a bend in Deptford Creek. The windows of the first three bays share continuous white painted concrete heads which span all three bays.

Plate 6. Building A, east facing (rear) elevation (FCQ14-0007)

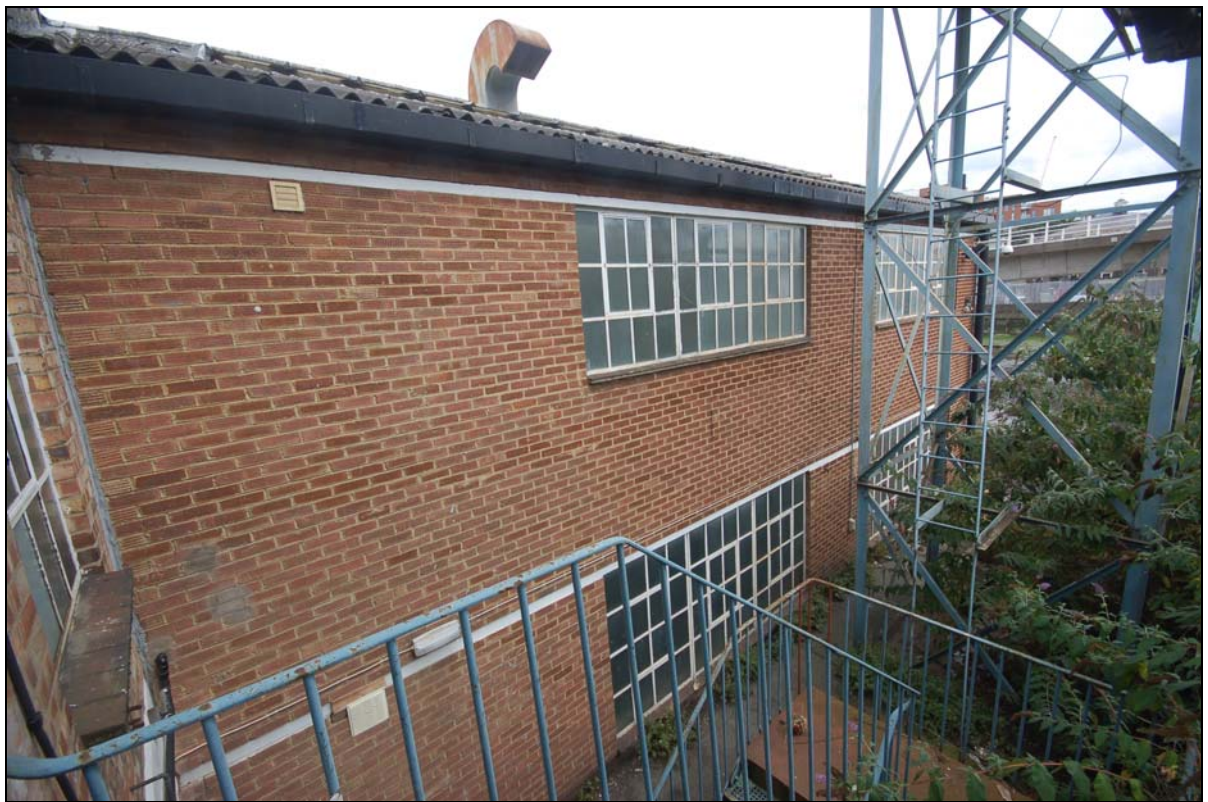
6.2.2.8 The majority of the south elevation butts the adjacent property, only the eastern bay being visible (Plate 8). This is again in textured red brick laid in stretcher bond and holds two windows at each level, each with an individual tile sill and continuous concrete head. Stepped back is a short two storey eastern bay (Plate 9) with fire escapes on both levels and a wide concrete band between floors. The ground floor is in stretcher bond with a single course of bricks laid on edge beneath the concrete band. The upper floor is in Flemish bonded fletton brick and also contains a 4x4 window unit to the right of the fire escape. The gable end is clad in corrugated asbestos sheeting.

Plate 8. Building A, south facing elevation (FCQ14-0017)

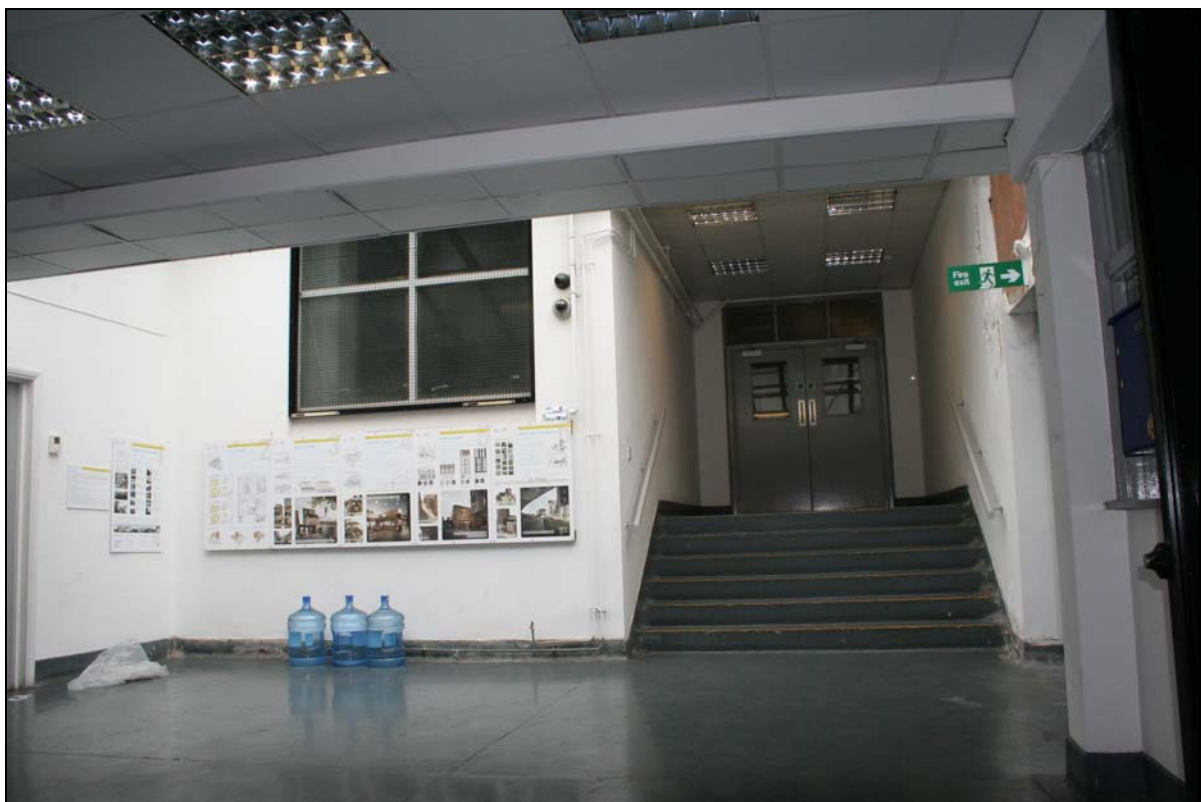
6.2.3.2 Access from Creekside opens into a central lobby within the single storey street frontage extension (Plate 10). From here a short flight of stairs leads into the main building's east-west central corridor (Plate 11) which runs to the rear of the building, and a corridor to the south provides access to the external loading bay fronting Creekside. A reception/office space lies to the south of the lobby area (Plate 12).

Plate 10. Building A, ground floor, lobby area (FCQ14-0050)

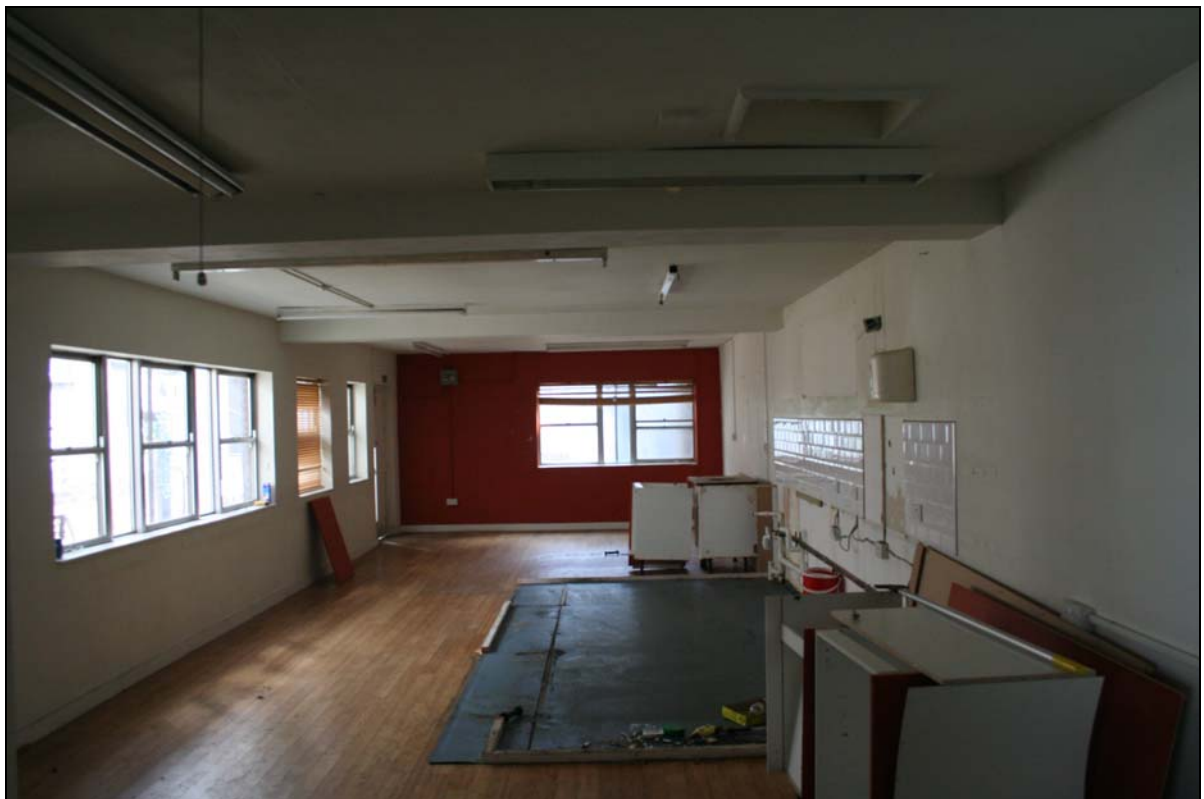
Plate 12. Building A, ground floor, office space to south of lobby area (FCQ14-0055)

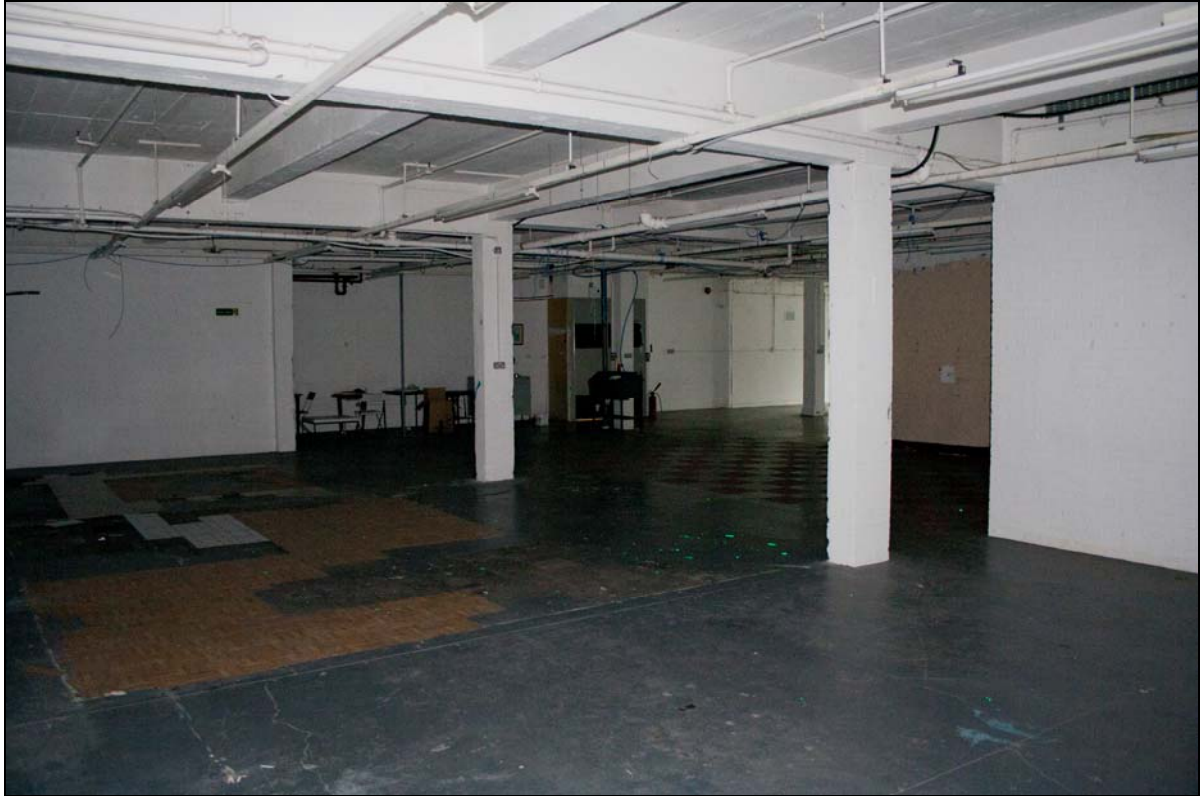
6.2.3.3 The only workshop area accessible to survey was room A004A (Plate Plate 13), which is thought to be typical of the general form and layout of the ground floor workspaces. The external wall to this room is of brick, as are those to the rooms in the northwest (intake room, disused oil tank and A006). The walls to the corridor and adjacent room A4, however, are breeze block and may indicate the later

subdivision of the internal space. The floor is shuttered concrete with shuttered concrete pillars supporting the ceiling. Only two of the ancillary rooms were accessible, one of which was a toilet and the other a disused toilet (Plate 14 and Plate 15). However, a store room to the north of room A3 was visible through a window in the north elevation (Plate 16). The walls of this room were of brick laid in stretcher bond with concrete corner pillars and beams supporting the ceiling. No internal features were evident.

Plate 13. Building A, ground floor, room A004A (FCQ14-0060)

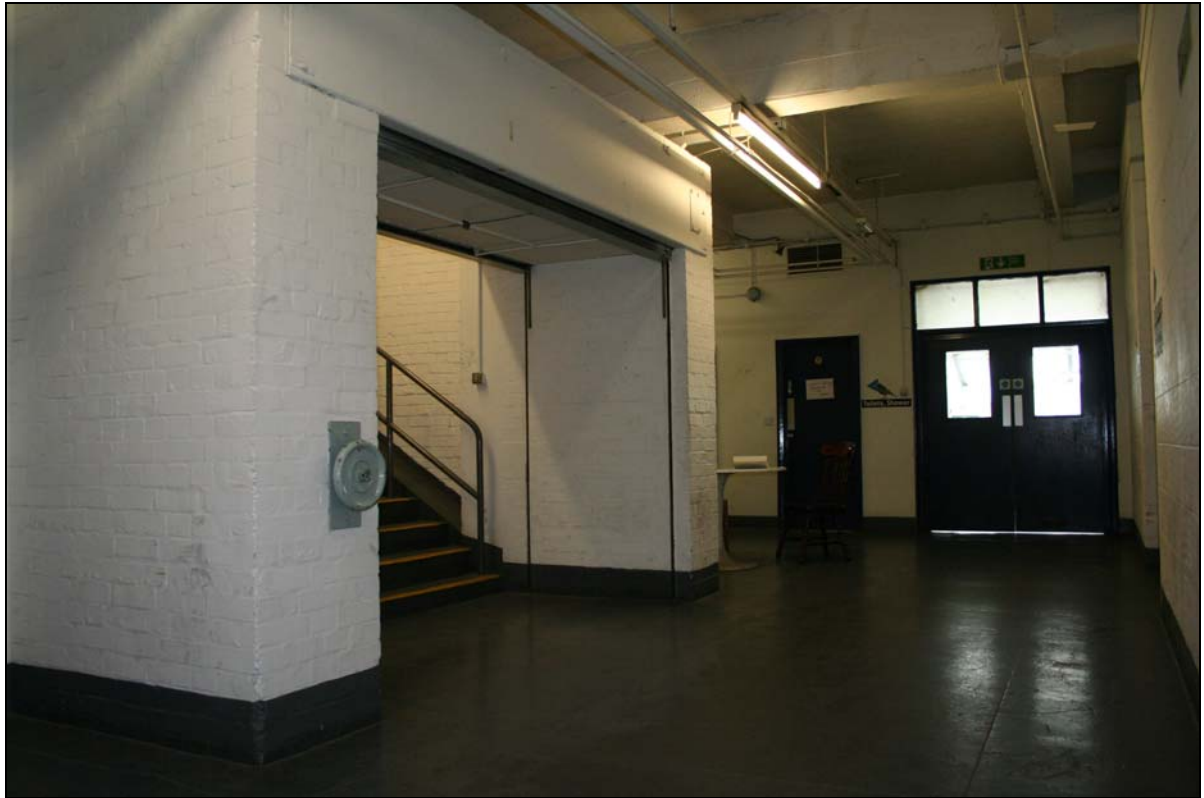
6.2.3.4 The main stairs to the first floor are located off the central corridor via a wheel operated roller shutter door (Plate 17), and a second staircase provides access from the east of the loading bay in the north elevation (Plate 18).

Plate 17. Building A, ground floor, main stairs to first floor (FCQ14-0042)

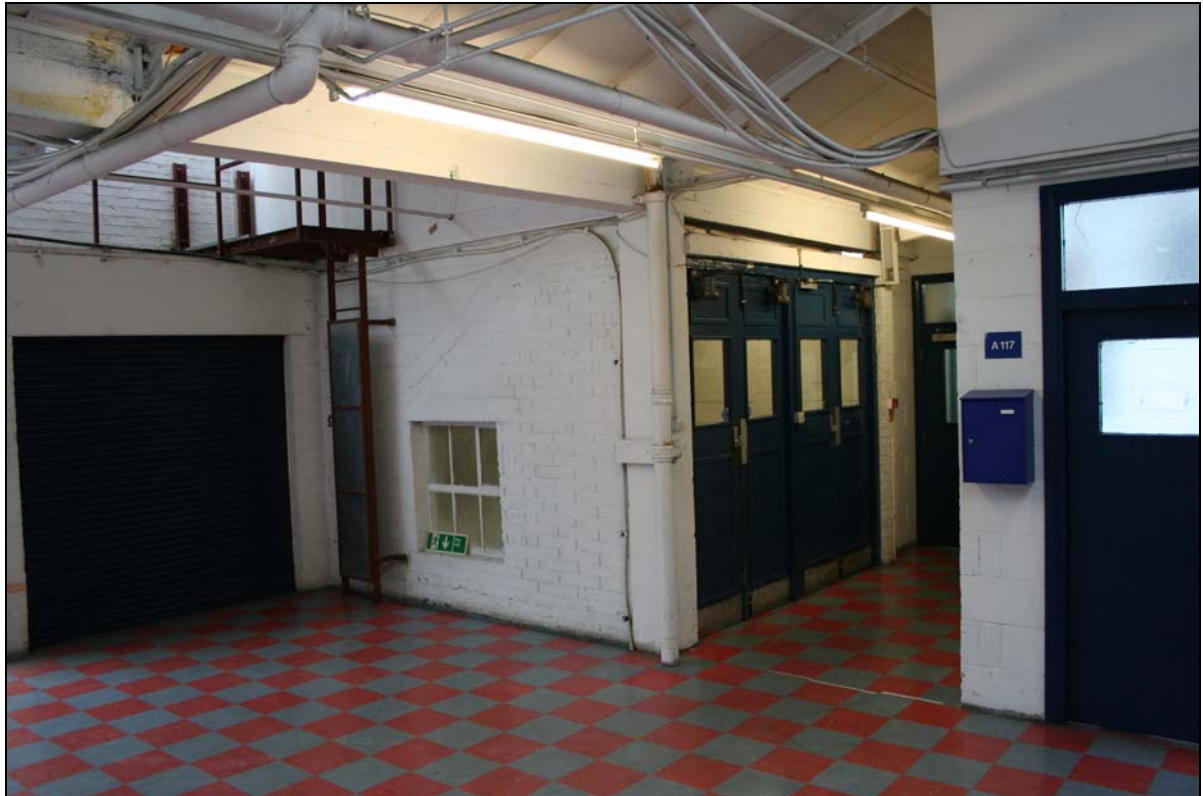
6.2.3.5 The first floor bears a much greater resemblance to the original building form than does the ground floor, being divided into three areas mirroring the original conjoined warehouses. These are separated by two east-west corridors running the length of the building. The corridor floors are generally covered in two-tone vinyl (Plate 19) and major internal divisions are of breeze block.

Plate 19. Building A, first floor, lift / stairs area (FCQ14-0064)

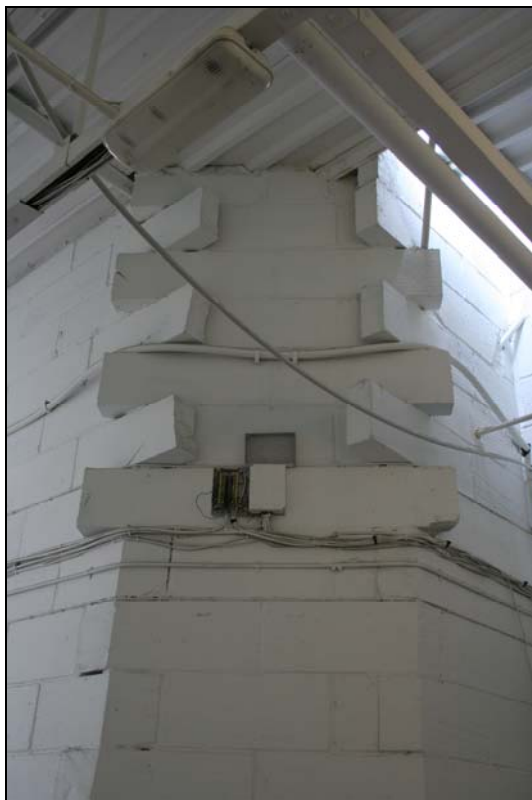
Plate 42. Building B, second floor, detail of chamfered breeze block wall
(FCQ14-0142)

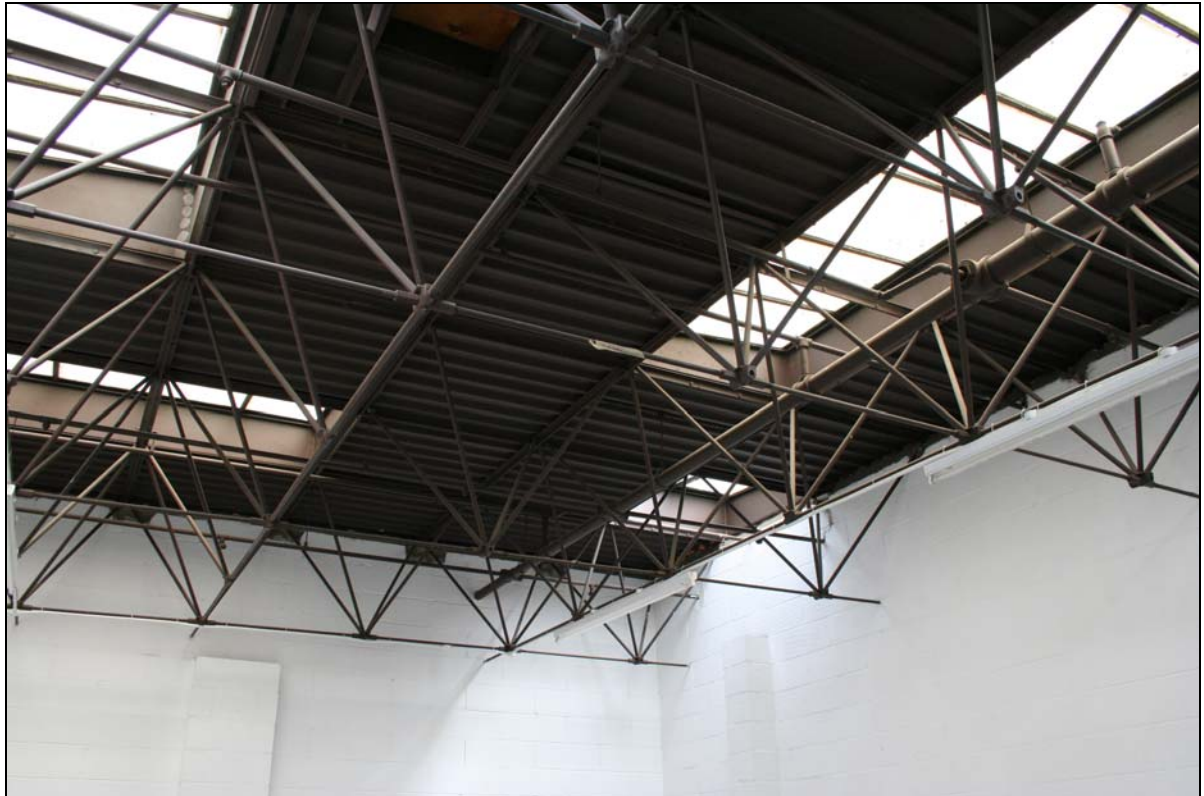
Plate 47. Building B, second floor, roof truss, unit B204 (FCQ14-0141)

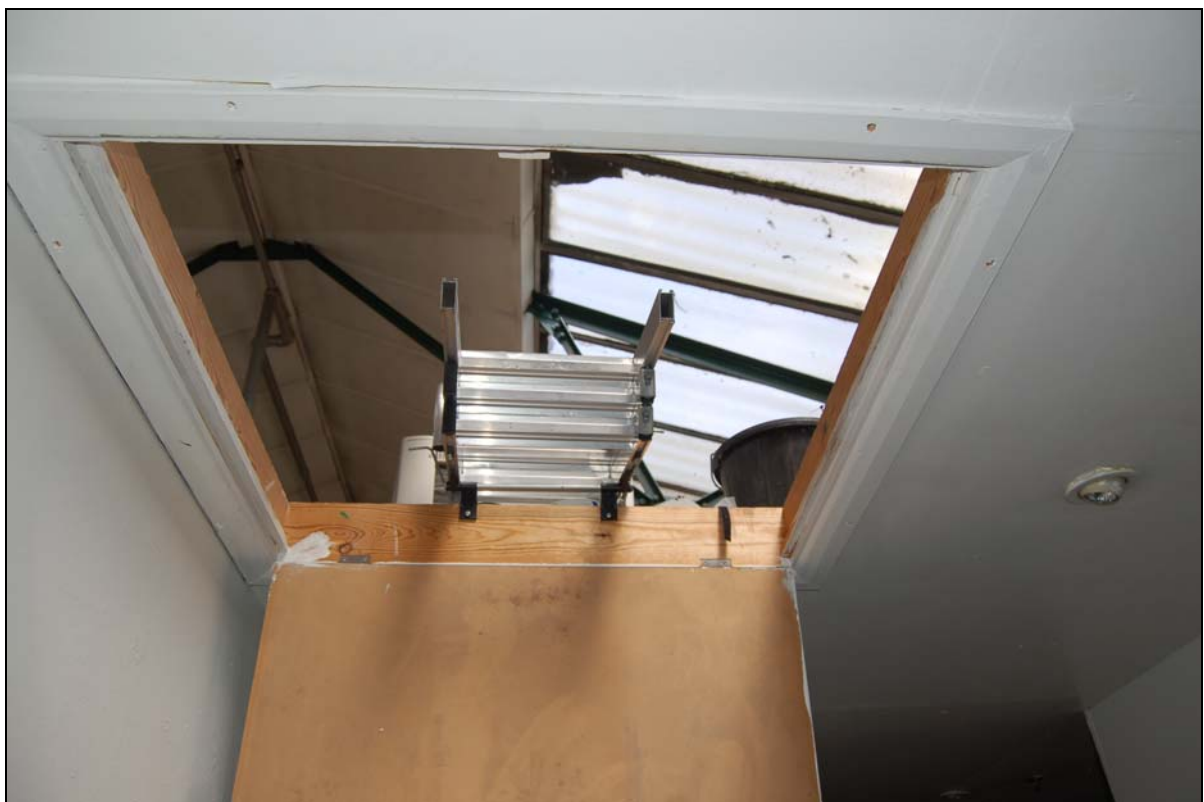
Plate 62. Building C, first floor, skylight over unit C102 (FCQ14-0194)

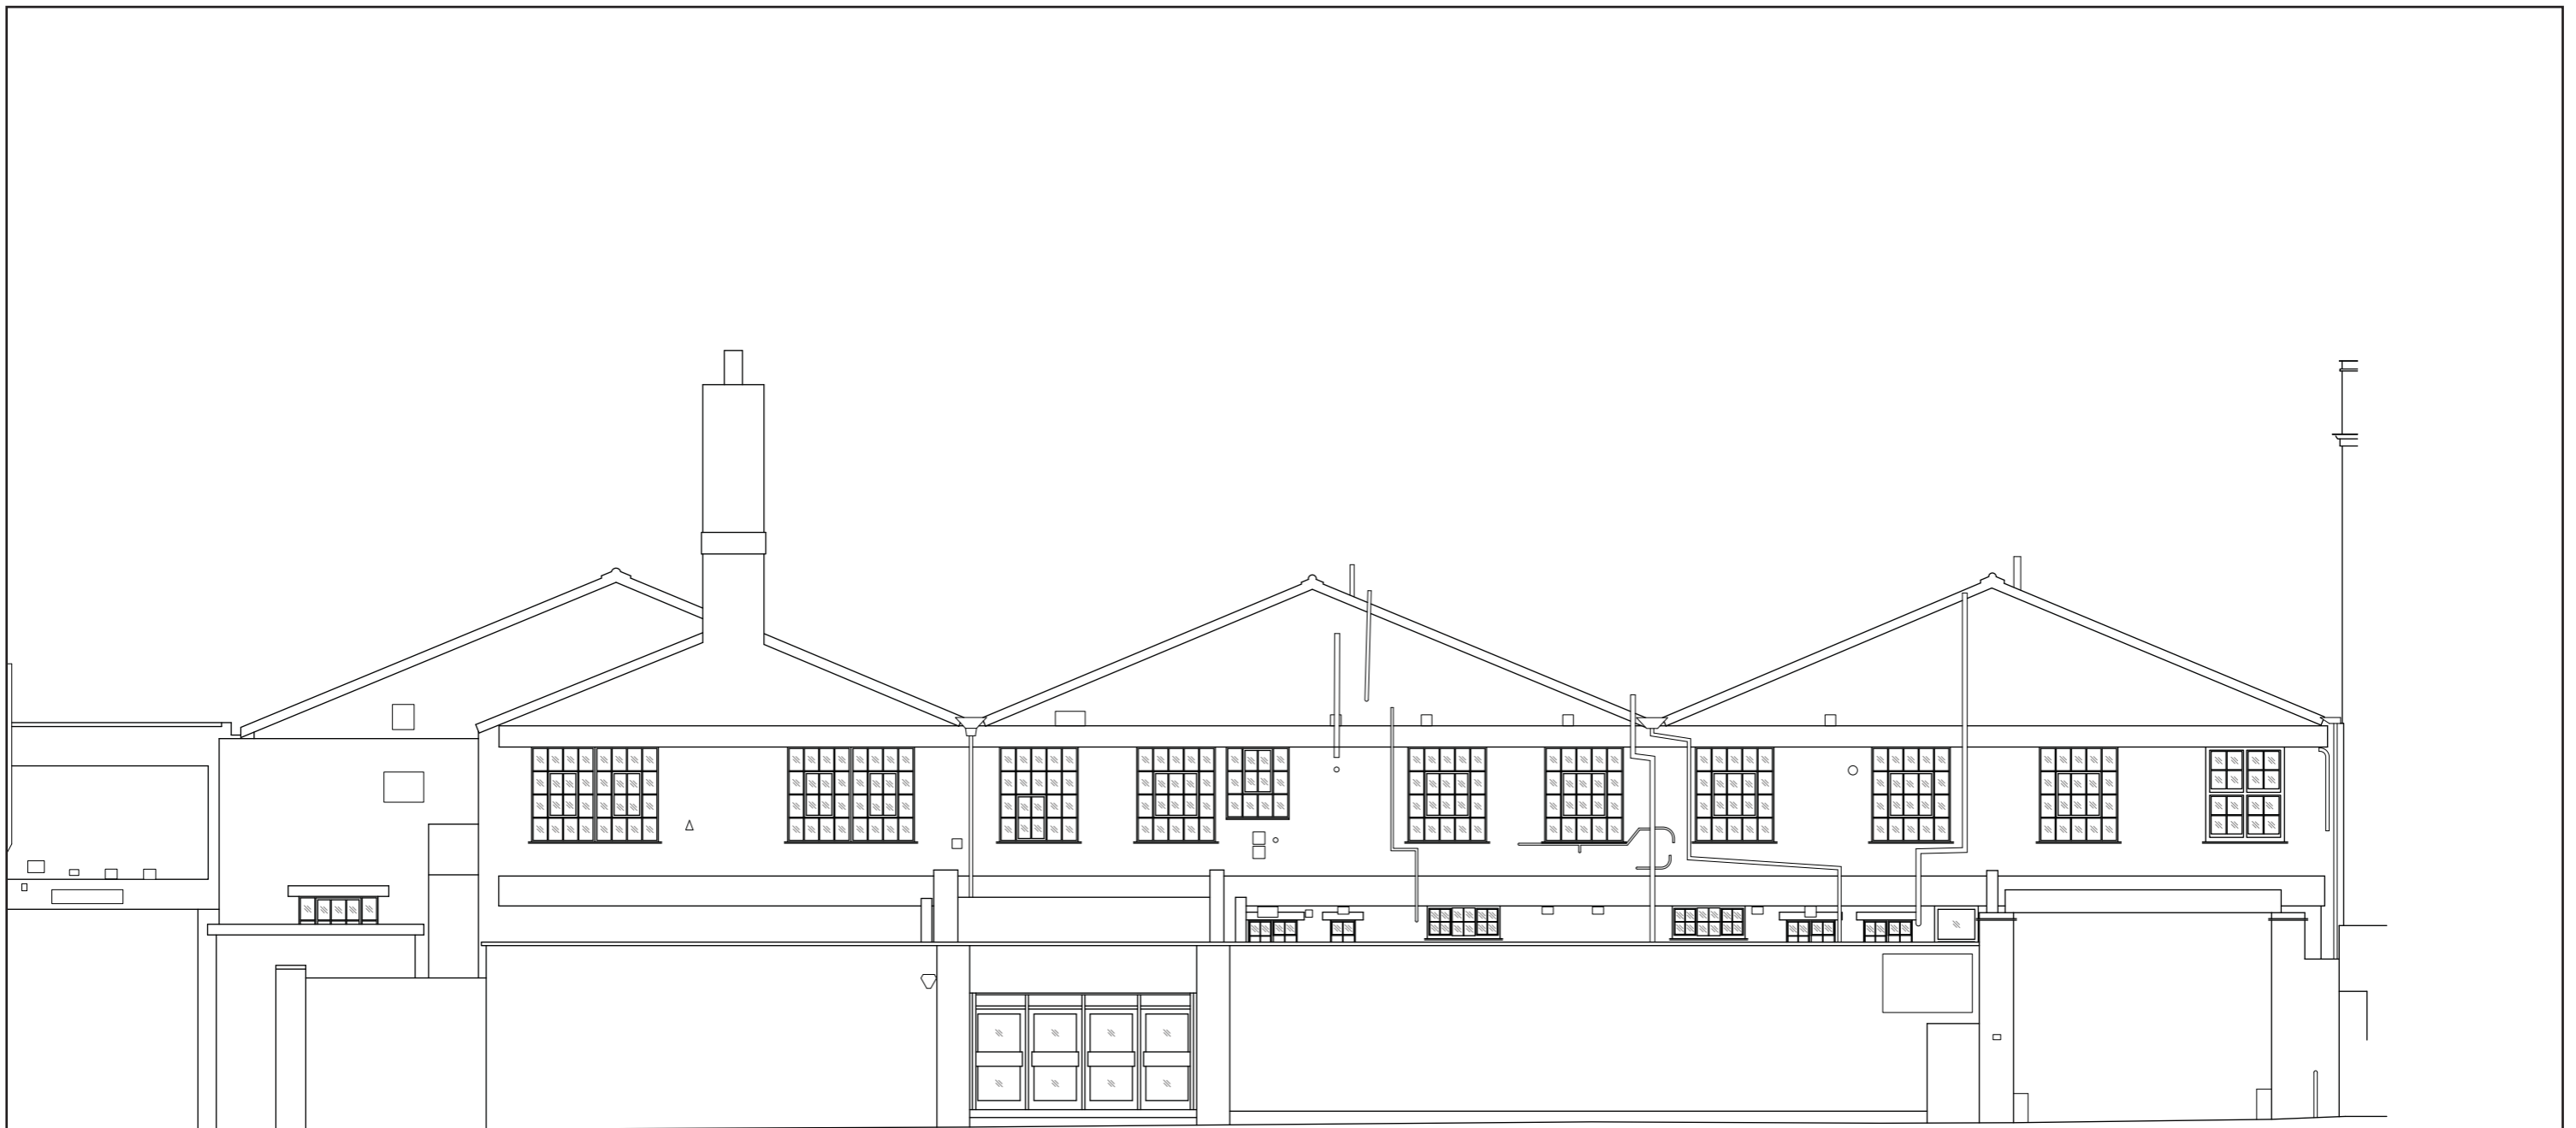
© Archaeology South-East		Faircharm Creative Quarter, Lewisham	Fig. 10
Project Ref: 6611	August 2014	Building A, west elevation	
Report Ref: 2014286	Drawn by: MGH
