**ARCHAEOLOGICAL AND HISTORIC BUILDING
RECORDING WATCHING BRIEF REPORT
STREAM COTTAGE, MOOR LANE, GLYNDE
EAST SUSSEX BN8 5UR**

**Site Code: MLR 13
ASE Project No: 6120**

**ASE Report No: 2014218
OASIS ID: archaeol6-190460**

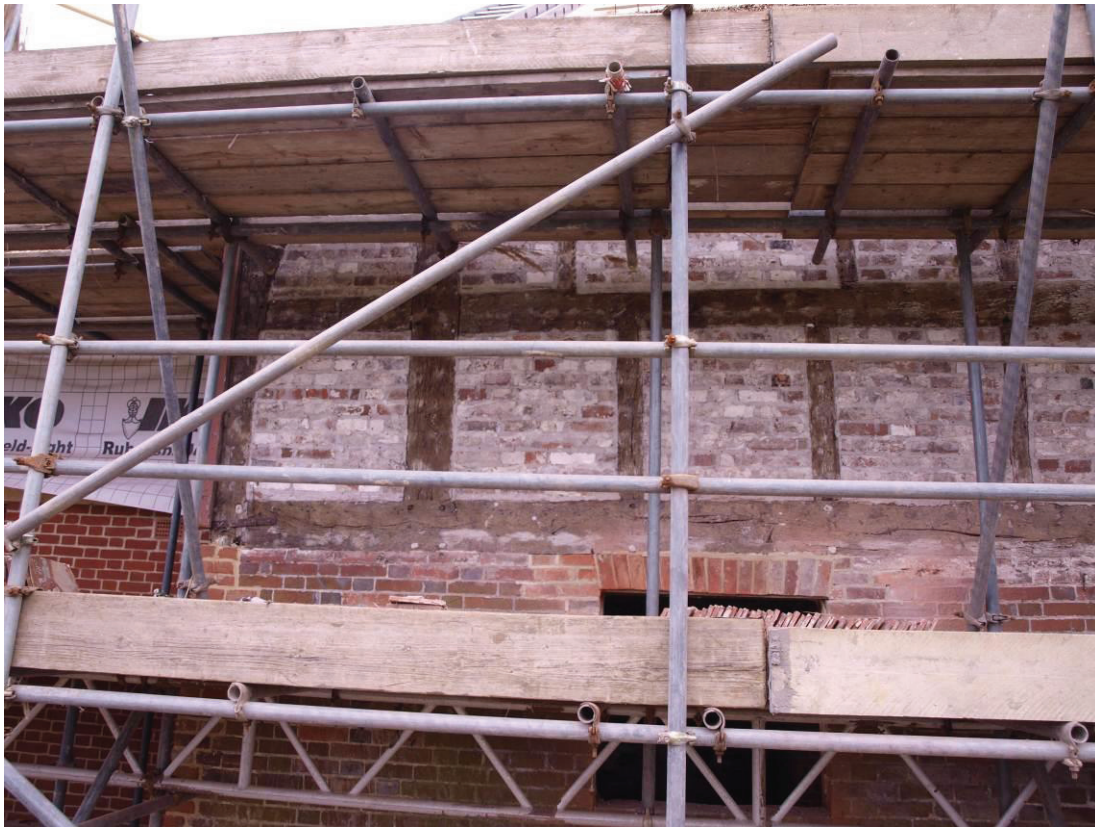
Plate 1: Small panel framing to the north-east elevation, showing substantial stud (44)

- 5.2 The removal of tile-hanging revealed the timber-framed construction of the first floor exterior walls, which comprise small panel framing, with the mid-rail generally interrupting the studs, and the panels being in-filled with later brickwork. To the north-east elevation, a substantial stud interrupts the mid-rail towards the eastern end of the elevation (Plates 1 & 2). The south-east elevation is constructed somewhat differently, with studs interrupting the mid-rail. Two foot braces are visible on the south-east elevation extending down from the southern corner post and the post south of the central chimney bay (Plate 3). The timber frame has been strengthened with the addition of iron straps between the corner posts and side and end girts, and between the posts to either side of the chimney bay and the side girt on the front (north-west) elevation. Neat carpentry marks are visible to the frame of the front and rear elevations (Plate 4).

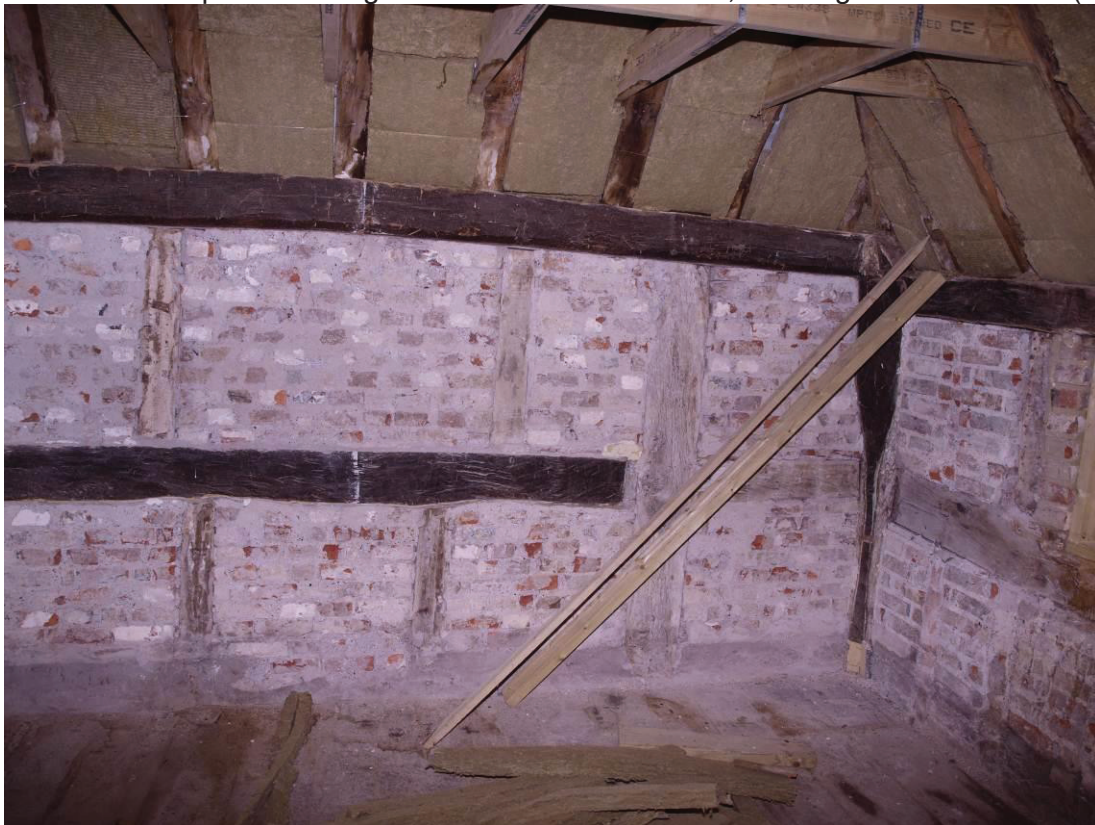
Plate 2: Interior view of first floor of the north-east wall (25)

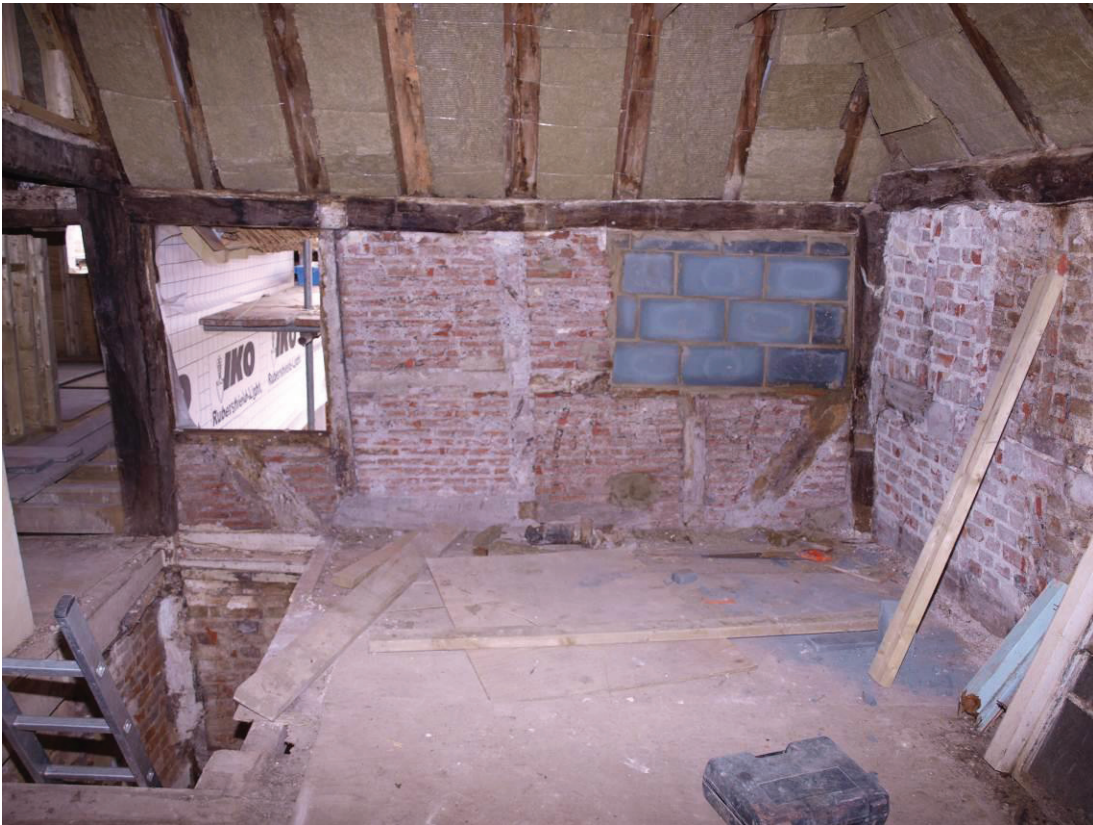
Plate 3: Interior view of first floor of south-east wall (34)

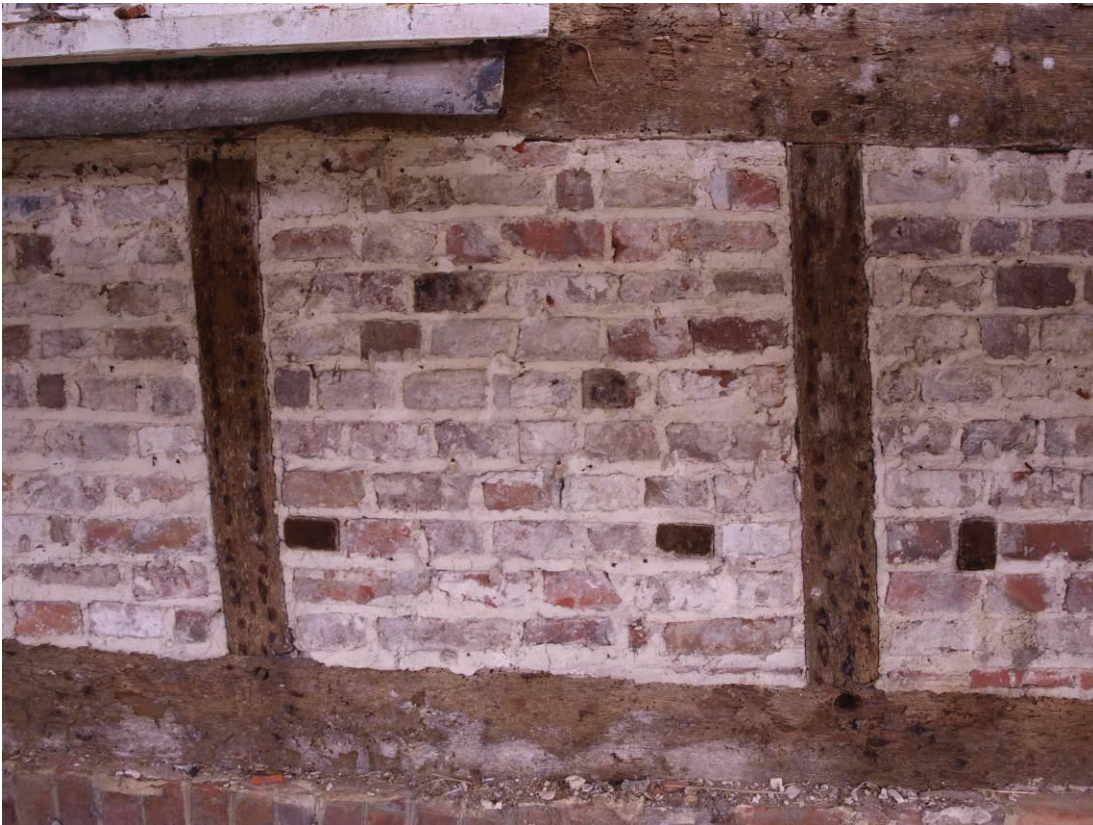
Plate 5: Brick infill to front elevation, showing small timber bearers (51)

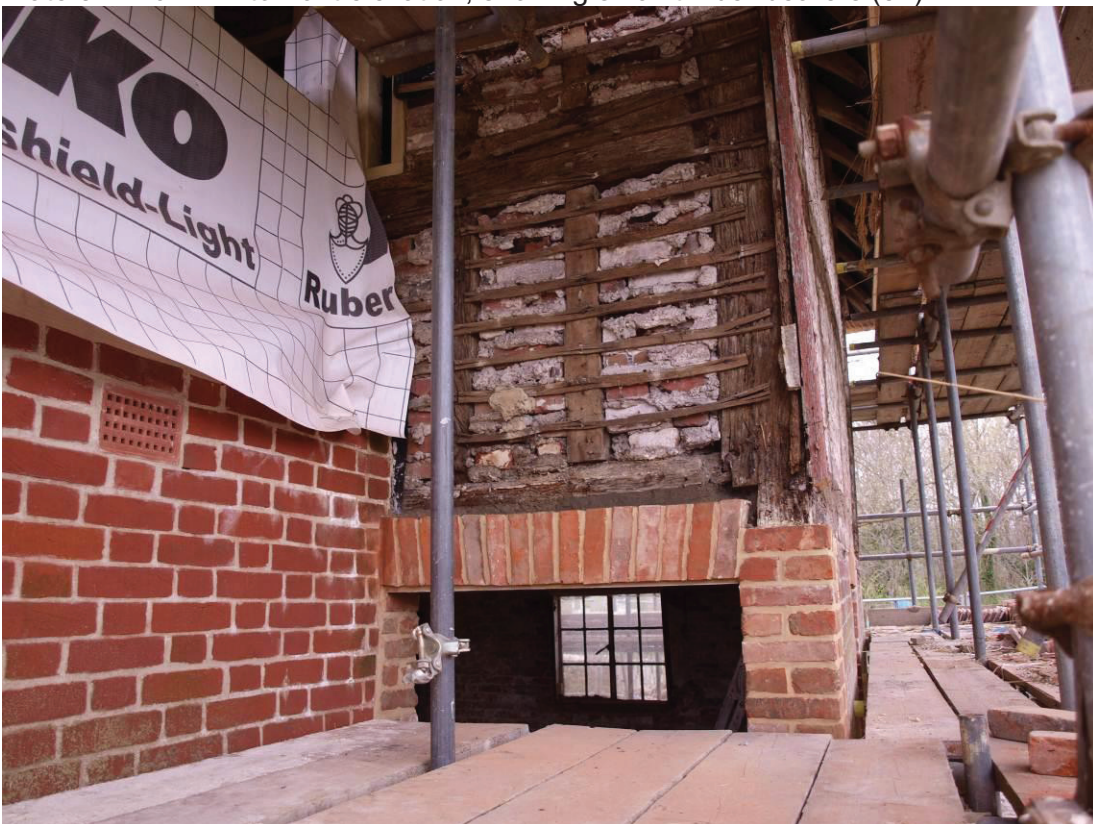
Plate 6: Intermediate stud and laths for tile-hanging (43)

- 5.3 The infill predominantly comprises dark orange-red brickwork, with some over-burnt kiss marks, and includes occasional vitrified headers. The stretchers measure approximately 200-225 x 60mm. Many of the bricks retain remnants of a painted finish suggesting they have been reused. The brickwork is coursed but not arranged in a distinct bond. To the front elevation the infill includes a course of intermittent, header-sized timber bearers, above the level of the first floor (Plate 5). These were presumably included to facilitate the addition of laths for tile-hanging of the upper floor. To the rear elevation, intermediate studs have been nailed in place to carry the laths; at the eastern end of the elevation long riven laths survive *in situ* (Plate 6).

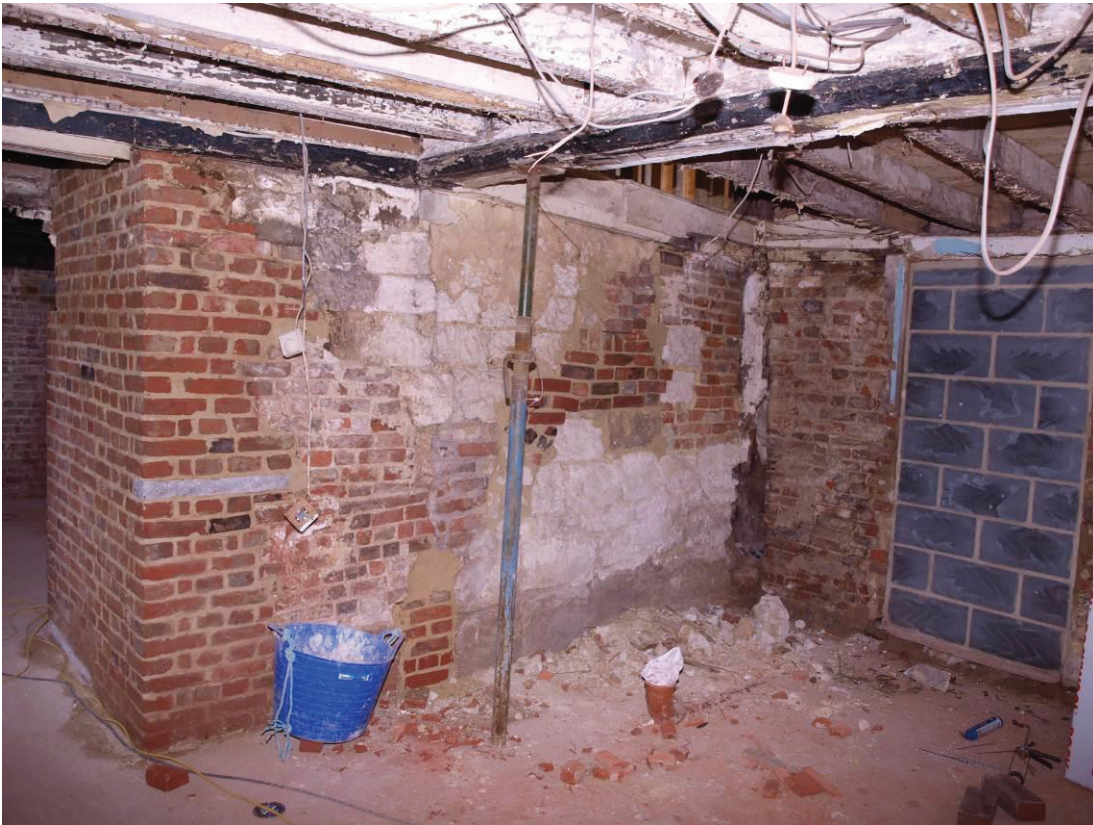
Plate 7: The exposed construction of the back of the chimney stack at ground floor level (1)

- 5.6 The construction of the chimney stack had been exposed. The back of the chimney, facing south-west into the service end of the building (1), is constructed in a combination of chalk blocks and brickwork (Plate 7). A substantial area of chalk blocks is located at the base of the stack at its southern end. These blocks are dressed and are irregular in size, with smaller blocks added in to allow for rudimentary coursing. The largest visible block measures 730 x 240mm. A further area of chalk blocks is located towards the northern end of the stack, forming its upper half at ground floor level. The chalk blocks here are smaller measuring approximately 300 x 150-200mm and again are roughly coursed. The areas of chalk construction are interspersed with a variety of brickwork; this appears to be predominantly of 19th century date, with the exception of a small area of possible earlier brickwork at the southern end of the stack, at its junction with the outer wall and ceiling. This area of brickwork is approximately 400mm high x 740mm wide, and comprises orange bricks with darker, over-burnt patches, measuring 155-160 x 55mm, set in a fairly hard grey lime mortar. The stack also bears evidence of some modern repairs.

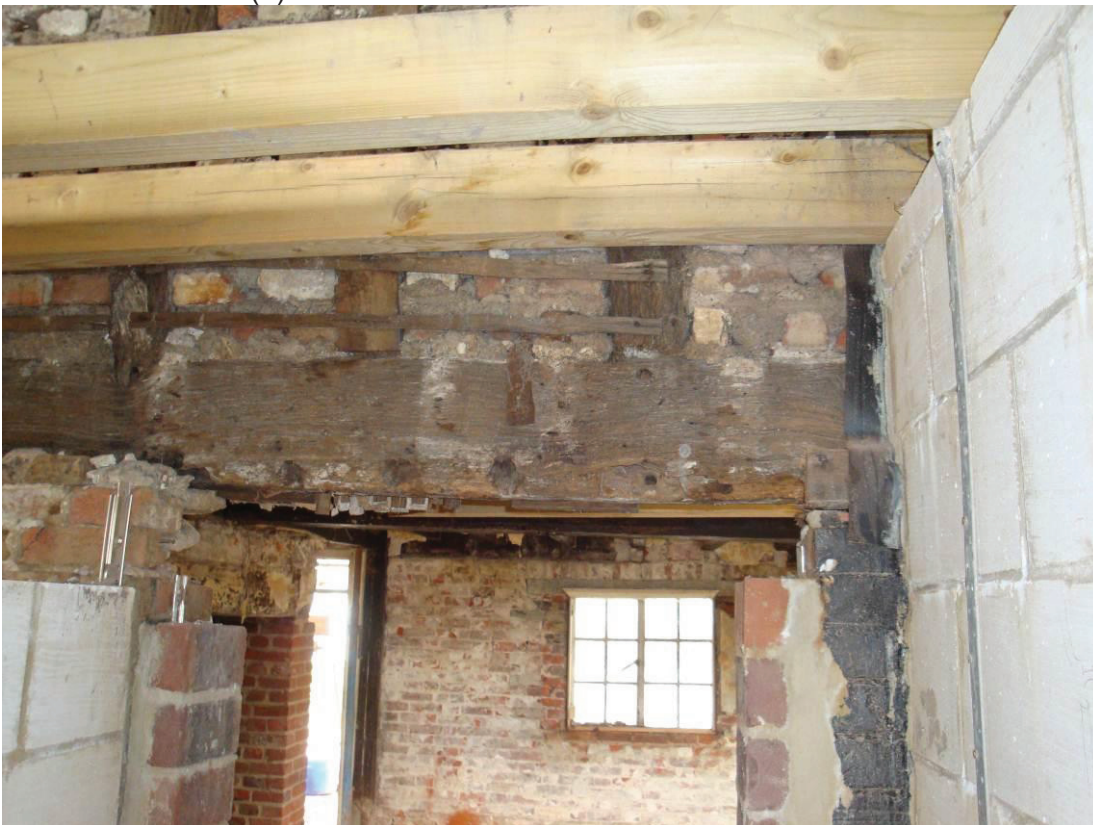
Plate 8: Redundant mortices for window jambs and mullions in south-east side girt (56)

- 5.8 The bread oven itself, which had been blocked, was partially opened up, revealing it to have a segmental brick apex and a slender iron lintel above the oven opening.
- 5.9 The side girt to the south-east wall contains three diamond-shaped mortices for a four-light window (Plate 8).

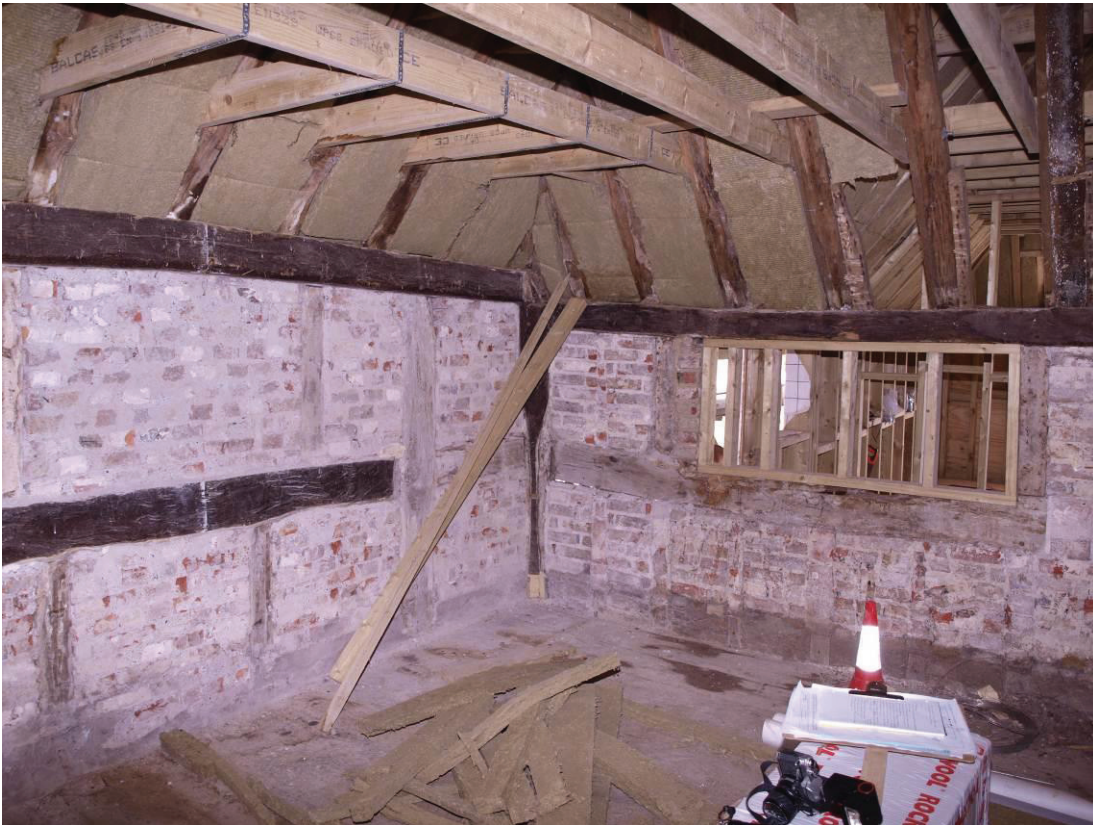
Plate 9: Hall chamber, looking east, showing interior brick/tile cladding to studs of south-east wall (22)

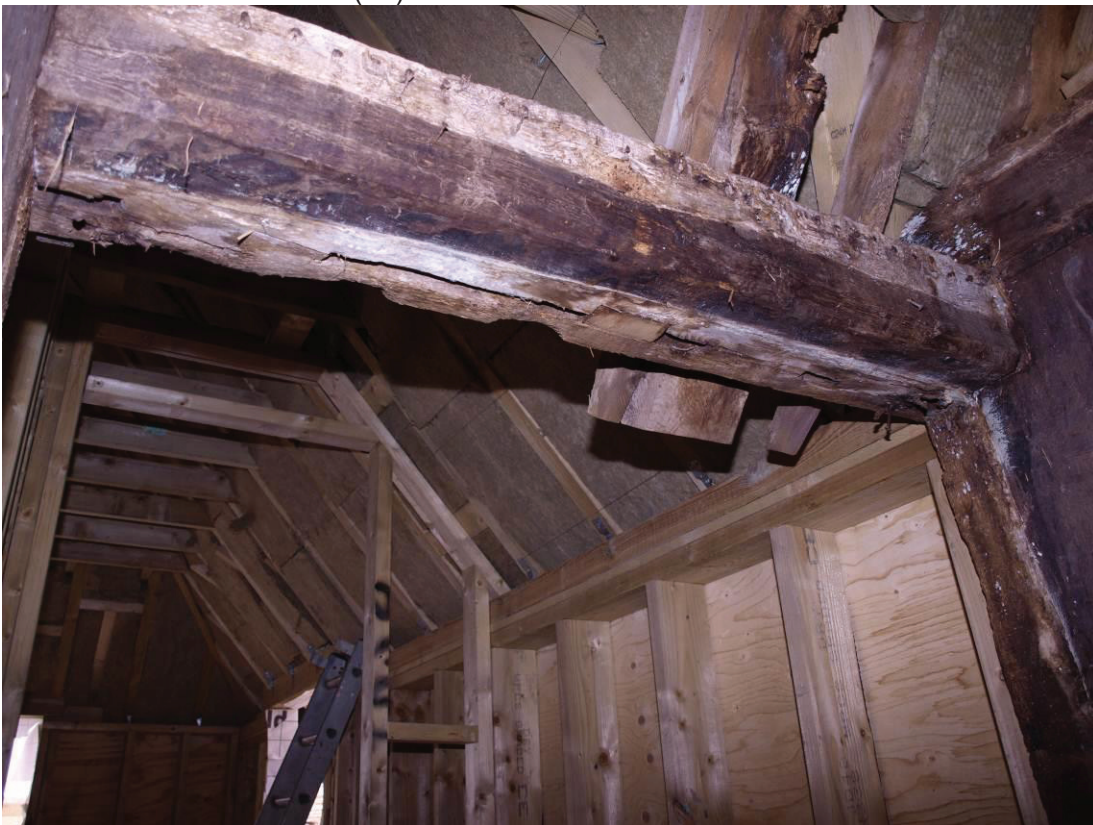
Plate 10: Redundant mortices in soffit of wall-plate on first floor landing (28)

- 5.11 The wall-plate to the landing on the south-east side of the chimney stack is similarly chamfered and run out. The soffit of the wall-plate had been exposed to provide access to the first floor of the rear extension and contains a central stud mortice with a single stave mortice to either side (Plate 10). The posts flanking the chimney bay bear no evidence of mortices for a mid-rail.

- 7.3 Stave mortices in the soffit of the south-east wall-plate, visible on the first floor landing, confirm that the original infill to the timber frame would have been lath and daub. This has been replaced with brick infill; the rough appearance of the infill compared to the facing brickwork at ground floor level suggests that it was always intended to be hidden by external tile-hanging and an internal plaster finish. There is some similarity to the internal brickwork at ground floor level, suggesting that the infilling and tile-hanging of the first floor probably occurred at a similar time to the rebuilding of the ground floor, to give the house an updated appearance. The use of what appears to be brick paviours to infill the framing of the south-east wall possibly relates to a separate, perhaps slightly later phase of updating.

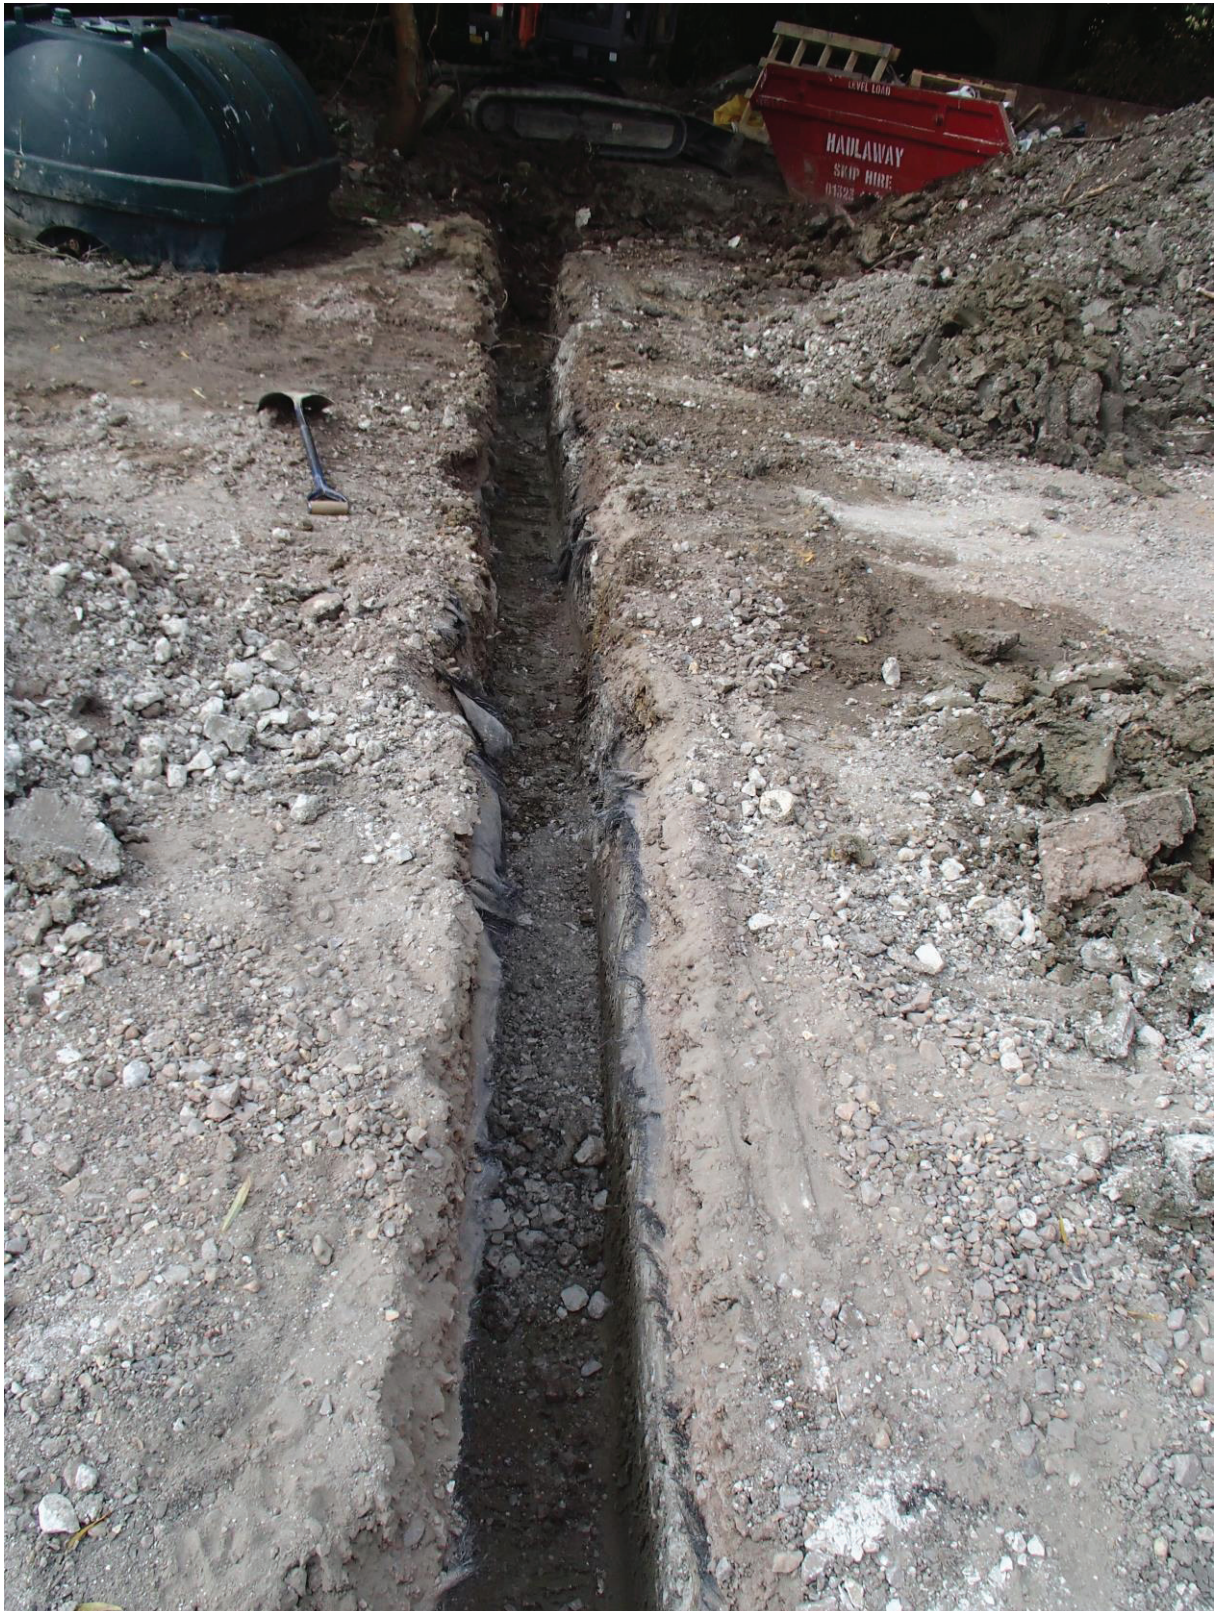
Plate 11: Oil trench looking SW in centre of site

- 6.1.1 Mechanical excavations for the base of a new oil tank in a copse of trees to the east of the house, measured 3.1m by 2.1m by 300mm in depth. The only encountered deposit was a heavily rooted disturbed humic, mid-brown silty clay topsoil, context [001].
- 6.1.2 A 300mm wide, 600mm deep trench was mechanically excavated between the new tank and the existing house. The topsoil adjacent to the new tank was similar to context [001] and was recorded as context [012]. As the trench proceeded across the previous site access, the stratigraphy consisted of a layer of 'Type 1' crushed stone, context [008], laid on a terram sheet, context [009]. This overlay a layer of crushed chalk, context [010], which in turn overlay a mixed deposit of made ground, context [011], which extended to the base of the trench.

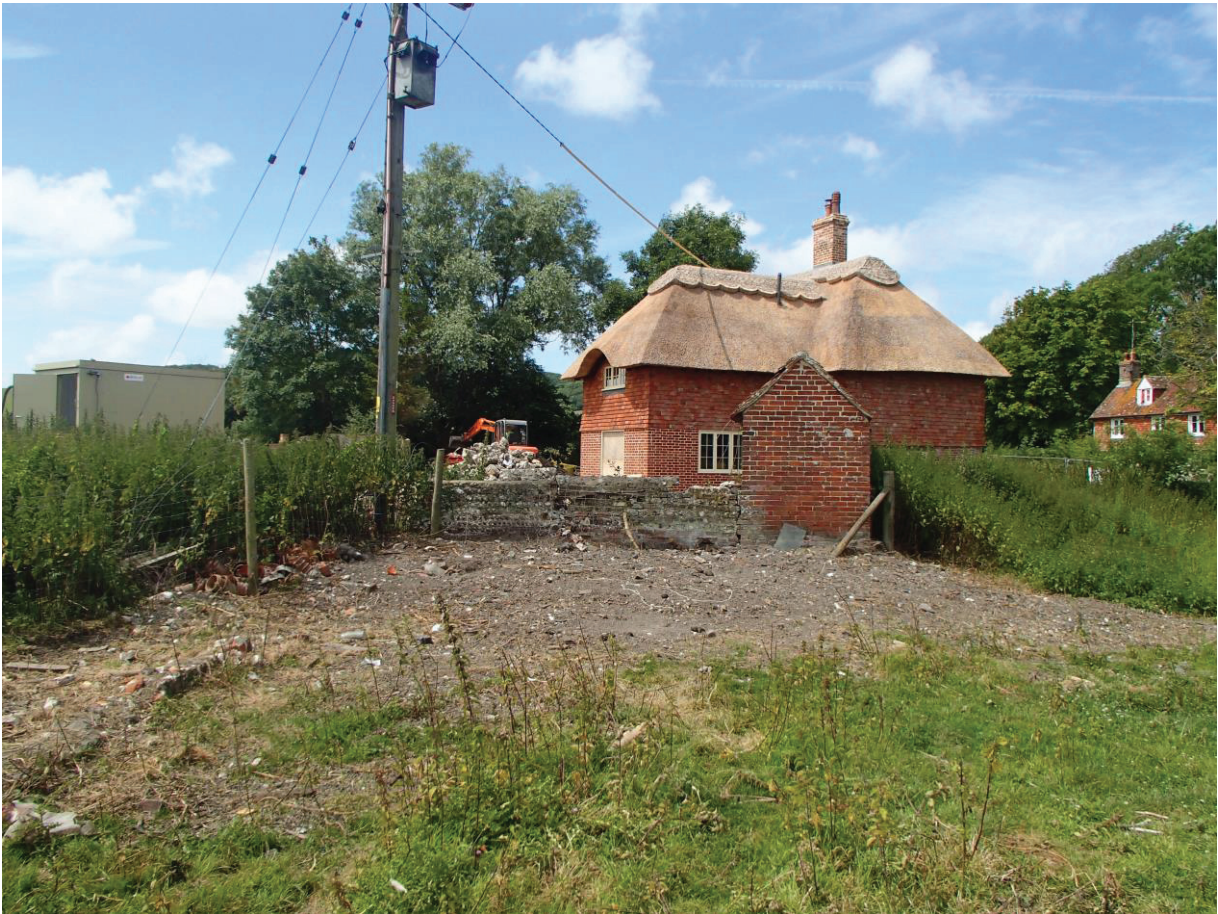
Plate 12: Midden visible on surface to the east of the main house looking W

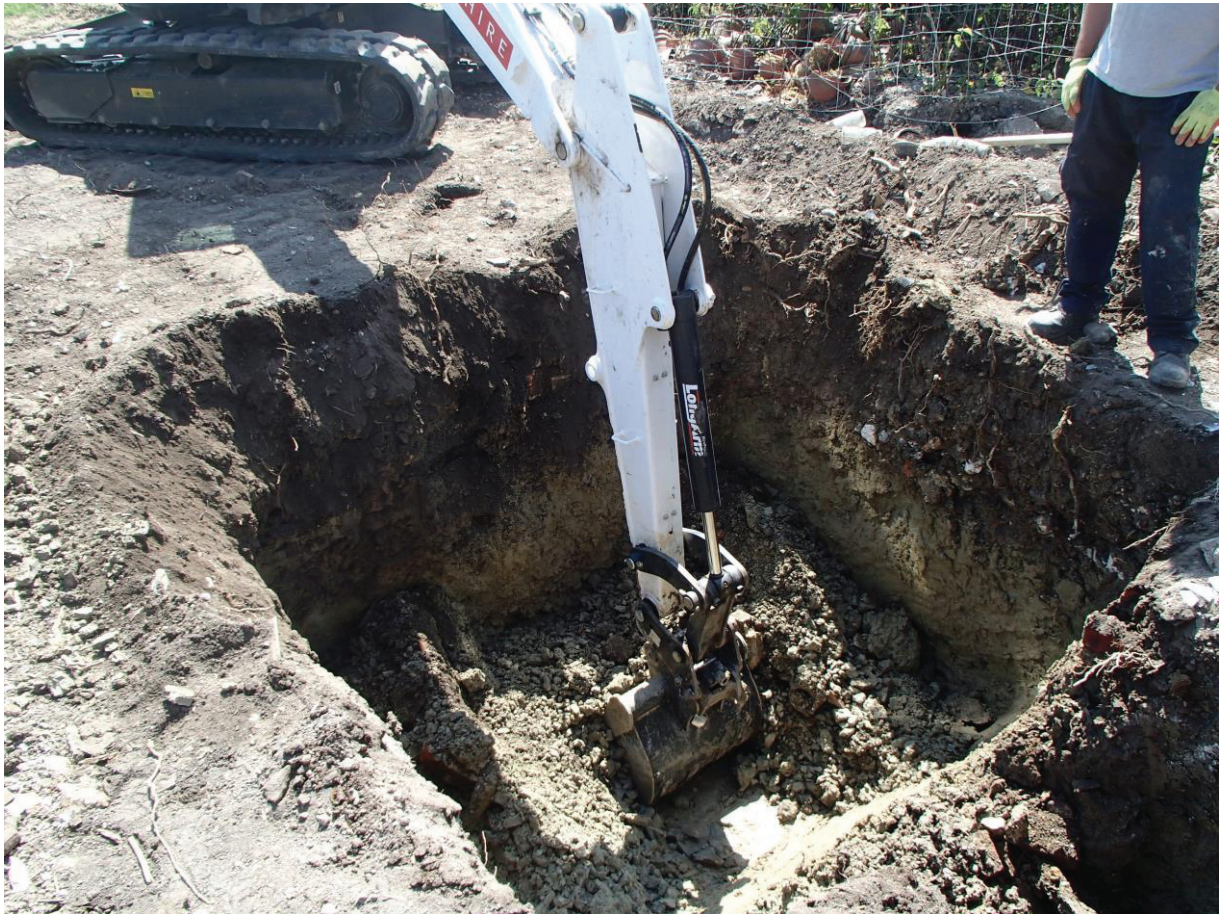
Plate 13: Excavations for the septic tank

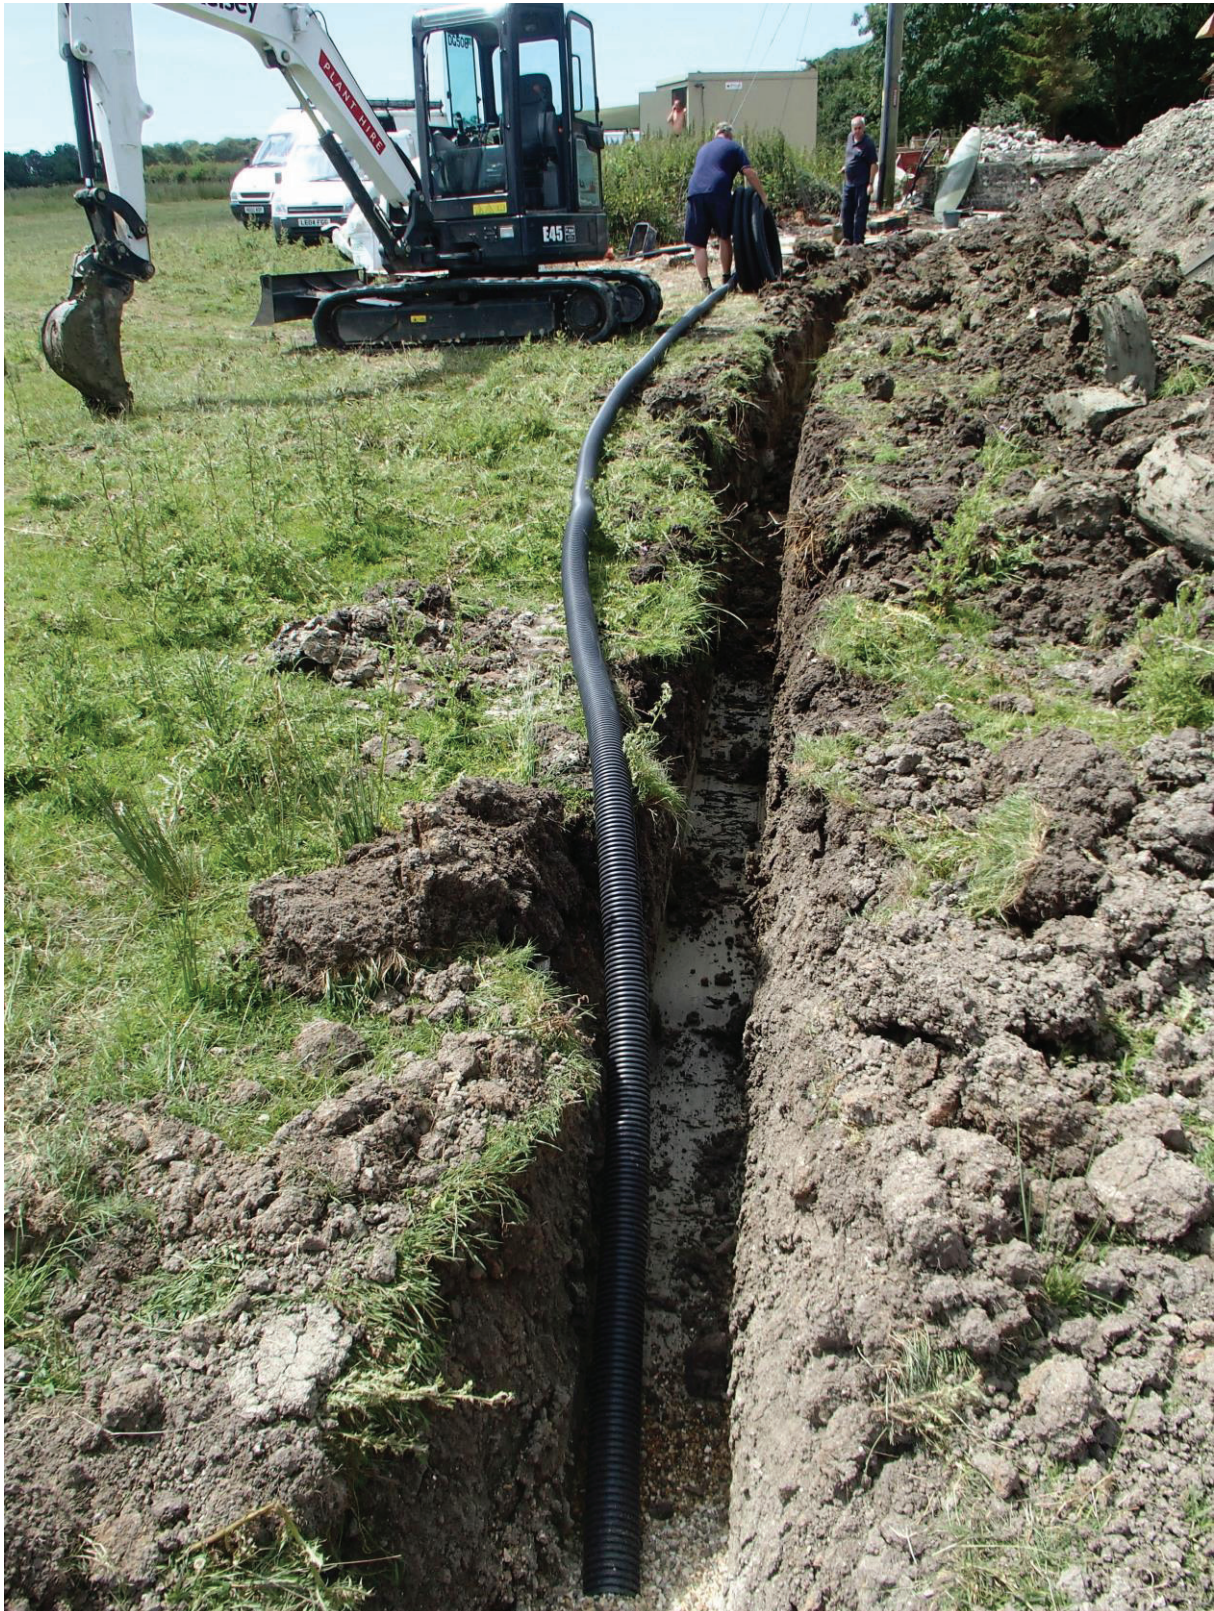
Plate 14: Outflow trench looking west

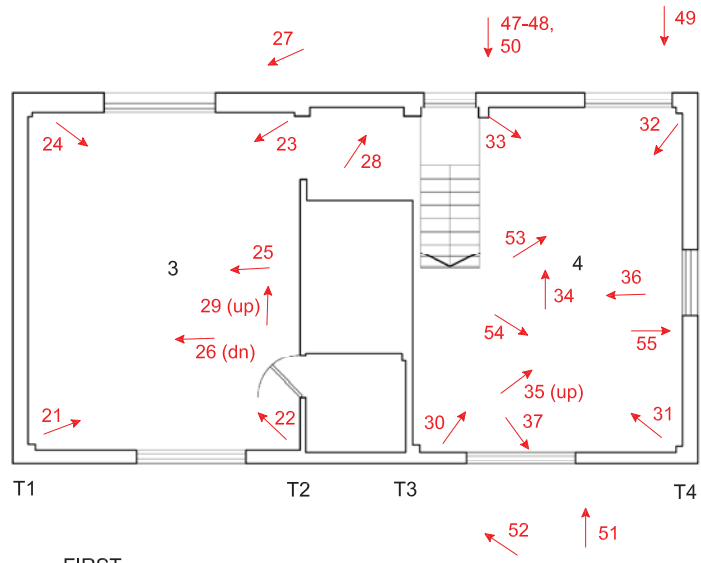
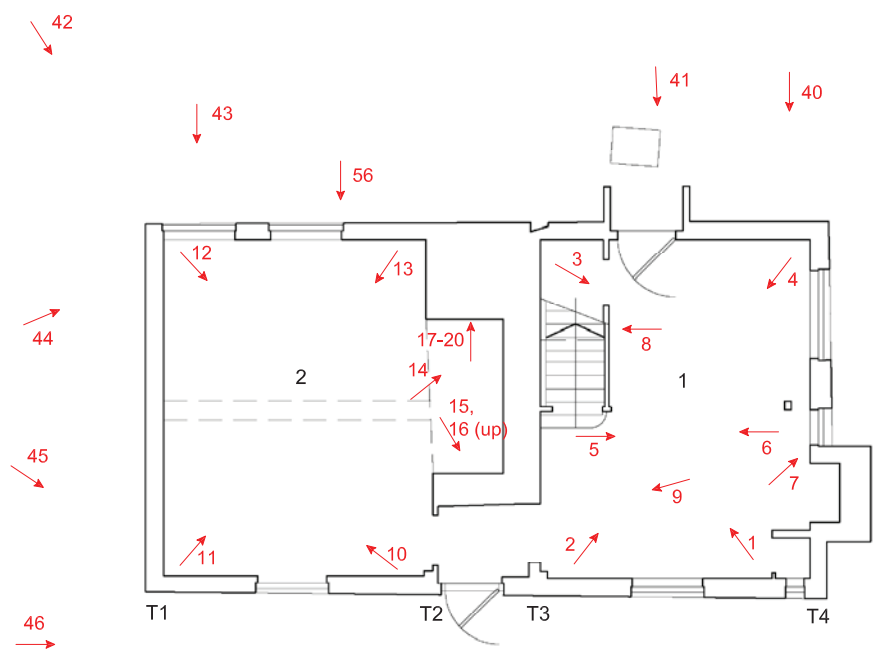
© Archaeology South-East		Stream Cottage, Moor Lane, Glynde	Fig. 3
Project Ref: 6120	Jun 2014	Floor plans and photograph locations	
Report Ref: 2014218	Drawn by: KRH

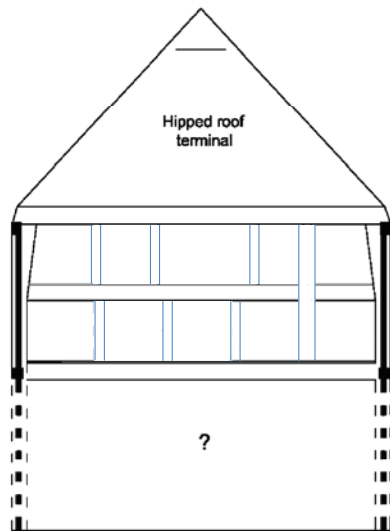
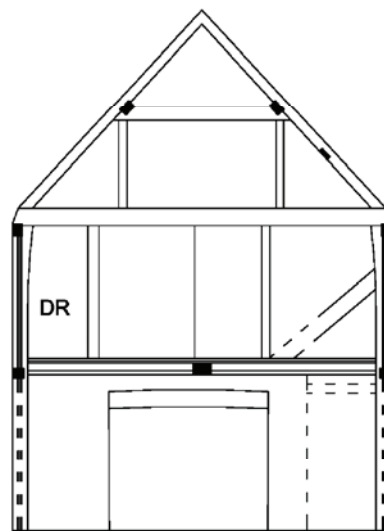
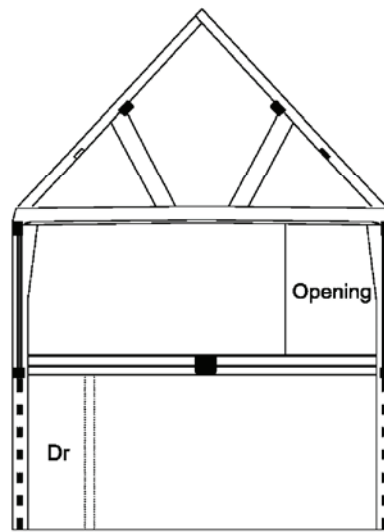
T1 - southwest facing

T2 - northeast facing

T3 - southwest facing

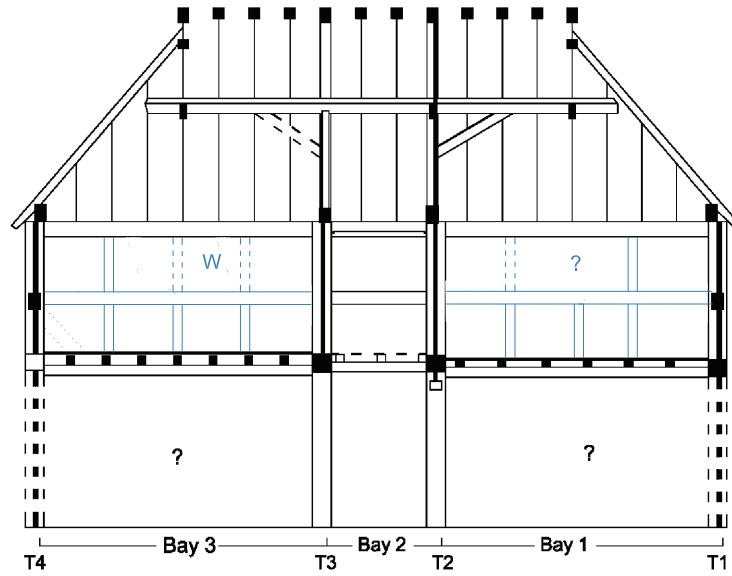
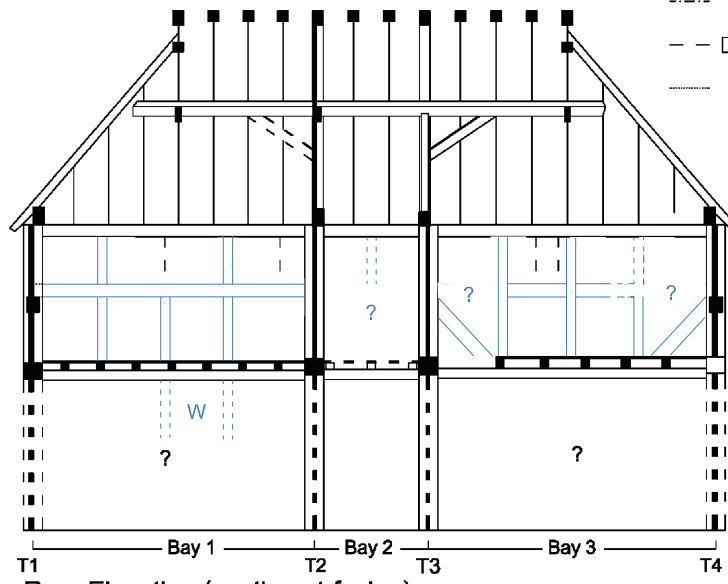
Principal Elevation (northwest-facing)

Rear Elevation (southeast-facing)

- 7.4 The location of two original windows was confirmed, both of which were four-light diamond-mullioned windows and in locations occupied by later windows.
