**Detailed Magnetometer Survey Report
First Time Sewerage Scheme
Three Oaks, East Sussex**

**Rother District Council (Delegated to ESCC)
Planning Reference: RR/2014/2177/CM**

**Site Code: TOS 14
ASE Project No: 6599**

September 2014

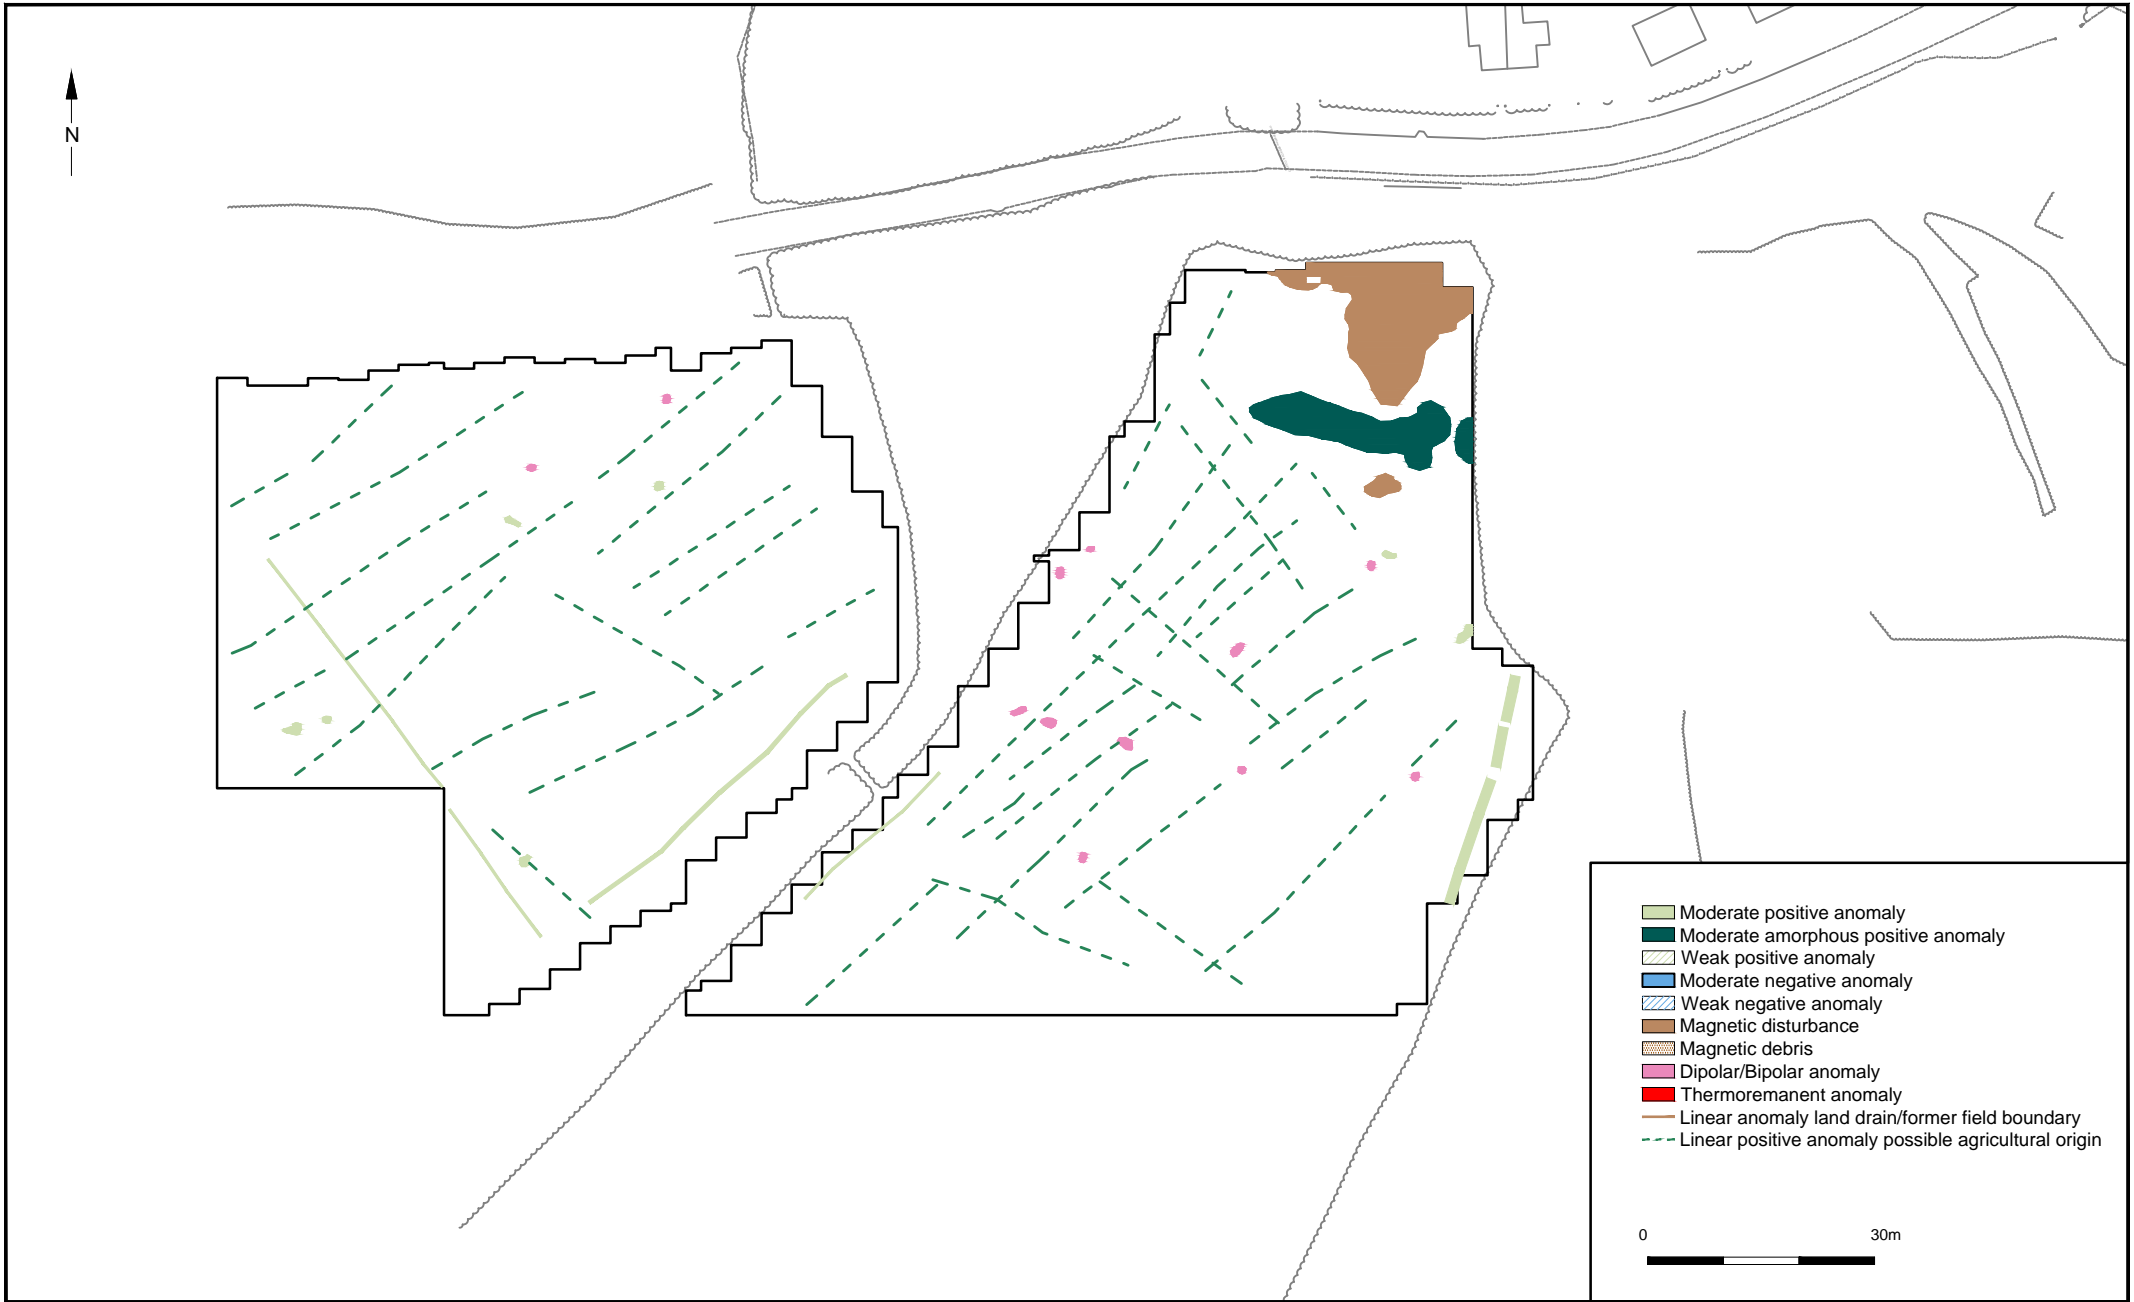
4.4.1 The most significant anomalies noted in Area 1 comprised linear moderate positive anomalies. Two corresponding linear moderate positive anomalies identified in the west field and another in the east field may represent cut features such as ditches.

4.4.2 A number of surrounding linear moderate and weak positive anomalies throughout the area may represent agricultural practices such as ploughing. The anomalies are all quite equally spaced apart and appear to be on the same alignment as the field boundaries.

4.4.3 Occasional discrete moderate positive anomalies may reflect cut features such as pits. However, these anomalies may also relate to in filled natural features or more modern agricultural activity.

4.4.4 A moderate amorphous positive anomaly in the north-east part of the area may indicate a change in geology.

4.4.5 An area of magnetic disturbance was identified in the north-east end of the field. This is probably related to an electricity service in the corner of the field. A smaller area of magnetic disturbance may result from previously excavated boreholes in this area.

4.4.6 A scattering of dipolar/bipolar anomalies may reflect buried kilns or ovens or may result from discreet ferrous objects in the near surface of the field.

- 5.1.2 The anomalies identified have been assessed in relation to historic mapping (ASE 2014a). Several linear moderate positive anomalies of probable agricultural origin were identified. These anomalies run in at least two different directions indicating multiple phases of agriculture. Cartographic evidence shows Areas 1 and 2 have been mostly open land used for agriculture from as early as 1668. However, these anomalies are also cut features and a number of them may also relate to archaeological features. The moderate amorphous positive anomaly noted in Area 1, Figure 5, may relate to the former watercourse marked as Sailors Stream on the Hundred of Guestling, 1788.
