**Archaeological Monitoring
Colville Hall
Chelmsford Road
White Roding
Essex**

**Project No: 8195
Site Code: WHRCH 12 & 14**

Report No: 2014317

**ASE Report No: 2014317
OASIS No: 192086**

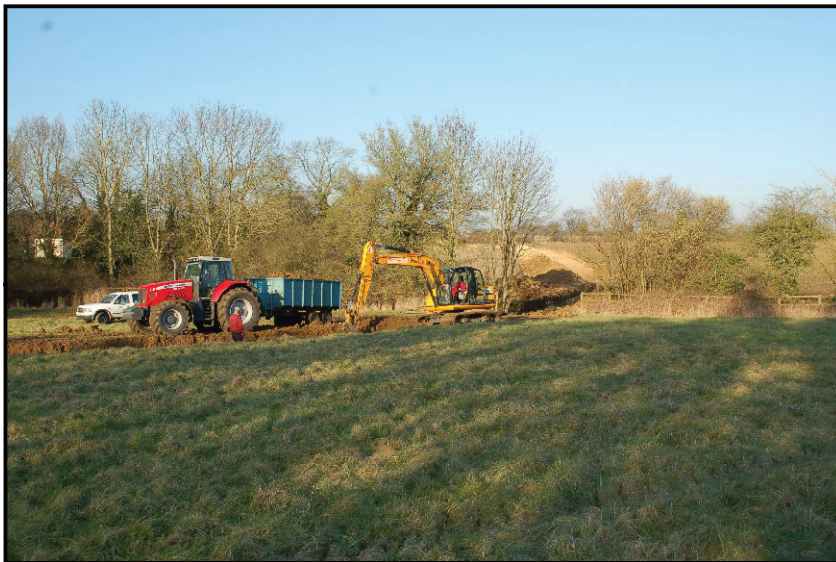
4.1.1 A c.240m long and 5m wide access road for the proposed wedding venue was excavated by machine on the north-east side of the site in February 2012 (Figs. 2 and 3.1). Its route followed a course from the main road in a curvi-linear south-westerly direction across arable land, following the natural slope of the valley down to the brook at the bottom, from where the ground again rises across meadow land up to the existing farm track on the east side of Mill Pond Barn. Land on the north side of the brook was outside the Ancient Monument but land on its south side was within it (Fig 1).

3.1 General view of the access road, looking north

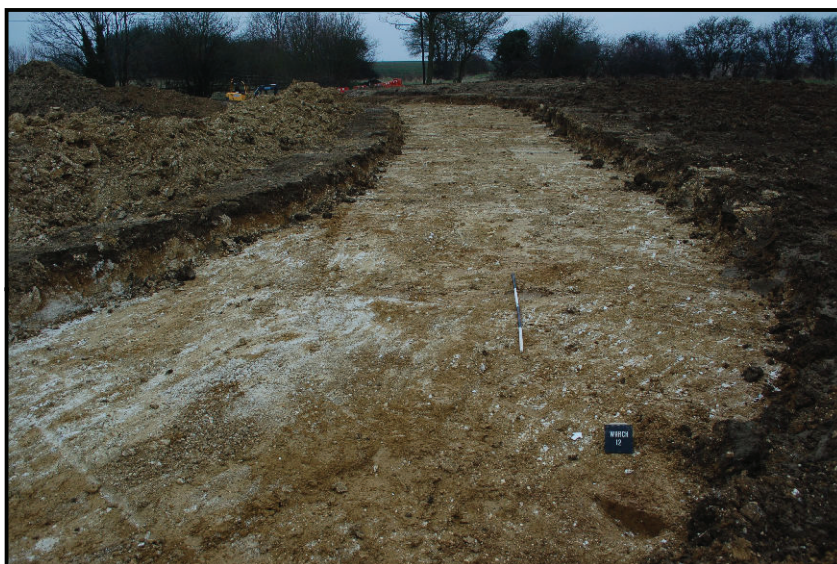
4.1.5 At the northern end of the access route was oval post-hole [12], approximately 0.5m in diameter, on the east side of the trench (Fig. 3.2). It was filled by [11], a natural-looking clean single brown silty clay with occasional chalk flecks typical of the fill deposits here. The feature was shallow, at only 0.12m, with a flattish base and was either a naturally-derived feature or perhaps part of an undated structure of some sort. There were also several narrow curvi-linear features to the south that appeared to be natural in origin and were not excavated.

3.2 Feature [12], 2m scale, looking north-west

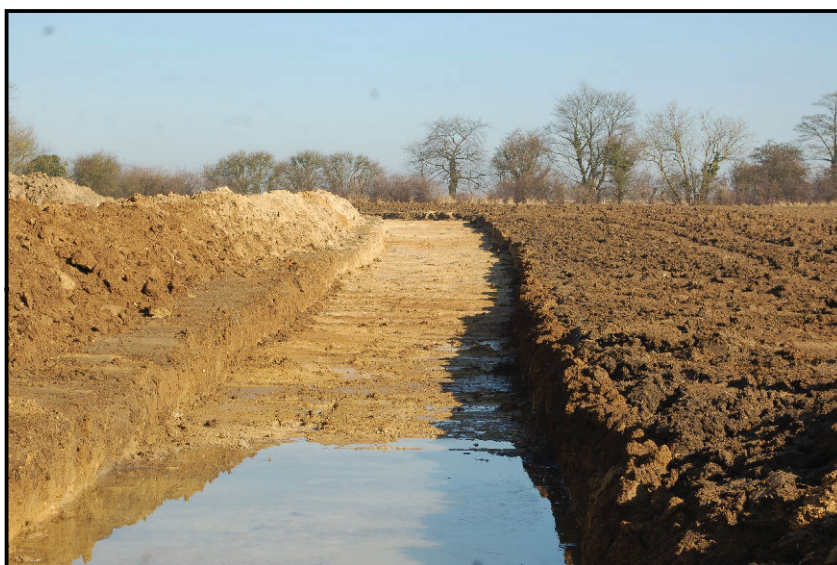
4.1.7 Just to the south of these were two linear features, [18] and [20]. Again, these were shallow and filled with the same brown silty clay and their irregular edges suggested they were also natural features. Beyond this was an east-west aligned probable old field boundary [22] which was not excavated because a field drain and water main were cut through by the machine and the lower part of the trench became flooded (Fig. 3.3).

3.3 General view showing the flooded access track in the vicinity of feature [22]

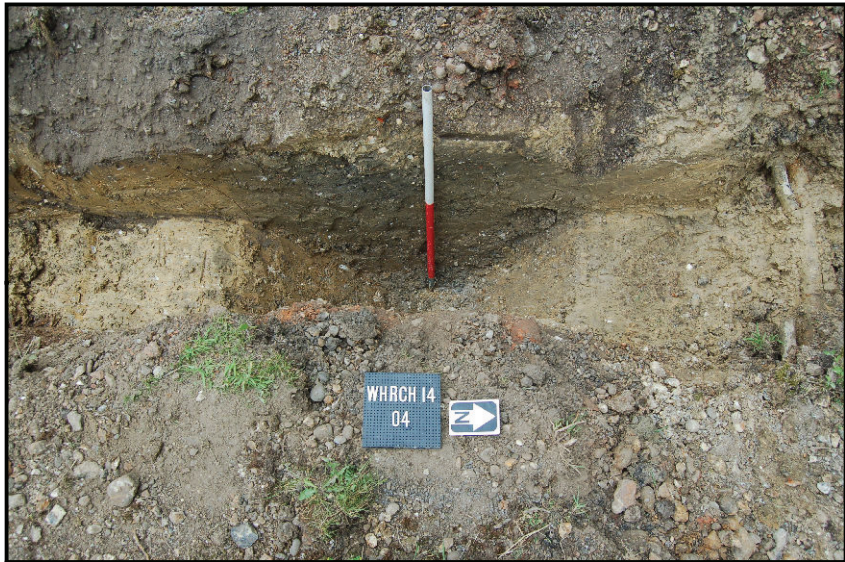
4.2.3 Two linear features were identified within the trench. The first was an east-west aligned ditch [04] located on the short L-shaped arm of the trench, feature (Fig. 4). This was a fairly substantial linear cut measuring 1.65m wide and 1m deep, into the natural clay and overlain by track deposits (Fig.5.1). It was filled with [03], a brown-grey silty clay, which contained burnt daub and charcoal fleck inclusions and finds of two pot sherds, bone and brick/tile dating it to the early post-medieval period. The second feature was a 2.1m length of north-south aligned ditch that terminated within the spur of the barn extension trench. Ditch [06] had steep sides and a rounded profile. It appeared to cut another feature, possibly a pit, [08], on the west side; although both features had similar fills (Fig. 5.2). No finds were collected from these features. Excavation showed it to be 1.25m deep, again cutting into the natural clay soil. A dark reddish brown layer was found mixed in with the natural further along the spur that was initially suspected to be a burnt deposit. However, the absence of burnt material associated with it, and its irregular nature, suggested it was a natural geological feature (Fig. 5.3).

5.1 Ditch [04], looking west, 1m scale

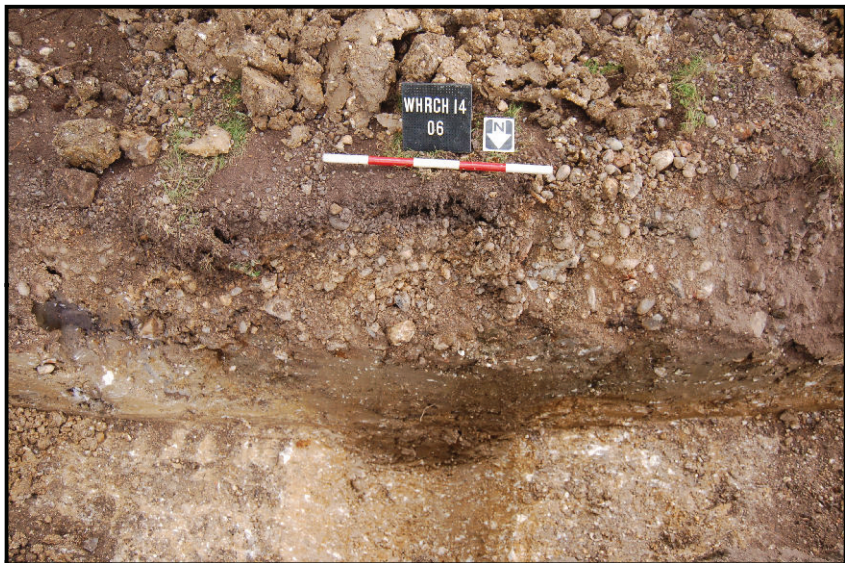
5.2 Ditch [06] and pit [08], looking south, 1m scale

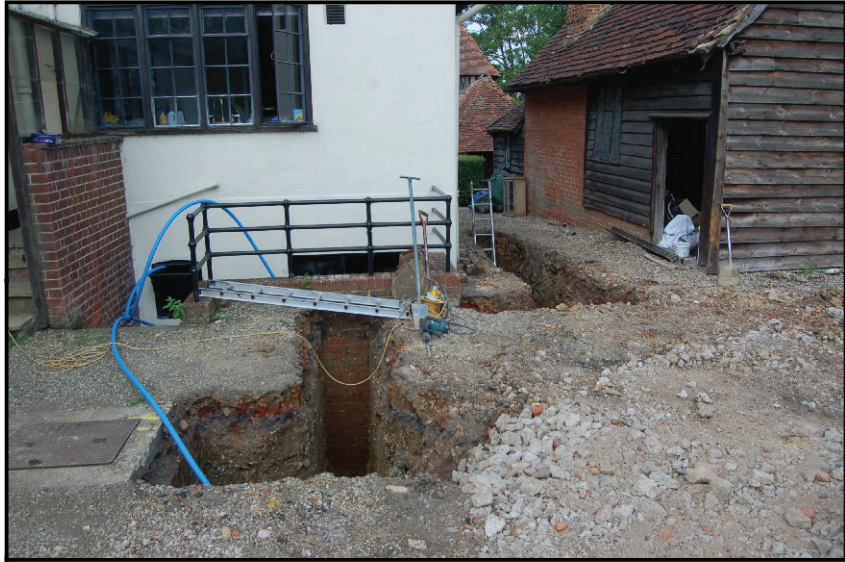
- 4.4.1 Service and foundation trenches in the vicinity of the kitchen and utility rooms were subject to archaeological monitoring in July 2014 (Fig. 6). These trenches were generally between 0.3m and 0.45m wide and up to 1.5m deep (Fig. 7.1).

7.1 General view of the kitchen foundation trenches

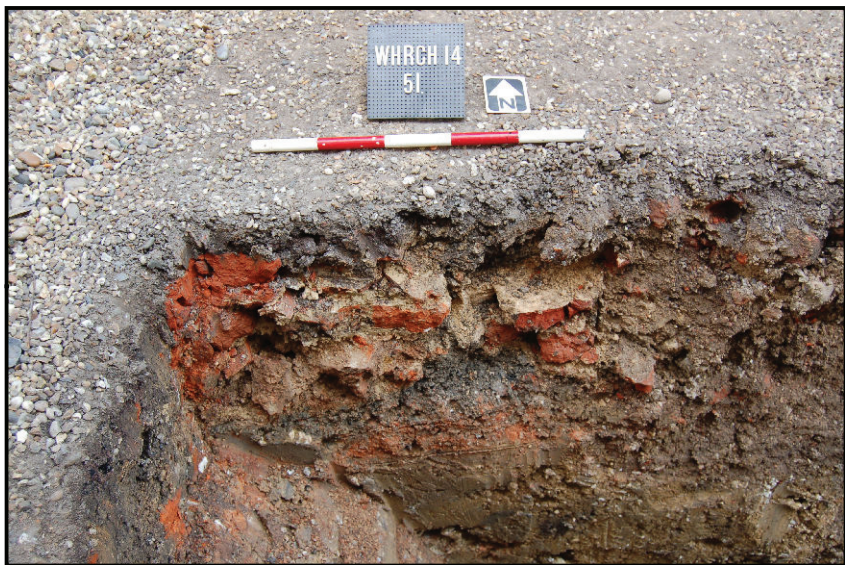
- 4.4.2 A north-south aligned wall [51]/[52] was located to the north of the kitchen extension (Fig. 7.2). Two courses of probable Tudor brickwork [51] were identified, adjacent to a course of similar un-mortared bricks [52]. They were constructed on a clay and mortar deposit [55] and a silty clay [56] which overlaid a mixed layer of crushed brick and clay layer [57] lining construction cut [54].

7.2 Wall [51], looking north, 0.5m scale

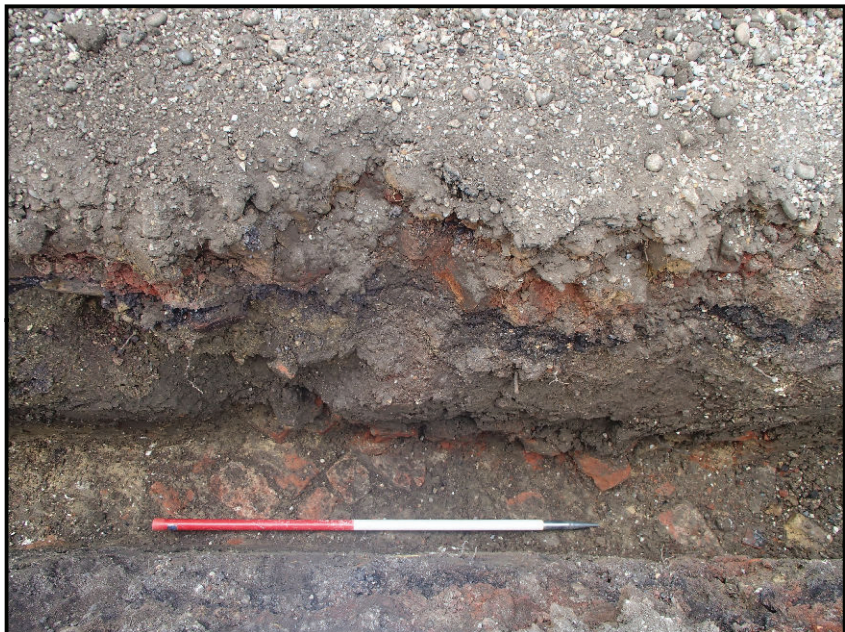
- 4.4.5 Deposit [39] was also identified to the north of the utility room. In this instance it overlaid the remains of two walls [46] and [48] (Fig.7.3), both built with Tudor brick and orientated north-south and east-west. These were in construction cuts [47] and [49]; the latter may link with wall [30]/[34] identified in the water pipe trench to the north.

5.3 Walls [46] and [48], 1m scale
