**FORMER CATERHAM VALLEY BOARD SCHOOL,
FARNINGHAM ROAD, CATERHAM**

**HISTORIC BUILDINGS RECORD
(ENGLISH HERITAGE LEVEL 2)
&
ARCHAEOLOGICAL WATCHING BRIEF**

Report No. 2014324

Site Code: FCA 14
Project No. 7064
Report No. 2014324

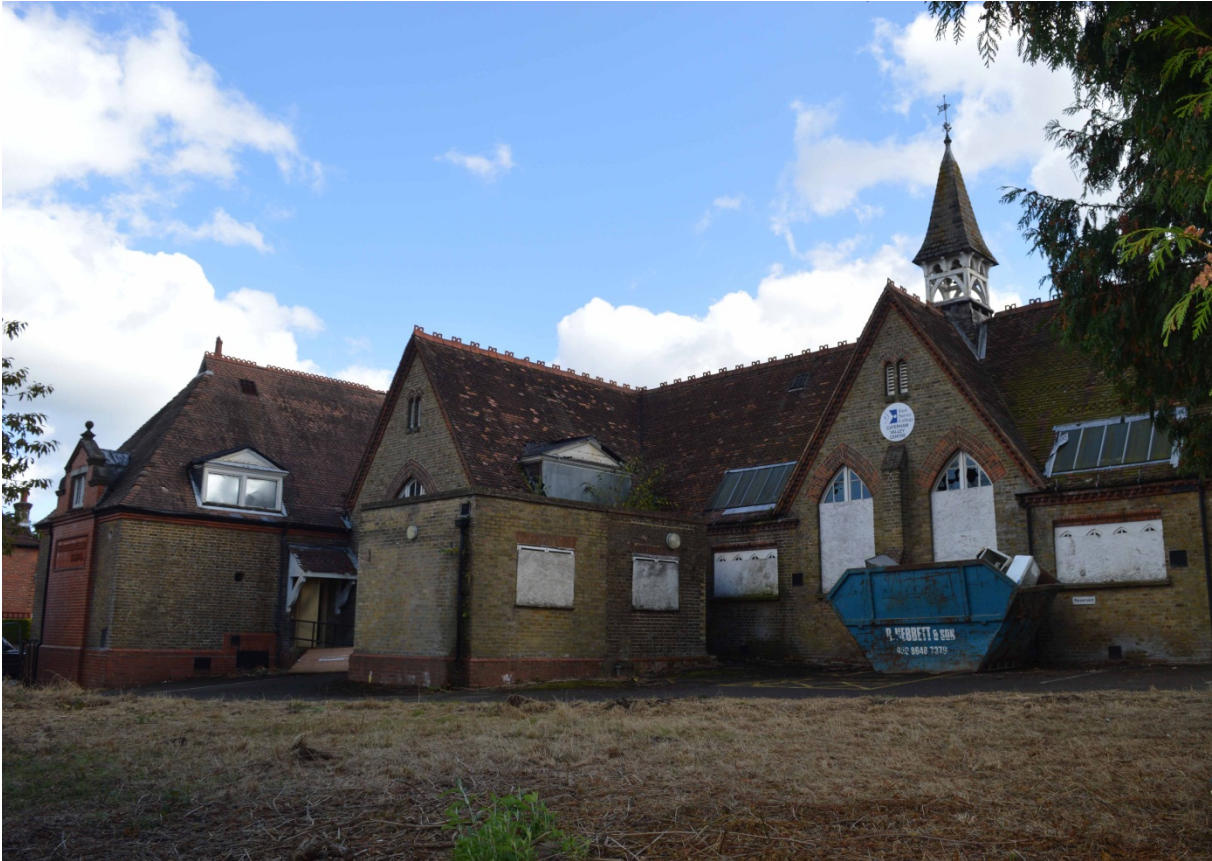
Plate 1: West elevation, looking north-west (42)

- 5.5 The south range is of similar character and has been extended to the south by approximately 2.5m with closely-matching brickwork and detailing (Plate 1). Its roof has a projecting gable with steeply-pitched roof, above which is a timber-framed bell turret, with arched timber braces and trefoils, sited on the ridge of the main roof. A bell is still *in situ*. These features would have been located centrally on the original roof. The gable contains a pair of lancet vents with timber louvres, below which is a pair of large pointed-arched windows with timber casements with glazing bars, separated by a brick buttress. Additional windows take the form of pointed-arched casements in timber frames set in flat-arched openings. These are later additions, probably inserted when the building was extended to the south. The south elevation contains a large central, metal-framed window with segmental-arched brick head, to either side

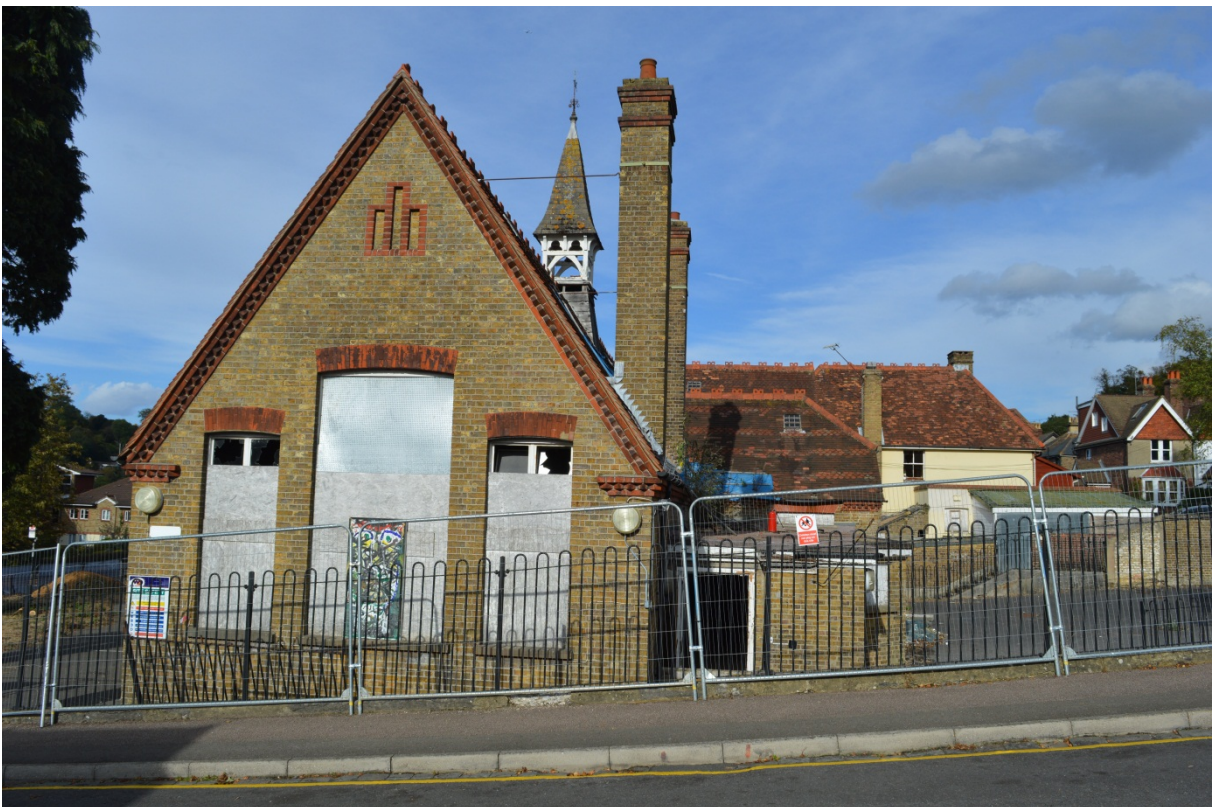
Plate 2: South elevation of south range (130)

of which is a smaller, matching window (Plate 2). The brickwork of the gable contains three narrow recesses arranged in a similar configuration and echoing the gable vents of the original parts of the building. The west elevation of the range is largely blank, and partially obscured by a low, flat-roofed addition of probable mid-20th century date (Plate 3). The roof of the main range has two tall chimneys, constructed in matching yellow brick close to the base of the roof slope; the southernmost chimney is a later addition associated with the extension of the range. A short range projects eastwards at the northern end of the range, constructed in matching brickwork, with a half hipped roof and containing a large segmental-arched window beneath its gable, and a blocked window to the south, largely obscured by later additions. A small, flat-roofed structure, in matching brickwork, links it with the north range.

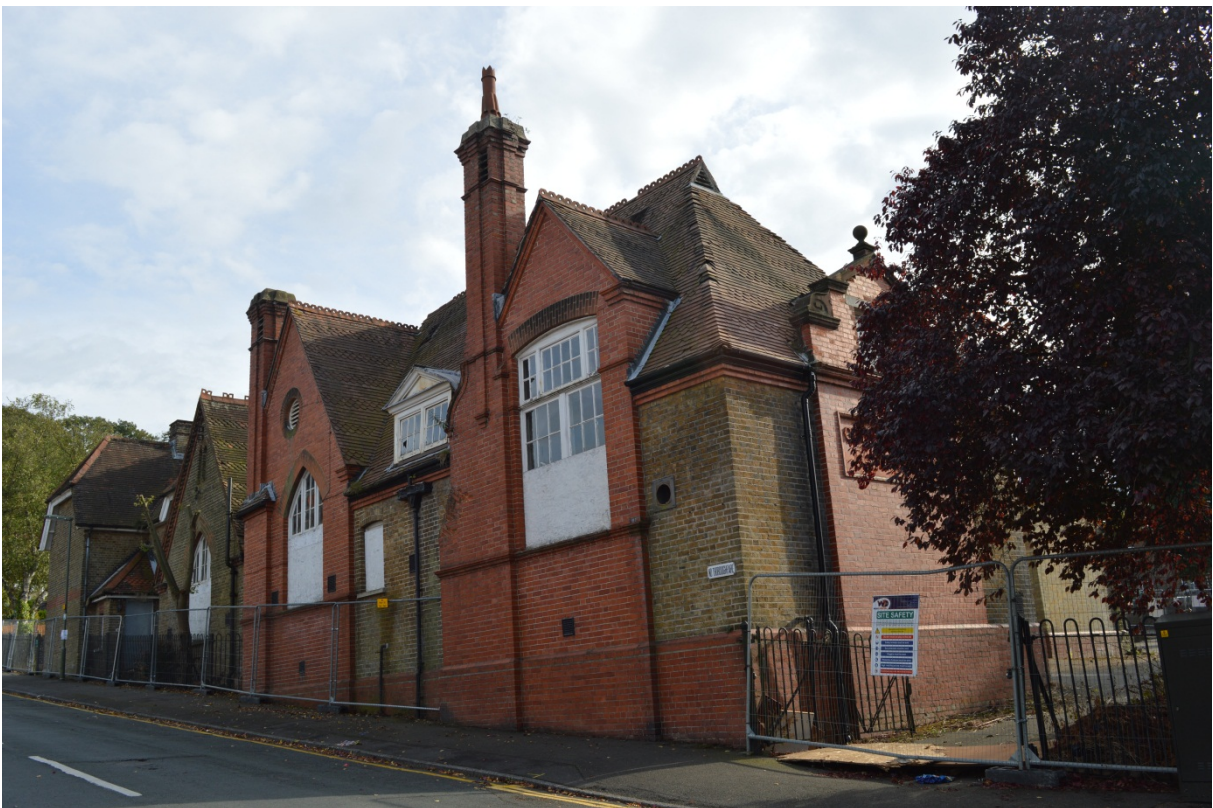
Plate 4: North elevation of north-east range, looking south-east (135)

- 5.6 The north-east range forms an addition to the original building, constructed c.1900 (Plate 4). Its construction utilises both yellow and red brick, arranged in Flemish bond with a red brick plinth; its roof is hipped with sprocketed eaves and a gablet at its southern end. The roof is covered with clay tiles, again laid with bands of decorative club tiles, and continuous crested terracotta ridge tiles with pierced trefoil decoration. The principal elevation of the range faces north and features red brick gabled projections; that to the east containing a pointed arched window with roundel window above, that to the west containing a large segmental arched window, all with gauged brick dressings. Both projections include ornate red brick chimneys on their eastern side. A dormer window with pediment is situated between the two gables. To the east is a doorway with red brick surround and three-centred arched gauged brick head with foliate keystone, containing a glazed timber fanlight and modern timber door. The elevation continues eastwards with the north gable end of the original school building, with a pointed-arched window and paired lancet vents above, and the north elevation of the teacher's house (see section 5.20). The west elevation of the range is detailed with a central projecting panel of red brickwork, which continues above the eaves line with a Queen Anne-style gable containing a pair of tilting timber windows with glazing bars and detailed with stone volutes, moulded coping and a ball finial (Plate 5). Below the gable is a large terracotta panel with lettering in relief which reads 'Caterham Valley Board School'. The south elevation is relatively plain, with a single door at its eastern end sheltered by a clay-tiled, mono-pitched door hood, with timber brackets supported by stone corbels. A dormer window with pediment is sited centrally on the roof slope.

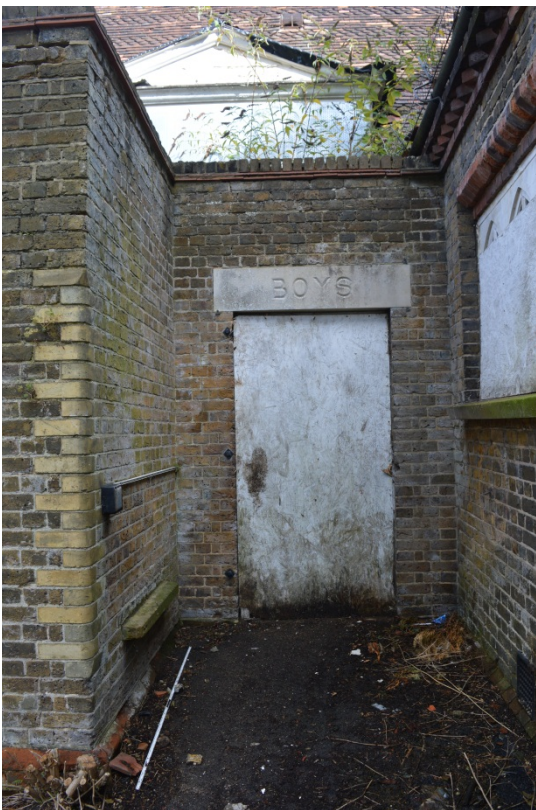
Plate 6: Doorway in late 19th/early 20th century addition on west side of south range (29)

- 5.7 A small, single storey extension has been added to the western side of the building: initially this comprised a late 19th/early 20th century addition in the angle of the main north and south ranges, subsequently extended westwards in the mid-20th century in a matching style. It is constructed in yellow brick which is arranged in English bond to the original part and stretcher bond to the extension, with a red brick plinth and bull-nosed yellow brick dressings to the south-east corner. The roof is flat and hidden behind a brick parapet. A doorway is located on its southern side, adjacent to the south range, above which is a stone lintel engraved with 'BOYS' (Plate 6). Two modern windows

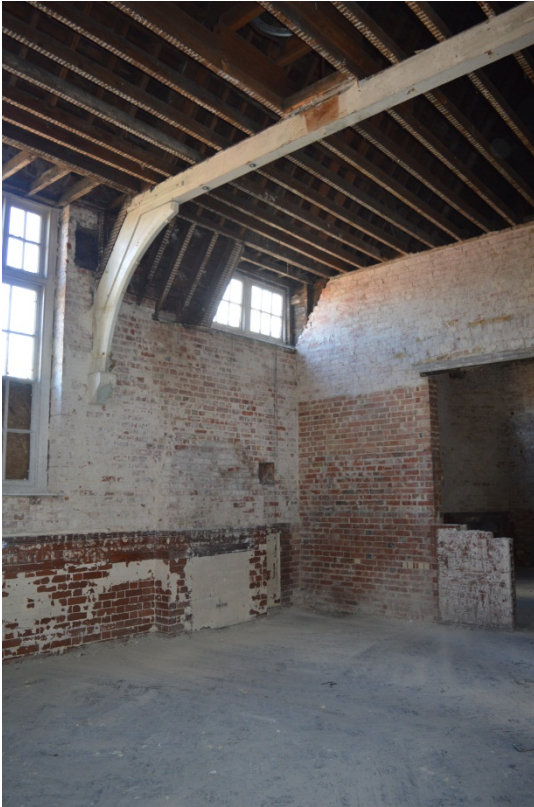
Plate 7: Room 1, looking north-east (44)

- 5.9 Rooms 1 & 2 are located in the north-western corner of the building and form the main portion of the late 19th/early 20th century addition to the building (Plate 7). A wide door opening provides access between the two rooms. The walls of both rooms are faced with brown glazed bricks up to dado height, above which the now-exposed brickwork would have had a plastered finish. The floor is covered with wooden parquet arranged in a herringbone pattern; the floor on the western side of Room 2 is concrete. The roof is of clasped purlin type with paired common rafters meeting at a ridgeboard. The trusses are bolted together and comprise substantial principal rafters, supported by chamfered arch braces springing from stone corbels midway up the walls. Striping on the rafters and joists, characteristic of a former lath and plaster finish, shows that the rooms would originally have been ceiled above collar height with skelings. Room 1 is lit by dormers to the north, west and south walls, and a large pair of sliding sashes, with top lights above, on the north wall. Room 2 is lit by a large, pointed-arched window on its northern wall and a high level window/dormer on the west wall. Both rooms were heated: Room 1 has a fireplace on its north wall and Room 2 a fireplace in its north-east corner (Plate 8). Small metal grilles inserted into the walls would have provided ventilation

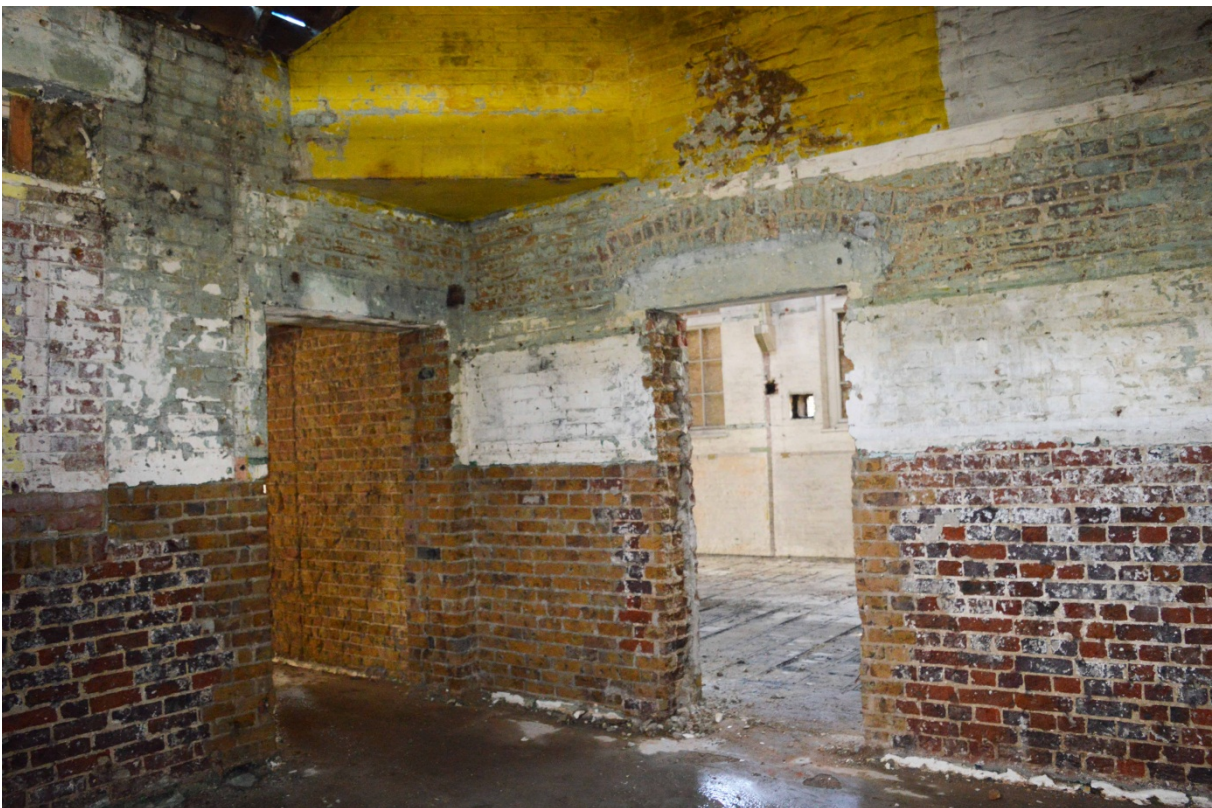
Plate 12: Room 7, showing possible remnants of stack in south-west corner (79)

- 5.14 Room 7 occupies the small projecting range on the east side of the original school building, formerly subdivided, with partitions now removed. The room appears to have been clad up to dado height, possibly with glazed tiles, with a painted/whitewashed finish to the brickwork above. The roof is formed of simple paired rafters and was formerly ceiled with skelings. A large mullion and transomed window with multi-paned casements lights the room on its eastern side; a further window on the southern side has been partially bricked up to form a high-level window, now blocked by later additions. The room was possibly heated by a fireplace in its south-east corner: remnants of a stack appear to have been retained above the height of two inserted door openings to the south and west, although no evidence of the stack is visible externally (Plate 12).

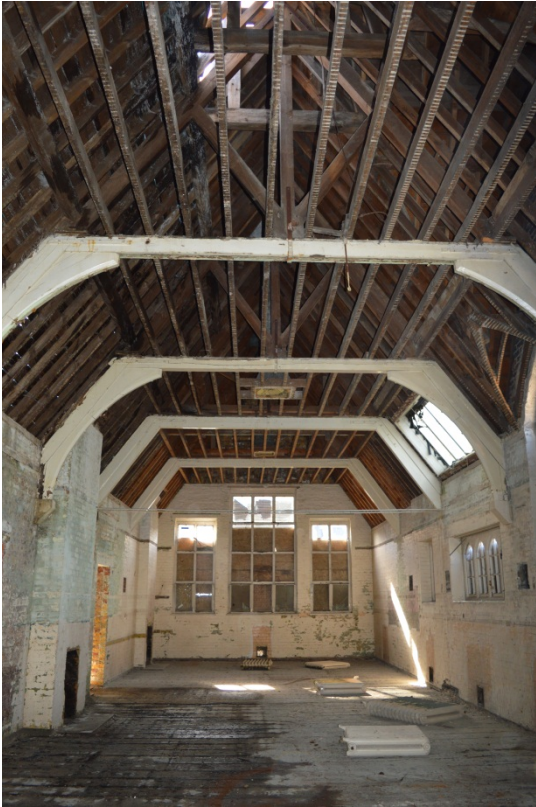
Plate 13: Room 8, looking south (85)

- 5.15 Room 8 occupies the southern range of the original school building, aligned north-south (Plate 13). It appears to have functioned as the school hall and was accessed via a central double-width doorway at its northern end, now blocked. The walls of the room are of brick with a painted finish, and the floor is set with timber bearers with nails, probably for a boarded finish. The roof matches the form of the north range, with king post trusses, formerly ceiled above collar level with skellings. The room was ventilated by three roof vents and metal grilles on the east and west walls. It is lit by two original large pointed-arched windows with multi-pane casements to the western wall, the small pointed-arched casements set in flat-headed surrounds being a later addition. The room contains three doorways on the east side, the north and south of which are later insertions with concrete lintels; the central doorway occupies the position of an original doorway that has been modified. The original northern part of the hall was heated by two fireplaces on its eastern side.

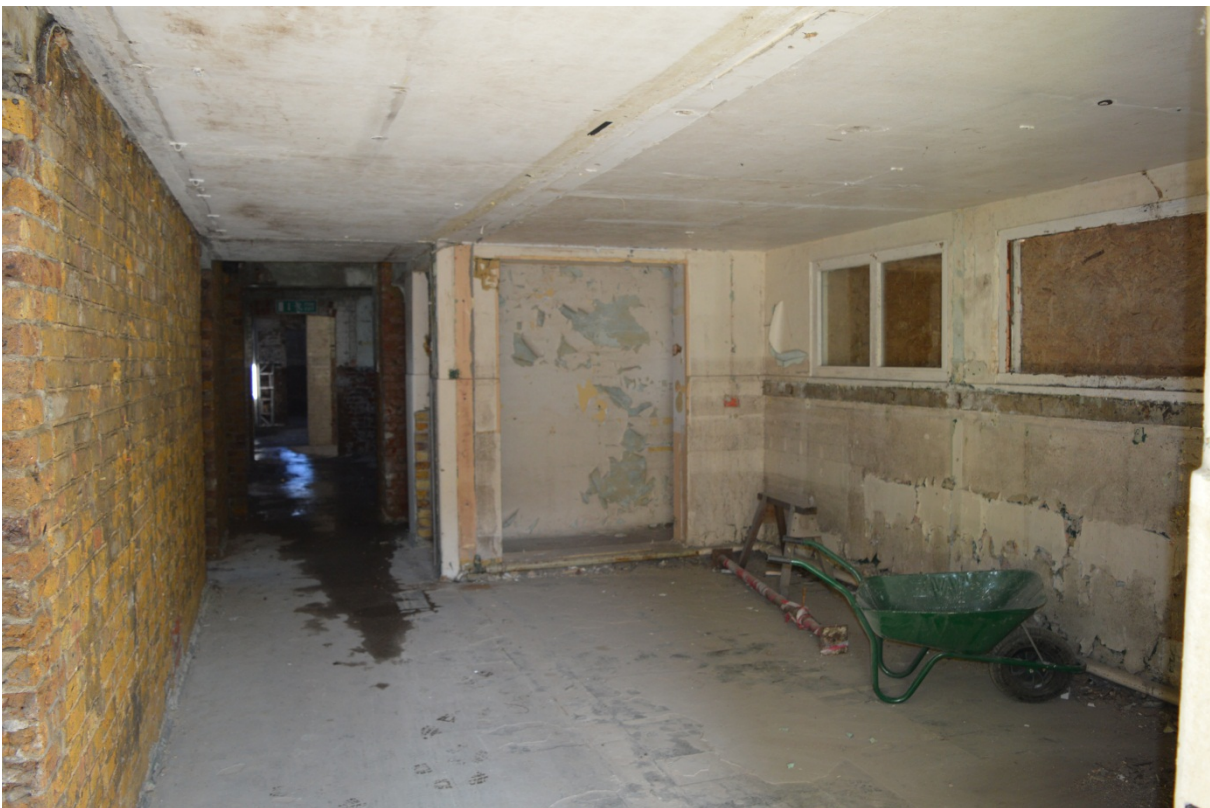
Plate 14: Room 9, looking north (97)

- 5.17 Room 9 occupies a later addition on the eastern side of the south range, which previously formed a series of small storage cupboards and WCs, the majority of the partitions having been removed by the time of the survey (Plate 14).

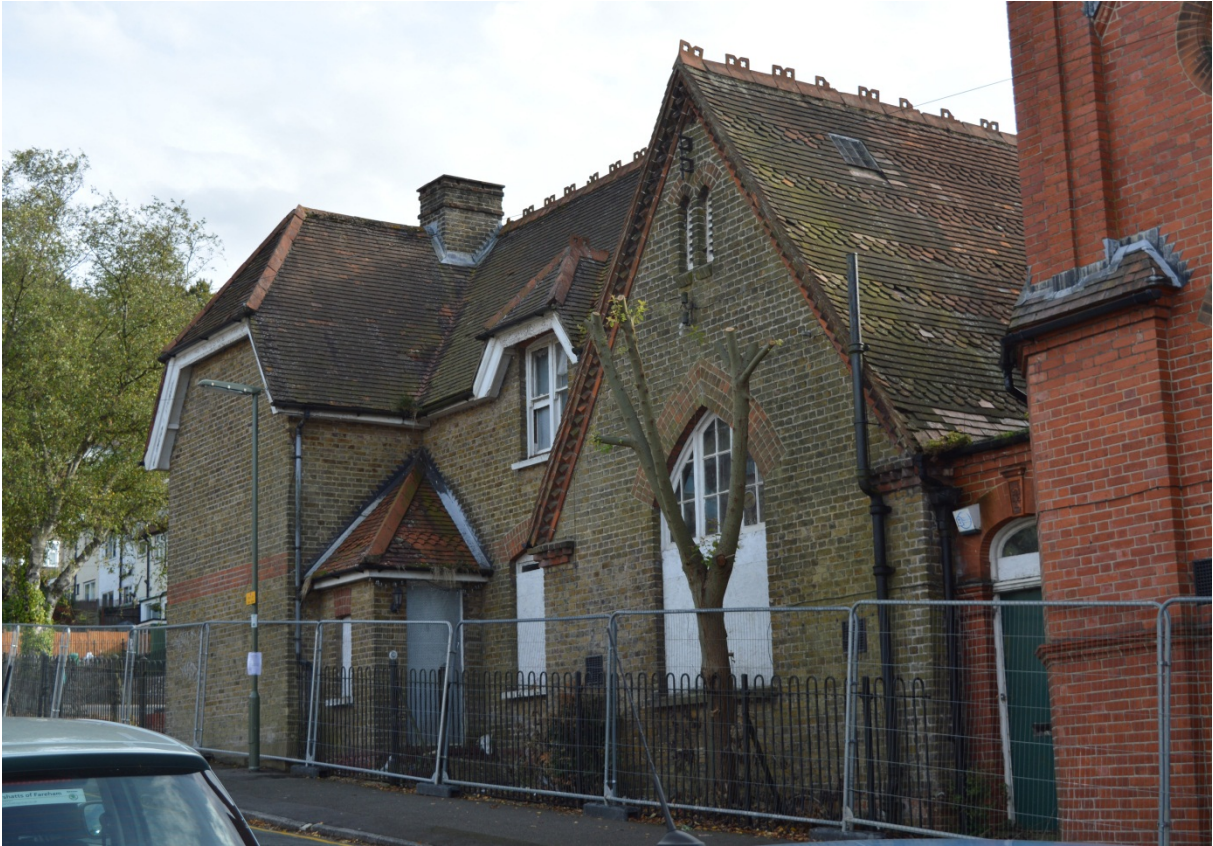
Plate 15: North elevation of teacher's house and original school building, looking south-east (137)

- 5.20 The principal elevation faces north (Plate 15). It is constructed in brickwork and is relatively plain, with a single window at ground floor level with a lucarne window with half-hipped roof punctuating the eaves above. The gabled projection at the eastern end is blank save a red brick band roughly mid-way up the elevation. A small porch with hipped, clay-tiled roof, with doorway facing west and a small sash window facing north, is located in the angle of the two wings. The east elevation is similarly plain, constructed in brickwork with two windows at both ground and first floor levels; those to the first floor are sliding sashes punctuating the eaves, the southernmost of which has a half-hipped dormer roof (Plate 16). A chimney of matching yellow brick is located close to the ridge at its southern end.

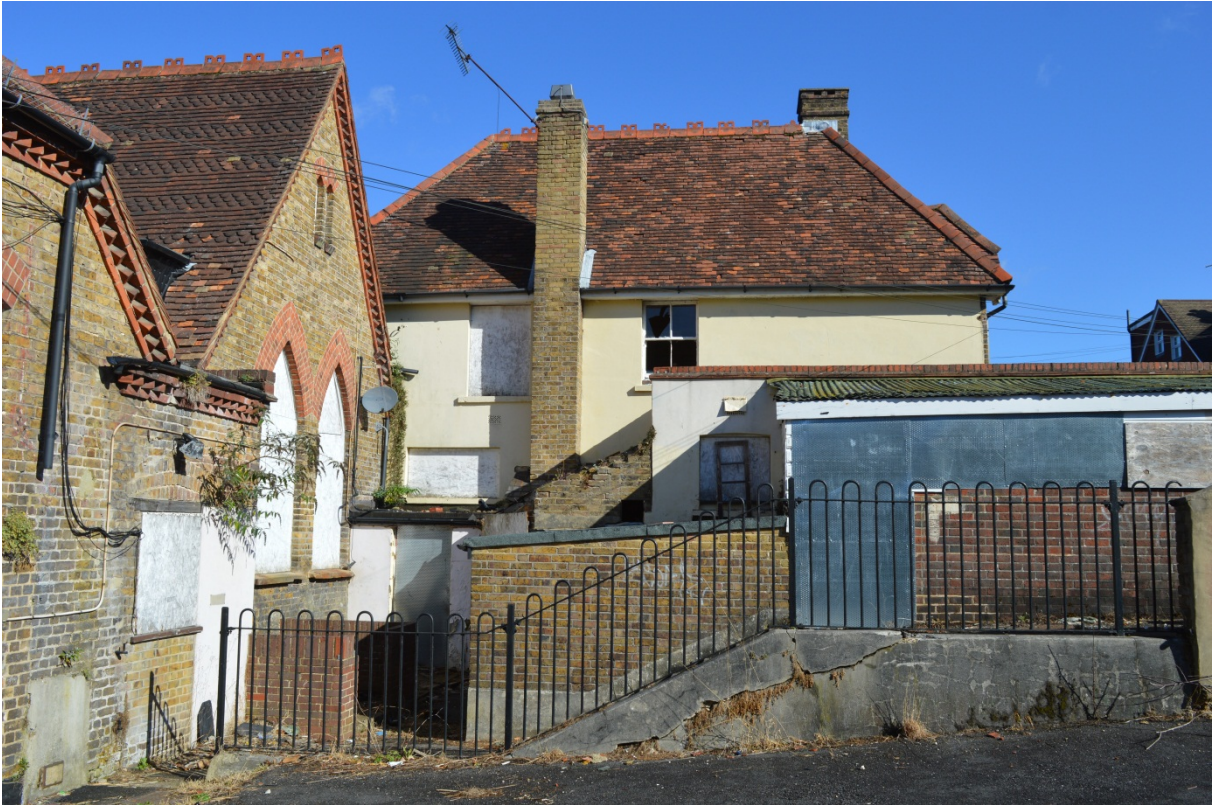
Plate 17: South elevation of teacher's house (4)

- 5.21 The south elevation is faced with render (Plate 17). It contains two windows at first floor level, one of which could be seen to be a sliding sash of two-panes-over-two and one at ground floor level, and an external yellow brick chimney which projects from a brick small lean-to with slate roof. The remainder of the elevation is obscured by later additions: a single storey addition, likely to have been constructed between 1896 and 1912-13, with rendered walls and a brick parapet, is sited at the eastern end. Two further small additions to the south, faced with a combination of brick and weatherboarding, are of probable mid-20th century date.

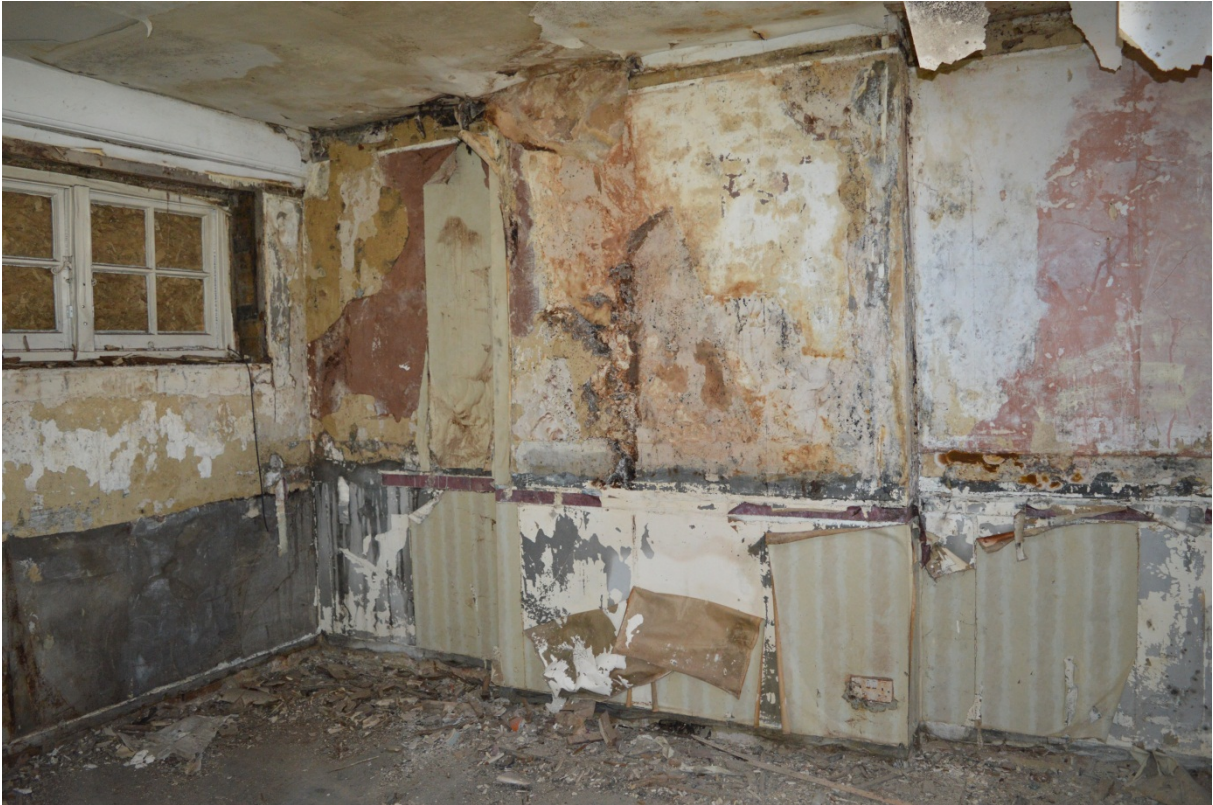
Plate 19: Room 11, looking south-west (114)

- 5.24 Room 11 is a large room west of the stair hall (Plate 19). It is relatively plain with a shallow skirting, and is lit by two windows: a triple sliding sash window to the north and a later high level paired casement to the south. It was heated

by a fireplace on the western wall, now blocked with the surround removed. The concrete floor retains evidence of nails, presumably for a boarded finish.

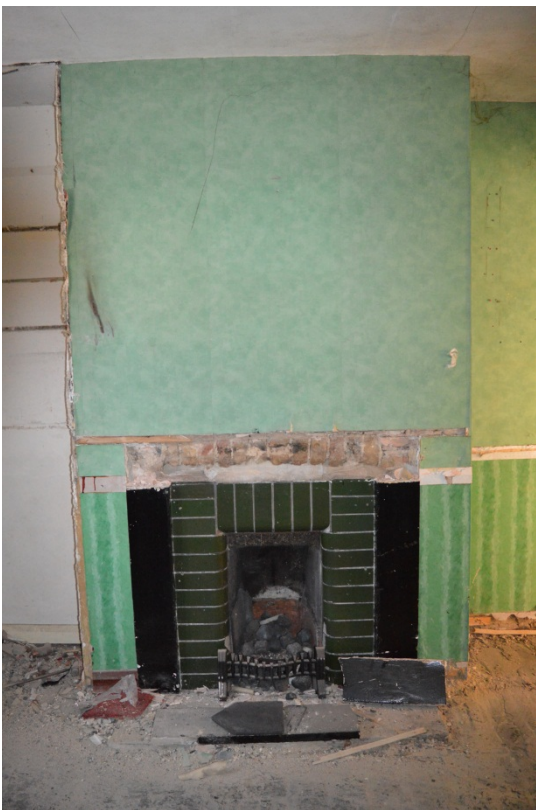
Plate 20: Fireplace in Room 12 (112)

- 5.25 Room 12 occupies the northern side of the building, to the east of the stair hall. It has a plain shallow skirting, a concrete floor that was previously boarded, and is lit by a pair of sliding sash windows on the eastern wall. It was heated by a fireplace on the southern wall; the fire surround is of green glazed tiles and of probable mid-20th century date with a gas fire (Plate 20).

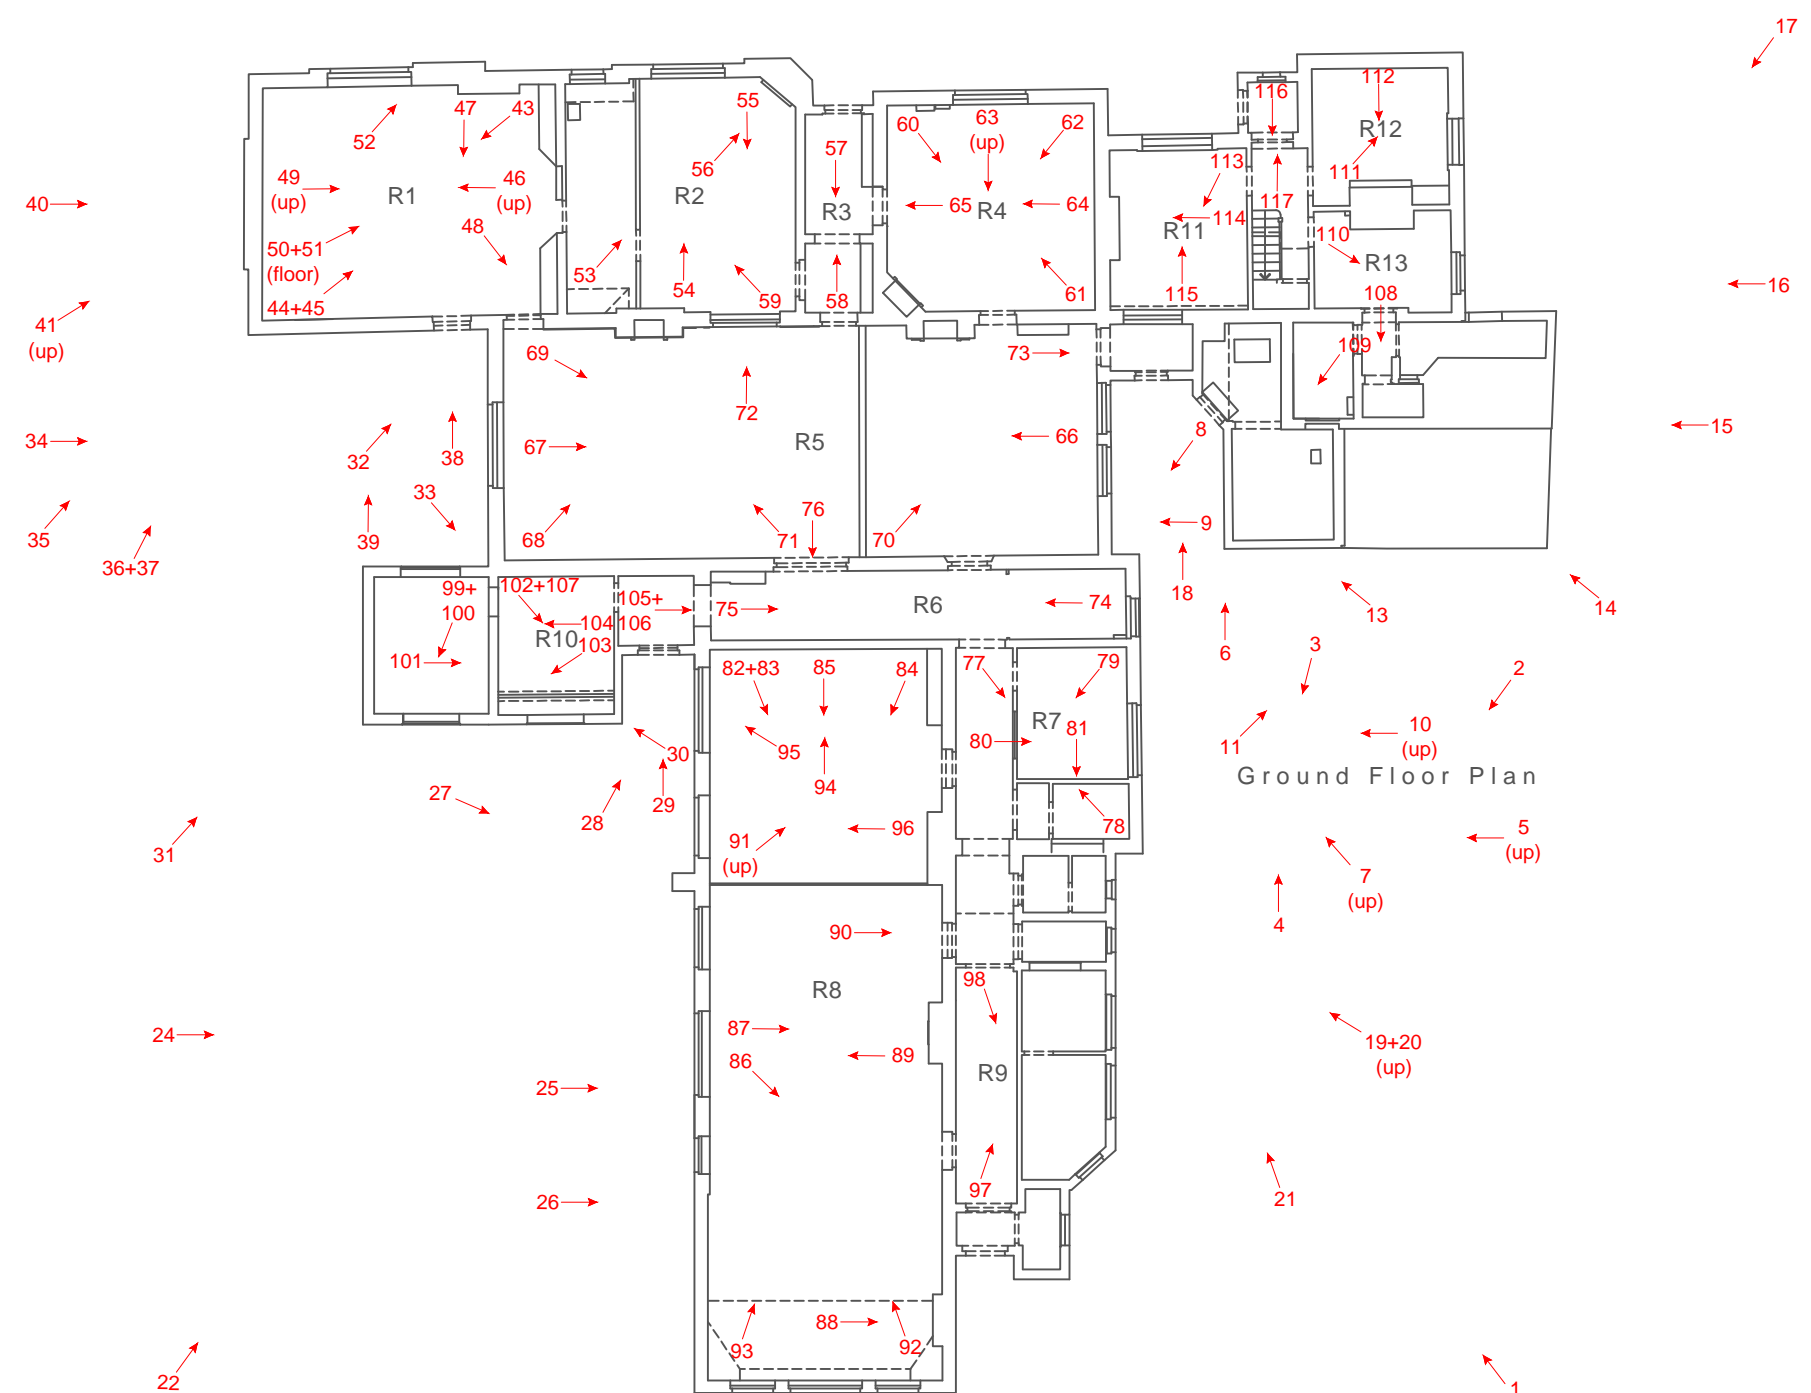
Archaeology South-East		Farringham Road, Caterham	Fig. 9
Project Ref: 7064	Oct 2014	Floor plans & photo locations	
Report Ref: 2014324	Drawn by: HG

Ground Floor Plan

- 5.3 The school building comprises a number of original and later ranges, forming an irregularly T-shaped plan (Fig. 9). The original late 19th century school building is single storey, constructed in a Gothic revival style and formed of two linear ranges constructed perpendicular to each other, the north range being aligned east-west and the south range north-south, with two shorter, projecting ranges on the north and east elevations. Unless otherwise stated, all are constructed in yellow stock brick laid in English bond, with red brick dressings and a red brick plinth which varies in height to accommodate the slope of the site. The steeply-pitched roofs are clad with handmade clay tiles with bands of decorative club tiles and alternate crested terracotta ridge tiles with pierced quatrefoil detailing. Metal vent terminals are noticeable at regular intervals close to the ridge line. At the north-east corner is a two storey cottage, attached to the main school building and of contemporary date, likely to have formed teacher's accommodation. At the north-west corner of the school is a later addition to the building, constructed c.1900.

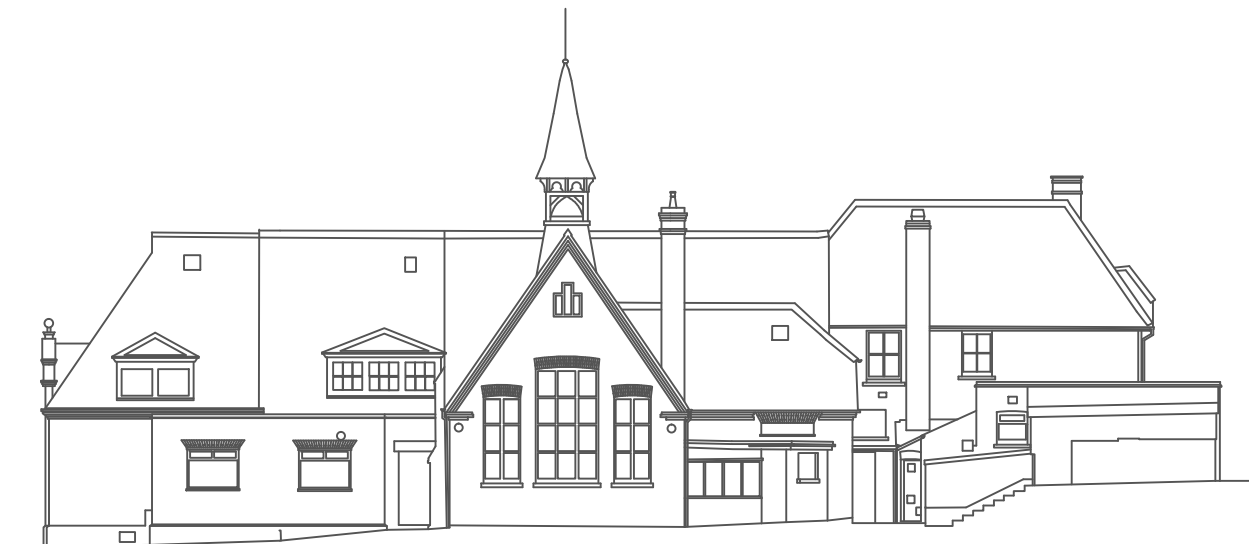
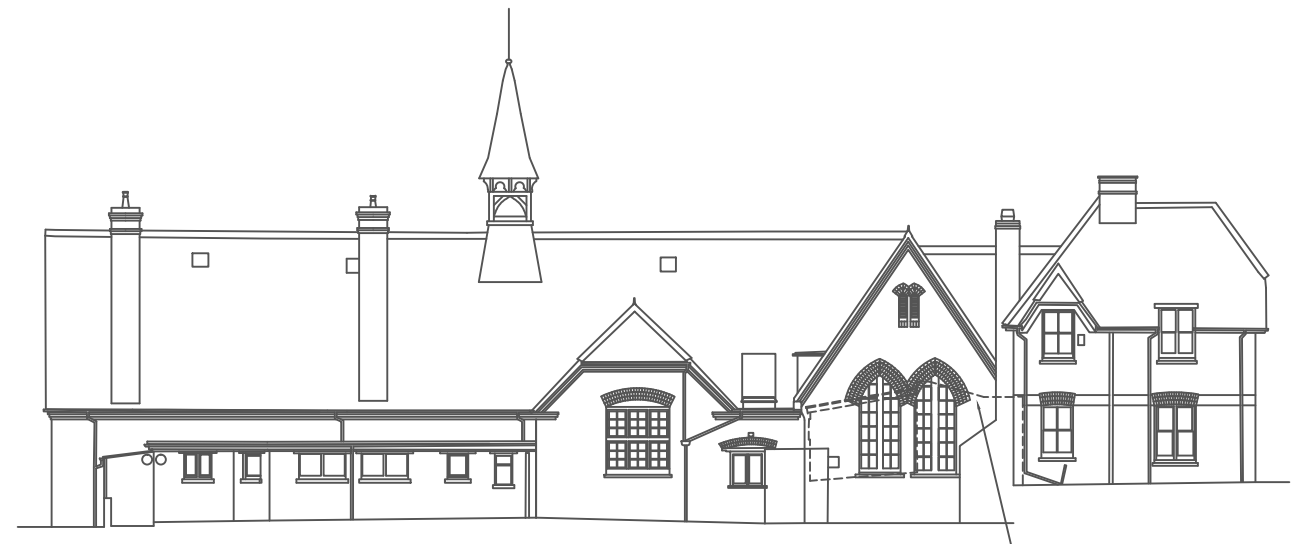
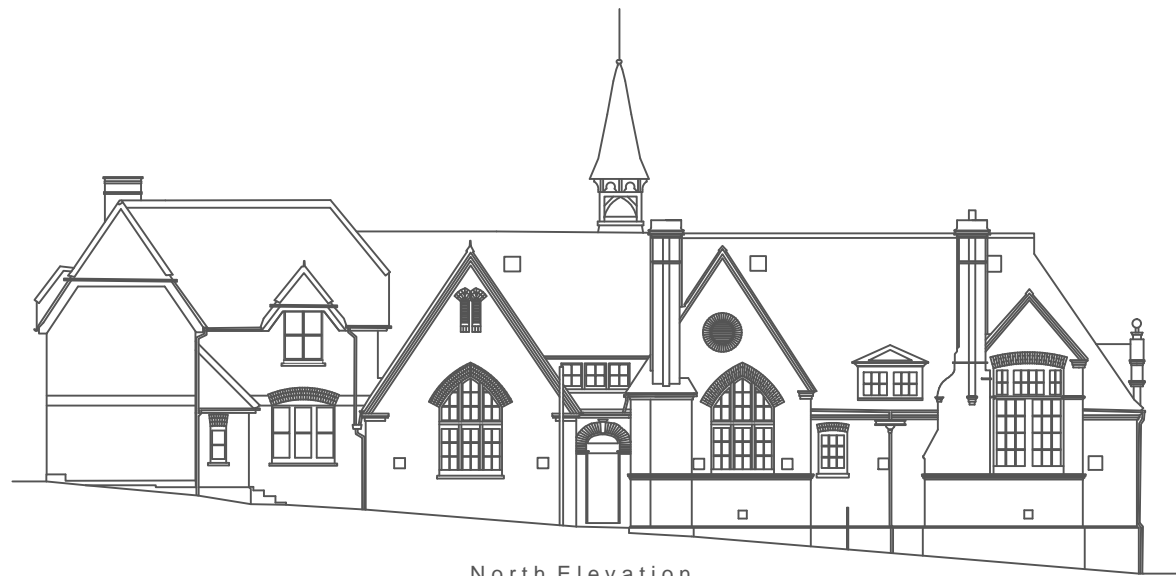
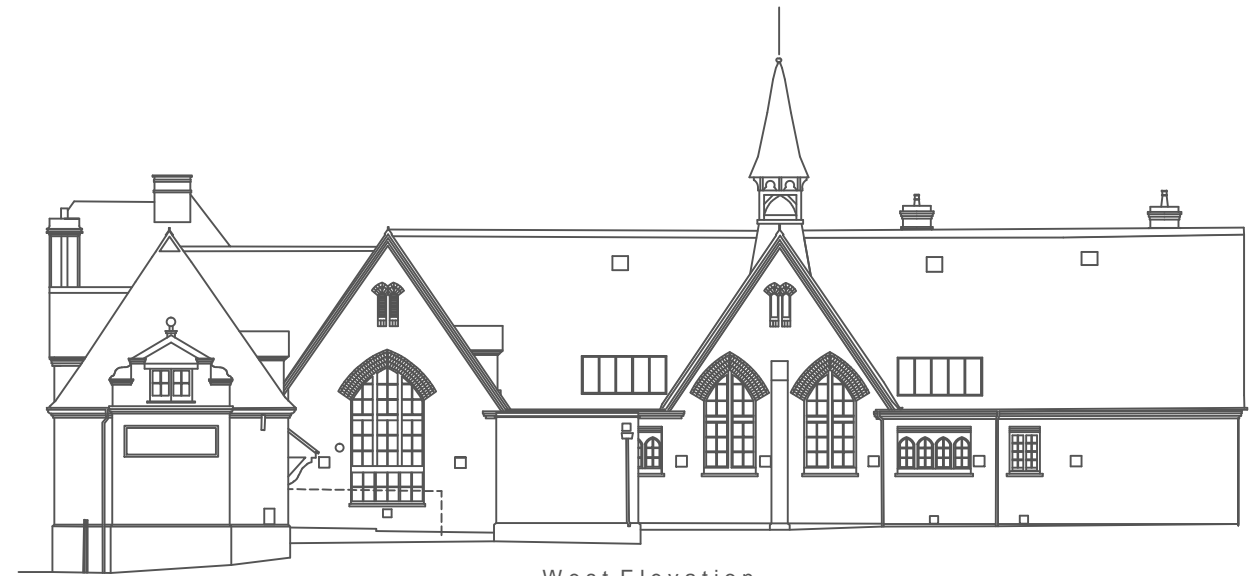
South Elevation

East Elevation

North Elevation

West Elevation

- 2.4 The drawn record comprises floor plans of the building to illustrate its layout, together with external elevation drawings. These are based on existing measured drawings supplied by Frank Reynolds Architects, which have been verified for their accuracy, and amended and annotated where necessary. The resulting scaled drawings are included within the report as Figs. 9 & 10.

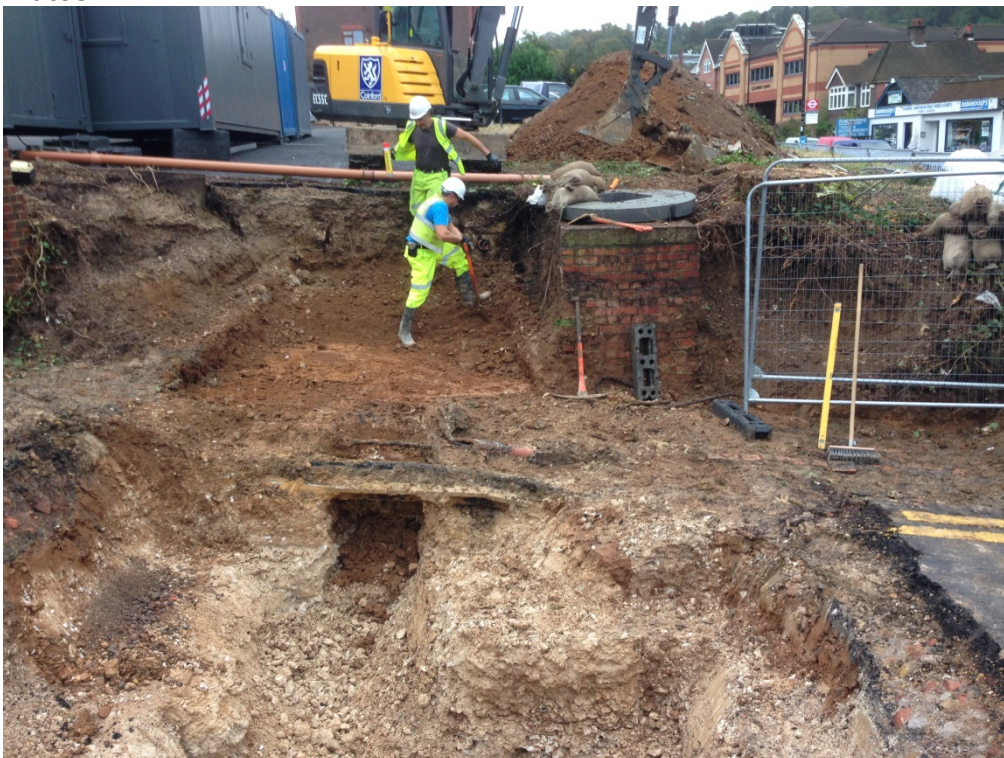
Plate 1: Monitoring the edge of the road service trench, looking south.

4.1.1 The excavation of the road service trench across Farningham Road, at a north-south orientation, was undertaken on the 17th October 2014 (Fig. 3.1). No archaeological deposits were observed at the time. Several modern service cuts were observed within the subsoil (Plate 1).

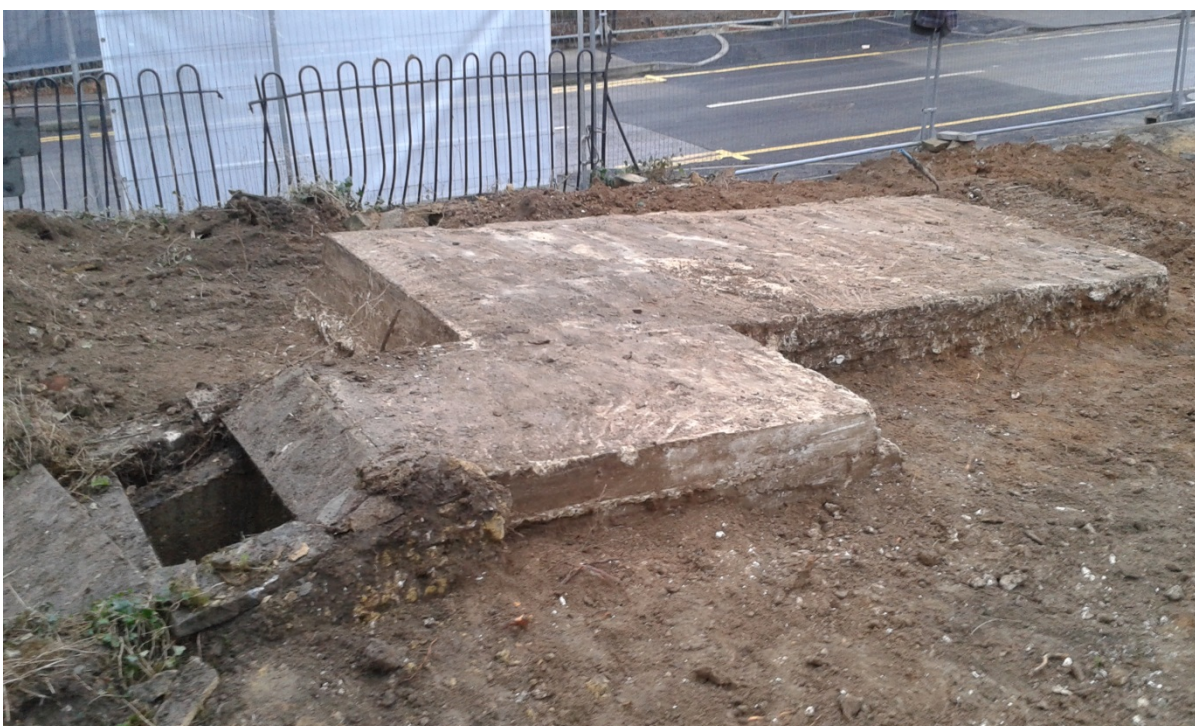
Plate 2: The top of the air raid shelter uncovered, looking north.

4.2.1 The groundworks south of Farningham Road for the construction of a roadway were observed on the 13th and 14th November 2014. An air-raid shelter was uncovered within the north-west corner of the site close to the junction of Farningham Road and Croydon Road, to the west of the expected location of the shelter identified through GPR (Fig. 3.1, Plate 2).

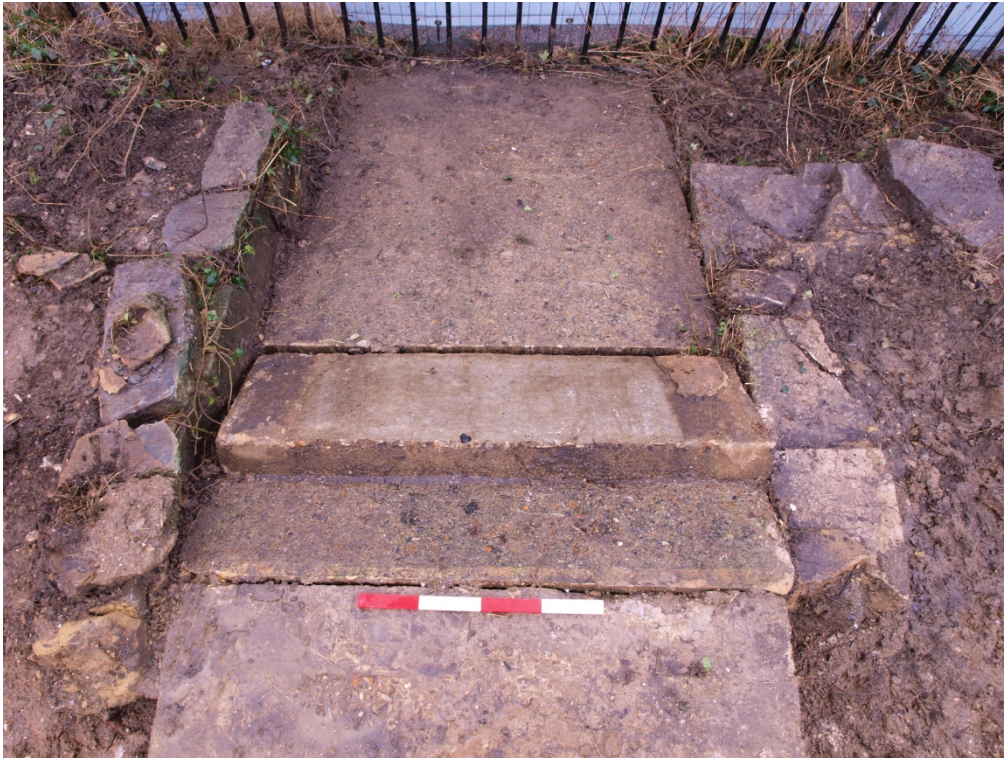
Plate 3: Entrance to the shelter, looking west.

shelter staircase at the end of the structure's use (Plate 3). The shelter itself had been cut into the natural chalk (1/004) to a depth of c. 2.10m. The entrance to the shelter was never buried, and remained visible above ground prior to documentation. Post-war materials found within the shelter's staircase elucidate its occasional accessing by local inhabitants (Plate 4). The revetting wall tied into the blast walls leading to the shelter, and may therefore date to a similar period, along with the earth embankment. The blast resistance of an air-raid shelter can be substantially increased by embanking it with earth and setting it below ground level (Lowry ed., 1996: 71).
