**FORMER CATERHAM VALLEY BOARD SCHOOL,
FARNINGHAM ROAD, CATERHAM**

**HISTORIC BUILDINGS RECORD
(ENGLISH HERITAGE LEVEL 2)
&
ARCHAEOLOGICAL WATCHING BRIEF**

Report No. 2014324

Site Code: FCA 14
Project No. 7064
Report No. 2014324

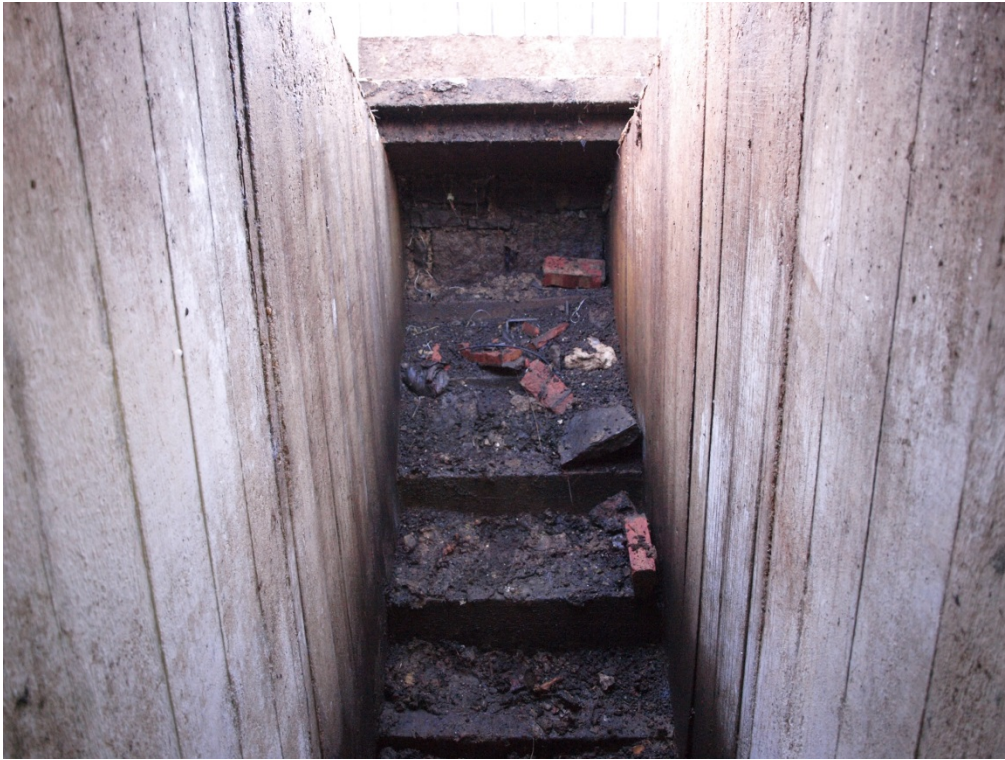
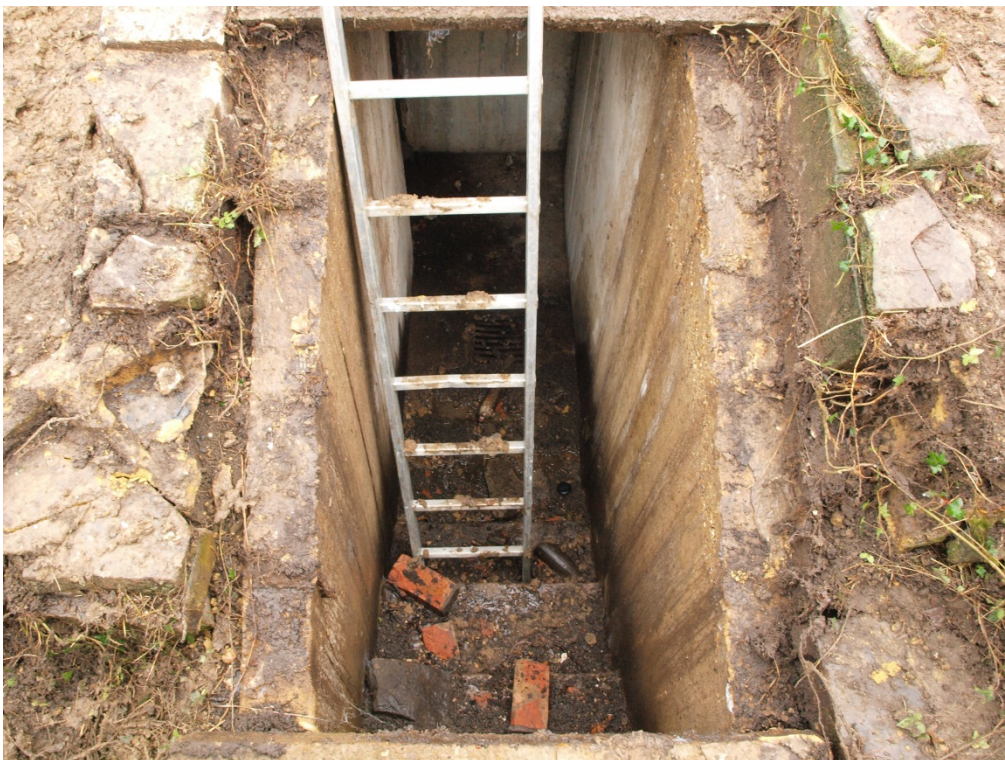
Plate 7: Steps down to the shelter, looking west.

Plate 8: Steps down to the shelter, looking East.

- 4.2.4 The shelter features a staggered entrance along a flight of five concrete steps and a short hallway, flanked by blast walls (Plates 7 and 8). The staggered entrance would help protect occupants of the shelter from blast damage. The blast wall was 0.14m thick. A drain was situated within the hallway to prevent flooding (Plate 9).

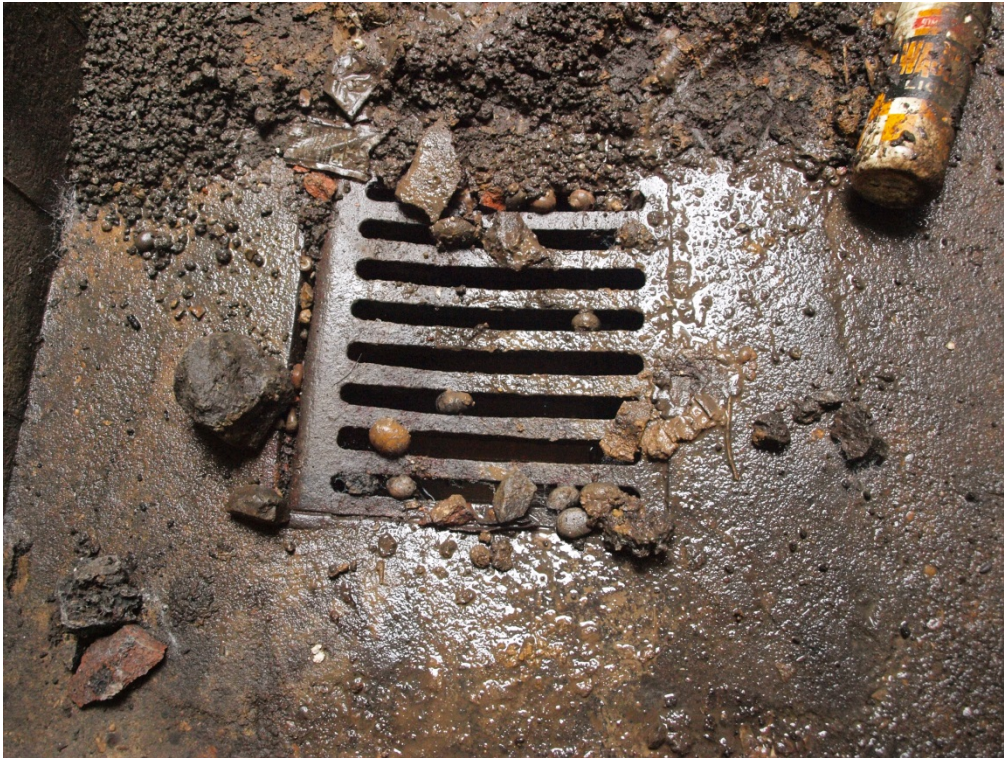
Plate 9: Drain in hallway, looking west.

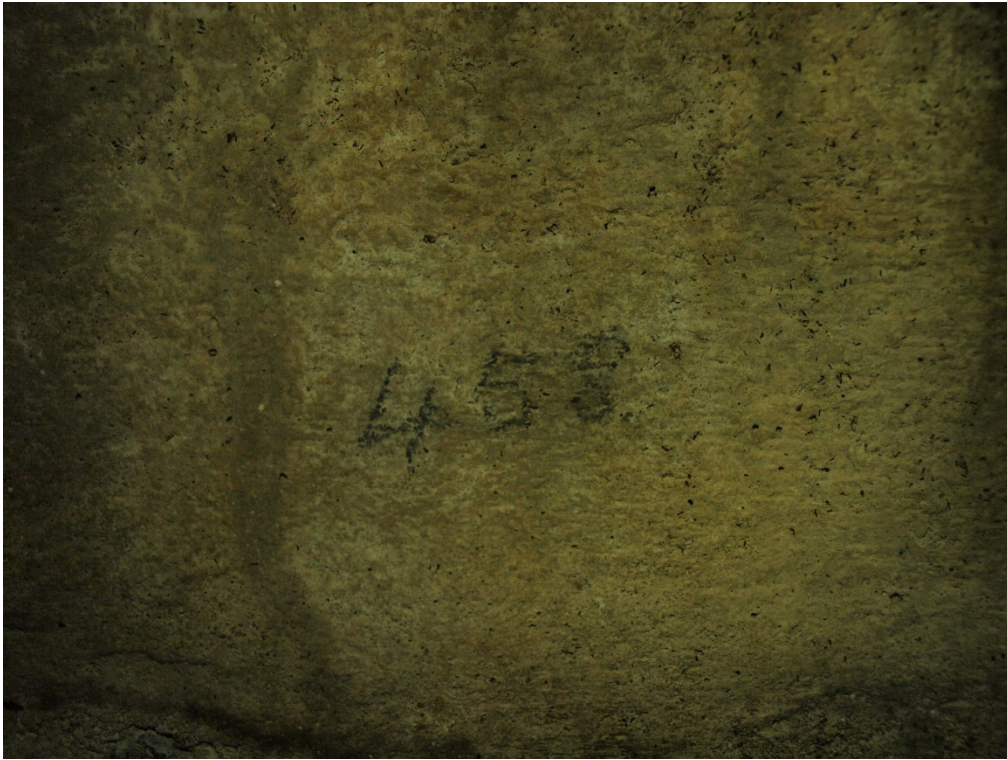
Plate 17: Pencilled number on wall of the shelter.

- 4.2.9 A variety of nails were set within the walls, though with no apparent purpose. In addition, the number '458' had been pencilled on the south wall of the shelter, again for no apparent purpose (Plate 17). Due to the very damp conditions within the shelter it is likely that any organic materials left within the structure would have decomposed.

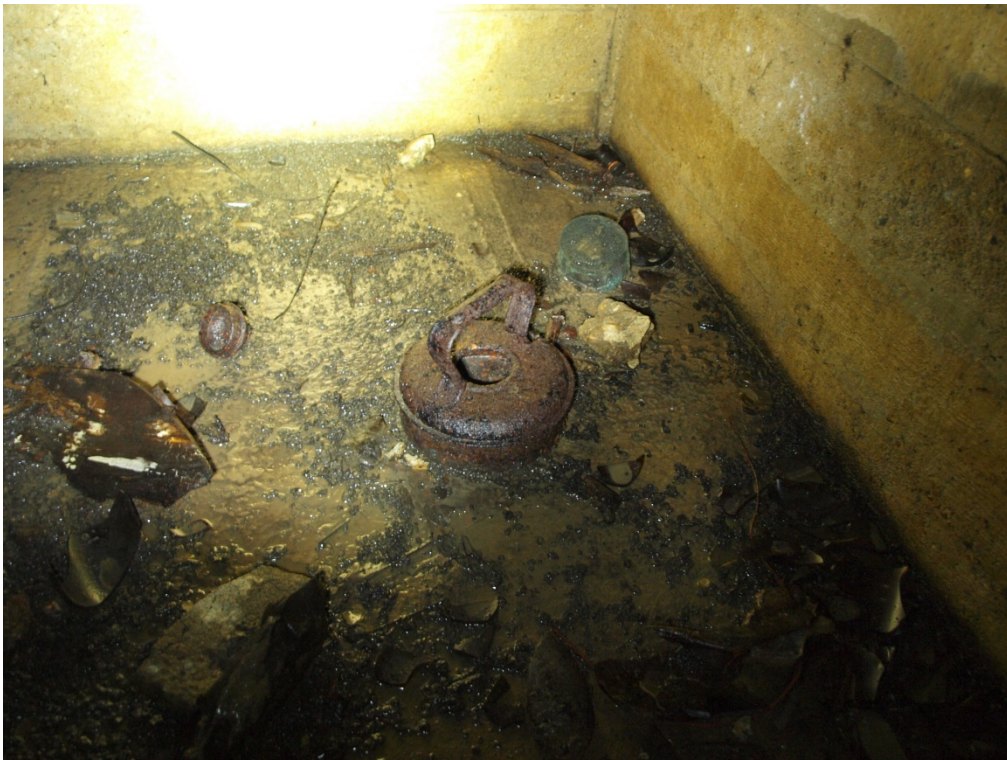
Plate 18: Rusted kettle and glass fragments.

- 4.2.10 A small number of finds were found scattered within the shelter. The finds included a range of smashed bottle glass, and a heavily rusted iron kettle (Plate 18).

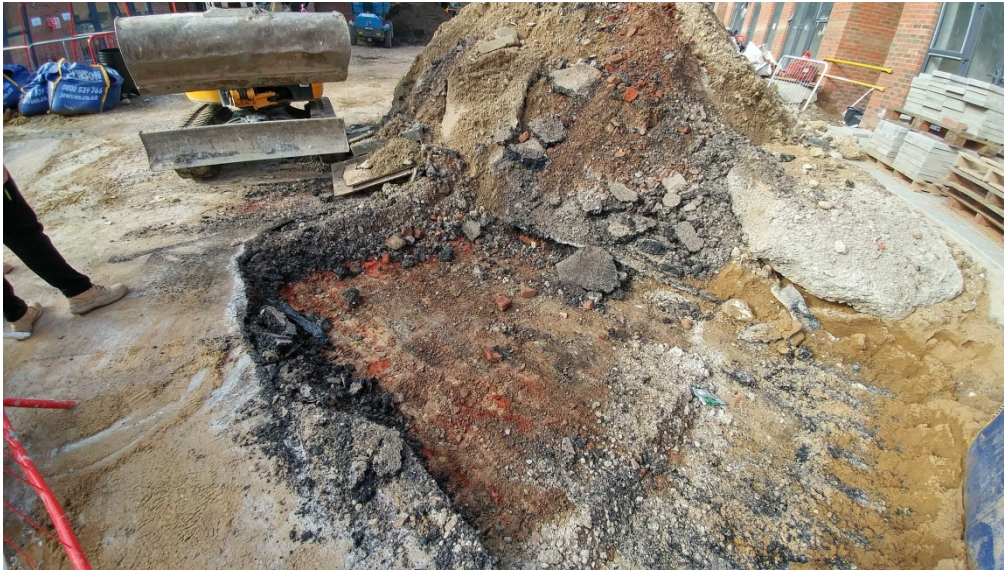
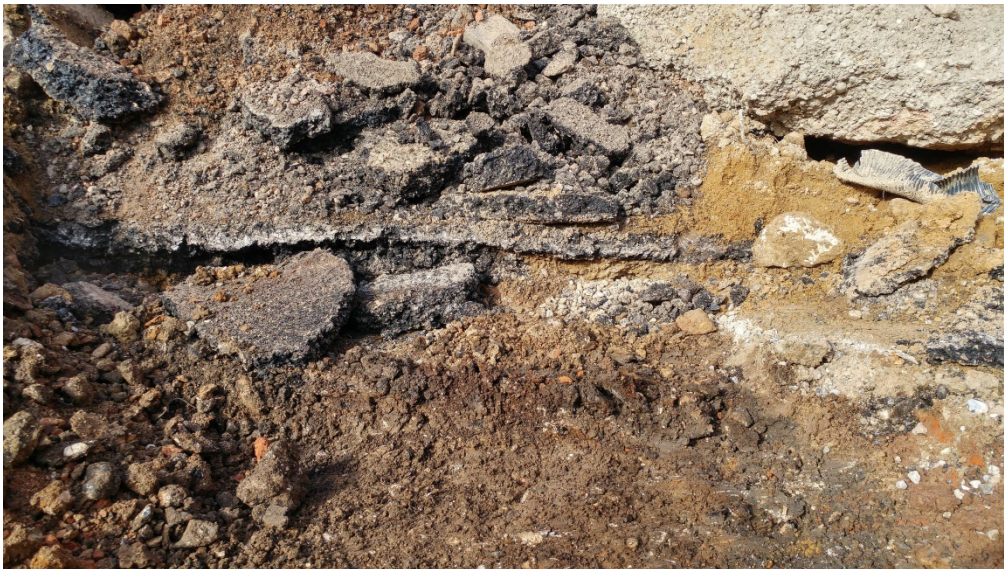
Plate 19: Made-ground underlying tarmac in the area of the predicted air-raid shelter, looking south. The new ground level will be level with the rear of the new-builds seen to the right.

Plate 20: Section through tarmac.

4.3.2 A mid-brown clayey-gravelly made-ground levelling deposit was found underlying 100mm of tarmac hardstanding (Plates 19 and 20). The made-ground contained early 20th century CBM, glass, and metal. Further reduction of the made-ground produced an increasingly homogenous clay, suggesting a depth to the deposit of <100mm. No further deposits were encountered as the reductions were below the target level of the development. Should the predicted shelter survive it was not encountered, and will not be impacted by the development of the back gardens in that area.
