**An Archaeological Watching Brief
On Land at Heron Cottage, Westham.**

(NGR TQ 564085 104538)

Project No. 2449

November 2006

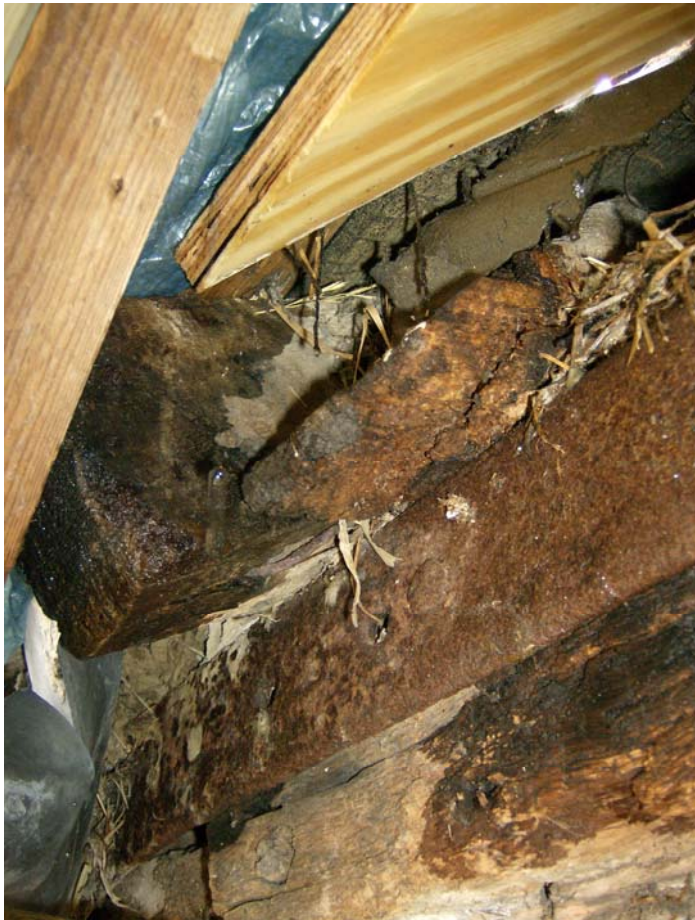
4.4.3 The top wall plate was the continuation of the plate extending from the eastern corner of the property. The plate measured 160 by 170 mm. Where the extension had been removed, the plate could be seen to be abutting the adjacent members to the west, with a straight line join re-inforced with an iron stirrup strap (PLATE 1). Access to the timbers was inhibited by the construction of the framework for the new extension and by the adjacent tile hung part of the house.

Plate 1: The straight line join and stirrup strap between the top wall plates

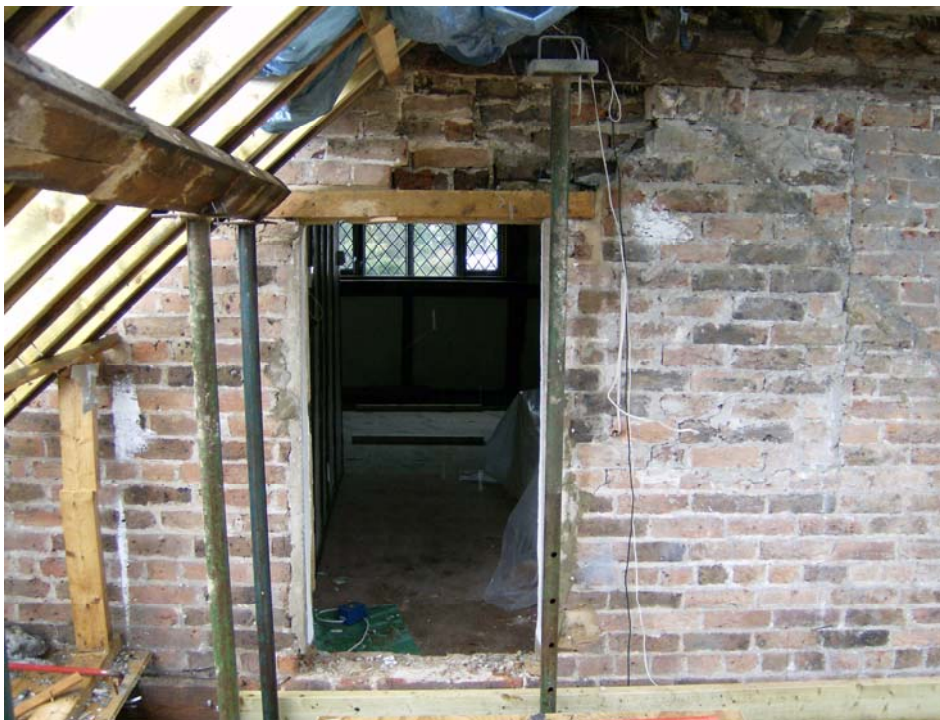
4.4.4 The blocked window had been truncated to the west by the creation of the access from the extension to the rear of the property (PLATE 2). The eastern edge was situated some 0.93 m from the edge of the current opening and c. 1.40 m from the eastern corner of the house. The window had been in-filled with brick in stretcher bond. The arched brick soffit over the blocked opening was still *in situ*.

Plate 2: The blocked and truncated window in the later phase of brick construction to the rear of the property

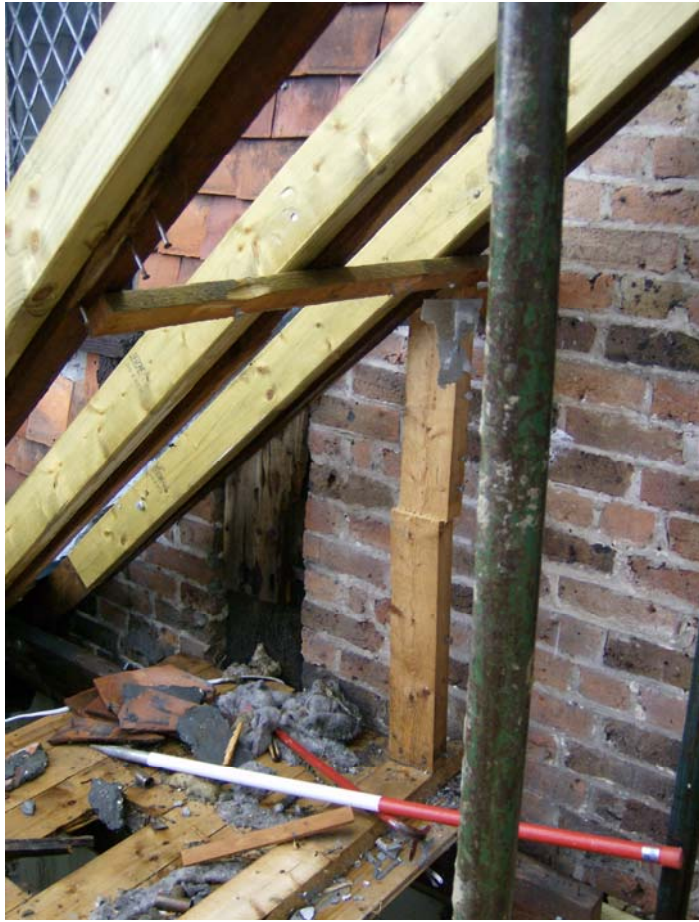
4.4.5 The vertical timber post was 1.02 m from the edge of the doorway from the house to the now removed extension, on the eastern side of the chimney stack. The post was 250 mm wide and only a small area had been revealed. An additional plank had been fixed to the front of the post (PLATE 3).

Plate 3: The exposed timber post (scale 1m)
