**An Archaeological Recording Brief  
On Land at Emmaus, Drove Road,  
Portslade, East Sussex**

**(NGR 525532 106403)**

**Project No. 2525**

**November 2006**

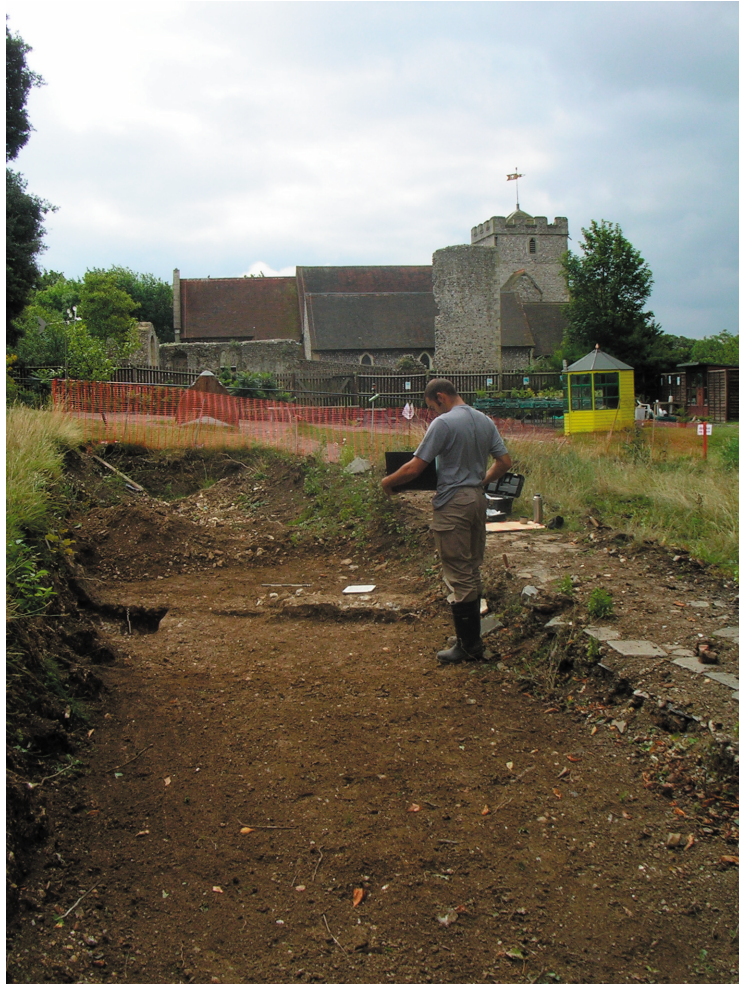
Plate 1: General site shot looking south towards ruins of Portslade Manor

**4.1** Ground work at the site had cleared an area of 3m by 14.2m in the area of the proposed car park (Figure 2). The area had been excavated through a bank of made ground, and the deposits (Contexts 1-7) had been truncated to a variable depth of between 200mm to a maximum 1.16 meters below the current ground level. The height of the stripped area ranged between 34.68–34.57mOD, with a heap of spoil masking the southern part of the excavated area (Plate 1).

- 4.7** A heavily truncated a flint and lime mortar wall which was located running approximately northwest – southeast across the site (Context 5) (Plates 1 and 2, Figs 2 and 3). This feature measured approximately 420mm in width and was in excess of 3m in length. It was constructed of angular flint nodules generally between 100mm-130mm in length, with no evidence of finishing or consistent coursing. It was bonded with an off-white lime mortar with abundant flint grits/pebbles to 7mm. Although not reliably datable this mortar may indicate a possible medieval to early post-medieval date. The excavation of a small sondage has indicated that the wall has been heavily truncated during groundwork, with only approximately 120mm of its depth remaining in situ within the stripped area (Fig 3b).

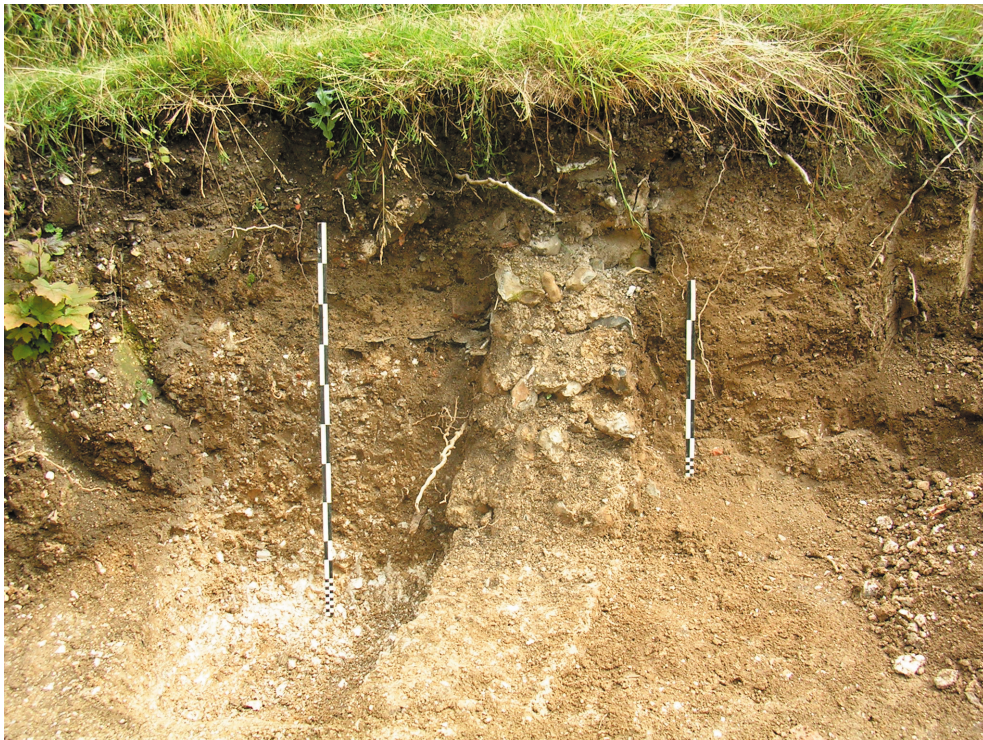
Plate 2: West facing section of trench showing extent of truncation of wall

- 5.1** The wall had been heavily truncated to a maximum depth of 820mm at the eastern edge of the site. As this project consisted of a recording project only, no thorough intrusive archaeological investigation took place. As a result it is not possible at this stage to date the wall, or fully explain construction methods. However a number of observations can be made. No footing trench was identified during the recording project, and the wall appears to be situated directly on the surface of the weathered upper chalk natural. It may perhaps represent a garden or ornamental wall. As the wall shares a similar alignment to the remains of the medieval Portslade Manor to the south it is possible that they may be broadly contemporary.
