**LAND REAR OF 20 / 21 HIGH STREET, LEWES,
EAST SUSSEX**

**HISTORIC BUILDINGS RECORD
ENGLISH HERITAGE LEVEL 3**

ASE Project No. 6969

Report No. 2014397

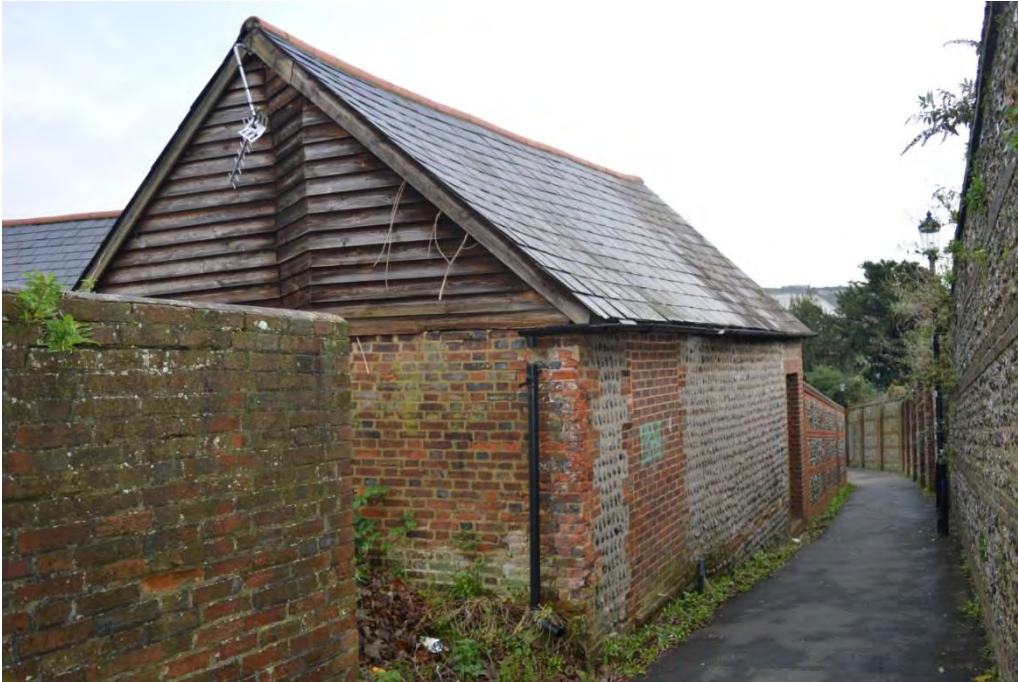
Plate 1: Building 1, view of south elevation fronting Brooman's Lane, facing east (6969_0016)

- 5.1.2 The original principal elevation of Building 1 appears to be the surviving south elevation which faces onto Brooman's Lane. It is constructed in neatly coursed flint cobbles, set in a coarse aggregate cement mortar with brick dressings (Plate 1). The entirety of the south-east corner has been rebuilt in modern purple-red brickwork (Plate 2); however, elsewhere original brickwork survives. The original bricks are soft in texture and are predominantly orange-red in colour, with some variation visible on the door jambs, including darker bricks, bricks with grey kiss marks and occasional grey headers (Plate 3). A brick string course, two bricks in height, runs the length of the elevation. The string course is raised above ground level to correspond to that of the internal floor level. The elevation contains two single-leaf doorways: one at either end. The doorway located to the west end is original to the building but is now in-filled with modern brickwork. Towards the east end is an inserted doorway of a later date, probably inserted in association with the later 20th century phase of modification to the building. The doorway to the east (Plate 2) is formed by modern purple-red brickwork and has a brick soldier course head. The doorway is deeply recessed and accessed by three brick steps from ground level; it comprises a modern timber boarded door.

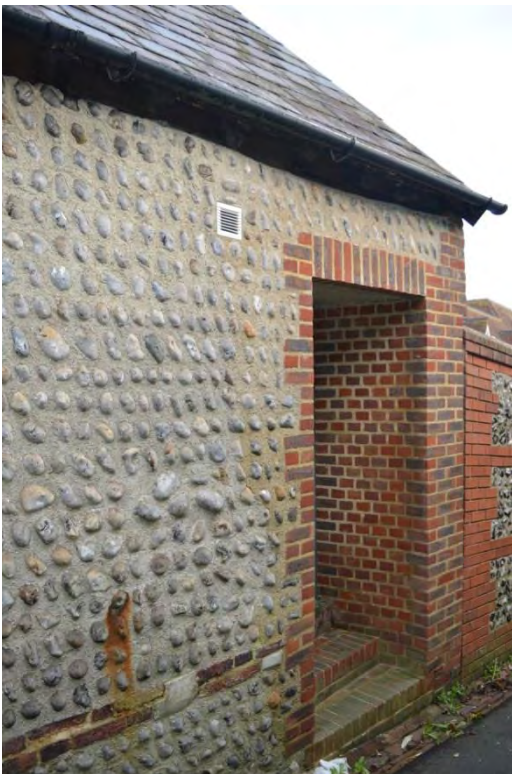
Plate 2: Building 1, view of south-east corner and modern doorway, facing east (6969_0010)

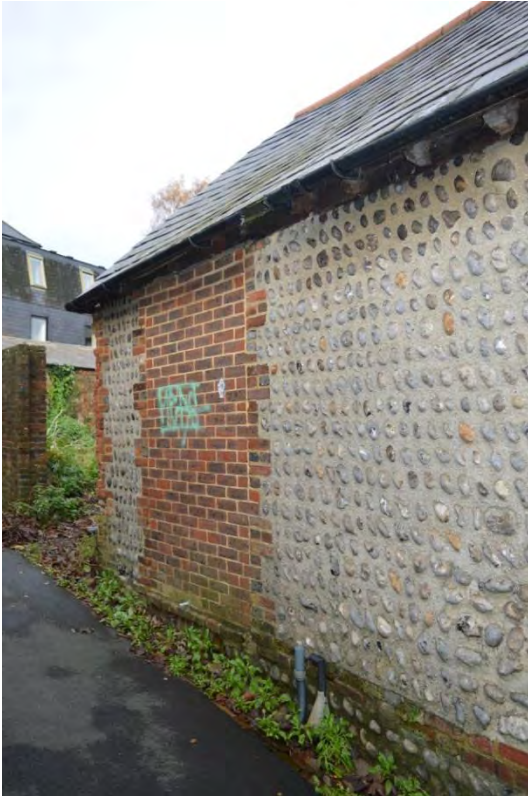
Plate 3: Building 1, view of south elevation and blocked original doorway, facing west (6969_0013)

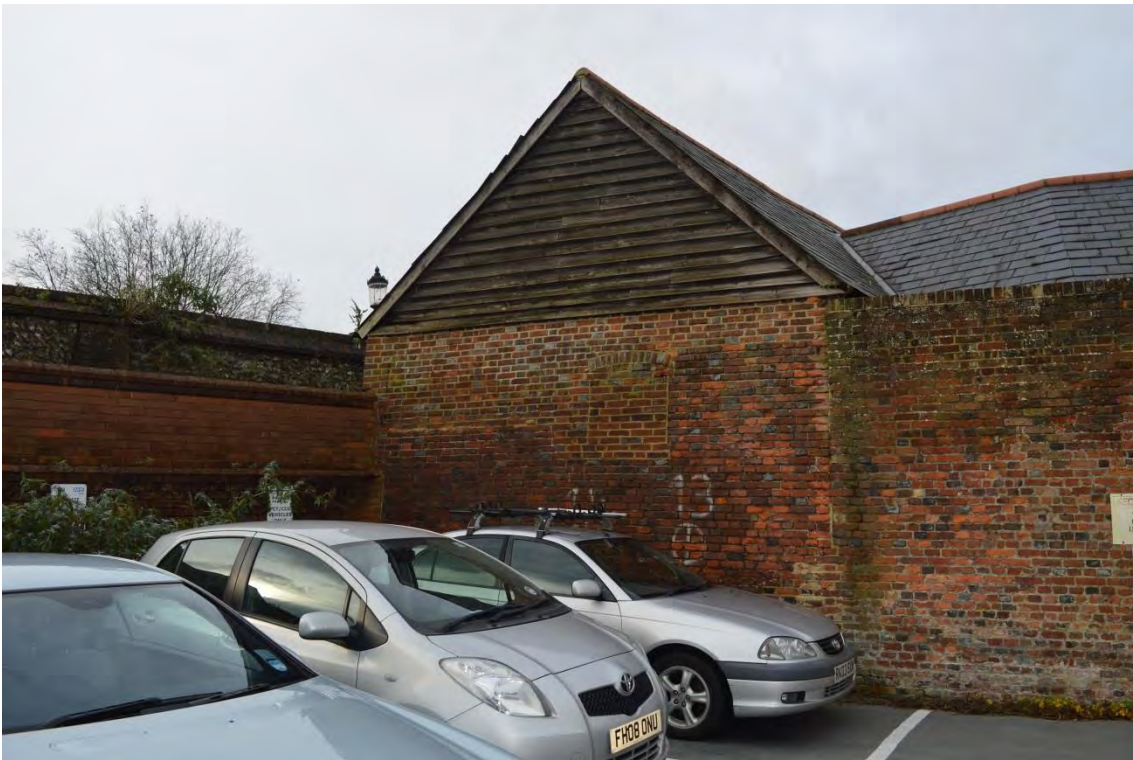
Plate 4: Building 1, view of east elevation, facing south-west (6969_0002)

- 5.1.3 The east elevation of the original range is constructed wholly in orange-red brickwork, with occasional grey headers, laid essentially in Flemish bond. The gable is clad in modern timber weatherboarding. The bricks are set in a soft lime-based mortar containing a coarse aggregate typical of a 19th century construction date. The lower third of the wall, to its north end, bears evidence of modern cement repair with a loose attempt at a penny-struck finish between courses. The elevation has a single feature in the form of a small rectangular (now infilled) window with segmental brick head, located off-centre to the north (Plate 4). Queen-closer bricks to the window jambs indicate the window is an original feature.

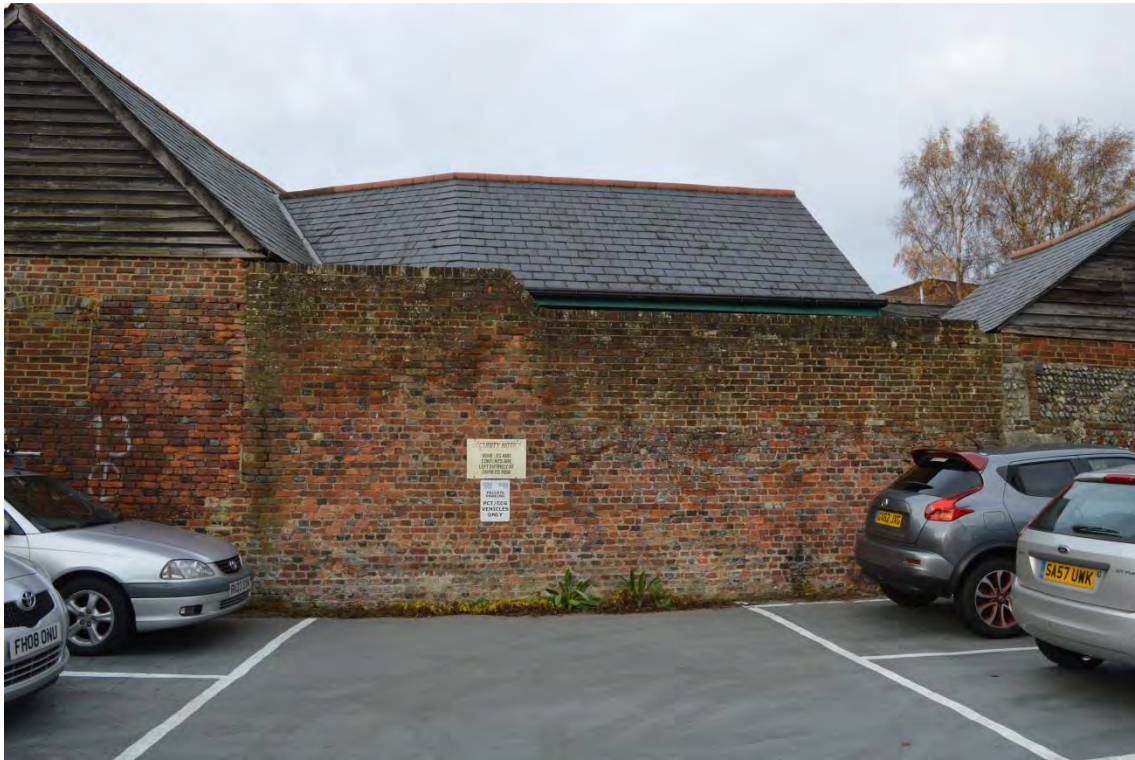
Plate 5: Building 1, view of boundary wall to the east, facing west (6969_0003)

in later brickwork with a cement-based mortar to the height of 3 metres, which ramps up at the southern end to 3 ½ metres. The full length of the wall is topped with brick headers.

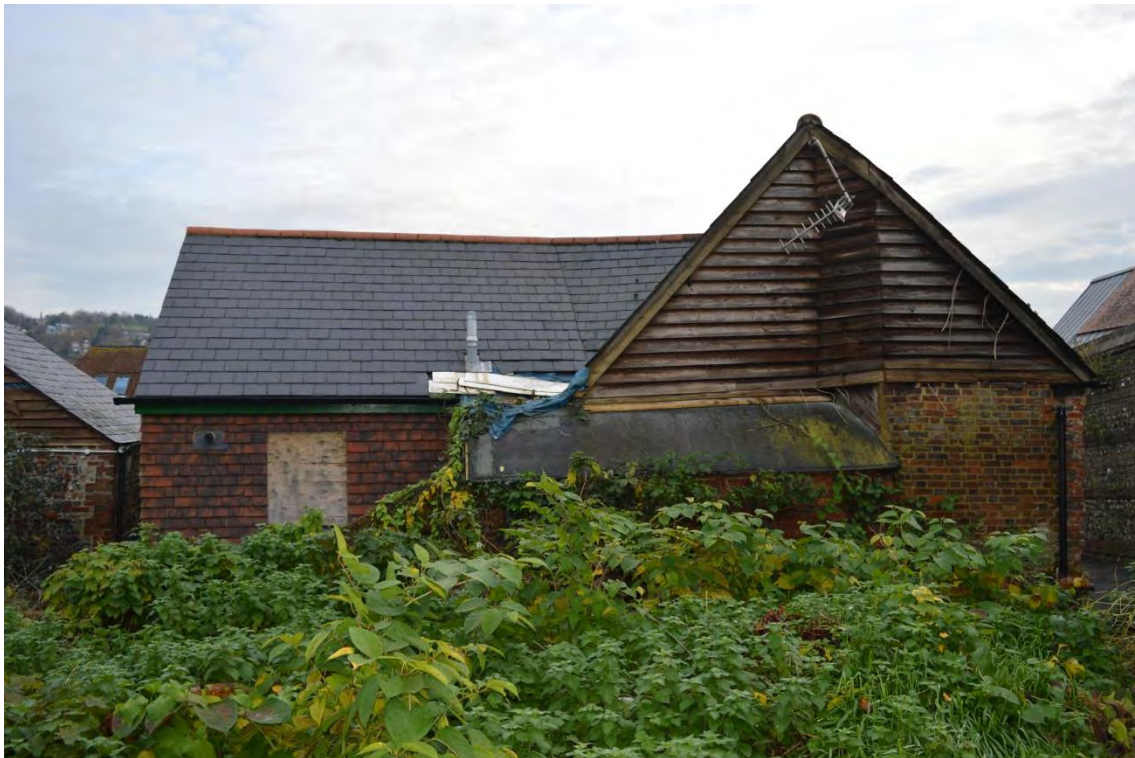
Plate 6: Building 1, view of west elevation, facing east (6969_0017)

- 5.1.5 The west elevation is of irregular form, articulated with a small full-height projection at the south end (Plates 6 & 7). To the north, the original building line, which is set back by approximately 0.4-0.5 metres from the protruding south section, survives at the upper level. At the lower level, the north end has been extended westwards to bring it in line with the south end. A straight joint, and differentiation between the brickwork of the two, confirms the northern end as a later addition. The existing layout of the south end corresponds to a small projection noted on the 1873 Ordnance Survey mapping 1873 (Fig. 6). The south end is constructed in Flemish-bonded orange-red brickwork similar to that already described. The gable is covered in modern timber weatherboarding reflecting a similar arrangement to that on the east elevation. The lower level north end addition is constructed in a hard red brick with occasional darker bricks, set in a grey coloured cement mortar, with a steeply angled rudimentary lean-to roof made of plywood covered with roofing felt.

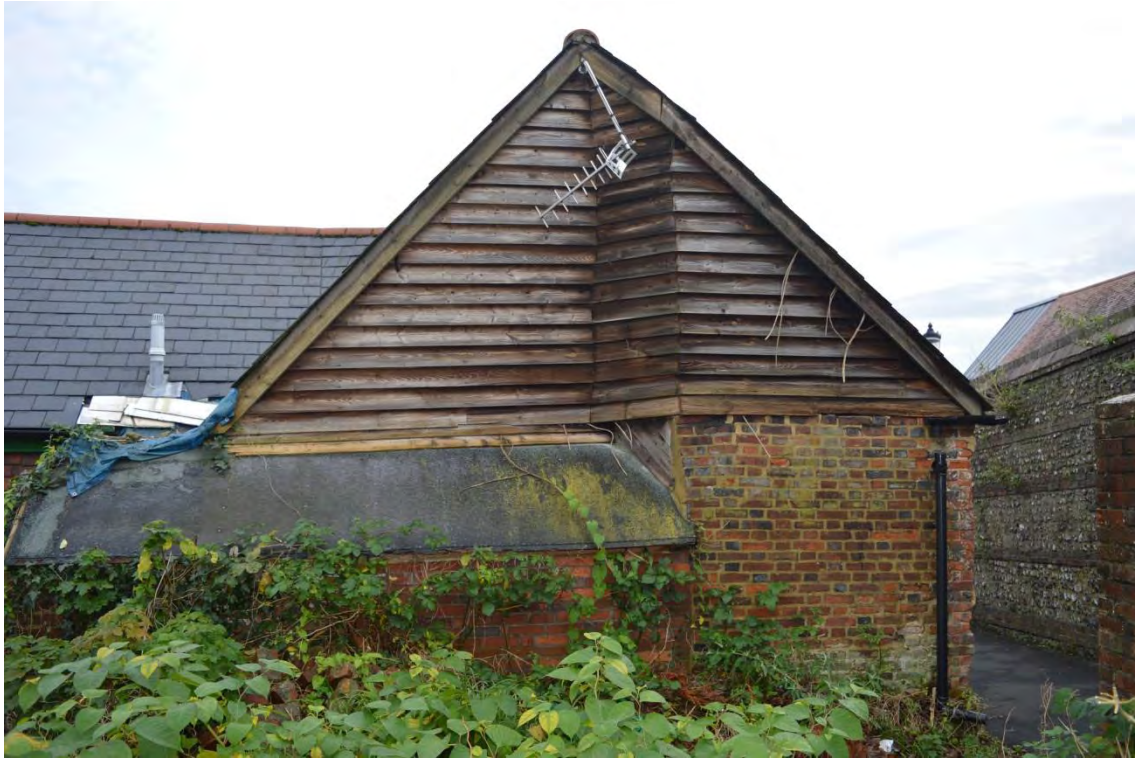
Plate 7: Building 1, view of west elevation of the southern range, facing east (6969_0018)

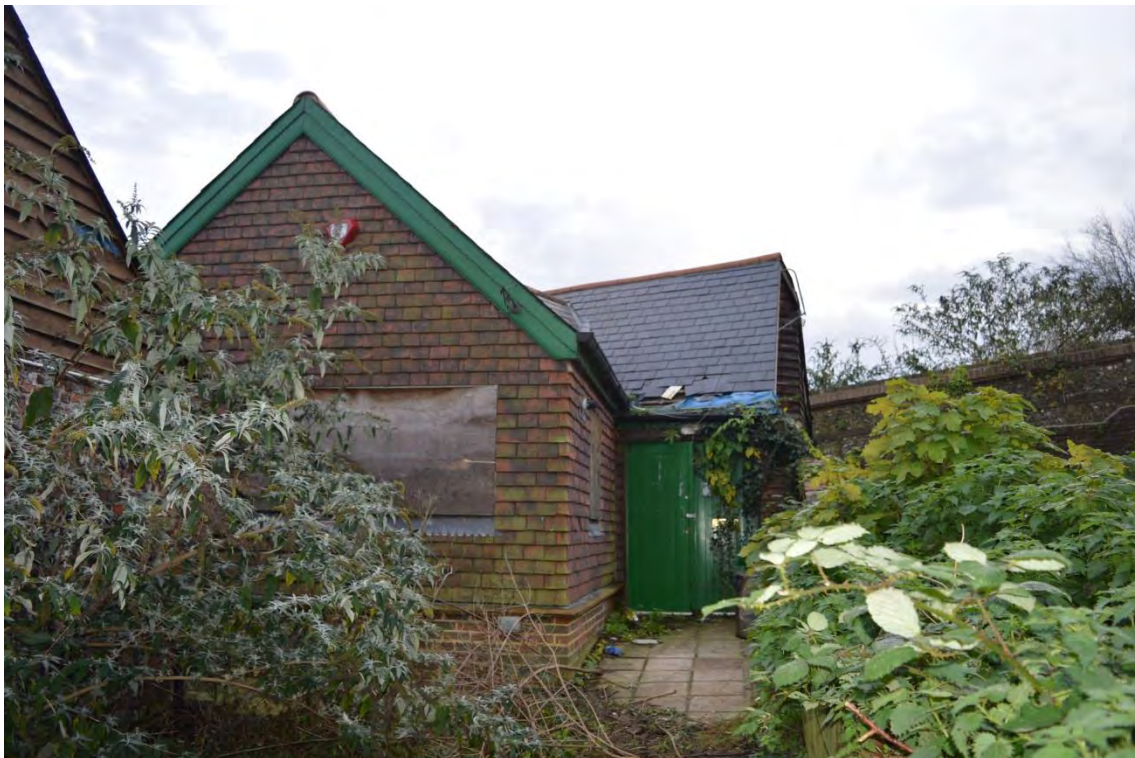
Plate 8: Building 1, view of modern north elevation and porch, facing south (6969_0025)

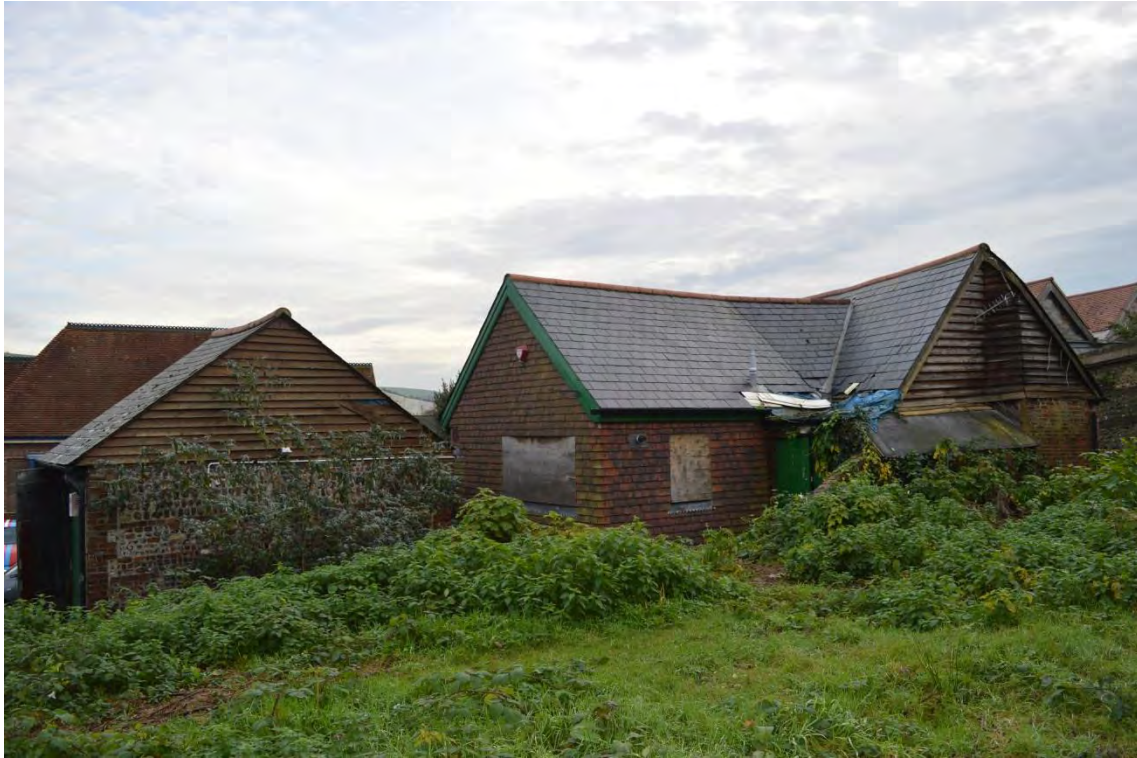
Plate 9: Overview of Buildings 1 & 2, north and west elevations, facing south-east (6969_0022)

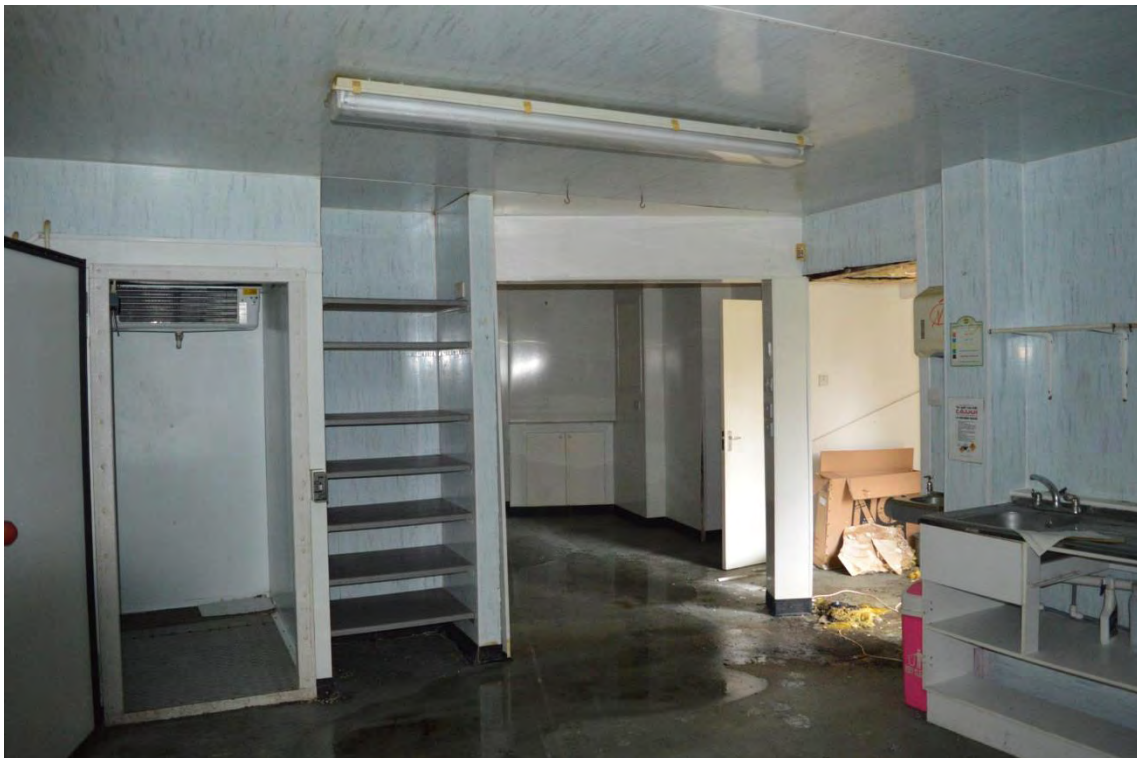
Plate 10: Building 1 interior, main circulation area between the southern and northern ranges, facing south-west (6969_0043)

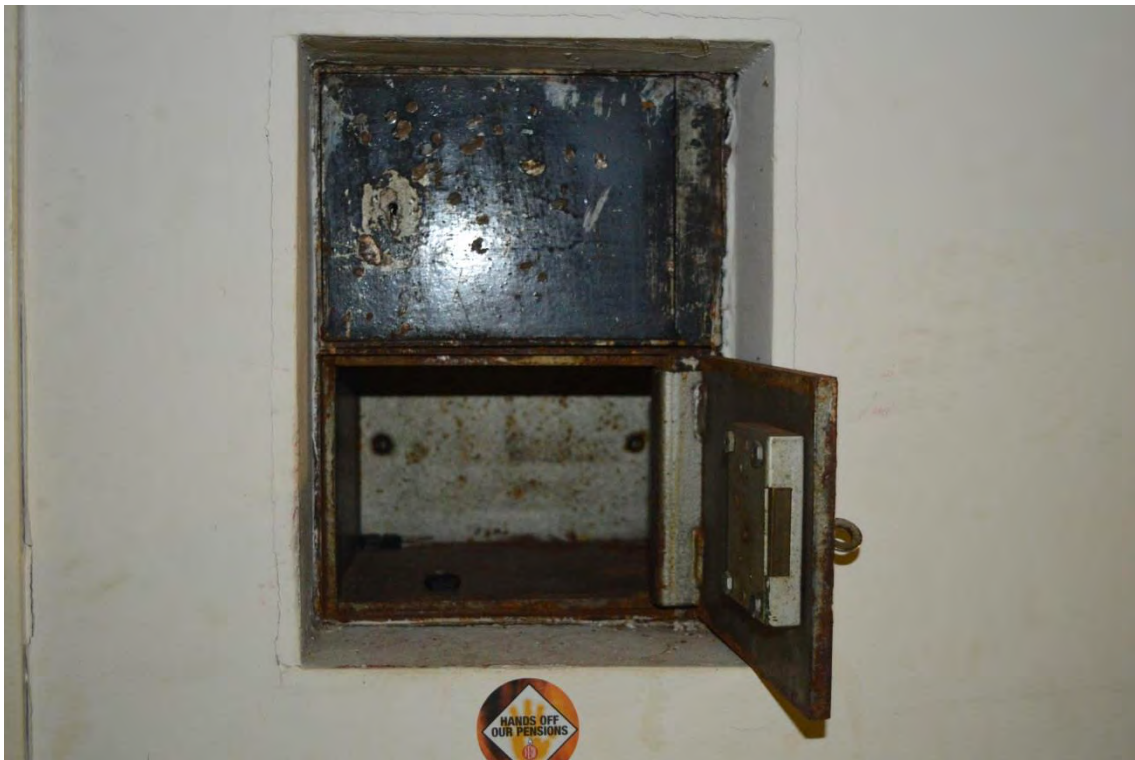
Plate 12: Building 1 interior, south-east room (office), safe detail, facing south (6969_0074)

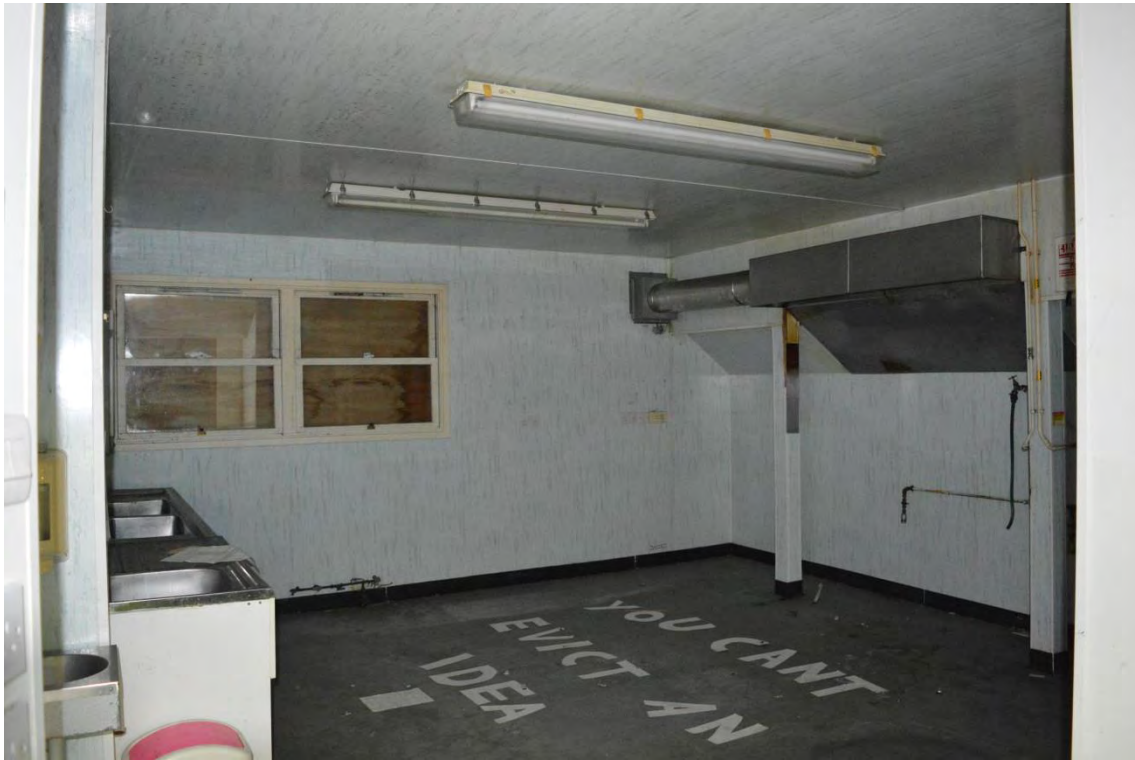
Plate 15: Building 1 interior, north-east corner of northern extension, facing north-east (6969_0041)

- 5.1.10 The later addition to the north comprises a large open room serving as a food preparation area (Plate 15), which is open onto the principal circulation area of the southern range to the south-west. The room houses modern stainless-steel food preparation units along the western side, including sink and work surface area. The eastern side incorporates the lower level lean-to roof section with a low sloping ceiling; underneath this is a modern stainless-steel extraction fan / ventilation hood with vent leading to the external northern elevation. The south-east corner of the northern addition houses a single small room, used as a food cold store (produce freezer). Immediately to the west of this room are two built-in cupboards, one with metal steel shelving, the other with timber shelving; both are recessed into the wall.

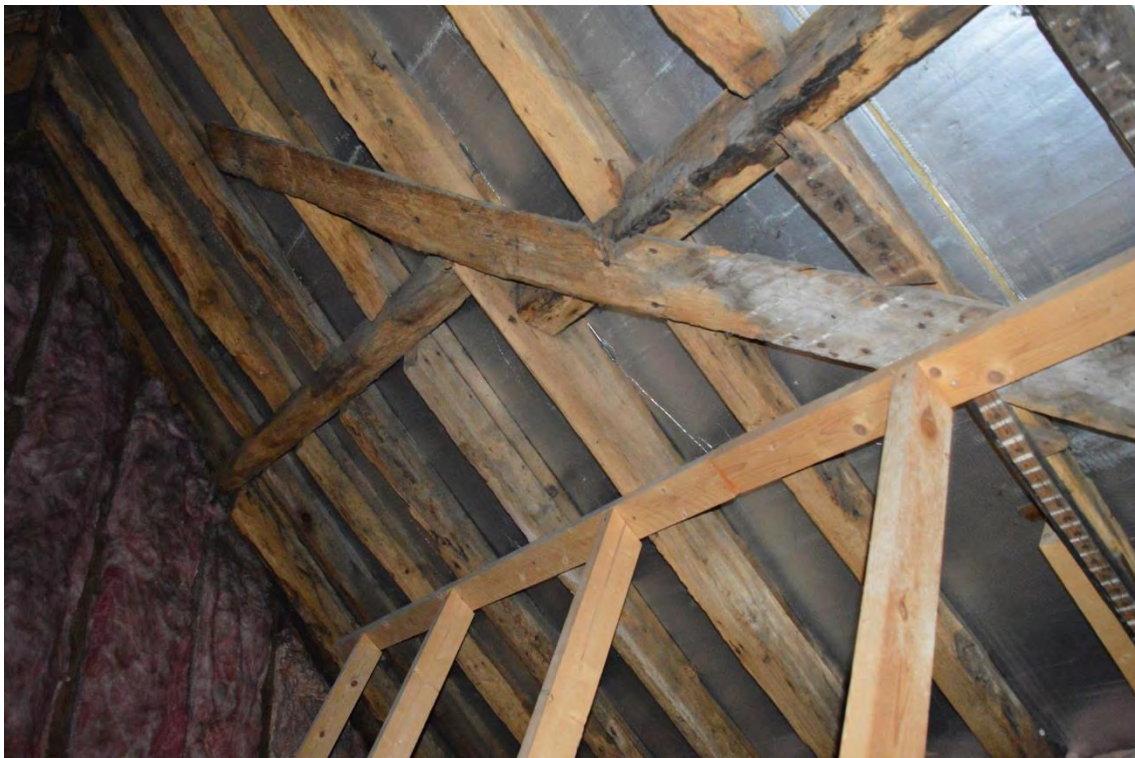
Plate 16: Building 1 roof interior, detail of rafter and purlin construction, facing south-east (6969_0055)

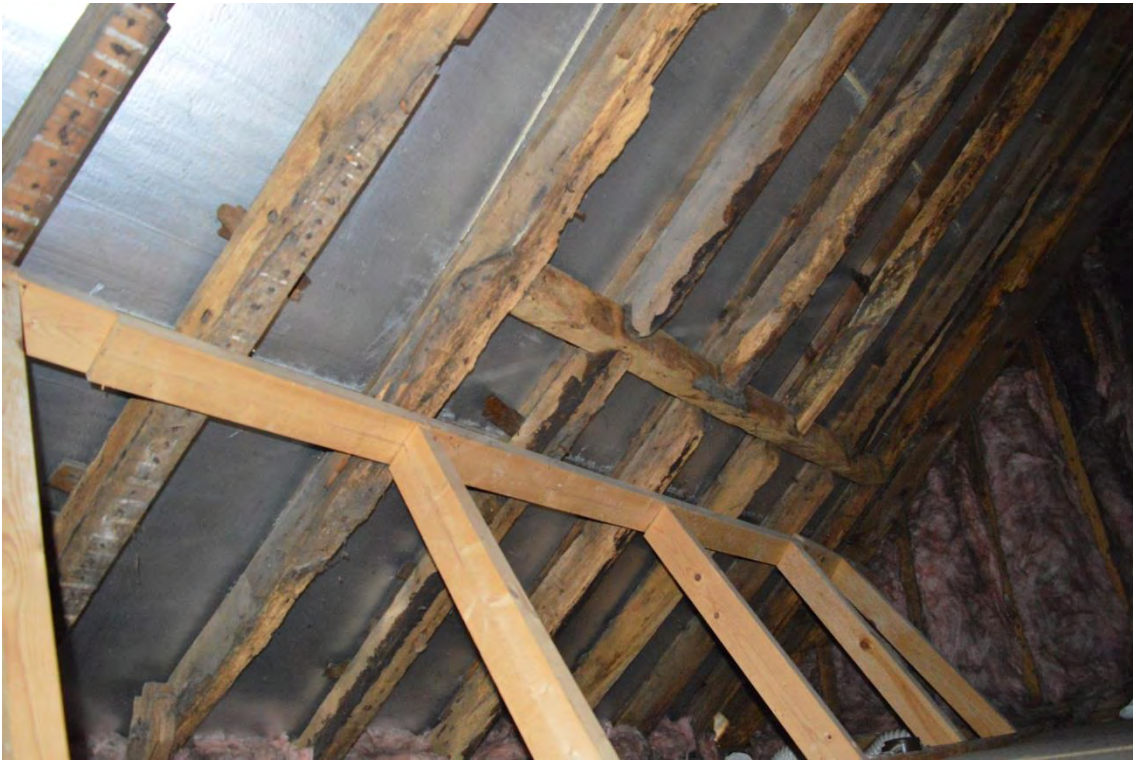
Plate 17: Building 1 roof interior, note the gap in the purlins for a probable loading bay, facing south-west (6969_0056)

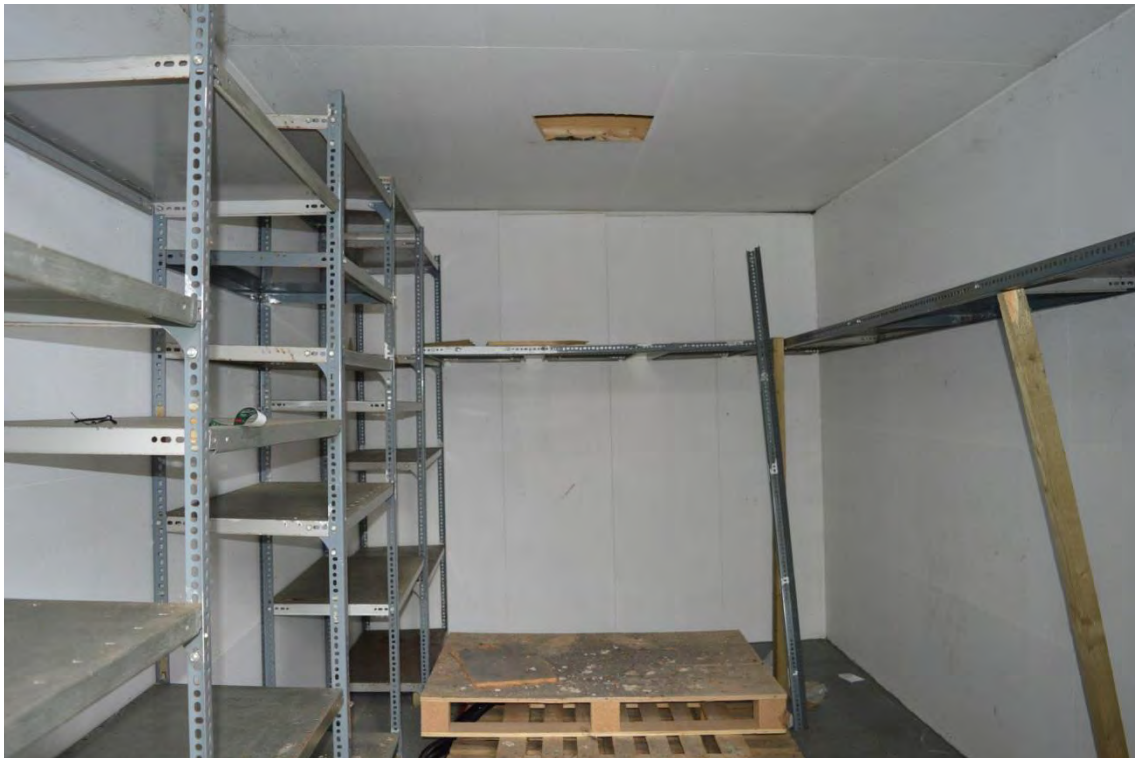
Plate 20: Building 2 interior, facing south (6969_0014)

- 5.3.4 The building comprises a single storey room with modern stainless-steel shelving units attached to its three walls (Plate 20). Much like Building 1, the interior of Building 2 has been lined out in recent years with modern materials which cover the original walling behind. The walls and ceiling comprise plywood boards with

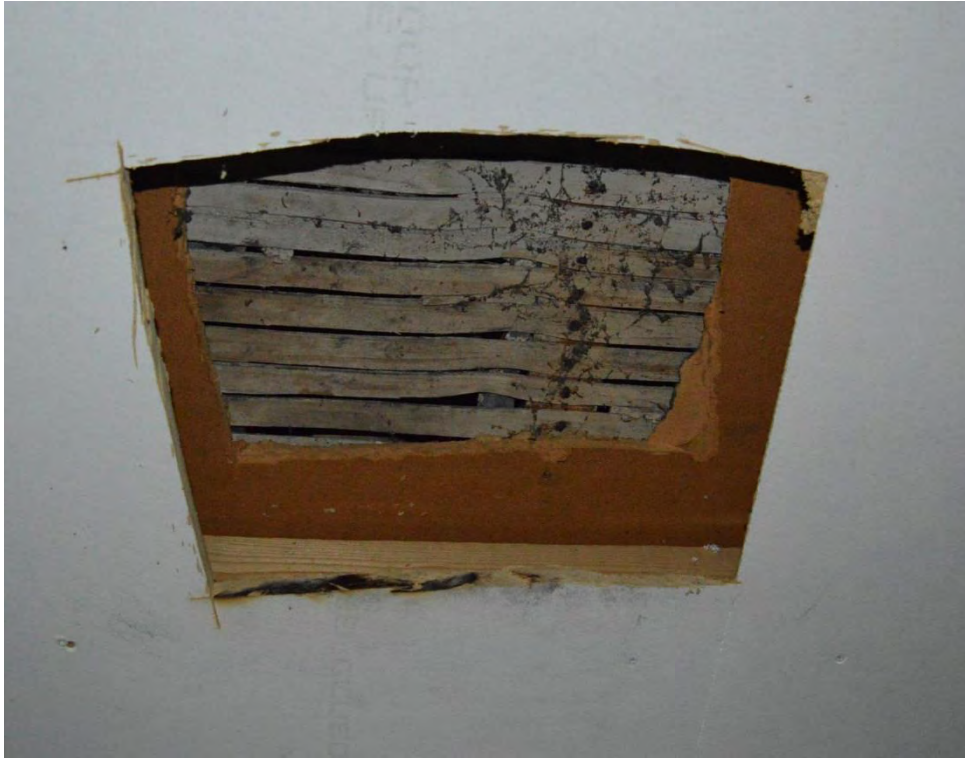
Plate 21: Building 2 interior, timber lathe ceiling, facing south (6969_0036)

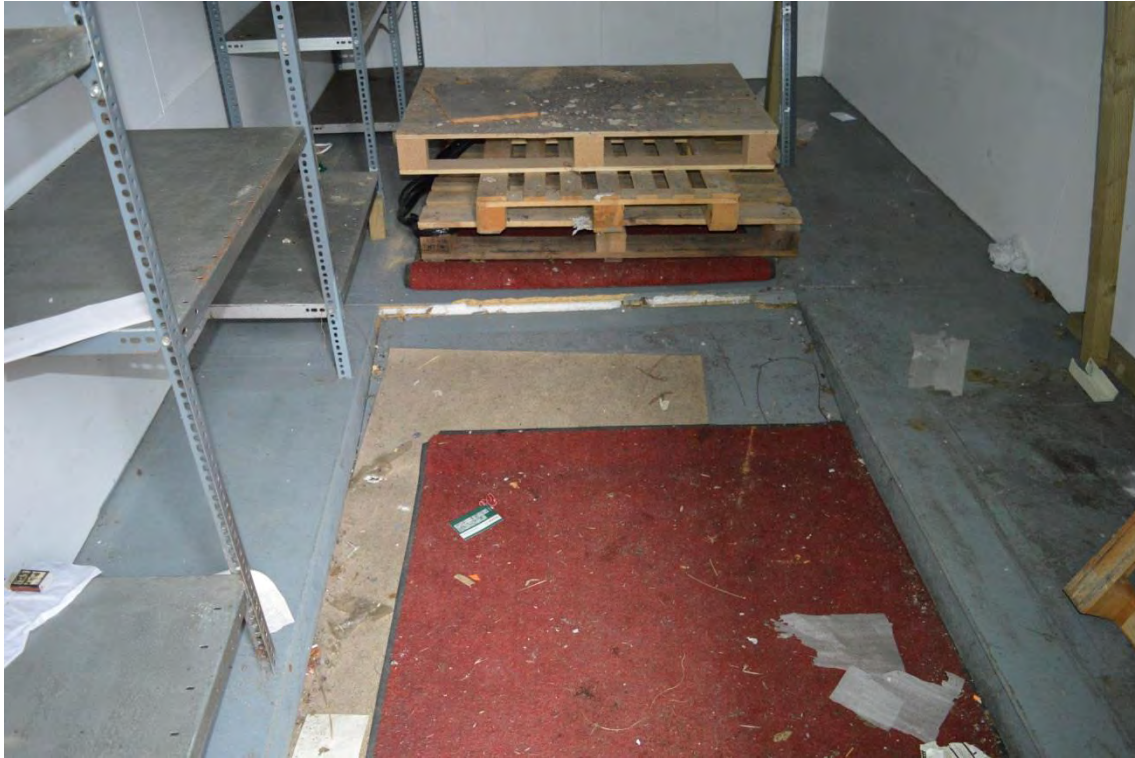
Plate 23: Building 2 interior, recessed floor level (vehicle inspection pit), facing south (6969_0037)

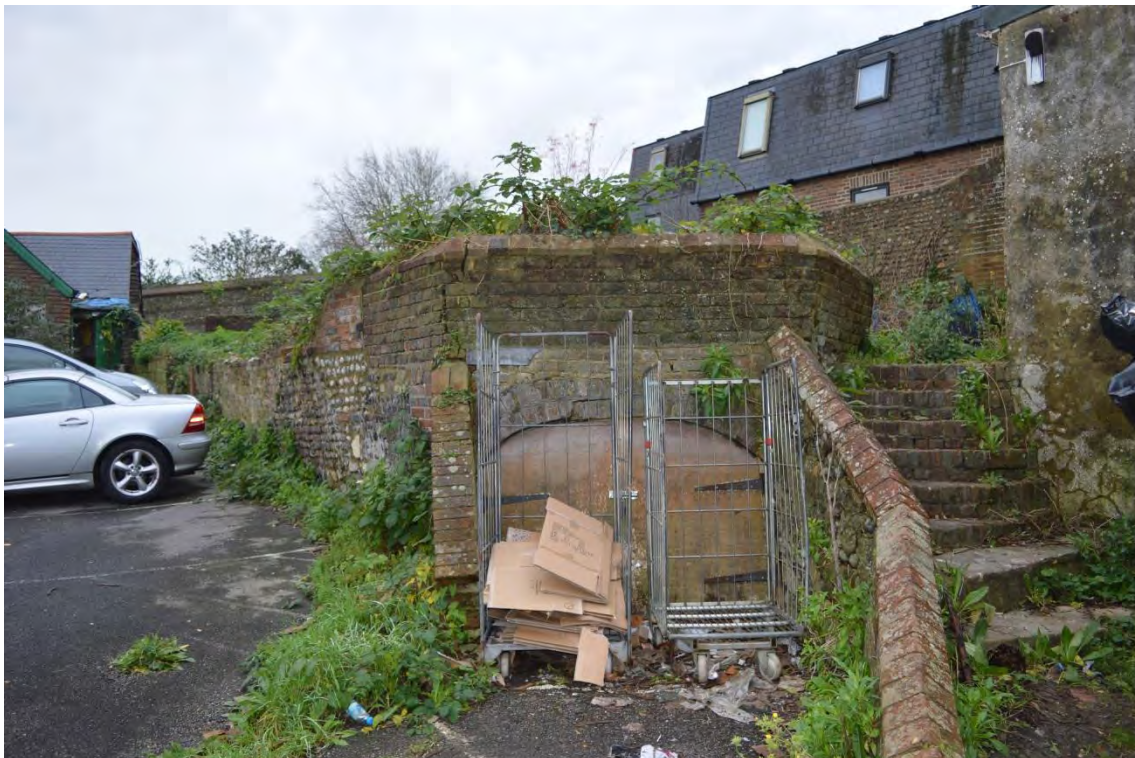
Plate 24: Retaining wall, showing entrance (Section 1) towards the northern end, facing south-west (6969_0062)

5.4.1 The retaining wall located to the west of Buildings 1 and 2 forms a low retaining wall for the east side of the subterranean vaulted cellar (Plate 24). The wall consists of several phases of construction with evidence of later patch repairs. For ease of description, the wall has been divided into six separate sections (Figs 13 & 14).

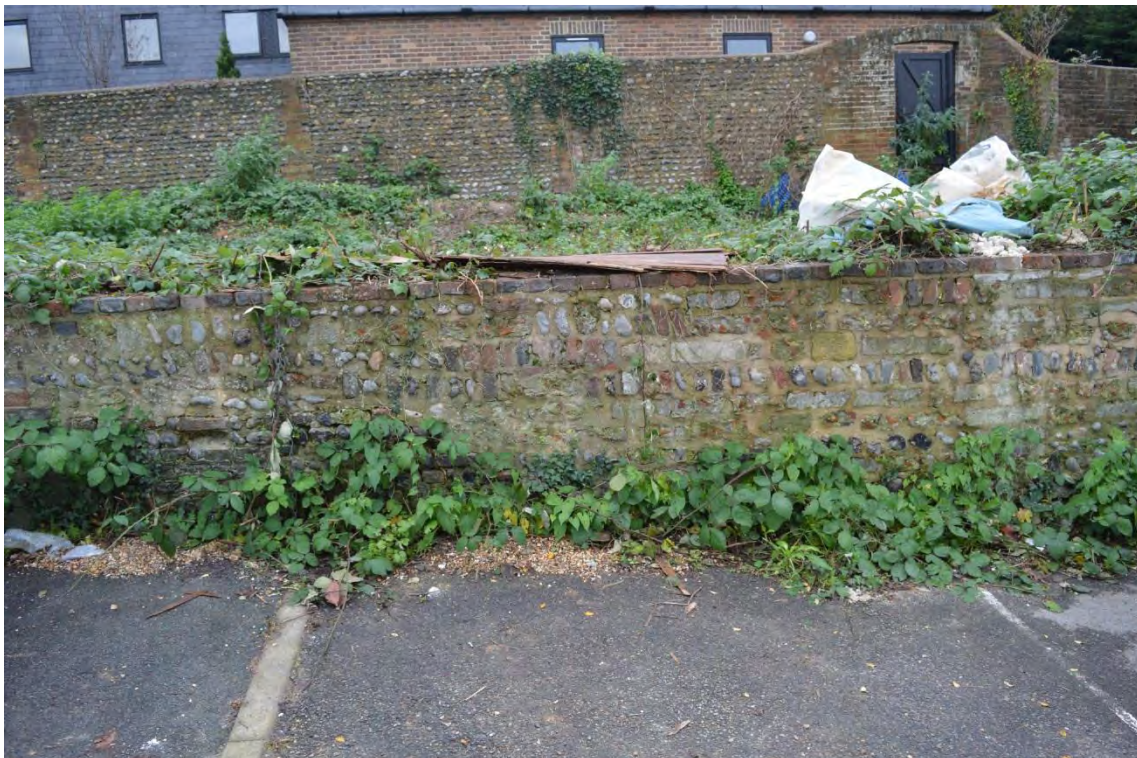
Plate 26: Retaining wall, Section 3, facing west (6969_0067)

broken concrete (Plate 26). Towards the middle of this section are a series of inlaid glazed terracotta tiles characteristic of the late 19th to early 20th (Plate 27).

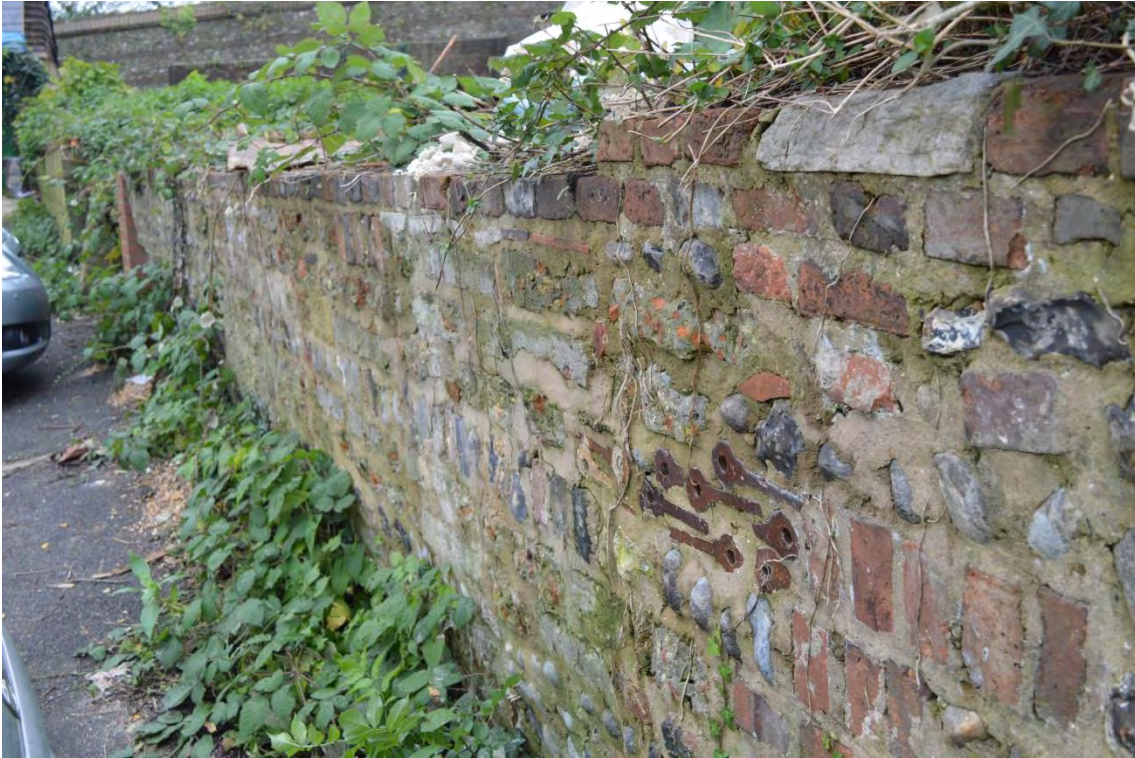
Plate 27: Retaining wall, Section 3, inlaid tile detail, facing south-west (6969_0065)

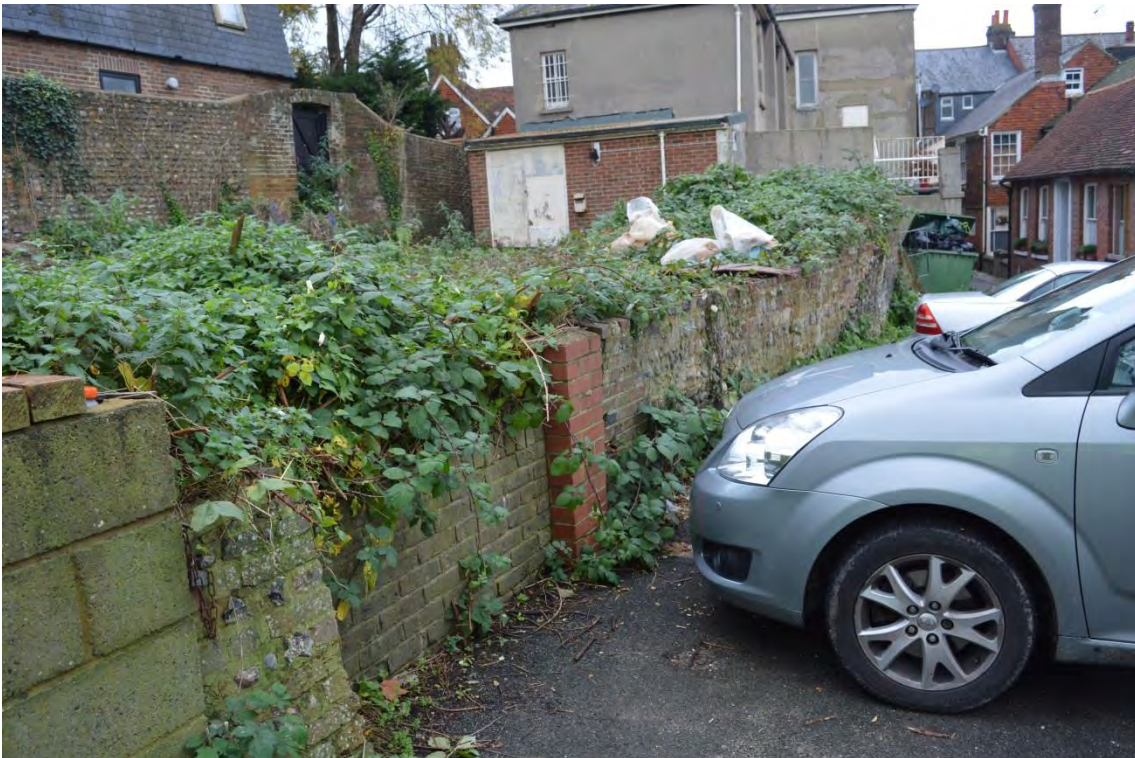
Plate 28: Retaining wall, Section 4, modern in-fill of suspected former access point, facing north-west (6969_0070)

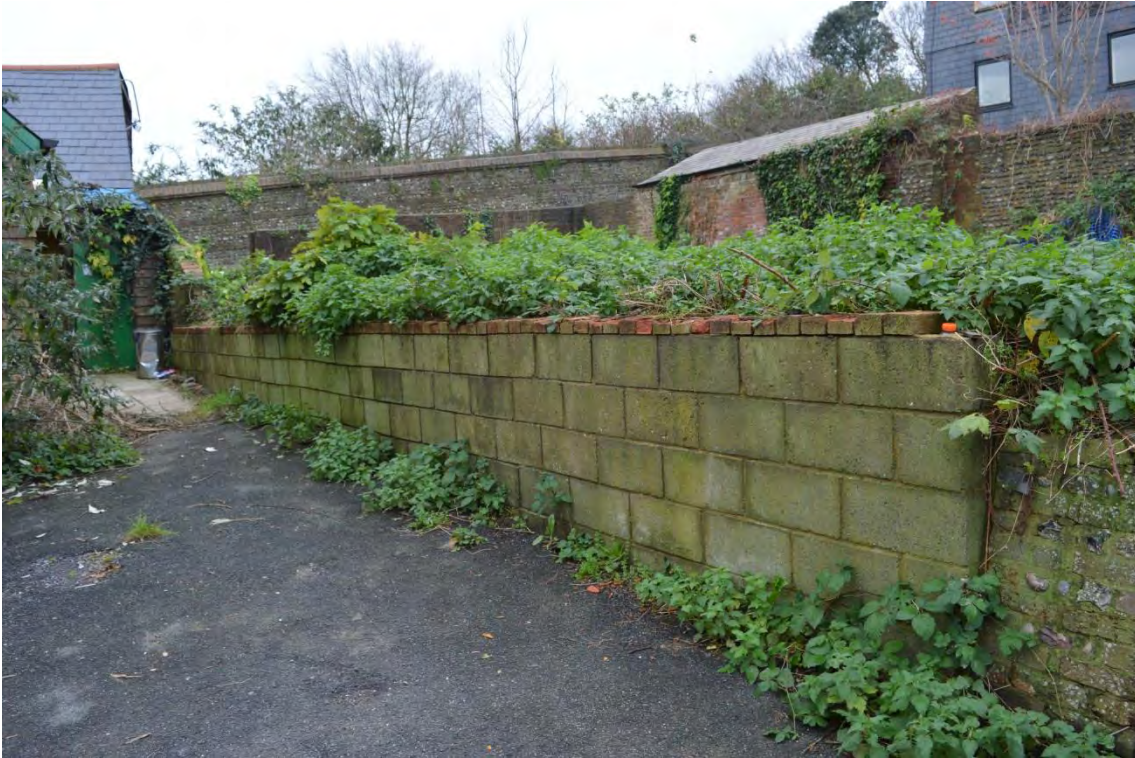
Plate 29: Retaining wall, Section 5, concrete block construction, facing south-west (6969_0071)

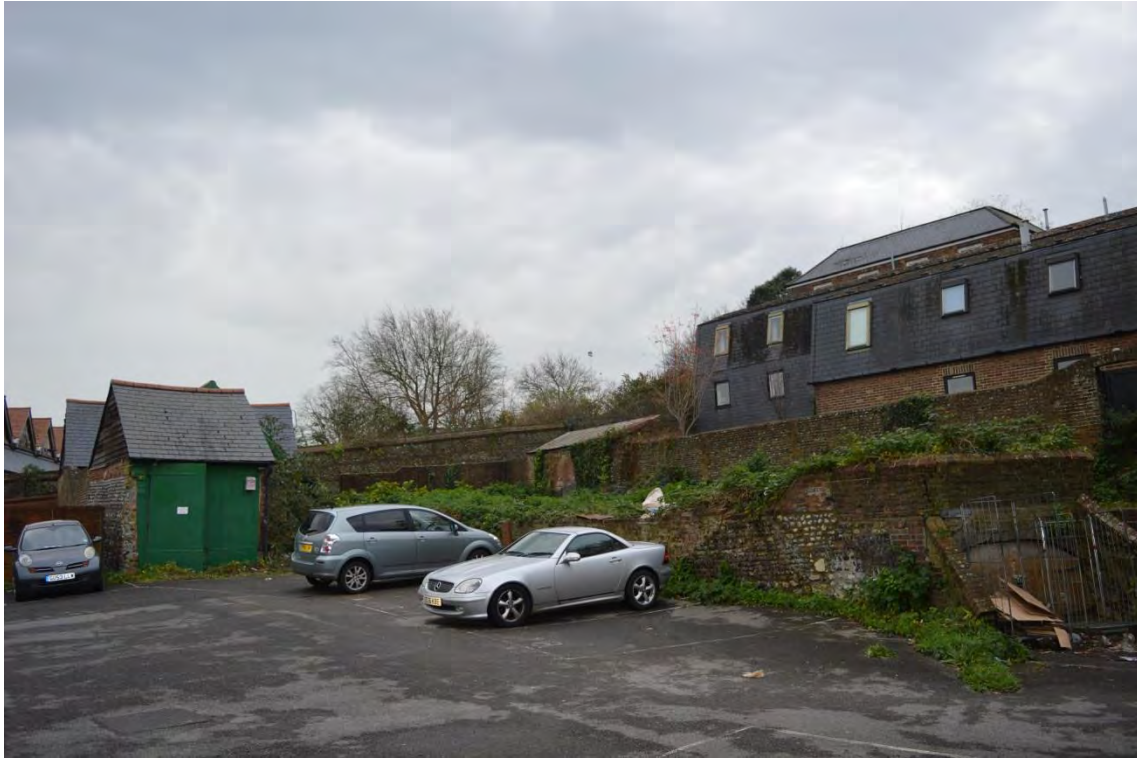
Plate 31: Overview of Building 2 and retaining wall, facing south-west (6969_0059)

- 6.3 The retaining wall to the west of Buildings 1 & 2 seems originally to have been constructed as a boundary wall to the land titled 'Fuller's Yard' on historic mapping and a retaining wall for the subterranean vaulted cellar. Although the wall has various phases of construction, the earliest appears to date to the 19th or possibly 18th century, with various later phases of repair and reinforcement.
