**LAND REAR OF 20 / 21 HIGH STREET, LEWES,
EAST SUSSEX**

**HISTORIC BUILDINGS RECORD
ENGLISH HERITAGE LEVEL 3**

ASE Project No. 6969

Report No. 2014397

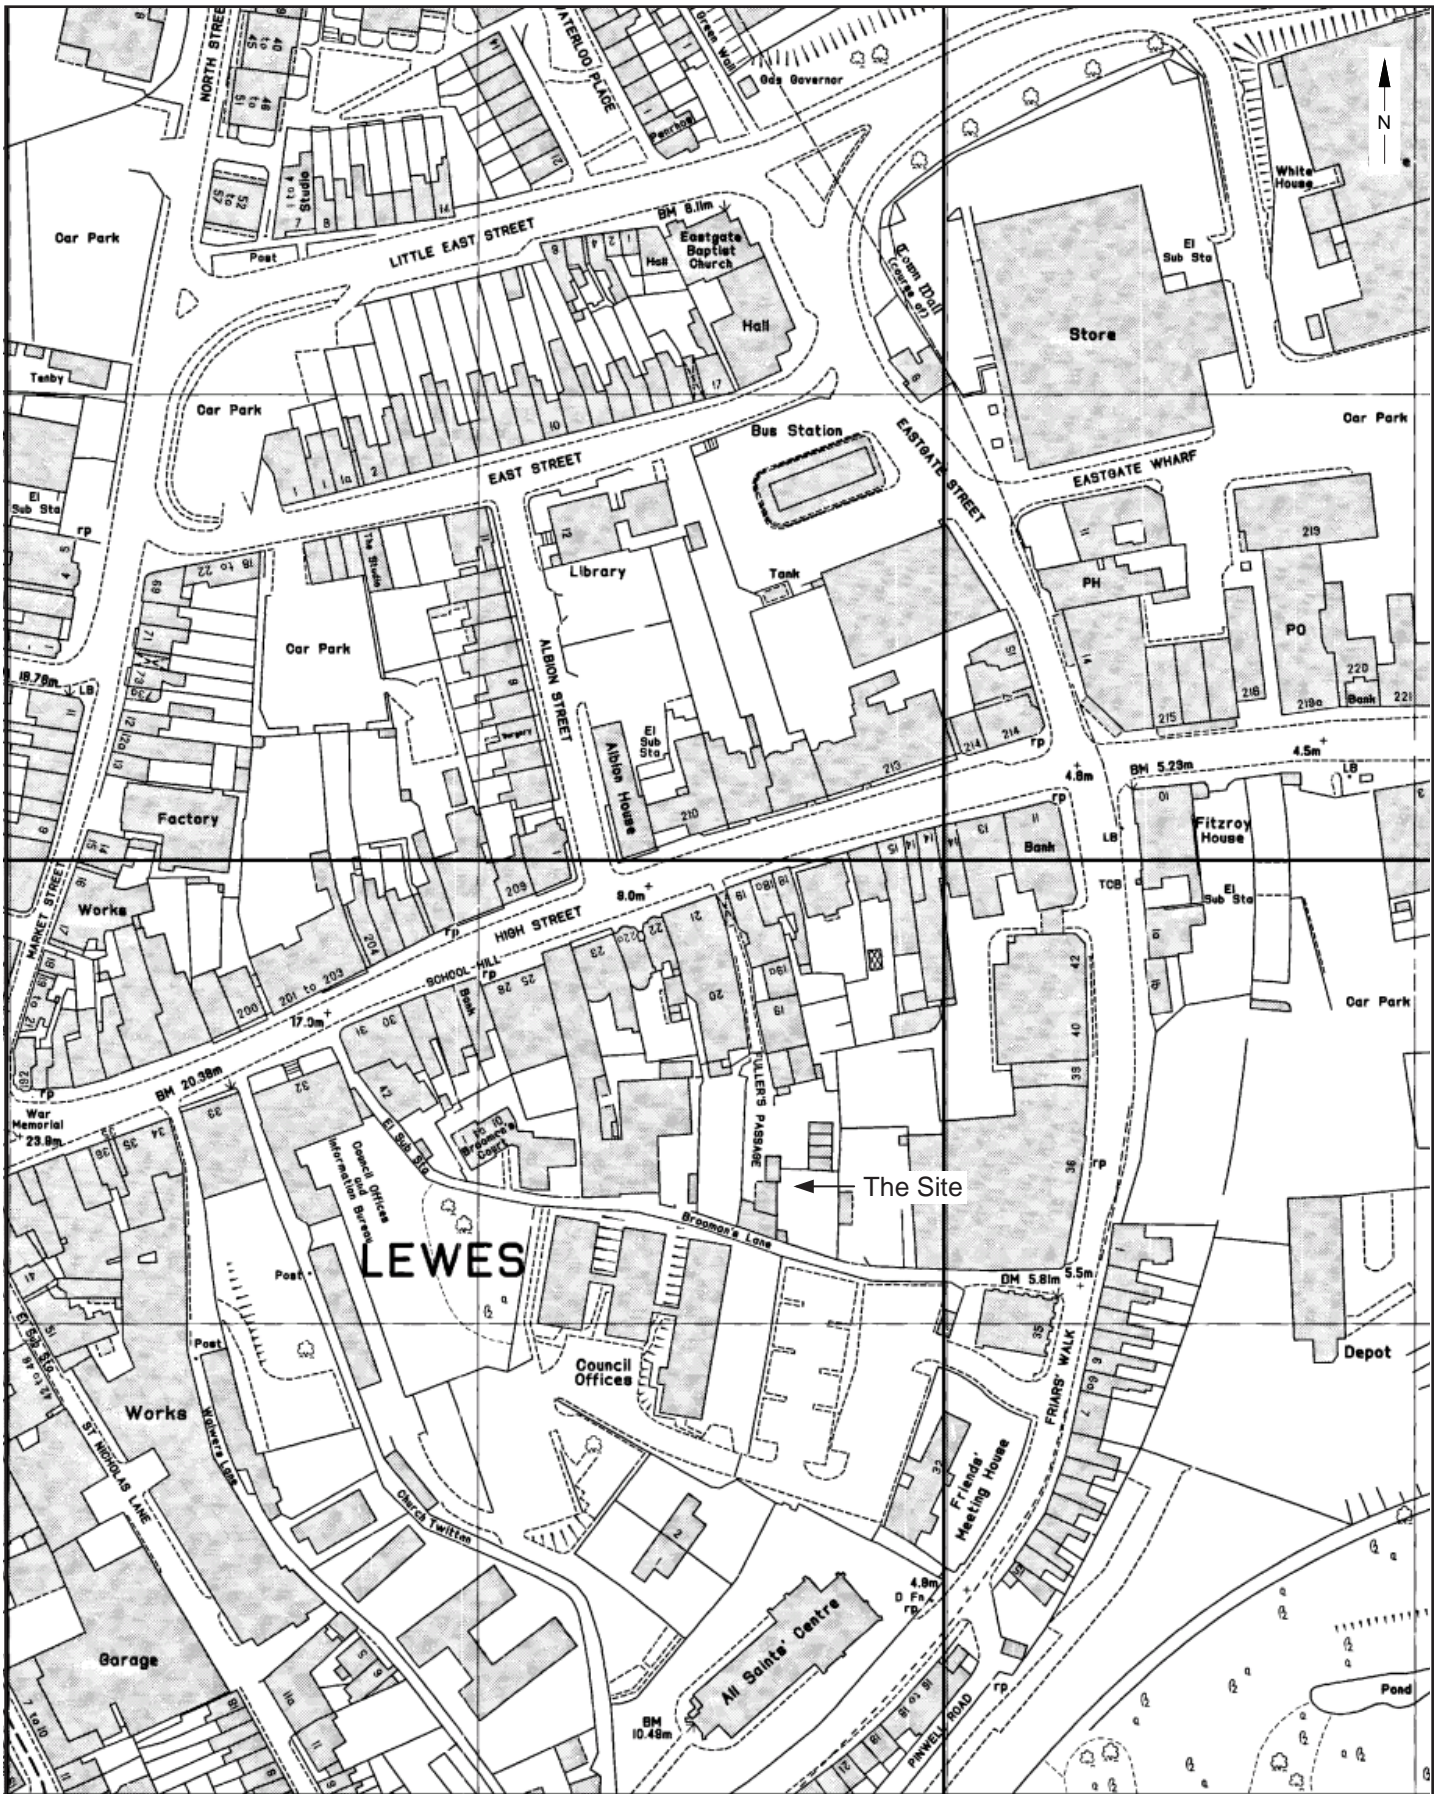
© Archaeology South-East		Land rear of 20-21 High Street, Lewes	Fig. 12
Project Ref: 6969	December 2014	Ordnance Survey Map 1:1250 Sheet (1971-1988)	
Report Ref: 2014397	Drawn by: HG

- 4.7 The 1988 Ordnance Survey map (Fig. 12) shows a substantial addition to the north side of Building 1, and the removal the structure previously noted in the vicinity of the entrance to the cellar.

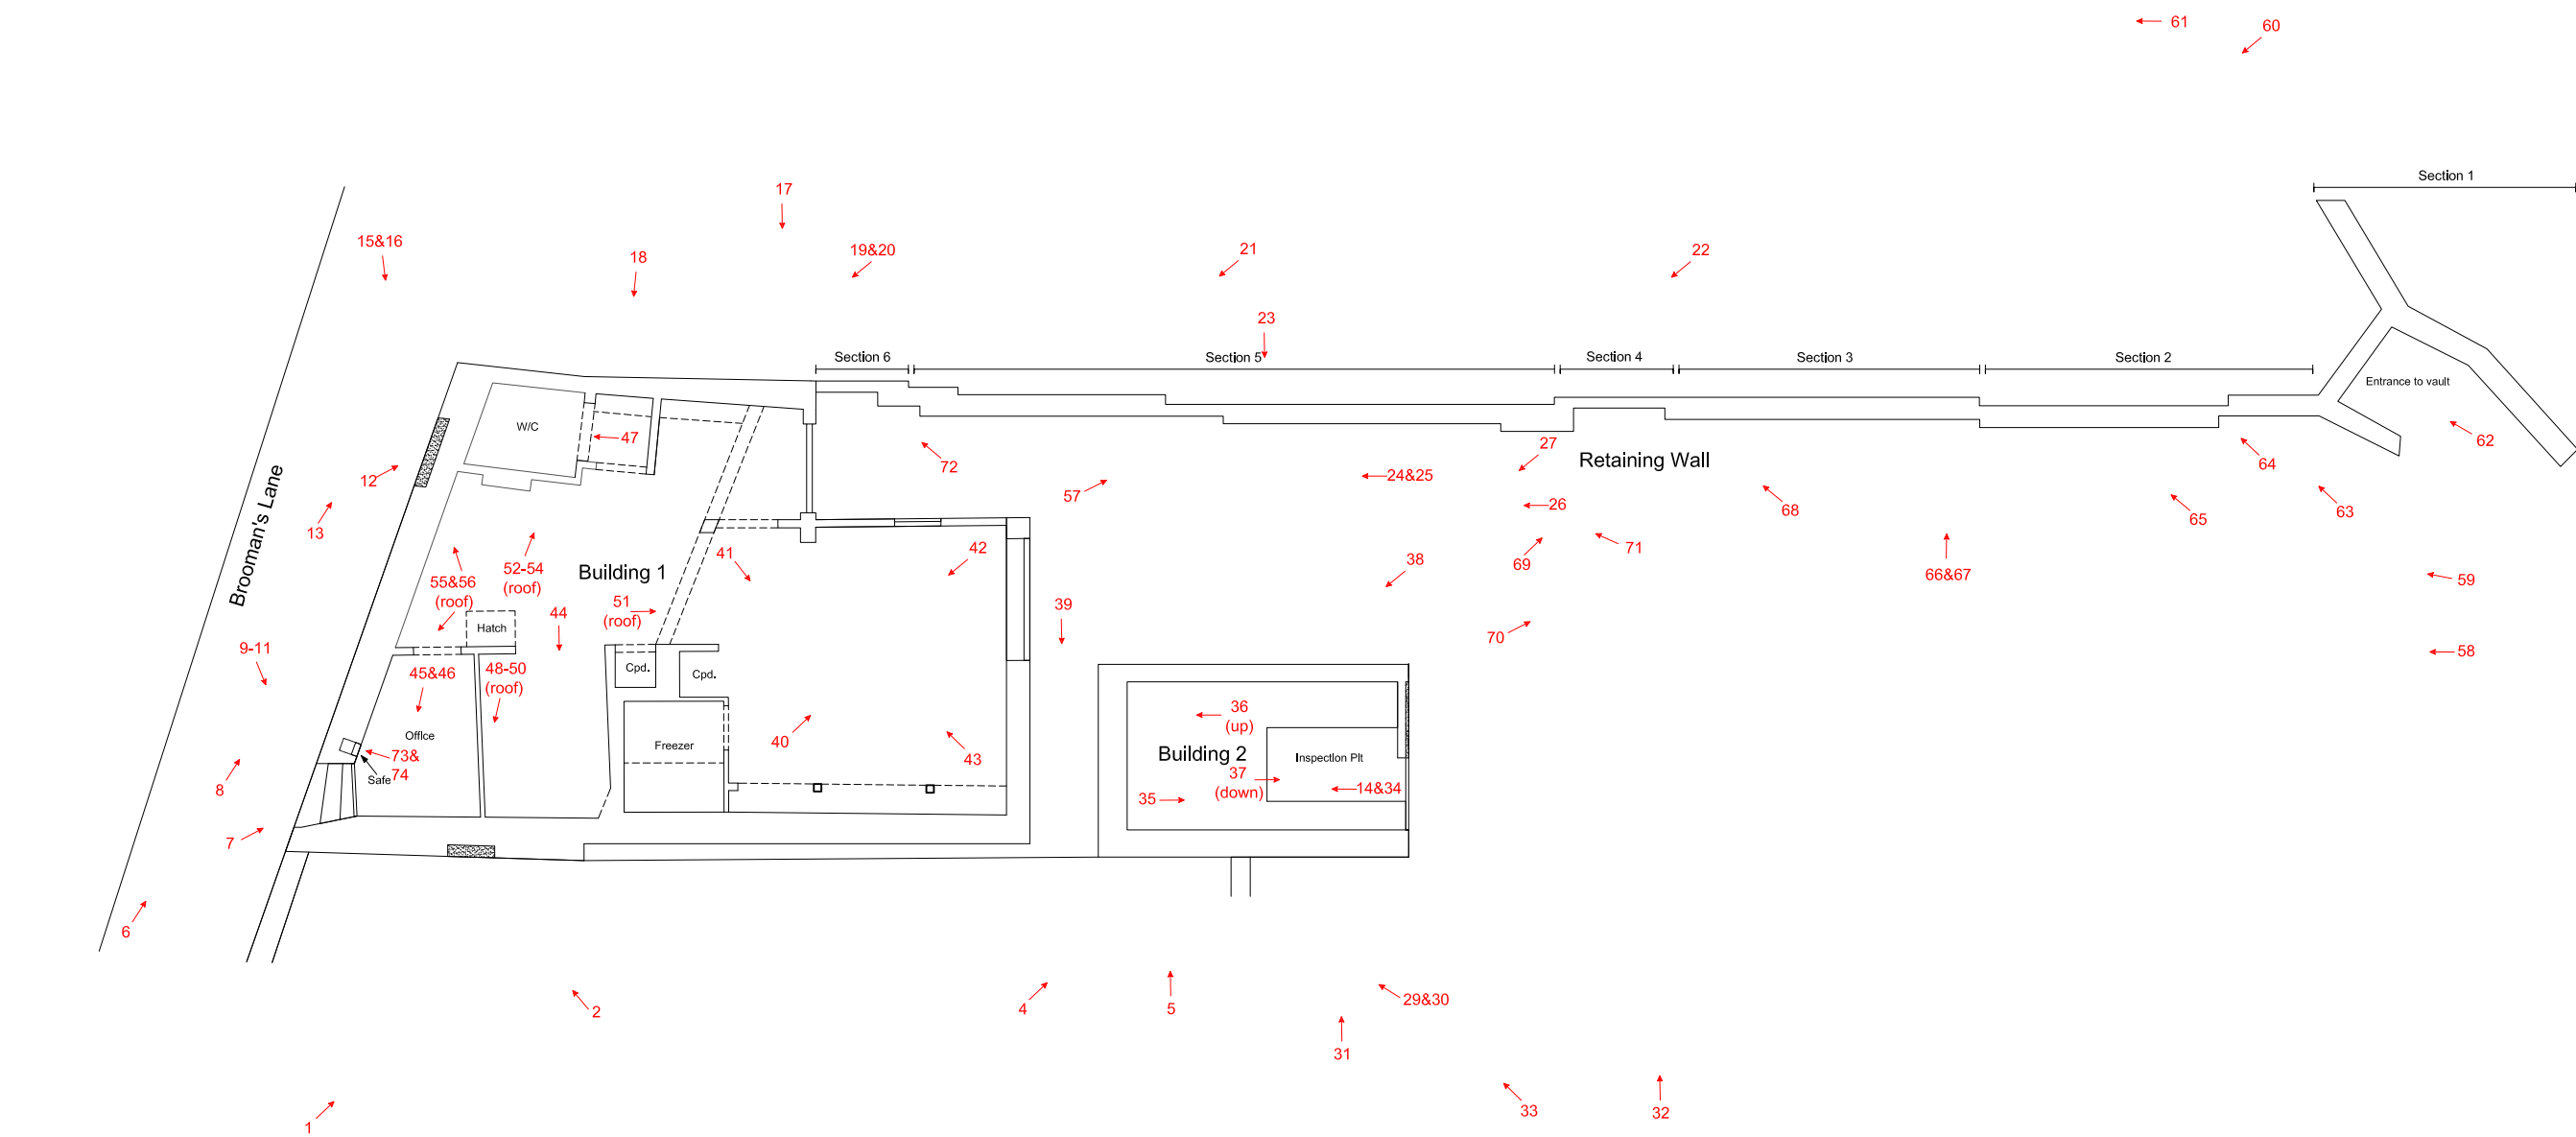
© Archaeology South-East		Land rear of 20-21 High Street, Lewes, East Sussex		Fig. 13
Project Ref: 6969	Decmeber 2014	Floor Plans and Photo Locations (1:125)		
Report Ref: 3014397	Drawn by: HG

- 2.4 The drawn record comprises floor plans of the buildings to illustrate their layout. These plans are based on measurements taken during the recording exercise. The resulting scaled drawings are included within the report as Figure 12.
