**An Archaeological Evaluation
at the former site of Osborne House, Station Road,
Burgess Hill, West Sussex**

**ASE Project No: 7231
Site Code: BHO14**

**ASE Report No: 2015005
OASIS id: archaeol6-200019**

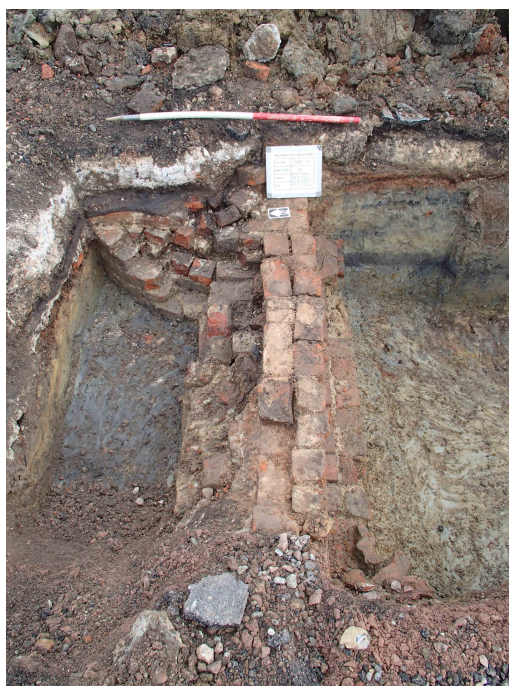
- Front Cover: Brick walls in Trench 1 under excavation
- Figure 1: Site Location
Figure 2: Trench Location
Figure 3: Trench 1: plan and photographs
Figure 4: Trench 2: plan and photographs
Figure 5: Trench 3: plan and photographs
Figure 6: Trench 4: plan, sections and photographs

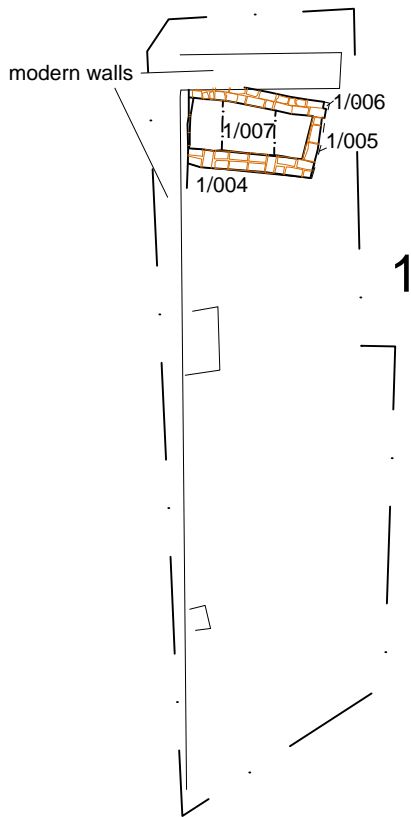
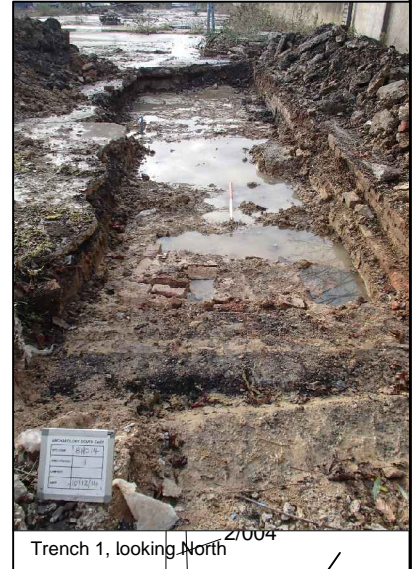
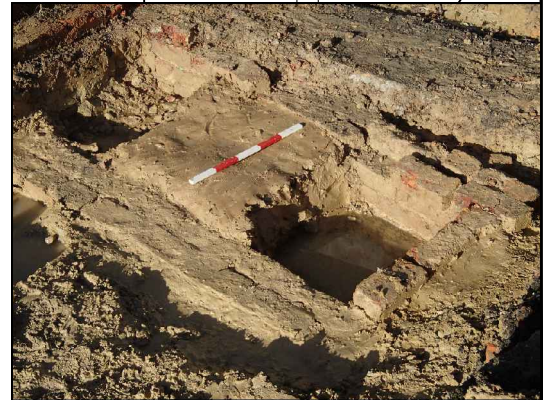
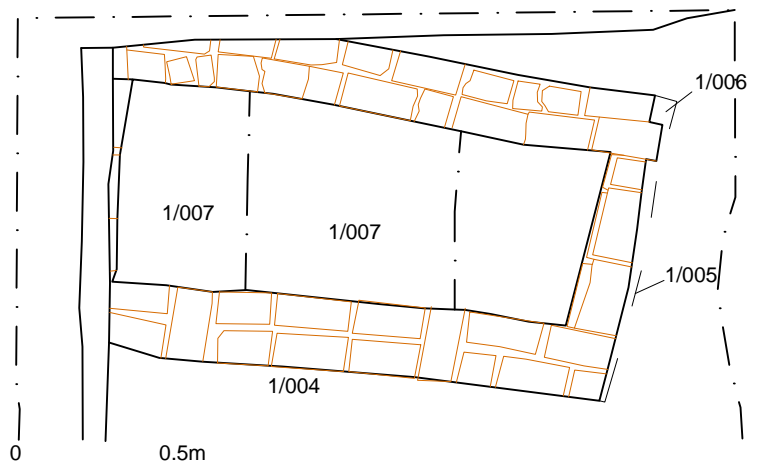
Fig. 3

- 4.1.3 Two modern brick walls ran along the western and northern sides of the trench. These can be tied in with printworks buildings shown on the Ordnance Survey map from 1962 and a later expansion shown on the map from 1978 (see CgMs 2008, figs 12 and 13) and were not subject to detailed recording.

- 4.1.4 The walls of the printworks had been constructed over the top of an older red brick structure [1/004] which followed an east-south-east to west-north-west alignment, consistent with structures relating to the potteries illustrated on the Ordnance Survey map of 1878 (see CgMs 2008, fig 7). This structure was rectangular in shape with maximum external dimensions of c. 2.04m by 1.02m and was filled with clean yellowish brown clay [1/007]. The full depth of the feature was not excavated but it comprised at least five courses of brick in running, or stretcher bond, sealed with a very sandy mortar, or compacted sand mixed with crushed mortar, through which water was able to percolate.

- 4.1.5 The structure is in the same approximate location as a square building on the 1878 OS map of the site but is much smaller. Its uneven and poor construction suggest that its external dimensions were not exposed and the way that water filtered through the bricks suggests that it may have been either a brick soakaway or some sort of well associated with the brickworks. Bricks recovered from this structure are of early/mid 19th – early 20th century date, while a fragment of an iron shovel recovered from the fill of the structure [1/007] can be similarly dated to the mid 19th – early 20th century

Trench 1 : plan and photographs

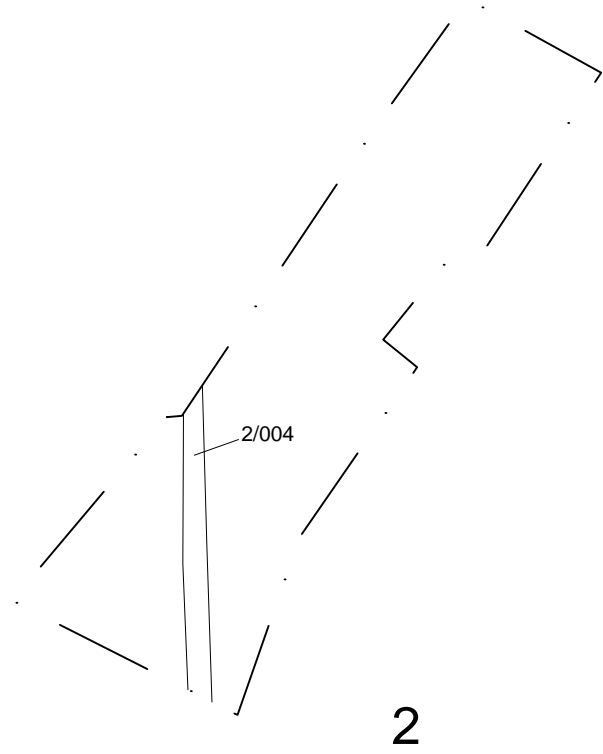
4.2.2 The sequence of deposits recorded in Trench 2 comprised a modern concrete and rubble make-up layer approx. 0.2m thick [2/001], over a layer of mixed yellowish brown clay subsoil 0.16m thick [2/002], sealing natural Weald Clay [2/003]. The Weald Clay was recorded at a maximum height of 36.42m OD at the south-western end of the trench, falling away to 36.26m OD to the north-east.

4.2.3 A modern wall [2/004] running north-south across the south-western end of the trench had concrete foundations and could be traced across most of the site. It corresponds with the extension to the printworks depicted on the 1962 Ordnance Survey map (see CgMs 2008, fig 12) and was not subject to detailed recording.

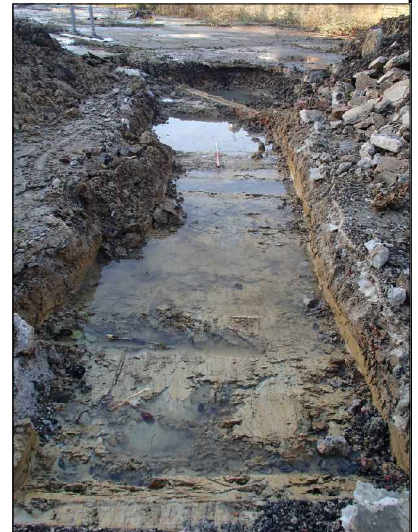
Trench 2, looking South West

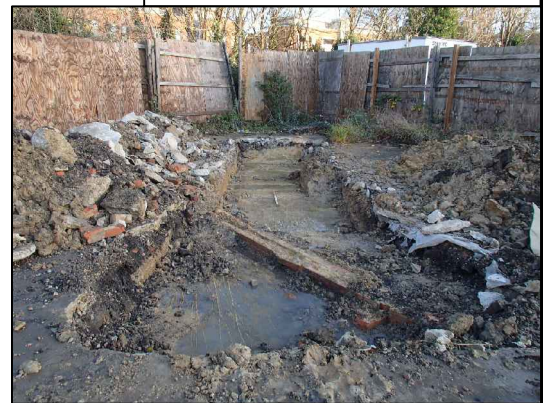
Trench 2, looking North East

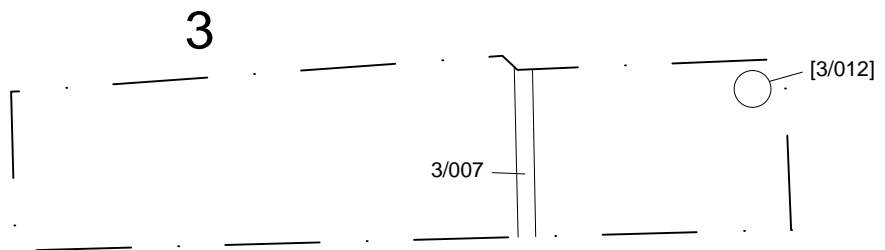
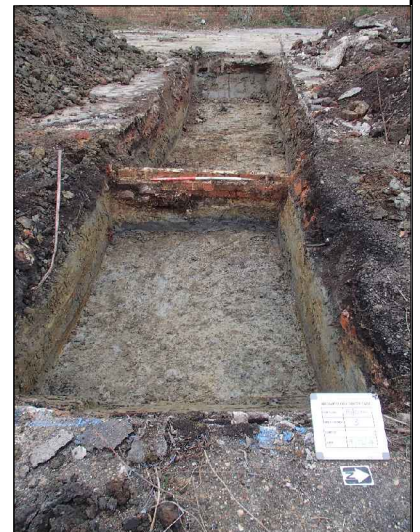
4.3.4 A wall [3/007] ran north-south across the middle of the trench. This had concrete foundations supporting red brick coursing in English Cross bond. The foundation cut for the wall [3/006] was visible from 0.15m below the current ground surface and was cut from the level of layer [3/002]. It is likely that this wall formed part of the printworks building first depicted on the 1962 Ordnance Survey map (see CgMs 2008, fig 12), although it is possible that it relates to a slightly earlier building shown on the OS map from 1955, as recent survey data does not always tie in perfectly to that from older maps. A 19th-early 20th century ceramic drain [3/009] was observed to the immediate east of wall [3/007].

4.3.5 A small circular feature measuring 0.45m-0.49m in diameter [3/010] was noted in the north-east corner of the trench. However, due to the combination of petrochemical contamination and heavy rain, it could not be investigated further.

Trench 3, looking West

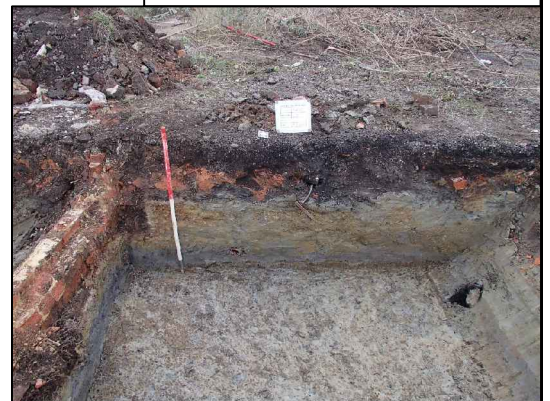
4.3.3 The general sequence observed in this trench consisted of a concrete surface and layer of modern make-up 0.15m-0.35m deep [3/001] over a layer of brick rubble and dirty clay 0.12m-0.3m thick [3/002]. Beneath this was a sequence of two layers of made ground layer of mixed yellowish brown and blue-grey clay [3/003] and [3/004]. These sealed a layer of mottled grey-green and orange natural Weald Clay [3/005]. The Weald Clay was recorded at a maximum height of 35.45m OD at the western end of the trench, falling away to 35.25m OD to the east

Trench 3, Section North

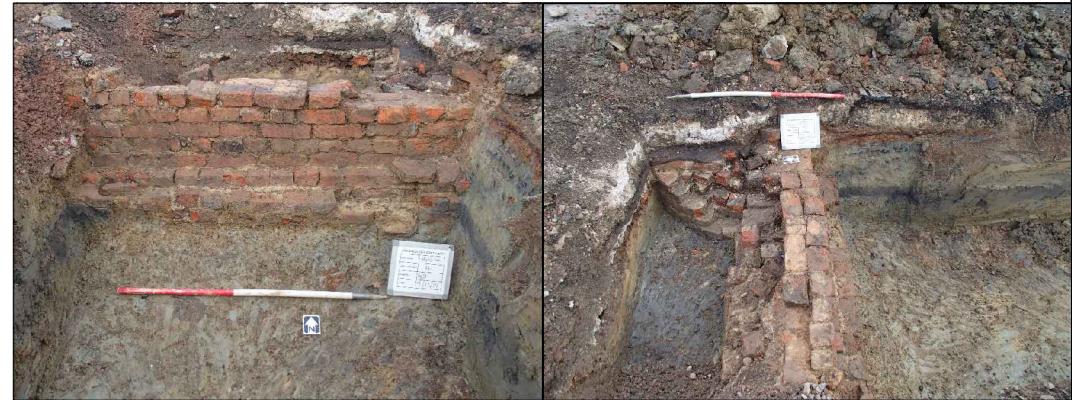
4.4.3 Two interconnected brick walls ([4/007] and [4/010]) were identified beneath the concrete surfaces [4/001] and [4/002] at the northern end of the trench and appear to have been cut from the level of made ground deposit [4/004]. The earliest of these ran east-west across the trench and stood to a height of eight courses in English bond. The lowest three courses formed a double-stepped foundation. The second wall [4/010] was partially exposed on the north side of the first, in the north-east corner of the trench. It was a curved wall, curving away to the north-east and presumably forming part of an external feature such as a bay or turret. Both walls were constructed of unfrogged red brick of a broad mid 18th -- mid 19th century date and are presumed to have formed part of the winged building shown on the Ordnance Survey maps from 1878 until 1955 (see CgMs 2008, figs 7–11)

Context 4/007, looking North

Context 4/007 and 4/010, looking East

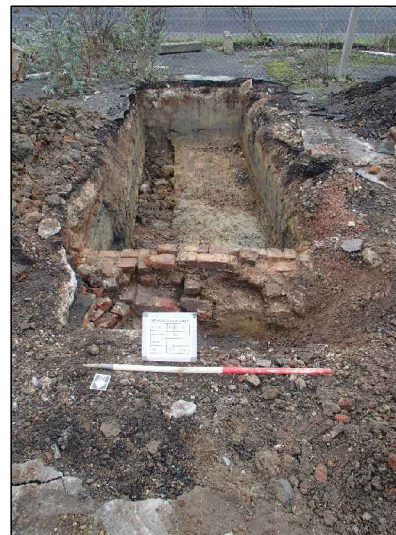
4.4.2 The sequence of deposits in Trench 4 consisted of a layer of tarmac 0.05m thick [4/001] capping an earlier concrete surface and make-up layer 0.25m thick [4/002]. This in turn overlay a sequence of three layers of made ground [4/003], [4/004] and [4/005], overlying natural Weald Clay [4/011]. The Weald Clay was recorded at 35.58m OD at the northern end of the trench and 35.07m OD at the southern end.

Trench 4 looking South

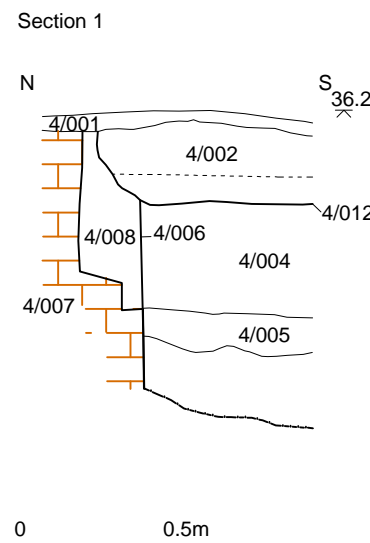
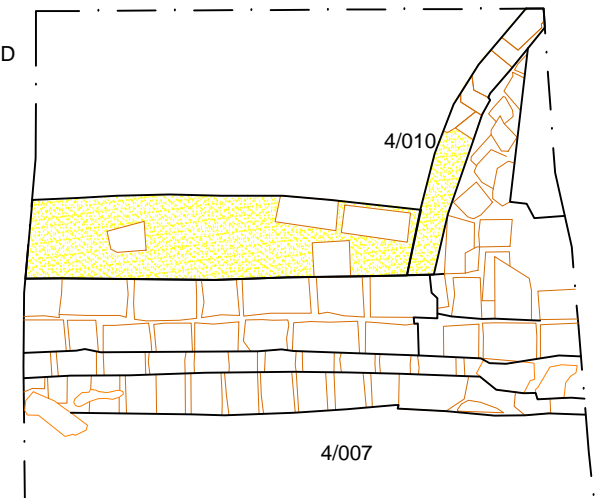
Section 1

Trench 4 : plan, sections and photographs
