**An Archaeological Topographic Survey on
Land at Marringdean Road, Billingshurst
German Prisoner of War Working Camp 46: Kingsfold**

**NGR 508810 124650
(TQ 088 246)**

**Prepared for
CgMs Consulting**

**Project No. 7051
Report No. 2015010**

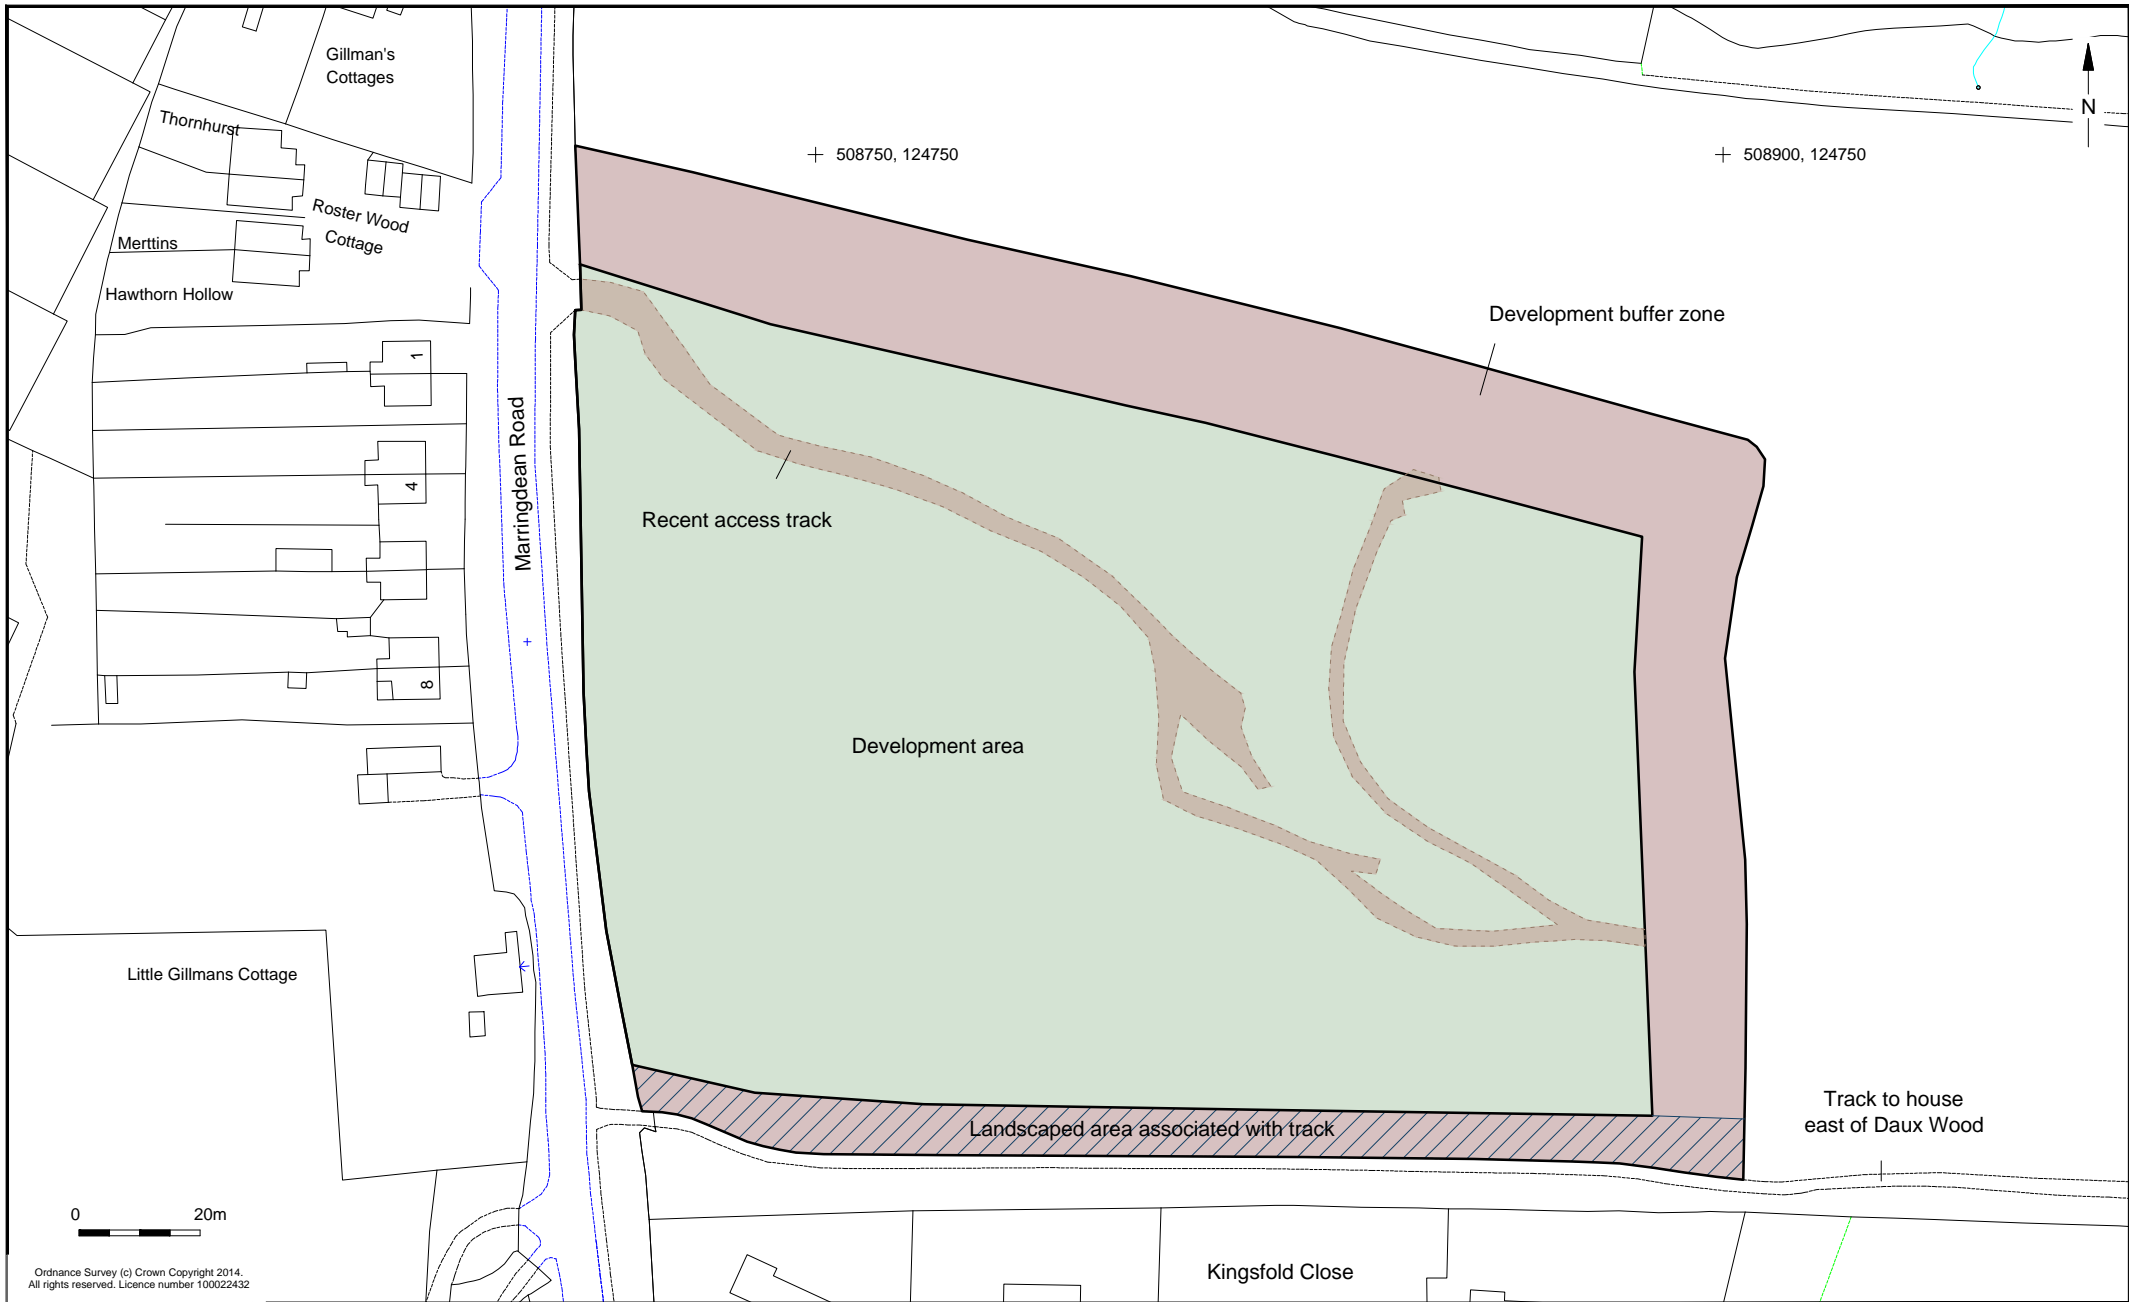
© Archaeology South-East		Land at Maringdean Road, Billingshurst	Fig. 2
Project Ref: 7051	Jan 2015	Site plan	
Report Ref: 2015010	Drawn by: JLR

- 1.1.2 The site comprises a single trapezoid plot to the east of Marringdean Road. It is bounded to the north and east by a tract of Ancient Woodland and to the south by the rear gardens of properties fronting Kingsfold Close and a private road to a house on the east of the site. The development area (in which the survey was focused) is centralised within the plot surrounded on the northern, eastern and southern sides by a 'buffer zone' (Fig. 2).

- 3.2.1 Partial tree clearance over the past number of years has disturbed the site, most notably an access track, running from the site entrance in a general south-easterly route, has deeply rutted and truncated a number of the earthworks (Fig. 2 and Fig. 3). A handful of trees have been pushed over causing large obstructions and root bowl damage. Piles of sawn logs and brushwood are scattered over the site and a proportion of the area appears to have been scraped with a toothed machine bucket. A number of pits, possibly tree bowls, have been recently backfilled.
- 3.2.2 The private road to the north of Kingsfold Close, built in the 1970s, split the original camp in half and resulted in the landscaping of earthworks either side, notably on the southern extremity of the buffer zone.

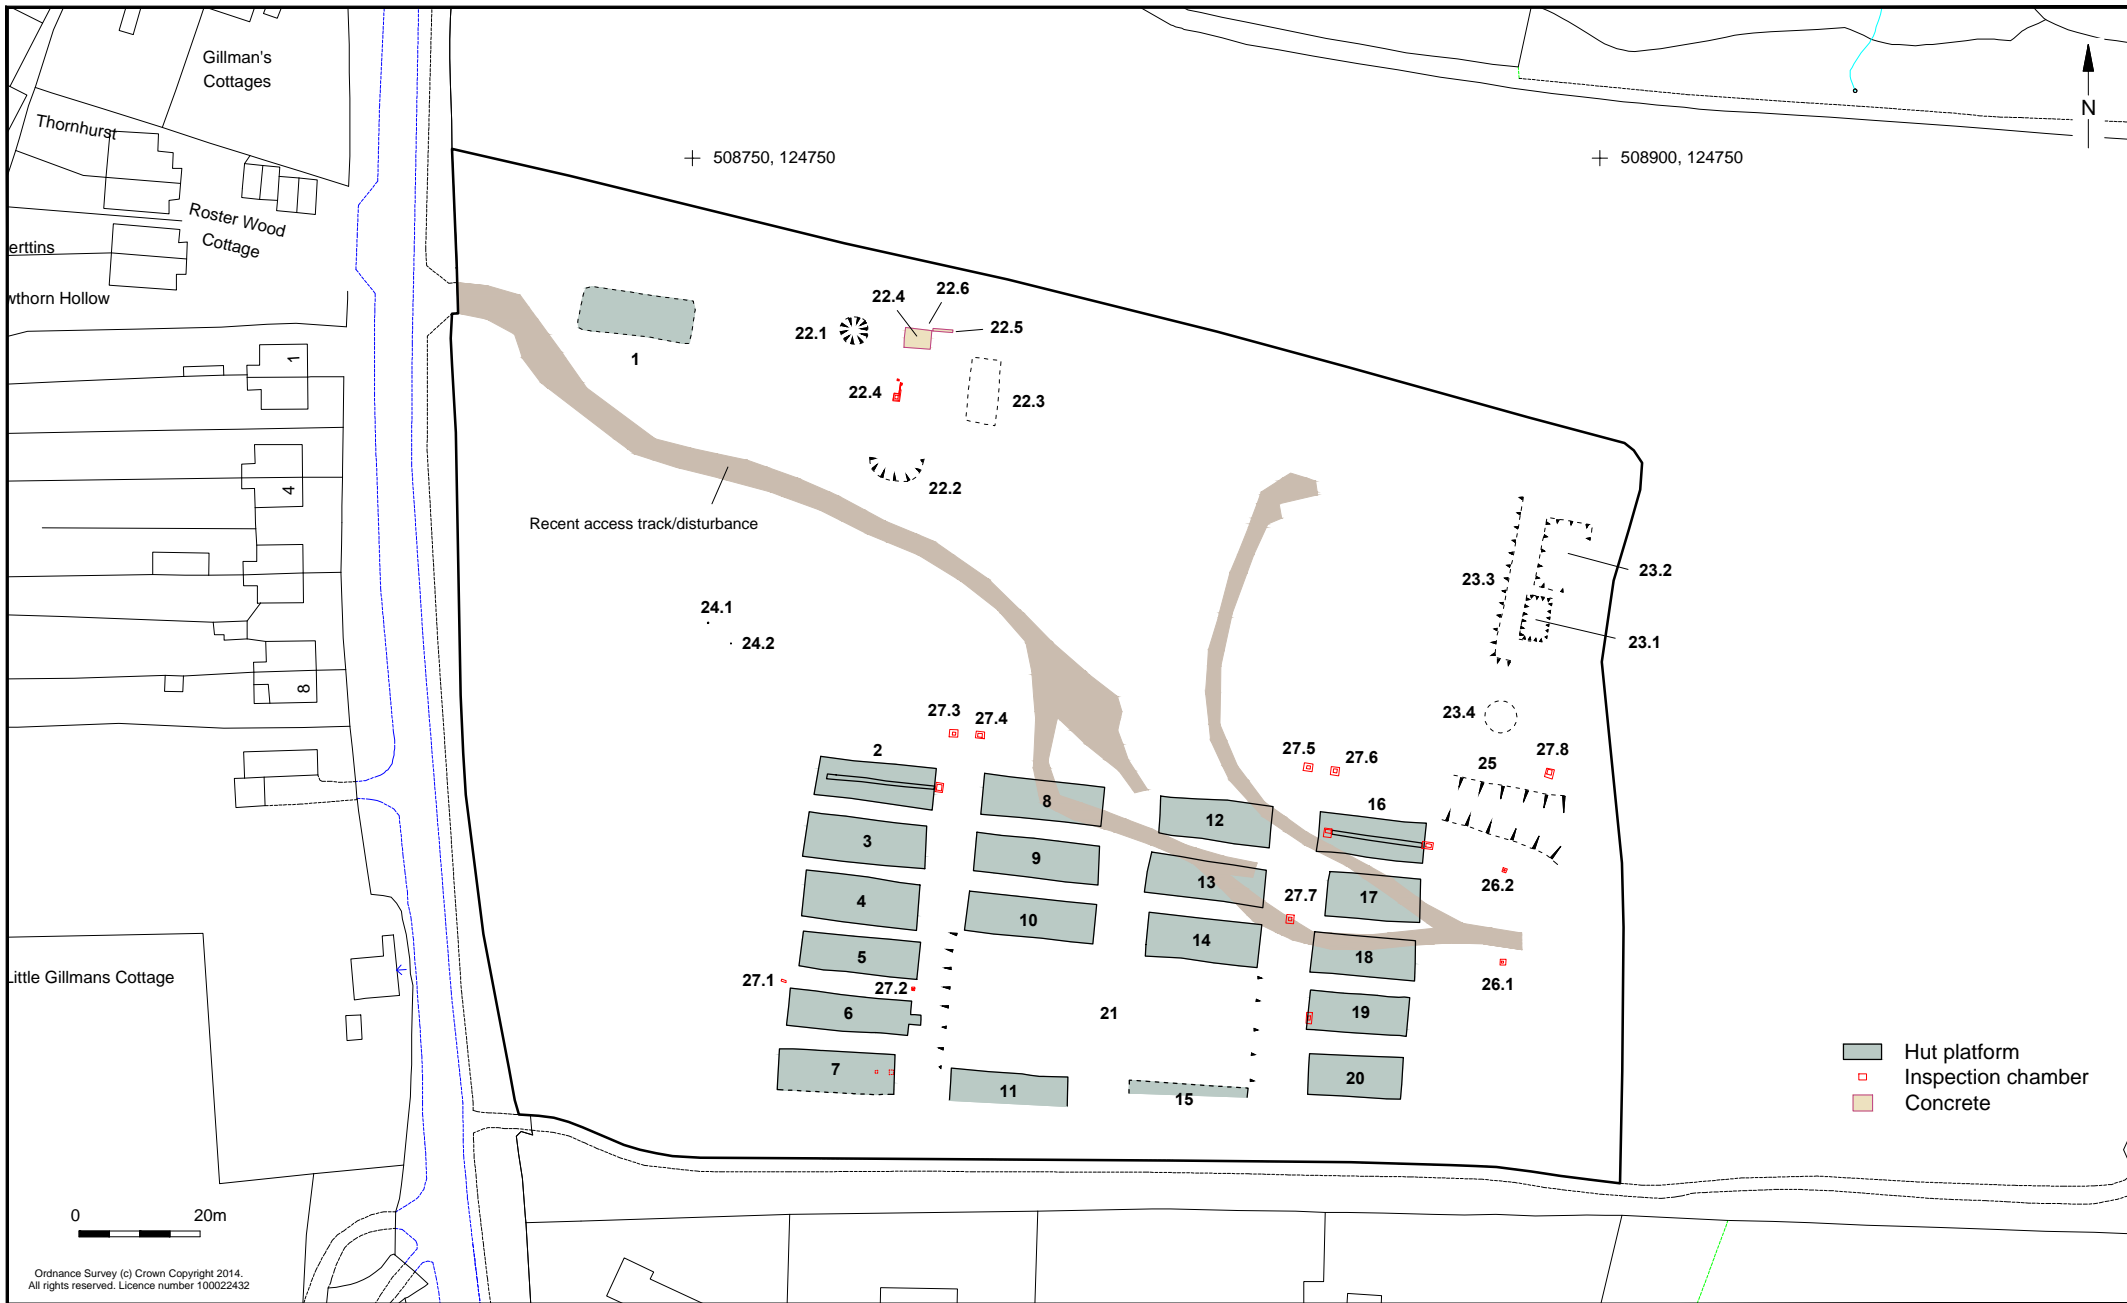
© Archaeology South-East		Land at Maringdean Road, Billingshurst	Fig. 3
Project Ref: 7051	Jan 2015	Results of topographic survey	
Report Ref: 2015010	Drawn by: JLR

4.1.1 The relative seclusion of this plot within the camp suggests that it is the commandant's accommodation area (Fig. 3). It is situated approximately 3m lower in the landscape than the main plateau (Fig. 4) and had direct access onto Marringdean Road. This original access track is now the main entrance to the site and as such has seen a large amount of recent traffic. A roughly rectangular low lying plot was noted and surveyed, which is only an approximate match with the house or hut seen on the aerial photograph (Figs. 5 and 6). Numerous irregular banks and hollows exist within the area, suggesting some form of disturbance post-dating the camp.

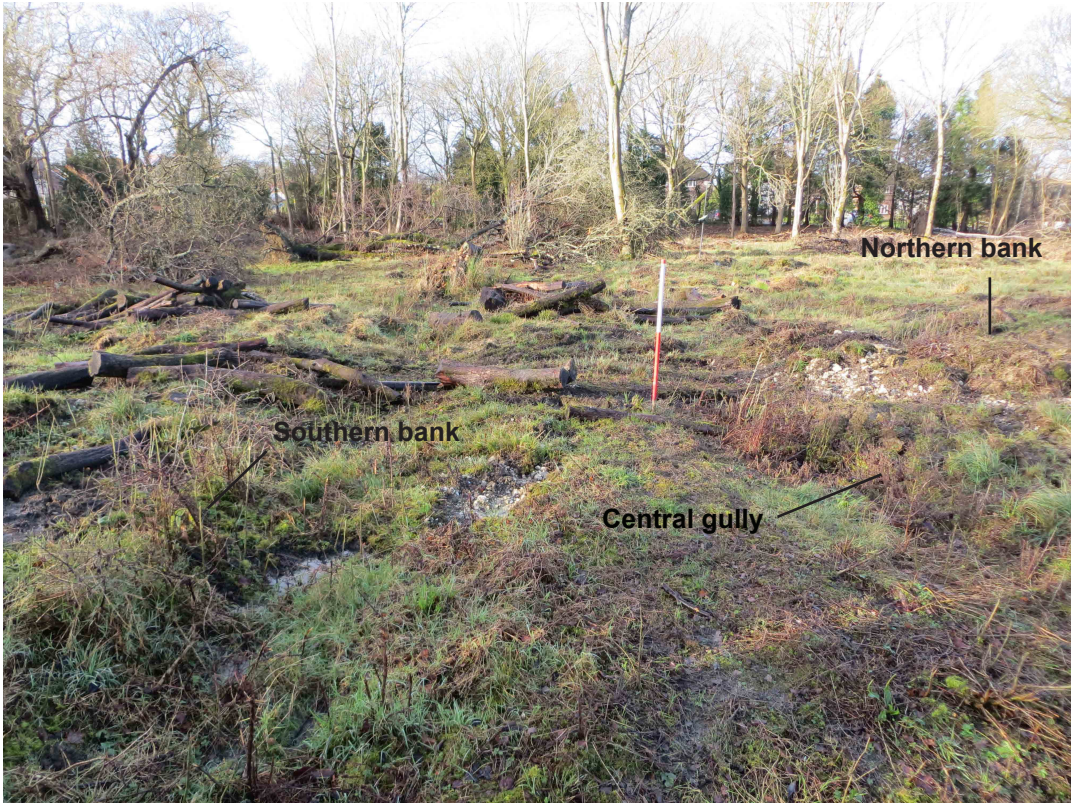
4.2.2 Site 2 differs to the other huts in its north-south row, notably in that it had inspection chambers (manholes) at its east and west end with a central gully connecting them both (Fig. 9). Only hut 16 had a matching configuration, though this was in a significantly poorer state (Fig. 10).

Site 2, hut platform and central gully looking west

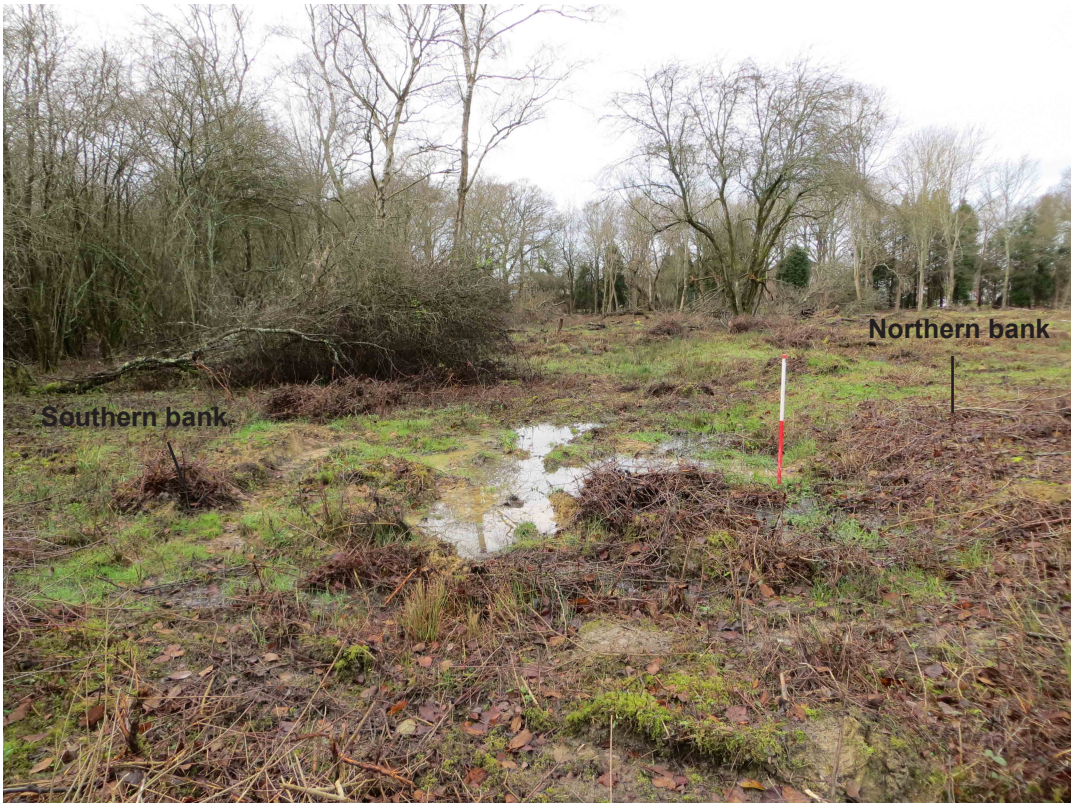
Site 10, hut platform looking west

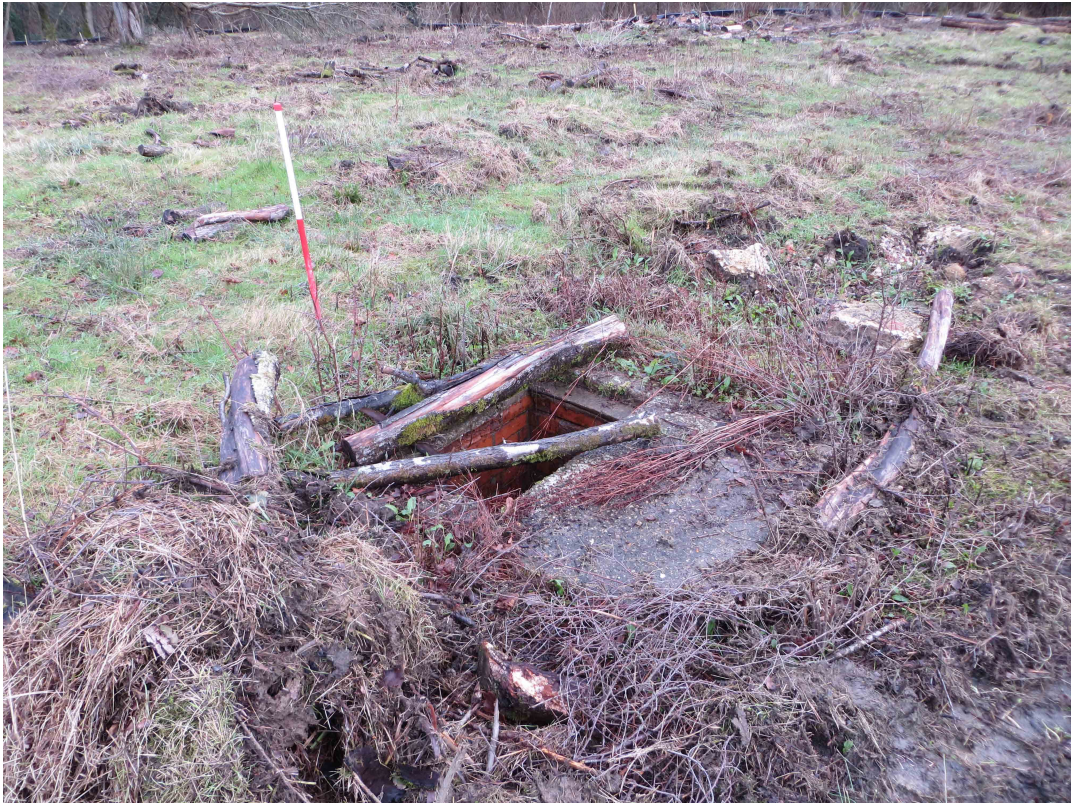
4.2.3 Other huts were noted to have inspection chambers and drainage features (7 and 19), but the location of these seems superficially random. Huts 8, 12, 13, 16, 17 and 18 were those most impacted by the track that runs through the site and are in an inferior condition. The other huts suffer to varying degrees from disturbance in the form of bucket scraping, tree felling and obscuration by debris collection: often the outlines could be picked up only in short stretches. The eastern edges of 16-20 were all virtually untraceable and the southern edges of 7, 11 and 15 were not visible due to truncation by the private road to the south.

Site 16, inspection chamber at western end of hut platform

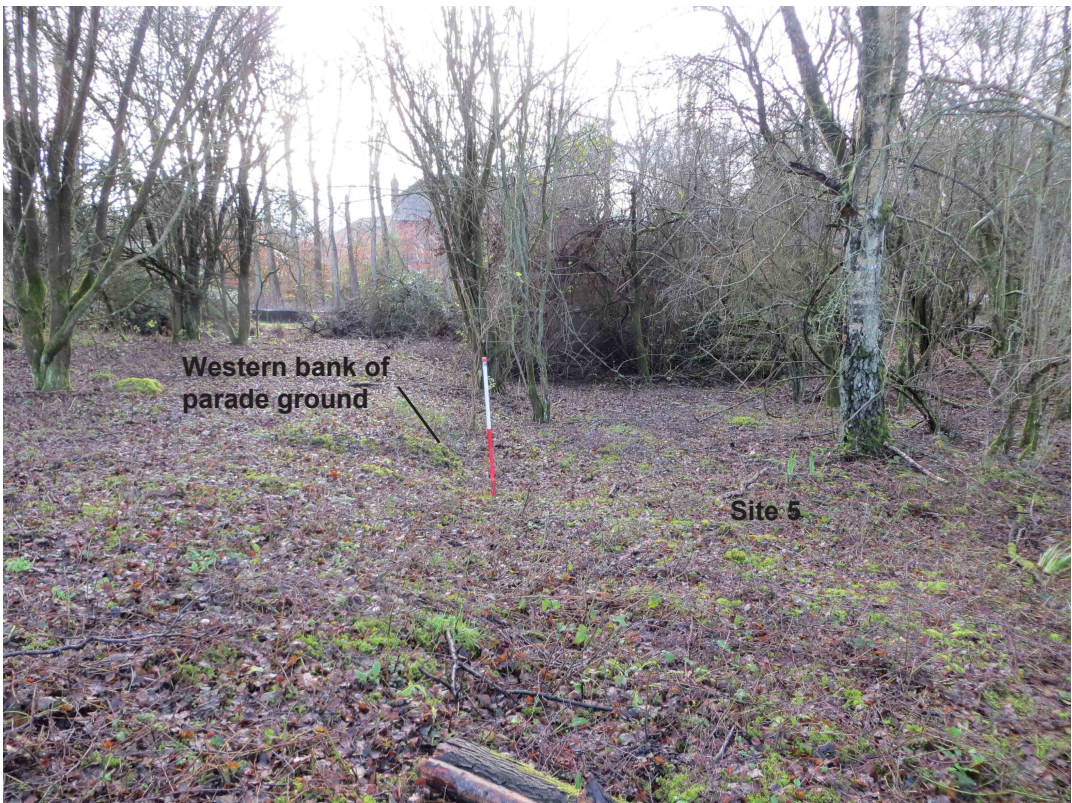
4.3.1 This constitutes a rectangular area, approximately taking up the space of four huts, in the centre of the compound area. Now covered in thick vegetation, the site is a level platform, which slopes downward on both the east and west edges, to the internal tracks (Fig. 10).

Site 21, western bank of parade ground.

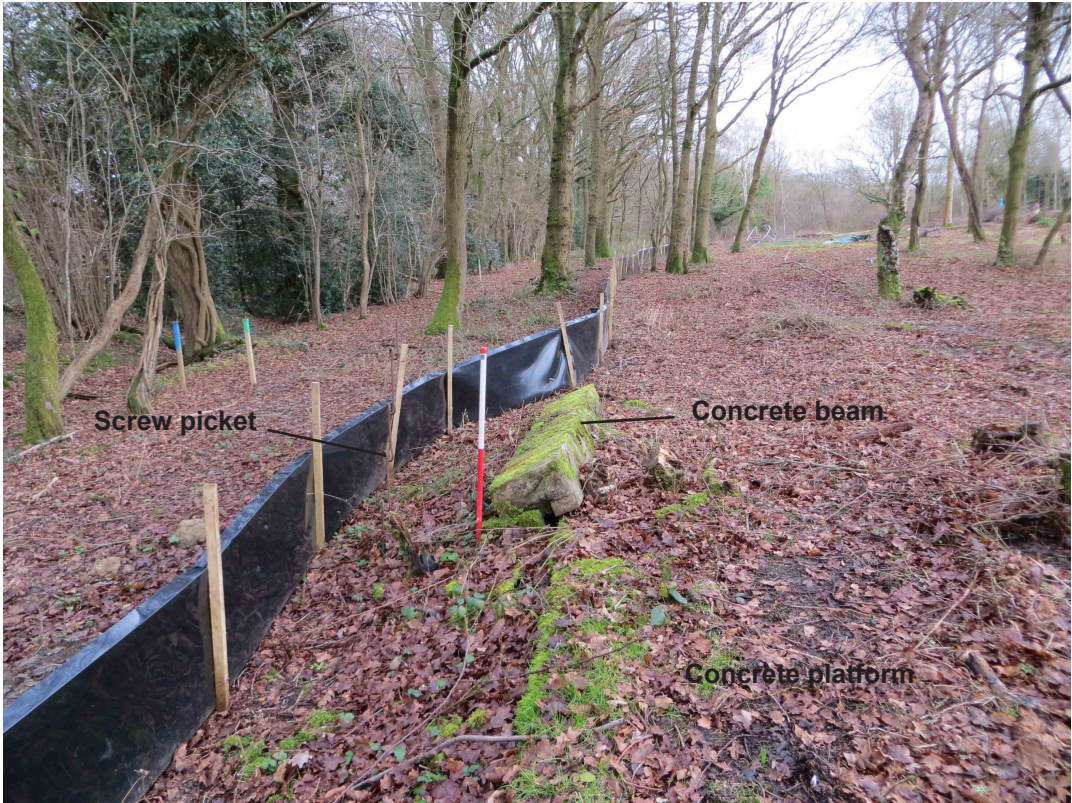
4.4.2 These are complimented by 22.4, a concrete platform (4m by 3m), 22.5, a concrete beam (3m by 0.4m) which has been displaced downslope slightly from its original location (Fig. 11), and two inspection chambers connected with a residual strip of brick footing. These would seem to relate to outbuildings of the vegetable garden plot, perhaps functioning as storage and watering facilities. A sole screw picket 22.6, typical of the type used in barbed wire placement in both world wars remains in place just to the north of the concrete. This would have originally formed part of the outer perimeter fence.

Site 22, concrete footing, concrete beam and screw picket, looking east

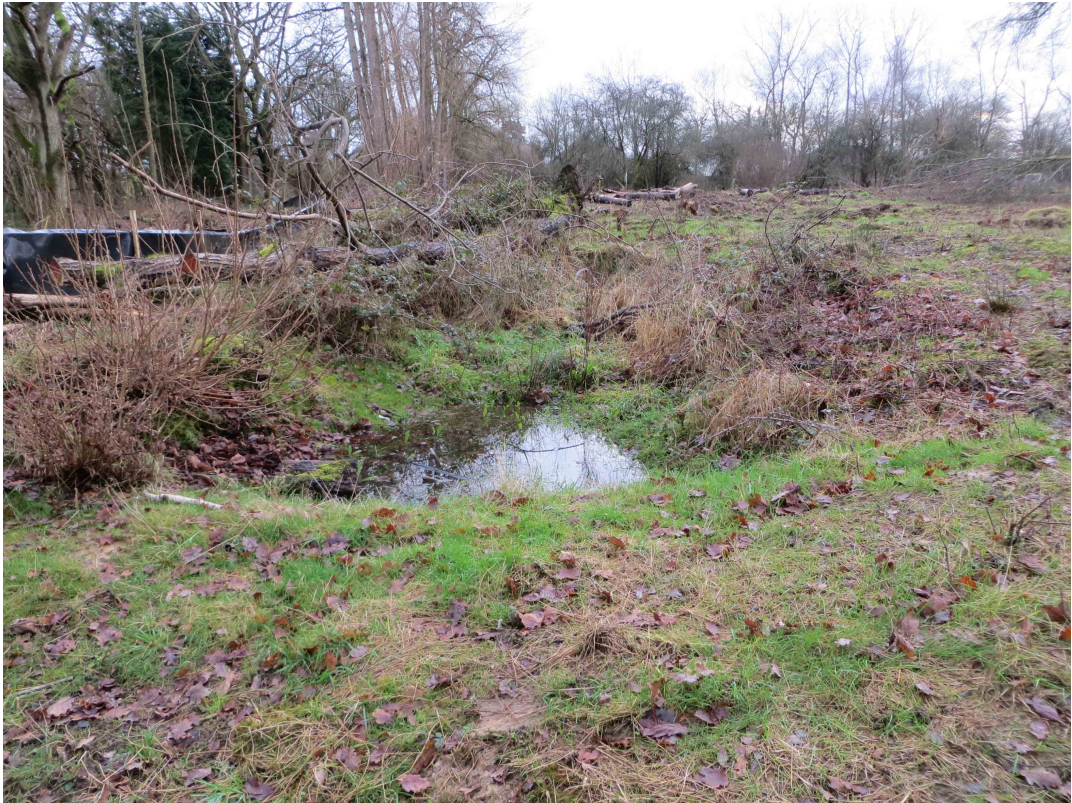
4.5.1 On the north-eastern extremity of the site, the predominant feature is a rectangular steep sided pit 23.1, (7.5m by 4.3m) the current depth was not possible to gauge as it is now partially filled with water (Fig. 11). To the north of this is a larger and shallower rectangular feature 23.2 (7.7m by 11.5m). The two pits are bounded to the east by a slope outside the study area, while on the west there is a low linear bank 23.3 running north-south, sloping to the interior of the site. Just to the south of these is a dump of metal 23.4, comprising mostly water tanks – these are possibly remains of the camp fresh water infrastructure. They are not in situ, however the pit they are placed within may have be related to the earthworks to the north.

Site 23, rectangular pit, looking south

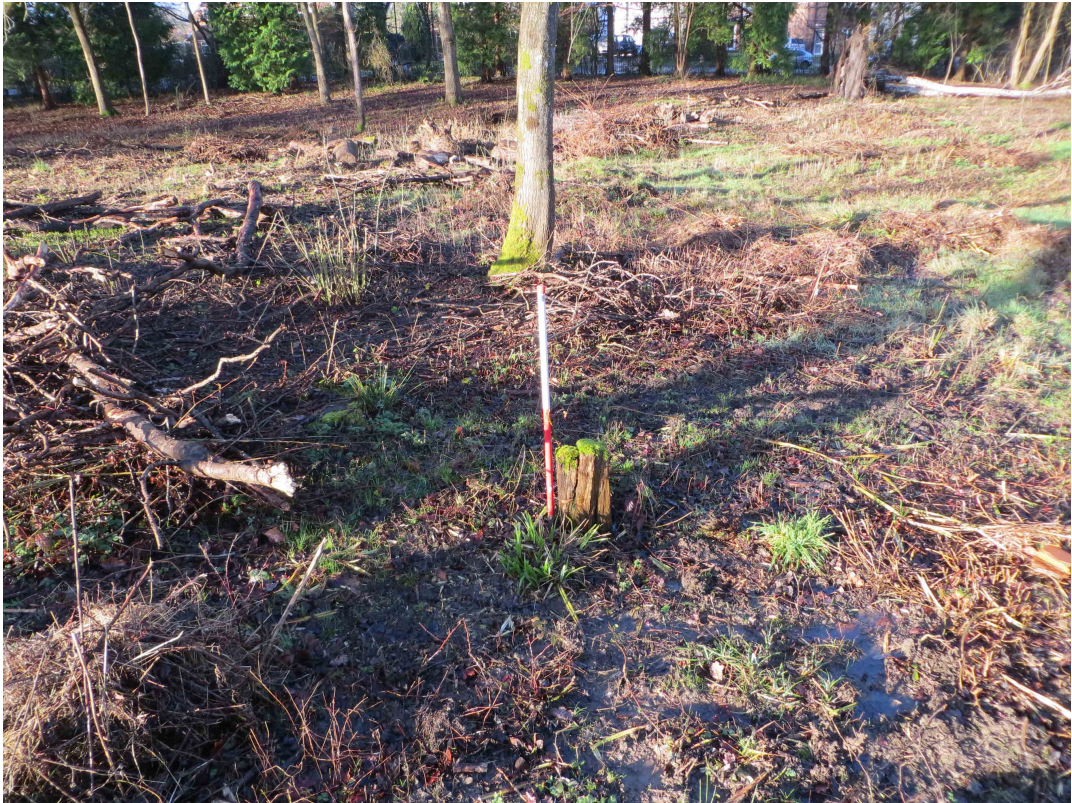
4.6.1 The western inner boundary of the prisoners' compound is defined only by the remains of a single wooden post (Fig. 12) measuring 0.2m by 0.2m in plan and 0.3m in remnant height. The original length of this western perimeter fence was approximately 145m, with posts such as this at every 2-3m.

Site 24.1 post associated with the main interior fence.

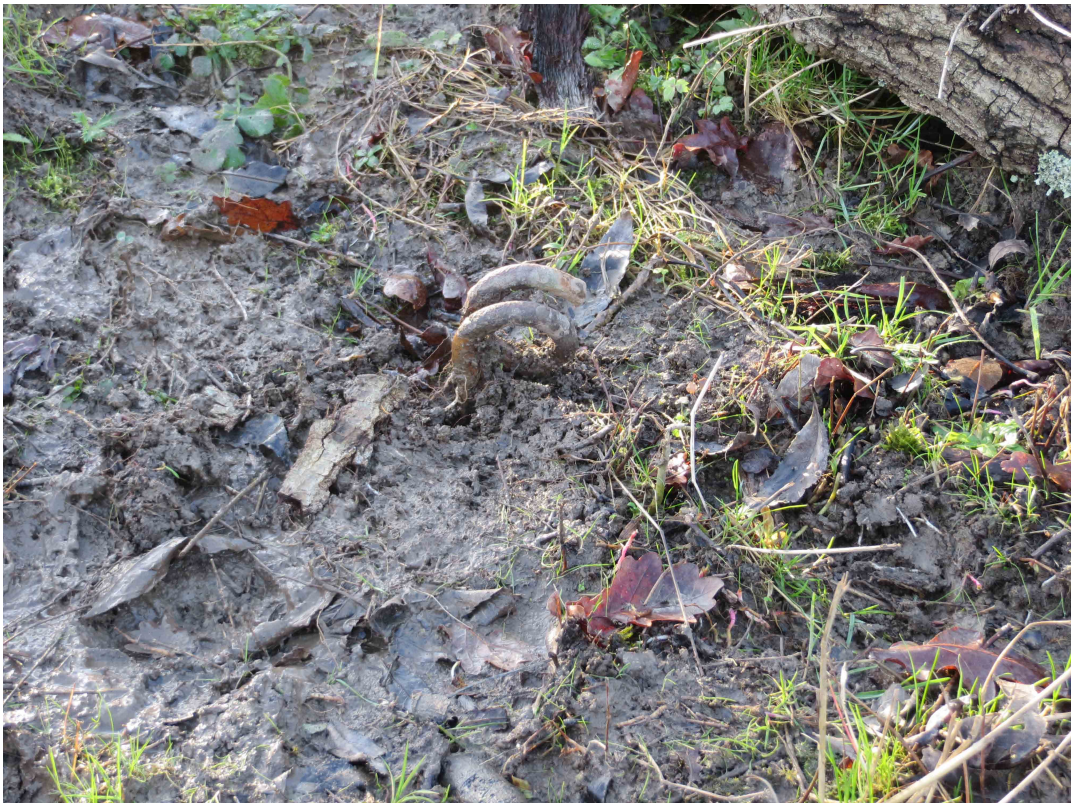
4.6.2 There were no other elements of the fence visible along the boundary, although a screw picket (Fig. 12), was located 3.6m to the east. Its position on the interior of the main prisoners' fence suggests that this is part of the wire entanglement that created the sterile area.

Site 24.2, screw picket associated with the interior fence.
