**Archaeological Watching Brief Report
Littlehampton East Bank Tidal Walls
Flood Defence Scheme
West Sussex**

**ASE Project No: 6403
Site Code: EBL 13**

**ASE Report No: 2015104
OASIS id: archaeol6-208166**

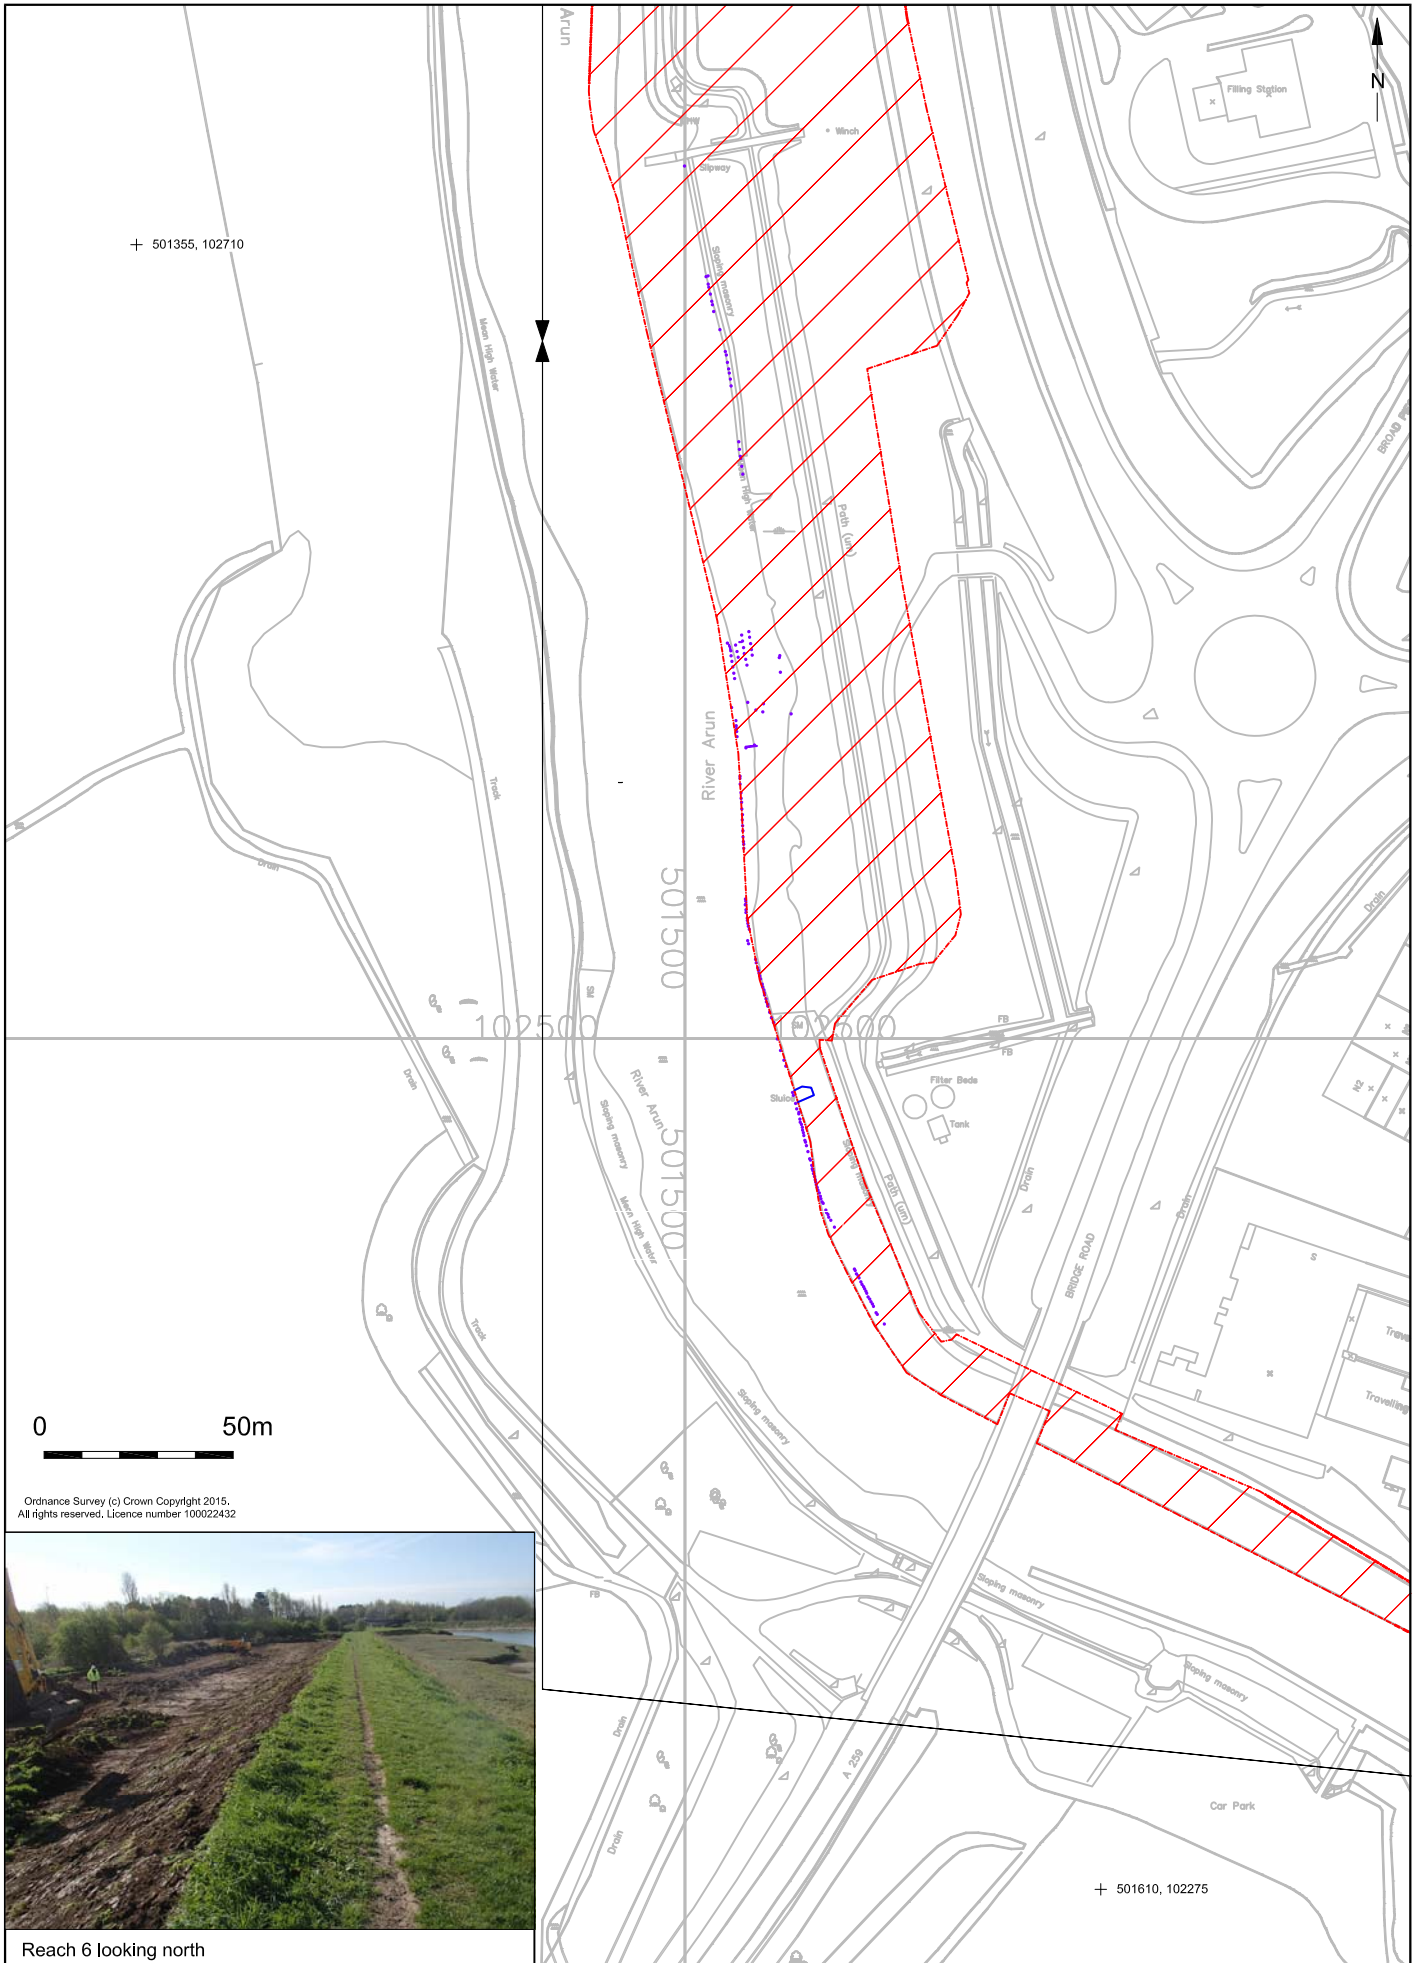
© Archaeology South-East		Littlehampton East Bank Tidal Walls		Fig. 4
Project Ref: 6403	04 - 2015	Reach 6		
Report Ref: 2015104	Drawn by: NG

- 4.3.1 Topsoil stripping of the compound and haul road area was monitored. An area measuring c. 50m x 40m had been stripped prior to the arrival of the ASE monitor and had been tracked over. No significant archaeological features or finds were identified or recovered.

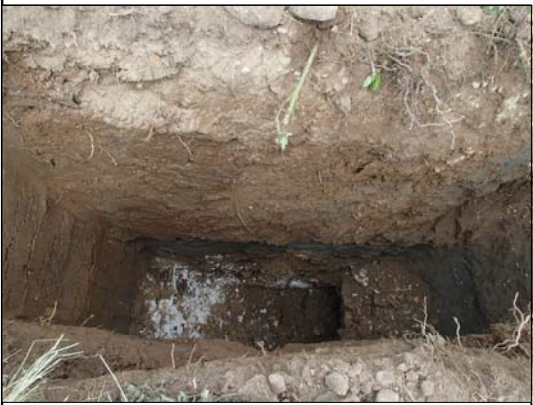
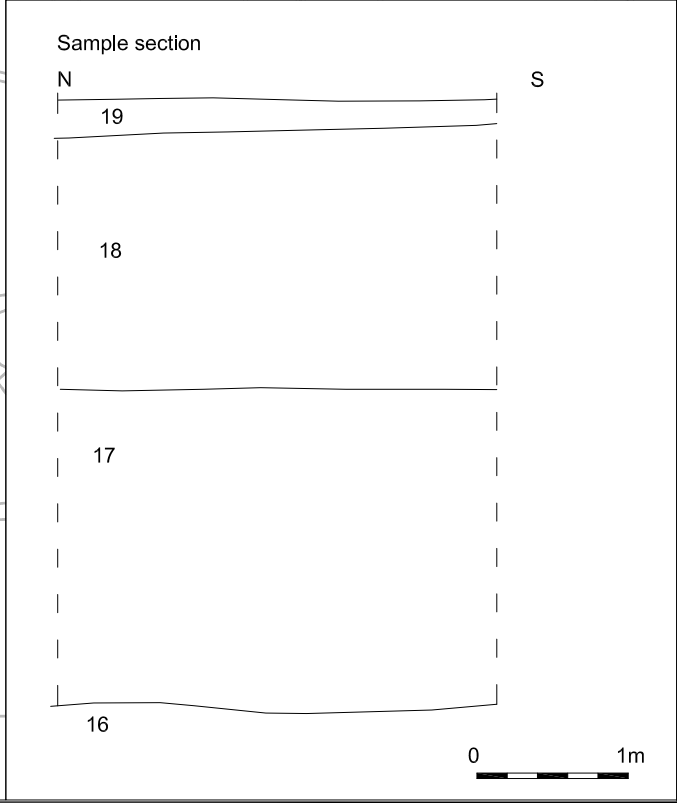
© Archaeology South-East		Littlehampton East Bank Tidal Walls		Fig. 5
Project Ref: 6403	04 - 2015	Reach 6		
Report Ref: 2015104	Drawn by: NG

- 4.4.1 The excavation of the tidal wall foundation trench was monitored. The trench measured 0.60m wide and approximately 2.1m deep. A sample of the west facing section of the excavation was recorded.
- 4.4.2 The recorded sequence of deposits was: natural [16] consisting of chalk; made ground [17] consisting of grey ash with modern metalwork; made ground [18] consisting of mid brown silt; [19] topsoil of dark brown silt.

Sample section, looking east

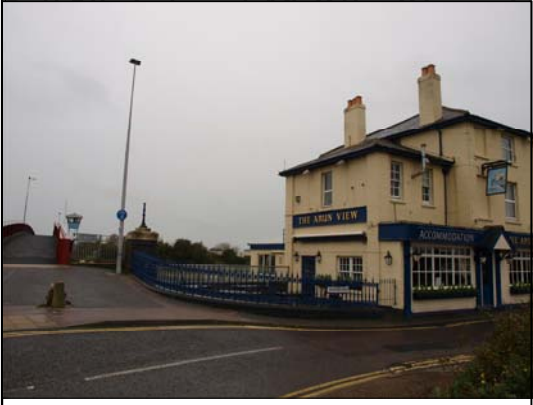
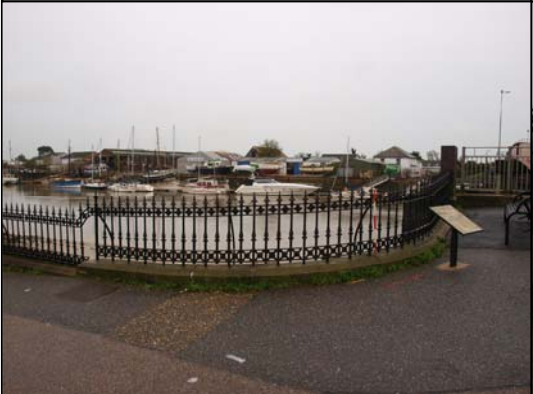
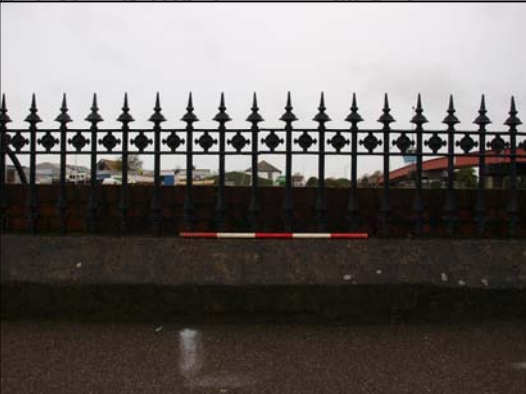
© Archaeology South-East		Littlehampton East Bank Tidal Walls		Fig. 7
Project Ref: 6403	04 - 2015	Reach 4		
Report Ref: 2015104	Drawn by: NG

- 4.2.6 The railings are wholly of cast iron manufacture, and consist of square-section rods which meet astragals topped by paired volutes halfway up their length. Above, the rods bulge into octagonal darts and are cylindrical in section thereafter, with spear pommel finials trailing stiff acanthus-leaf foliage. The rods are joined at base and top by twin bands, the lower containing a frieze of geometric diamonds and the upper of lobed rosette paterae. They are interrupted by a gate midway along their length, which has square posts with panels bearing drops of three inverted husks, topped by convex finials bearing simple palmettes. The gates themselves are modern.

- 4.2.7 The railings are leaded into a simple bevelled stone plinth which has been replaced by concrete to the southeast of the gate, which has subsumed the lower part of the

railings. The plinth rests in turn upon a battered brick retaining wall of red stretcher bond red banded with blue Staffordshire brick.

- 4.2.8 The railings terminate to the west in a brick pedestal with a bevelled plinth, and to the south-east in a low modern brick wall with brick coping. In both cases the railings articulate awkwardly with these features: an indication of their original termination is given by the railings to the north-west adjoining the Arun View public house. These railings terminate adjacent to the bridge in a panelled brick pedestal with two orders of bevelled limestone coping topped by the elaborate cast iron base of a gaslight. This would have been the original arrangement flanking both sides of the bridge.

Reach 4, General Shot, looking north west

Reach 4, General Shot looking South east

Reach 4, Railings details

6.4.1 The railings were erected in association with the adjacent footbridge over the River Arun, which replaced a ferry crossing in this location in c. 1900. This was a swing bridge with a toll, so the railings would presumably have originally incorporated a gate to prevent the unwary from crossing when the bridge had swung, whilst being sufficiently ornamental to justify the new charge for foot traffic. They do not survive on the south-west bank of the river, but will be retained along the stretch to the Arun View public house.
