**Archaeological Evaluation Report  
Former Merrydown Cider Factory,  
Horam, East Sussex**

**Planning Reference: WD/2011/2817/MAJ**

**ASE Project No: 7390  
Site Code: MCF 15**

**ASE Report No: 2015147  
OASIS ID: archaeol6-210195**

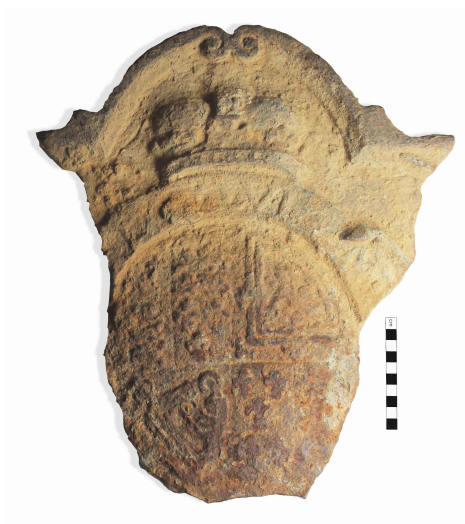
**Front Cover: 17<sup>th</sup> Century fireback**

5.4.1 The central and upper part of a cast iron fireback was recovered from unstratified deposits (c. 12.5kg) (report front cover photograph). It depicts the royal coat of arms of the Stuarts within a garter and probably belongs to the reign of either Charles I or II (1625-1685) and is of a type not previously recorded (J. Hodgkinson *pers comm*). The former Horam Manor was the home to the Dyke family who were Wealden ironmasters. It is highly likely the fireback, and indeed the window mullion, originated from this building.

- 6.3.1 Although it appears that the main structure of the *Old Manor House* known from cartographic sources has been comprehensively demolished, the window mullion is arguably evidence of its former grandeur. Similarly the Wealden sandstone blocks (and perhaps even the bricks) used in the drain construction encountered in Trench 1 may also have come from this structure, as may the 17<sup>th</sup> century fireback (report front cover photograph).

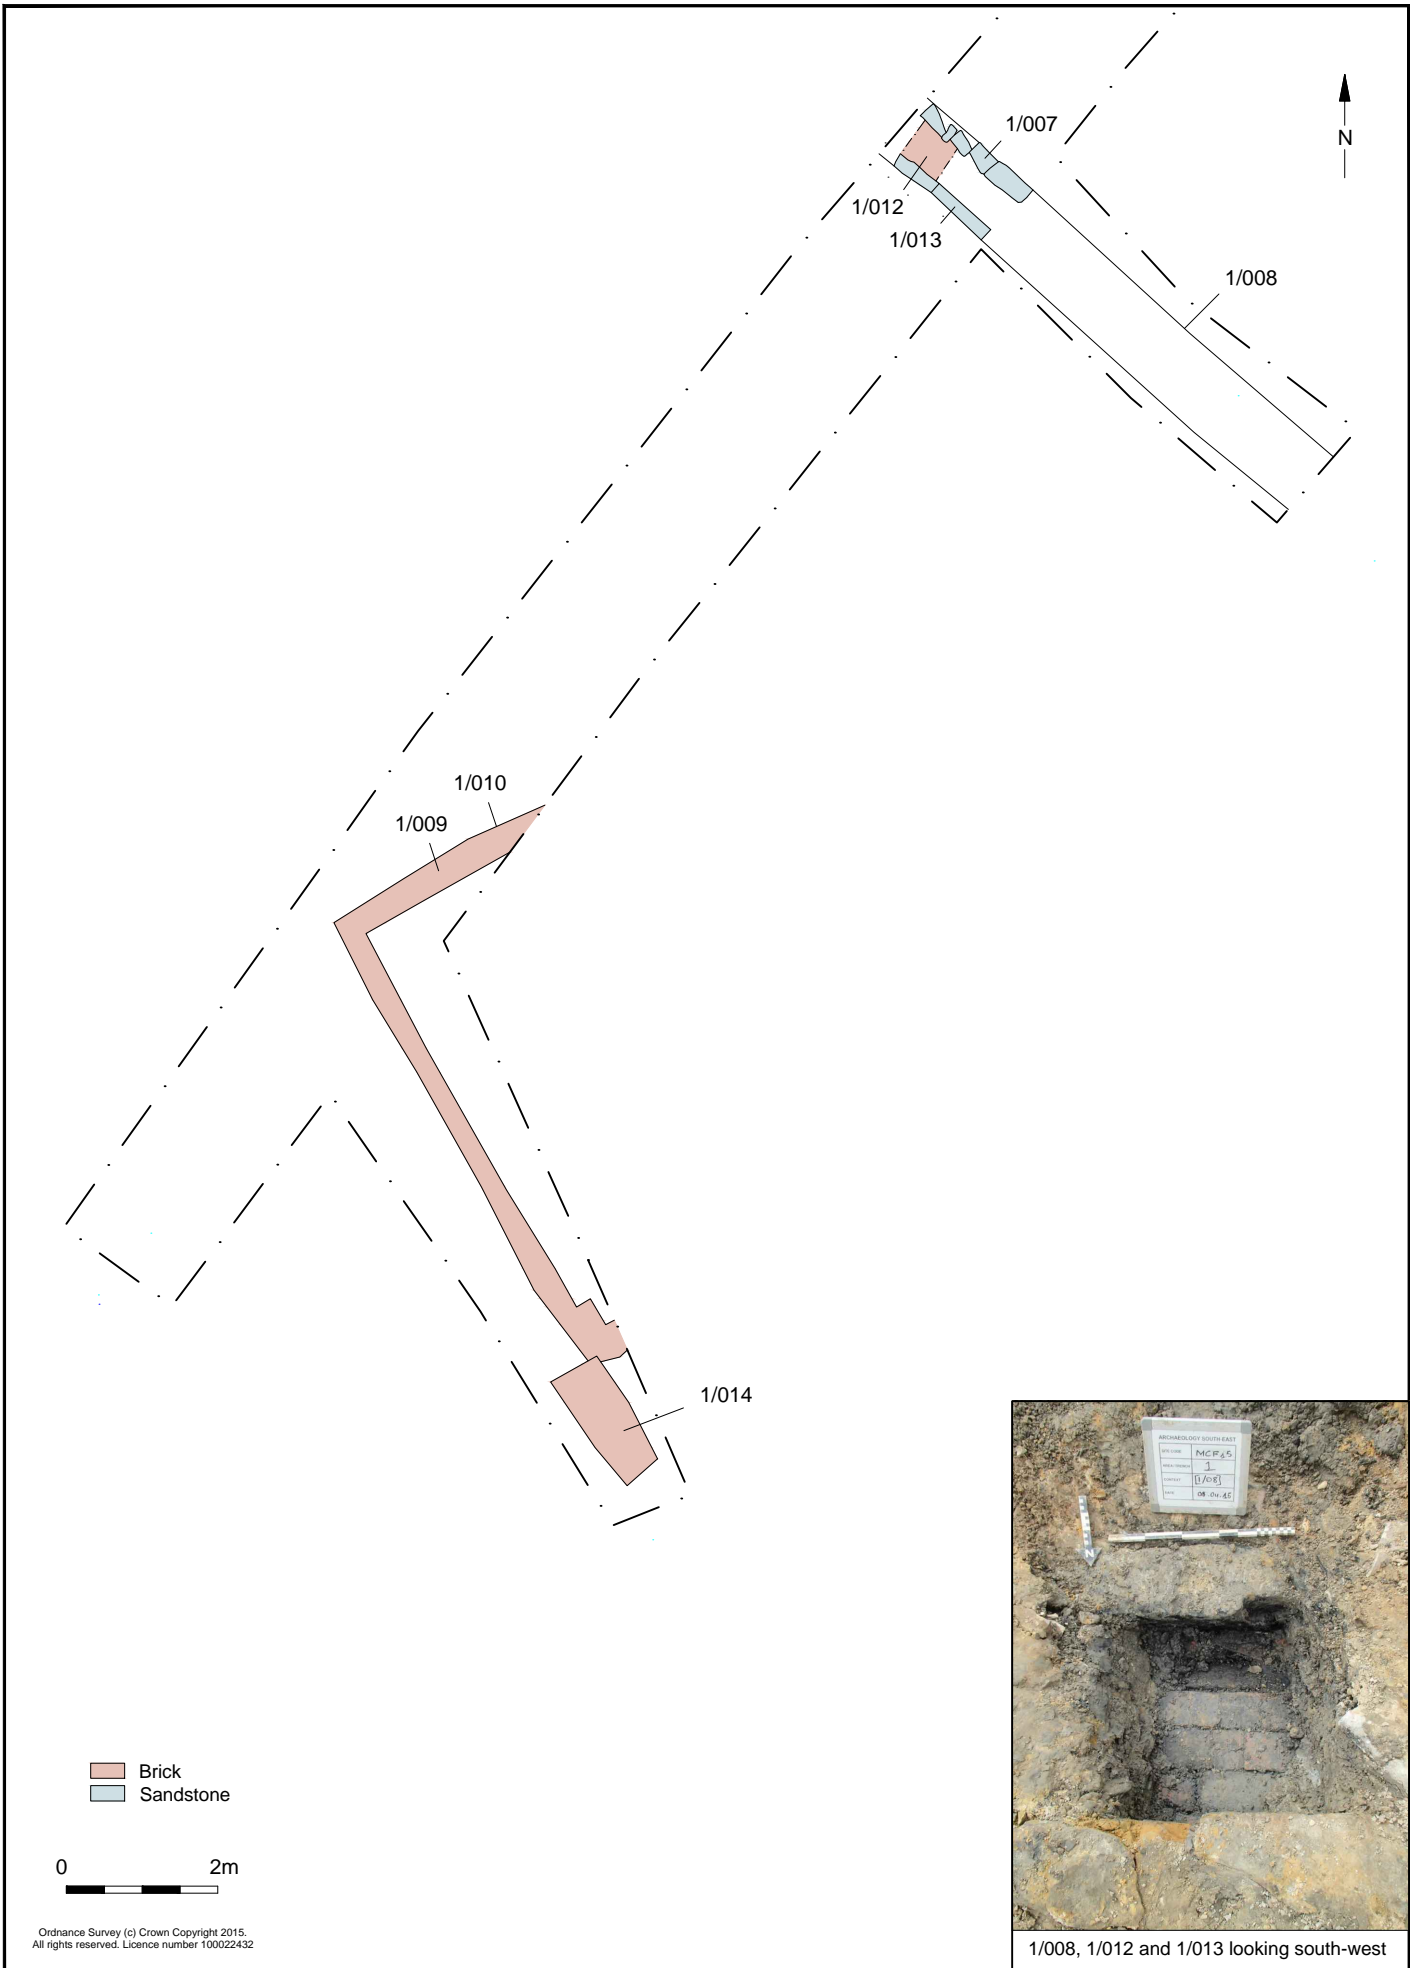
© Archaeology South-East		Former Merrydown Cider Factory, Horam	Fig. 3
Project Ref: 7390	April 2015	Trench location detail	
Report Ref: 2015147	Drawn by: JLR

- 4.2.4 Immediately to the south-west, a brick- and stone-lined drain, which ran from north-west to south-east across the trench was encountered and recorded. The drain lay in an undetected, presumably straight-sided, flat-based construction cut, context [1/008], 1.1m in width and 560mm deep with sides made of reused Wealden sandstone ashlar blocks bonded with a sandy grey mortar (context [1/013]), and a base made from unfrogged red bricks with no obvious bonding material (context [1/012]). A retained sample of the brick measured 232mm x 106mm x 50mm. These bricks date from the 15<sup>th</sup> to 17<sup>th</sup> centuries. The drain was filled with a highly mixed deposit, context [1/007] containing mid-brown garden soil, 19<sup>th</sup> century brick rubble, pieces of green sandstone rubble and a fragment of 16<sup>th</sup> or 17<sup>th</sup> century window mullion.

- 4.2.6 The other feature encountered in the original trench was a length of red brick foundation, set in a 260mm wide foundation cut, context [1/010], consisting of red bricks of similar dimensions and age to those used in the base of the drain, recorded as context [1/009]. The masonry survived to a depth of only one brick with no apparent bonding material. A further trench was added to trace the extent and state of preservation of the masonry, which was found to extent to the south-east for 4m before turning to the north-east.

- 4.2.7 There was an apparently associated block of brick masonry measuring 690mm by 1.7m immediately to the south of the turn, recorded as context [1/014], again consisting of a single surviving course of unfrogged red bricks of similar dimensions. There was no obvious construction cut, with the bricks apparently set directly on the underlying 'natural', context [1/011].

- 4.2.8 The orientation of the foundations broadly mirrors that of the layout of the *Old Manor House* on the cartographic sources, and it is possible that the brickwork forms the remains of part of an associated building/outbuilding, or
