DOCK WALLS AND CANAL & RIVER TRUST BUILDING
WOOD WHARF, WEST INDIA DOCKS,
LONDON BOROUGH OF TOWER HAMLETS

HISTORIC BUILDINGS RECORD
(Historic England Enhanced Level 2)

August 2015

Site Code: WUW15
Project No. 7525
Report No. 2015171
OASIS ID: archaeol6-211526

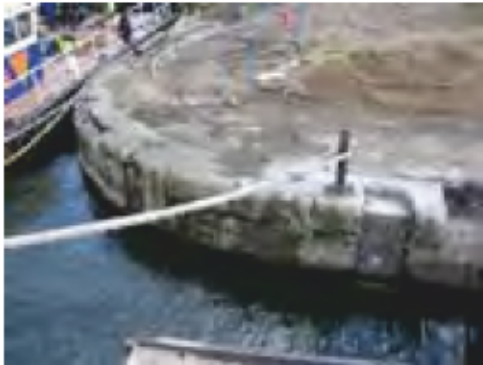
m. Detailed Survey 17 – Wood Wharf 3, Chainage 45.5
- Defect/Crack

Defect / Feature Description: Constructed Recess Running from 0.9m to Bed Level.

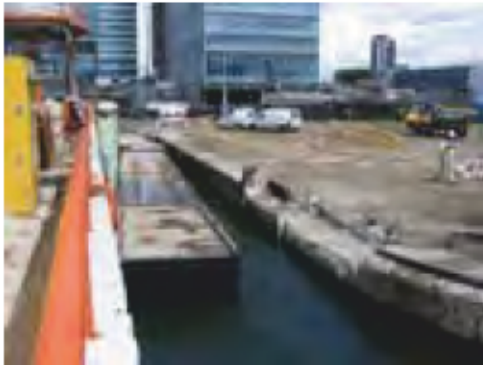
n. Detailed Survey 18 – Wood Wharf 3, Chainage 5
- Defect/Crack

Defect / Feature Description: Constructed Recess Running from 0.45m to Bed Level with Steel insert.

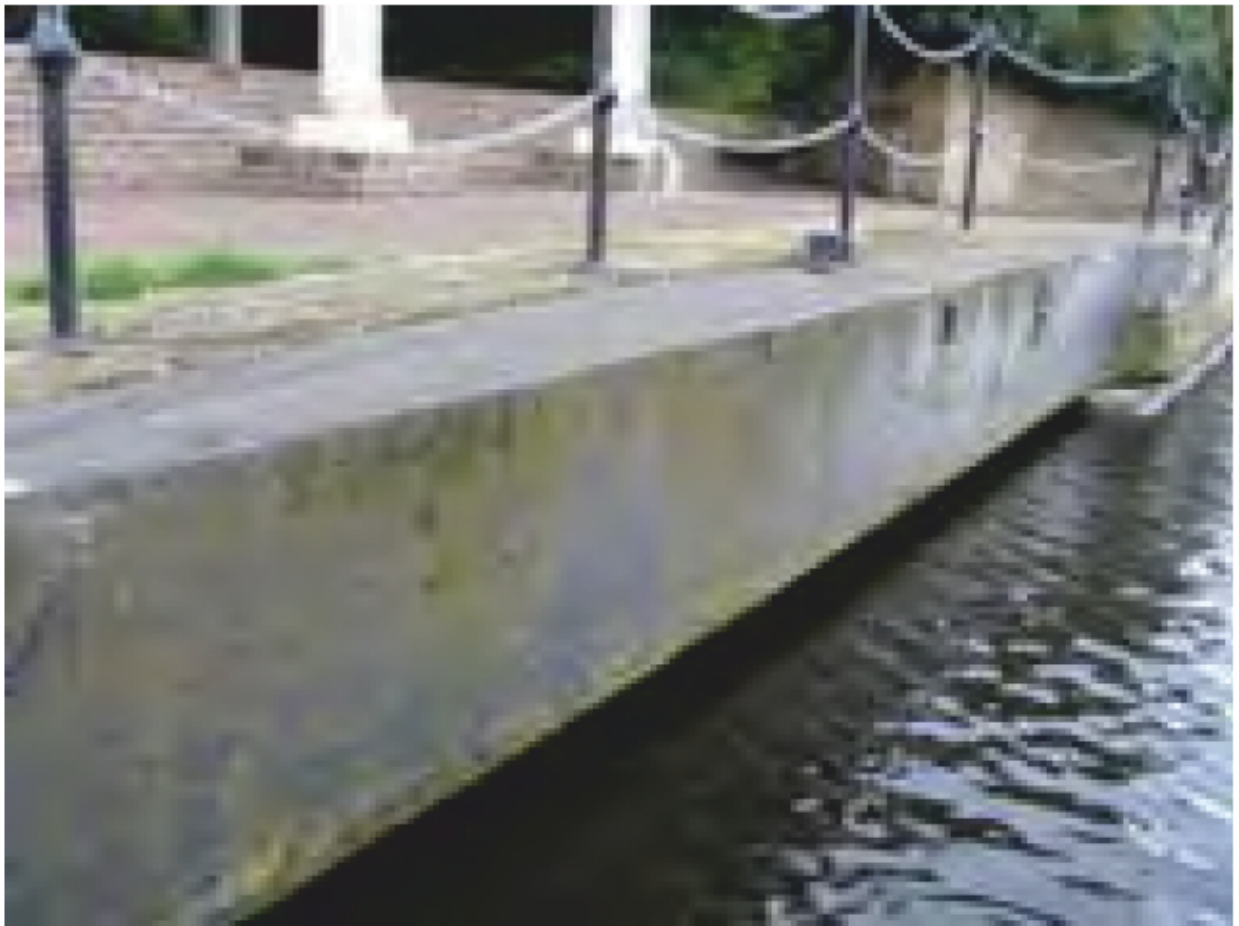
Plate 5: Surviving part of the swing bridge at the entrance to poplar dock

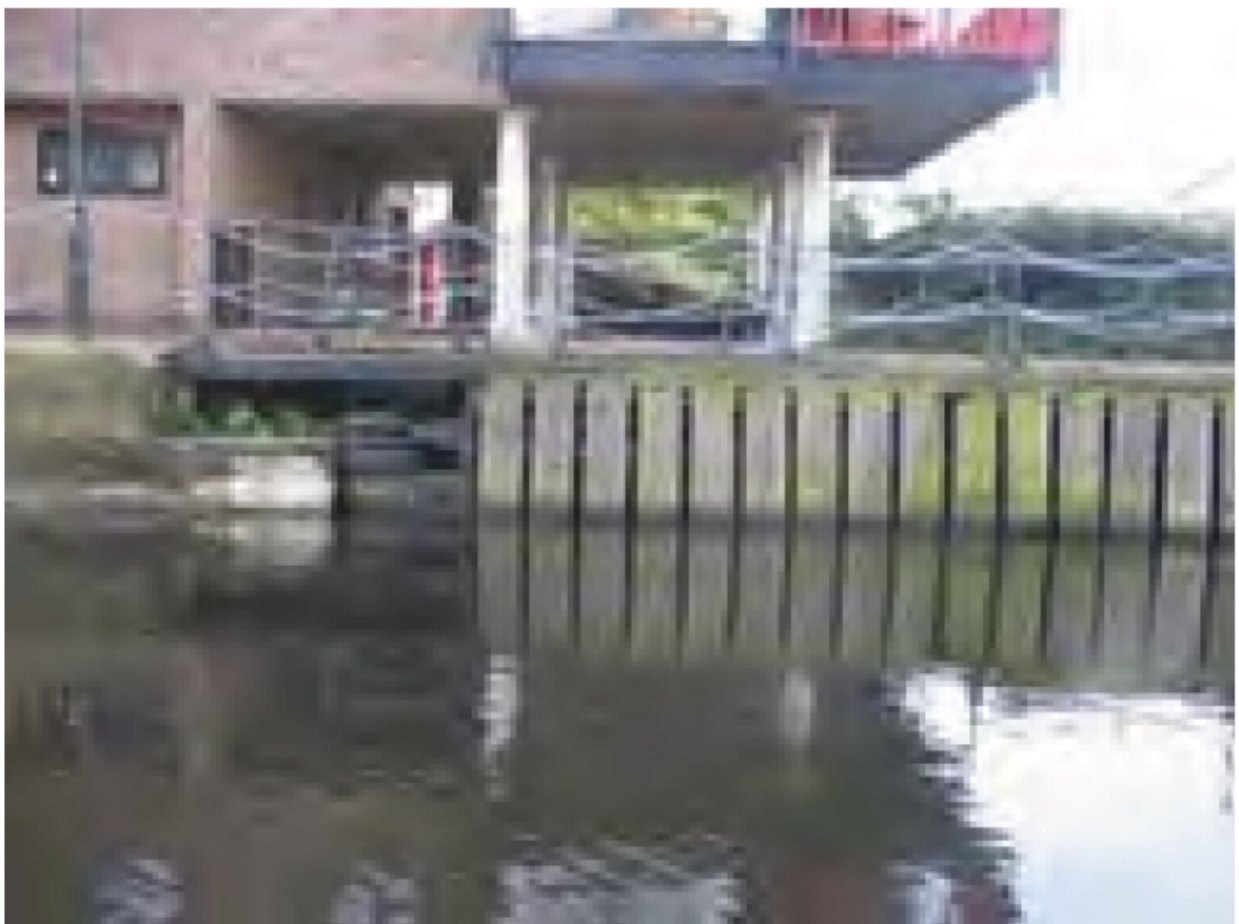
Plate 6: Surviving inner lock gates of the entrance lock to the basin

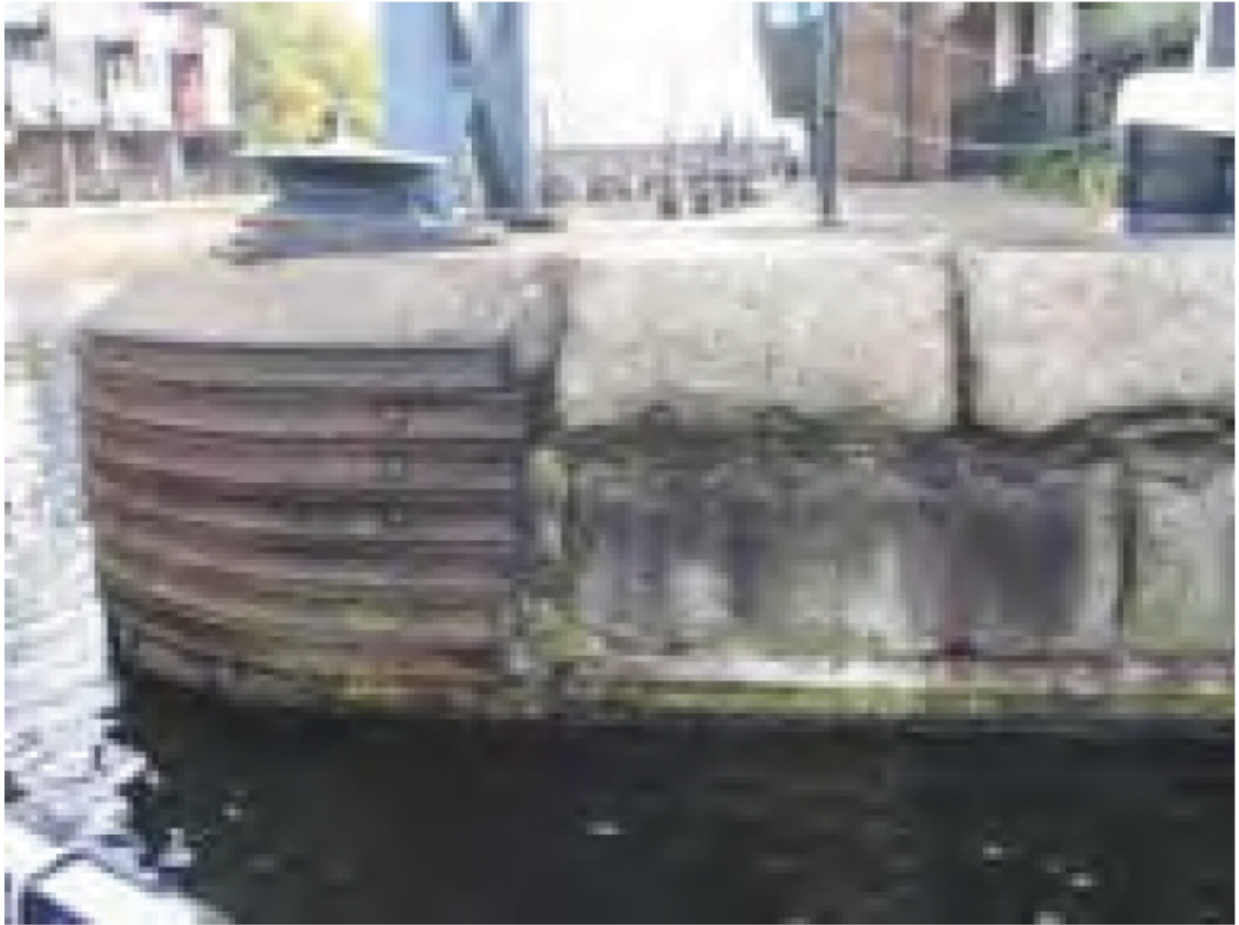
Plate 7: Knuckle at the inner end of the entrance lock

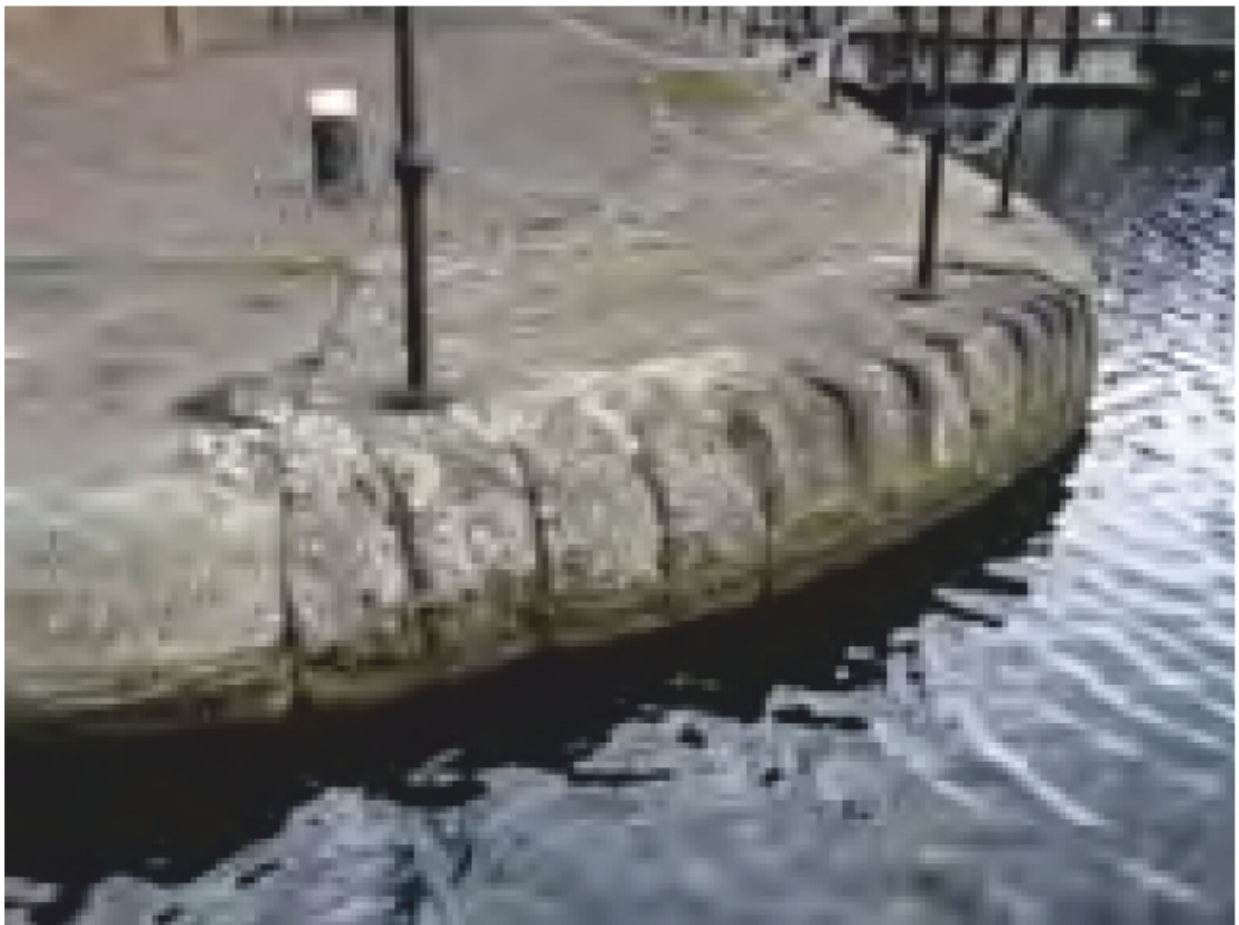
Plate 8: Steel reinforcing bars on the knuckle between the basin and the canal to poplar dock

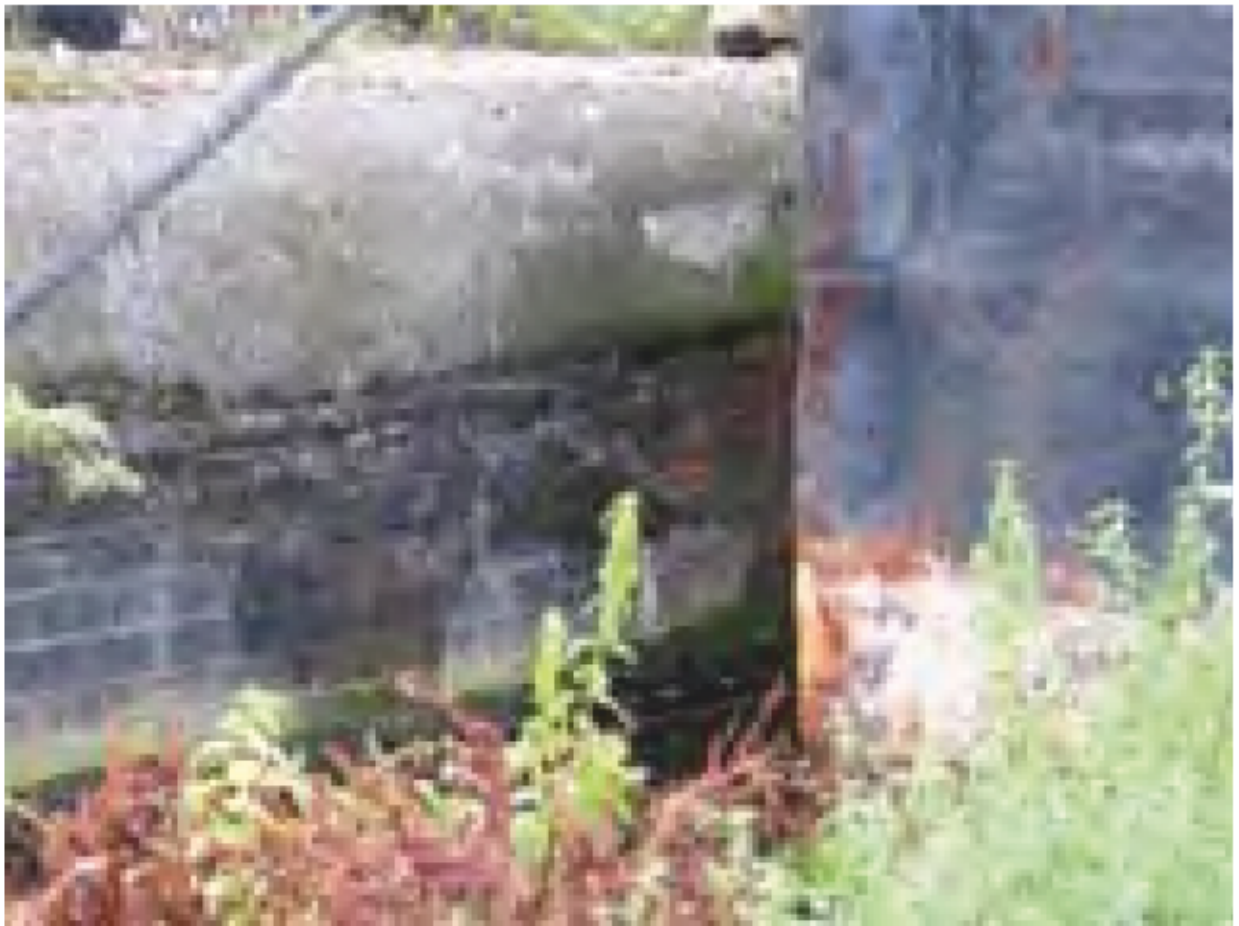
Plate 9: 'Blue' brick refacing and concrete capping to the south side of the Export Dock

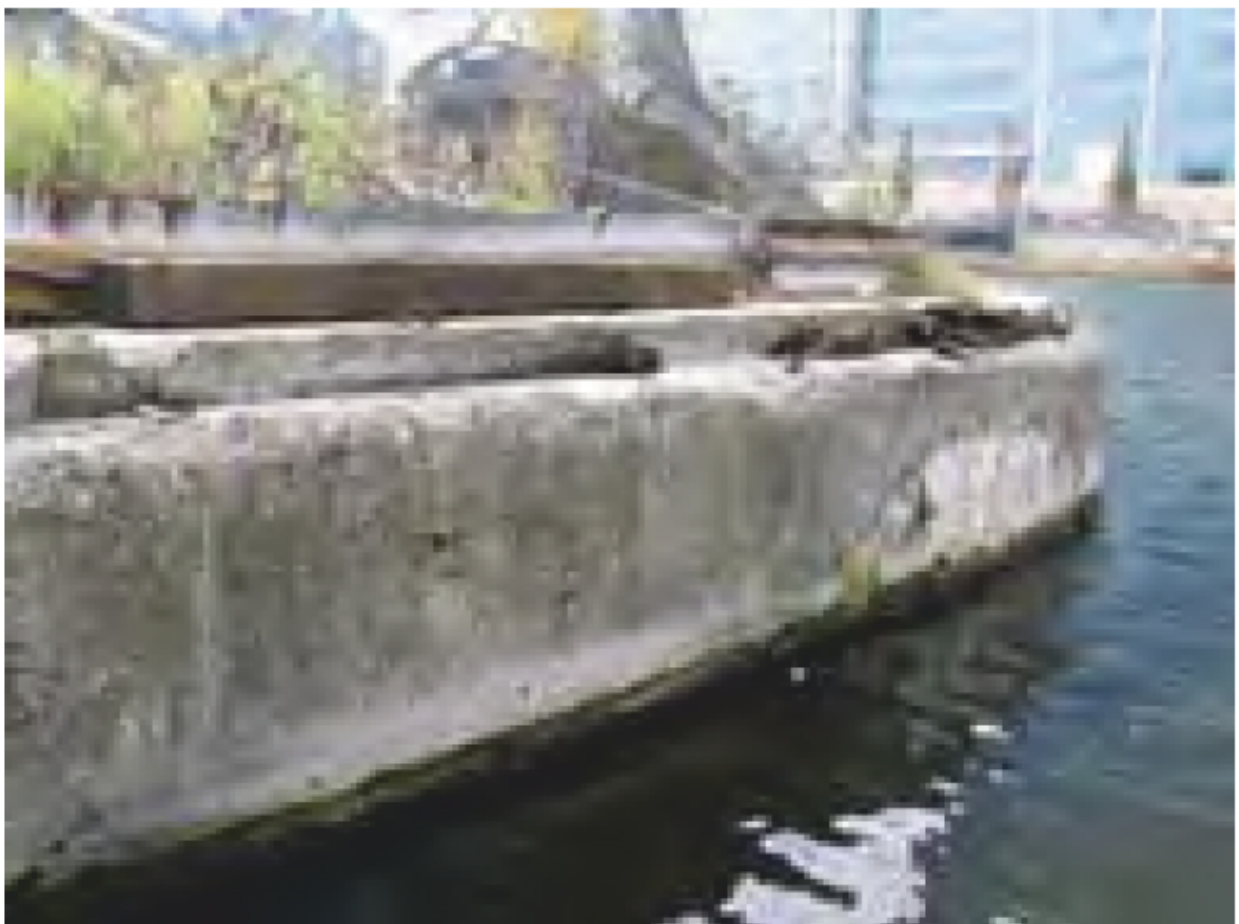
Plate 10: Concrete north eastern corner of the middle cut
