**An Archaeological Evaluation and Watching Brief  
at the Shoreham Adur Tidal Walls, Shoreham**

**ASE Project No: 6833  
Site Code: ATW 13**

**ASE Report No: 2015162**

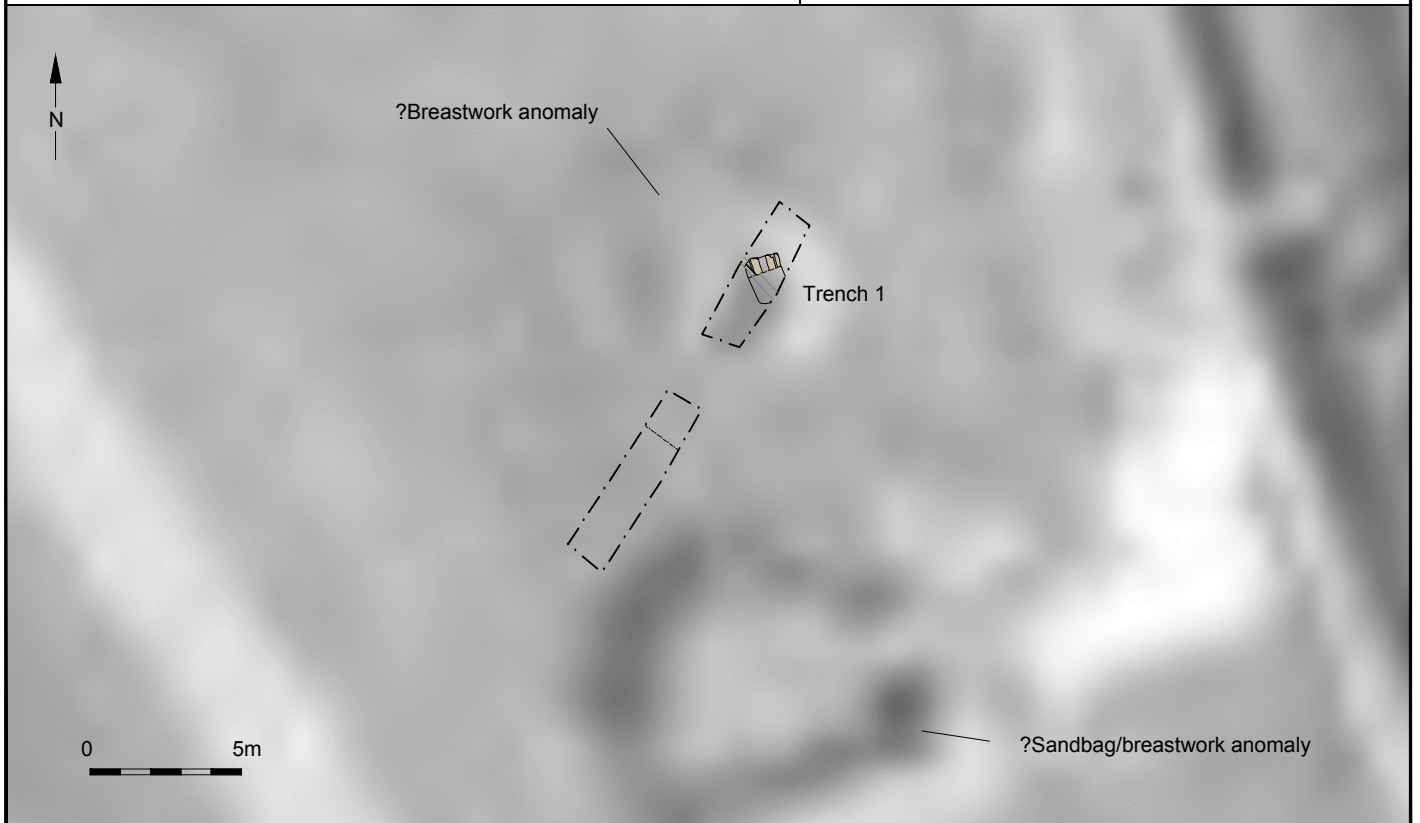
© Archaeology South-East		Adur Tidal Walls, Shoreham	Fig. 3
Project Ref: 6833	May 2015	Trench 1: plan, section, photograph and 1946 aerial photograph	
Report Ref: 2015162	Drawn by: JLR

4.3.1 Trench 1 was 11m long, orientated north-east – south-west and excavated to a maximum depth of 0.50m. Under guidance from the UXO and service scan this trench was finally situated slightly northward of the targeted anomaly (Figure 3). In addition, a gap of 2.5m in the middle of the trench was inserted due to the location of a service.

4.3.2 A sondage 1.5m deep to verify stratigraphy was situated towards the mid part of the trench. An alluvial deposit of dark bluish grey silty-sand [1/008] was attained at a depth of 1.26m below ground level and excavated to a depth of 0.20m. It was sealed by layer of mid-yellow brown alluvial sandy-silt [1/003] 1.14m thick with no inclusions. The alluvium was sealed by a subsoil deposit of friable mid reddish brown silty-clay [1/002] 0.10m thick and topsoil [1/001] 0.4m thick. A 0.50m thick dump of friable light greyish-brown silty-clay with ashy inclusions situated at the northern end formed an embankment just clipped by the trench and running to the south west of a major drainage ditch

4.3.3 A shallow sub-rectangular pit [1/005] with rounded corners was located in the northern part of the trench, truncated on the eastern side by a modern service trench. The pit continued under the baulk. An end segment was excavated revealing rectilinear traces of desiccated timber planking [1/006] partially lining the base and shallow concave sides of the pit. The planks were 0.20m wide, with spaces between. A sterile mid yellow silty-clay deposit sealed the timbers within the pit [1/007]. No other material culture traces were retrieved.

4.3.4 It is probable that the planks [1/006] once formed a level surface or platform set directly on the ground, which has now sunk into the underlying deposit forming the concave hollow.

Trench 1 was located in the area of two anomalies noted on the 1946 RAF aerial photograph. The larger southern anomaly appears to be an open topped thick walled feature, perhaps representing a sandbag/breastwork position for observation or a light anti-aircraft weapon. The footprint left by such a feature may well be negligible. The northern of the pair of anomalies is oval in form and contains three prominent shadows in the centre which continue uninterrupted to the southern boundary of the anomaly, suggesting openings within a banked surround.

The shallow wood lined pit [1/005] identified within Trench 1 broadly matches in location with the eastern-most of the openings. If the overall feature were interpreted as a breastwork, the pit would be one of three slots within the south side, the planks acting as a duckboarding to prevent slippage/sinking for personnel or storage during wet conditions.

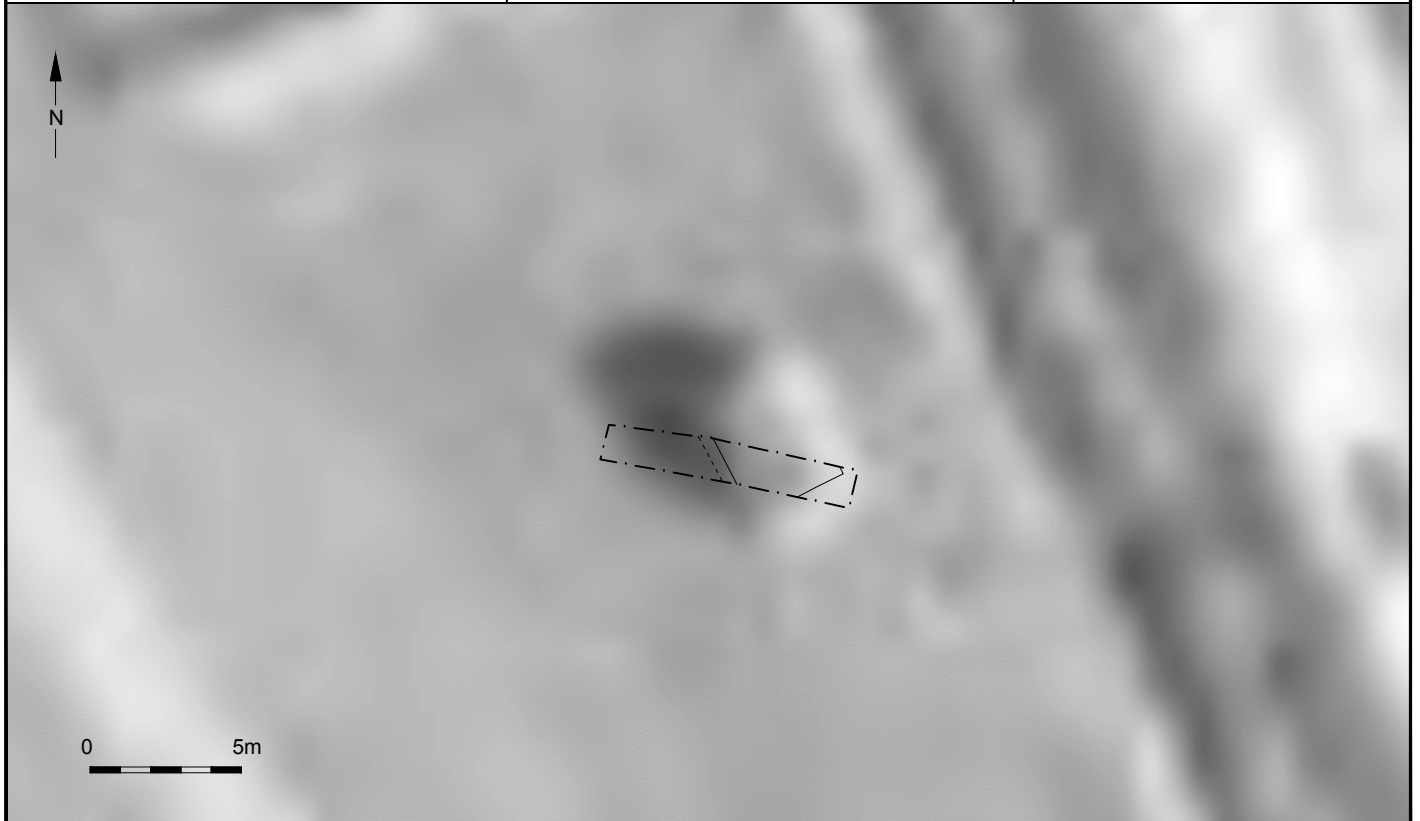
© Archaeology South-East		Adur Tidal Walls, Shoreham	Fig. 4
Project Ref: 6833	May 2015	Trench 2: plan, photograph and 1946 aerial photograph	
Report Ref: 2015162	Drawn by: JLR

4.4.1 Trench 2 was situated in close proximity to trench 1 and orientated north-west – south-east (Figure 4). Measuring 8.6m in length the trench was excavated slightly short owing to the presence of a brick-built modern service conduit exposed at its north-western extreme. It was excavated to a maximum depth of 0.40m at its south-western end. A concrete platform [2/002] forming a probable hut base was exposed.

4.4.3 The concrete platform [2/002] was exposed directly beneath a thin skim of topsoil [2/001] in the south-east half of the trench. The base of a rectangular or sub-rectangular structure, it was oriented north-west – south-east parallel to the shore and embankments to its east. Measuring 3.20m across, it was observed over a maximum of 2.74m on the incompletely exposed axis.

4.4.4 A gravelly deposit of dark blackish brown mixed topsoil [2/004] was excavated along the immediate edge of the platform to expose the full depth of the concrete slab.

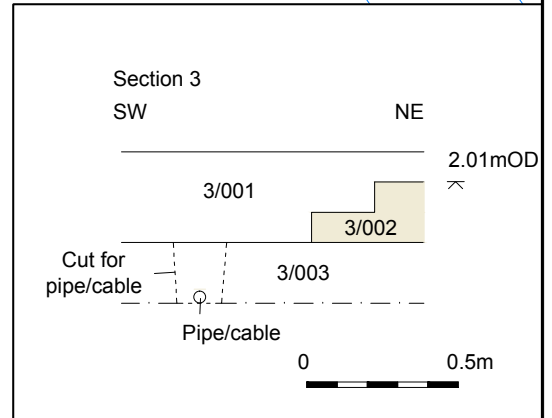
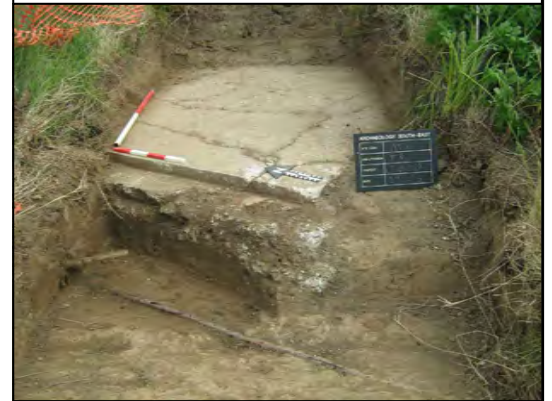
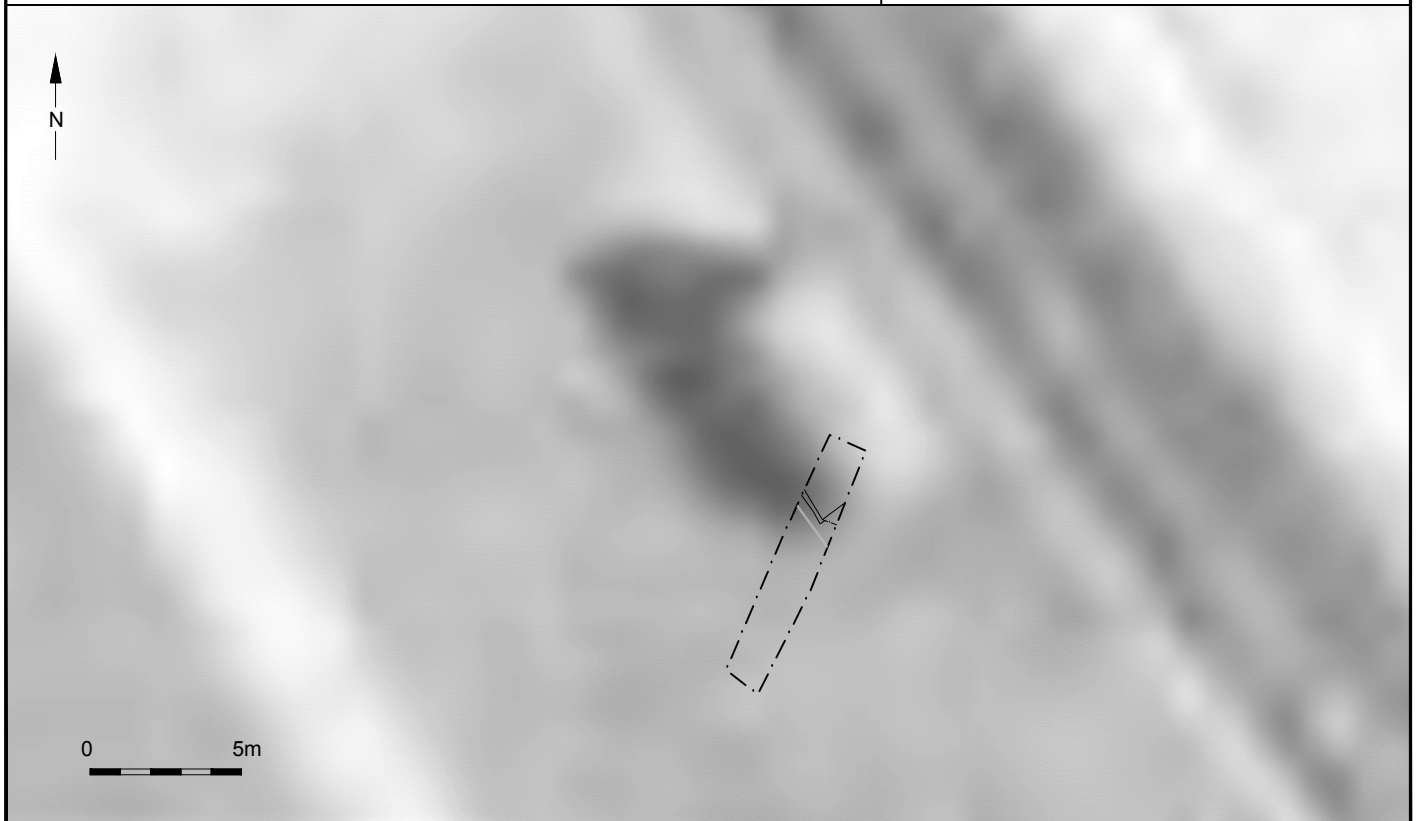
© Archaeology South-East		Adur Tidal Walls, Shoreham	Fig. 5
Project Ref: 6833	May 2015	Trench 3: plan, photograph and 1946 aerial photograph	
Report Ref: 2015162	Drawn by: JLR

3/002 looking north-east

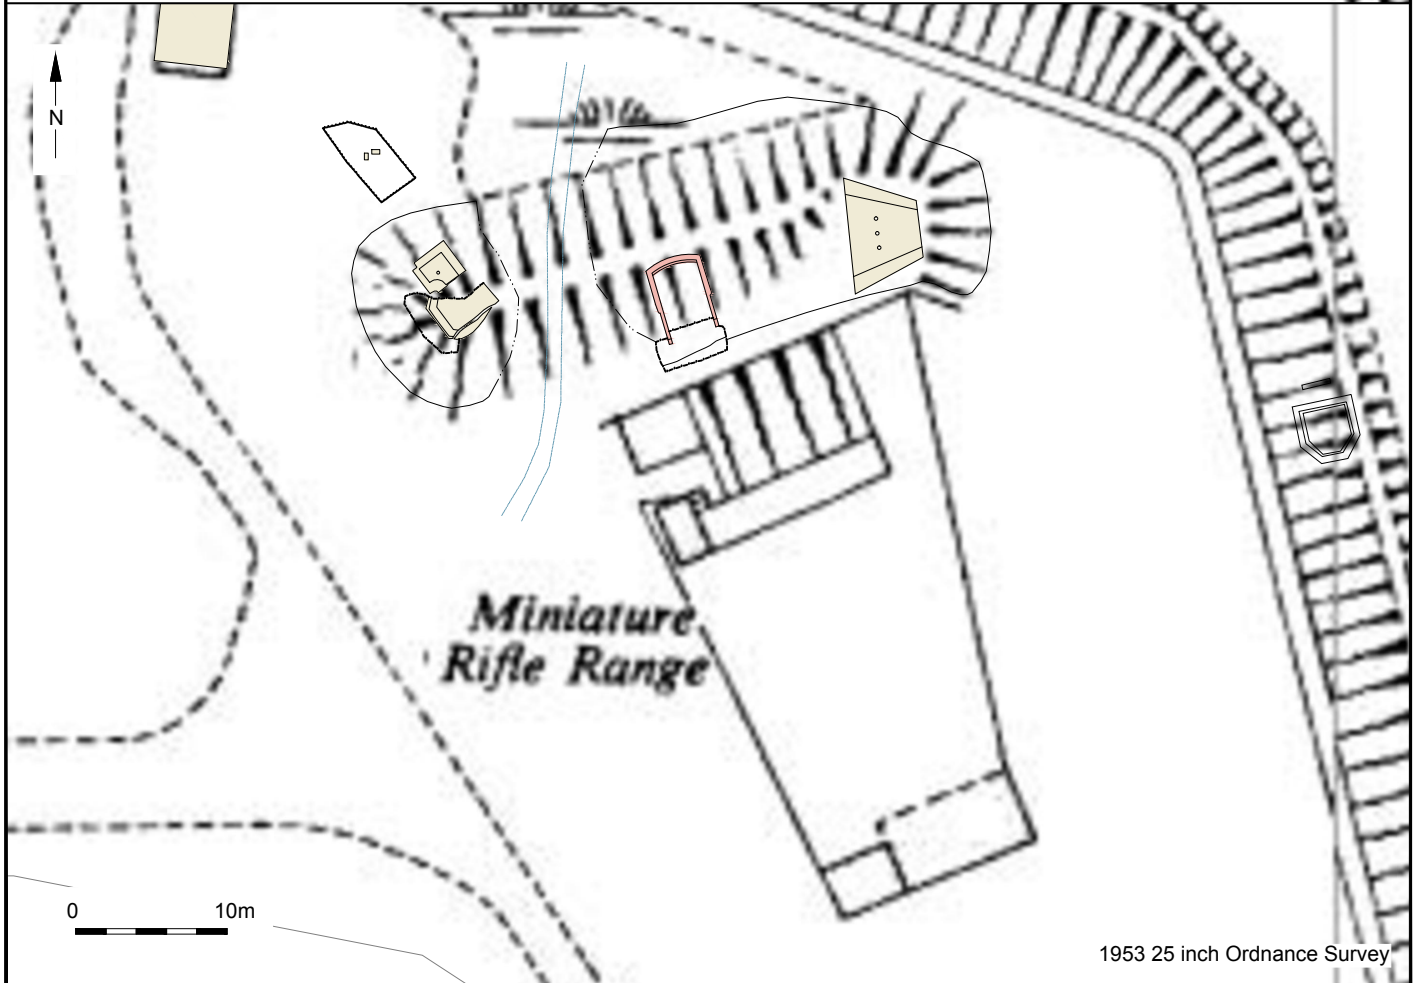
© Archaeology South-East		Adur Tidal Walls, Shoreham	Fig. 9
Project Ref: 6833	May 2015	1933 and 1953 25 inch Ordnance Survey maps	
Report Ref: 2015162	Drawn by: JLR

Brick structure [1116] was constructed for a purpose unknown. The bank in which it is placed first appears on the 1933 25 inch Ordnance Survey map (Fig. 9), shown as approximately 38m by 11m. The 1953 25 inch Ordnance

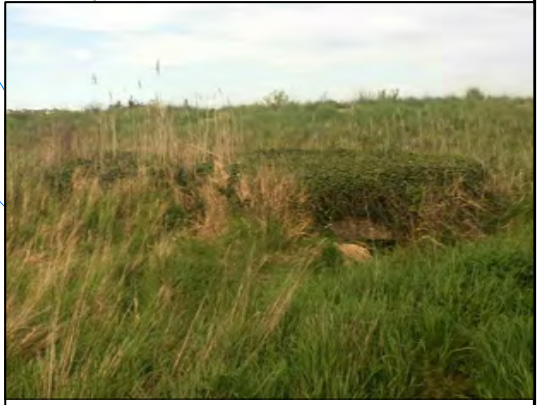
Overgrown pillbox in south-east corner of airfield

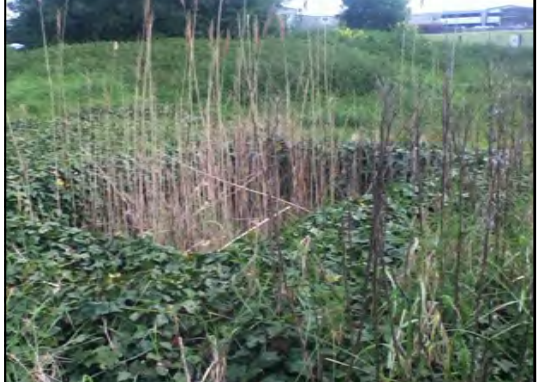
Anti-aircraft machine gun position adjacent to pillbox
