Archaeological Evaluation Report
Kingsgate Business Centre
Kingsgate Road
Royal Borough of Kingston

Planning Ref: APP/Z5630/A/142216303

ASE Project No: 7624 Site Code: KID15

ASE Report No: 2015249

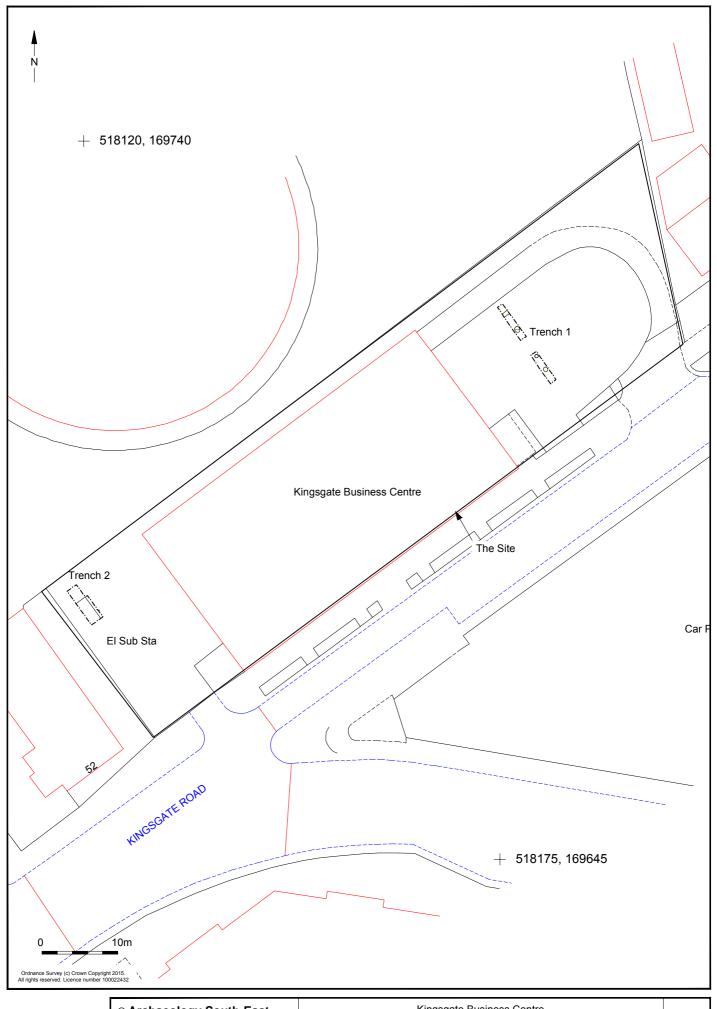
© Archaeology South-East		Kingsgate Business Centre	Fig. 2
Project Ref: 7640	July 2015	Cita location	
Report Ref: 2015249	Drawn by: JC	Site location

- 3.1.1 Two trenches were excavated on site, Trench 1 to the east of the existing building and Trench 2 to the west. Both trenches had to be moved from their prescribed locations (RPS 2015) because of live services. Trench 1 was 1.5m wide and a total of 11.8m long, and was split into two halves due to a live service and up to 0.5m deep. The trench was also narrower and longer than described in the WSI (ibid), where it was described as 1.8m wide and 10m long, due to space restrictions. Trench 2 was 1.5m wide and 5.5m long; 0.5m shorter than prescribed (ibid) due to live services, and was up to 1.6m deep. The actual locations of both trenches are shown on Figure 2.

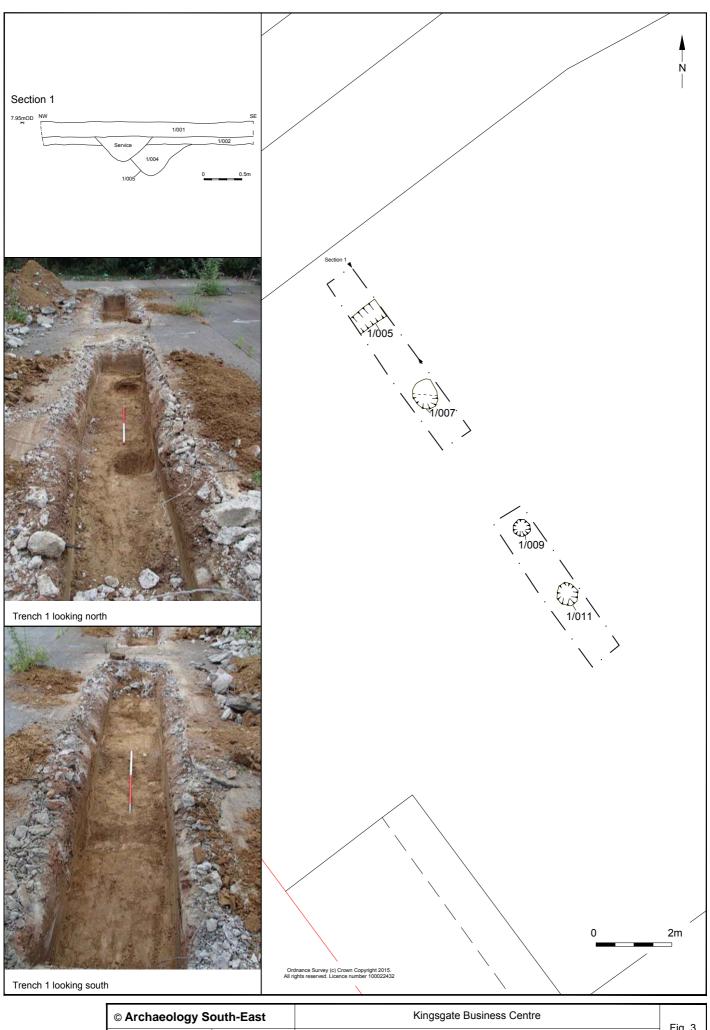
© Archaeology S	outh-East	Kingsgate Business Centre	Fig. 3
Project Ref: 7624	July 2015	Trench 1: plan, section and photographs	1 ig. 5
Report Ref: 2015249	Drawn by: JC	Treffor 1. plant, section and photographs

- 4.1.1 Trench 1 was located in the east the site, running north-west to south-east. The trench measured 14.8m long by 1.5m wide with a maximum depth of 0.5m. Excavation ceased at the top of the natural.

- 4.1.2 Natural sand and gravels [1/003] were between 7.55m and 7.75m AOD. A ditch and three possible pits were identified cut into [1/003]. The pits ([1/007], [1/009] and [1/011]) were all roughly sub-circular and filled with a sterile brown sandy gravels ([1/010], [1/008] and [1/006]).

- 4.1.3 In all of the pits the cut interface with the natural was indistinct and irregular. They are best interpreted as plant boles or geological features (Gill King pers comm to Rob Masefield).

- 4.1.4 In the north-east end of the trench was an apparent small ditch [1/005]. The ditch was roughly V-shaped and filled by a sterile brown sandy gravel [1/004]; a deposit almost identical to the adjacent pit fills. Similarly, the ditch fill contained no finds and its date therefore remains unknown. The feature was partially truncated by a modern service and while this feature has been called a ditch, the limited nature of the evaluation trenching makes this interpretation far from certain. It is quite conceivable that [1/005] is in fact a pit or a tree-throw, rather than a linear cut.

- 4.1.4 All of the features were sealed by *c* 0.2m of modern levelling material [1/002] and the existing concrete slab [1/001].
- 4.1.5 No finds were recovered from Trench 1.

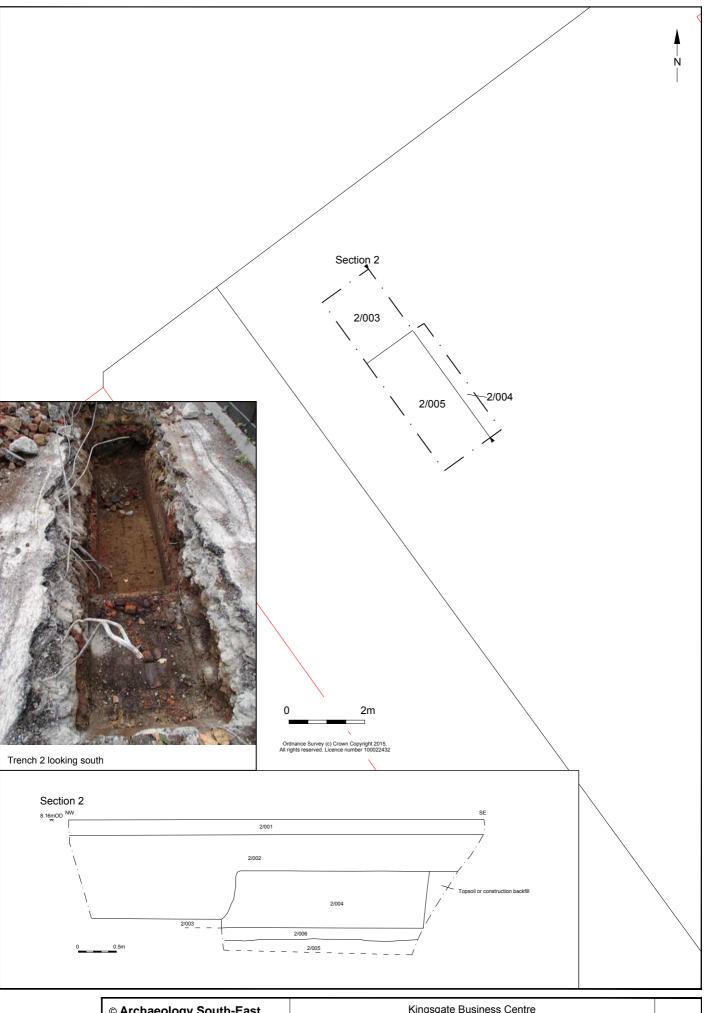
© Archaeology S	outh-East	Kingsgate Business Centre	Fig. 4
Project Ref: 7624	July 2015	Trench 2: plan, section and photograph	ı ıg. -
Report Ref: 2015249	Drawn by: JC	Trendit 2. plan, section and photograph

- 4.2.1 Trench 2 was in the west of the site and was aligned north-east to southwest. The trench measured 5.9m by 1.5m in plan, with a maximum depth of 1.6m at the top of the natural sand and gravel. It was, therefore, too deep to enter safely and was recorded from the top of the trench accordingly.

- 4.2.2 The natural sand and gravel [2/005] was recorded at c 6.46m AOD at the southern end of the trench.
- 4.2.3 The natural deposits had suffered extensive horizontal truncation during the construction of a brick building. This consisted of an south-east to north-west orientated wall [2/004] and a red brick floor [2/003] constructed of unfrogged pavoirs. The wall was only seen in the section of the trench and was bonded using a yellow, non-lime, mortar. Beneath the floor was a layer of brown gravelly sand [2/006] with frequent brick and tile inclusions interpreted as a levelling layer for the brick floor [2/003] or as an alluvial layer.

- 4.2.4 A 1.3m thick layer [2/002] including modern plastics and metals, covered the building remains and represents the demolition of the building. Above [2/002] was the existing concrete slab [2/001].

- 5.2.4 It should be noted that at the western end of the site the natural topography probably sloped down from east to west, which is why Trench 2 was so much deeper than Trench 1, and that here the ground level has therefore probably been built-up (see section 2; Figure 4).

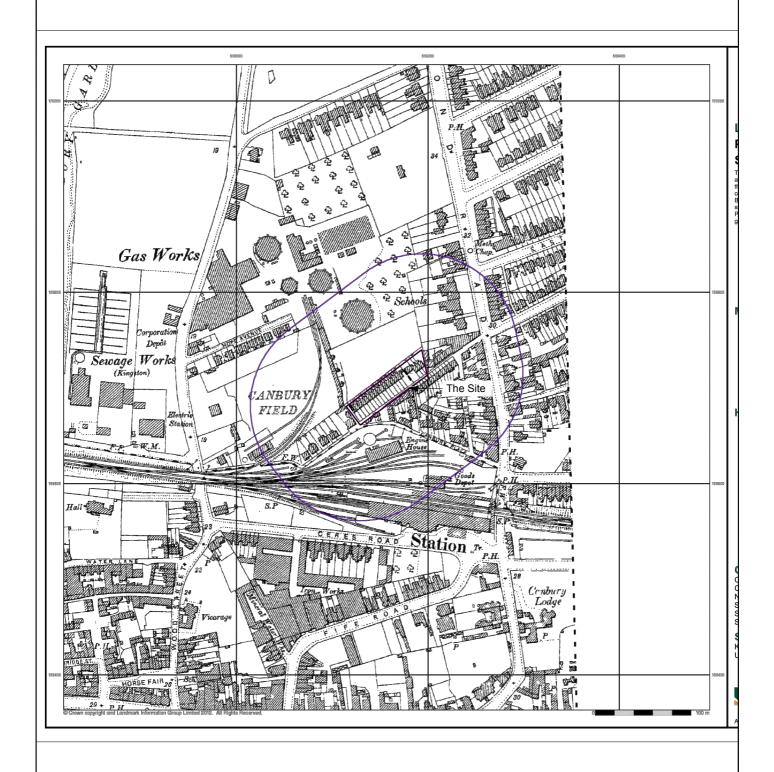
© Archaeology South-East		Kingsgate Business Centre	Fig. 5
Project Ref: 7624	July 2015	Ordnance Survey map of 1896	1 lg. 5
Report Ref: 2015249	Drawn by: JC	Ordinance Survey map or 1090

- 5.1.1 Trench 1 contained undated features; interpreted as possibly representing plant boles or geological features. Trench 2 contained the partly demolished remains of a brick-built building; surviving elements, visible only from the top of the trench which was too deep to enter safely, included a brick wall and a brick floor of unfrogged brick.
- 5.1.2 Ample historic mapping (Figures 9-15 in RPS 2015a) exists for the site and while it is not possible to exactly identify the building found in Trench 2 from the 1896 Ordnance Survey map (Figure 5), the remains perhaps represent one of the terraced houses in the south-west of Cadbury Passage.
- 5.1.3 Trench 1, on the other hand, may be located in the front garden of one the former houses at the north-eastern end of the same street shown on the 1896 OS map.

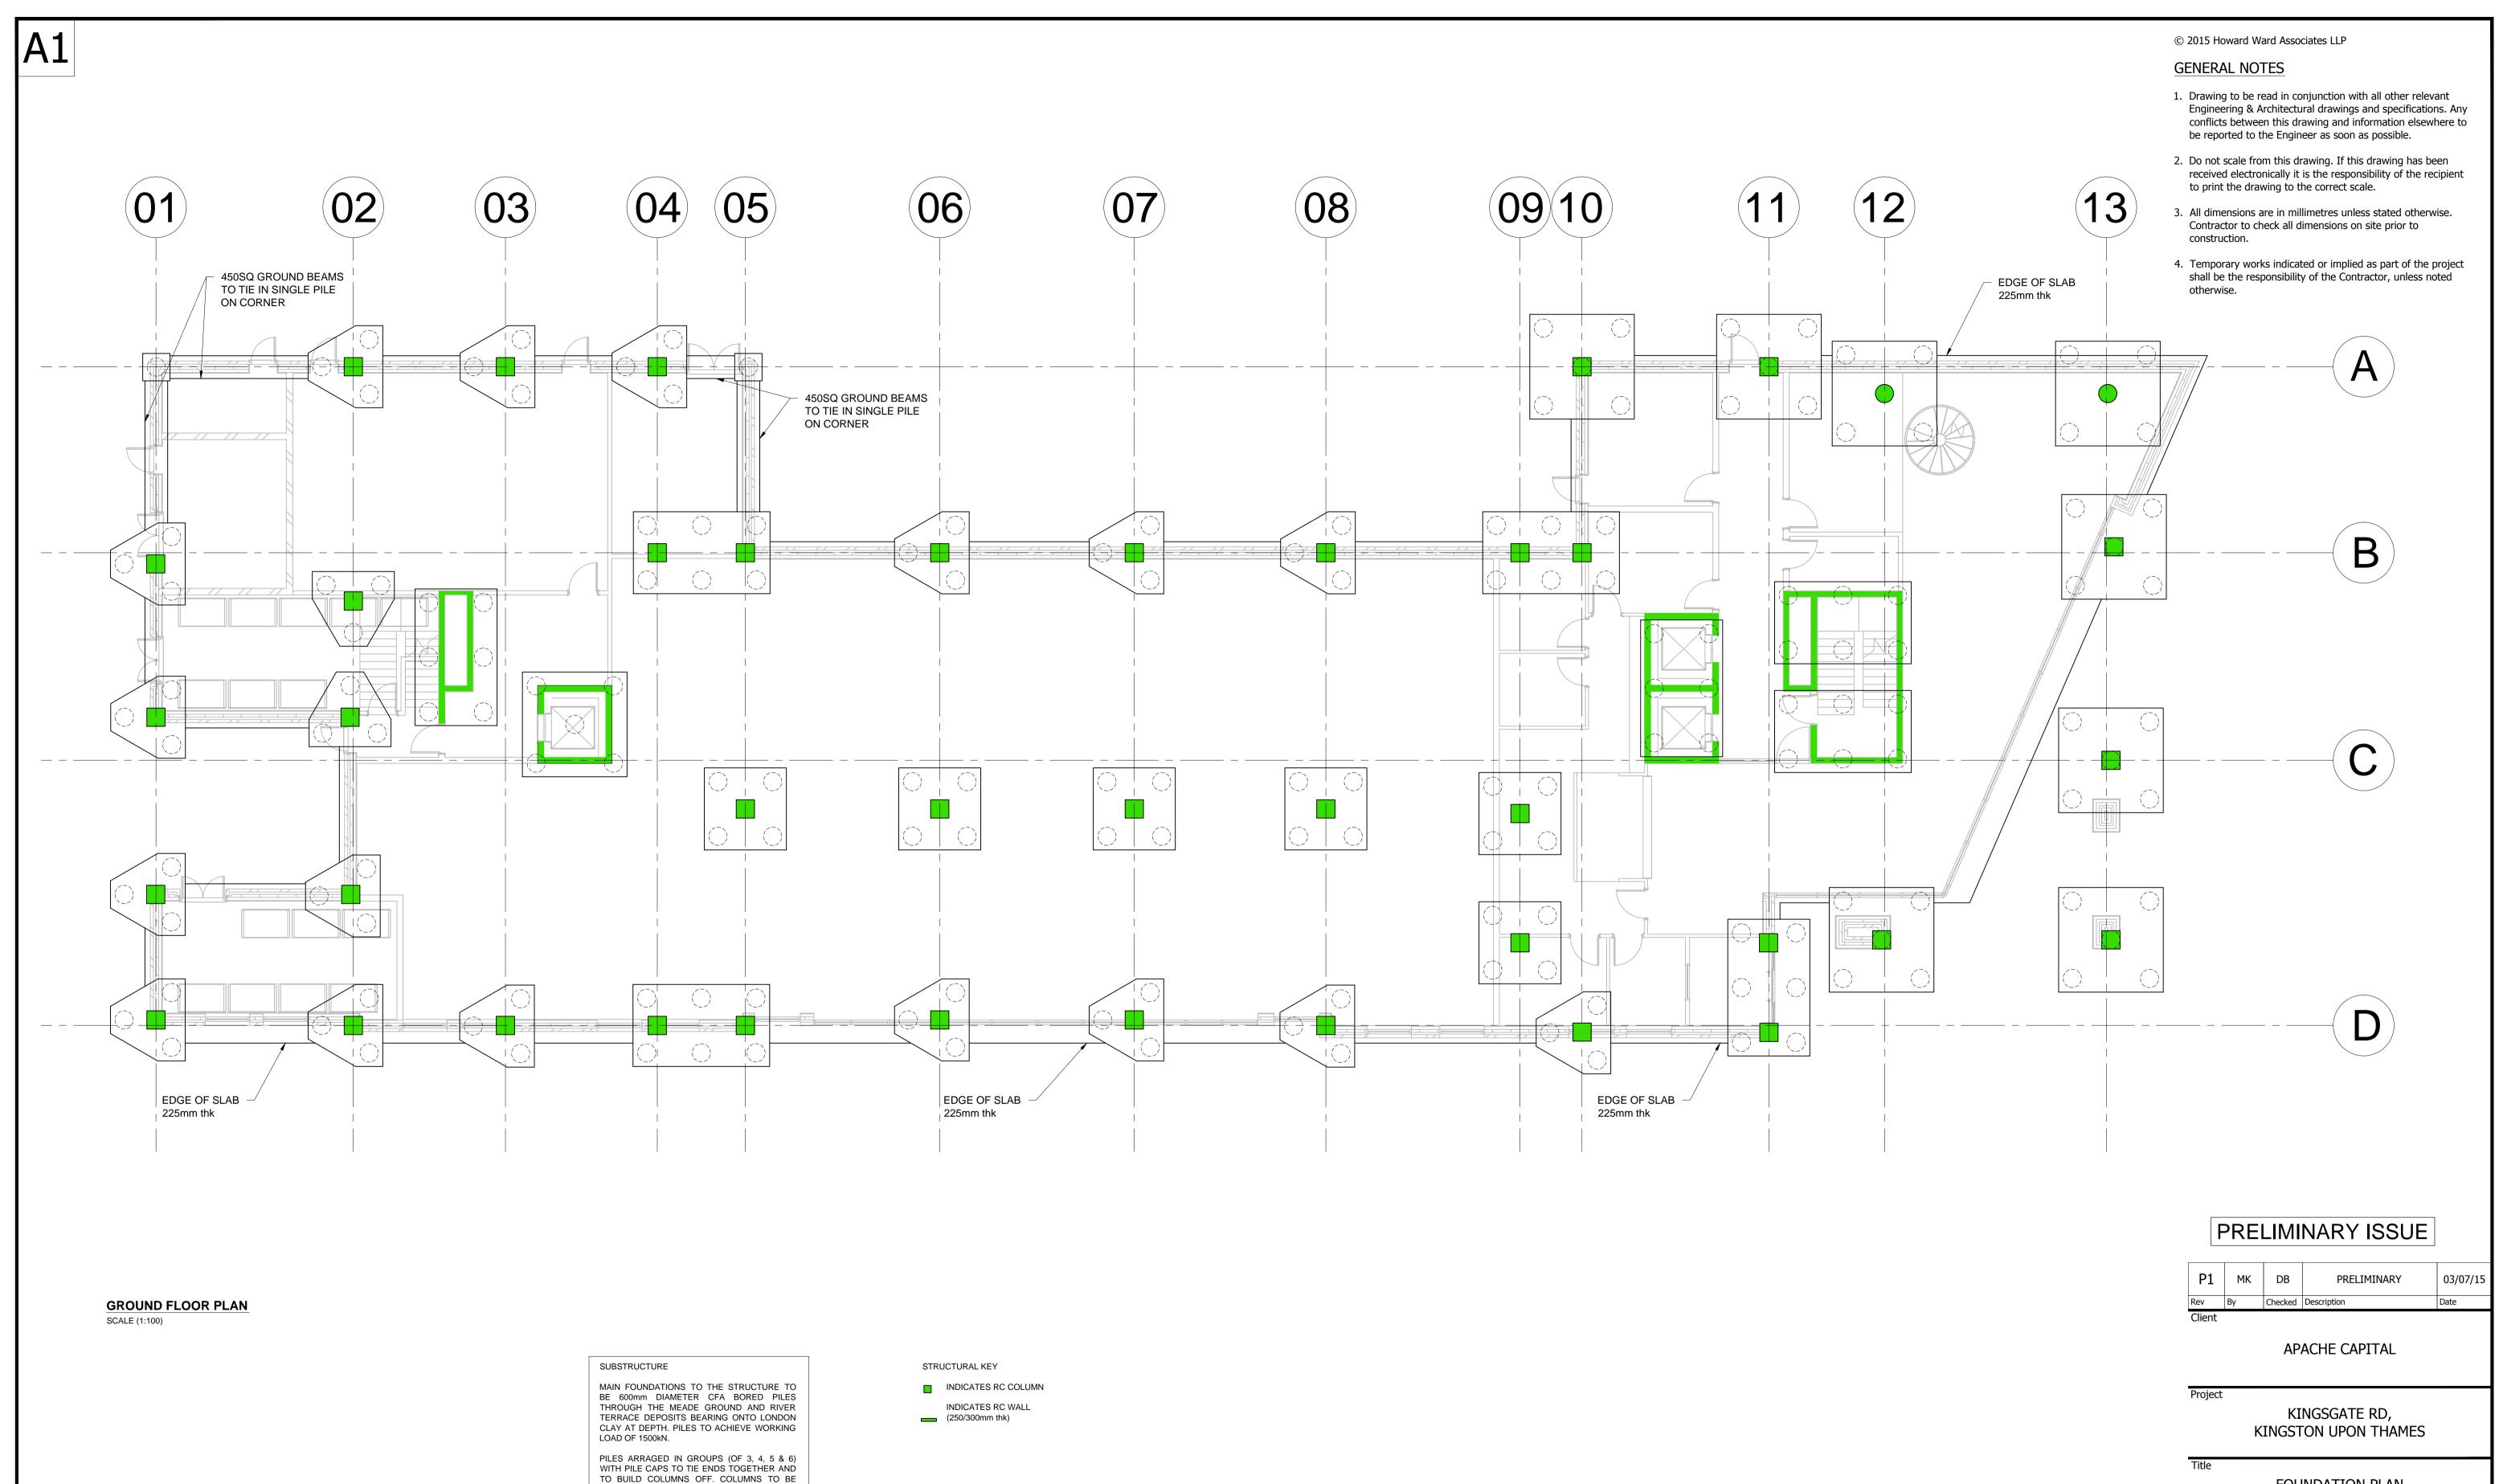
Drawing No.
SK200_01

- 5.5.3 Proposed Foundation Design
- 5.5.4 A figure showing the proposed foundation design is included at the back of this report.
- 5.5.5 Pile diameters are proposed to be 600mm but may increase to 750mm.

- 5.5.6 The proposed finished floor level surface is 9.1m AOD. Pile cap bases are proposed to be c. 1.3m below this, so approximately 7.8m AOD.
- 5.5.7 The ground floor slab, sub-base and insulation will be a maximum combined thickness of 425mm. Therefore the proposed horizontal truncation is expected to be at a level of c. 8.675m AOD.

GROUND FLOOR SLAB TO BE 225mm THICK AND TO BE GROUND BEARING CONSTRUCTED OFF (....). GROUND FLOOR WALLS TO BE BUILT

FOUNDATION PLAN TYPICAL PILING LAYOUT

- 5.5.10 Proposed Impacts on the Archaeological Resource
- 5.5.11 The underside of the existing building slab is estimated to be at c. 8.10m AOD. The proposed underside of the new slab is expected to be at a level of c. 8.675m AOD. Pile cap bases are proposed at c. 7.8m AOD.
