Archaeological Monitoring & Recording

Chisbon Heath Solar PV Farm

St Osyth

ASE Project No: 8295

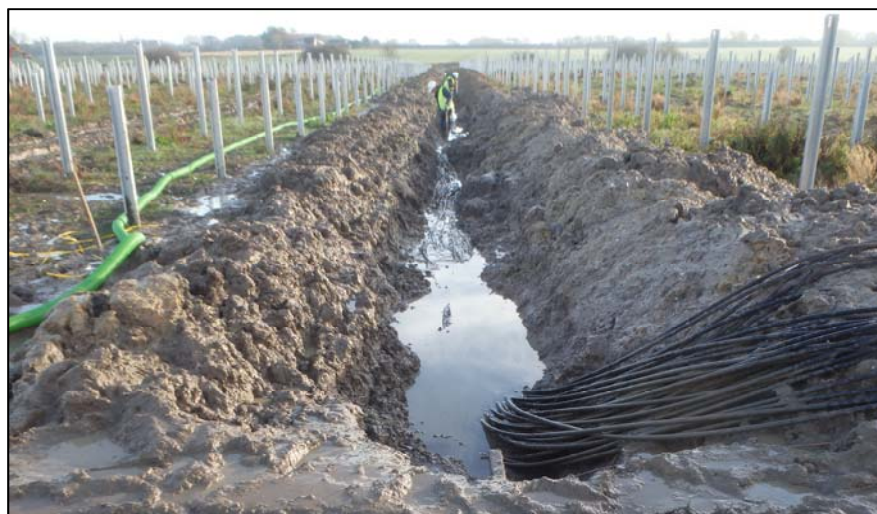
Front Cover Image: General view of cable installation works in progress

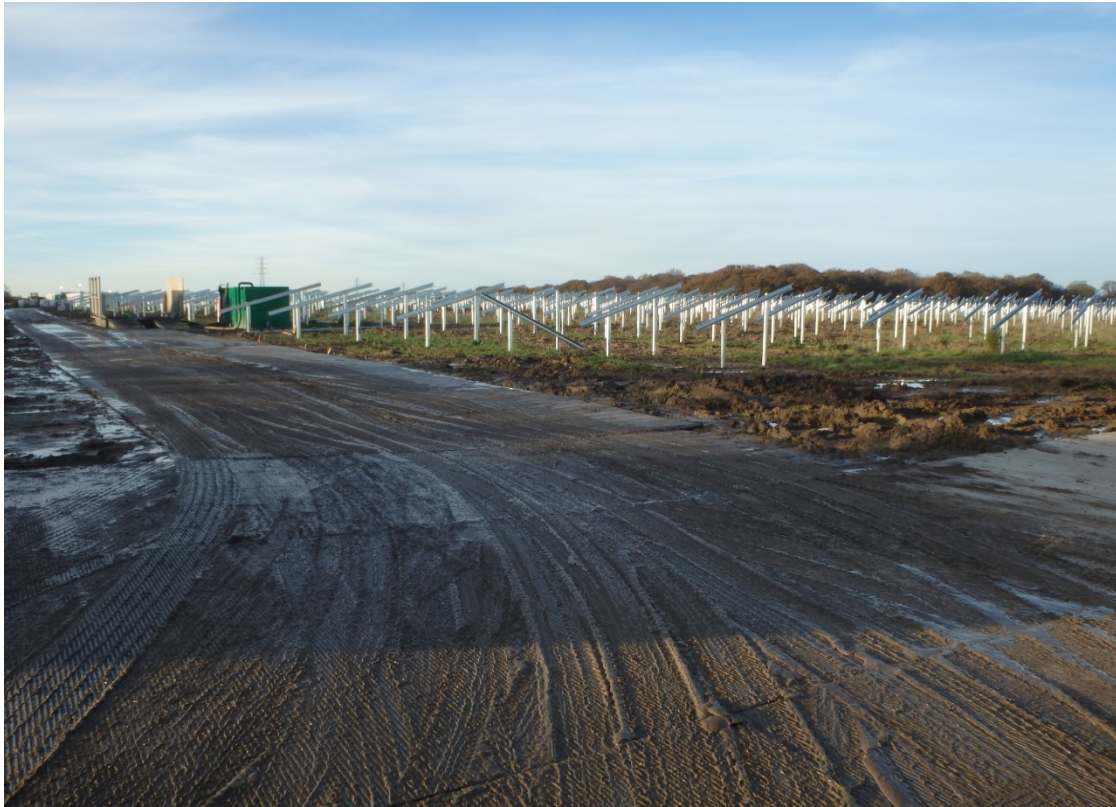
Figure 2: Temporary roads formed from mesh matting laid directly on the existing ground surface.

3.1.2 It was originally envisaged that construction of the access and service roads serving the solar farm would also be monitored; however, due to temporary nature of the solar farm and planned low-impact construction methodology the roads were not stripped of topsoil and were instead formed from reinforced mesh matting laid directly on the ground surface (see Figure 2).

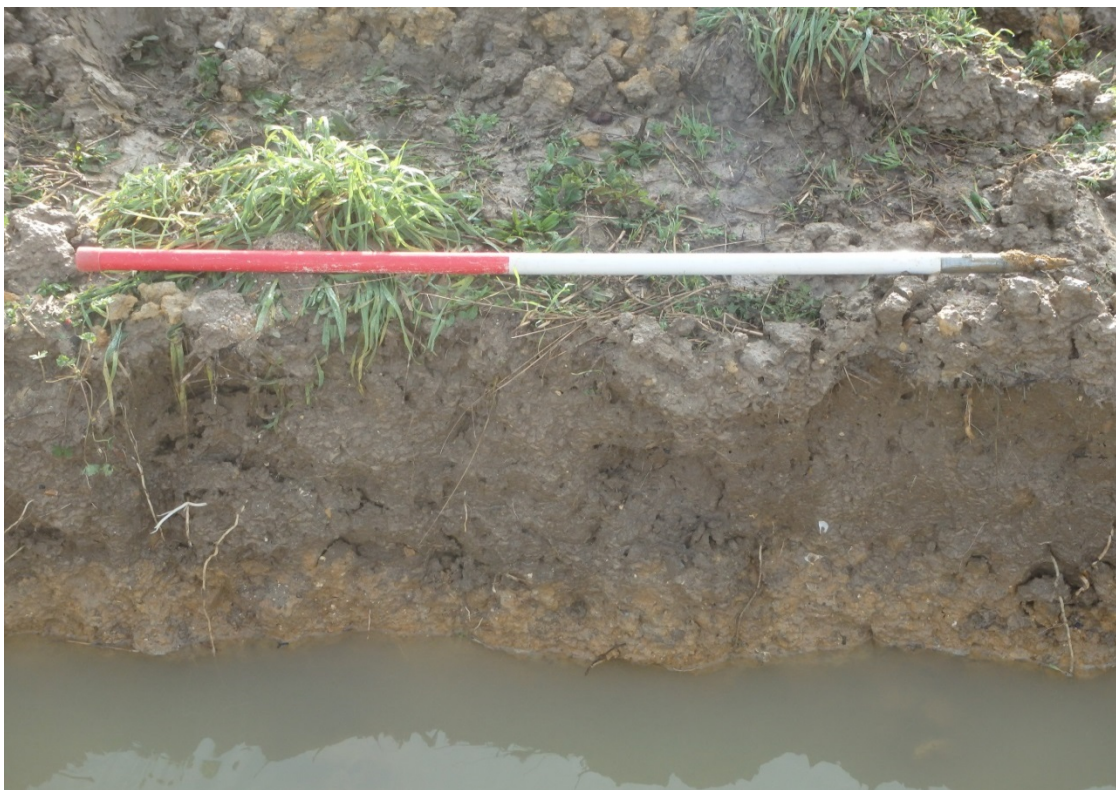
Figure 3: Typical cable trench section showing topsoil overlying subsoil and illustrating ground conditions.

- 4.1 The deposit sequence revealed across the site consisted of an approximately 0.3m thick layer of mid-brown silt clay topsoil (1) overlying a 0.28m thick light grey clay sand subsoil with grey-brown mottles (2). This sealed undisturbed natural geology which varied across the site, varying between a mid orange-brown sandy clay with dark brown clay mottles and lenses of gravel or light grey sandy clay with orange mottles (3).

- 4.2 Due to the relatively shallow depth of the groundworks the principle opportunity to observe and record any archaeological remains that were present was afforded by the cable trenches that link the rows of panels to the transformer/ inverter stations. Cable trenches were on average 0.8m deep, cutting through the full thickness of the topsoil and subsoil, into the top 20cm (average) of the natural deposit (Figure 3).

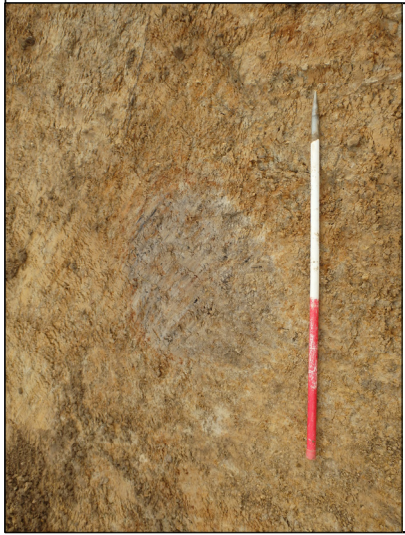
Pit 004, 1m scale

- 4.4 In the central part of the site topsoil stripping for a transformer/ inverter station revealed a single roughly circular pit (4), approximately 0.67m wide, that contained a compact light blue-grey silt clay fill with frequent charcoal flecks and occasional subrounded gravel (5), and a north – south orientated gully (6). The gully was approximately 0.54m wide, extending across the full length of the area stripped for the transformer base, and also contained a light blue-grey silt clay fill with occasional gravels and dark grey mottles (7). The area was subsequently preserved in-situ beneath a geotextile membrane and layer of roadstone (see Figure 4).

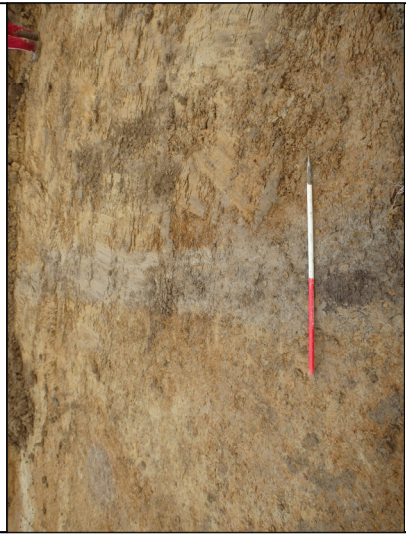
Gully 006, 1m scale

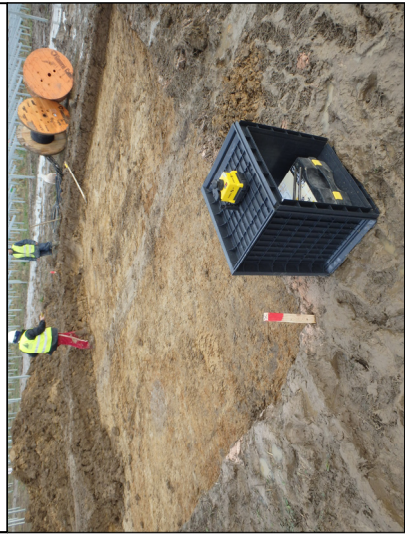
Trench 13 with 004 and 006 looking north-east

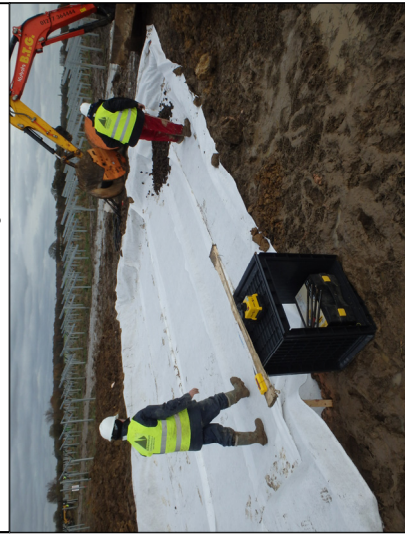
Trench 13, preservation in-situ

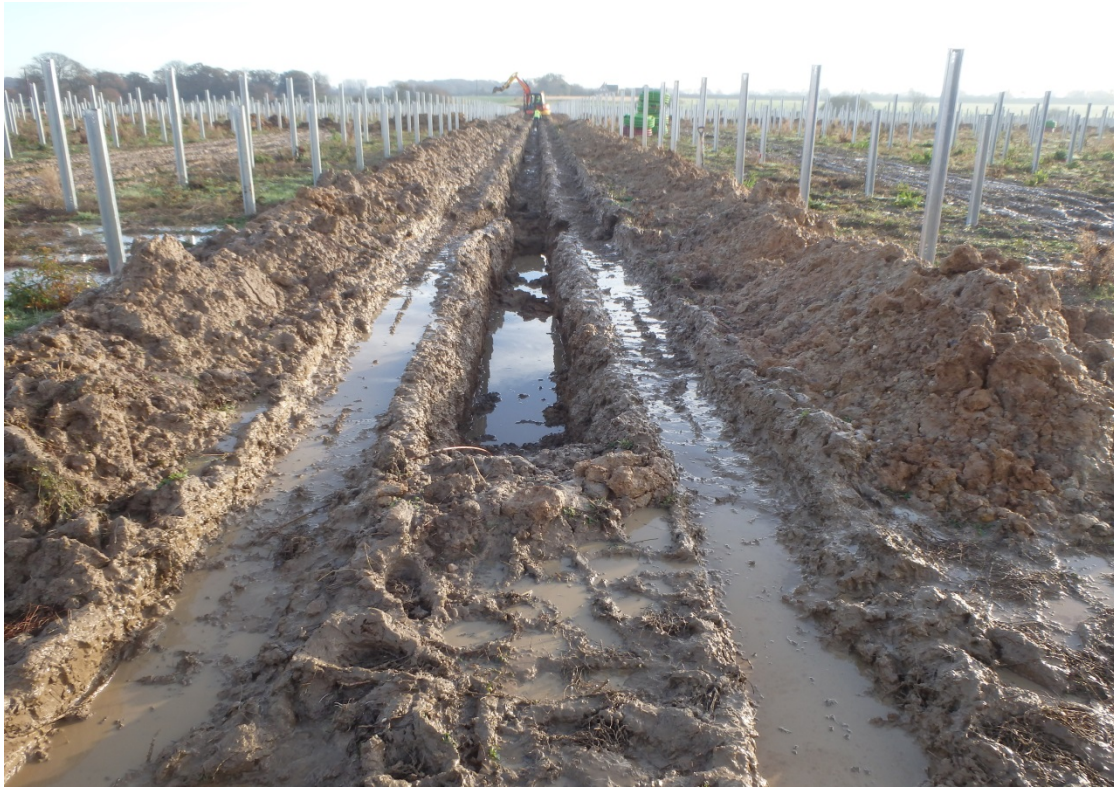
Figure 5: General view of cable trench under excavation illustrating poor ground conditions – November 2014.

- 4.5 Observation of the cable trenches in the western part of the site was hampered by continuing poor weather and ground conditions, which made it difficult to recognise features in the narrow and often partially flooded trenches (see Figures 5 and 6), while some cable trenching works were not notified and took place without an archaeologist present. The southwestern part of the site was also crossed by a gas main, the line of which, along with a suitable buffer, was excluded from the working area. The route of the pipeline crossed a possible enclosure recorded on aerial photographs but not detected by the geophysical survey (ASE 2013) and consequently, as no ground works were undertaken in this area it was not possible to determine if the cropmarks corresponded with any underlying features of archaeological origin.

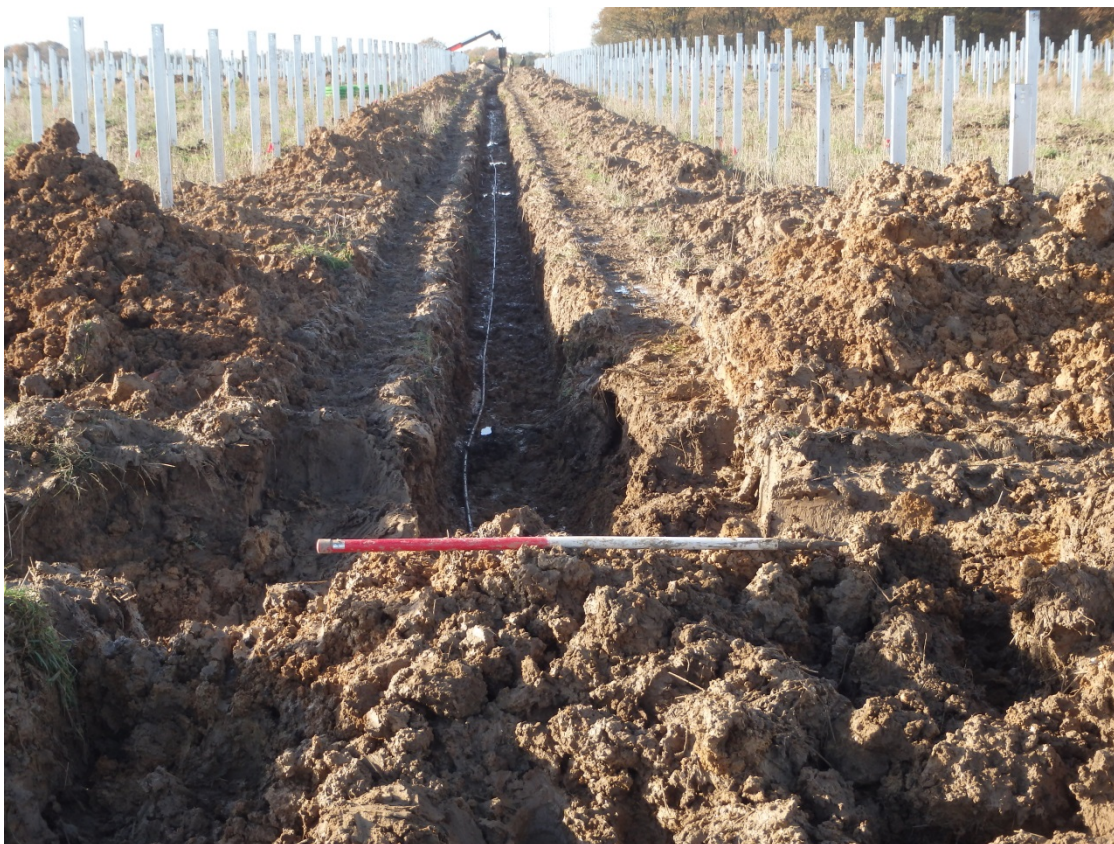
Figure 6: General view of pipe trench under excavation – November 2014.
