PIGGERY, CANE HILL HOSPITAL, COULSDON

HISTORIC BUILDINGS RECORD
(Historic England Level 3)

Report 2015267

**Project no. 7714
Site Code: PGD15
Report ref: 2015267
OASIS ID: archaeol6-219381**

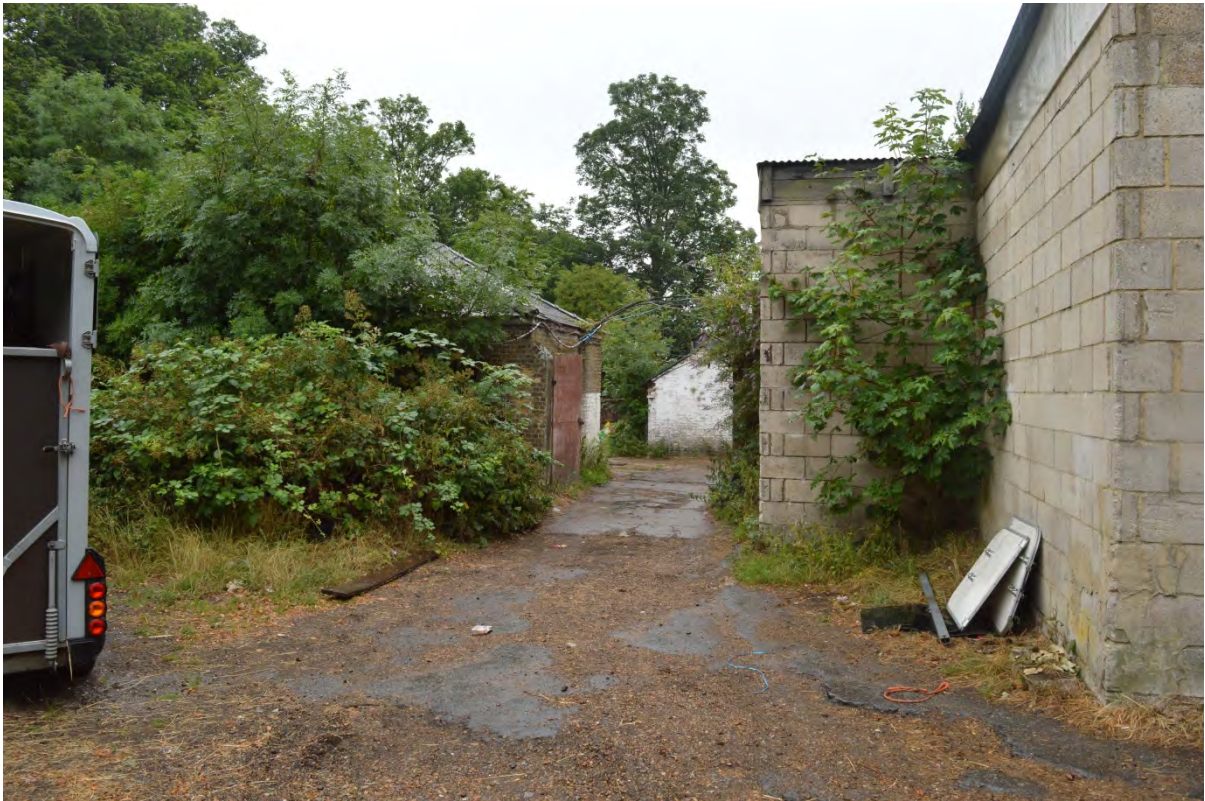
Plate 1: Principal elevation of the piggery – largely masked by vegetation and later development (Photo #128).

- 5.1 The site consists of a walled compound, with its principal elevation to the north (Plate 1). The principal circulation route, consisting of a pot-holed metalled track, runs through a gated entrance to the centre of the principal elevation. To either side of the entrance are two single-storey brick buildings – used as storage/tack rooms. Within the compound are the remains of a number of pigsties, to east and west, with remnant feeding passages running parallel. Later 20th century breezeblock walled stables run alongside the former feeding passage walls, facing onto concrete-paved yard spaces within. To the centre of the site is a linear structure, orientated north-south. The building is divided in two, with the southern half featuring a lower roof and walls. Two ancillary stable buildings, constructed of timber, are situated to the north-west of the site, along with a communications mast. Abutting the north side of the exterior wall of the compound is a breezeblock barn-type structure. Additionally, a dilapidated timber structure is situated within the northeast of the site.

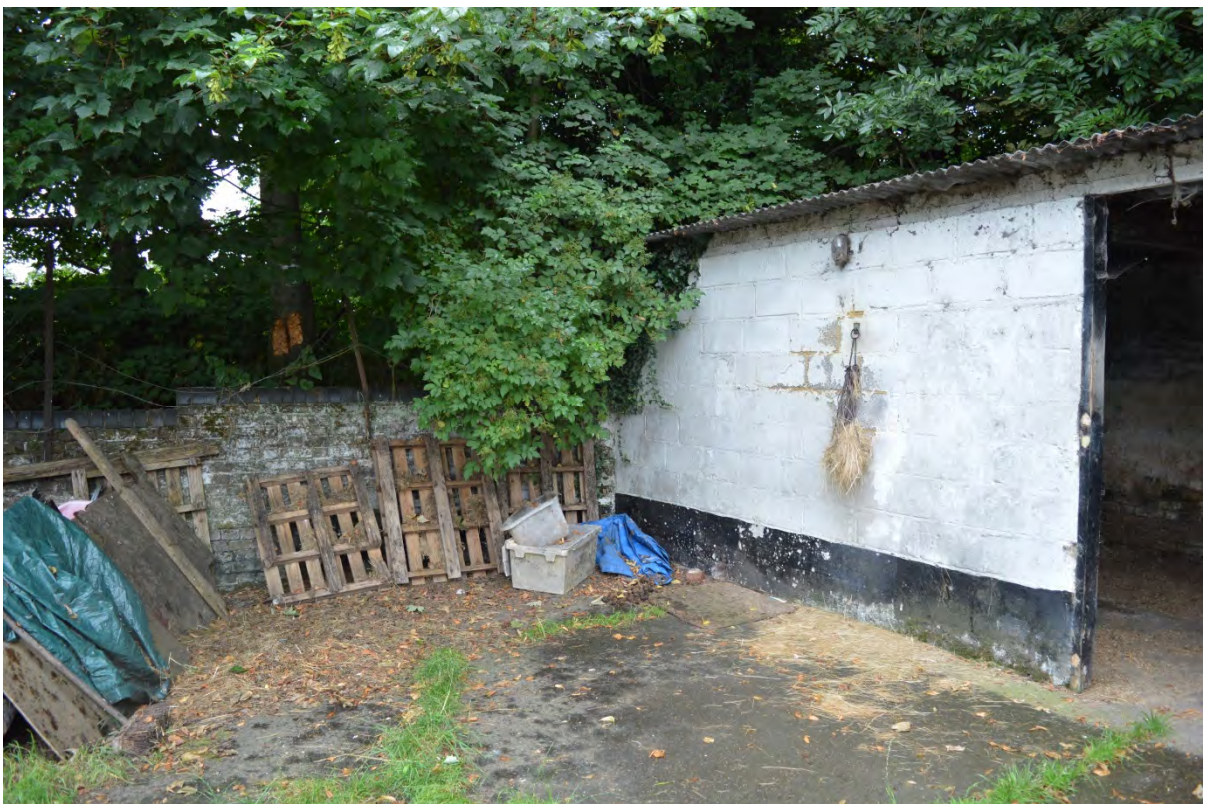
Plate 2: South wall of the compound – note half-round coping (Photo #63).

- 5.3 The site is bounded by a high wall, constructed of a mid-yellow brick set in Flemish bond with a chalky-white mortar. The wall is lower to the south of the site. The wall is one brick thick and is capped by a half-round brick coping (Plate 2). In places the wall is in a very poor state of repair – most notably to the east of the site where it has collapsed/been removed to within half a metre of the ground (Plate 3). The brick structures of the former pigsties, the two storage/tack room buildings, and the narrow building within the centre of the site are all joined into the external wall, suggesting a single phase of construction for the original piggery; a purpose built compound. The brick is consistent for the buildings, of the same stock as the perimeter wall. The storage/tack rooms differ in being constructed in English bond. Original door openings are framed by bullnosed bricks with segmental arch lintels. Original window openings have segmental arch lintels and lugsills.

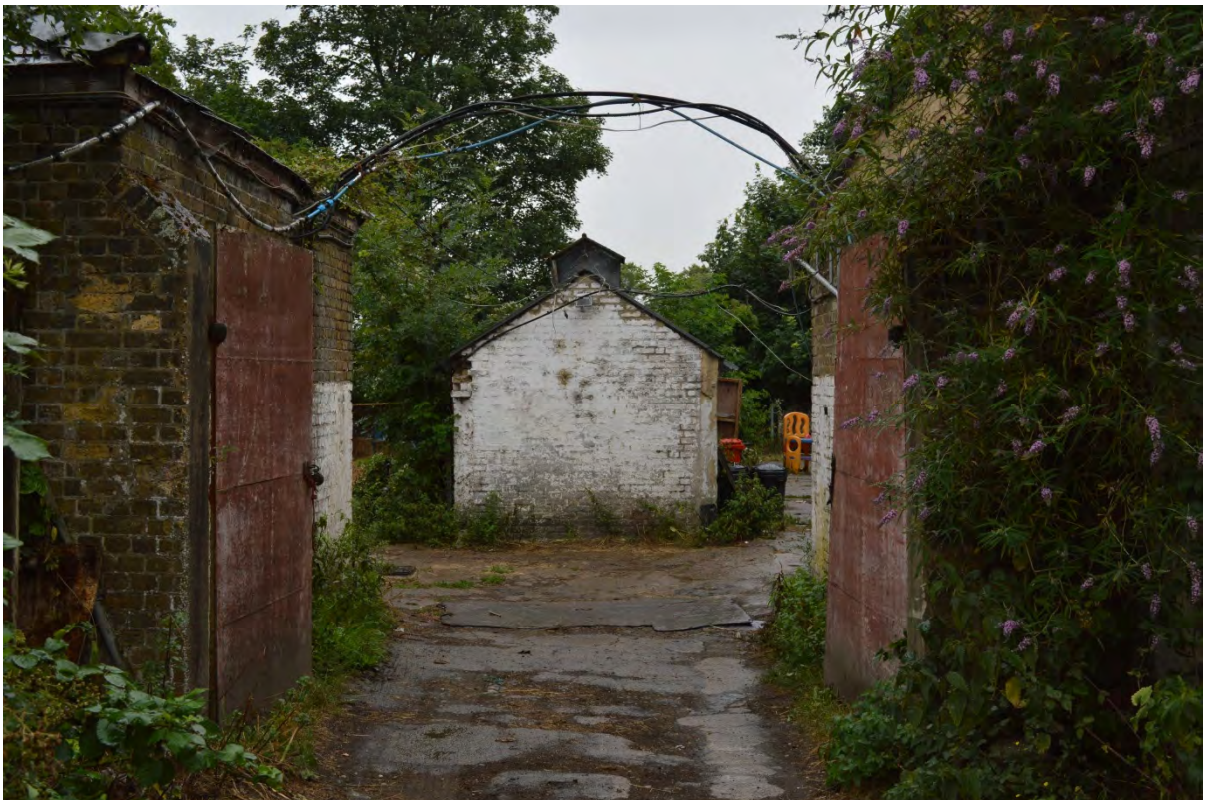
Plate 4: Site entrance (Photo #126).

- 5.5 The site entrance is wide enough to accommodate a cart or van, and is unornamented (Plate 4). Two brick buttresses extend from the adjacent structures to frame the entrance, forming jambs for the late 20th century timber gate. Electrical cables bridge the top of the gateway creating an accidental ornamental archway of sorts. The driveway runs through the entrance to split, east and west into the large paved yards.

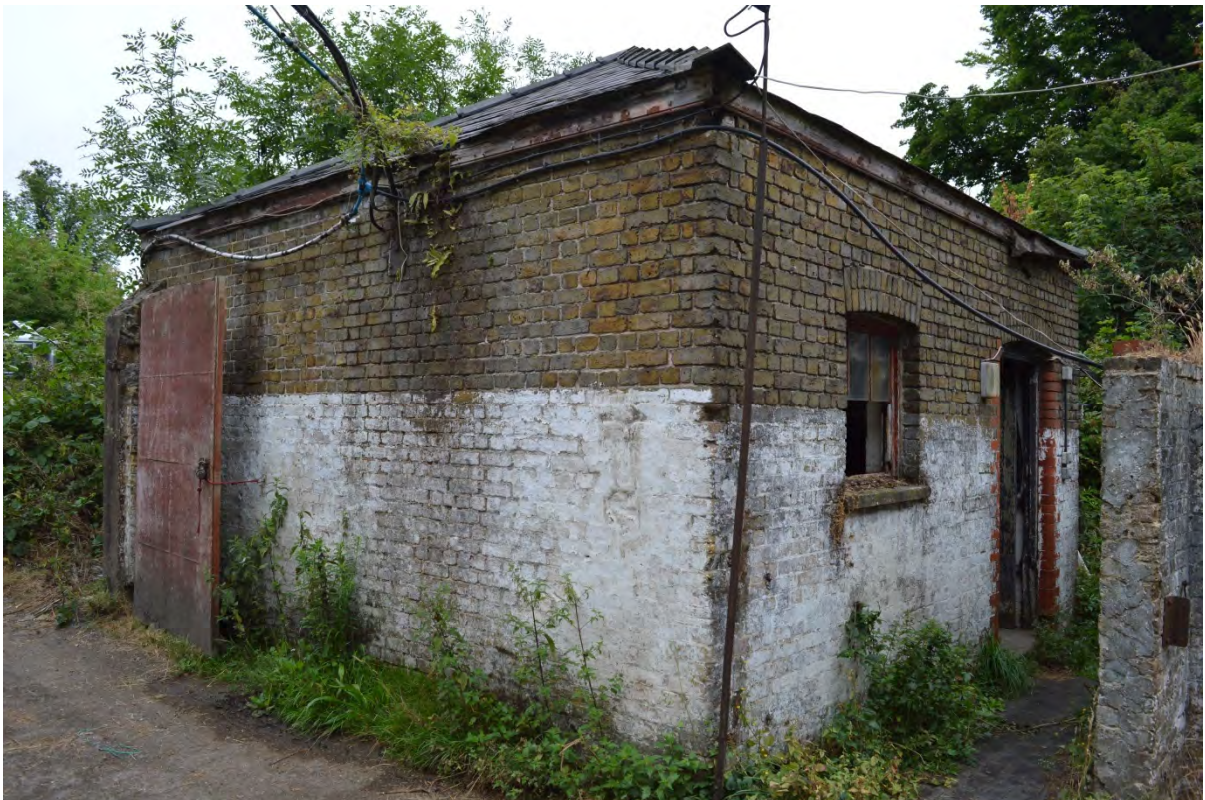
Plate 6: Eastern storage/tack building (Photo #25).

- 5.7 The eastern building is the more intact of the two, with a square plan and tiled hip roof (Plates 6). The east and west elevations are devoid of features of note. The south elevation is set with a single small window and a single-leaf doorway to the interior. The window is set with the remains of a timber-framed six-pane window. The doorway retains a likely-original timber door with strap-hinges. The north elevation, though largely masked by vegetation, is likewise set with a single small window, and a blocked double door (seen from within, Plate 7). The door is likely original, or at least early.

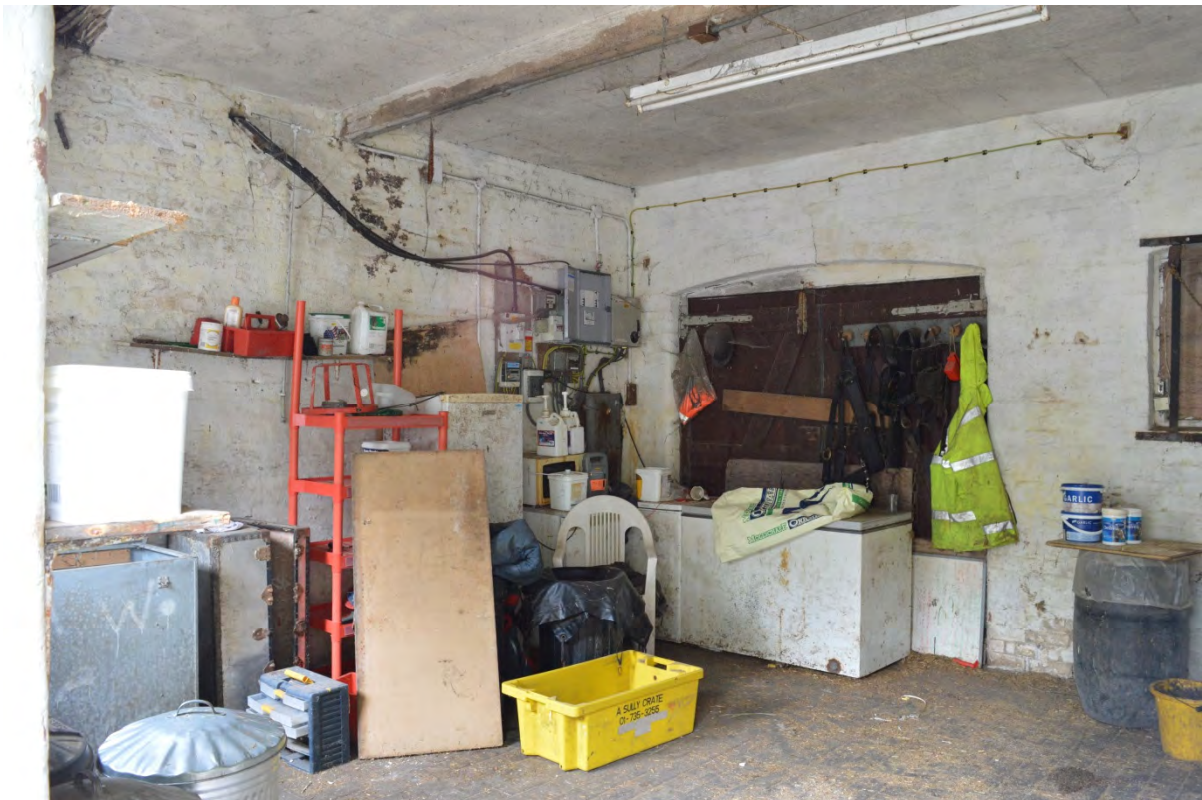
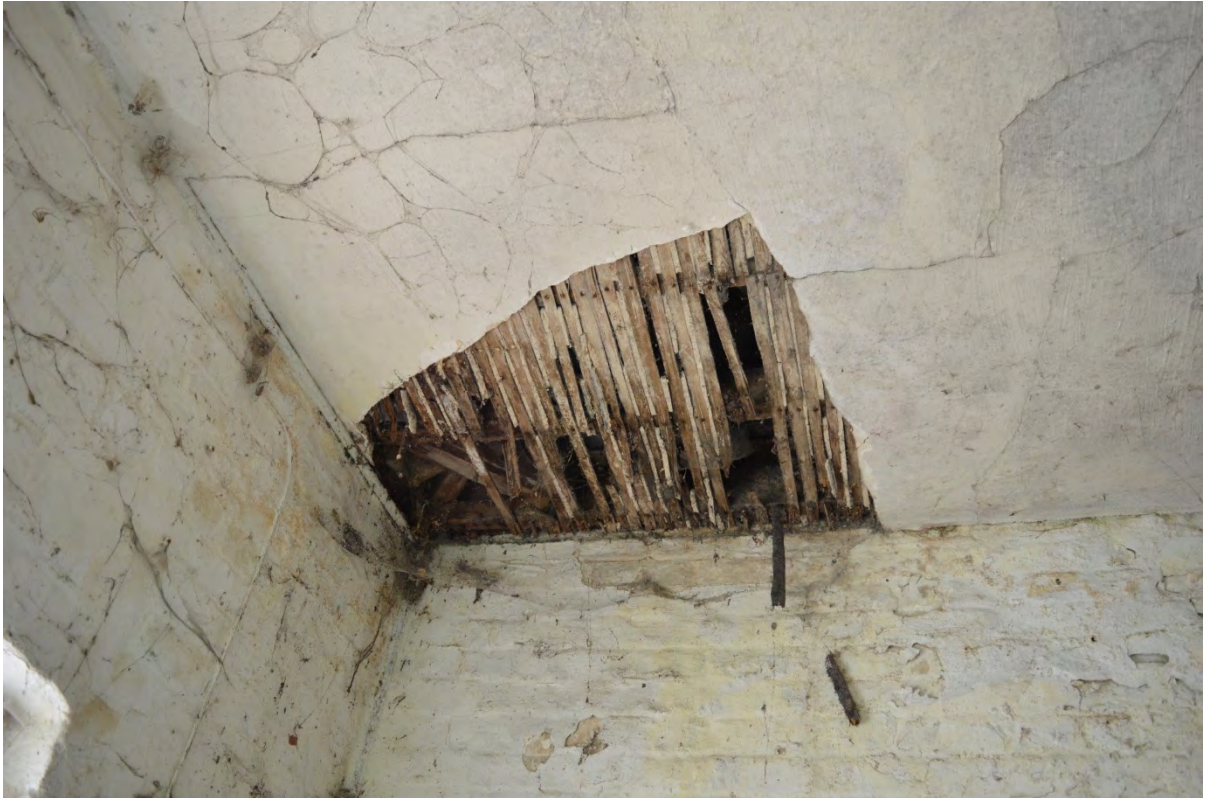
Plate 8: The interior of the eastern storage/tack building (Photo #28).

Plate 9: Exposed lath and plaster ceiling (Photo #29).

- 5.8 The interior of the building consists of a single room, with a black paving-block floor and a flat lath-and-plaster ceiling supported by a single timber joist (Plates 8 and 9).

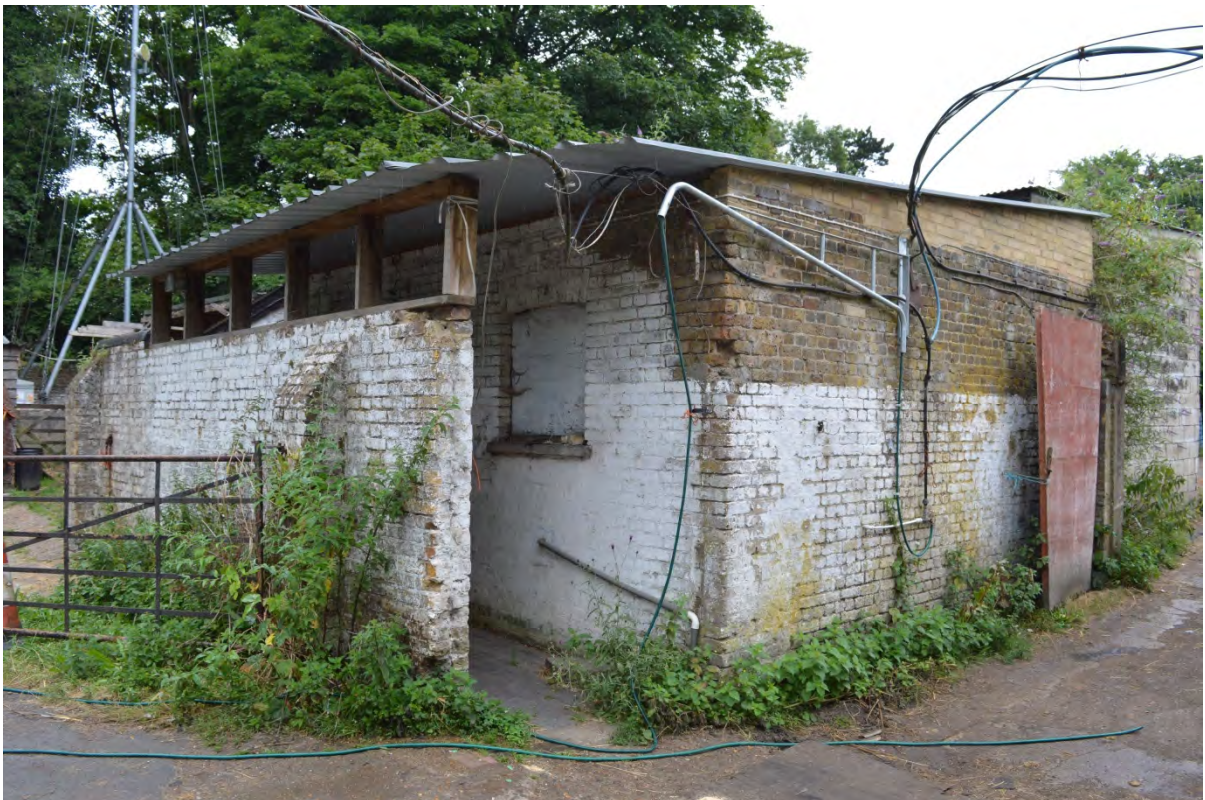
Plate 10: The western storage/tack building (Photo #39).

- 5.9 The western building has a rectangular plan and a replaced corrugated sheeting mono-pitch roof, sloping to the south, necessitating brick extensions to the upper walls in a cheap yellow brick in stretcher bond (Plate 10). To the west end of the building is a long narrow room which appears original. The east elevation is devoid of features of note, while the west is set with a blocked window opening. The north elevation is within the inserted breezeblock structure adjacent to the north wall of the site – and features a blocked window and double doorway. The doorway is blocked with breezeblocks. The narrow west room has its own inserted shed roof, set lower than the main roof and sloping to the west. The doorway to the west room has an inserted concrete
-

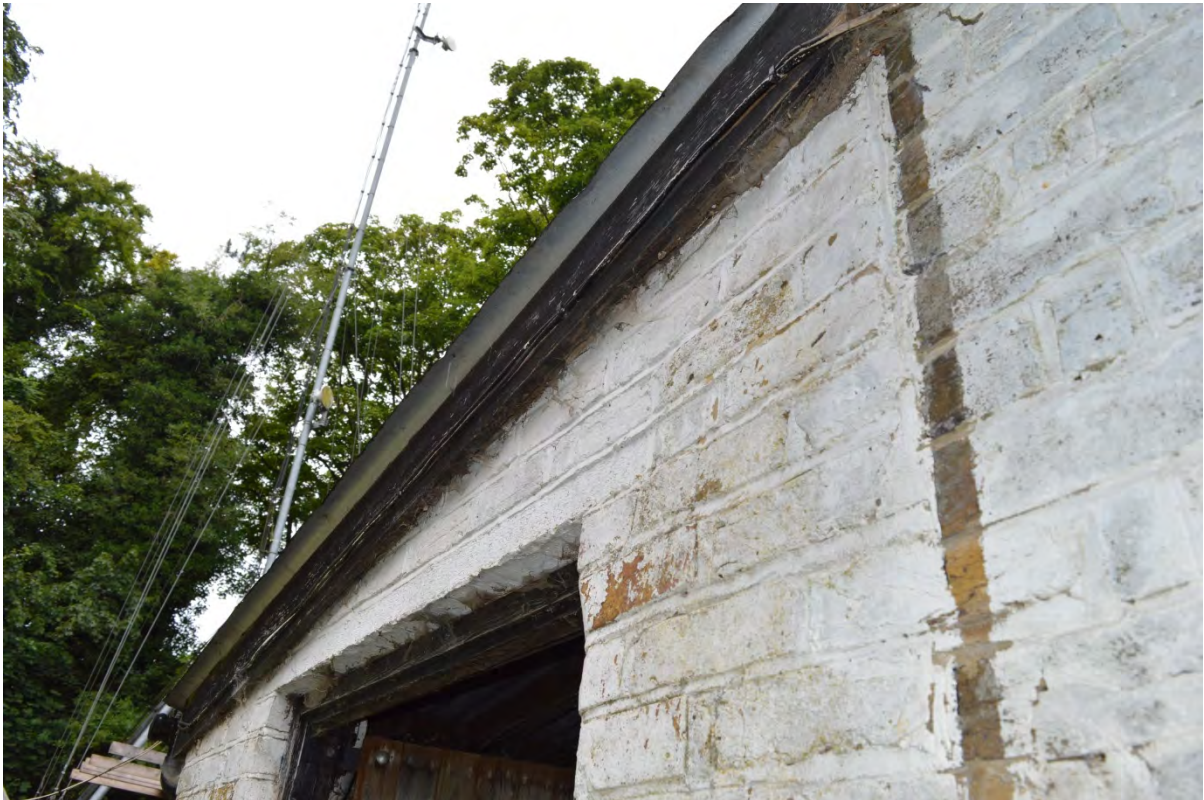
Plate 11: Inserted shed roof and brickwork at the west end of the western storage/tack building (Photo #55).

lintel, and inserted brickwork above, pertaining to the replacement roof (Plate 11). The window openings have all been blocked. The door to the larger room retains its original timber door.

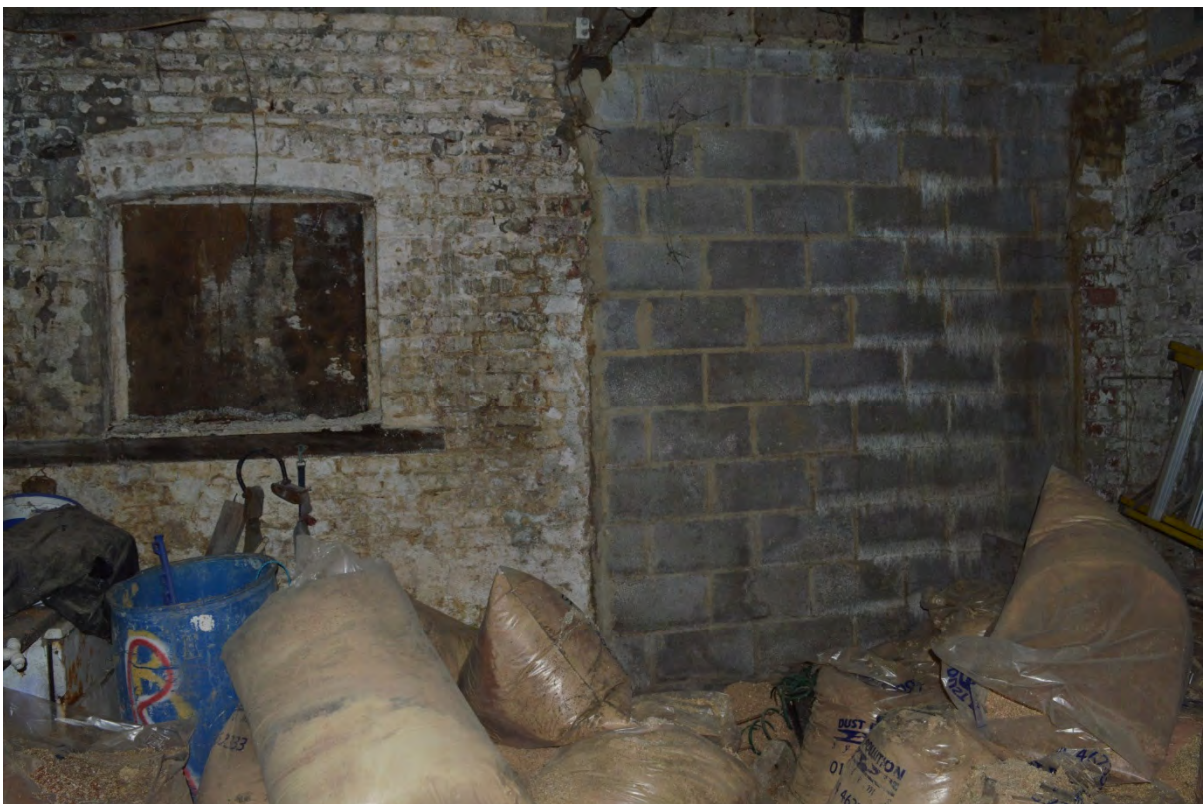
Plate 12: Interior of the western storage/tack building – note blocked openings (Photo #44).

- 5.10 The interior of the main room of the western building is currently in use as a store for wood-chip bedding for the horses (Plate 12). Originally the space would have been a single room, but a crude chipboard division has been inserted to create a porch of sorts. A small toilet cubicle in the southeast corner of the room appears to be early 20th century, though it may be original (Plate 13). The narrow west room is also in use as a store – though the late 20th century kitchen fittings and microwave imply that the space once had a more recreational role. Both rooms have paving-block flooring.

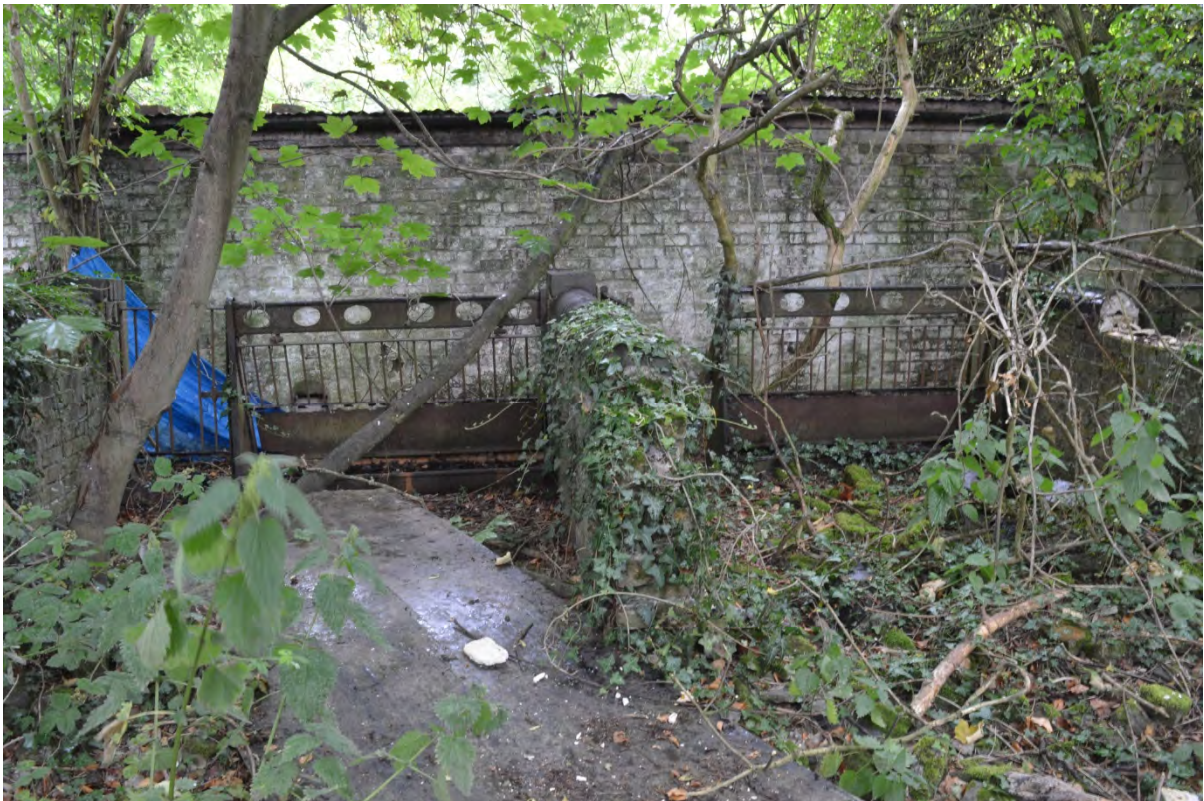
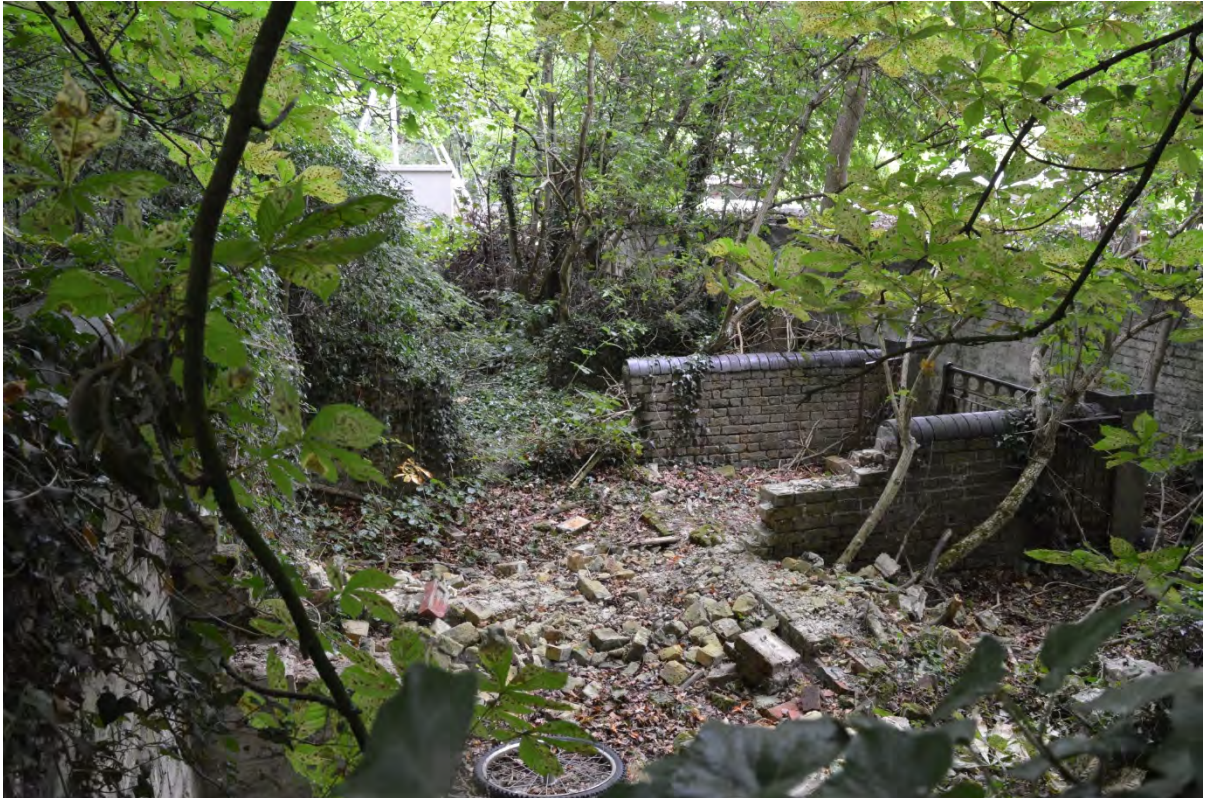
Plate 14: Pigsties in the east of the piggery (Photo #115).

Plate 15: Pigsties in the west of the piggery (Photo #109).

- 5.11 To the west and east of the site are the partially extant remains of the pigsties (Plates 14 and 15). The structures run in a regular course, originally with open fronted pighouses formed against the outer perimeter wall and open spaces to the fore. A number of sties remain in the northeast corner of the site, whereas they have all been removed in the northwest. It is likely that pigs of differing age or gender would have been housed along the ranges – with the larger sties along the north being reserved for farrowing pigs. There are no intact pighouses on the site – though they are evidenced by remnant wall footings. The pighouses would likely have had bullnosed bricks framing their openings and welsh slate roofs, as evidenced by scattered building materials (Plate 16). One such brick is stamped 'DENNIS RUABON' (Plate 17). Ruabon bricks (of Dennis Ruabon Tiles Ltd.) come from Wrexham, North Wales, and are famed for their distinctive red colouring. The open spaces have low brick walls capped by half-round brick copings (Plate 18).

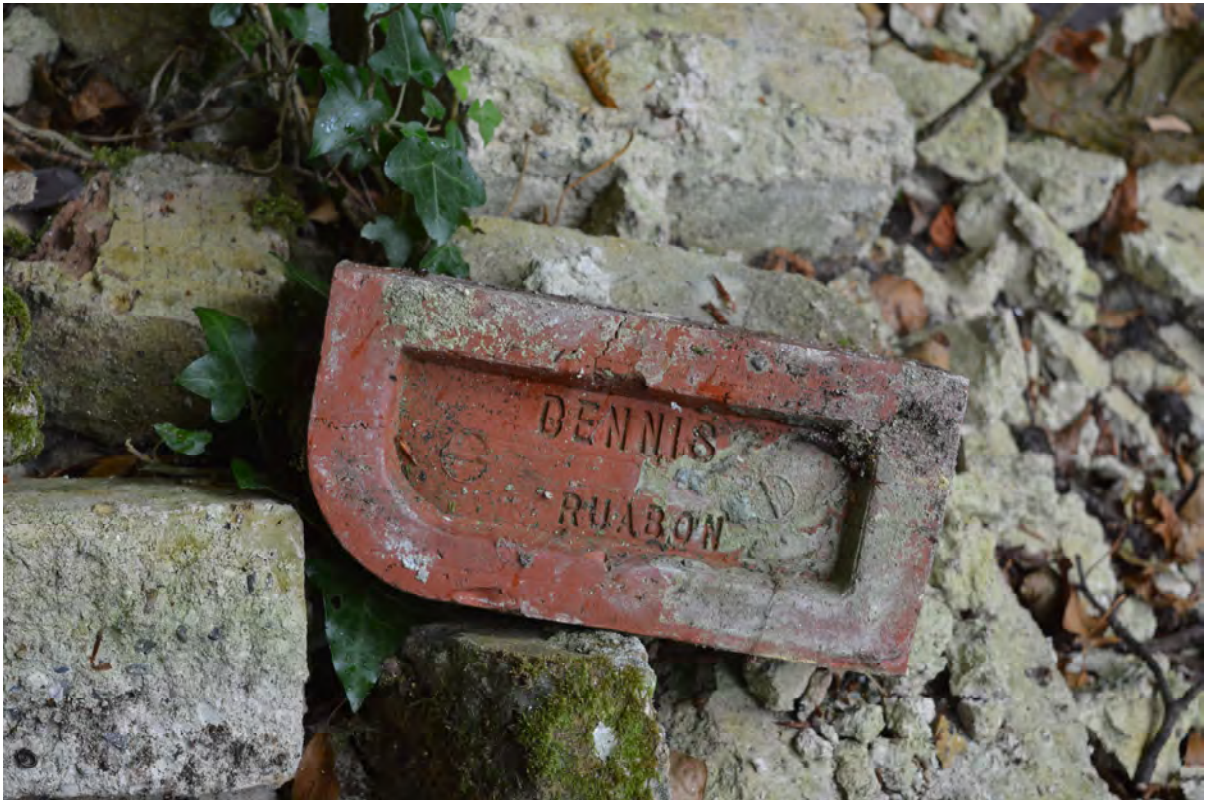
Plate 17: Dennis Ruabon bullnosed brick in the western pigsties (Photo #103).

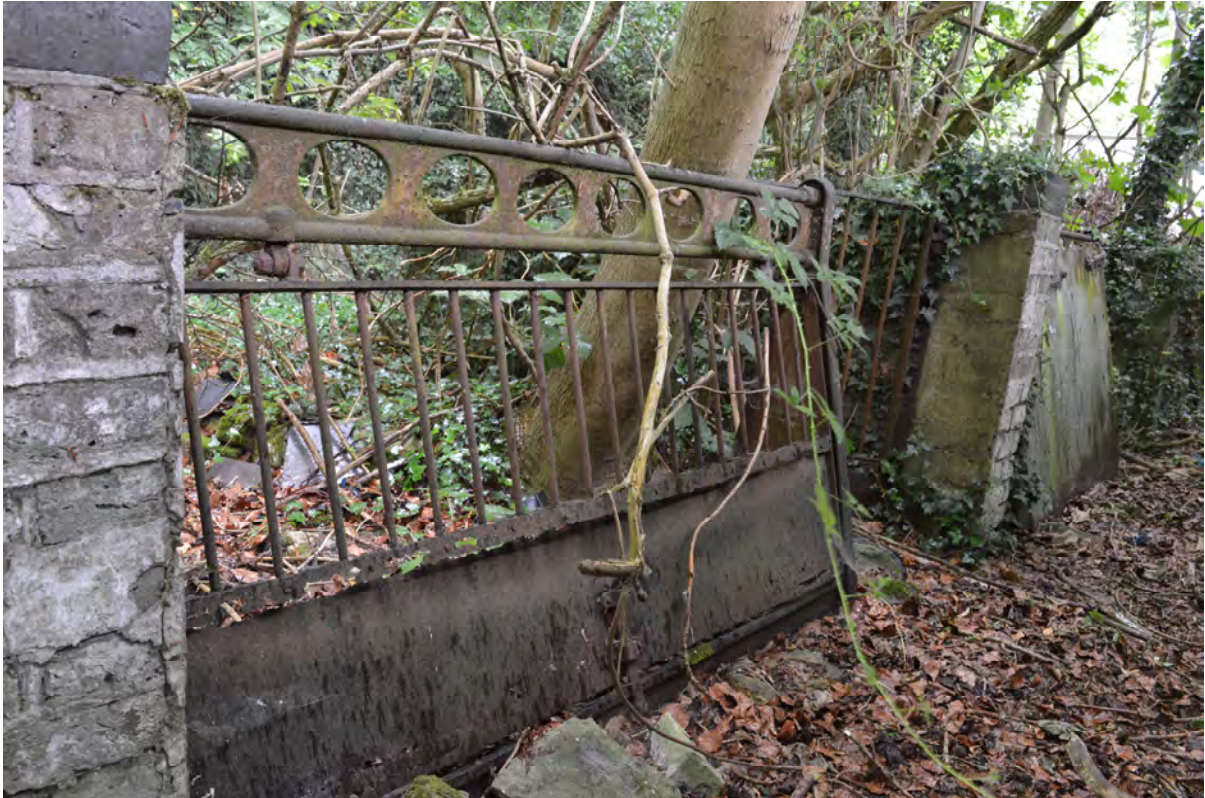
Plate 19: Pigsty fence/gate (Photo #96).

- 5.12 The fronts of the pigsties are set with somewhat imposing iron fences (Plate 19). Each consists of a simple access gate to the right, and a larger, moveable top-hung gate positioned over a feeding trough to the left. The latter is mounted within a triangular housing, which would have allowed the gate to be swung back (towards the pigsty) where it could be fixed in place by a heavy latch, thus closing off the feeding trough and allowing it to be filled unimpeded by hungry animals. Once filled, the gate could be swung forwards and again fixed in position, allowing the pigs access to the trough. The gates have regular circular holes within their wide top-rails. The holes are likely a product of casting, but create a pleasing aesthetic.

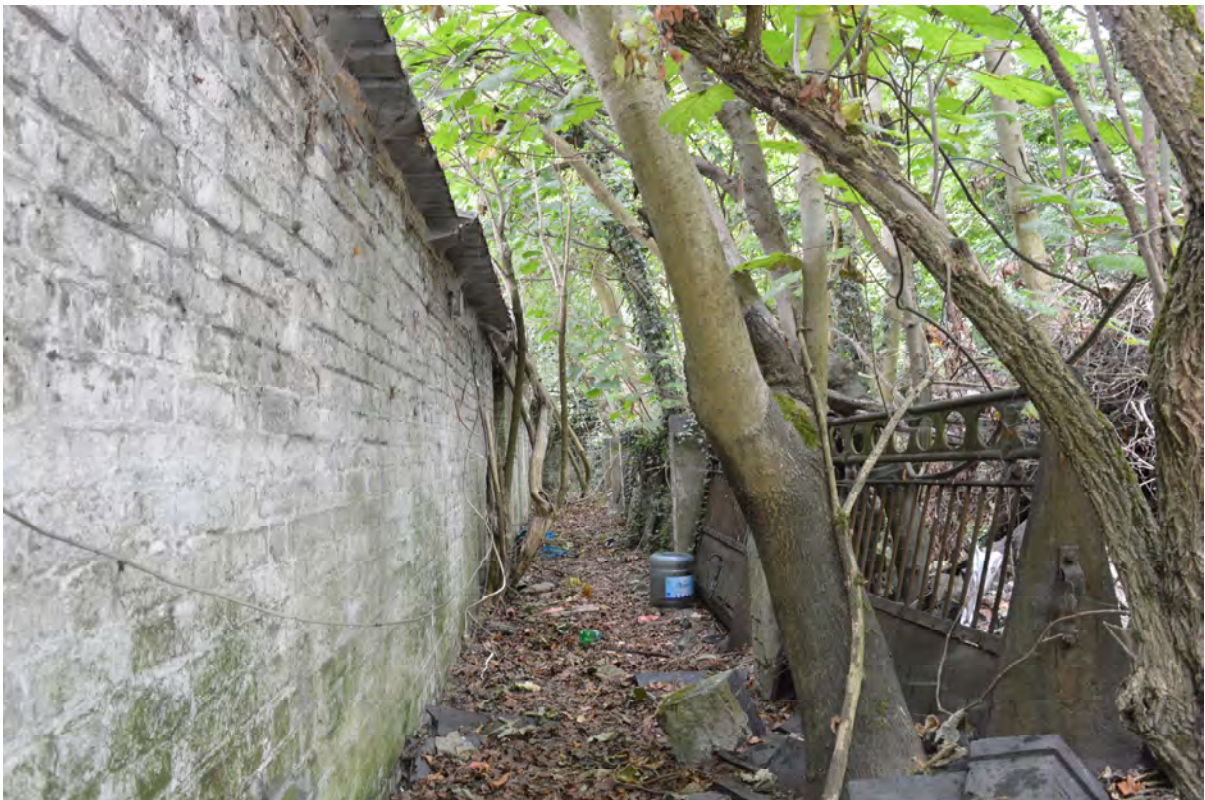
Plate 20: View along former feeding passage (Photo #89).

- 5.13 Narrow feeding passages run parallel to the pigsties, with a high wall dividing the passages from the yards beyond (Plate 20). The floors of the passages are presumably paved in paving-blocks as seen elsewhere, but heavy vegetation masks the surface. Towards the centre of the yard walls are blocked doorways (Plate 21).
-

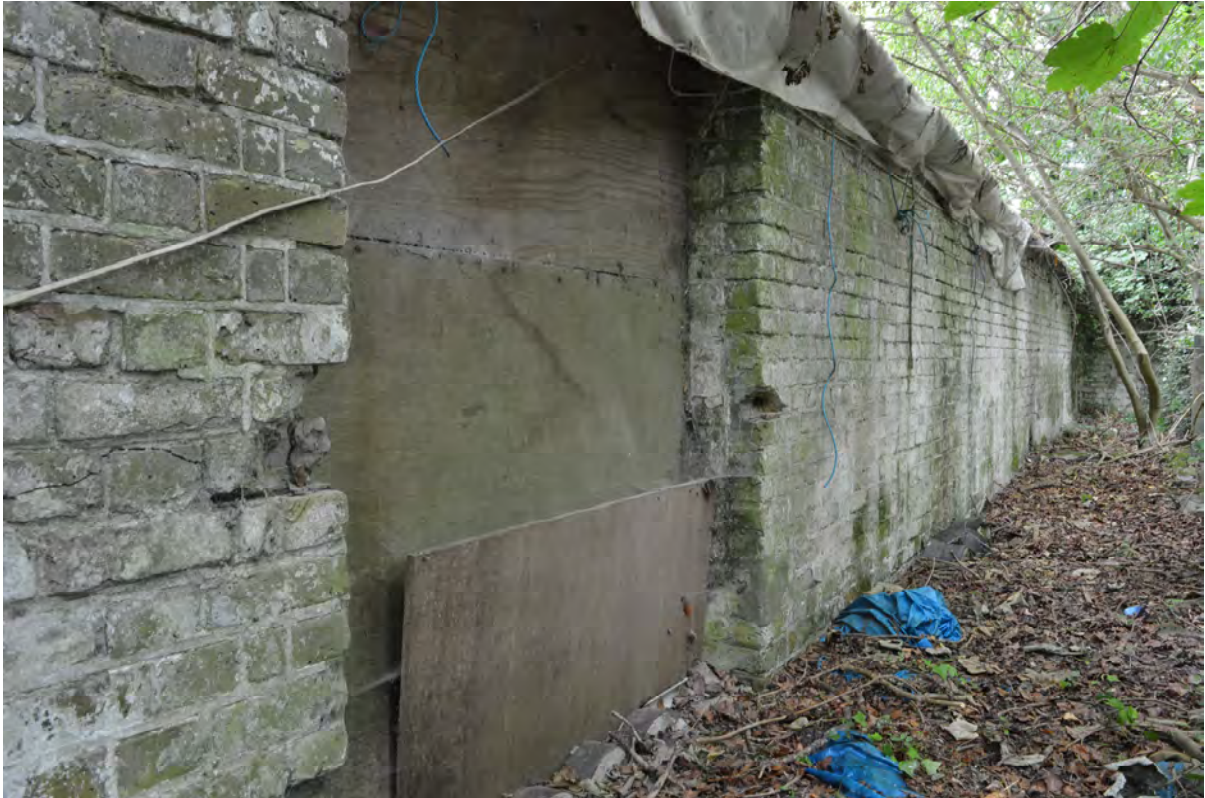
Plate 21: Blocked doorway from feeding passage to yard (Photo #93).

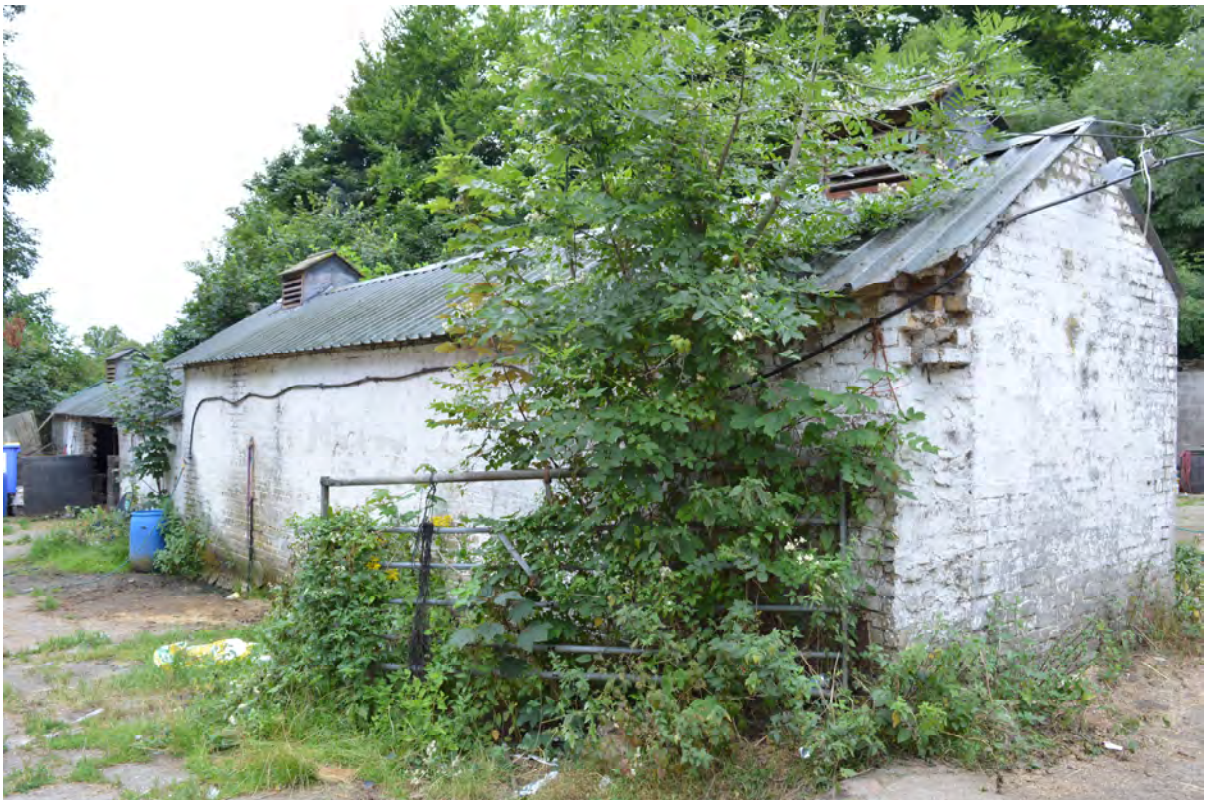
Plate 22: Central building, east side (Photo #2).

- 5.14 The long narrow building within the centre of the site (Plate 22) is currently in use as storage, within its north half, and as a stable, to its south. The original use of the structure is unclear – perhaps it was used for storage or slaughter. The building's gable roof has been re-clad with a corrugated metal. The southern half of the building has been reduced in height, as evidenced in truncated brickwork on its southern elevation, possibly to improve heat retention for its use as a stable (Plate 23). A small window within the northern part of the west elevation has been blocked. The building has two wide original doorways: one within the northern part of the west elevation, and one within the southern part of the east elevation (Plates 24 and 25). The building is set with a series of vented cupolas with timber louvres, which appear to be retained original features despite subsequent re-roofing (Plate 26). The north end of the building has had its corners crudely chamfered to accommodate vehicular access to the yards (Plate 27).

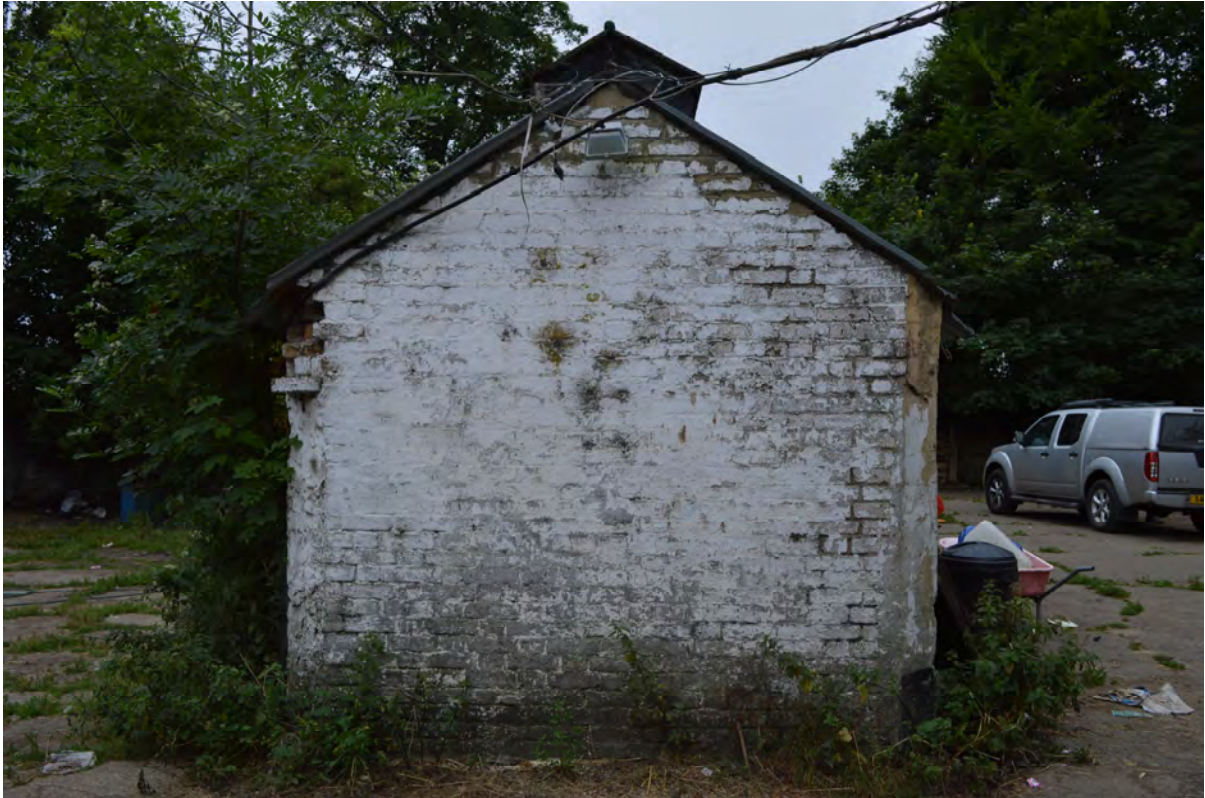
Plate 27: North elevation of the central building (Photo #20).

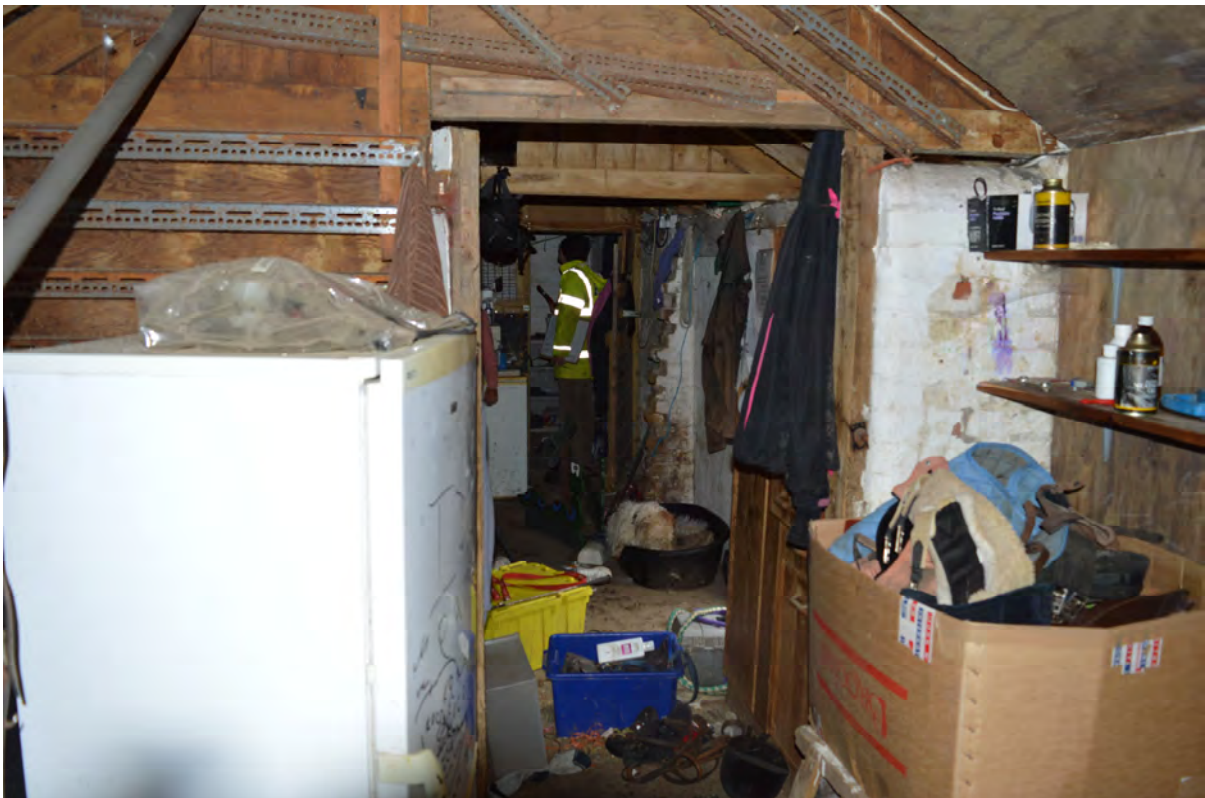
Plate 28: Looking south from the northernmost of the three rooms within the north of the central building (Photo #77).

- 5.15 The interior of the northern part of the building is divided into three rooms (Plate 28). The rooms serve as tack room, storage, and recreational space simultaneously (Plate 29). Sections of brick wall mark original divisions, coinciding with the present divisions, being retained to the north, and crudely removed to the south. The roof appears to be original, with sawn timber common rafters overlain by timber sarking boards.

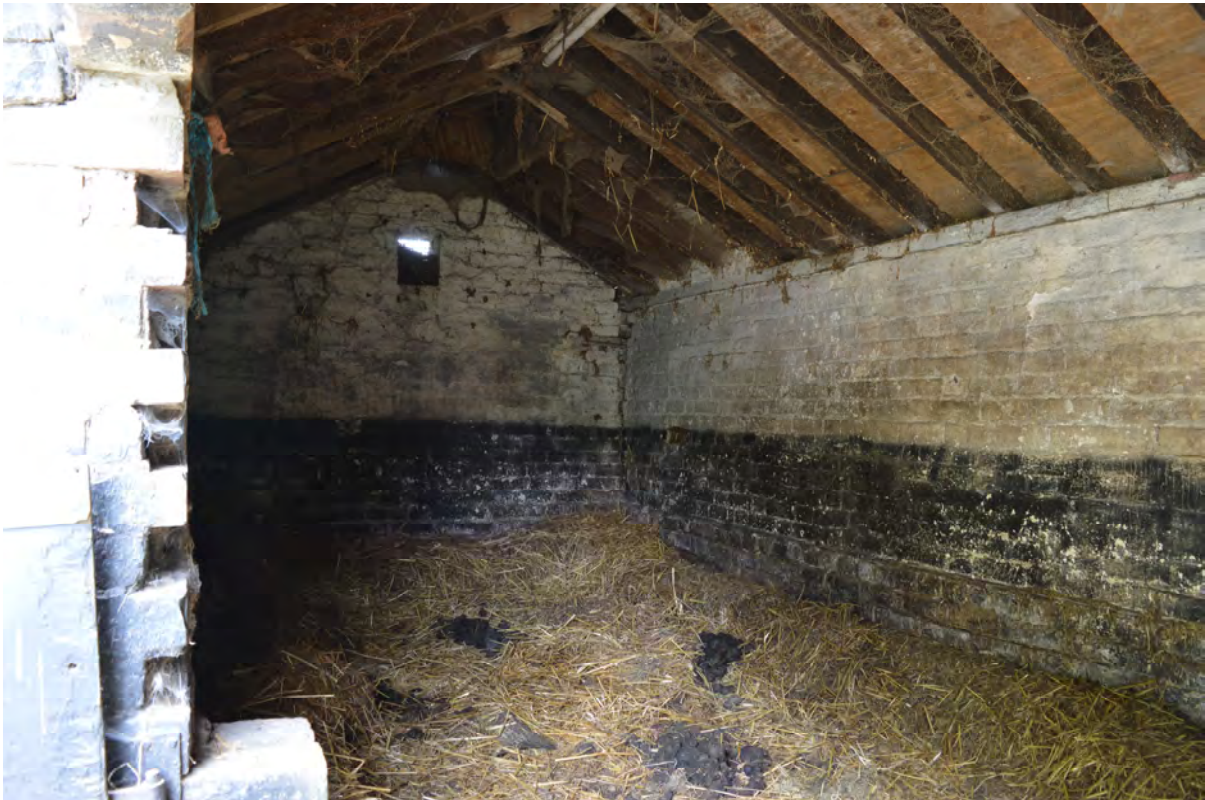
Plate 33: Stable in south of the central building – note the roof and upper walls (Photo #10).

- 5.16 The entrance to the southern half of the building is divided by an inserted breezeblock wall with iron fencing above. The wall divides the space within into two stable rooms. The walls either side of the entrance originally projected into the building, but have since been clumsily hacked out (Plate 30). Above the entrance a stop-chamfered timber beam forms the door lintel (Plates 31 and 32). The roof appears to use the building's original timber rafters, though is overlain with later chipboard roof boarding, and reset atop inserted brickwork (Plate 33).
