PIGGERY, CANE HILL HOSPITAL, COULSDON

HISTORIC BUILDINGS RECORD
(Historic England Level 3)

Report 2015267

**Project no. 7714
Site Code: PGD15
Report ref: 2015267
OASIS ID: archaeol6-219381**

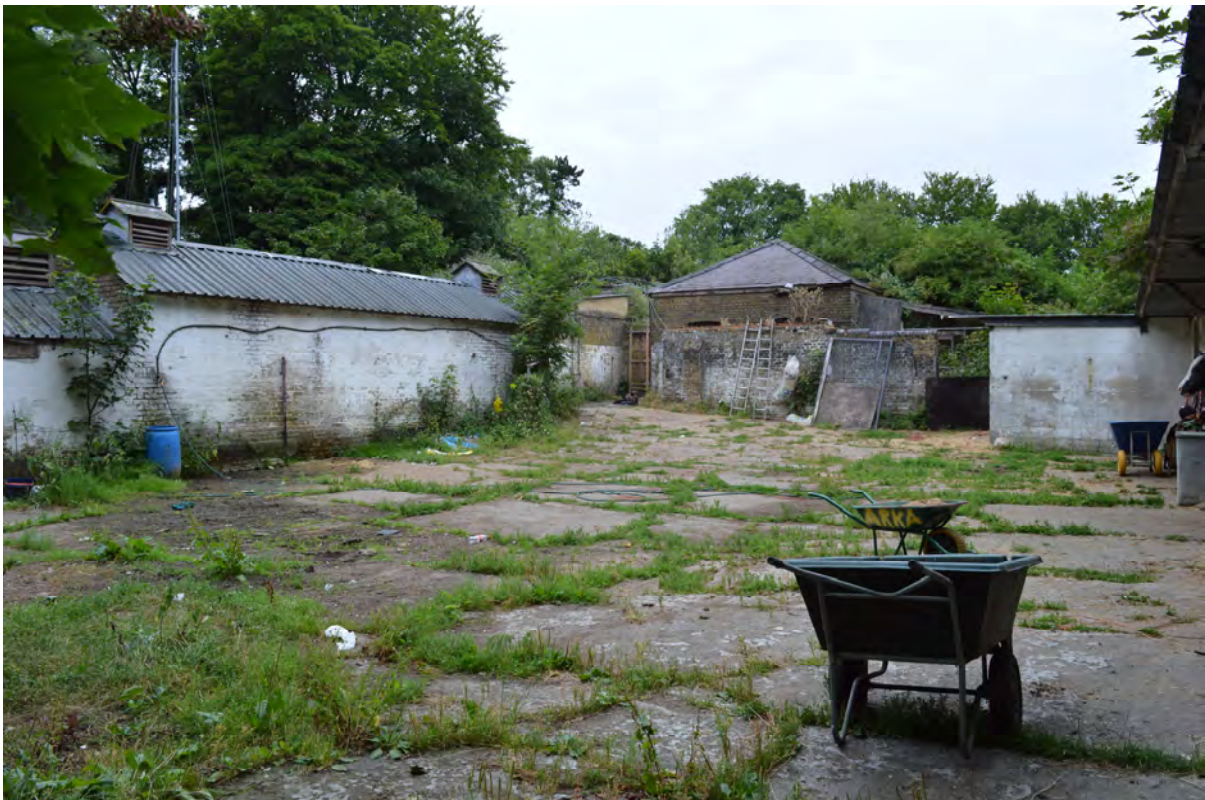
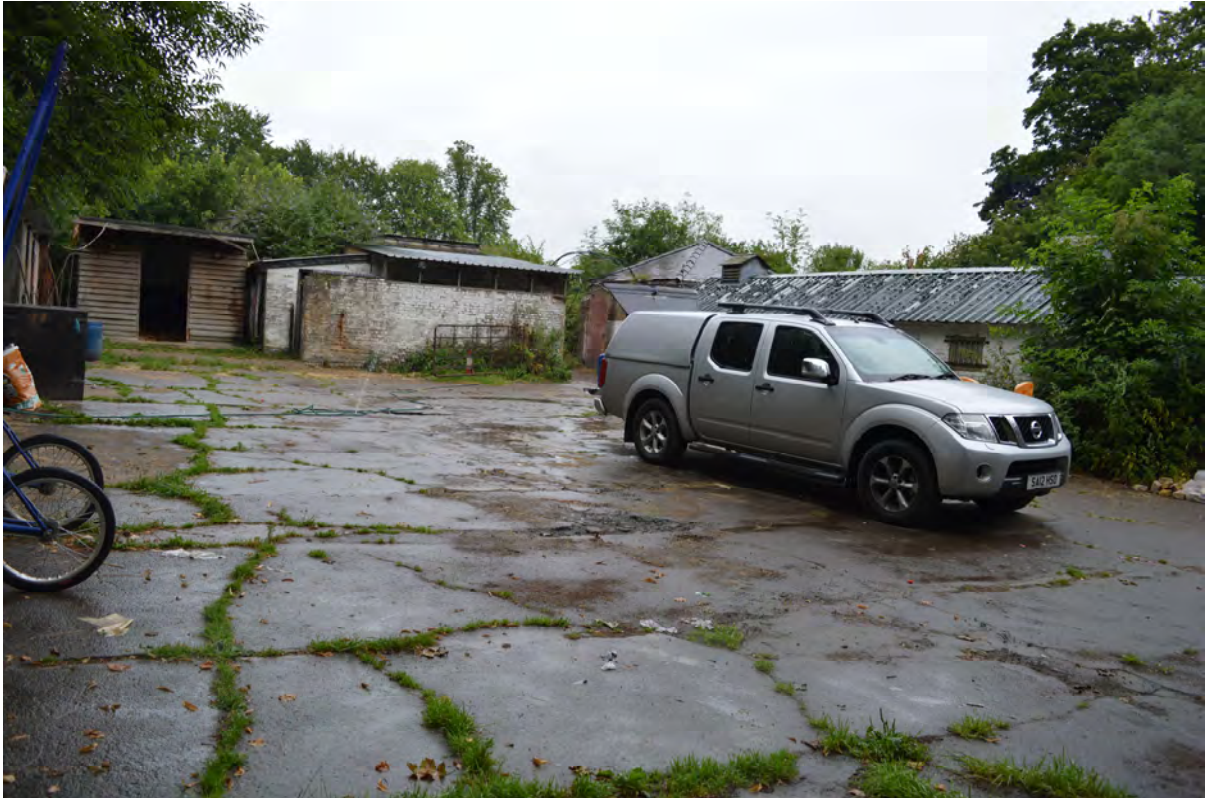
Plate 34: Eastern yard (Photo #5).

Plate 35: Western yard (Photo #68).

- 5.17 The yards are two large open spaces with concrete paving which are used for parking, saddling and brushing horses, and general works (Plates 34 and 35). The yards would originally have been used for accommodating the pigs while the pigsties were mucked out, for moving stock, and as work yards. Within the south of the western yard a farm gate provides access to the fields beyond. The south walls of both yards are set with sunken drains (Plate 36) – to facilitate the draining and cleaning of the yards and pigsties beyond.

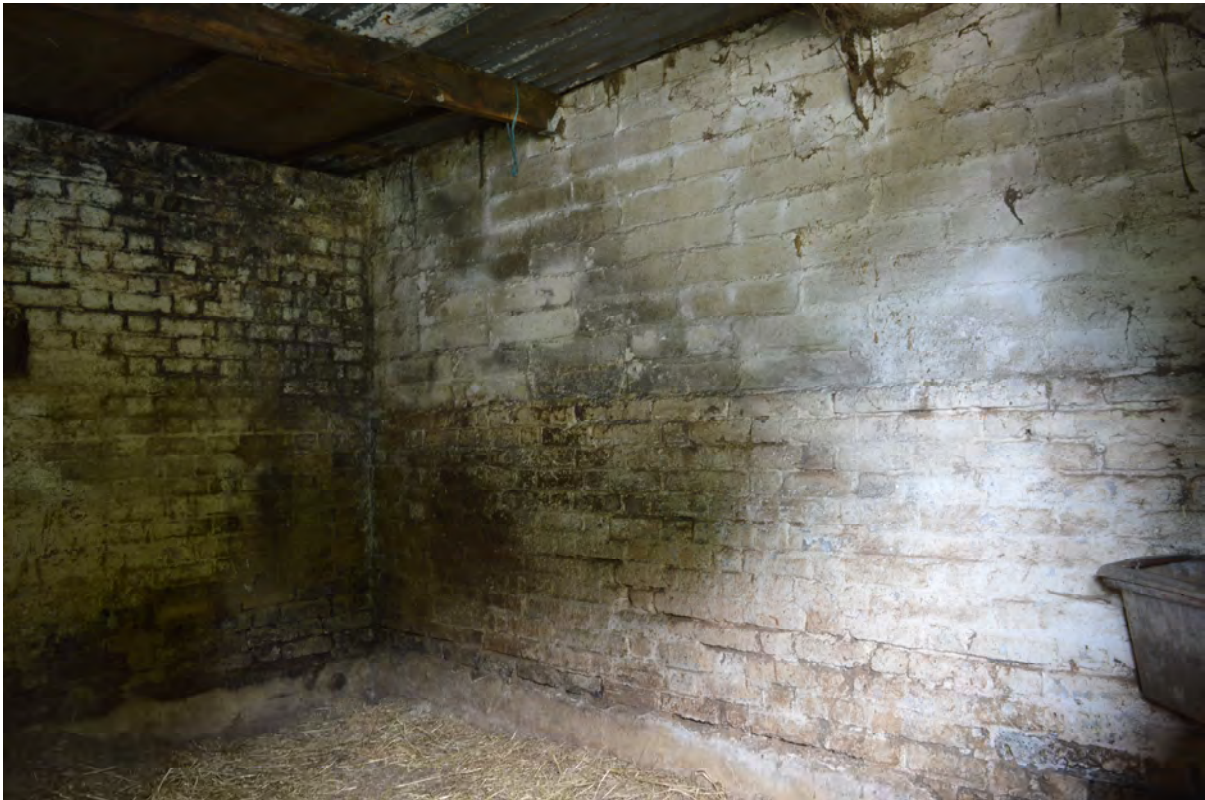
Plate 37: The stables are constructed against the walls of the former feeding passages and the southern wall of the piggery (Photo #22).

- 5.18 The site features a number of later structures of no particular note: the stables, timber stables, timber structure, and communications mast.
- 5.19 The stables are constructed up against the feeding passage walls and the south wall of the compound (Plate 37), and are set with half-height doors with
-

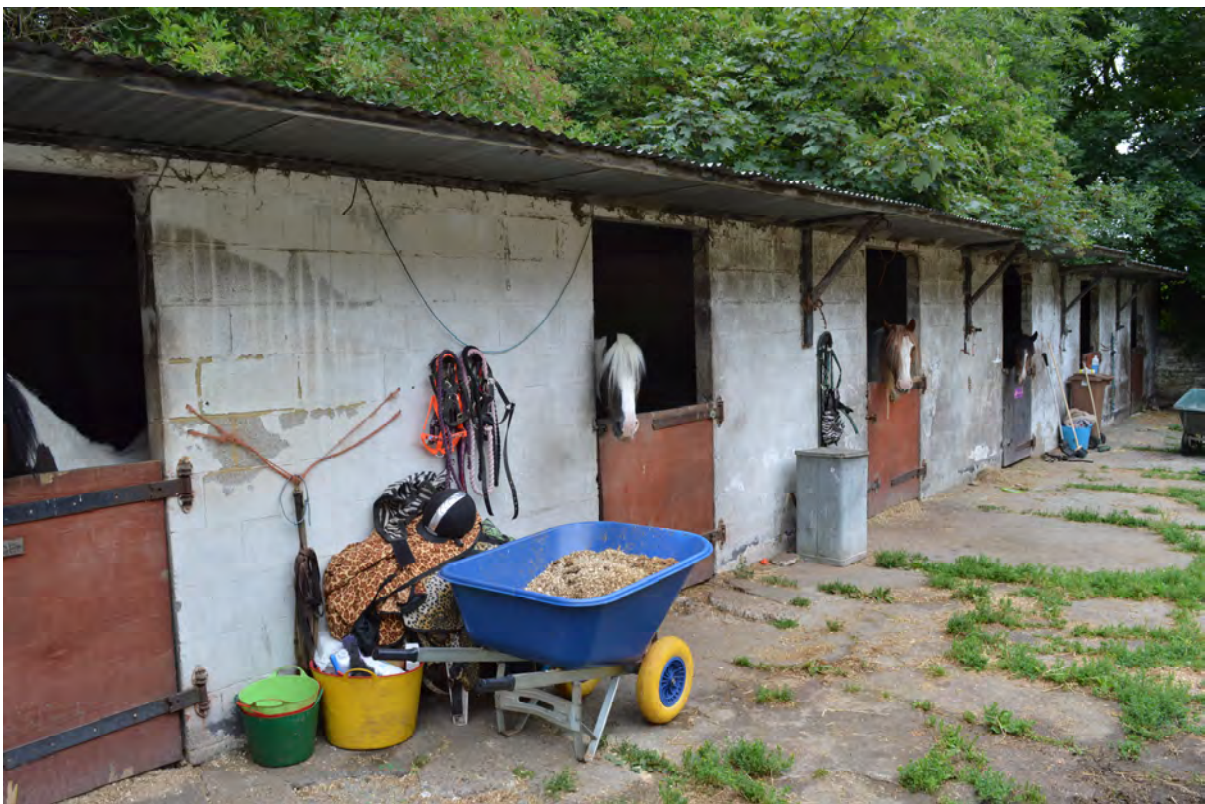
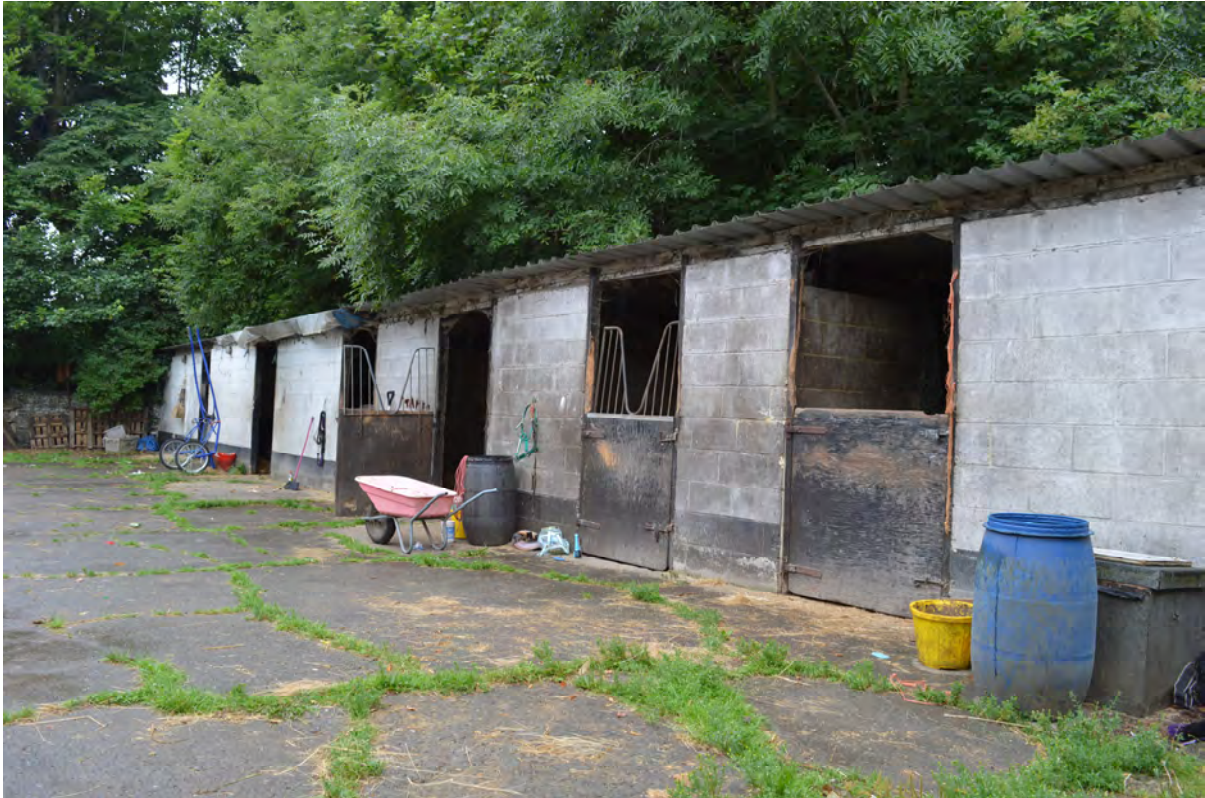
Plate 38: Stables in the eastern yard (Photo #4).

Plate 39: Stables in the western yard (Photo #60).

what appear to be reused strap-hinges in places (Plates 38 and 39). The stables have flat corrugated metal roofs, which project to the front.
