**LAND AT TUNBRIDGE LANE, BOTTISHAM,
CAMBRIDGESHIRE, CB25 9DU
(Centred at NGR TL 5452 6088)**

**HISTORIC BUILDING RECORD
(HISTORIC ENGLAND LEVEL 3)**

**Site Code: TLB14
Project No. 6796
Report No. 2015237
OASIS ID: archaeol6-219713**

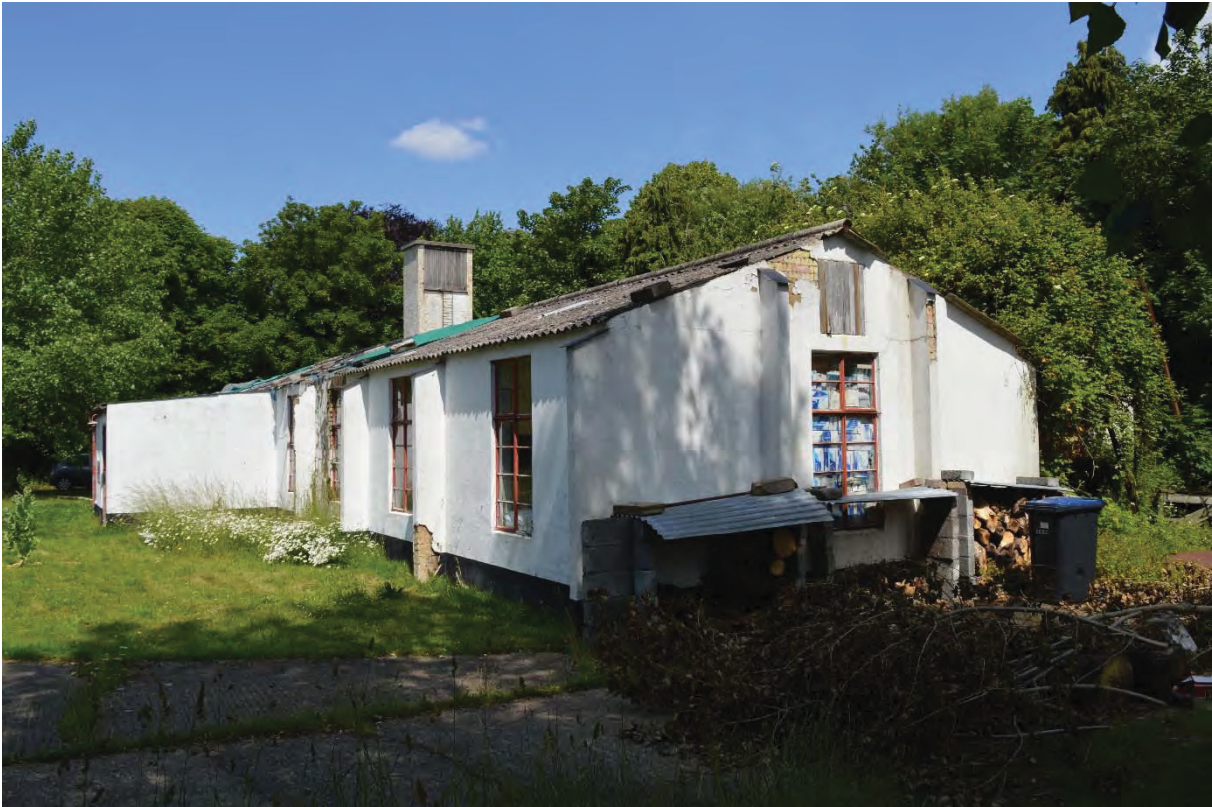
Plate 1 Building 1, looking north-west (10)

- 6.2 The building is a single storey structure, with an irregular footprint, principally formed of two linked parallel ranges aligned north-west – south-east. It is constructed in yellow brickwork with regular brick piers supporting the roof trusses, and is clad with painted cement render. The roof is shallow-pitched to both ranges and clad with profiled fibre-cement/asbestos sheet (Plate 1).

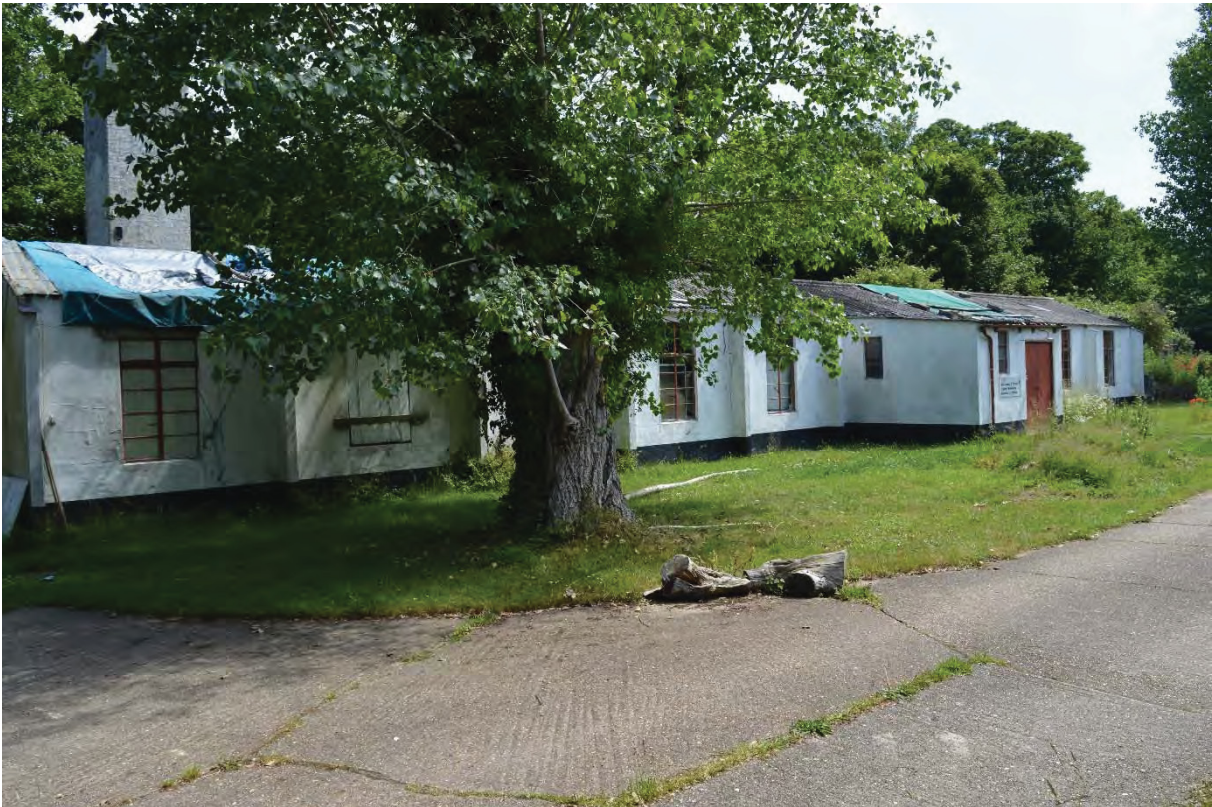
Plate 2 Building 1, principal elevation, showing projecting entrance (1)

- 6.3 The principal elevation faces south-west, its brick piers creating nine bays, each of which contains a tall, metal-framed window with horizontal glazing bars, an opening casement and over-light (Plate 2). A projecting entrance porch is off-centred in the elevation. It has a shallow, mono-pitch roof, clad with profiled fibre-cement/asbestos sheet, and appears to be part of the original structure. It contains a set of double doors on its south-west elevation, originally ledged-and-braced timber doors, and later clad with fibreglass (G. Wooster, pers.comm.). A metal lamp fitting remains *in situ* above the doorway.

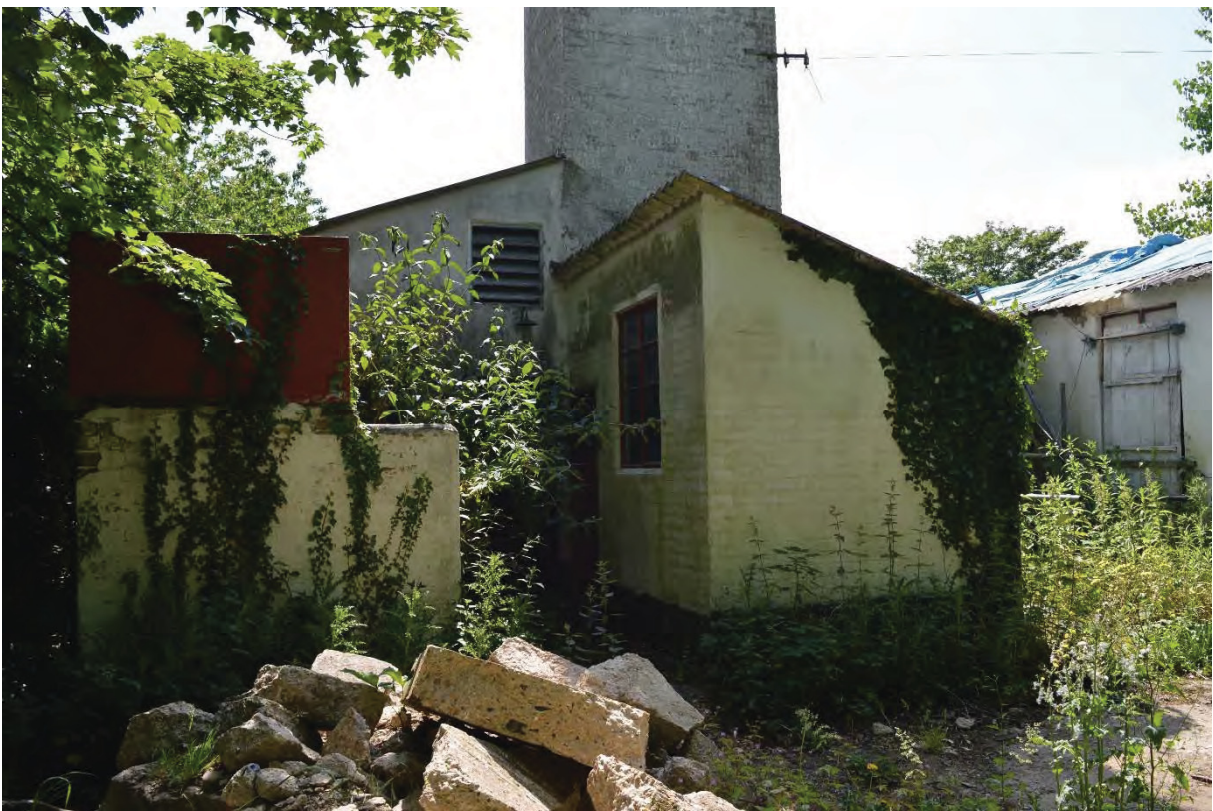
Plate 4 Brick-built extension and walls to north-western end of rear range,
Building 1 (4)

- 6.5 The rear range was heavily overgrown at the time of the survey and, with the exception of its north-west end, its exterior could not be surveyed in detail. A substantial water tower, constructed in yellow brick with a concrete capping, is sited at the north-western end of the range (Plate 3). A timber hatch and a metal ladder on its south-eastern side would have provided access to the water tank for maintenance. The gable end of the range contains a recessed single-width doorway with a timber door of four recessed panels. Above the doorway is a vent with louvred timber cover, and a metal lamp fitting. The doorway is accessed externally via a small yard which is formed by brick walls and a small brick-built extension with mono-pitched roof, adjacent to the water tower, which appear to be additions to the original structure (Plate 4). A double-width doorway was observed at the south-eastern end of the range.

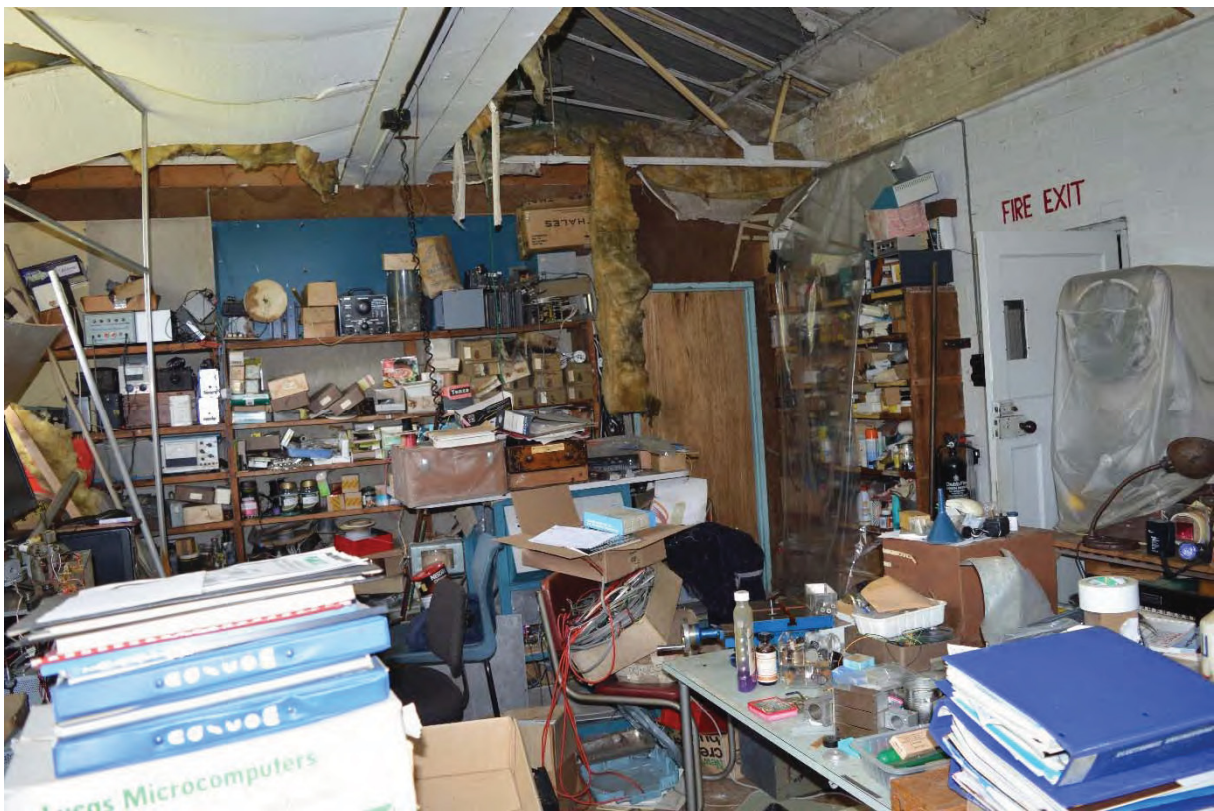
- 6.8 The roof is constructed with slender bolted steel trusses, steel purlins and slender steel rafters, infilled with plasterboard between the rafters (Plate 6). Vaulted polystyrene ceiling cladding found throughout the building is a later addition (Plate 7) (G. Wooster, pers. comm.).

Plate 6 Building 1, with metal roof truss visible (21)

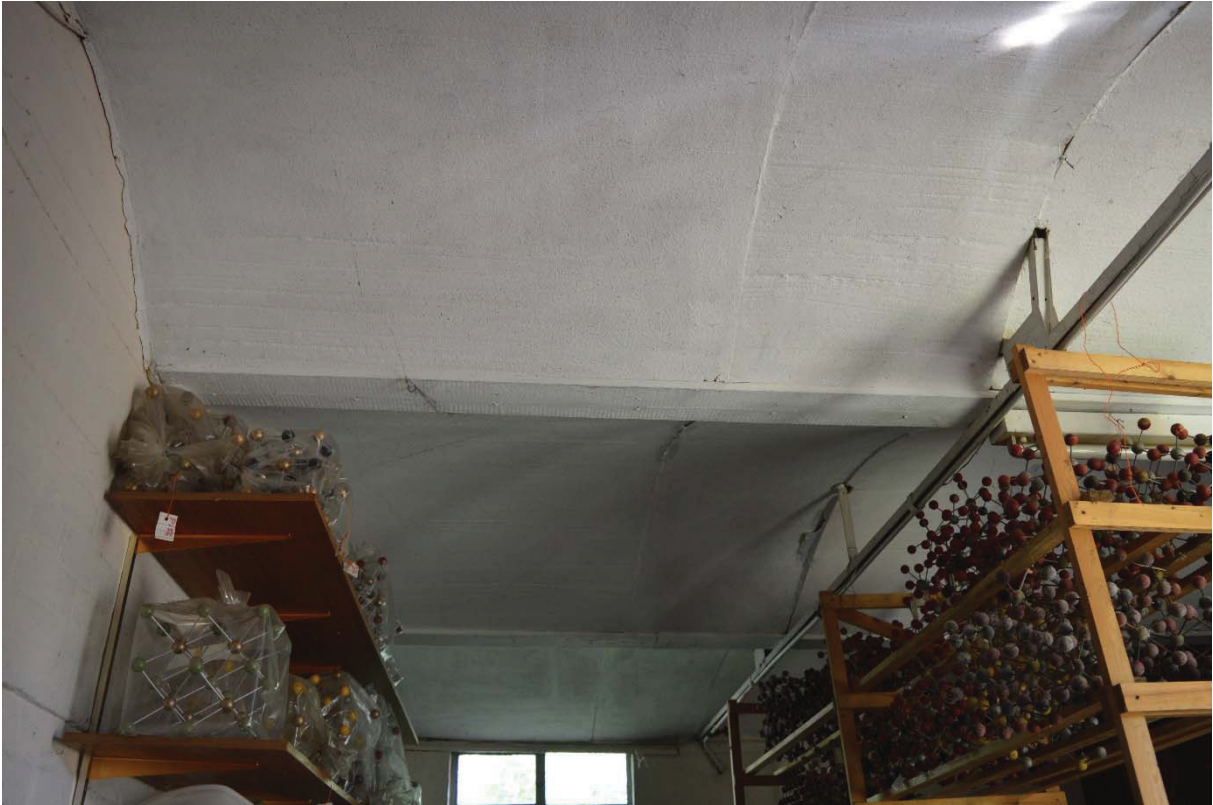
Plate 7 Example of vaulted polystyrene ceiling cladding in Building 1 (18)

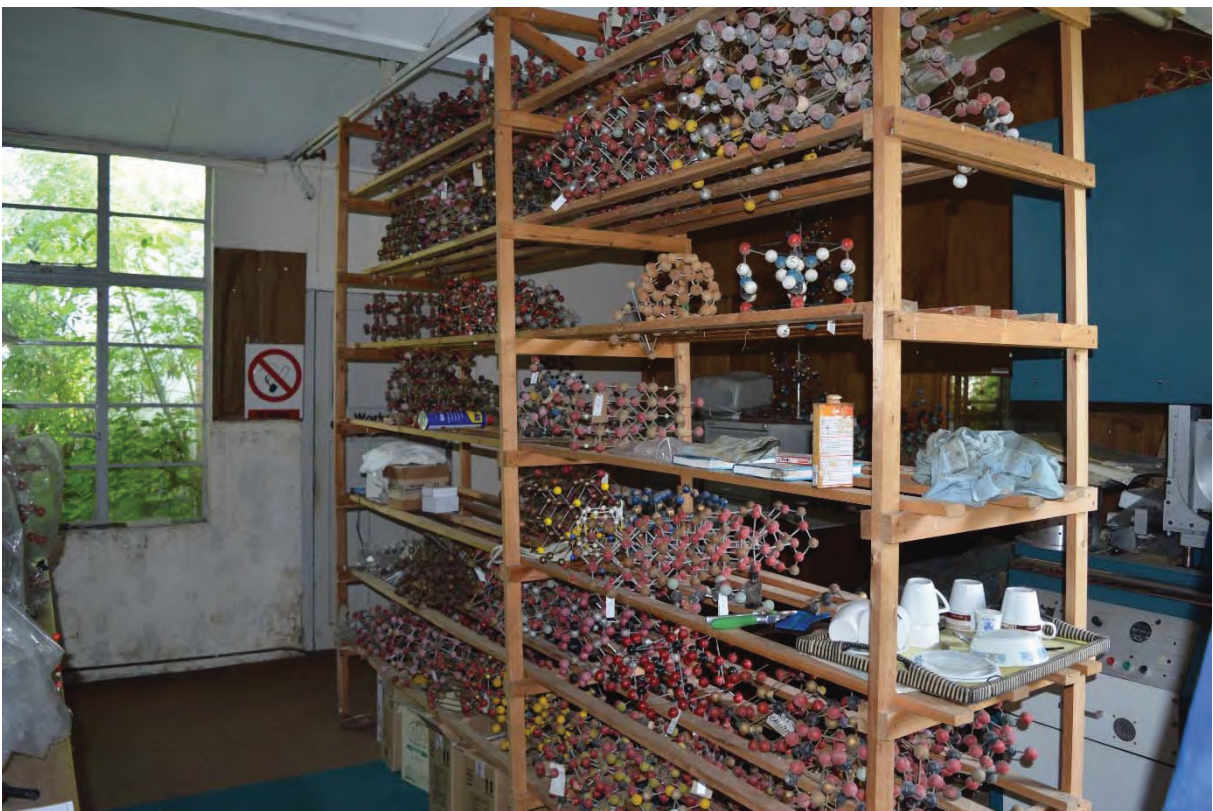
Plate 8 Room 2, Building 1 (17)

- 6.10 The lobby opens into a main reception room (Room 2) with substantial shelving units for ball-and-spoke models occupying the majority of the room (Plate 8). It originally formed part of a larger room which has been subdivided with a plywood partition with a glazed panel serving as a reception counter. A doorway at the north-eastern end of the partition, with a flush plywood door, provides access to a series of interconnecting rooms, now serving as offices and file storage, at the south-eastern end of the front range (Rooms 3-5, Plate 9).

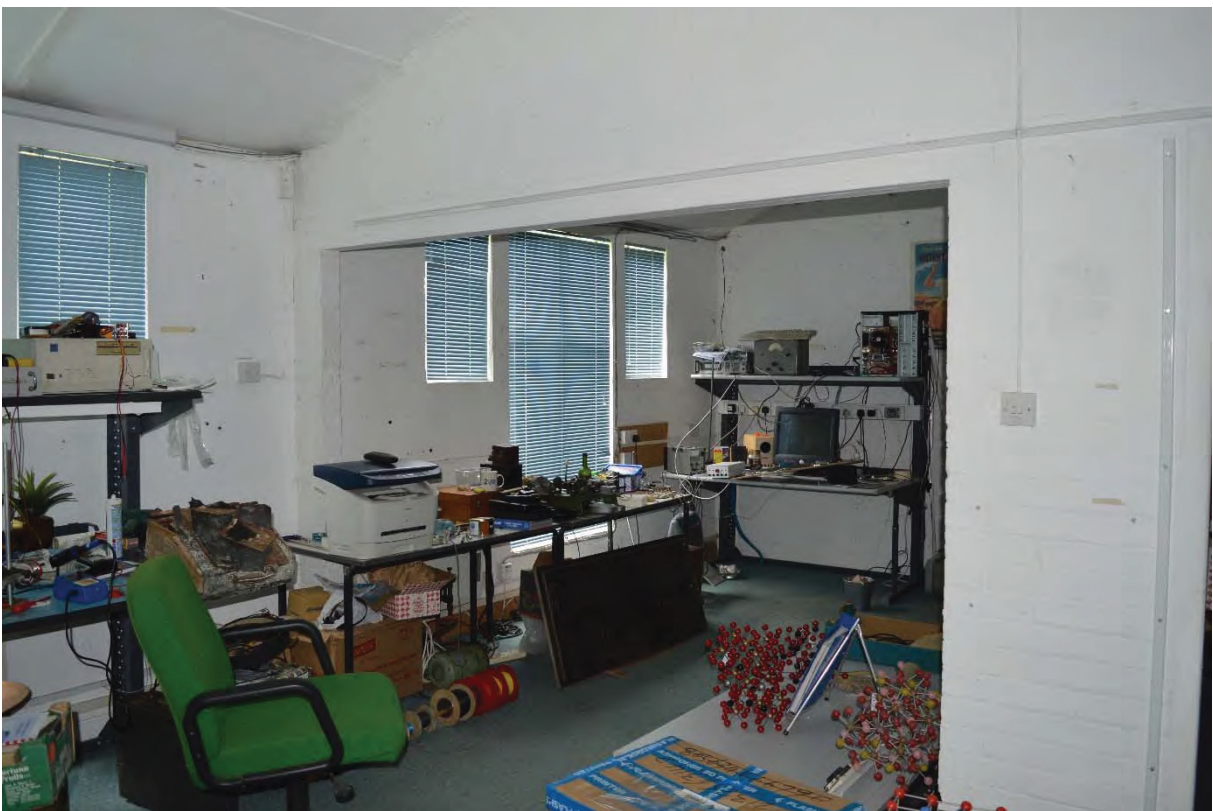
Plate 18 Building 2, L-shaped room in north-west range (Room 1), showing wide opening through former brick partition (63)

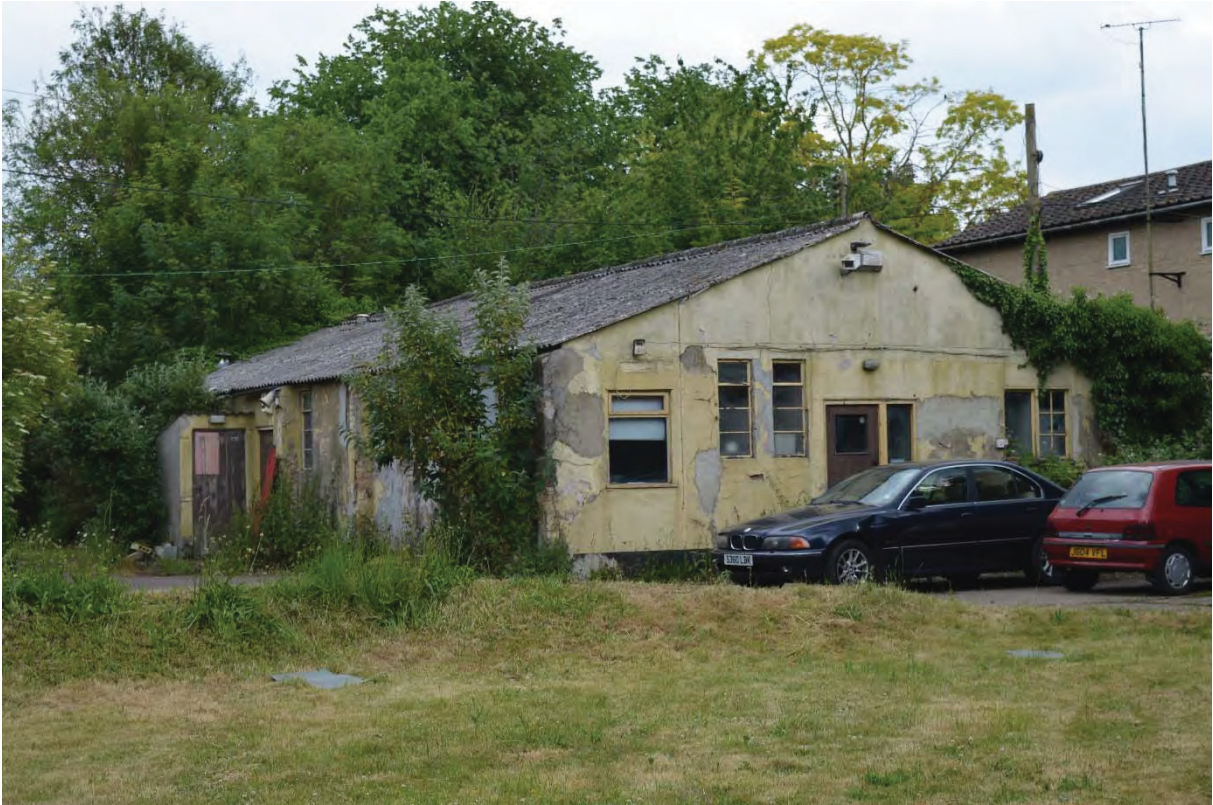
Plate 27 Building 3, looking south (78)

- 6.28 The principal elevation (Plate 27) faces north-west and contains a central single-width doorway with flush timber door with a small glazed upper panel and a full-height sidelight, set within a plain timber architrave. The door is flanked on either side by a variety of original metal-framed and replacement windows.

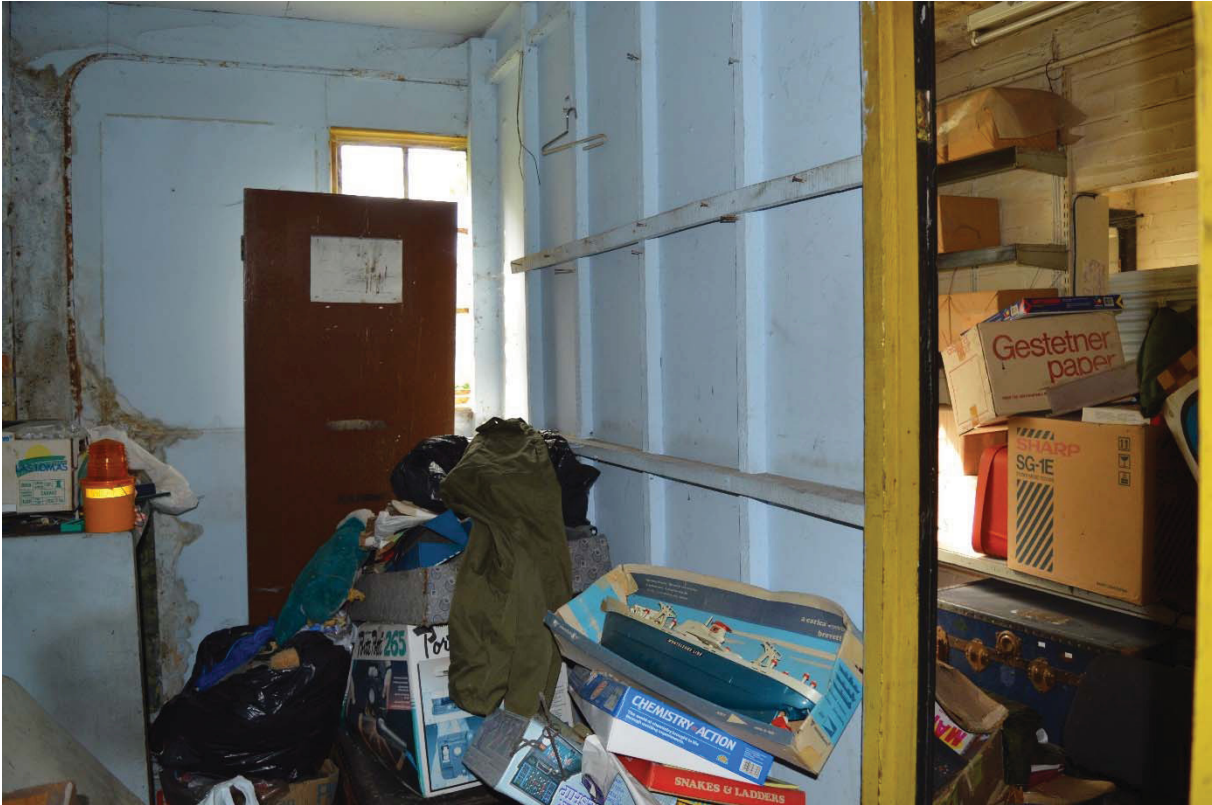
Plate 31 Building 3, Room 2, showing lightweight timber stud partition dividing the room (83).

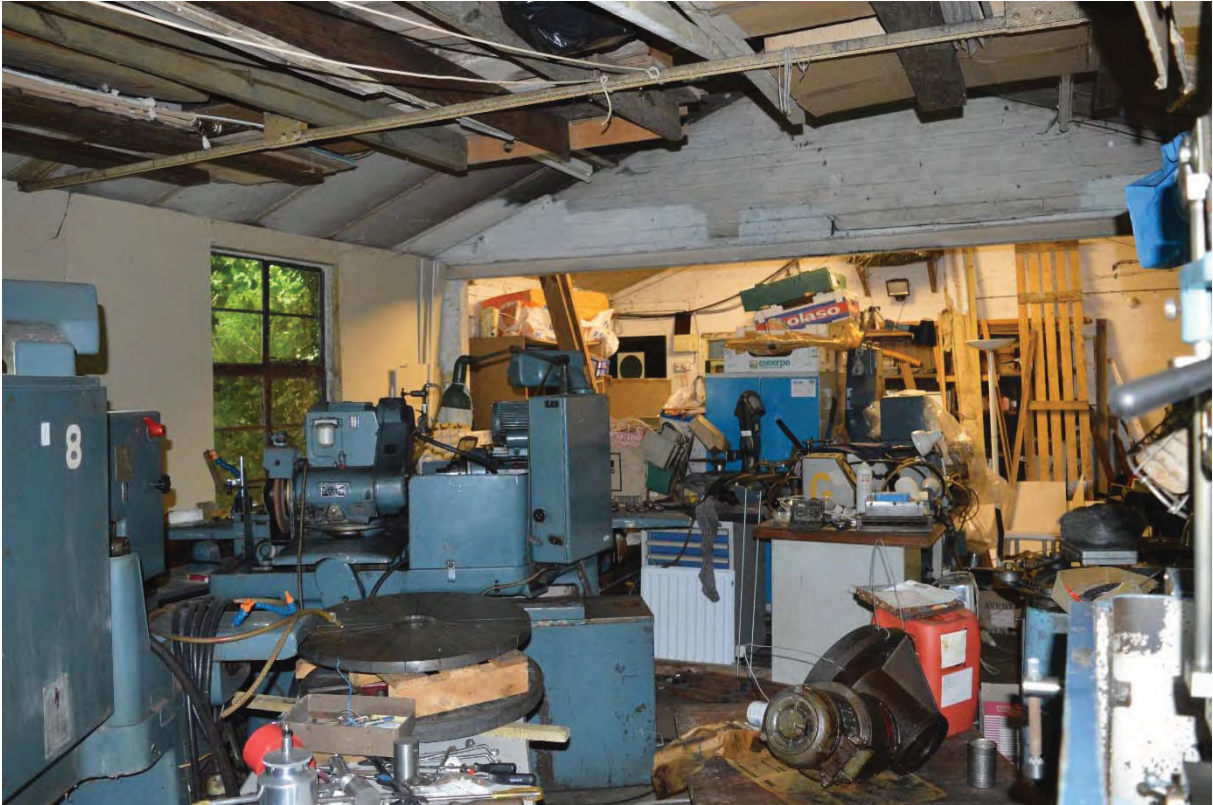
Plate 47 Workshop in north-western range (Room 5), showing former brick partition which has been removed below eaves level (103)

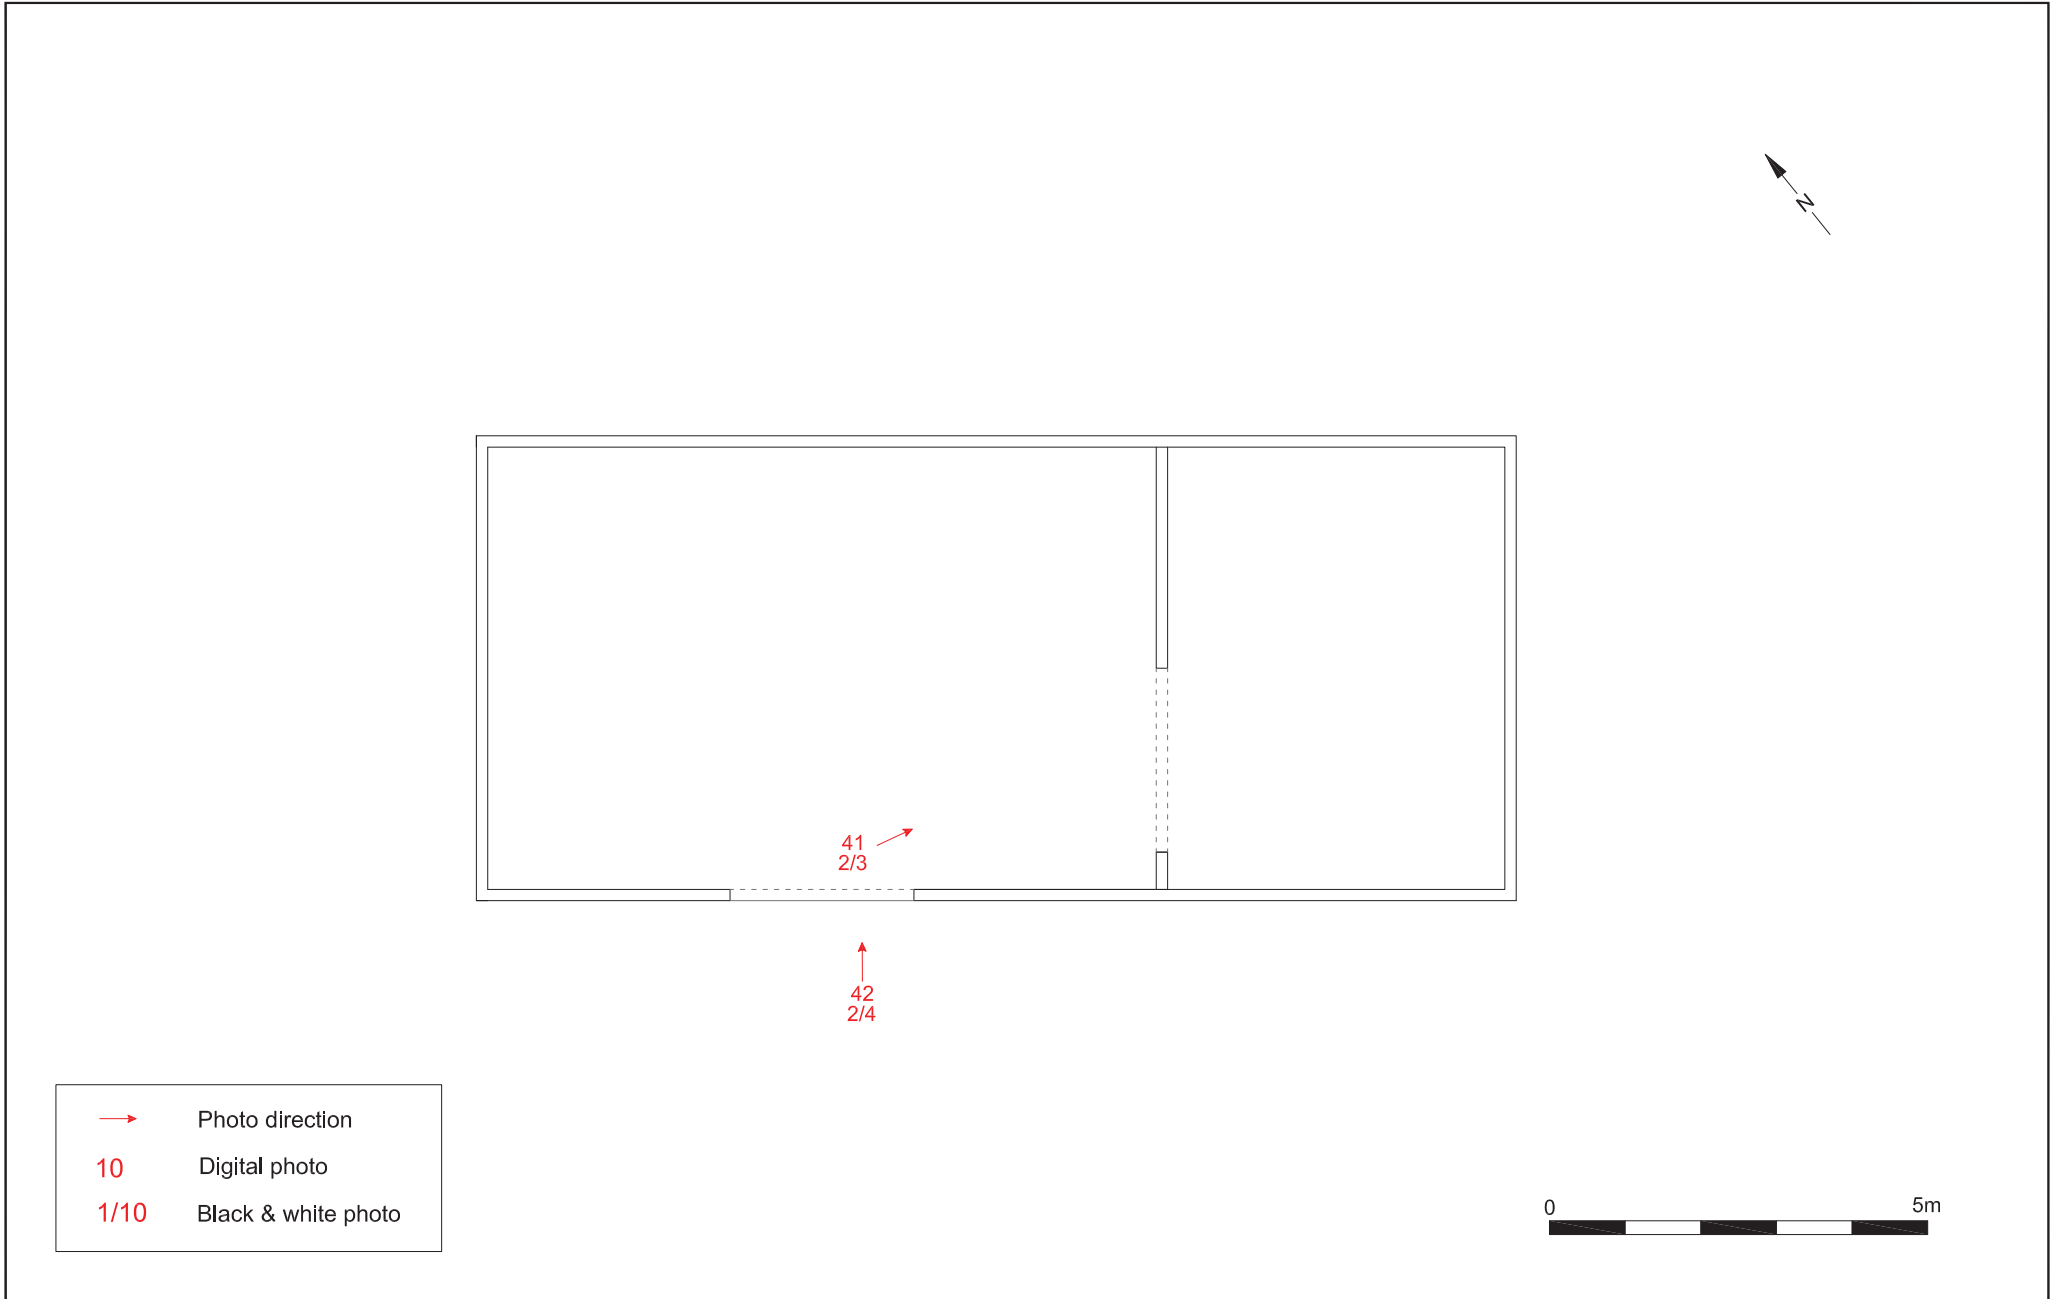
© Archaeology South-East		Land at Tunbridge Lane, Bottisham, Cambridgeshire	Fig. 20
Project Ref: 6796	August 2015	Building 6 floor plan and photo locations	
Report Ref: 2015237	Drawn by: HG

- 6.50 Building 6 (Figure 20) is a single storey structure to the south-east of Building 1 and replaces a former Barrack Hut (Figure 9). The building is a relatively modern addition to the site and first appears on the Ordnance Survey Map of 1972 (Figure 12). The building is currently utilised as store, but was previously used as a cabinet-making workshop, producing woodwork for sound-recording studios, including the BBC (G. Wooster, pers. comm.). The building comprises a large linear range, aligned north-west – south-east and is located adjacent to the north-eastern boundary of the site. It was heavily overgrown at the time of the survey.
