Archaeological Monitoring and Recording

**The Friary Wall
Adult Community Learning
Carmelite Way
Maldon
Essex**

ASE Report No: 2015370

Archaeological Watching Brief

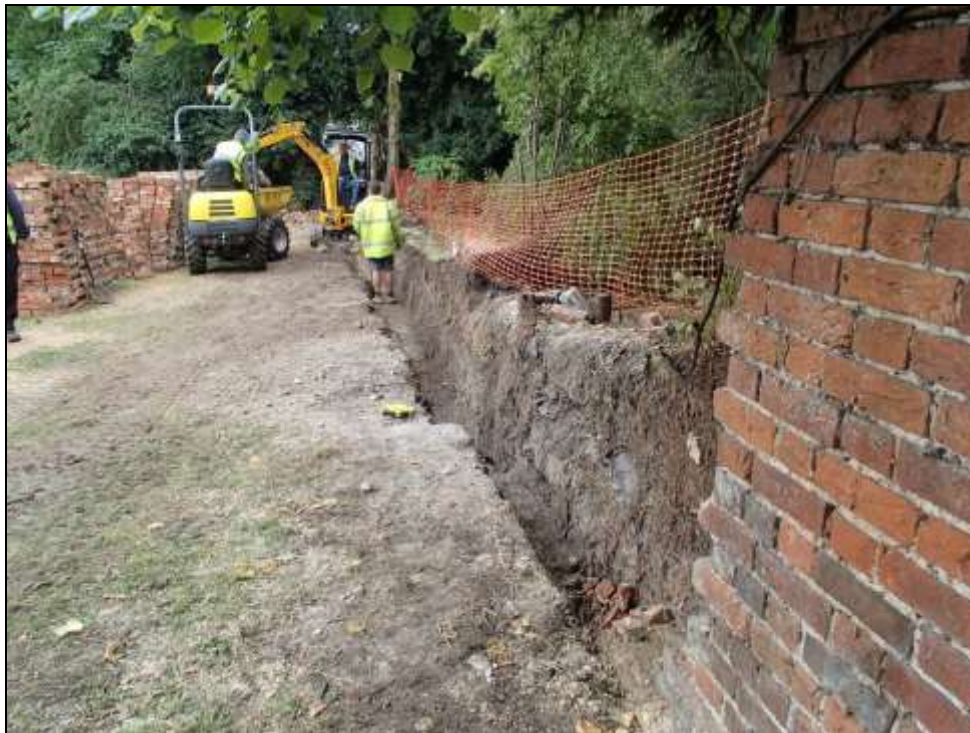
Front Cover: Wall trench, looking south-west
Figure 1: Site Location
Figure 2: Location of monitored wall
