**An Archaeological Watching Brief at
Land North of Fingringhoe Wick
Fingringhoe
Essex**

**ASE Project No: 8380
Site Code: COLEM:2014.86**

**ASE Report No: 2015407
OASIS id: archaeol6-227853**

**By Robin Wroe-Brown
Illustrations by Andrew Lewsey**

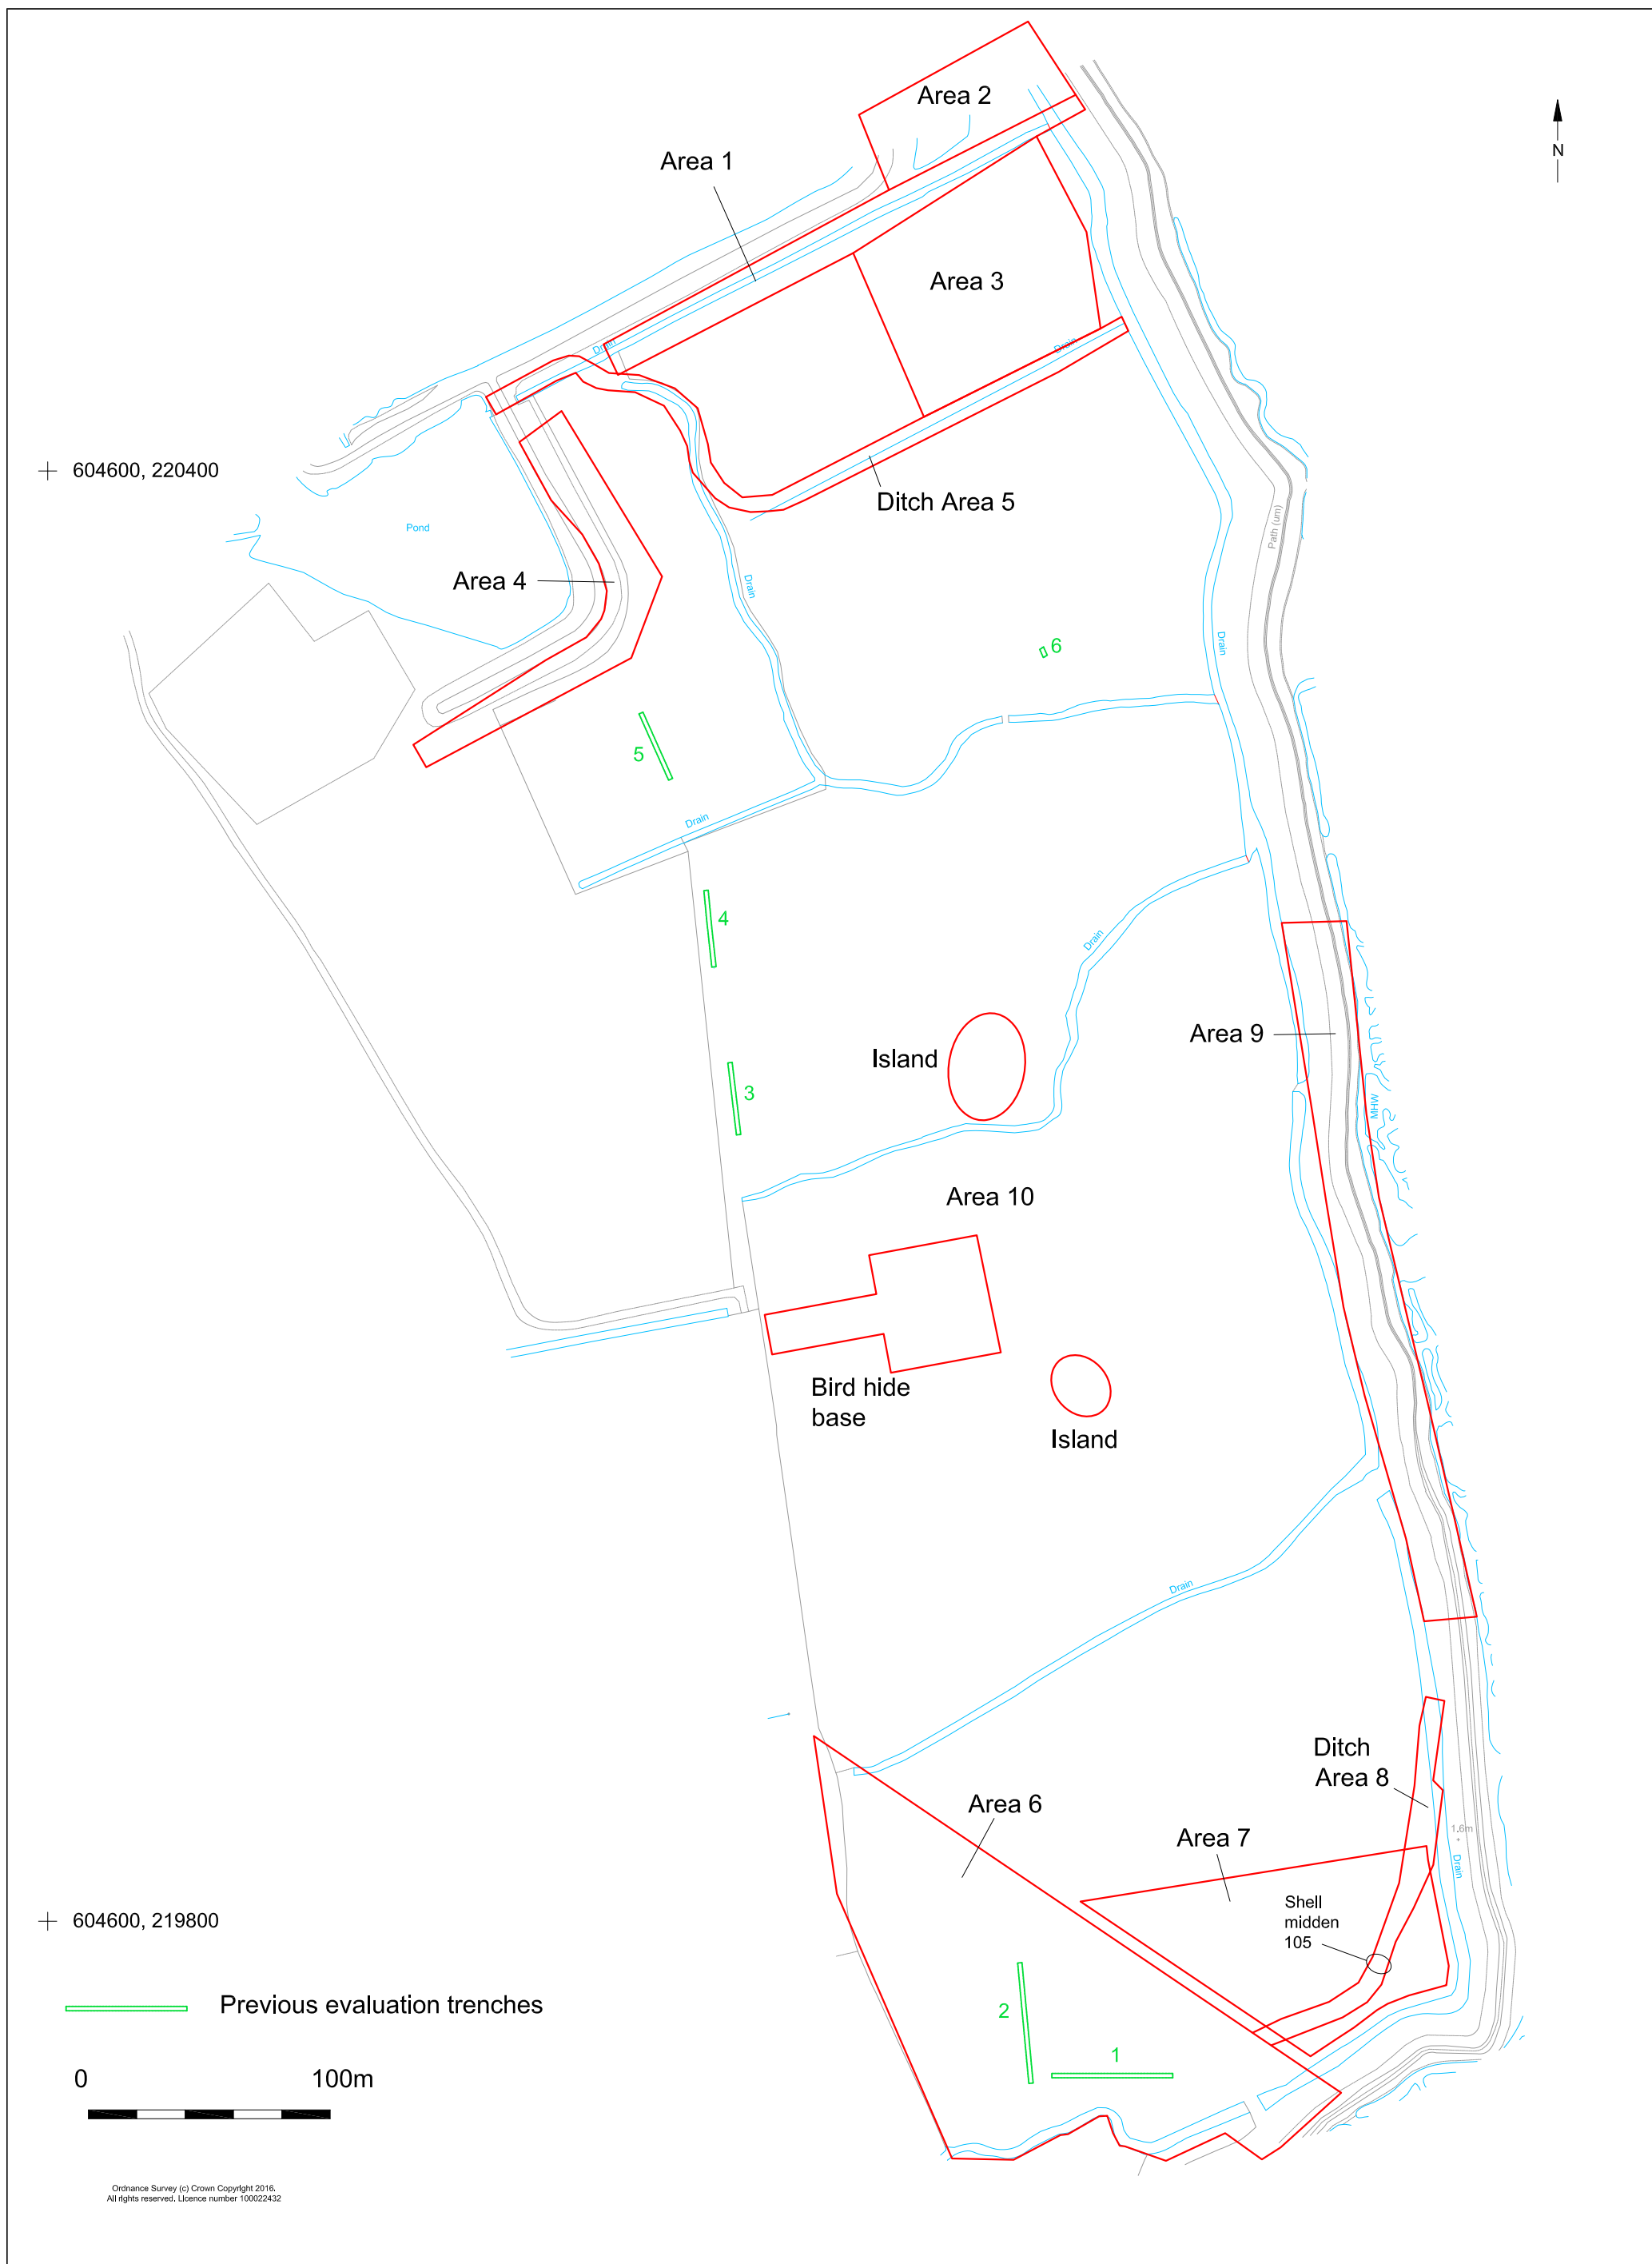
© Archaeology South-East		Land north of Fingringhoe Wick	Fig.2
Project Ref: 8380	Mar 2016	Areas of work	
Report Ref: 2015407	Drawn by: APL

3.1.1 The site works comprised a number of elements requiring archaeological monitoring, divided between north and south areas of the site. Figure 2 shows the numbered areas referred to below:

- Reinforcement of an existing earth bund (Area 1) to create north embankment
- 25 m long new extension (Area 2) to create north embankment
- Excavation of a borrow pond to the south of Area 2 in order to extract clay for the embankment (Area 3)
- Reinforcement of existing earth bund surrounding the pond to the north-west of the site (Area 4)
- Excavation of a new section of ditch draining the pond and enhancement of the existing drainage ditch (Area 5)

- Creation of 84 m long southern embankment (part of Area 6)
- Excavation of pond to rear of southern embankment (Area 6)
- Excavation of a borrow pond to produce clay for the embankments, the islands and the bird hide base (Area 7)
- Excavation of a new ditch draining the Area 6 pond to the main drain behind the sea wall (Area 8)
- Reducing the height (by c.1 m) of a 100m length of existing sea wall to a target tide level after which the rear face of the sea wall will be cut back to reduce the depth of the embankment to the minimum required to be stable for the expected tide level (Area 9)
- Construction of the base of a bird hide and several islands in the centre of the site (Area 10)

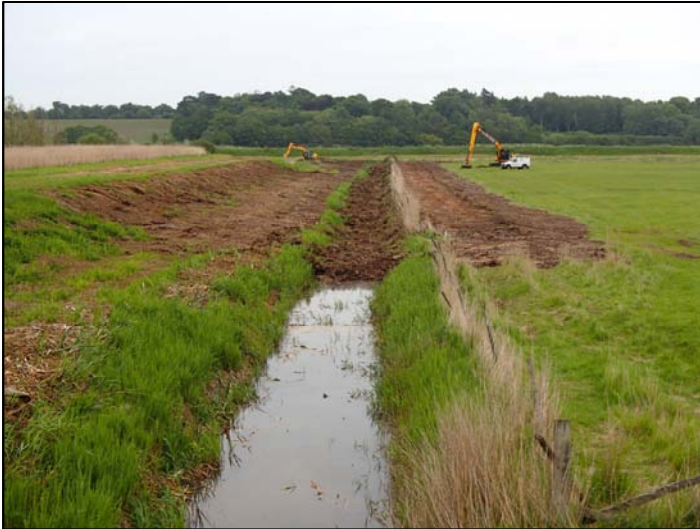
4.2.3 The topsoil was stripped off the extant north embankment and the area in front (south) of it, on both sides of an east-west ditch. The stripped area extended 7-8m south of the ditch to include the slightly raised area where the risings from the ditch were originally dumped when it was dug. The ditch was backfilled with the excavated material (figure 3a) to the point where the Area 5 ditch was dug. Natural deposits were present beneath the topsoil at the base of the embankment. No archaeological features were observed.

Fig. 3a. Stripping the topsoil and backfilling the ditch in Area 1, looking east

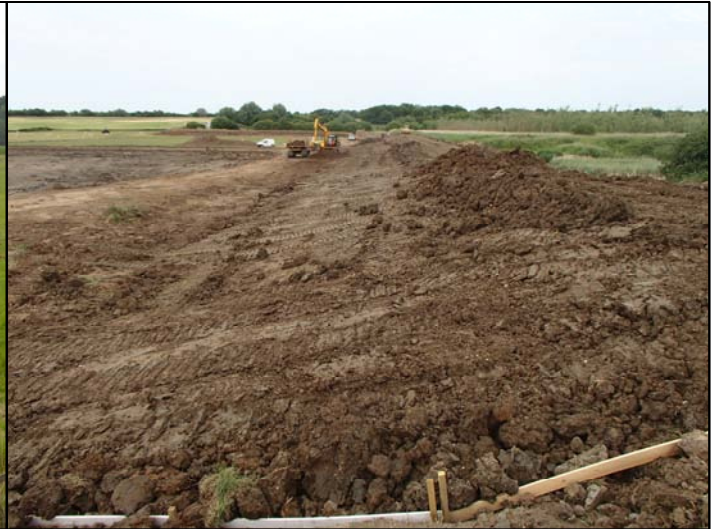
4.2.4 In the north-east corner of the works, where the extant embankment turned north, an area of topsoil was stripped for 35m north of the east-west ditch. This was to provide topsoil to backfill the ditch, the north-south ditch and part of a pond/reed bed to the north in order to create a platform for new length of embankment. The new embankment connected the extant east-west embankment with the sea wall on the east side of the site (figure 3b). The stripping extended to the top of the sea wall.

Fig.3b. The new and built-up north embankment, Areas 1 and 2, looking west

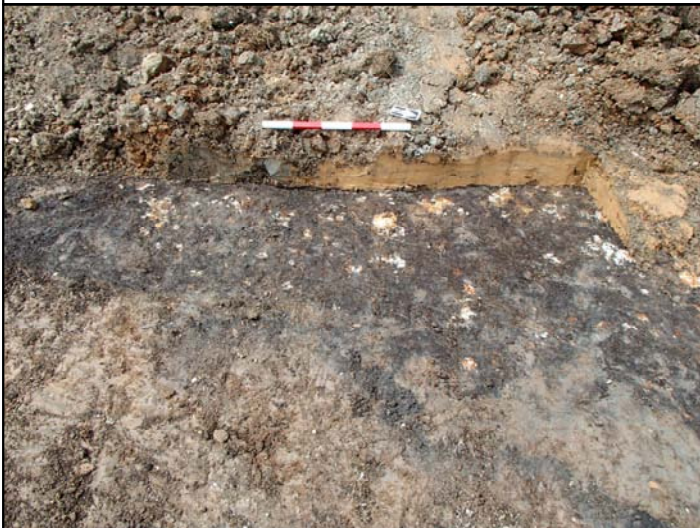
4.2.5 Recorded contexts in this area included the turf and topsoil [101], which was very thin and was stripped by machine down onto natural clay [104]. The north-south bank on the east side of the site was also recorded where it was excavated, consisting of redeposited natural clay [102] laid over a thin dark grey silt [103] (figure 3c). The bank was originally created by excavating the north-south ditch and depositing the risings onto vegetation, the decay of which produced the darker context [103], visible beneath the clay in figure 3c. No dating material was found in either the low bank or the material beneath.

Fig.3c. A small cleaned area of 103 beneath redeposited clay 102 in Area 2, looking west

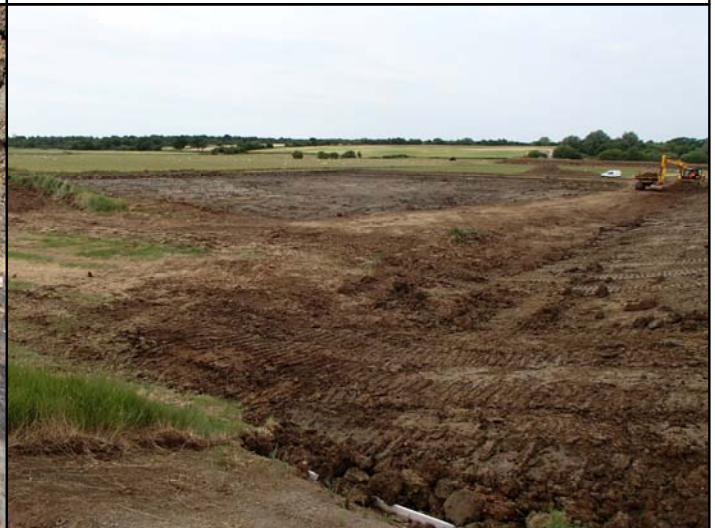
natural clay. The area was then excavated to a depth of c 0.5m (figure 3d) to provide further material for backfilling and as a borrow pit for clay to create the new section of embankment in the north-east of the site. The excavation included the southern part of the low bank (context [102]) adjoining the north-south ditch. The decayed vegetation layer [103] was also present here.

Fig. 3d. Area 3 excavated borrow pit, looking south-west

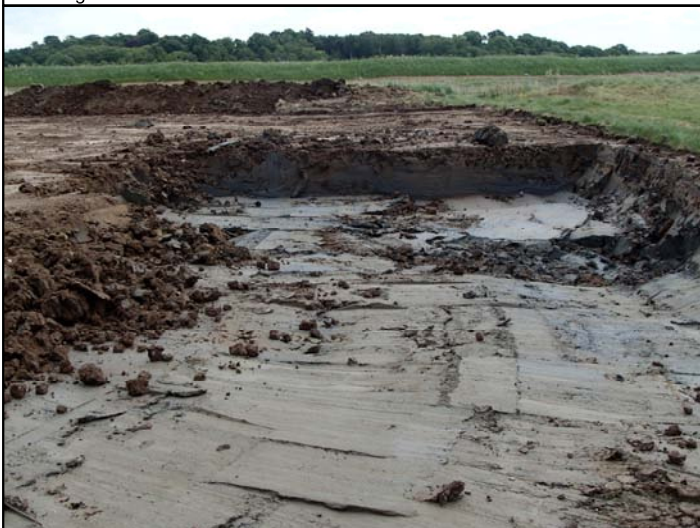
- 4.2.7 The topsoil stripping and excavation of the top of the clay (figure 3e) was carefully monitored but no archaeological features or artefacts were recorded or recovered, in spite of the fact that it extended into the area of high potential, where suspected saltern deposits and the ring-shaped feature noted on the EHER (EHER2600) were situated. An examination of the deposits beneath the topsoil revealed a slightly higher concentration of chalk fragments and flecks than was the case further north, but no redness, briquetage or evidence of burning was present.

Fig. 3e. Excavation of the borrow pit, Area 3, showing the thin topsoil and the clay, looking east

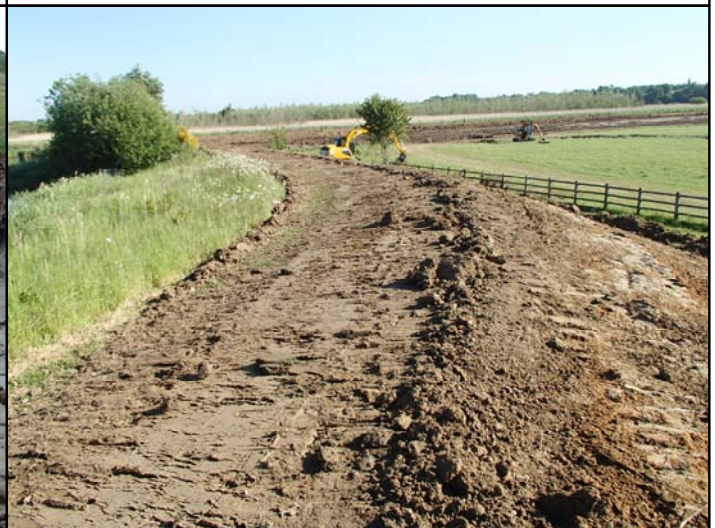
- 4.2.8 The extant embankment forming a corner around the pond to the north-west of the site and an area at its base was stripped of topsoil and enhanced to form the new northern sea wall (figure 3f). Natural clay was observed at the base of the bank but no archaeological features were observed in this location.

Fig. 3f. The north-west bank in Area 4 being stripped, looking north

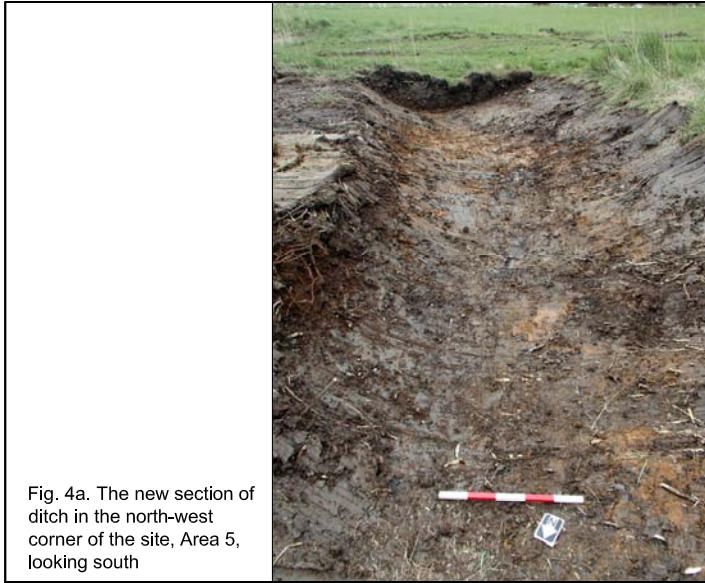
- 4.2.9 In order to divert the redundant and backfilled east-west ditch in Area 1, which drained the outflow from the pond to the west, a length of new ditch was dug from the west end to join with an extant ditch to the south. The new ditch was 8.4m long and 2.8m wide, and was dug in a U-shape to a depth of 0.65m (figure 4a) into the natural clay. The extant ditch was then recut to enhance its drainage capability (figure 4b), diverting water around the new works and into the north-south main drain beside the sea wall. A new drainage pipe was inserted over a 7m-long section and buried to provide access for machinery across the ditch. The work was partially observed and all of the freshly excavated sections were examined. The new section of ditch was planned, but no archaeological remains were observed and no artefacts recovered.

Fig. 4a. The new section of ditch in the north-west corner of the site, Area 5, looking south

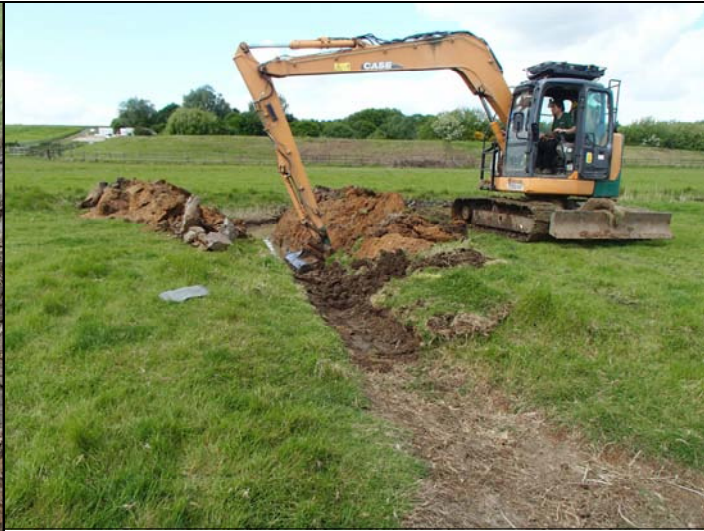
Fig. 4b. Recutting the Area 5 ditch, looking west

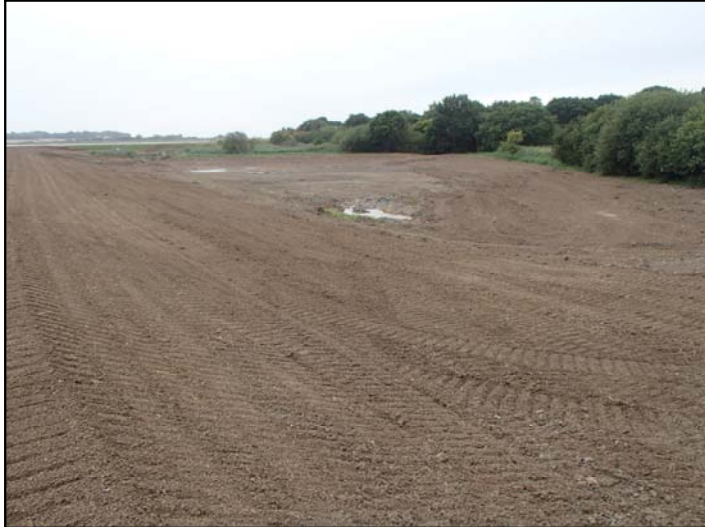
- 4.2.10 A new pond, roughly triangular in plan, was created in the south-west corner of the site (figure 4c). Natural clay was excavated from the centre and used to make an embankment to the south and north-east. The natural upslope of the land formed the west side.

- 4.2.11 This was a part of the site where in the past the dry land met the edge of the marsh and there was considered to be a high potential for archaeological remains to be present. A Roman saltern was found during the evaluation in a similar location relative to the estuary c. 300m to the north, but higher above sea level at c. 2.35m OD on a raised terrace. In the event no archaeological remains were observed in Area 6.

Fig. 4c. The new pond in Area 6, in the south-west corner of the site, looking south

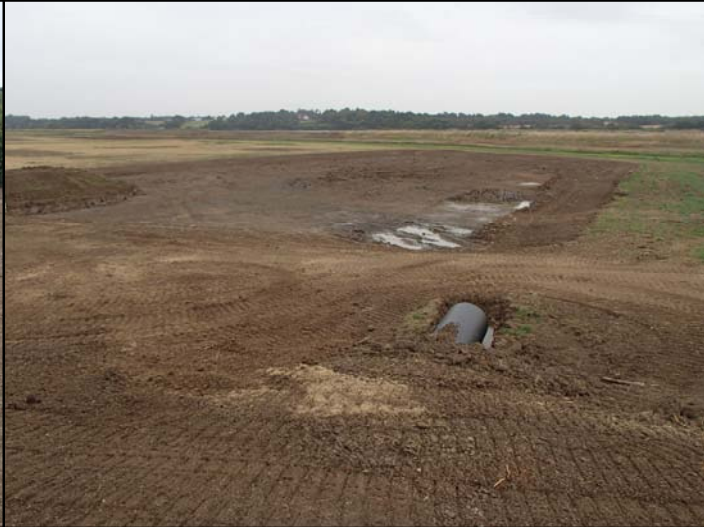
3 operation (figure 4d). The topsoil was stripped over the entire area and the natural clay beneath was excavated to c. 0.5m deep on the north side only. The clay was used to enhance the sea wall at the south end of the site and to create islands and the base of a bird hide in Area 10. No archaeological features were observed apart from a concentration of shells in the ploughsoil which was further recorded in Area 8.

Fig. 4d. Extent of the south borrow pit Area 7, looking north-east. The sluice pipe for the new pond in Area 6 is in the foreground.

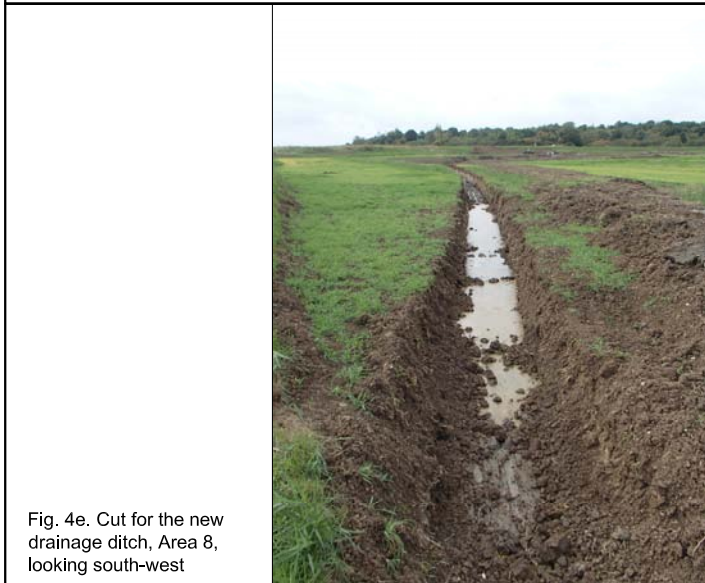
- 4.2.13 A new drainage ditch was excavated in order to drain the new pond eastwards to the main drainage ditch behind the sea wall (figure 4e). A shell midden was bisected by the ditch and recorded as context [105] (located on figure 2; figure 4f). It was c. 5m x 5m as observed and 0.20m thick and composed almost exclusively of oyster shell. It was not obviously within a cut and was also present in the ploughsoil above, observed in Area 7. There was no indication of a date for this feature but its presence on the surface and within the ploughsoil may indicate a late post-medieval date. Natural clay was present beneath the ploughsoil elsewhere.

Fig. 4e. Cut for the new drainage ditch, Area 8, looking south-west

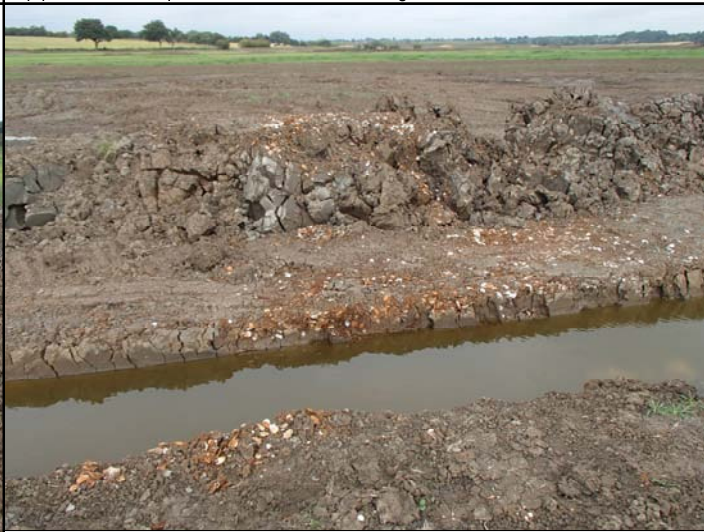
Fig. 4f. Shell midden truncated by the new drain in Area 8, looking north

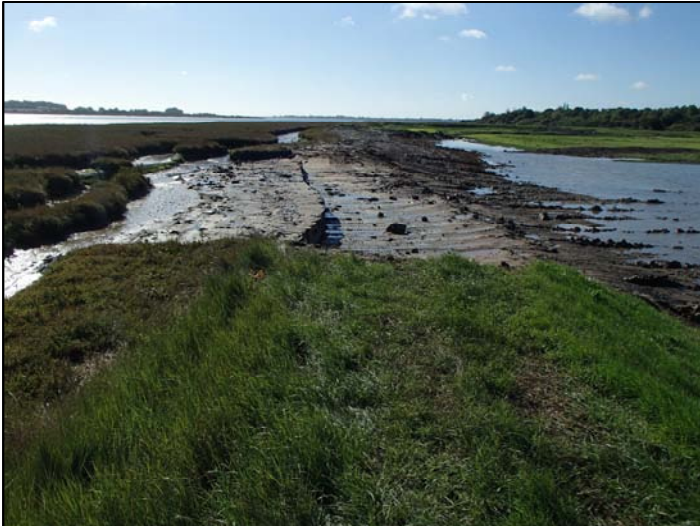
- 4.2.14 The sea wall was breached in order to allow tidal ingress into the site. Two sections of the sea wall each measuring 50m long were stripped of topsoil and then reduced to the level of the marsh outside the site (figure 5a). An island was left intact in between the breaches. It was clear that the sea wall had been constructed in two stages. A thin black layer of decayed vegetation was observed within the structure of the embankment between layers of redeposited natural clay (figure 5b). This is believed to represent the repair and enlargement of the bank after the 1953 floods, with the clay being deposited onto the vegetation growing on the previous bank.

Fig.5a. The south breach of of the sea wall looking south, Area 9. The water to the right was the result of the first tidal influx after the breach was cut.

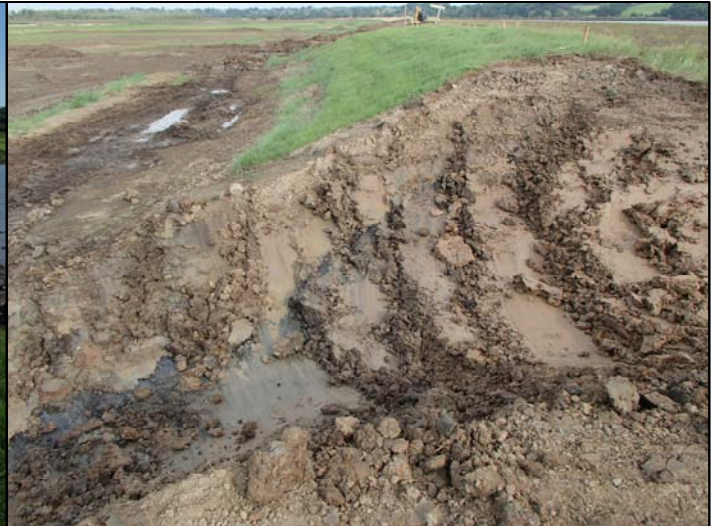
Fig. 5b. Section through the sea wall at the north end of the south breach Area 9, showing the two stages of construction separated by a black layer of rotting vegetation, looking north

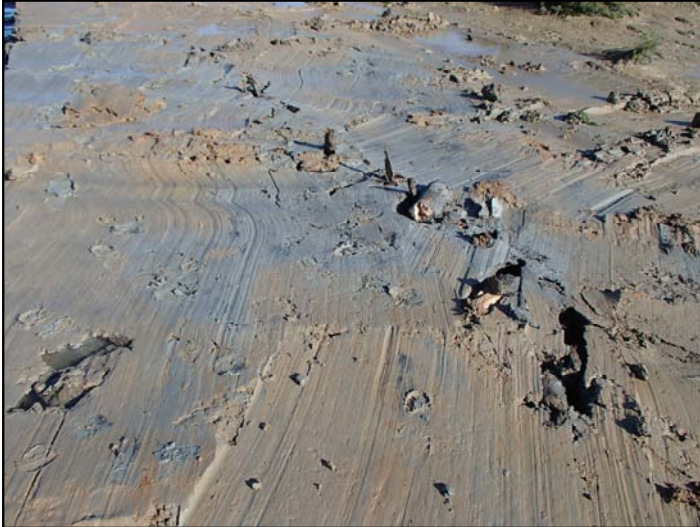
- 4.2.15 The excavation of the southern breach revealed a line of wooden stakes, context [106] (figure 5c). A total of 19 stakes had been driven into the natural alluvial clay in a curvilinear shape measuring 8.5m long. The individual stakes were mostly roundwood, (figure 5d) with one squared stake which showed evidence of having been machine-cut. Those stakes which had been pulled out by the machine were all cut to a point on the bottom end and all were decayed on the top end. The longest observed was 0.6m long and they were all 120mm – 140mm in diameter.

Fig.5c. Line of stakes 106 in the south breach Area 9, looking north-east

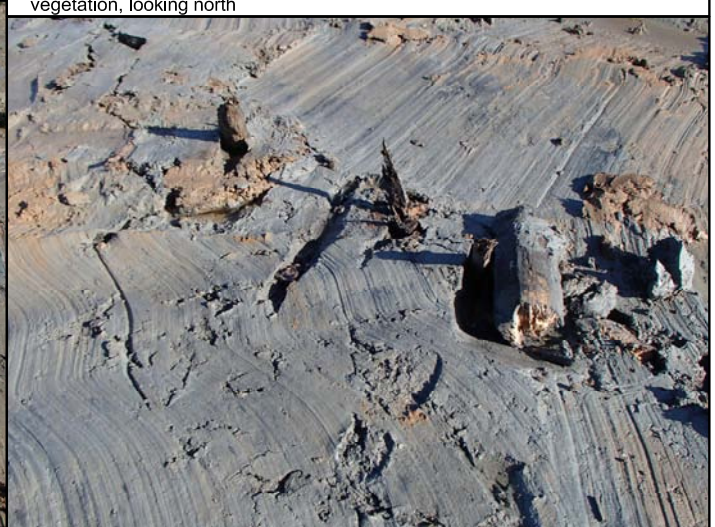
Fig. 5d. Detail of stakes in 106

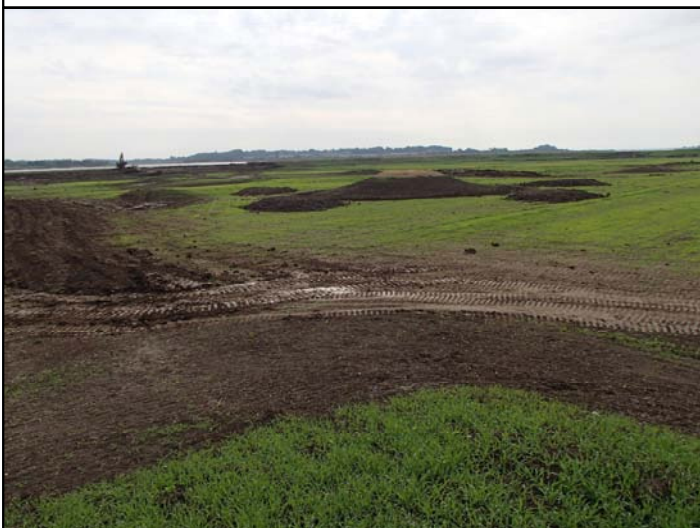
Fig. 5e. New islands in Area 10, looking south-east

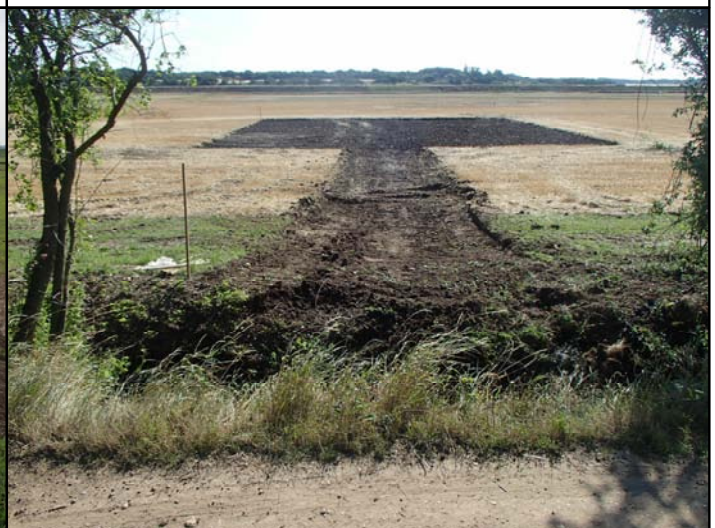
Fig. 5f. Topsoil strip of bird hide base in Area 10, looking east

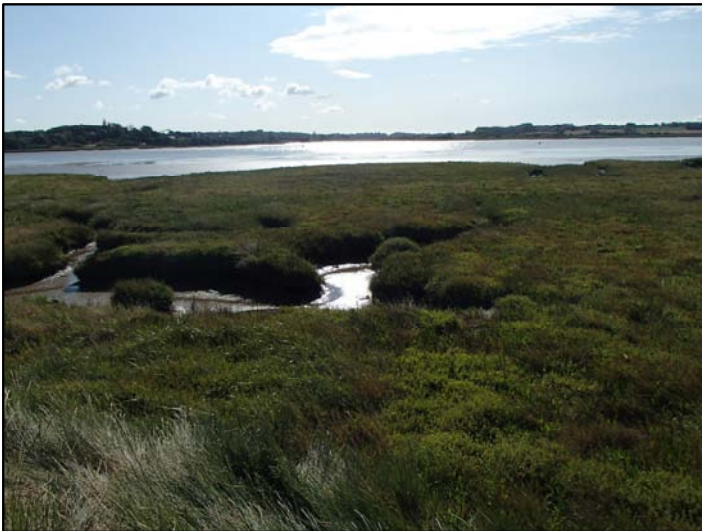
Fig. 6a. The salt marshes adjacent to the site from the sea wall, looking east

- 5.1.2 The character of the early landscape of the site was probably very similar to the salt marshes which are still present to the east of the sea wall today (figure 6a). A network of creeks which flood at each high tide divide clumps of salt-resistant vegetation which form small islands. The marshes would have been rich in resources, particularly wildfowl, but were relatively inaccessible except by boat.

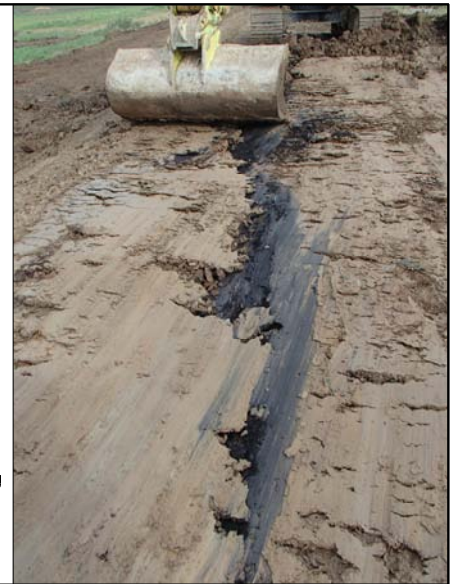
Fig. 6b. The layer of decayed vegetation dividing the sea wall stages of construction as it appeared during the sea wall works, looking north
