**FORMER PUBLIC CONVENIENCES, MILLFIELDS ROAD,  
LONDON BOROUGH OF HACKNEY**

**HISTORIC BUILDING RECORD  
(ENGLISH HERITAGE LEVEL 2-3)**

**December 2015**

**Project No. 8487  
Site Code: MIF15  
Report No. 2015450  
OASIS ID: archaeol6-233287**

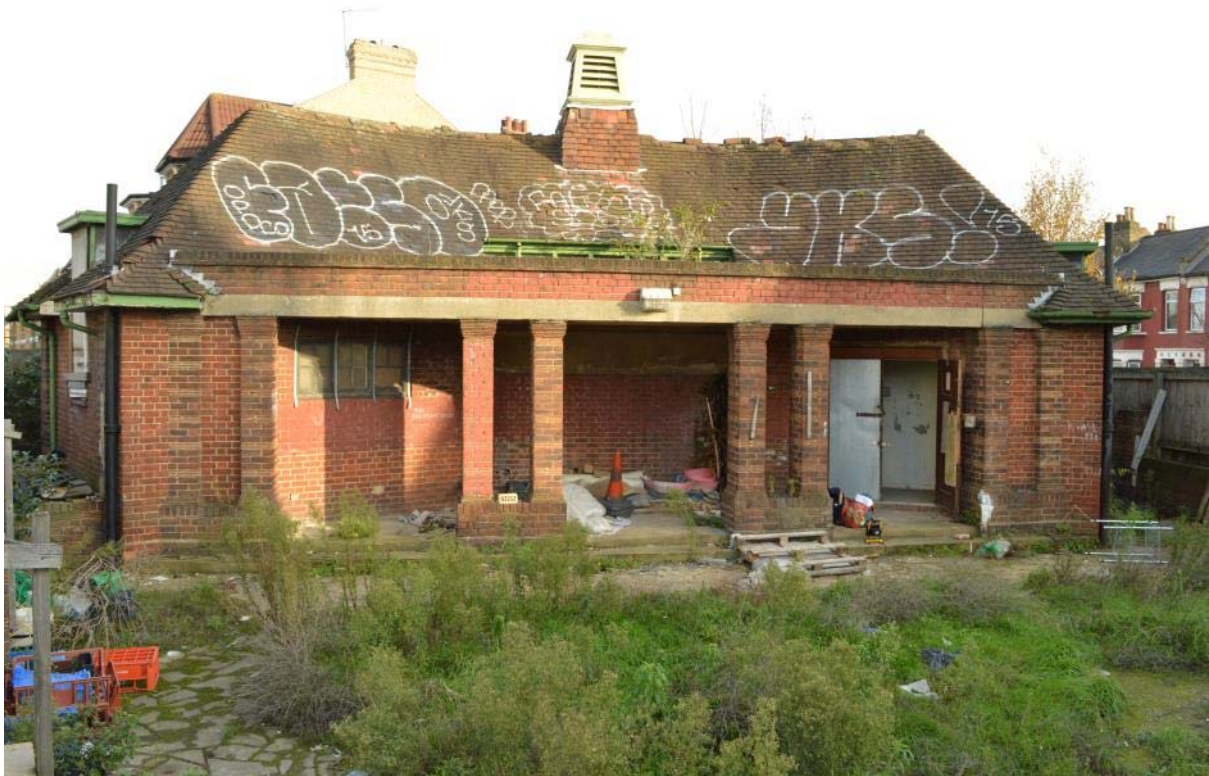
Plate 1: West elevation (69)

- 5.3 The principal elevation faces west towards Clapton pond and into a small garden area contained within the site. The paved areas have an original crazy paving surface and the garden is surrounded by a low brick wall, contemporaneous with the building.
- 5.4 The building is symmetrical and fronted with a simple classical portico comprised of two pairs of square brick columns and two pairs of brick pilasters, all of which rest upon a brick pedestal. The columns and pilasters are constructed from darker, contrasting bricks and have courses made up of tiles. The portico supports a flat concrete roof and parapet covering what was a seating area, created in the space made by the building's canted wings.
-

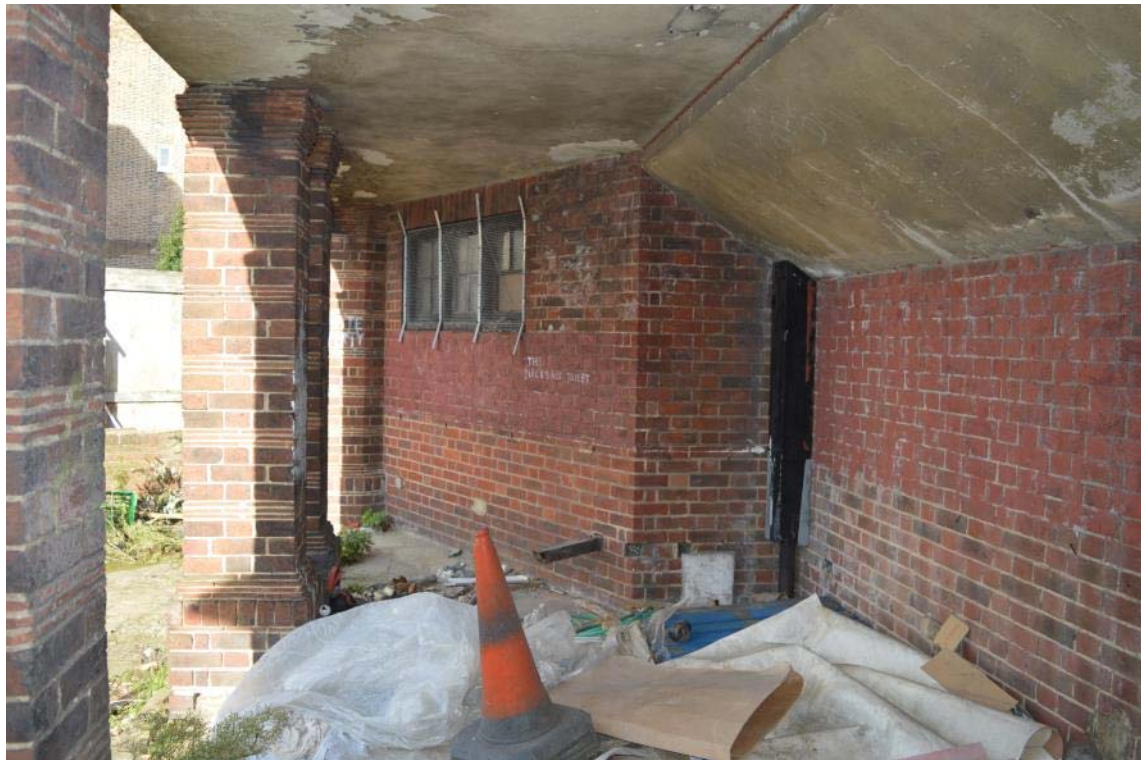
Plate 2: Seating area, looking north (18)

The parapet rises above the level of the surrounding eaves which project forward at either side. Evidence for former bench seating can be seen on the brickwork on the exterior wall (Plate 2). The inner part of the roof over the seating area slopes abruptly towards the building allowing light into a set of high level windows above it.

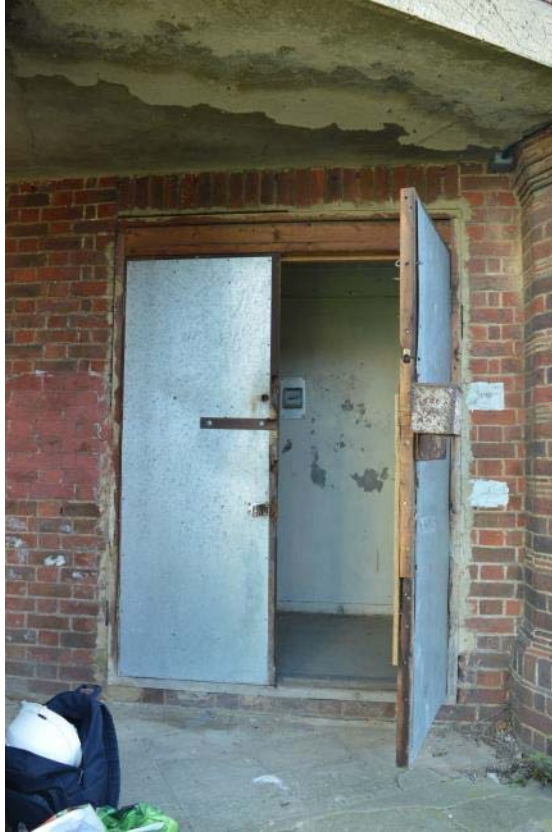
Plate 3: Inserted entrance to Room 1, looking east (16)

- 5.5 On the north wall of the front elevation, in the seating area, there is a three-light mullion window. The corresponding window on the south wall has been removed and replaced with a doorway. Evidence that the door was inserted can be seen in the brickwork; the queen closers on the jambs only reach as far down as the window would have reached (Plate 3).

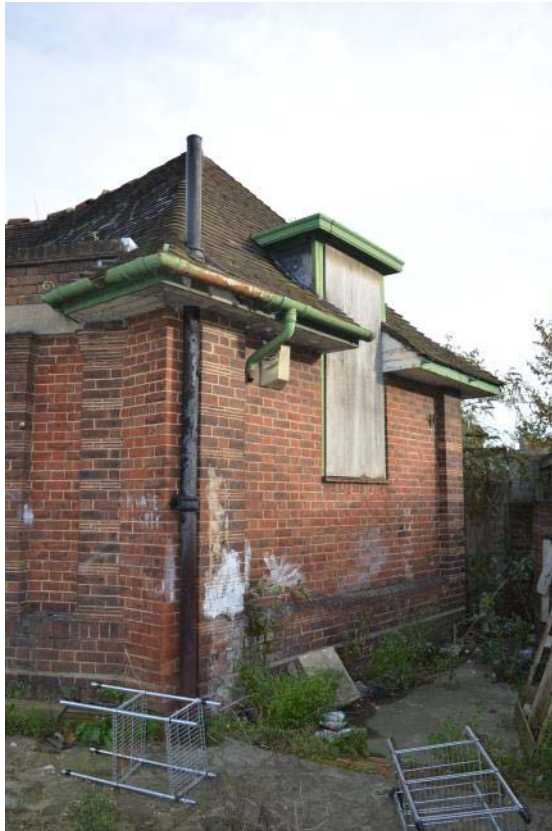
Plate 4: South elevation (9)

- 5.6 The two side elevations are identical and repeat some of the detail of the front (Plate 4). The walls are largely plain but retain the brick pedestal and are framed by two pilasters at either end of the walls. At this point roof comes down to a deep overhanging eaves, broken by a high central window in each wall. The eaves continue around the rest of the rear of the building.

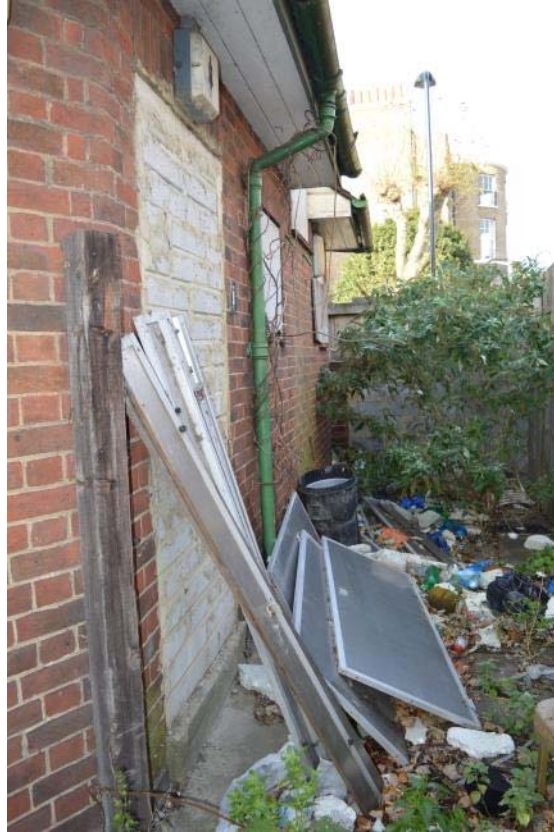
Plate 5: North-east elevation (12)

- 5.7 The canted rear elevations are also identical and are more austere, as they lack the embellishment of pilasters or a pedestal (Plate 5). Each wall is punctuated by two small low windows, flanking a higher one breaking the eaves. Towards the centre of the building each wall contains a doorway blocked with breeze blocks. The doorways still have signs to their sides indicating that the door to the south was the men's entrance and the door the north was the women's entrance.

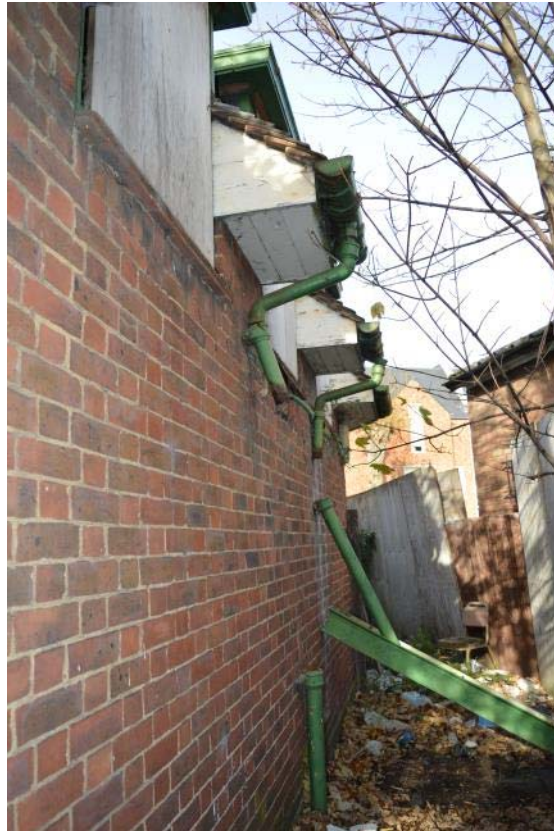
Plate 6: East elevation (11)

- 5.8 The rear (east) elevation is similarly plain and contains three large windows piercing the eaves (Plate 6). The historic plans indicate that the building's roof was served by ornamental green gutters, which partially survive around the rear and side elevations.

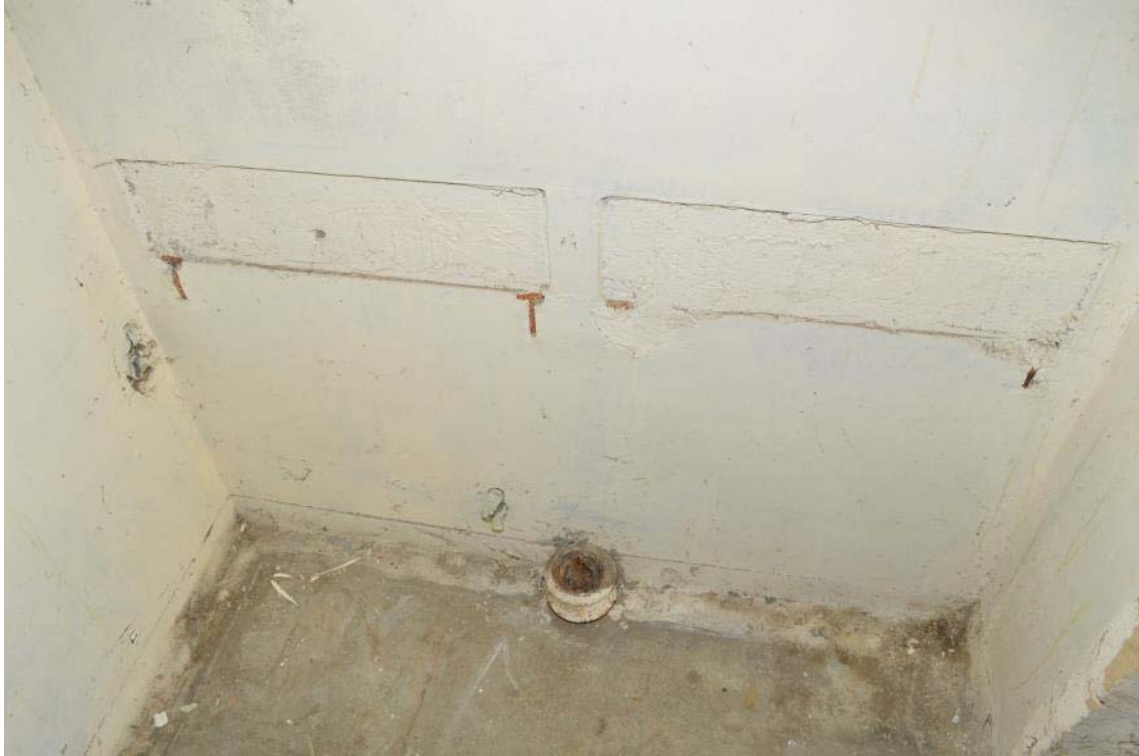
Plate 9: Room 1, looking south (64)

- 5.14 The floor in the angle of the room is made of concrete and slightly raised; the surviving plans indicate this housed a cupboard. The south wall shows evidence that two basins were attached. A waste water pipe can be seen underneath (Plate 9).

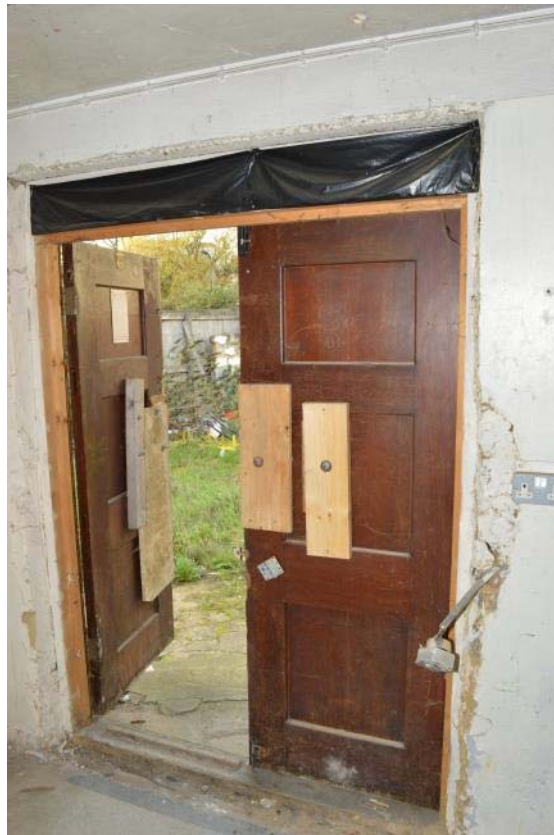
Plate 10: Room 1, looking west (21)

- 5.15 The entrance door comprises a set of heavy hardwood double doors framed in a traditional manner (Plate 10). The outer face of the doors is covered in sheet metal to prevent break-ins. The style and construction of the doors is consistent with a date from the 1930s or 40s, around the time that the WC was built and the style is almost identical to another surviving door in the building. It is likely that the doors are reused; there is not another double doorway in the building but it is possible that two single doors were reused.

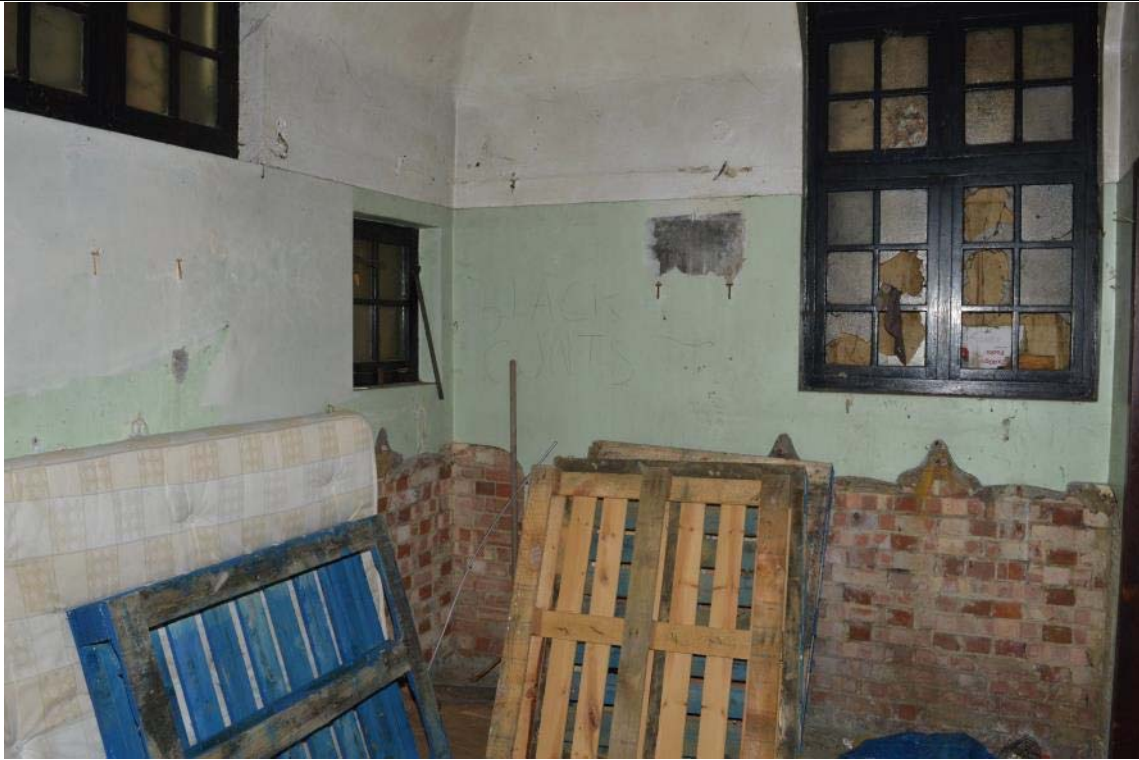
Plate 11: Room 2, looking south (22)

- 5.16 Room 2 forms one of the main parts of the men's toilets (Plate 11). It is now accessed from Room 1 but originally would have been entered from a doorway to the rear of the building, separated from the rest of the room by a partition acting as a baffle.

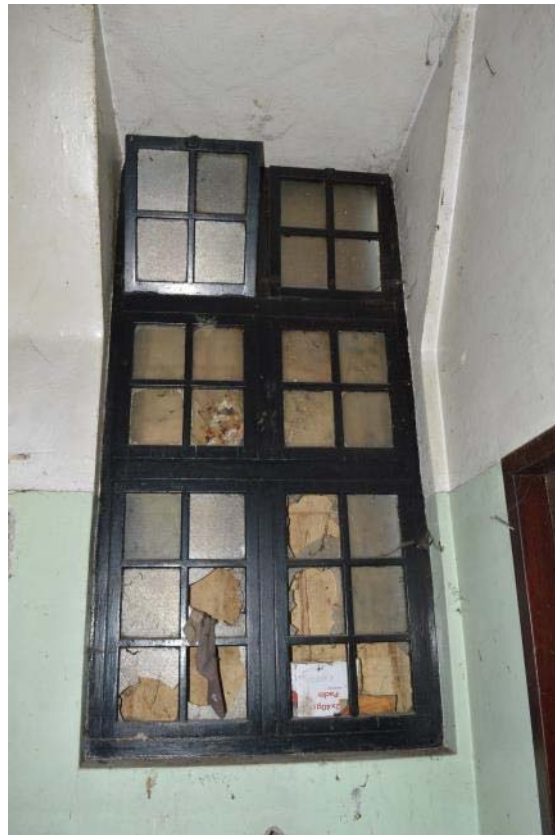
Plate 12: Room 2, looking south (29)

- 5.18 It seems likely that the west wall, and possibly Room 1 would have been used for handwashing, although little evidence of this remains.
- 5.19 The room is lit from a high level half-dormer window on each external wall, as well as two lower, smaller windows on the east wall. All of the windows are of timber construction with mullions, transoms and small panes held by glazing
-

bars (Plate 12). The room is ventilated with a vent in the ceiling leading to the central louvre outside.

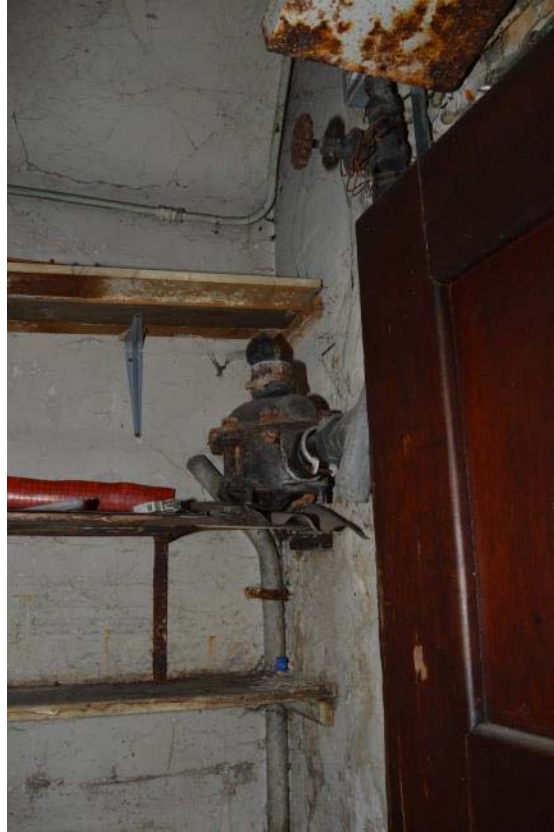
Plate 13: Room 3, looking west (31)

- 5.20 Room 3 is a cupboard leading off Room 2 (Plate 13). It retains its original three panelled door, similar to that of the main entrance (Plate 14). Like all the door cases it has a plain hardwood architrave. It contains shelves and antiquated electrical fuse boxes.

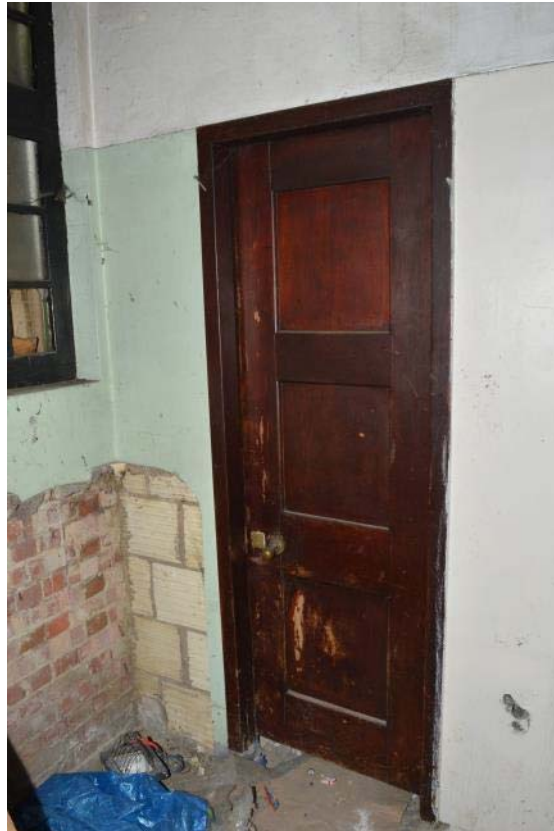
Plate 14: Room 2, looking west (30)

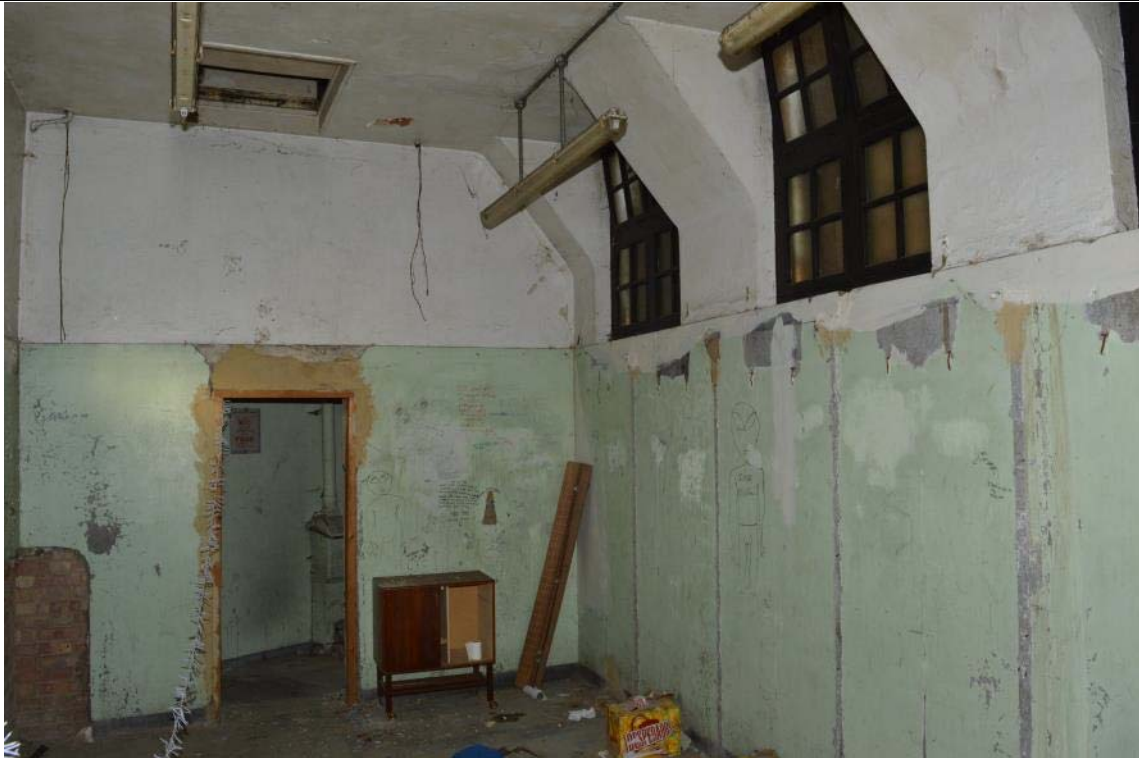
Plate 15: Room 4, looking north (34)

- 5.21 Occupying the central bay of the building, Room 4 is accessed from an arched opening into Room 2. The room was also part of the men's WC and was used for both urinals and cubicles (Plate 15). Evidence for the position of the urinals can be seen on the west wall, while scars left by cubicle partitions, cisterns and waste pipes can be seen on the east wall. The layout of the cubicles is also reflected in markings on the floor and is consistent with the early plans. A doorway leads from Room 4 to 5, this is an insertion of poor quality.

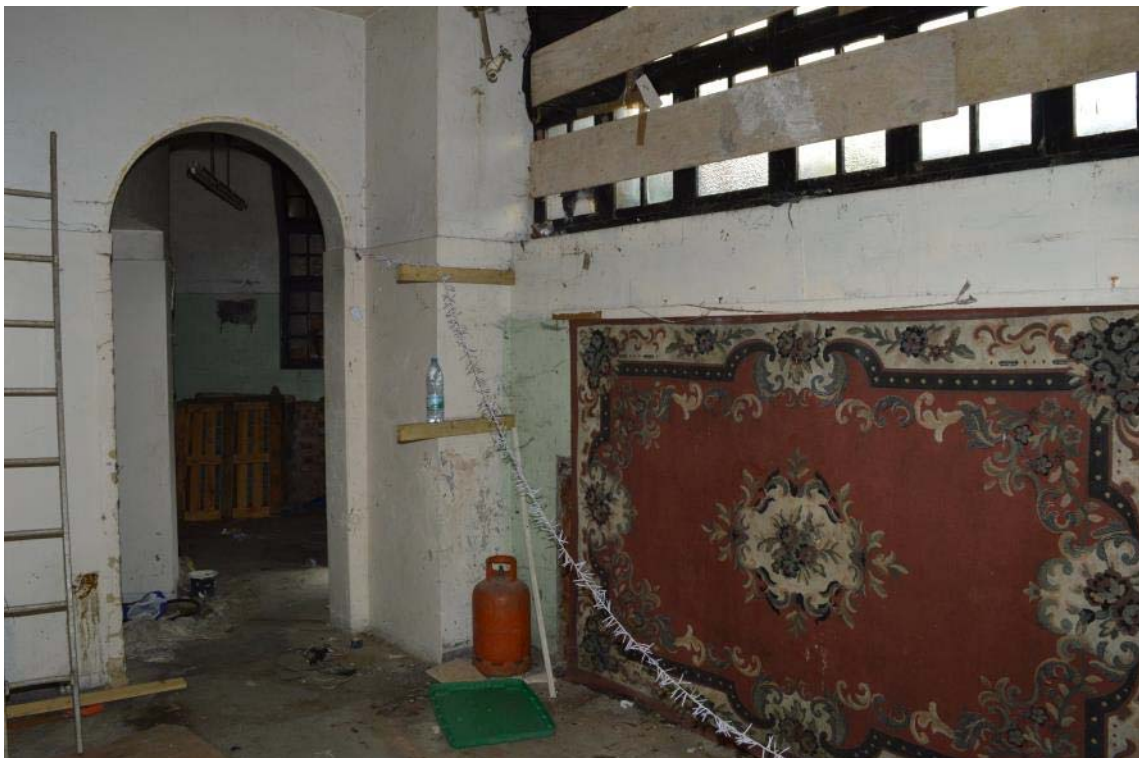
Plate 16: Room 4, looking south (35)

- 5.22 The room is very well lit, with a continuous clerestory window on the west wall (Plate 16), and three large half-dormers on the east wall. As in Room 2, the room is served by a vent and air-duct leading to the central ventilator (Plate 17).

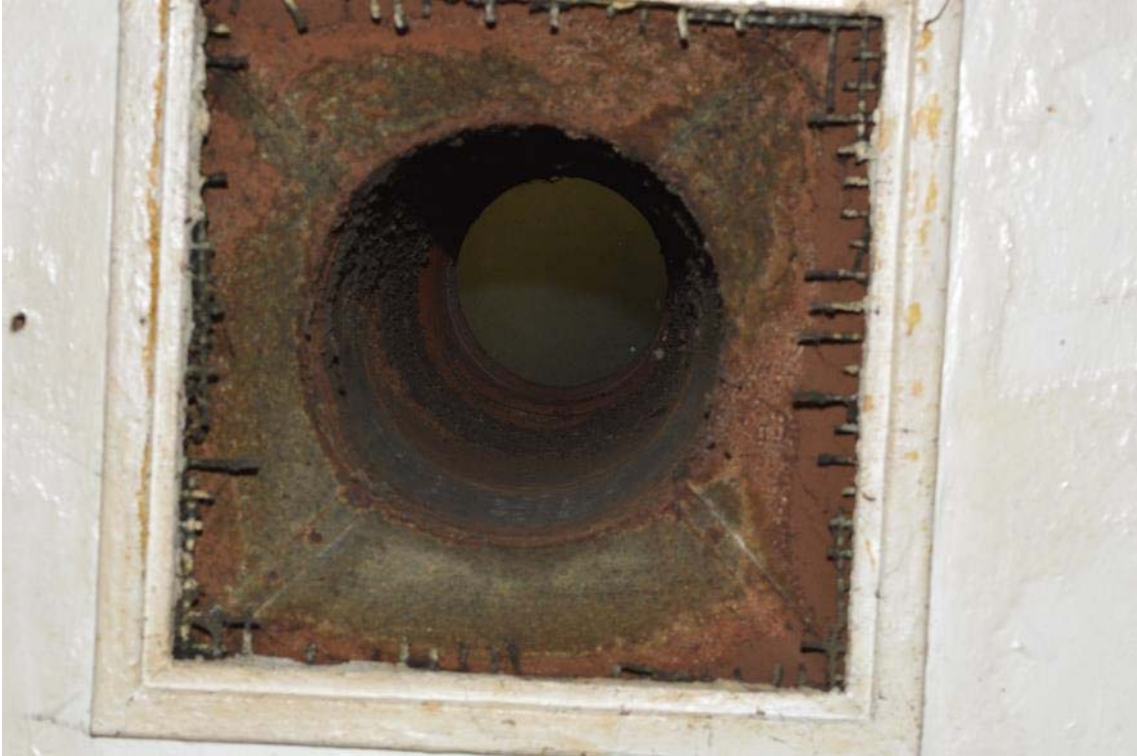
Plate 17: Room 4 looking up (40)

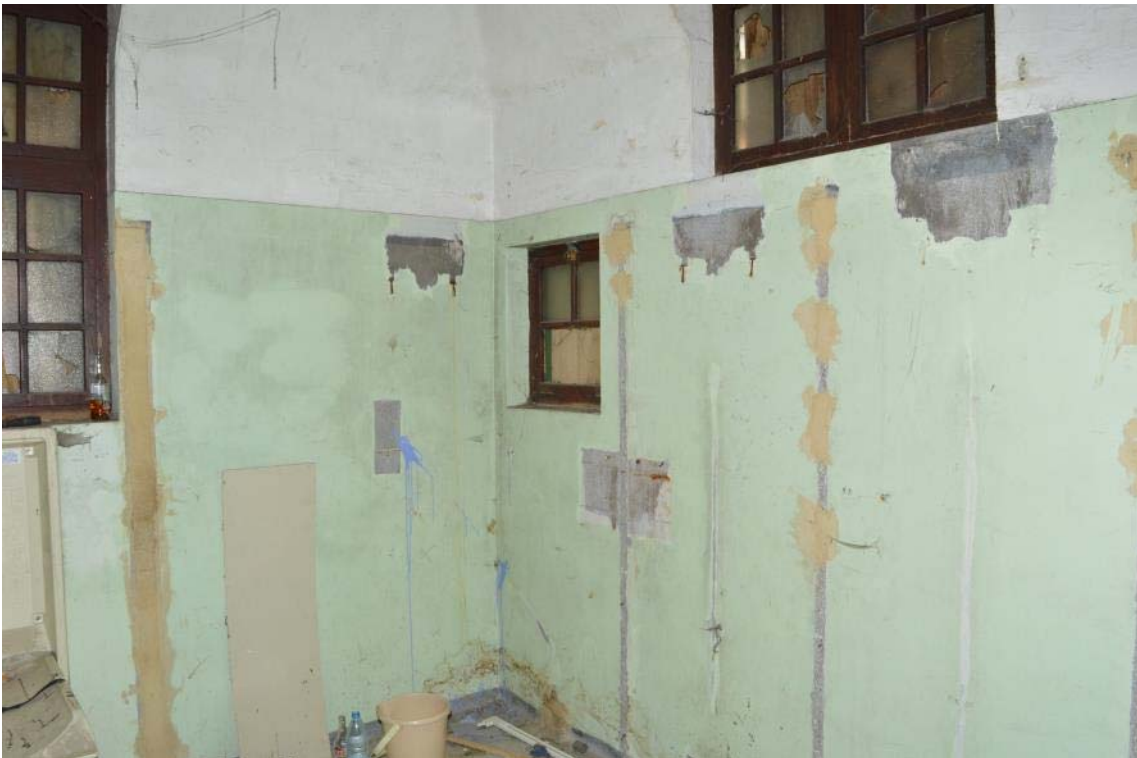
Plate 18: Room 5, looking north (47)

- 5.23 Room 5 occupies most of the north wing and makes up the women's WC (Plate 18). The room has a similar layout to room 2, with identical windows and a baffled entrance lobby in the south-east corner from which the room was originally accessed. The external entrance is now blocked.

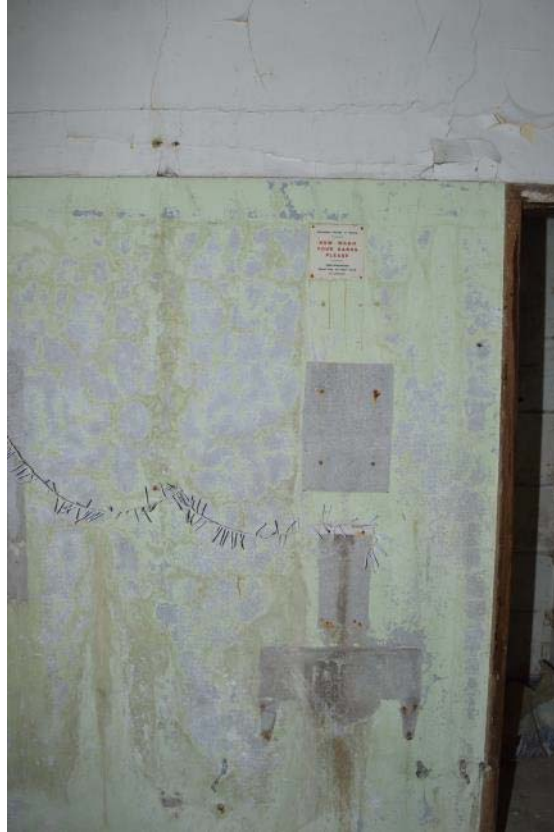
Plate 19: Room 5, looking west (53)

- 5.24 The layout of the former cubicles can be seen in the floor and walls. Scars from cubicle partitions, cisterns and waste pipes can be seen along the east wall. The position of the wash basins is more clearly discernible in this room with the scars from a wash basin, soap dispenser and mirror left on the west wall (Plate 19).

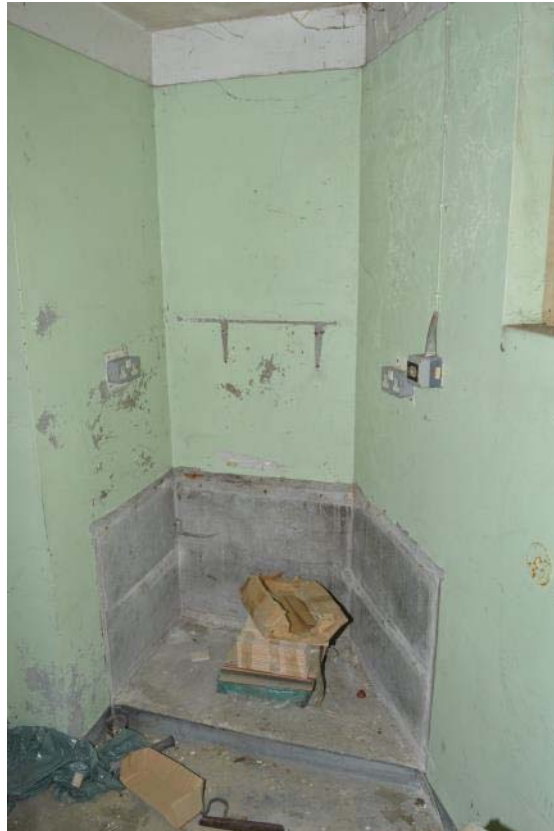
Plate 20: Room 6, looking south (56)

- 5.26 The original function of Room 6 seems to be identical to Room 1 (Plate 20). It is accessed from a door into room 5 and lit by a window to the west. The angled space to the south of the room has a raised concrete floor and is marked on original plans as a cupboard. The room itself is marked as an attendant's room on the plans and lavatory and bears the scars of two basins. The wall above the basins has what appears to be the remains of a large mirror.
-

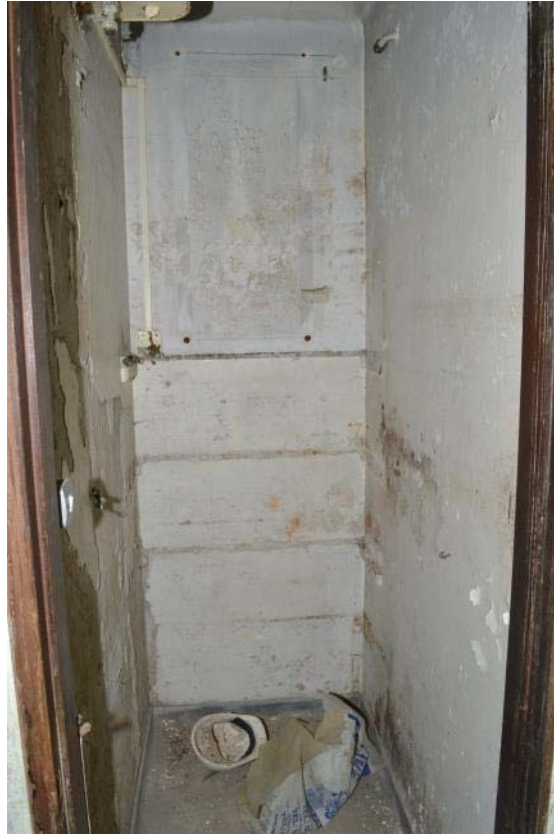
Plate 21: Room 7, looking west (54)

- 5.27 Room 7 is a store cupboard, mirroring that of Room 3. It retains nothing of interest.

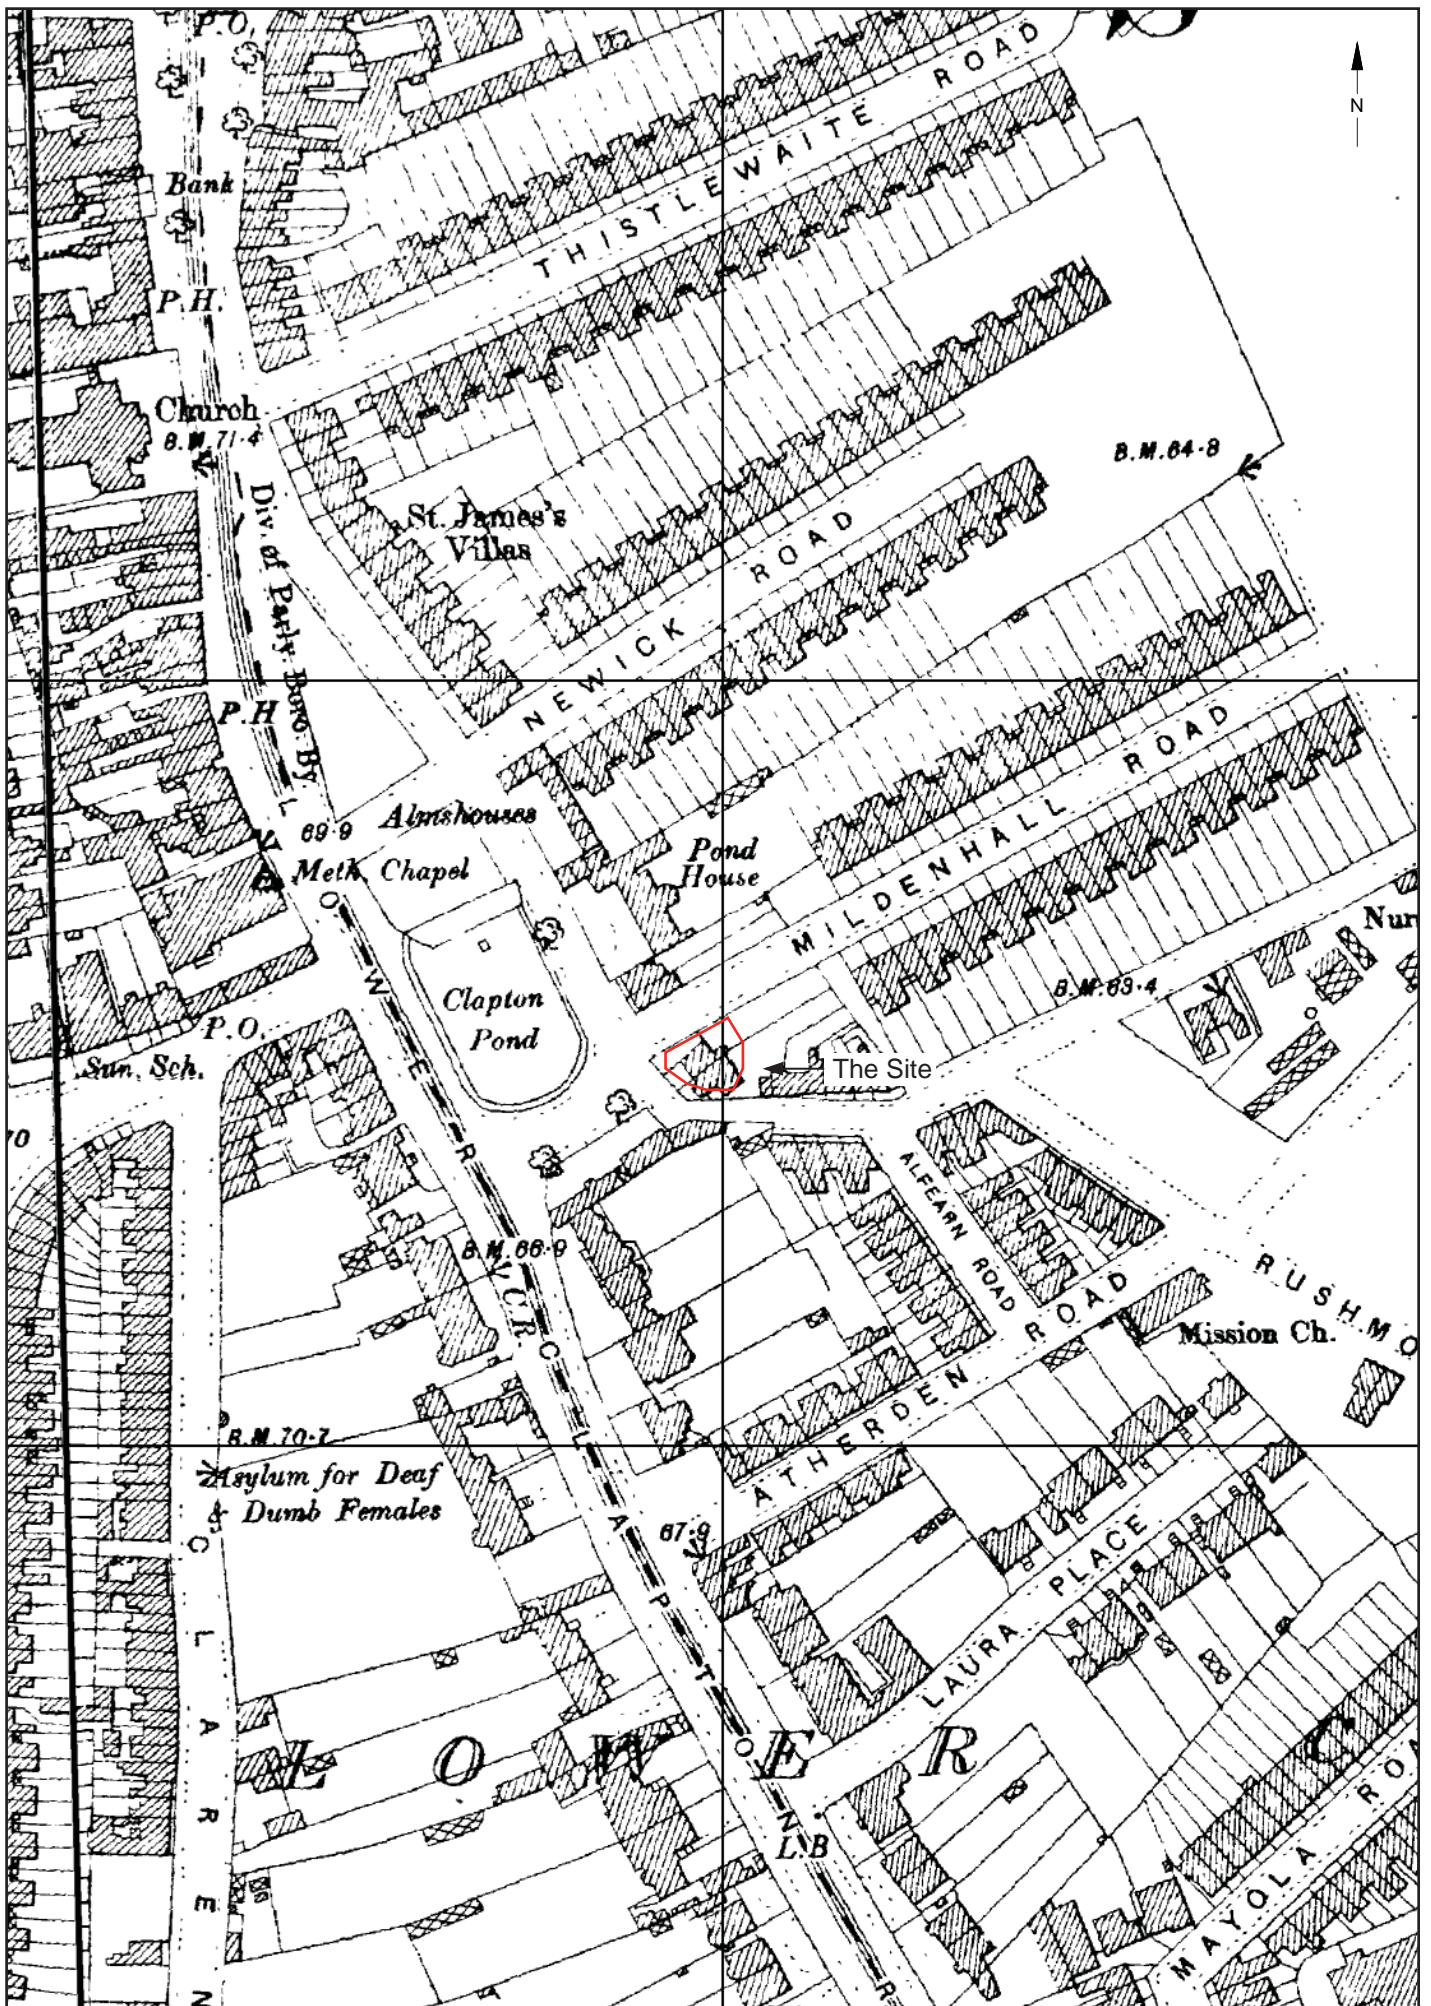
© Archaeology South-East		Former public conveniences, Millfields Road, Hackney		Fig. 5
Project Ref: 8487	Jun 2015	Ordnance Survey, 1896		
Report Ref: 2015450	Drawn by: KRH

- 4.3 By 1896 (Figure 5) the area to the east of the site had been developed, while to the north the central portion of St. James's Terrace had been demolished
-

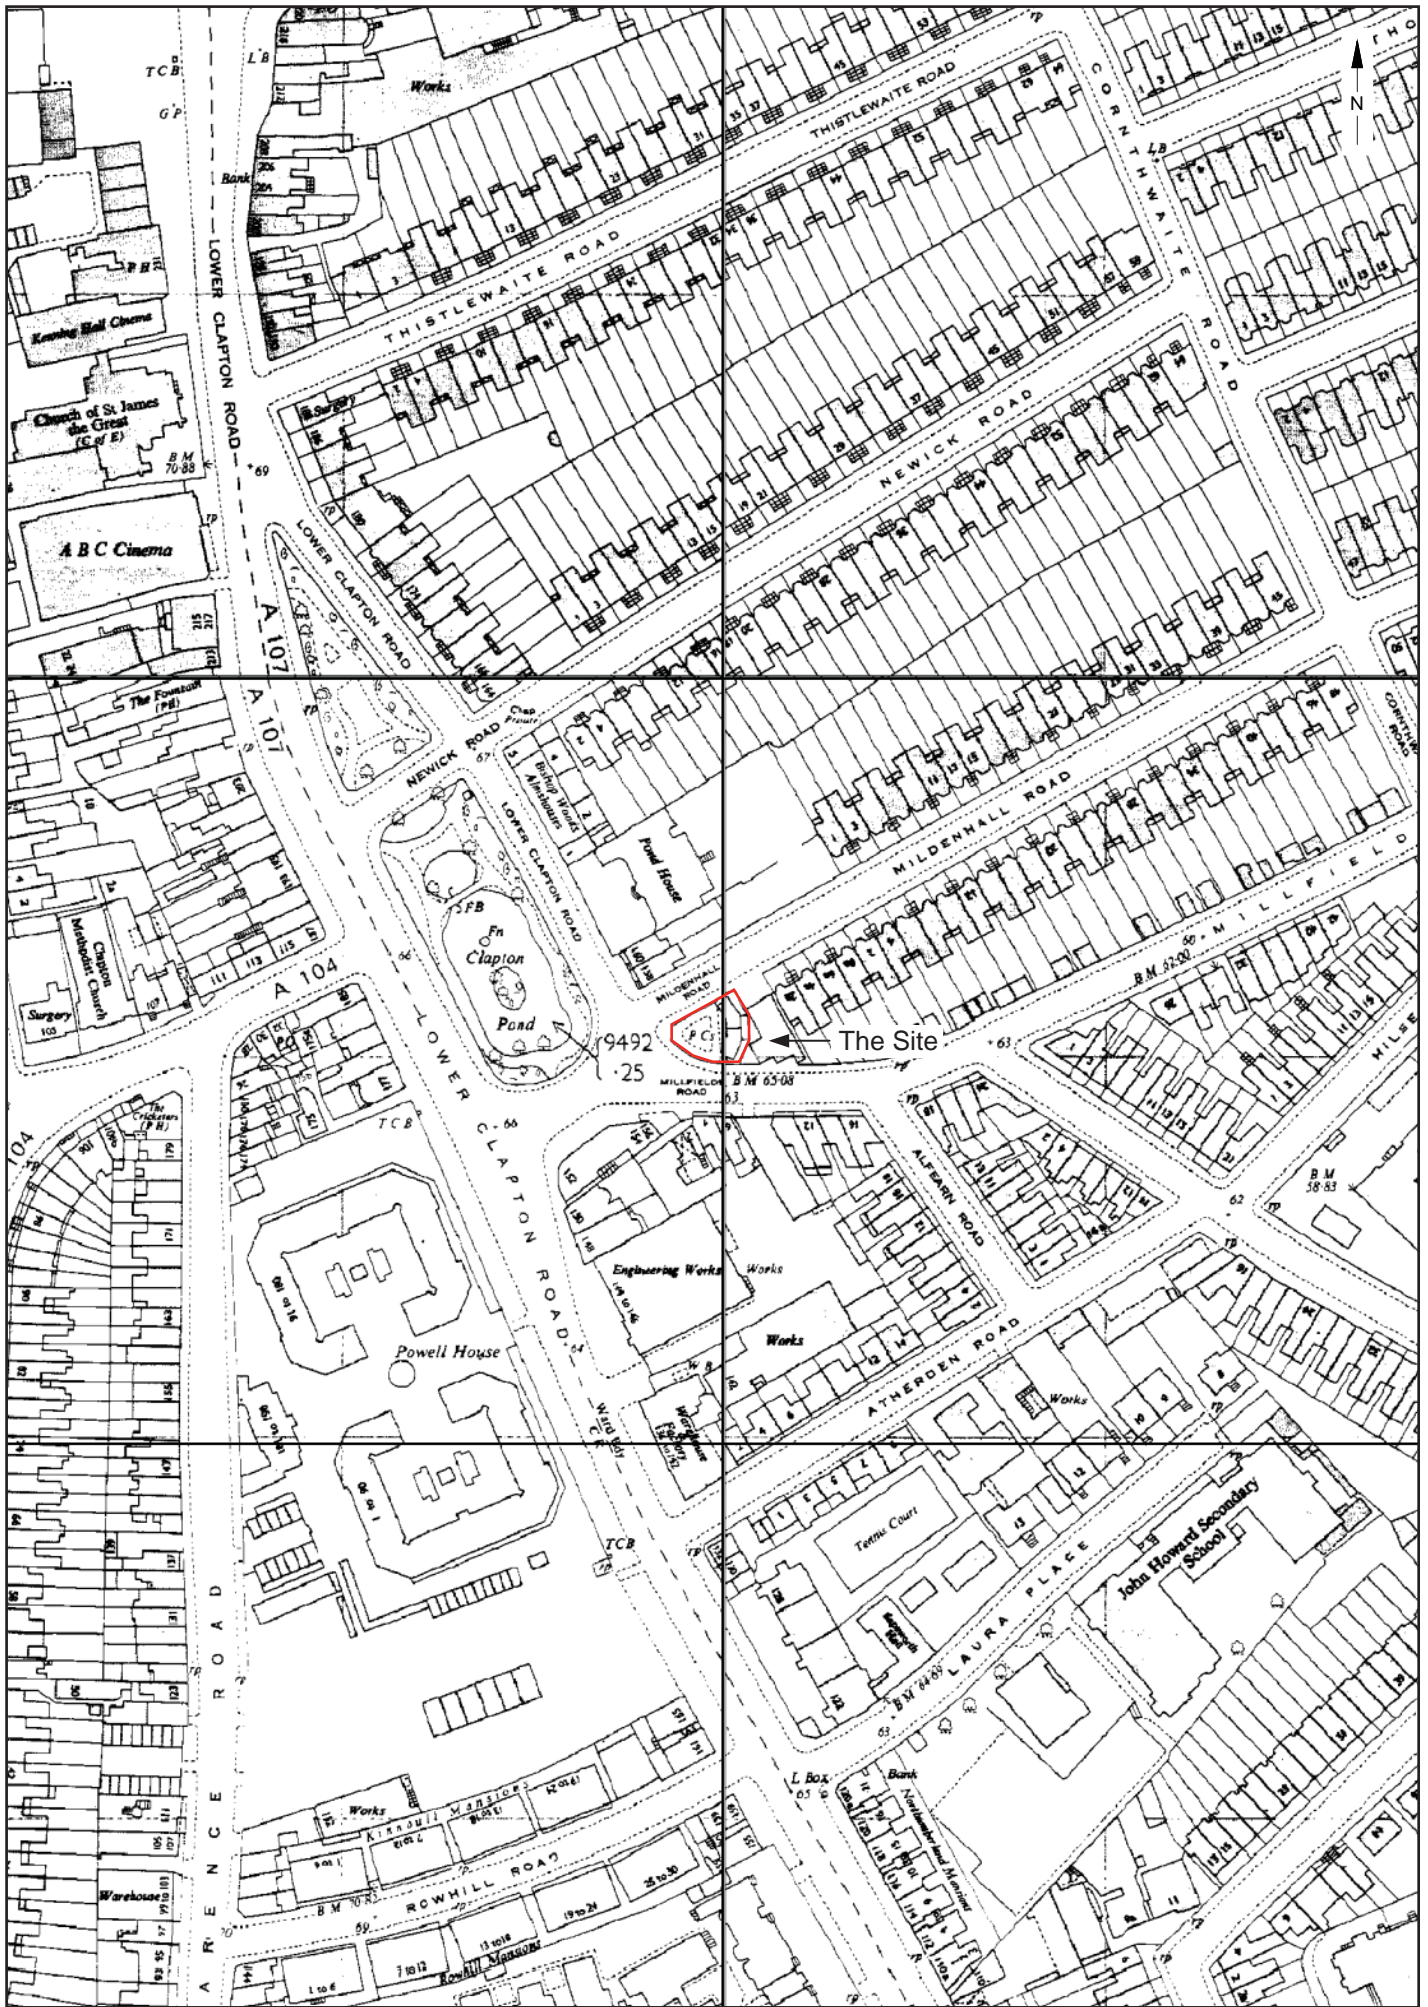
© Archaeology South-East		Former public conveniences, Millfields Road, Hackney	
Project Ref: 8487	Jun 2015	Ordnance Survey, 1966-1970	
Report Ref: 2015450	Drawn by: KRH	Fig. 8

- 4.6 The 1966-70 OS map (Figure 8) shows little change to the site, other than the building of the St. John's Ambulance station to the east. The public conveniences were closed in the late 1990s and sold to private developers.
