**ARCHAEOLOGICAL WATCHING BRIEF AT  
THUNDERLEY HALL, THAXTED ROAD  
WIMBISH,  
ESSEX**

**NGR: TL 56018 36026  
Planning Reference: UTT/13/2930**

**An Archaeological Watching Brief at  
Thunderley Hall, Thaxted Road,  
Wimbish, Essex**

**By Robin Wroe-Brown  
With contributions by  
Gemma Ayton, Isa Benedetti-Whitton and Helen Walker  
Illustrations by Andrew Lewsey**

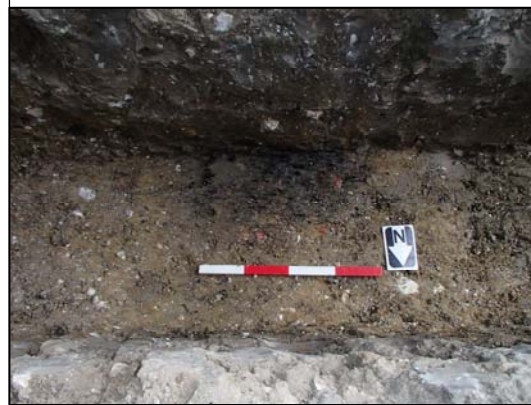
- 4.3.2 Two features were recorded at the base of the trenches (figure 3). The northernmost foundation trench exposed an oval pit cut [018] measuring 0.40m x >0.40m. It was filled with [019], a charcoal-rich silty clay with fragments of burnt clay and chalk fragments. It was not excavated as it was observed at the base of the trench only. Its function was not clear but it could have been a post-hole.

Pit 018 looking south, 0.5m scale

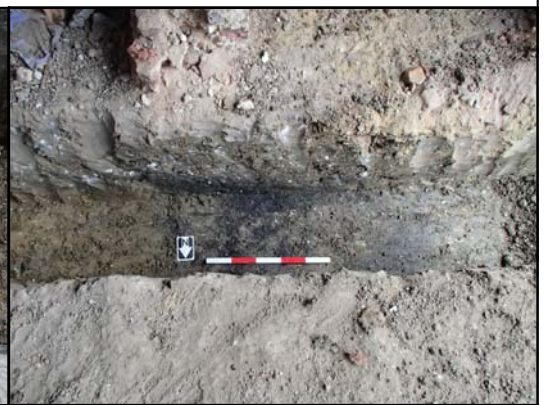
- 4.3.3 At the south end of the south wing's interior was a very similar burnt silty clay, layer [020], which also contained charcoal, burnt clay and chalk fragments. It was observed to overlie the natural [003] and it sloped down to the west to a depth greater than the foundation trench (figure 3, section 1). The highest point at its east end was 0.30m below the ground surface and it continued down to the west beneath the base of the trench at 0.60m deep.

Layer 020 looking south, 0.5m scale

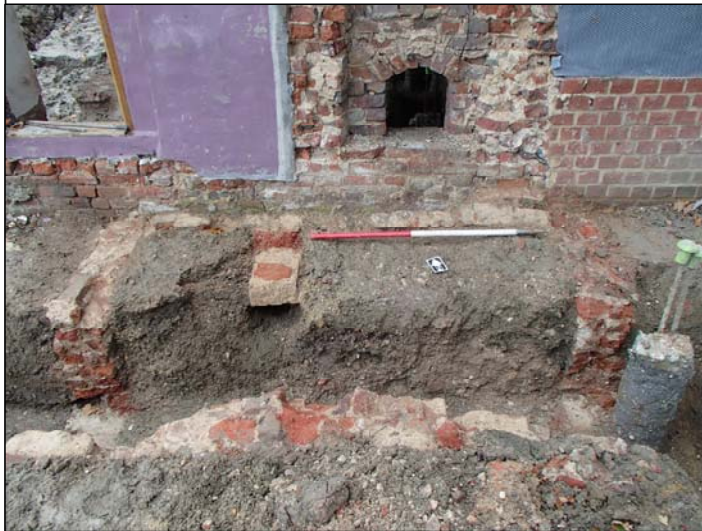
- 4.3.6 This brickwork formed the footings to a small rectangular structure measuring 2.52m e-w x 1.45m n-s and extended more than 0.60m deep. The north side was a single line of bricks built against the south wing footings. An additional north/south interior footing was present towards the west side which was arched underneath and bonded into both the north and south walls of the structure. There was evidence for a stepped base on the south wall where the bottom of the cut for the new foundation trench uncovered part of a line of bricks.

Structure 021 looking north, 1m scale

- 4.3.9 Structure [021] to the south was, in its final use, the footing to an outside toilet (Nick Wilson pers comm). However, this was not its original purpose. It was plainly built with at least some reused bricks of both the 17th and 18th centuries (see 5.3.2 below) making it difficult to date, and it may have been constructed in two different builds. One possibility is that the small north-south arched foundation was the remnant of the footings for an oven, the front of which is present in the standing south wall of the south wing of the hall, although the east wall of [021] did not quite match the position of the east wall of the oven. The arch was bonded into the south wall footing, showing that it was contemporary with this part of the structure (photos, figure 4). Perhaps the most likely scenario is that the oven, and the building to which it belonged, was built along with the south wing in the 18th century, then later demolished to ground level and the footings were adapted for the outhouse construction. Without full excavation it was not possible to determine the full extent of the alterations.

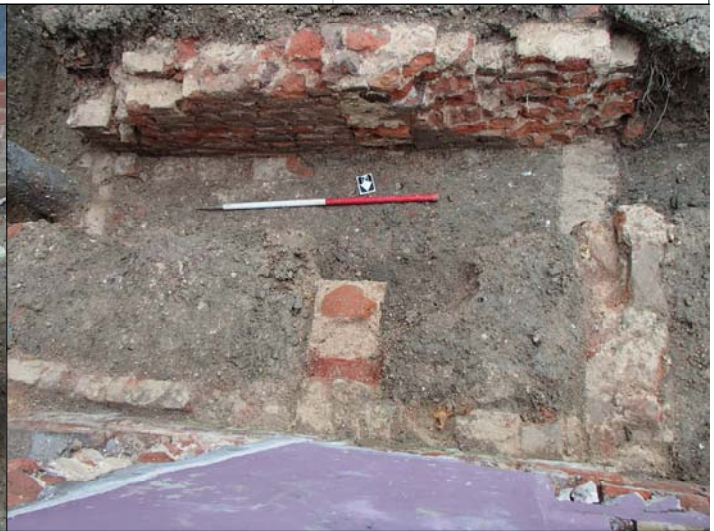
Structure 021 south looking south, 1m scale

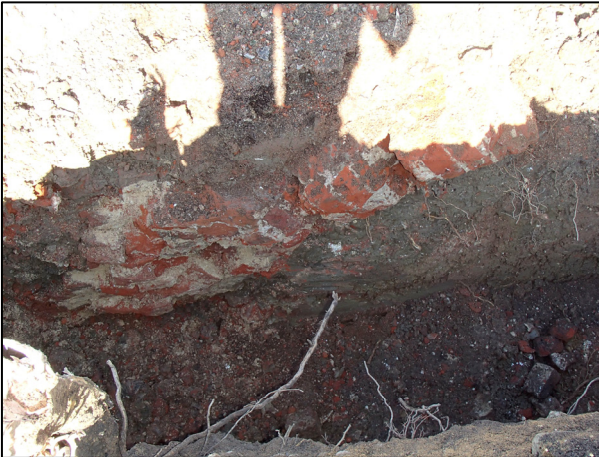
4.4.3 The remains of a red brick wall [012] was recorded in the north section of the south foundation trench in Area 7 (photo, figure 5). The bricks measured 230mm x 110mm x 60mm and the wall was bonded with a coarse pale yellow mortar. The structure was arched and partially collapsed, and would have stood over 1m high, and the highest part of the remaining brick was 0.16m below ground level. The base and part of the arch were still in situ. As with the north trench access was not safe and it was recorded from the top of the trench.

Arched foundation 12 looking north

- 6.1.3 On the west side of the Hall (Areas 7 and 8) the presence of a substantial cut filled with water-lain material suggests that the moat extended northwards from its present terminus. A post-medieval brick arched foundation recorded in section may have spanned the softer deposits in the moat but it had partially collapsed and the relationship was not clear.

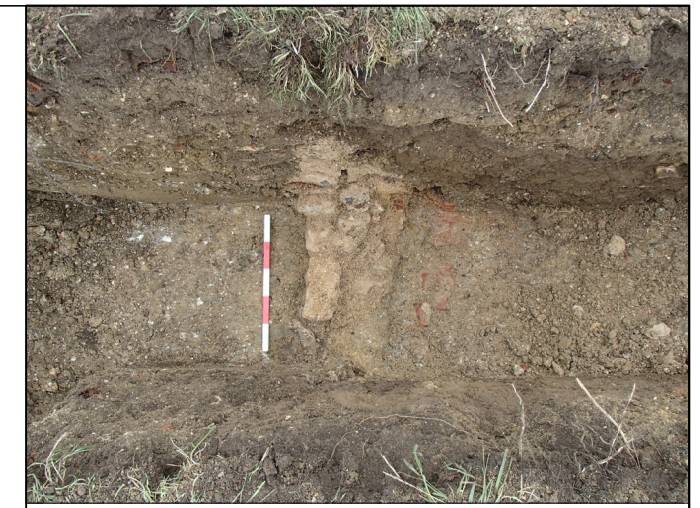
- 4.7.2 An east-west wall footing [004] was observed in the eastern trench (figure 7, section 2 and photo). It was constructed of red brick and flint in a light yellow sandy mortar. Few of the bricks were whole, those that were complete measuring 230mm x 110mm x 52mm, and the flint cobbles were up to 0.14m in size. The bricks were dated to the 16th-17th centuries. It was un-coursed and the mortar formed a high percentage of the context. The footing as recorded was more than 0.50m long, extending beyond both trench edges, 0.40m wide and survived to a height of 0.22m from the base of the trench. The top was 1.05m below the modern ground surface. It was not seen in the foundation trench less than 2m to the west.

Wall 004 looking east

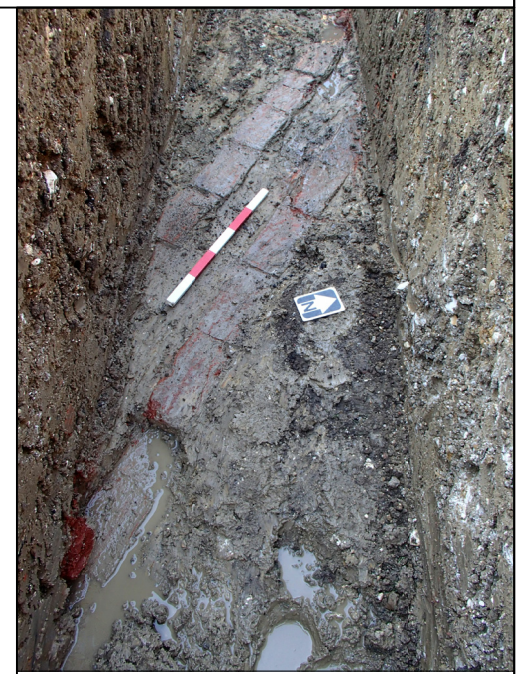
- 4.7.5 Excavation of the northern foundation trench exposed two brick drains [007] and [009] at the base of the foundation cut. They were very similar in construction, each built with two lines of red bricks laid as headers in at least three un-mortared courses forming a drainage channel 0.17m wide between

- 4.7.6 Drain [007] was orientated NNW-SSE and truncated to the south. It was filled with [008], a light grey/brown clay. Recording of this drain was problematic due to its depth at 1.6m below the surface and therefore beneath the water table. A length of 1.20m was found and it was 0.43m wide. The bricks were dated to the 16th-17th century.
- 4.7.7 Drain [009] was 2m to the west on a different alignment, running WNW-ESE (figure 7 photo). It was also filled with a soft light brown clay [010] and it was 1.50m below the ground surface. It measured 1.54m in length as found and was 0.42m wide. It was not traced further south-east across the other garage foundation trenches. Neither drain was excavated as they were only exposed at the full depth of the foundation trench. The bricks were of the same type and date as those from drain [007].

Drain 009 looking west, 0.5m scale

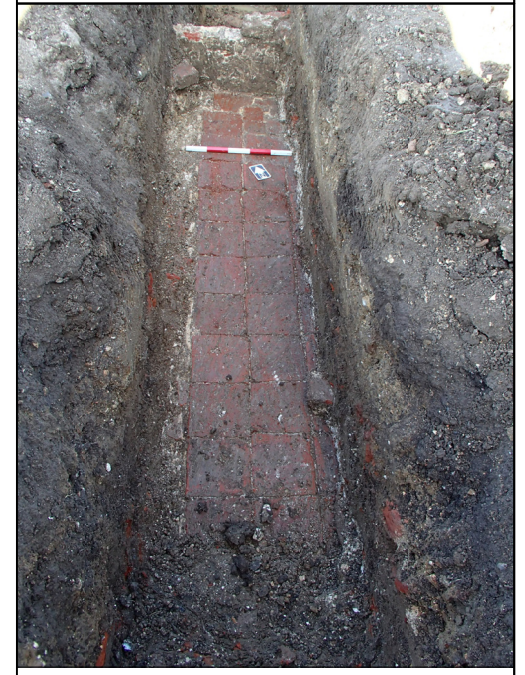
- 4.7.3 An east-west brick wall footing [005] more than 0.65m long and 0.26m wide was recorded slightly further south in the central foundation trench 0.56m below the ground surface. It stood to a height of 0.37m but was deeper than the base of the trench. It was mainly built with half bricks in courses, set in a soft pale cream sandy mortar, but with no particular standard bond. The bricks were 110mm wide and 52mm thick. Up to five courses were observed and the wall was faced only on the south side, the north side being roughly made and un-pointed. The south side was covered with a very thin white plaster.

- 4.7.4 Wall [005] was associated with a tiled floor [006] (figure 7 photo) constructed with red floor tiles measuring 195mm square and 28mm thick, set onto a soft pale cream sandy mortar very similar to that used in wall [005]. The floor was laid up to wall [005] and extended over 2.50m southwards, the length of the foundation trench and beyond. They were laid in a standard checkerboard pattern, apart from some apparent repair work at the north end, and 12 rows survived in the trench. The western extent of the tiles was a true edge of the floor, with compacted mortar and brick rubble beyond. The top of the floor was at 0.92m below the ground surface.

Tile floor 006 & wall 005 looking north, 0.5m scale
