**ARCHAEOLOGICAL EVALUATION**  
**LAND AT THE CENTRAL PILING SITE**  
**COLCHESTER ROAD**  
**HALSTEAD**  
**ESSEX**

**ASE Project No: 160079**  
**Site Code: HSCP16**

**ASE Report No: 2016170**

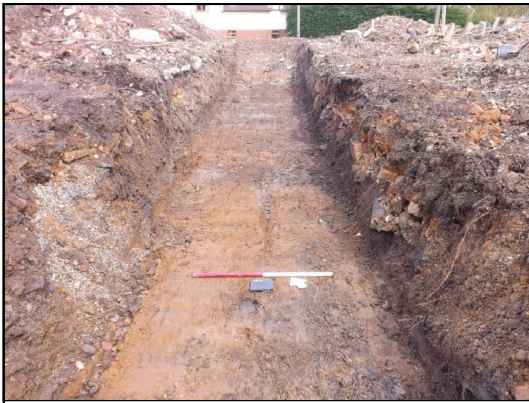
4.5.2 In the eastern half of the trench was a north-west/south-east aligned linear feature [4/008] filled with mid-dark greyish brown clay silt [4/007] seemingly sealed by subsoil [4/004]. Excavation revealed the feature to be a service trench containing a modern ceramic drain pipe. A modern feature containing brick rubble was noted cutting subsoil [4/005] at the eastern end of the trench and a second feature containing plastic pipe was noted in the west. No archaeological features of significance were identified.

Trench 4 (east half) looking north-east, 1m scale

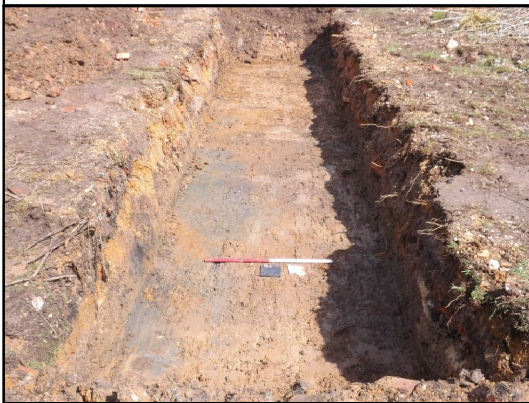
Trench 4 (west half) looking north-east, 1m scale

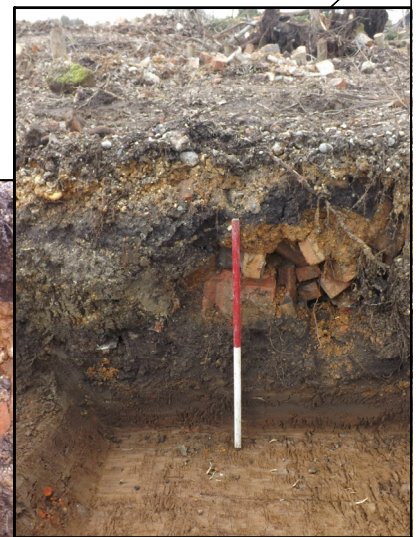
length varied between 1m and 1.1m in depth. The removed overburden consisted of a small amount of modern topsoil [4/001] overlaying mixed modern deposits of brick rubble, ashy silt, sand and gravel [4/002] up to 0.71m thick. These sealed a deposit of buried topsoil [4/003] generally 0.1-0.15m deep but deepening to 0.4m at the eastern end of the trench. Underlying this topsoil was a thin layer of slightly lighter and browner subsoil ([4/004] and [4/005]) which also became deeper (up to 0.3m) towards the east. Three pieces of post-medieval brick were recovered from this deposit including one firmly dated to the 19th century. Natural deposits [4/006] exposed in the base of the trench consisted of orange brown silty clay [4/006] with one or two patches of bluey grey clay possibly resulting from contamination.

Trench 4 sample section north-west facing showing subsoil 4/005, 1m scale

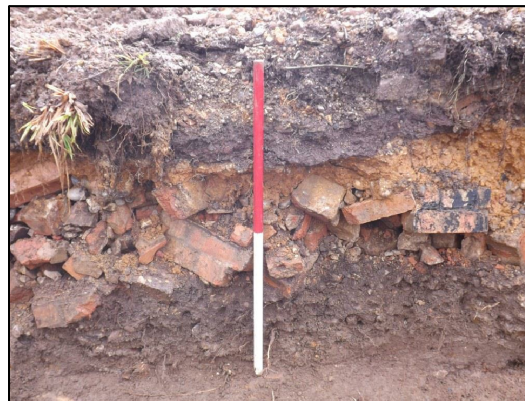
Trench 4 sample section north-west facing, 1m scale

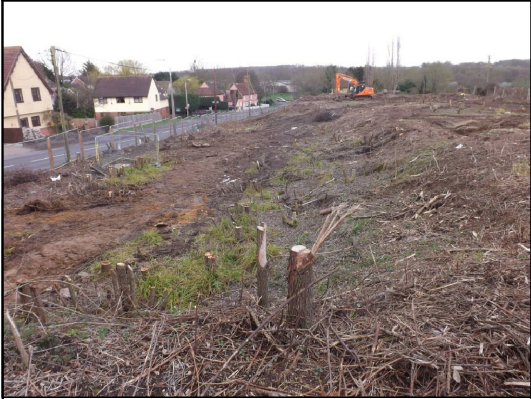
- 7.2.1 Truncation of underlying deposits has clearly occurred in Trench 1 where the top of the c.2m high bank at the north-west end of the trench probably represents the original land surface. It is likely that the truncation occurred during landscaping works associated with the construction of the former petrol station. Elsewhere, there appears to be only localised truncation associated with modern features.
- 7.2.2 Trench 4 was located at the south-east end of a promontory of land which has been cut away on three sides. The land in this area had been artificially raised mainly by the dumping of modern building debris perhaps originating from the near-by demolished garage/workshop buildings. The significant raising of the ground level in this area may not have adversely impacted upon any potential archaeological remains and indeed may have assisted in their survival.

The site looking south-east showing modern terracing
