**Archaeological Watching Brief Report  
Spear Hill Solar Farm, West Sussex  
NGR: 513465 117994**

**Planning Ref: DC/15/1651**

**ASE Project No: 7905  
Site Code: SPF`15**

**ASE Report No: 2016147  
OASIS id: archaeol6-248062**

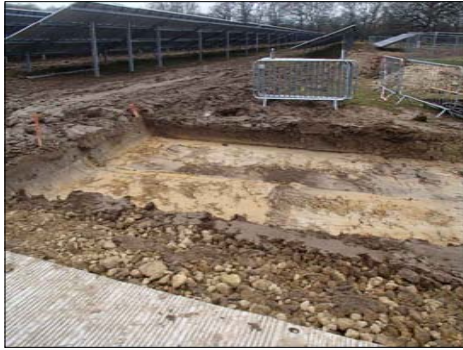
4.1.1 The excavation of all transformer foundation trenches proved to be archaeologically negative.

4.1.2 The nature of the geological deposition remained the same throughout the three foundation trenches. This consisted of:

- [01] A soft brown, mid-grey clay silt topsoil. Small and infrequent amounts of charcoal within and slightly truncated by rooting throughout with a max depth of 0.29m
- [02] A firm, mid-grey yellow natural weald clay with small amounts of natural flint and frequent manganese throughout. Occasional sandy lenses occurred throughout the natural

Fig. 3a West facing photograph of transformer foundation trench

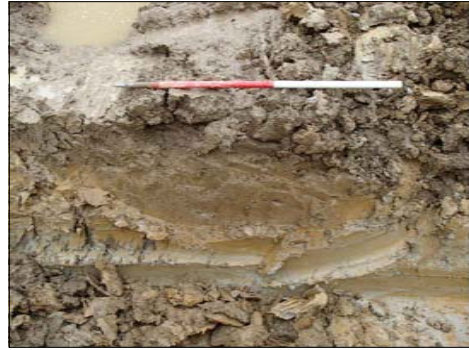
4.2.3 The weald clay natural [02] of earthing trench 67 is truncated by a possible post-

medieval boundary ditch [04] measuring at 1m (visible length) x 1.12m x 0.37m. Occasional CBM fragments were found within its mid brown-grey silt clay fill [03] but no finds were recovered as trench flooded immediately after excavation. It did not reoccur in any other trench excavated.

- 6.3 Earthing cable 67 contained a single archaeological deposit, consisting of a single fill post-medieval ditch [04]. This is most likely part of an old field boundary possibly relating to ones seen in the Ordnance Survey Draft map of c.1800.

Fig. 3b West facing Section of ditch [04] earthing cable trench 67

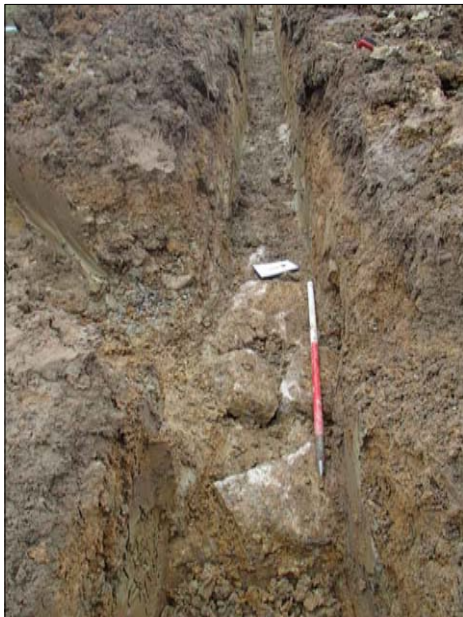
4.2.2 Within the very north of the site there is modern truncation of the natural [02] in the form of crushed/rubble concrete in small areas of deposition around earthing cable trenches 18, 19 and 20.

- 5.0.1 No Archaeological finds were recovered from the post-med ditch [04]; small amounts of CBM and slate appeared in the topsoil throughout the entire site. Broken concrete slabs were found in the north of site within Earthing Cable Trenches 18, 19 and 20 and look to be a modern dump deposit of building rubble.

Fig. 3c Northwest facing photograph of Concrete dump deposit

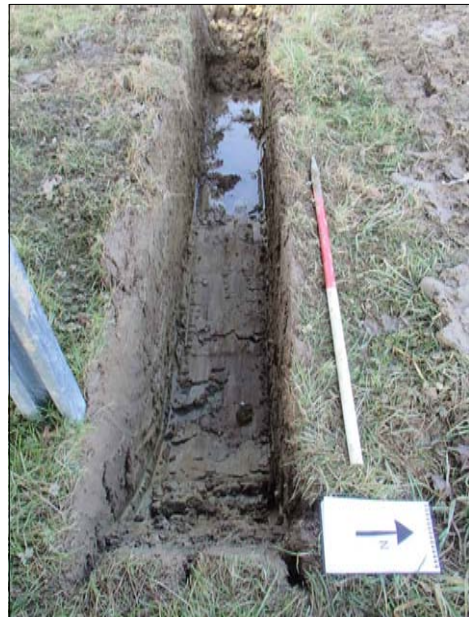
4.2.1 Earthing Trenches 1-66 and 68-91 are all archaeologically negative. These consisted of 1m x 0.6m x 0.8m trenches running parallel to the solar panel frames. The same sequence of geological deposition was recorded in all these Trenches, this consisted of:

Fig. 3d west facing photo of Earthing cable trench 65
