**Hammond's Mill, Billingshurst,
West Sussex, RH14 9GT**

**Historic Buildings Record
(Historic England Level 3)
and Trial Trench Evaluation**

**ASE Project No: 6948
Site Code: MIL 15**

**ASE Report No: 2016168
OASIS id: archaeol6-249746**

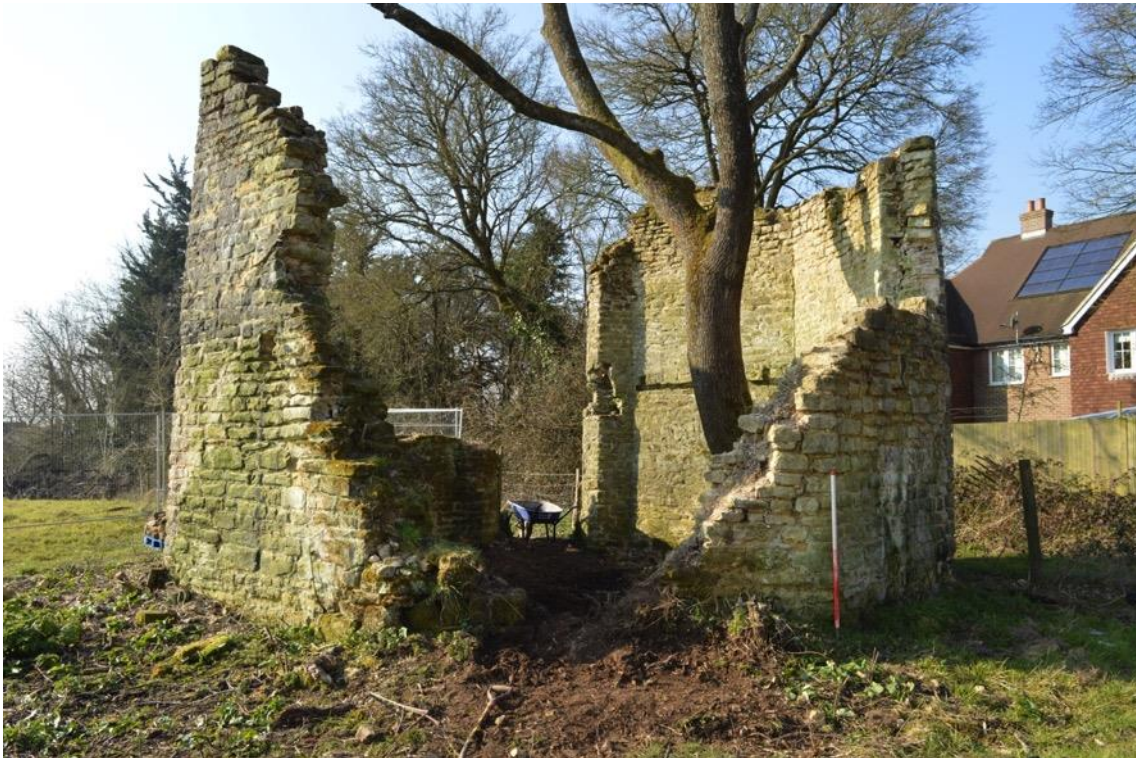
6.3.1 The extant walls of the stone base have been substantially negatively affected by heavy overgrowth and vegetation. The masonry to the north is fragmentary and largely denuded to just above ground level (Plate 1); this has primarily been due to root damage caused by a self-seeded ash tree within the structure's interior. The remaining masonry to the east is in a relatively good condition, with elements of the eastern and western elevations standing to a height of c. 4m. The removal of vegetation has revealed a series of large structural cracks particularly within the western side of the base (Plate 2); these have been identified on Figures 6-13.

Plate 1: Stonework displacement caused by vegetation and overgrowth, Elevation 5 (6948_0015)

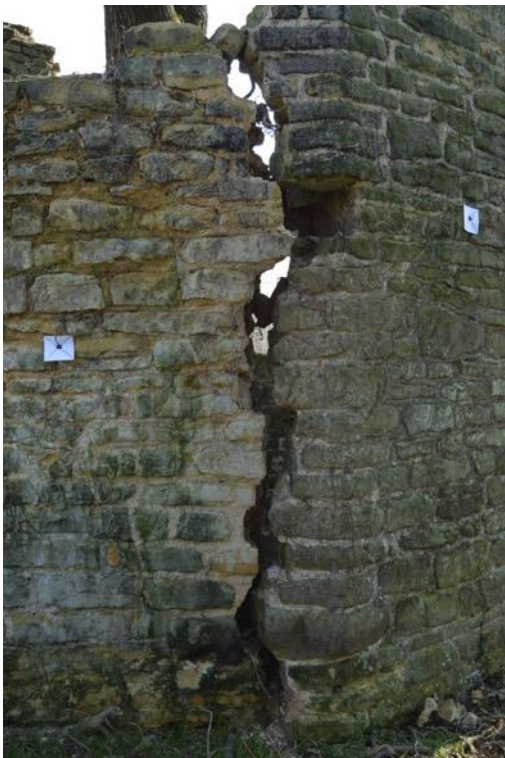
Plate 2: Example of the structural cracks with the base, Elevation 4 (6948_0054)

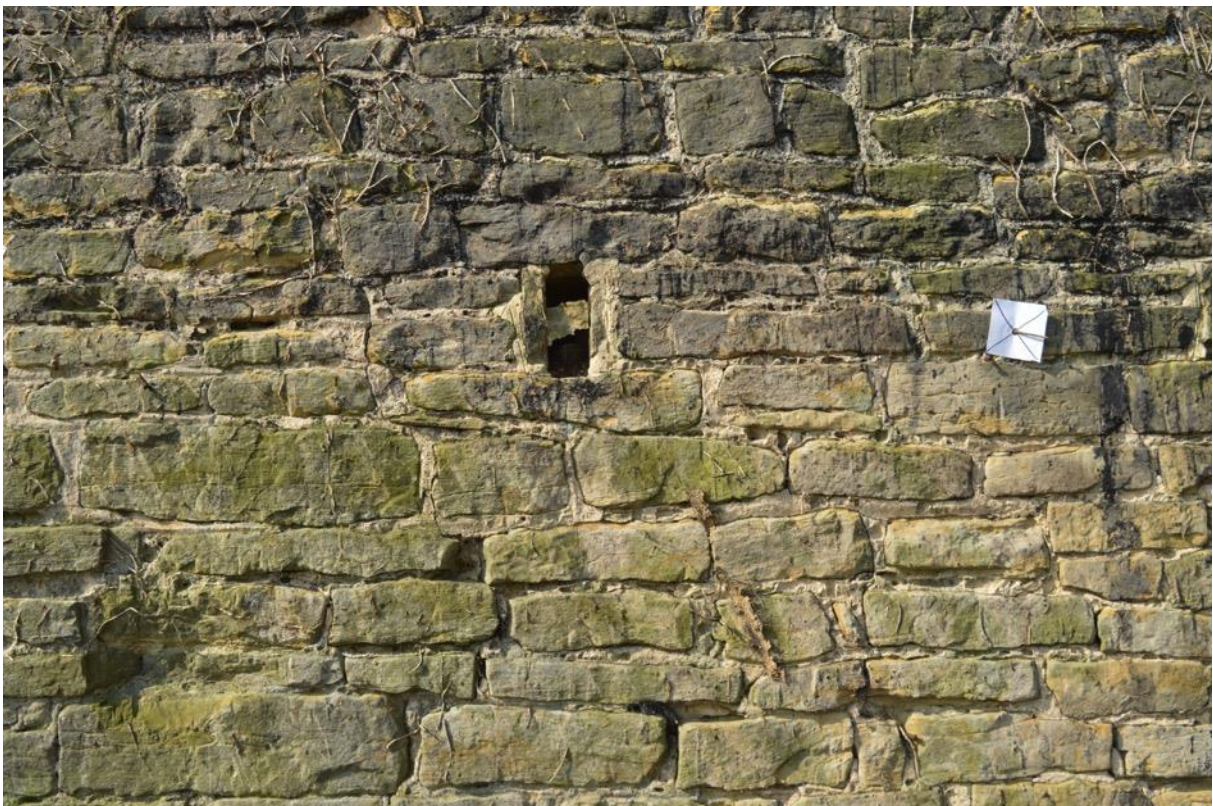
- 6.3.3 The stone is set within a white / yellow lime mortar (Plate 4) with a fine gravel aggregate. Additionally, a substantial degree of repointing and patch repair has been made using modern cement (Plate 5), which is grey in colour, and is found in numerous locations throughout the structure. Cement use appears particularly dominant around the base of the structure on all eight elevations, both internally and externally and is more prevalent on the walls to the north.

Plate 4: Detail of the stonework and the lime mortar composition, Elevation 7 (6948_0023)

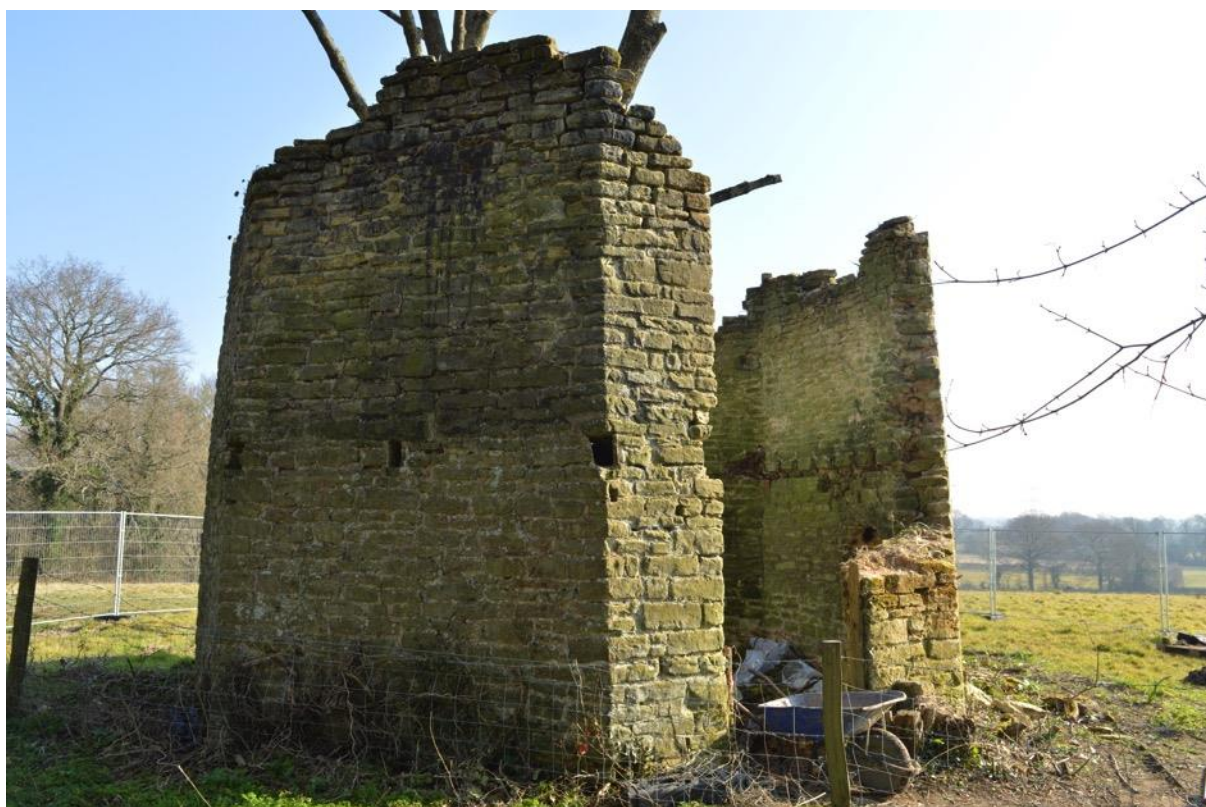
- 6.3.4 The walls of the mill that rise above a standing height of 1.6m (Elevations 1 – 4, 6 – 8) retain evidence of their tar coating, in the form of retained tarred stones and residual staining (Plate 6). The use of tar to coat the walls of the mill was a common practice in the area and was done to protect the walling stone from the weather and to resist damp conditions affecting the produce (Sussex Mills Group 2015).

Plate 6: Detail of the tar staining of the upper level of the stone base, Elevation 2 (6948_0014)

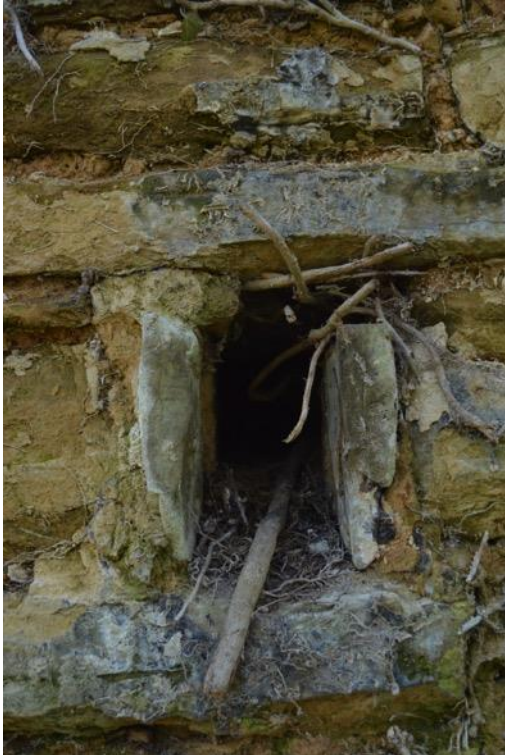
- 6.3.5 Each elevation is relatively featureless, with the exception of three small openings situated on each face (Plate 7) (not visible on Elevation 5 due to degraded nature of the stonework). Each rectangular opening measures a relatively consistent 100mm in width and 200mm in height, and is located approximately 1.93m above ground level, retaining a constant level around the structure's circumference. Each elevation has an opening situated one each at the outer limits and one placed centrally. The openings are angled level with the wall at 90 degrees and extend into the wall's interior face, a small number stop short of the structure's interior wall face, extending to a depth of between 250 – 300mm into the stone. These openings comprise redundant sockets that formerly held the timber brackets forming the underside support posts to a timber reefing stage situated above (also referred to as a 'reefing stage'). The reefing stage would have been comprised wholly of timber and would have run around the full circumference of the base to allow access to the sweeps (Sussex Mills Group 2015) (see Appendix 1). Due to the angle and location of the sockets, the reefing stage structure appears to have been supported by the means of upright posts from ground level, opposed to the use of angled struts as is more commonly found within the Sussex area.

Plate 7: Detail of an external socket for the gallery timber brackets, Elevation 6 (6948_0055)

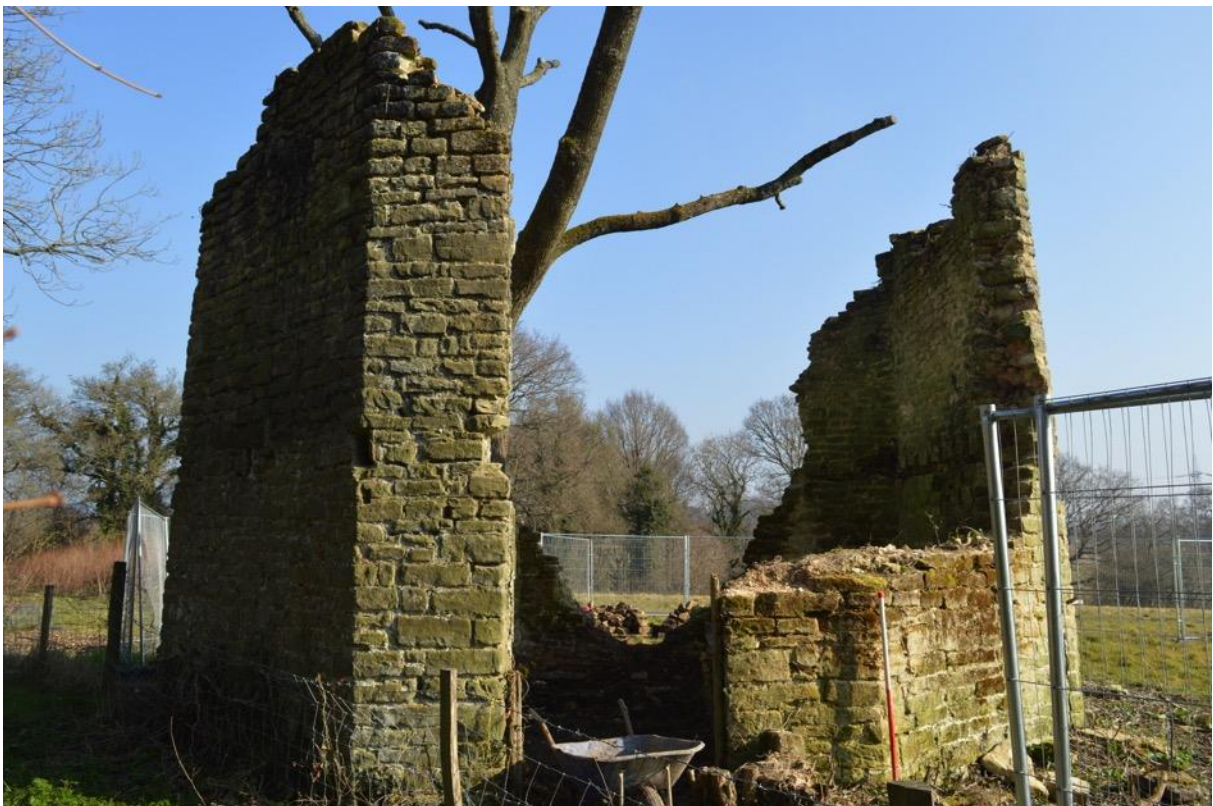
- 6.3.6 The structure is accessed at ground floor level by a single doorway situated within Elevation 1 on the south-west side of the mill (Plate 8). The opening is located centrally within the wall and measures a width of 1.20m. Located to either side of the doorway are the remains of two slender timber jambs, measuring a width of 40mm, 100mm in depth, and surviving to a height of 0.86m and 1.28m. The relatively sound condition of these suggest they form a later phase of development than the building's original construction date, and are as such unlikely to form part of the original door fitting (Plate 9). The western door jamb has a thick strip of cement render situated down the internal edge.

Plate 8: Retained ground floor level entrance, stone lintel and date stone formerly situated above not removed, Elevation 1 (6948_0017)

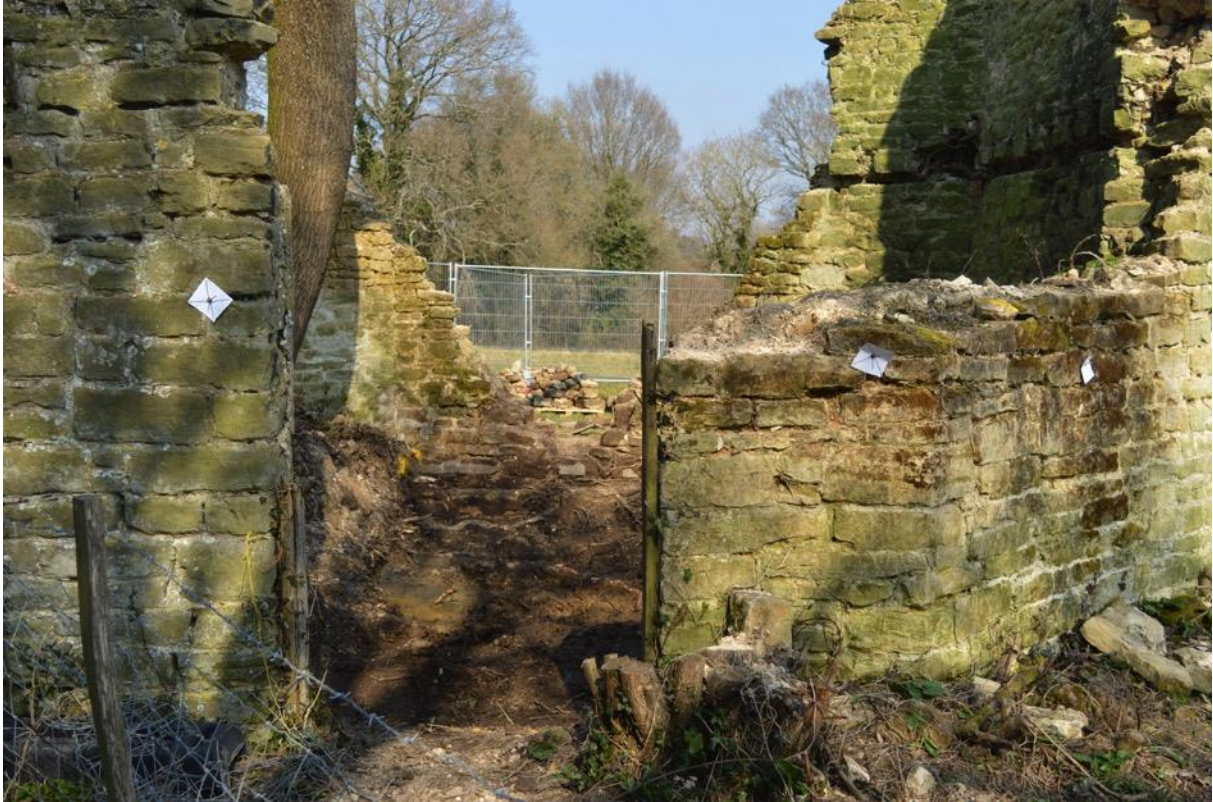
Plate 9: Detail of the timber door post located either side of the south-west ground floor level doorway, Elevation 1 (6948_0026)

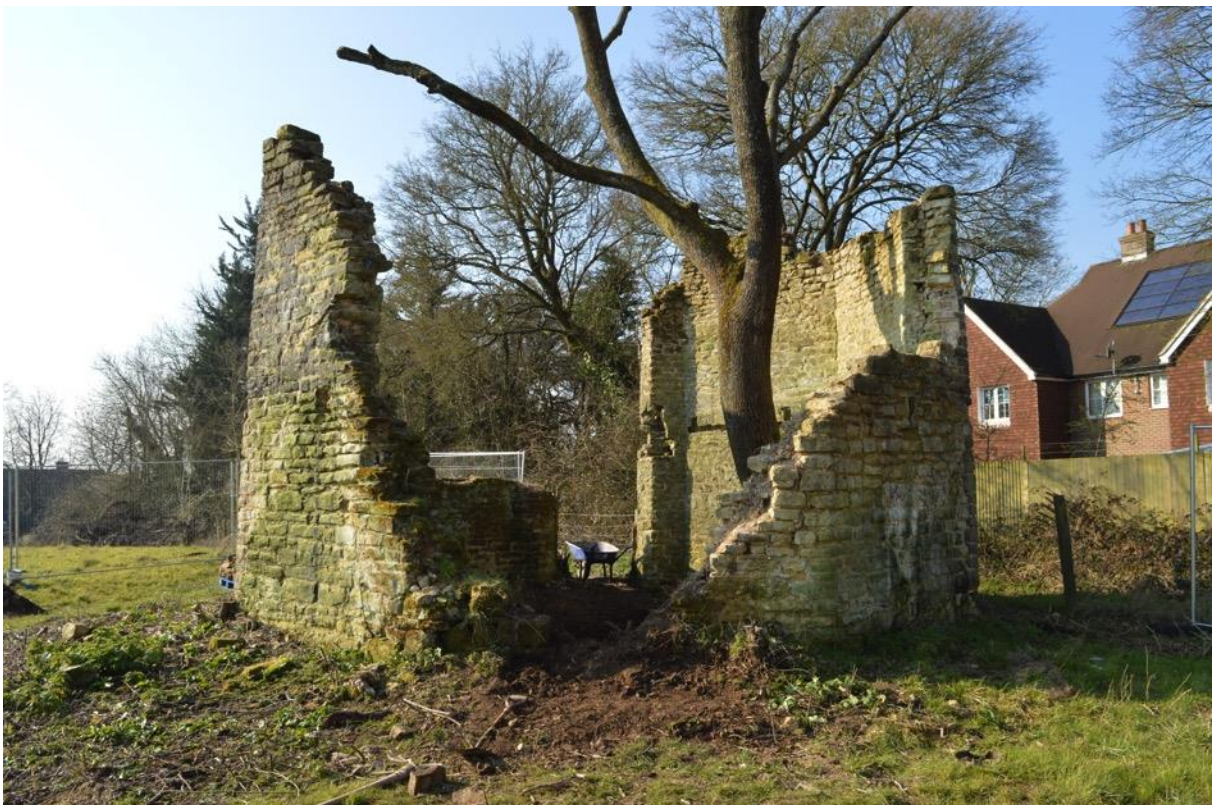
to the reefing stage in the occasion that the sweeps were situated adjacent the south-west doorway. Evidence of a doorway within this elevation can no longer be evidenced due to the degraded nature of the stonework (Plate 10).

Plate 10: Location of former doorway to the loading bay at first floor level, Elevation 5 (6948_0016)

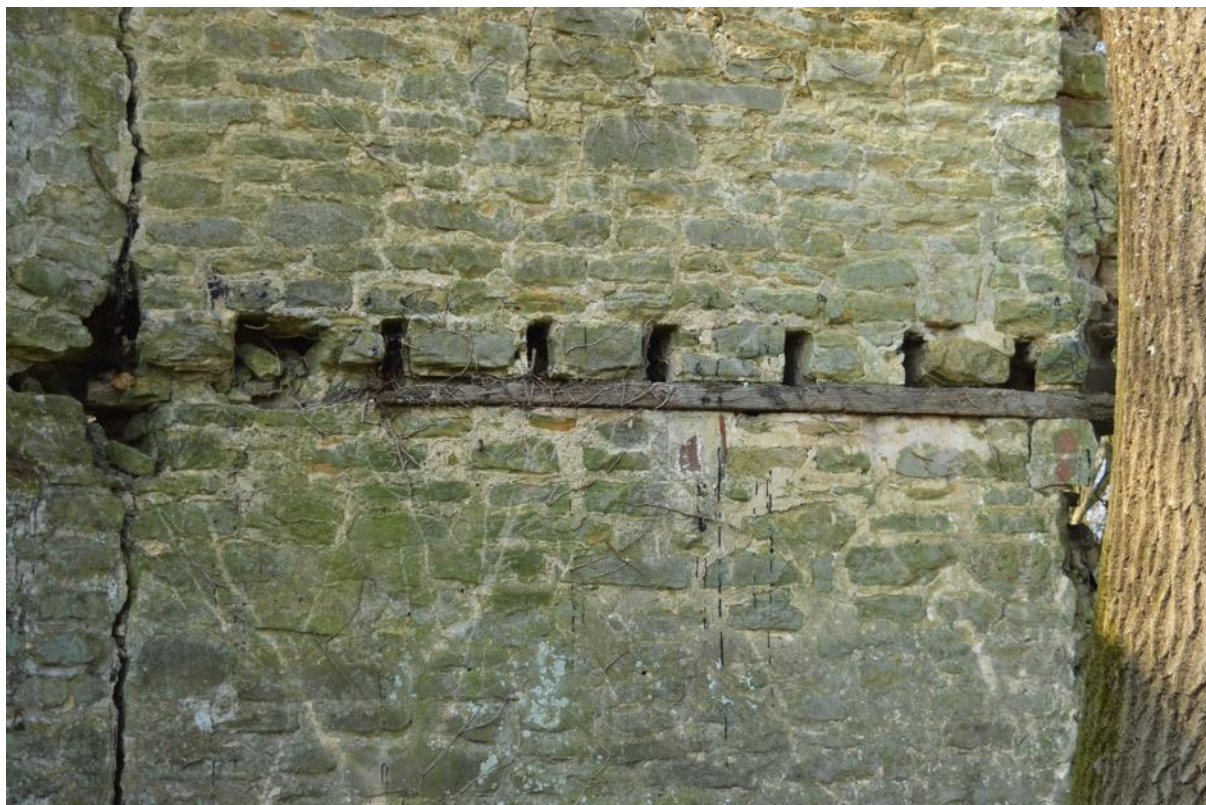
Plate 17: Detail of a wall set horizontal timber beam and floor joist sockets, Elevation 3 interior (6948_0041)

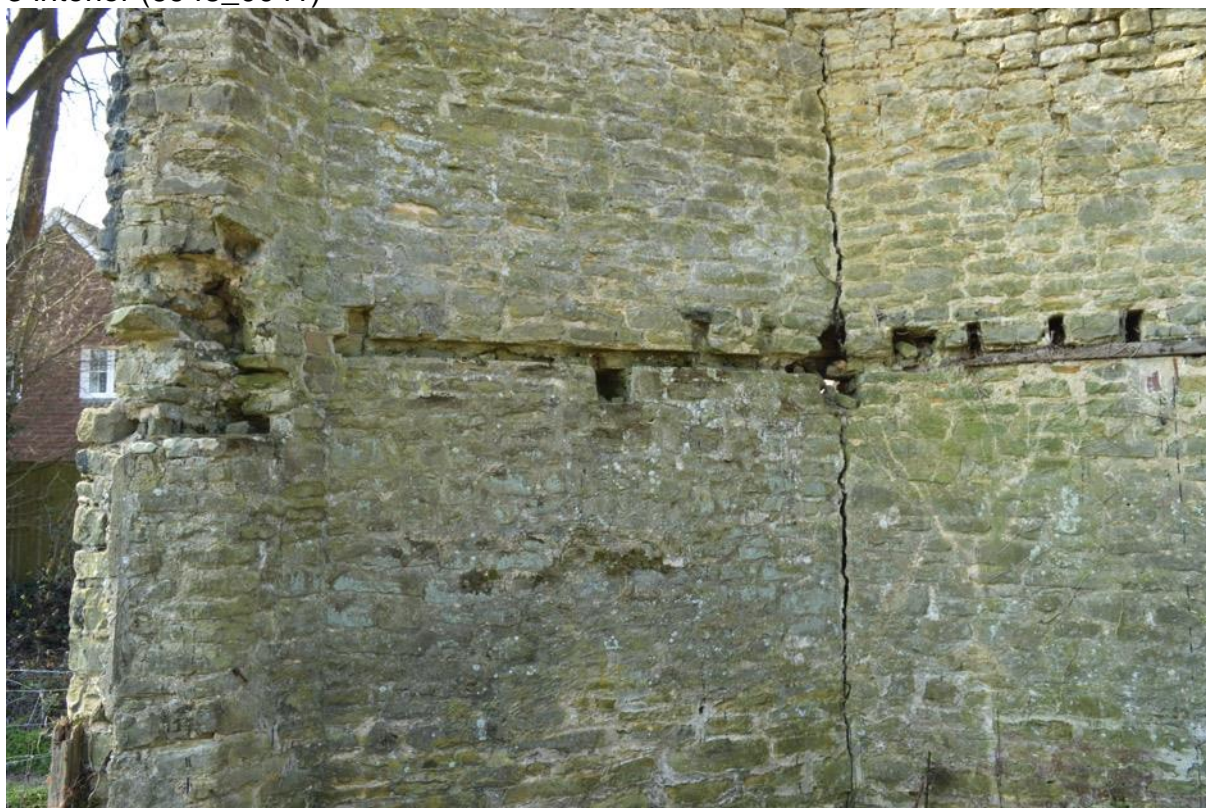
Plate 18: Detail of the redundant incision left by the location of a former horizontal beam, note the fewer floor joist sockets, Elevation 2 interior (6948_0039)

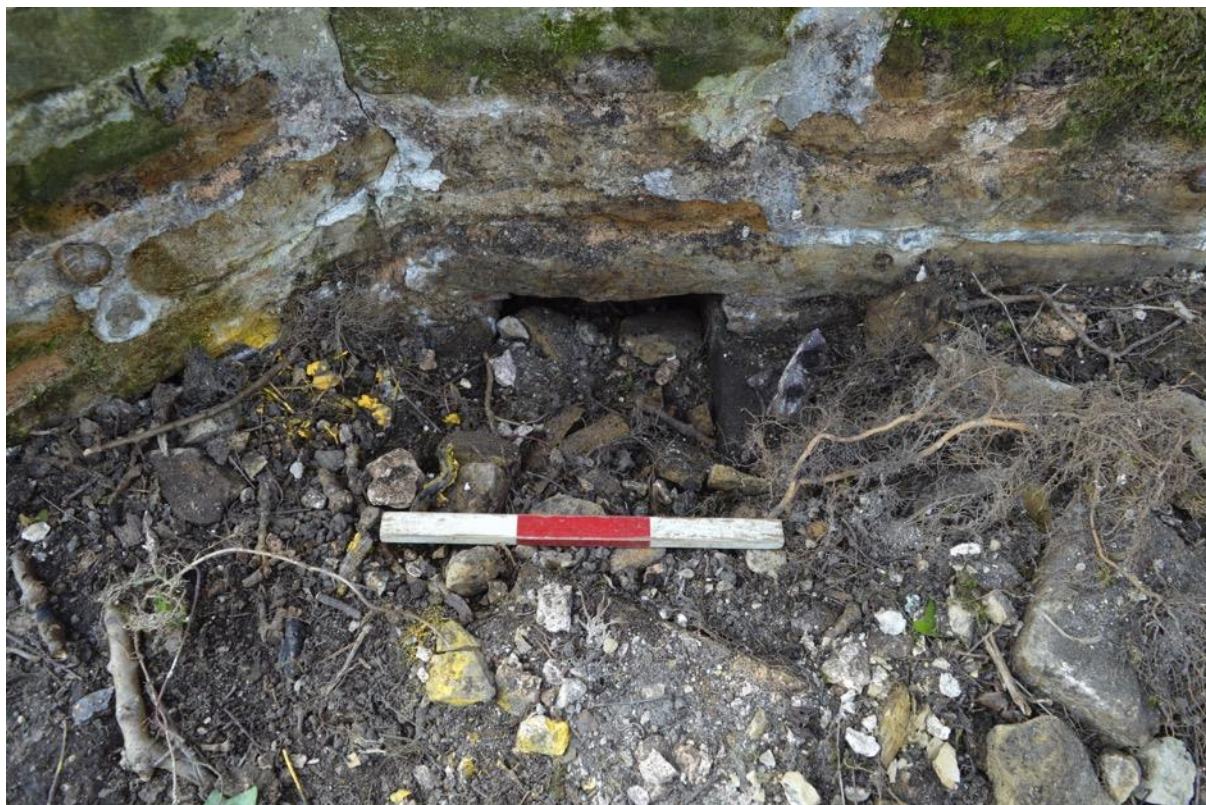
Plate 19: Detail of the opening within the south-west corner of the mill, possible drainage channel or ventilation shaft, Elevation 2 (6948_0036)

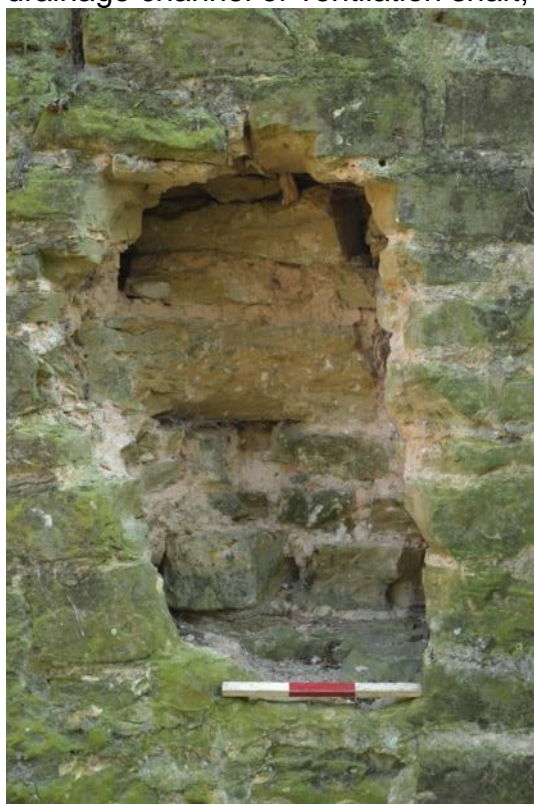
- 6.4.4 Other features of note within the mill's interior include a large recess (Plate 20) within the eastern wall measuring a width of between 280mm and 660mm and stretching to a height of 920mm. However, it appears as though this recess is due to structural failure rather than an intended feature.

Plate 20: Detail of the large recess within the stone base internal wall face, Elevation 7 (6948_0043)

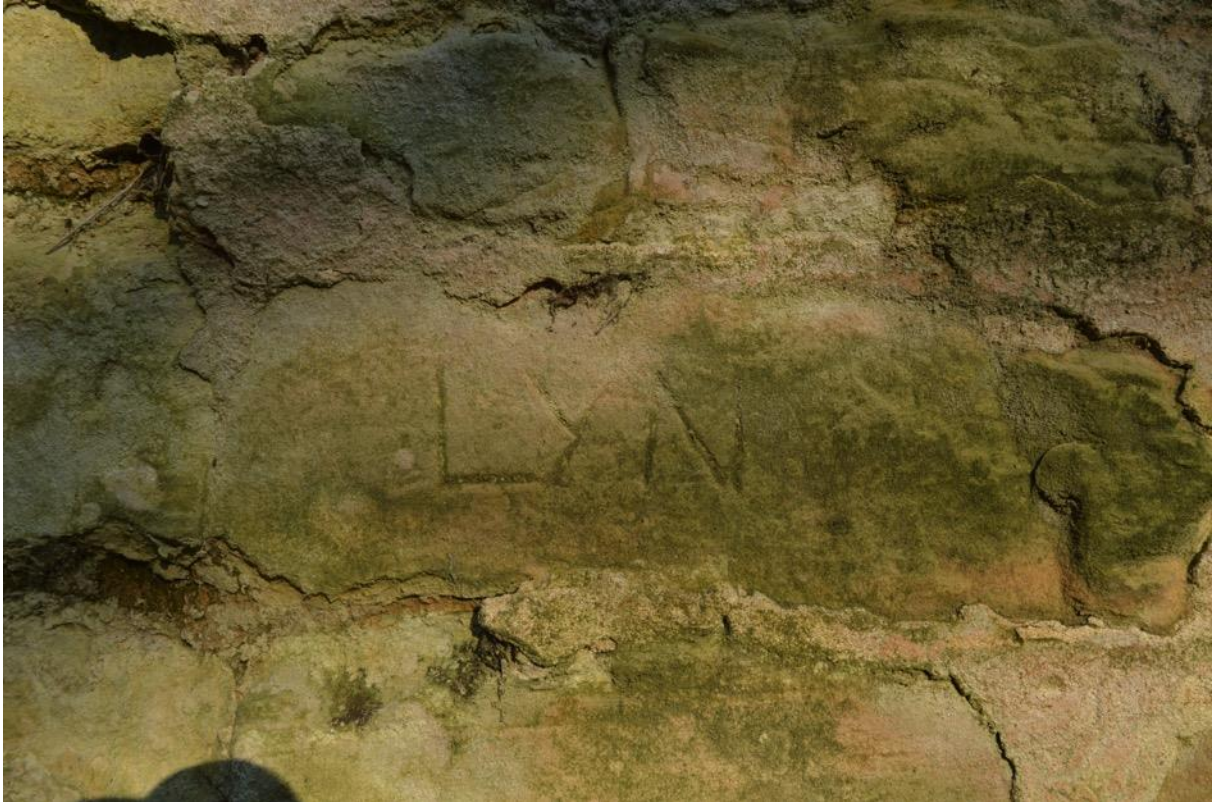
- 6.4.5 Within Elevation 6 is an additional graffiti inscription (Plate 21) it reads the name or initials 'LYN' (Ref. 5) The incision comprises a deep scratching of the stone face and lacks the clarity of those found externally (refs. 1,3 & 4); the identity of the maker could not be identified.

Plate 21: Detail of Inscription 5, 'LYN', Elevation 6 (6948_0080)

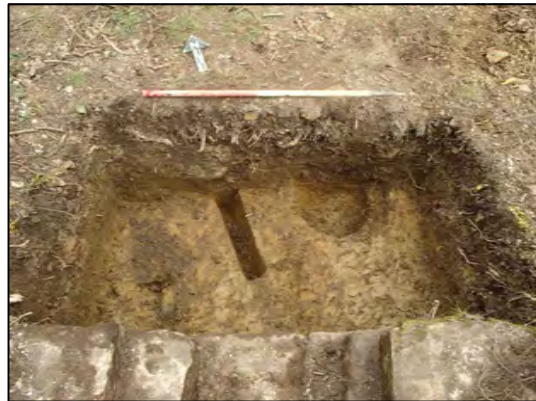
- 7.2.5 A second smaller circular posthole [3006] was partially revealed at the far north-east end of the trench, external to the windmill. The feature was sealed by rubble deposit [3002] and cut subsoil [3008]. Posthole fill [3007] comprised a friable mid brown silt clay with occasional orange staining and occasional sandstone inclusions. An assemblage of pottery and iron artefacts were retrieved from the feature with a date range of AD 1800-1840.

- 7.2.8 Finally, a land drain [3015] was identified to the north-east of the mill, immediately to the west of posthole [3006], orientated on a north-south alignment. The feature cut the natural substrate [3013], was sealed by subsoil [3008] and was filled with a deposit almost identical to subsoil [3008]. The drain appeared to be truncated by the windmill foundation [3005]. No finds were retrieved from the feature.

3006 and 3015 looking north-east

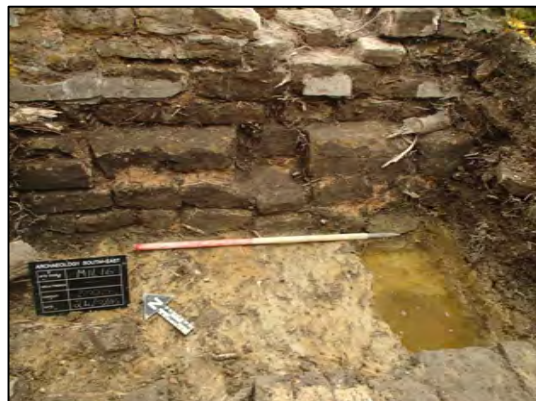
- 7.2.6 A sondage was excavated internally to the mill to assess the depth of foundation [3005]. The foundation did not appear to lie within a construction cut but instead sat directly on the natural deposits [3013]. The foundation stood to a height of 0.85m and was overlaid by wall [3000].

Foundation structure 3005 looking north-east
