**AIR-RAID SHELTERS AT THE FORMER PRITTLEBROOK INDUSTRIAL ESTATE,  
PRIORY CRESCENT, SOUTHEND, SS2 6JX**

**HISTORIC BUILDING RECORD  
(HISTORIC ENGLAND LEVEL 3)**

**Site Code: SSPB15  
Project No. 8231  
Report No. 2016215  
OASIS ID: archaeol6-253697**

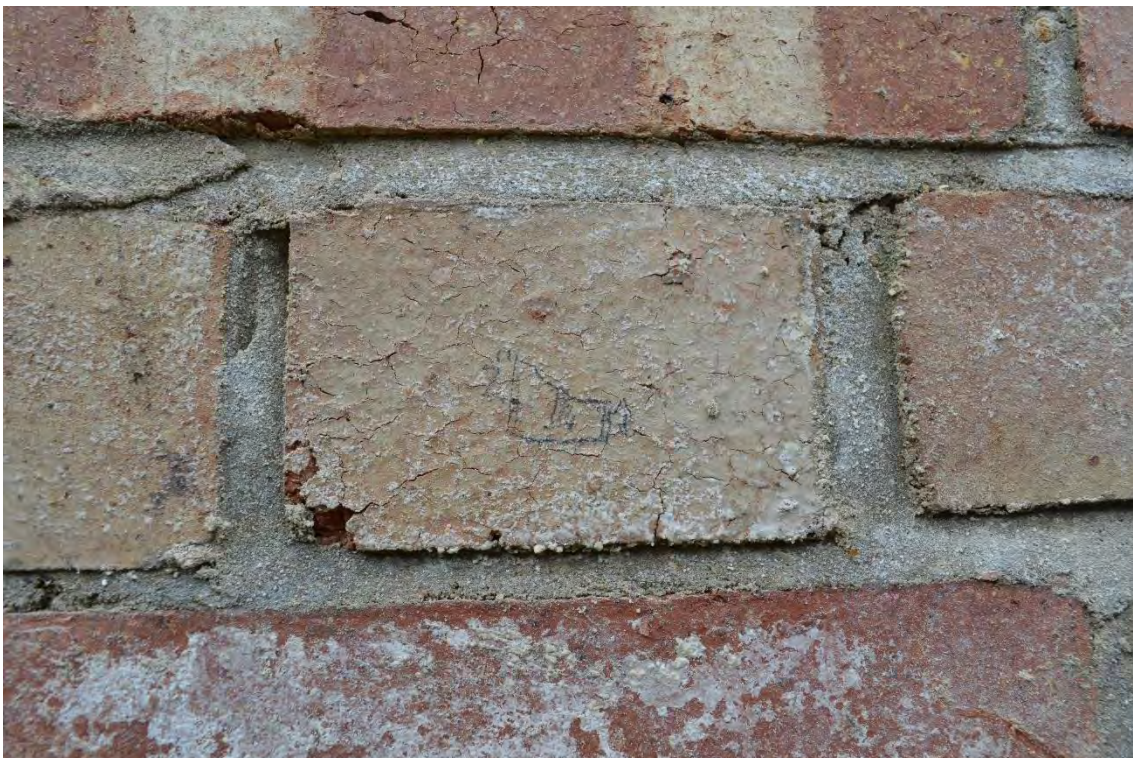
Plate 6: Shelter 4, fitting-out diagram within the west gallery, facing west (52)

- 5.3 A collection of pencilled graffiti was recorded on the Fletton brickwork throughout the structure. These inscriptions included various measurements, initials and dates (Plates 6, 7 and 8). The most notable of which include two dated examples; the first noted within the southern end of the west gallery, upon the western wall read '28 – 3<sup>rd</sup> – 40 / 45 / 46 ?' (Plate 9), the second was located to the west side of the south-west escape hatch passage, 'D.S.C.N. 1939 / 89' (Plate 10). Due to the nature of the pencilling and dark brickwork inclusions it was difficult to define the dates, as such it is important to note that the graffiti recorded above are interpretations only. The dates do however appear to conform to the period of occupation of the shelter during WWII, the probable 1939 date in particular coincides with a period of pre-war expansion of the Ekco factory works over the western half of the site, suggesting a probable date for the shelter's construction.

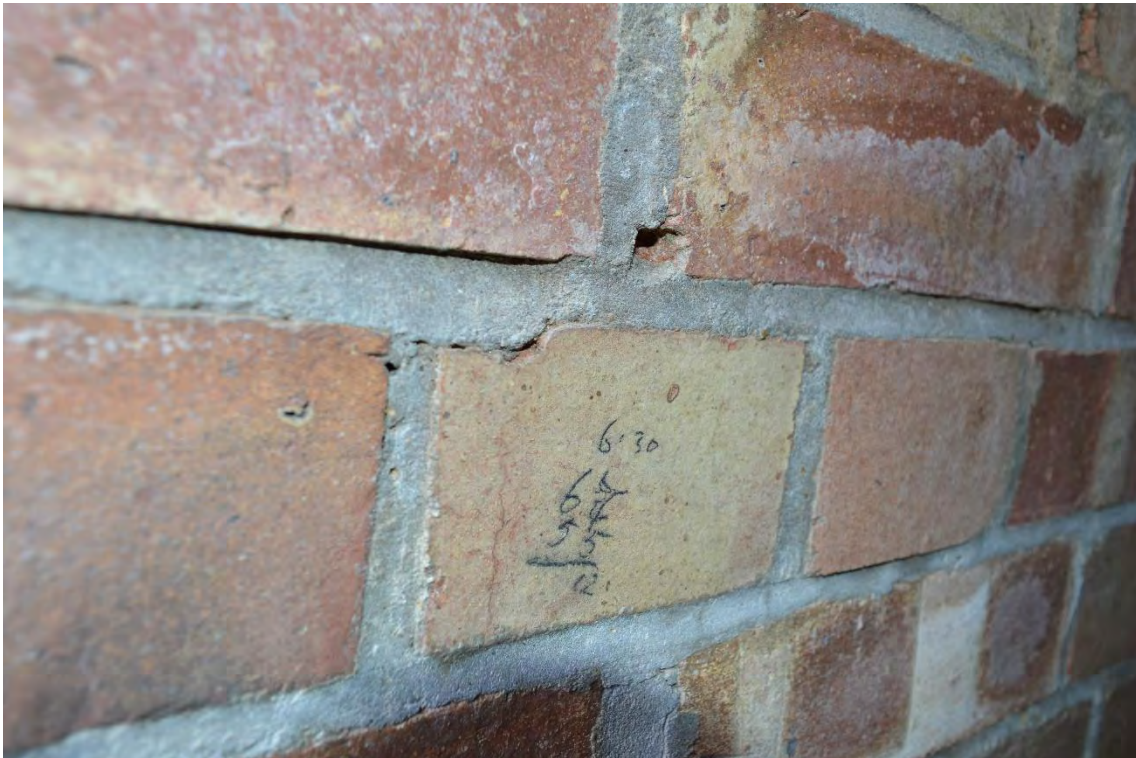
Plate 7: Shelter 4, fitting-out measurement located within the southern passage, facing north-east (58)

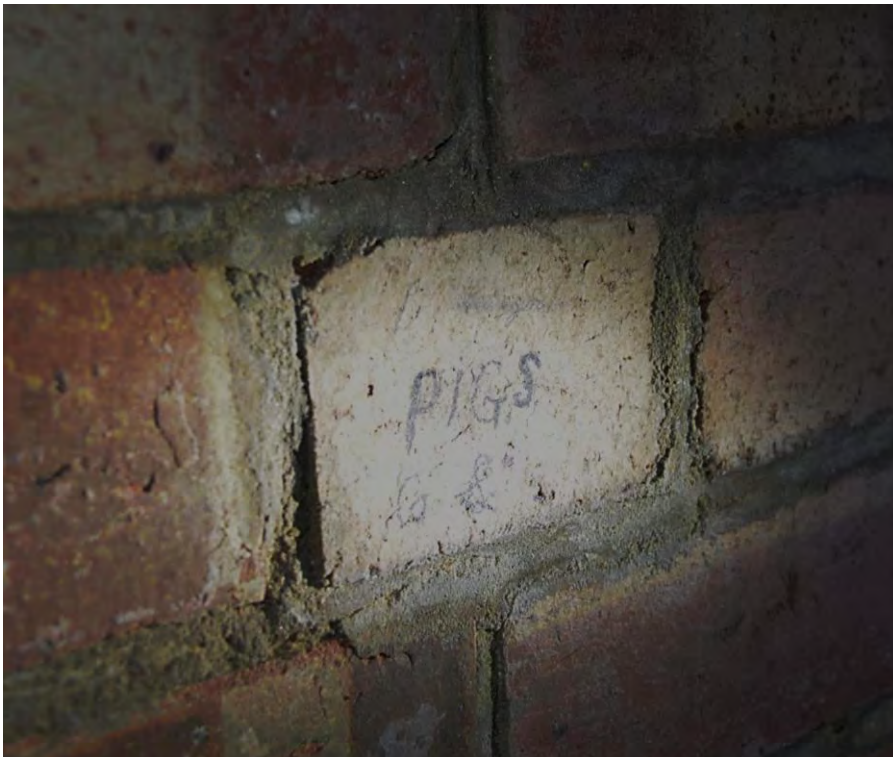
Plate 8: Shelter 4, written graffiti reading '? PIGS Co. &', located within the southern passage below the south-west escape hatch, facing south-east (66)

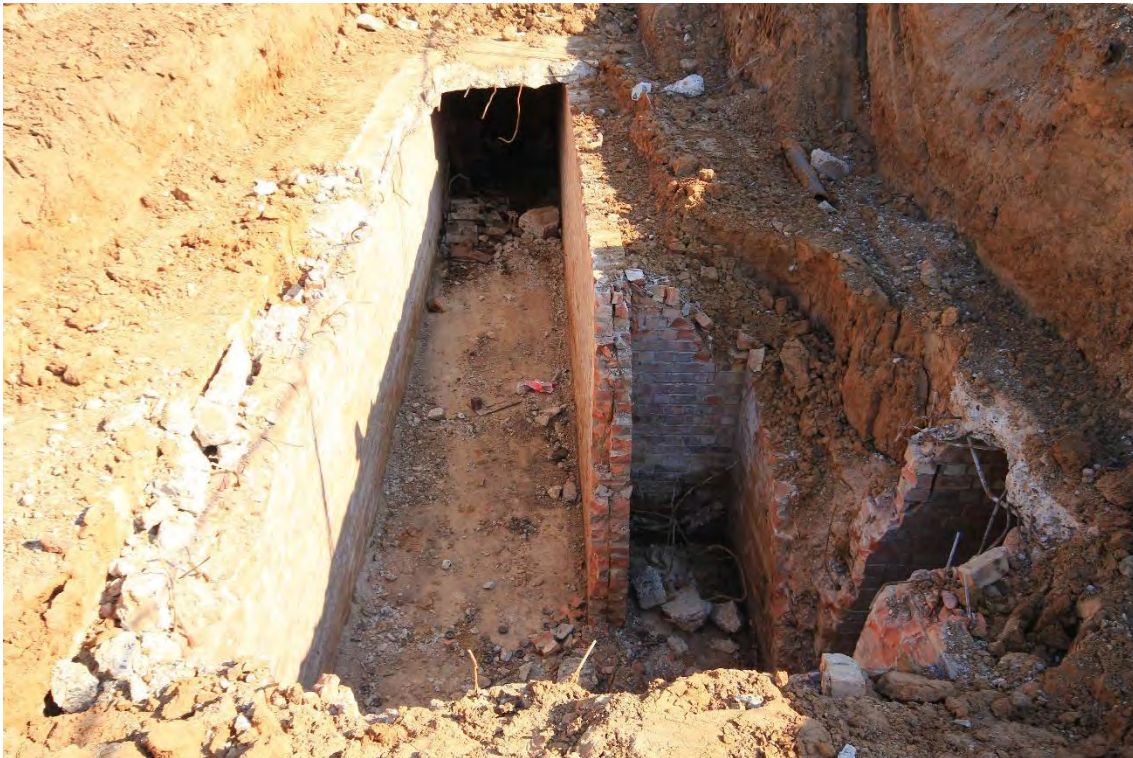
Plate 11: Shelter 4, west gallery viewed from ground level, facing north (9)

- 5.4 The western gallery (Plates 11 and 12) follows the usual arrangement as elsewhere, constructed with English-bonded Fletton brickwork, with concrete floor and ceiling. The gallery is set beneath c.1.28m of earth with a ceiling height of 1.99m. The east and west walls appear to be reinforced on their outer edge by an additional concrete skin measuring a width of c. 0.10m (Plate 13). The gallery measures a width of 1.52m and extends 12.81m in length, which conform to the recommended dimensions required to accommodate 50 persons per gallery/100 per shelter (Nash 2008).

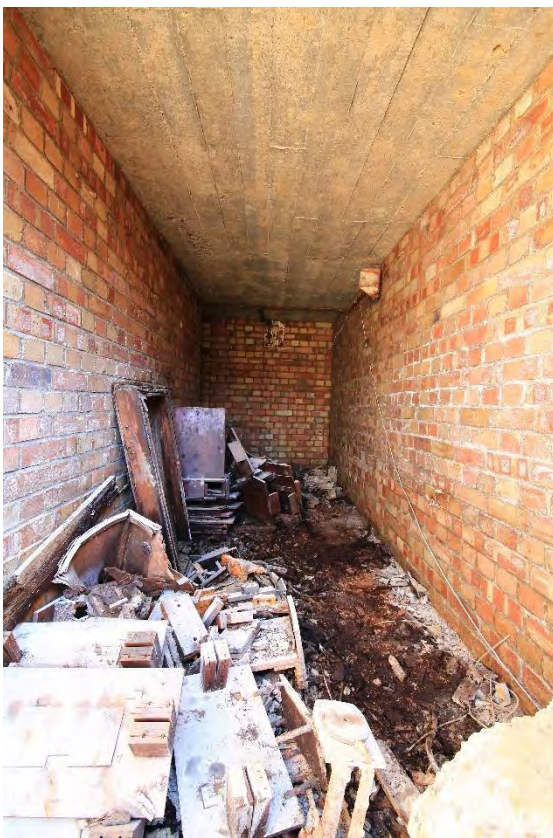
Plate 12: Shelter 4, northern end of the west gallery, facing north (27)

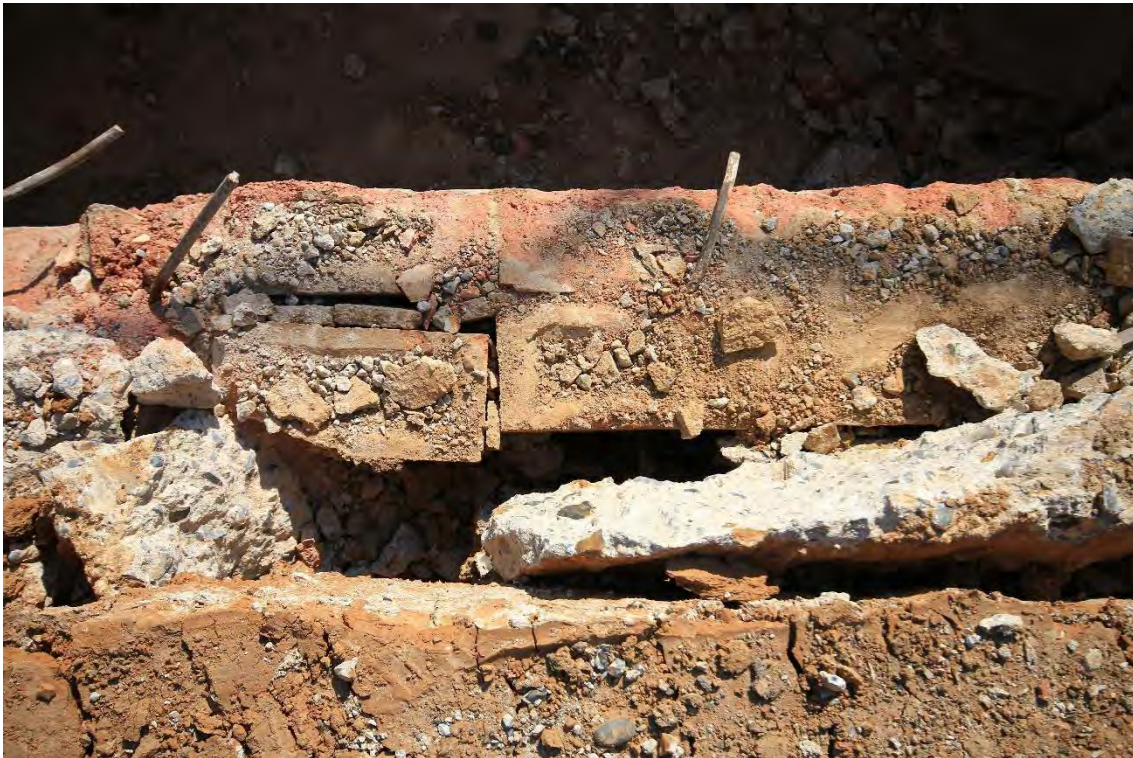
Plate 13: Shelter 4, western wall of the west gallery, note: combined brick and concrete construction, facing east (down) (7)

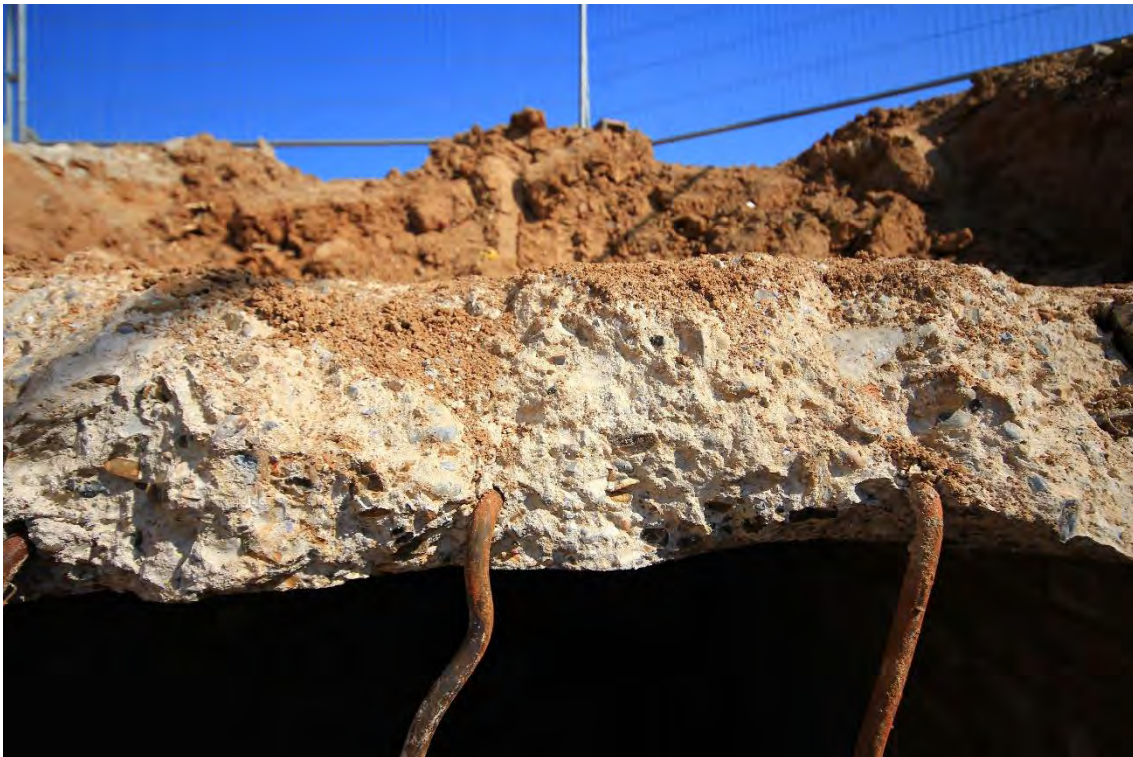
Plate 14: Shelter 4, detail of the reinforced concrete ceiling above the west gallery, facing north (30)

- 5.5 Both galleries comprise a thick reinforced cast concrete ceiling with large coarse gravel inclusions (Plate 14). The partially surviving ceiling above the northern end of the western gallery measures 0.22m deep. The concrete is faced with indentations left by the casting process, in the form of timber grain markings. No evidence of any openings, such as ventilation valves were observed within the remaining ceiling section of the western gallery or within the southern end of the eastern gallery.

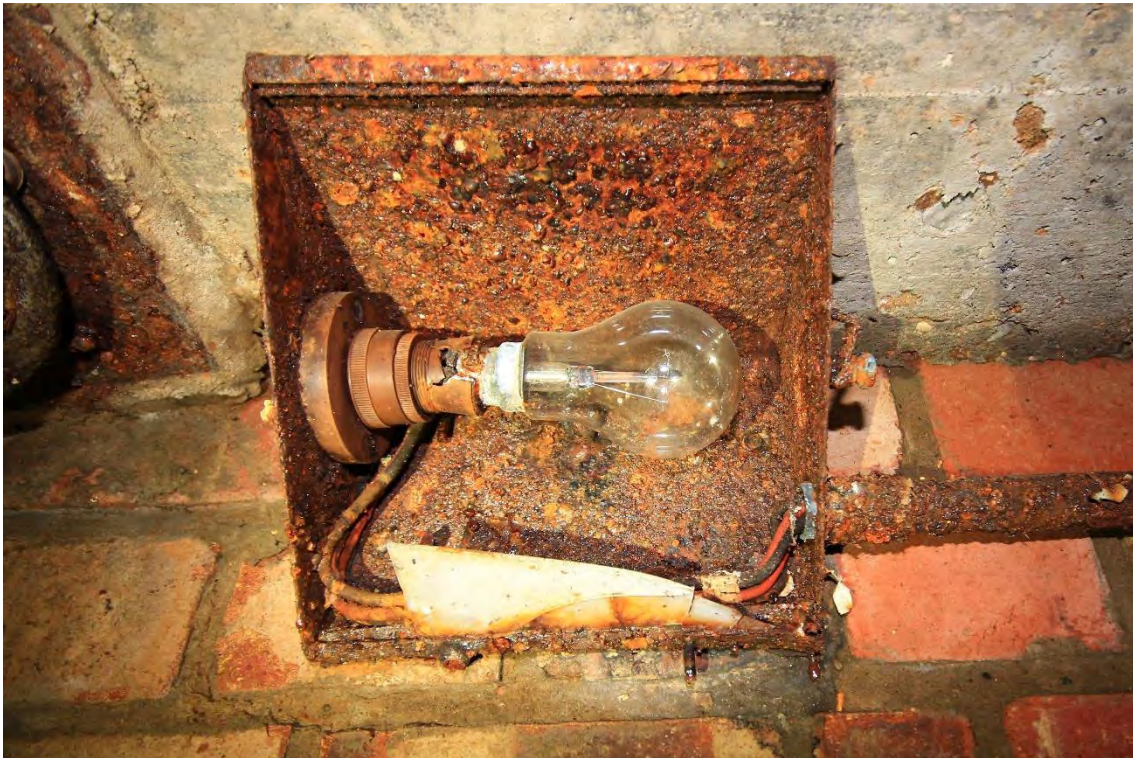
Plate 15: Shelter 4, typical example of the light fittings found throughout the structure, facing west (15)

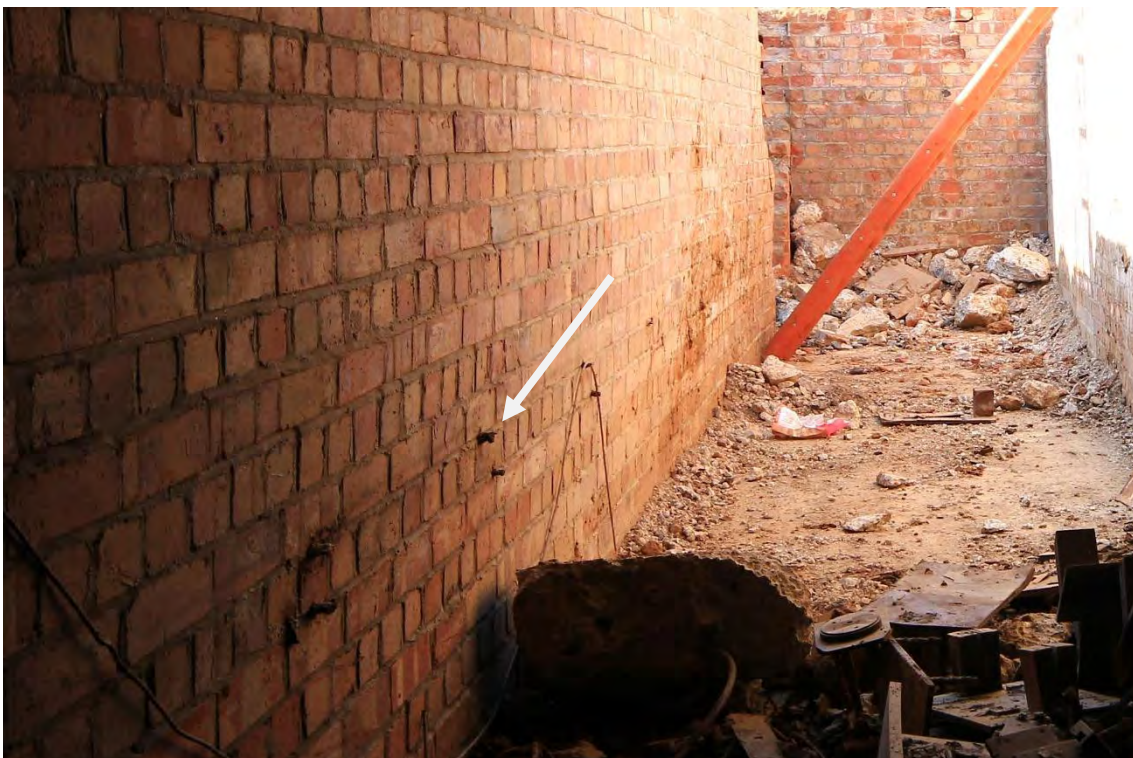
Plate 16: Shelter 4, detail of the redundant brackets formerly supporting the west gallery bench seating (no longer *in-situ*), facing south-east (23)

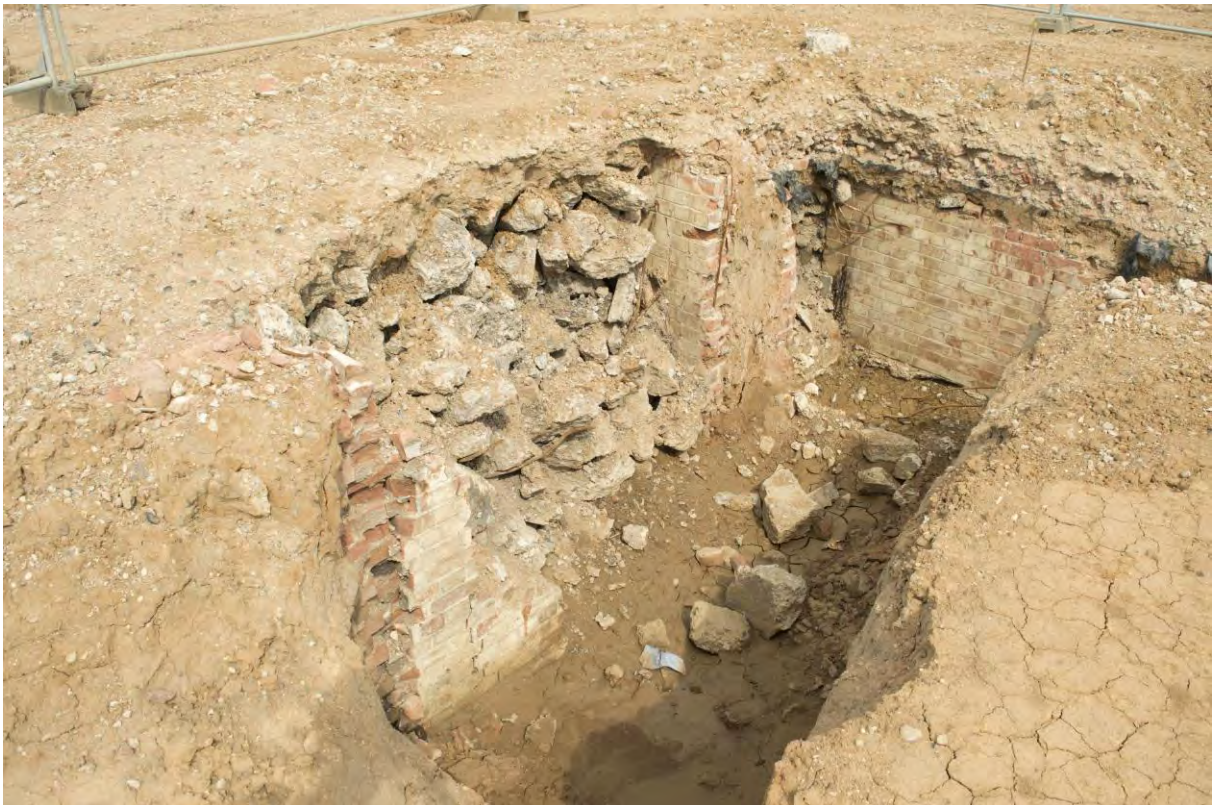
Plate 22: Shelter 4, exposed baffle section of east gallery (the main part of the gallery is backfilled with rubble). Vertical scar in brickwork to the left is from chemical closet wall. Facing north-west (137)

- 5.8 The north end of the eastern gallery was uncovered during groundworks in June 2017. The gallery was found to be in poor condition. The roof and upper part of the walls were truncated by later building works and the gallery and entrance passage were backfilled with rubble (Plate 22). Although some of the walls are missing, the excavated part of the gallery was found to be similar in plan to Shelters 2 and 3, containing a baffled entrance with stairs (Plates 23-25). The construction was also the same, comprising English-bonded brick walls reinforced with rebar. The entrance section was narrow, at 0.57m wide, while the gallery itself was 1.52m wide. The gallery had remnants of white paint on its walls with marks where the bench seating would have been fixed. Scars on the east wall of the gallery indicate where another wall would have been situated, south of the baffled section, to provide space for a chemical closet.

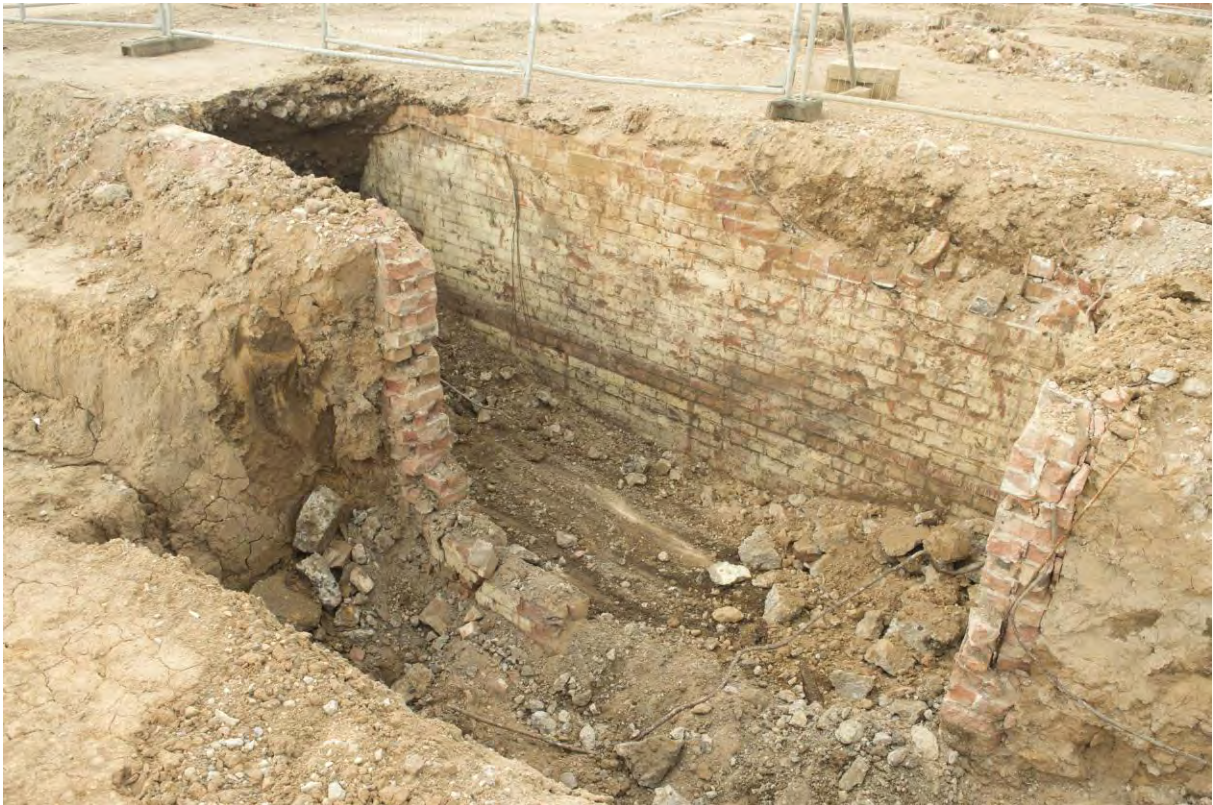
Plate 23: Shelter 4, partially excavated east gallery with bench marks on wall, facing south-west (163)

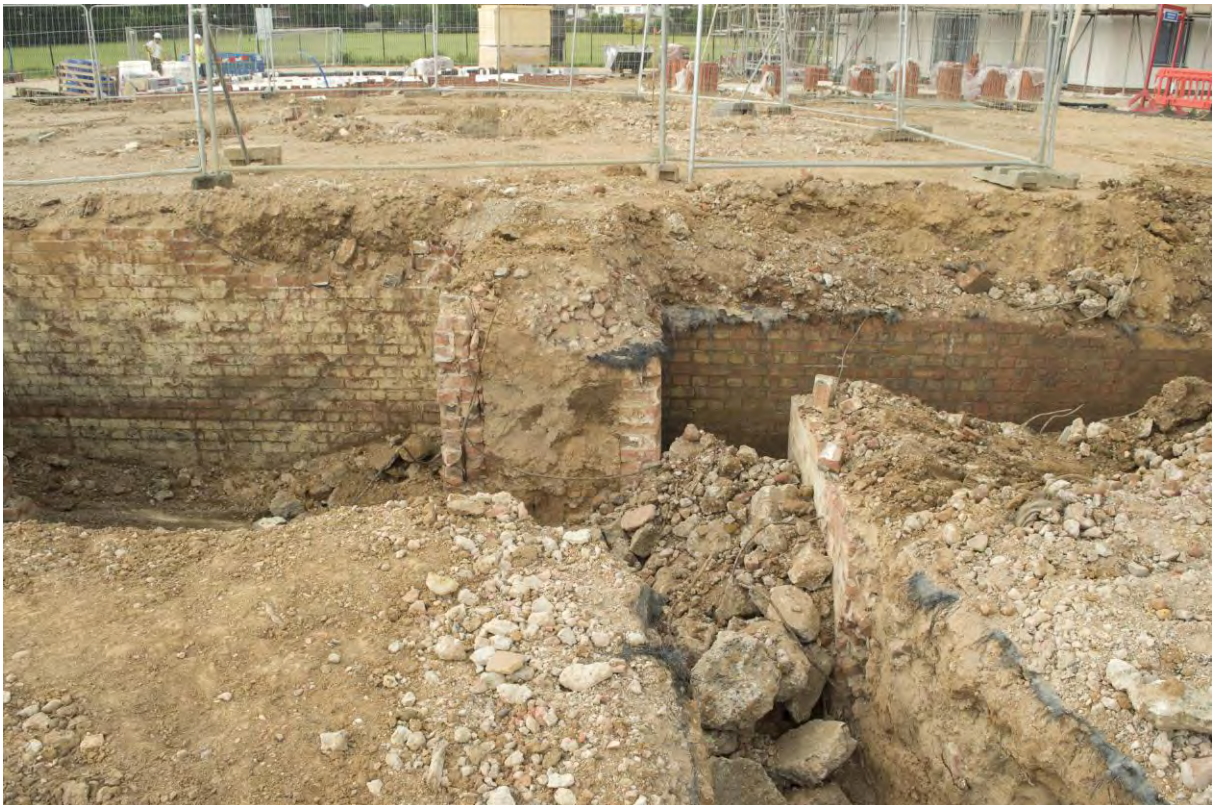
Plate 24: Shelter 4, excavated east gallery (left), baffle (middle) and entrance passage (right), facing west (162)

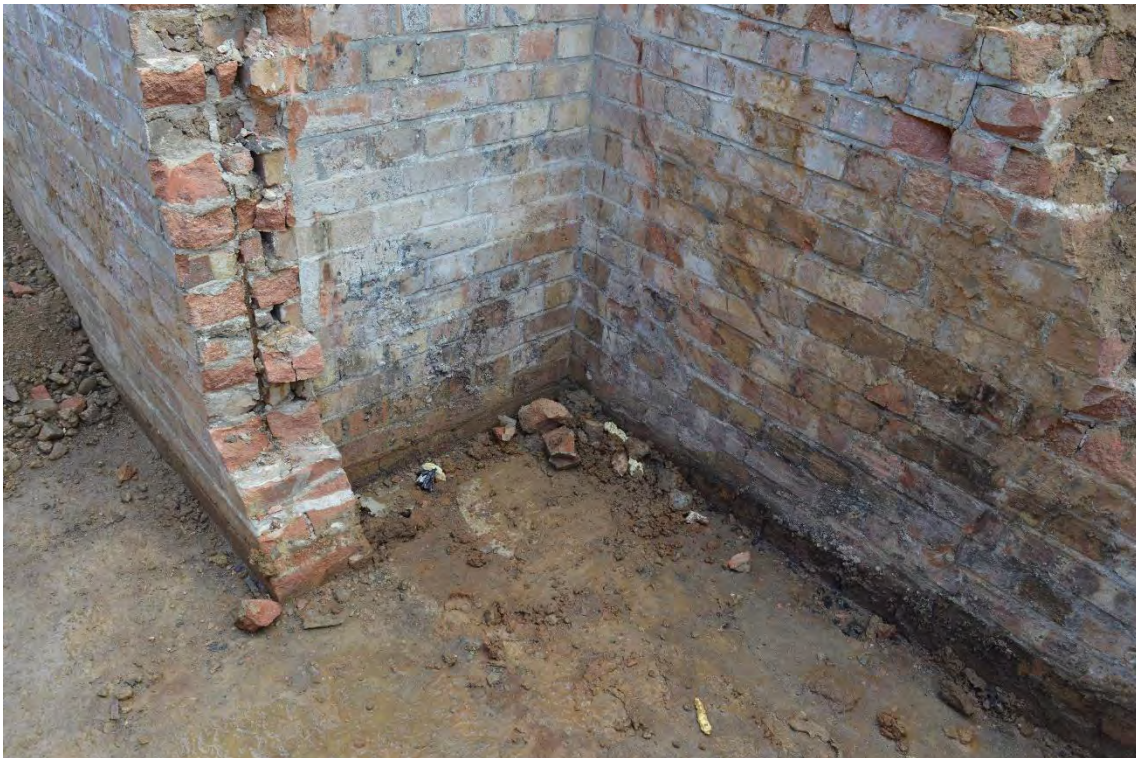
Plate 30: Shelter 4, detail of the scarring left by the former chemical toilet (removed) within the concrete screed flooring within the south-west closet, facing north-east (55)

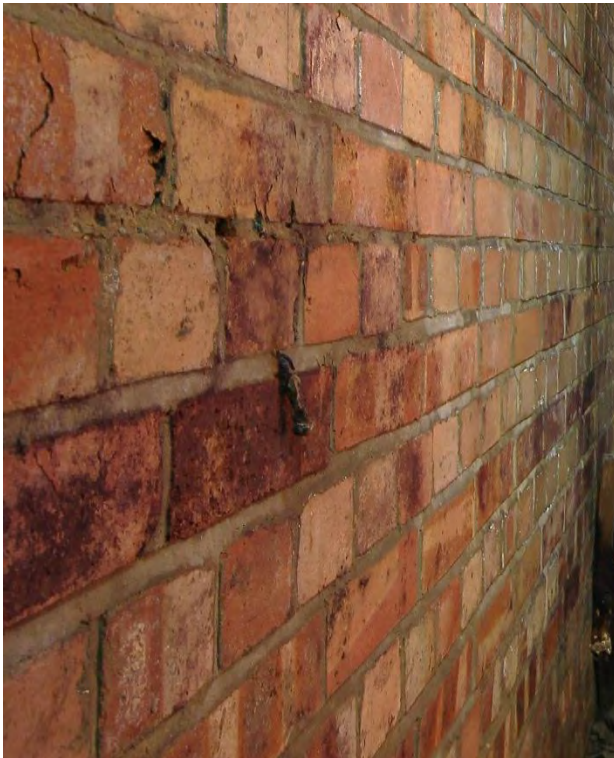
Plate 31: Shelter 4, protruding round headed steel pin (possible door pintle) located adjacent to the north-west chemical closet, facing north-west (13)

- 5.11 Adjacent to the north-west chemical closet is a rounded steel pintle which protrudes from the western wall (Plate 31), in addition to a single padlock secured to a timber plank (Plate 32) observed in the same location. The significantly better preserved condition of Shelters 1, 2 and 3 suggests these features could have formed part of the lightweight boarded toilet door that formerly separated the toilet from the passageway (Plates 33 and 34). However it is possible the padlock served one of the heavy perforated wooden doors that were fitted throughout the other structures (Plate 35) and are likely to have been situated at the entrances of this shelter also.
- 5.12 Each chemical closet was lit in the same manner as the galleries (described previously).

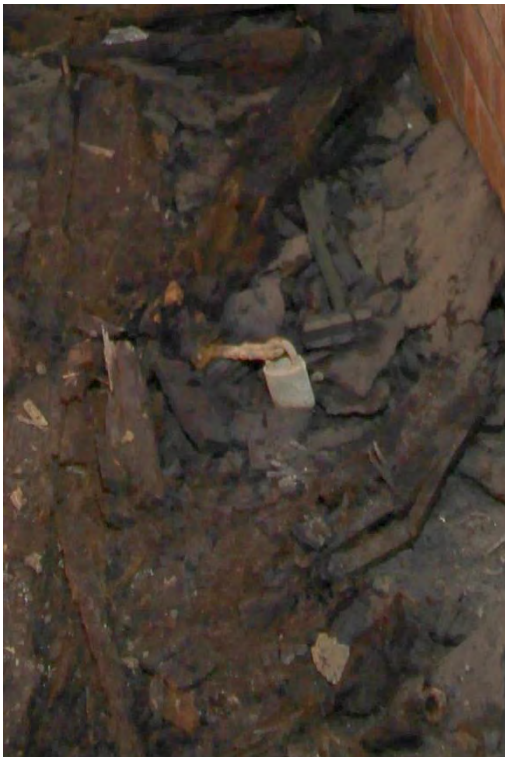
Plate 32: Shelter 4, padlock and timber planks found adjacent to the north-west chemical closet, facing south (12)

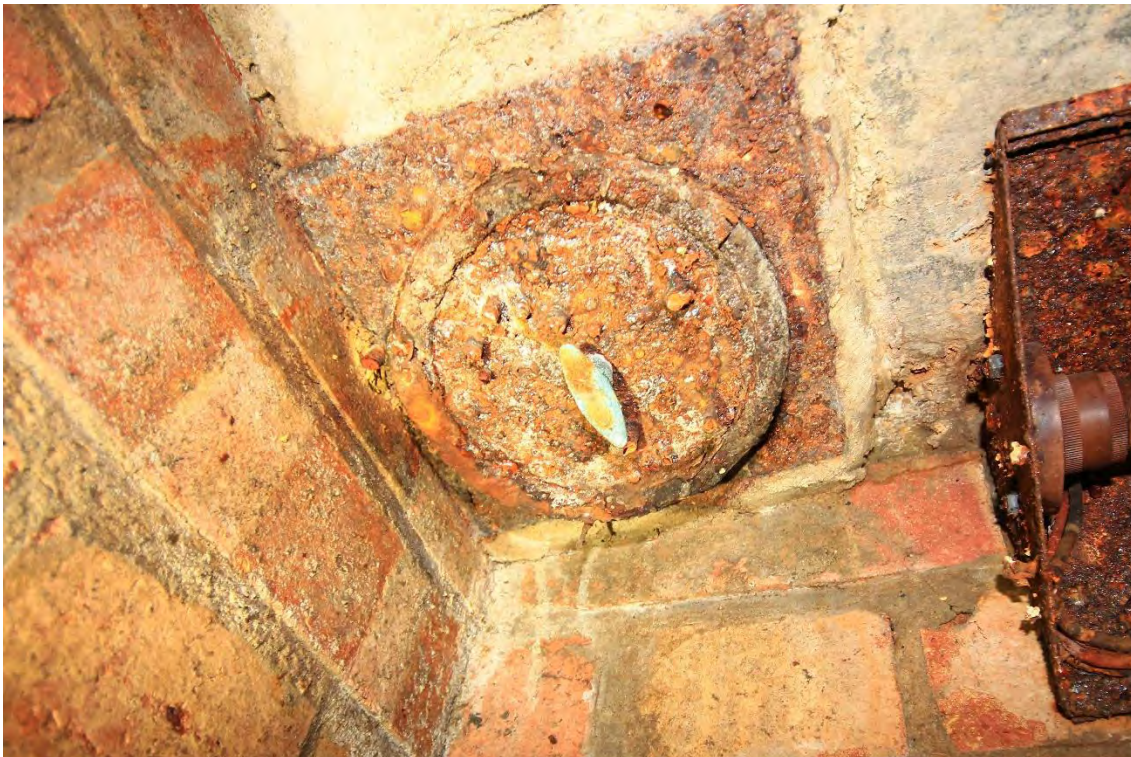
Plate 36: Shelter 4, spring-loaded air-vent located in the corner of the north-west chemical closet, facing south-west (16)

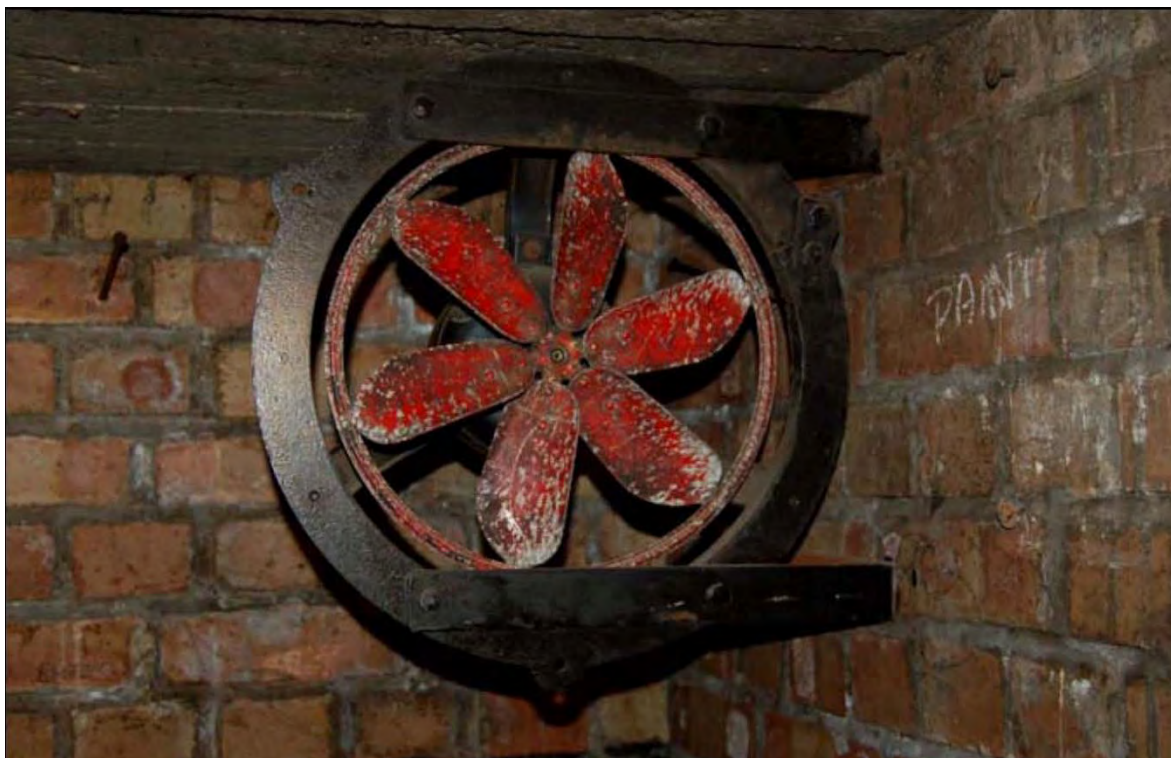
Plate 38: Shelter 2, example of the fan system providing air movement throughout Shelter 2, it is possible that Shelter 4 utilised the same system (FAU 2008, 52)

- 5.14 Within Shelter 2, a single ceiling mounted fan (Plate 35) was found within one of the galleries in order to circulate the air provided from the vents. Although no such system was observed within this shelter, it is possible the structure was served in the same manner. The manufacturer of the sprung air vents is unknown.

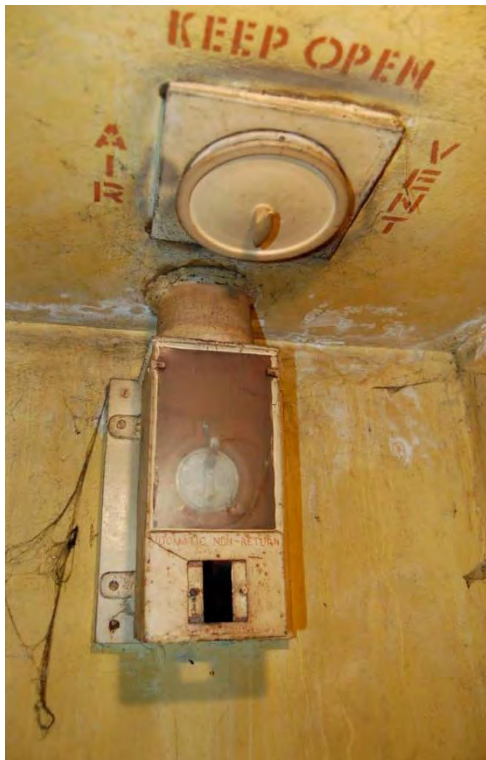
Plate 39: Shelter 1, example of the stink trap valve unit within the chemical closets in Shelter 1 (FAU 2008, 41)

- 5.15 In addition to the sprung air vents situated within each chemical closet, evidence of a wall-mounted stink pipe fitted with non-return rubber valve (Plate 39) (FAU 2008 41) was observed in the north-west closet (Plate 40), the redundant ceiling valve marks its former location.

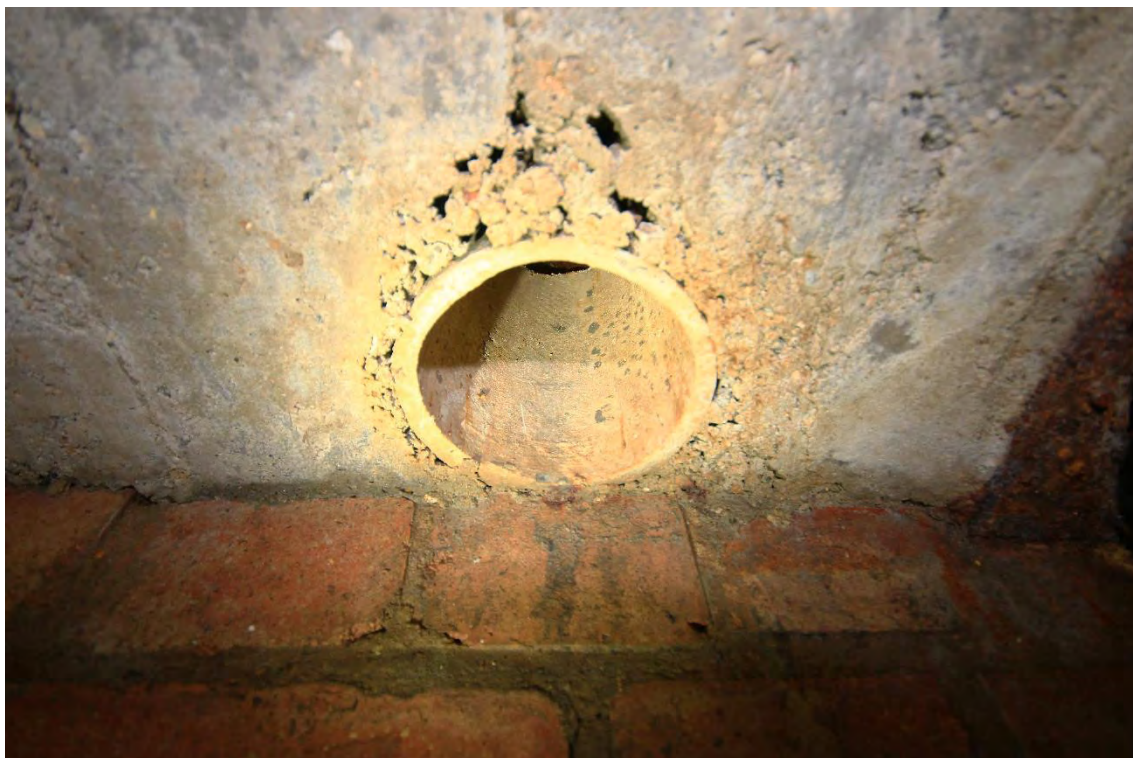
Plate 40: Shelter 4, redundant ceiling valve opening found within the north-west chemical closet that formerly held the stink trap unit, facing south (18)

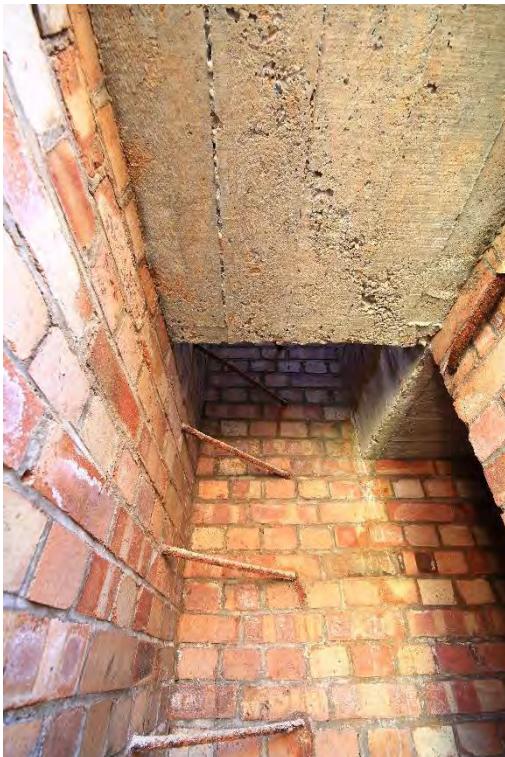
Plate 42: Shelter 4, south-west escape hatch with embedded metal rung access, facing east (up) (35)

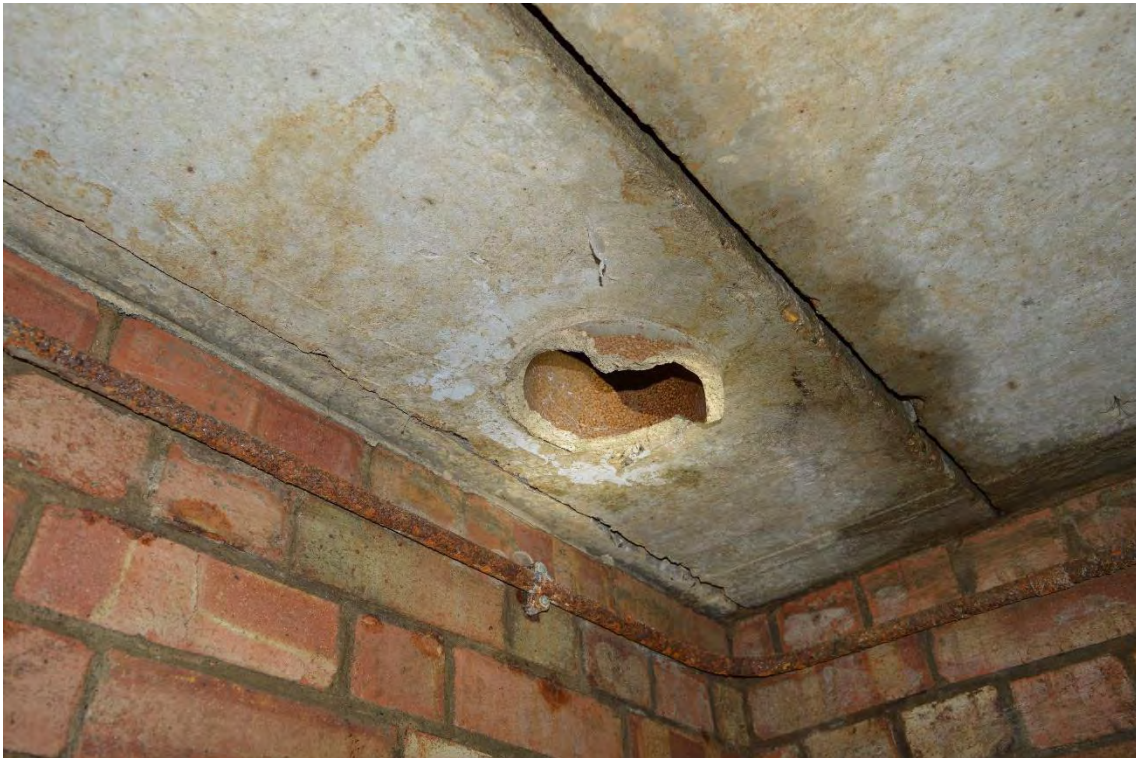
Plate 47: Shelter 4, detail of the redundant valve opening within the central circulation area, formerly serving ventilation purposes, facing south-east (63)

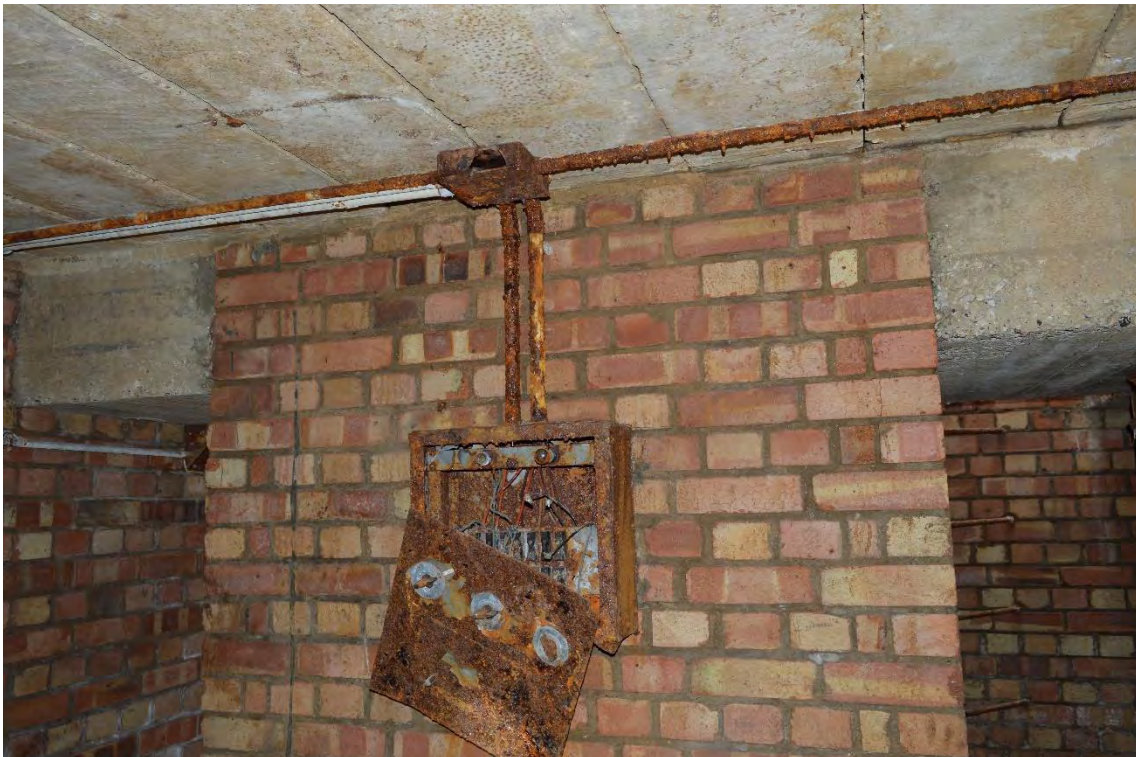
Plate 48: Shelter 4, detail of the electrical switch unit within the southern central circulation area, facing north (64)

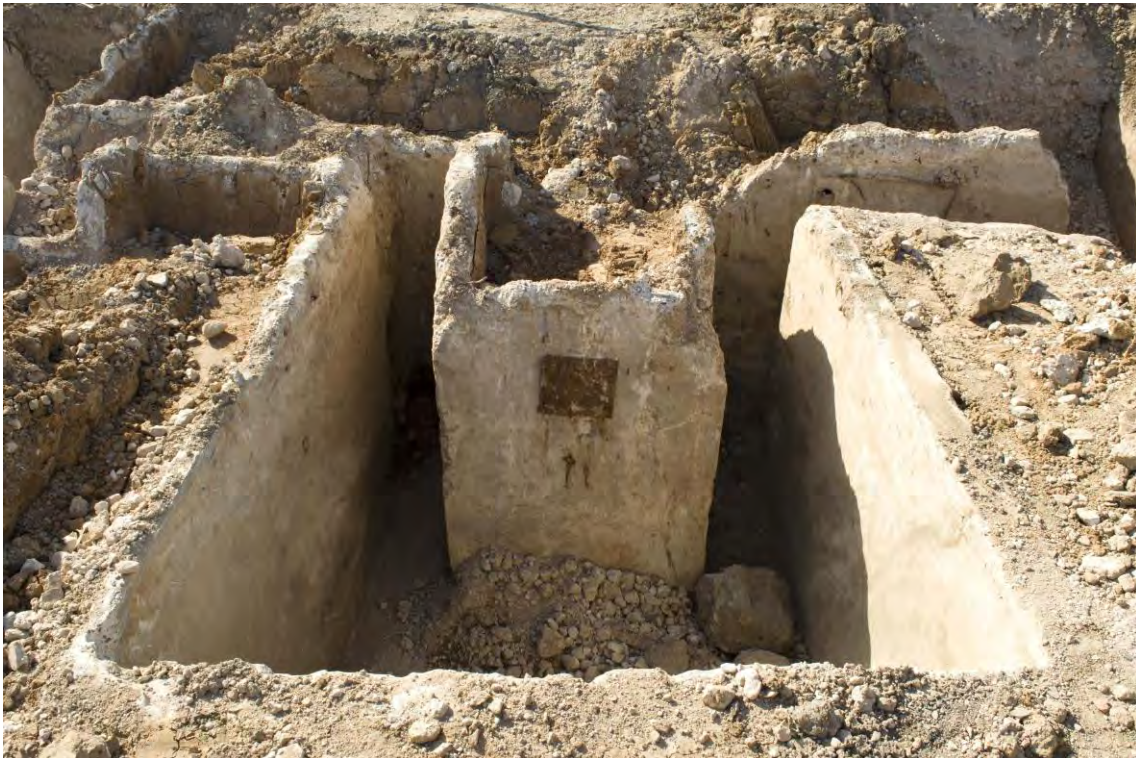
Plate 51: Shelter 5, view of link corridor and remains of switch unit, facing south (81)

- 5.19 The surviving section of the shelter consists of the northern link and a small part of the north end of each gallery. Like the other shelters, Shelter 5 has escape hatches in the link corridor and chemical/water closets at the north end of each gallery. The link corridor features a fitting for a switch unit in the same location as that found in Shelter 4 (Plate 51).

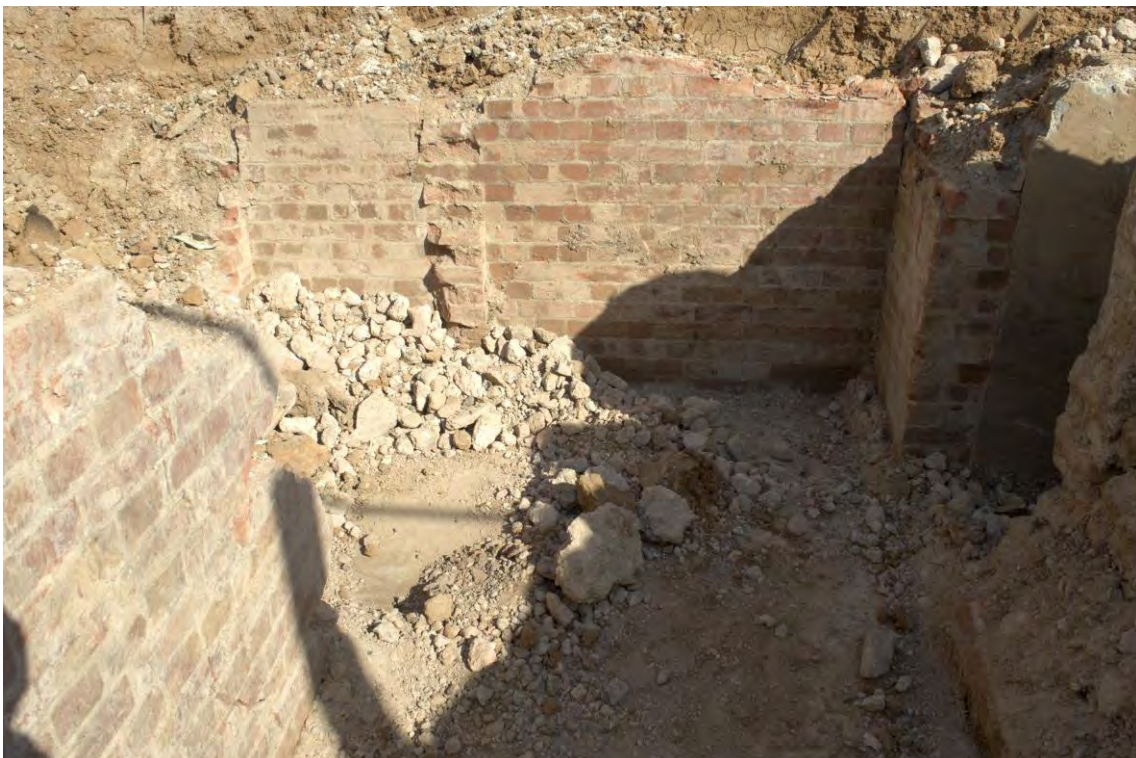
Plate 52: Shelter 5, north end of west corridor with scarring to the wall for a brick partition for chemical/water closet, facing north (87)

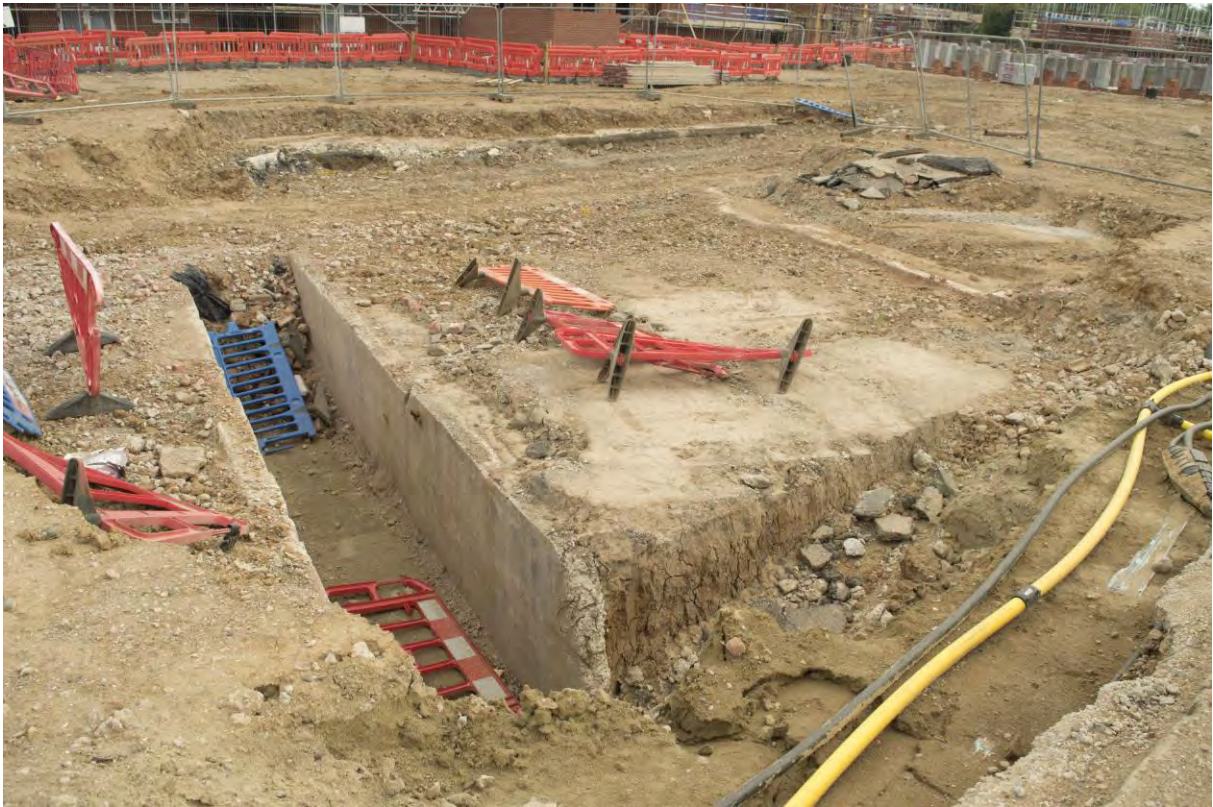
Plate 53: Service tunnel, east kerb of road to the top right of the frame, facing north-east (114)

- 5.23 During works to dig foundation trenches in June 2017 a structure was exposed to the east of Shelter 4 (Plate 53). The structure comprises a tunnel lined with cast concrete 1.21m wide. The tunnel has been truncated at either end leaving a 7.5 m section intact. The tunnel runs parallel and adjacent to the main road running through the site. The use of cast concrete rather than brick, as well as its smaller dimensions and its position away from a factory building suggests that the tunnel was not part of an air raid shelter. It is more likely that it formed a service tunnel running with the main road.
