## **RISBOROUGH ORDNANCE DEPOT SHORNCLIFFE GARRISON, FOLKESTONE, KENT**

### **Historic Building Record (Vol. 1)**

**RISBOROUGH ORDNANCE DEPOT, SHORNCLIFFE GARRISON,  
FOLKESTONE, KENT**

**Historic Building Record (Vol. 1)**

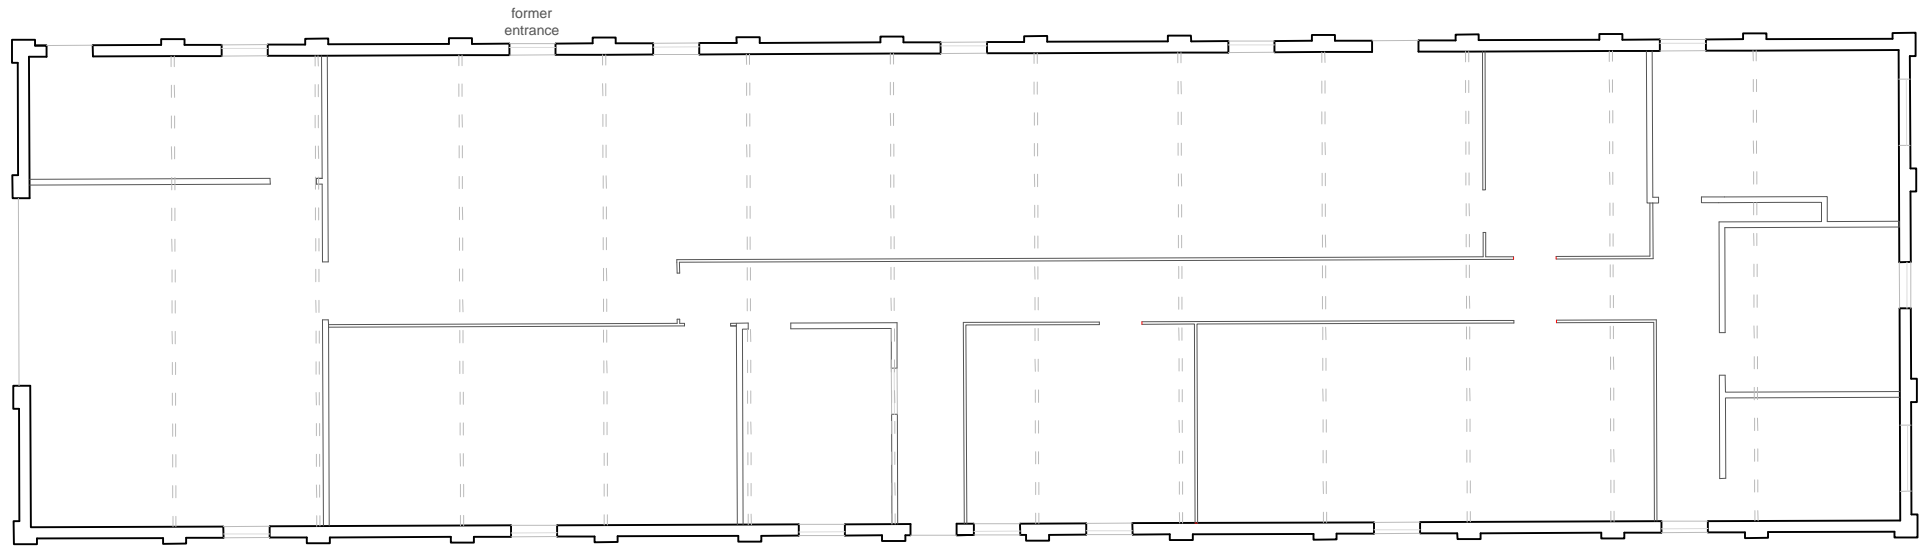
<b>© Archaeology South-East</b>		Risborough Ordnance Depot, Shorncliffe Garrison, Folkestone	Fig. 6
Project Ref: 7339	June 2016	Plan of Building 27 (Receiving Store)	
Report Ref: 2015397	Drawn by: MGS

Building 27  
Receiving store

- 6.8.6 The receiving store is a long, low, single-storey rectangular structure of red brick laid in Flemish bond. As with several of the other buildings in the vicinity, its elevations are broken into bays by brick pilasters topped by sandstone blocks, which segue into clasping buttresses at the building's corners. There is a pitched slate roof, with raking brick cornices to each gable end, which is supported by steel trusses with raking struts. Most alternate bays are occupied by modestly-sized windows with segmental brick heads, stone sills, and modern fenestration, which would never have provided enough light for a workshop, confirming the building's original function as a store. This is confirmed by the fact that it was unheated when built.

- 6.8.7 Entrance was originally via large doorways with ramps and sliding timber doors for the easy loading of goods (Figure 15), two to the long north elevation and one to the south, but these have been blocked and replaced with small pedestrian doorways. A large, modern loading door has been inserted in the west elevation, whilst the east elevation bears the date-stone '1900'.

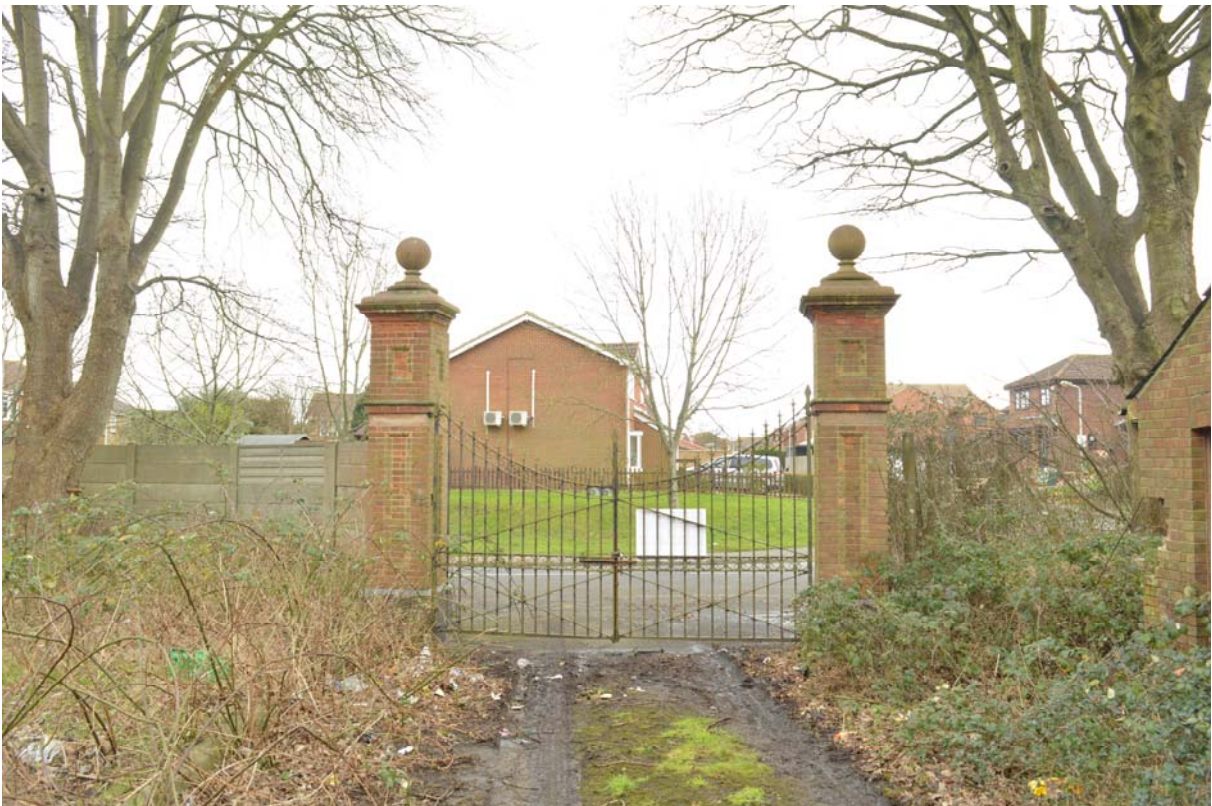
**Plate 10** – Main entrance gates, looking east (SGA15-051)

- 6.4.11 Elaborate gateways of this type are relatively unusual, being only found at the larger army camps, such as the two other 'great camps' of Aldershot and Colchester. This is the only known example to bear the arms of the Army Ordnance Department (source: listing description). The sentry hut was a relatively humane afterthought to the original construction of the site entrance, designed more for warmth and shelter than for monitoring of the approach road.

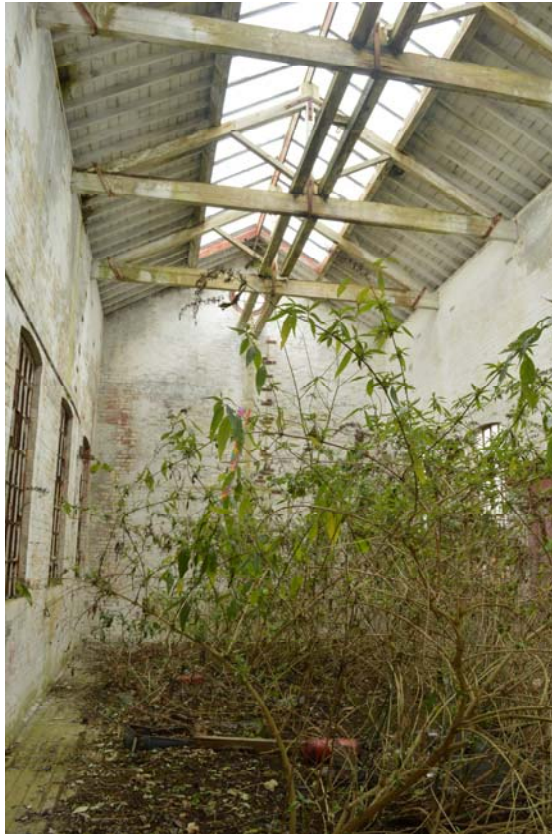
**Plate 13** – Tent repairing shed (Building 25), interior, looking west (SGA15-080)

- 6.6.8 Internally, the building has a single room open to its unusually lofty roof. This was necessary to accommodate long lengths of canvas for inspection and repair, which would have been suspended from beams ranged between the roof trusses. The presence of long, hanging bolts of opaque canvas was mitigated by the exceptionally light interior, with its large windows and roof light. The original architectural plan shows the workshop to have been heated by a magnet stove on its eastern wall.

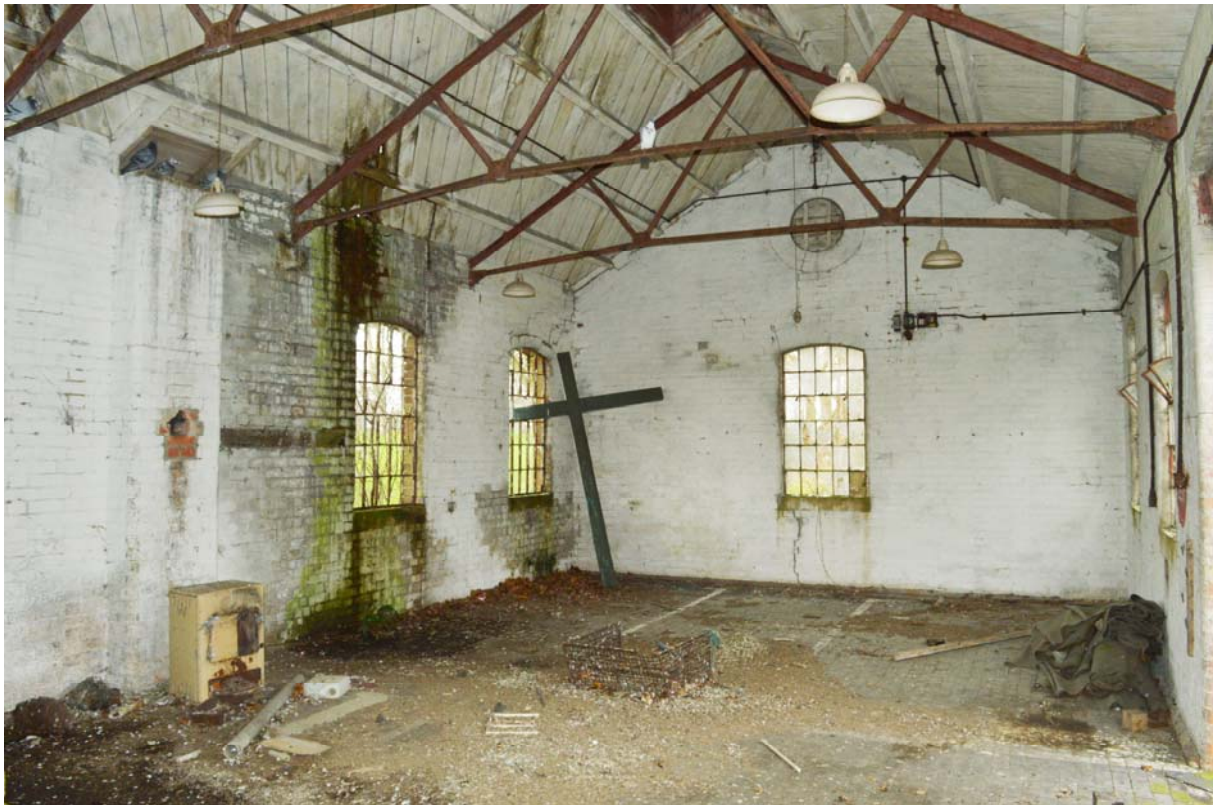
**Plate 15** – Carpenters' shop (Building 26), interior, looking west (SGA15-086)

6.7.8 The interior consists of a single workshop whose most notable feature is its floor, which is formed from a parquetry of timber blocks laid on their end-grain. The reason for this is unclear, but it may have made them more hard-wearing and resistant to rot. The workshop also retains an enamelled stove to its southern wall.

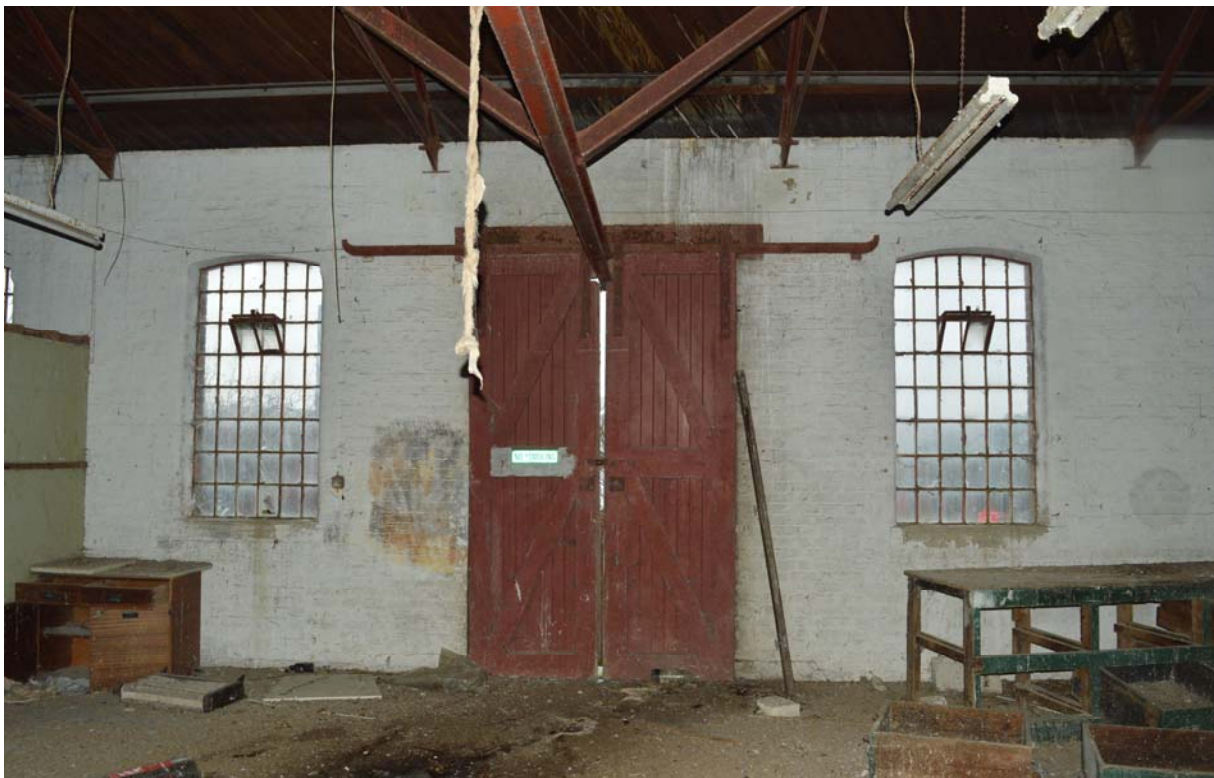
**Plate 32** – Equipment store (Building 31), first floor, goods crane and doorway, looking north (SGA15-208)

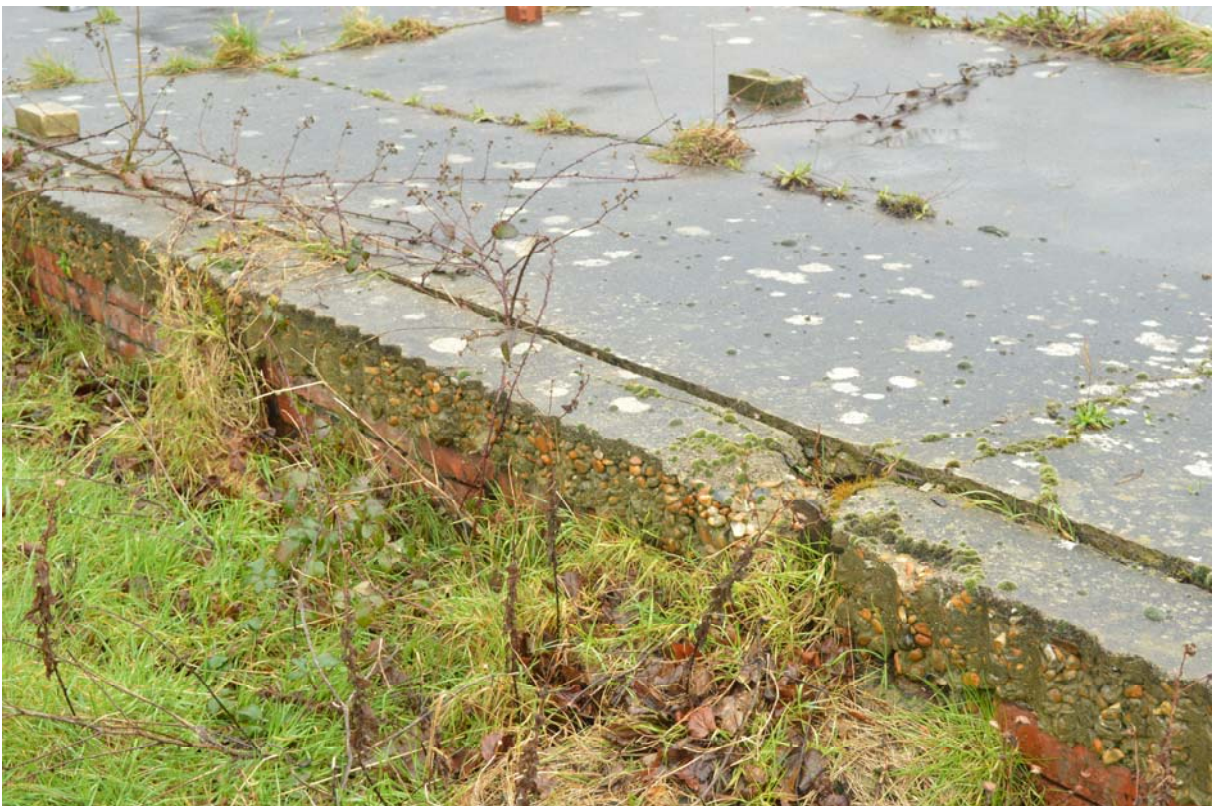
**Plate 38** – Nissen Hut platform, showing impression of corrugated iron cladding (SGA15-220)
