**THE BYRE, MILTON STREET, POLEGATE,
EAST SUSSEX, BN26 5RW**

HISTORIC BUILDING RECORD
(Historic England Level 3)

Project no: 160764

Report ref: 2016376

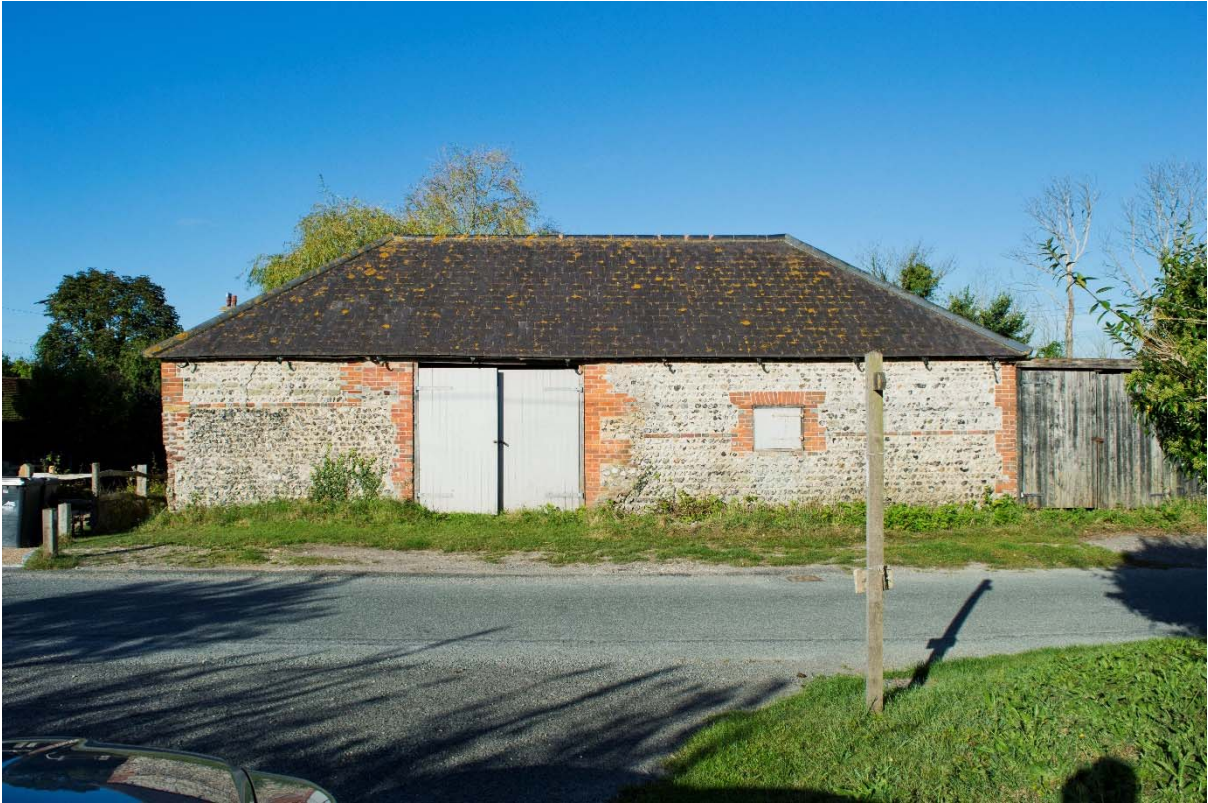
Plate 1: East elevation of the building (1)

- 5.2 The east elevation fronts directly onto Milton Street (Plate 1). It contains a full-height double-width doorway positioned off-centre to the south, north of which is an unglazed window closed by a modern timber shutter hung on iron pintels. The window's original pegged timber frame survives, but now contains two replacement diamond mullions. The doorway contains a pair of modern boarded doors and its jambs have clearly been reworked in modern times; however, it is possible that it may preserve the position of an earlier doorway, or perhaps another window matching that adjacent. North of the doorway, the wall includes a mid-height brick lacing course. To the south of the doorway, but at a higher level, there is a similar lacing course, although here it marks a differentiation in the building's fabric: the flintwork above being of the same date as that to the north of the entrance; the flintwork below being of more tightly-bonded split flints laid in rough courses (Plate 2). The associated brick quoining at the corner of the building is clearly of earlier date, being duller in colour than that elsewhere and measuring on average 210-230mm x 100-110mm x 50-55mm: a 17th century date would seem likely.

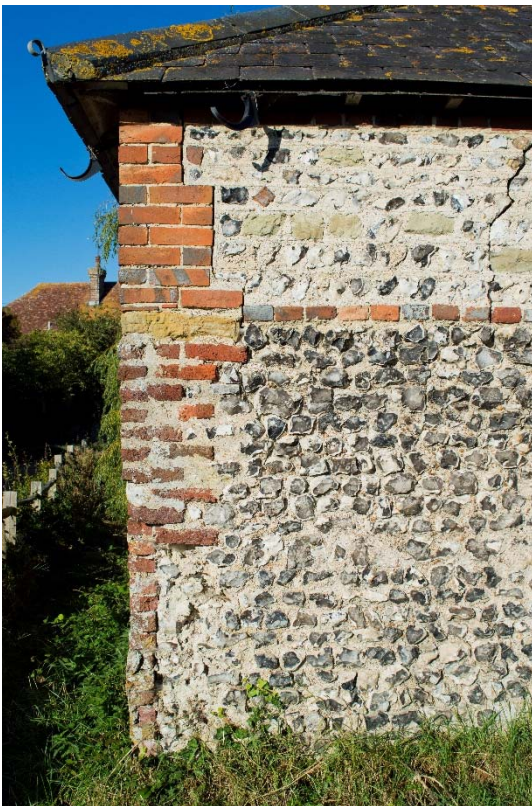
Plate 2: Variation in the wall construction, showing early fabric below and later fabric above (10)

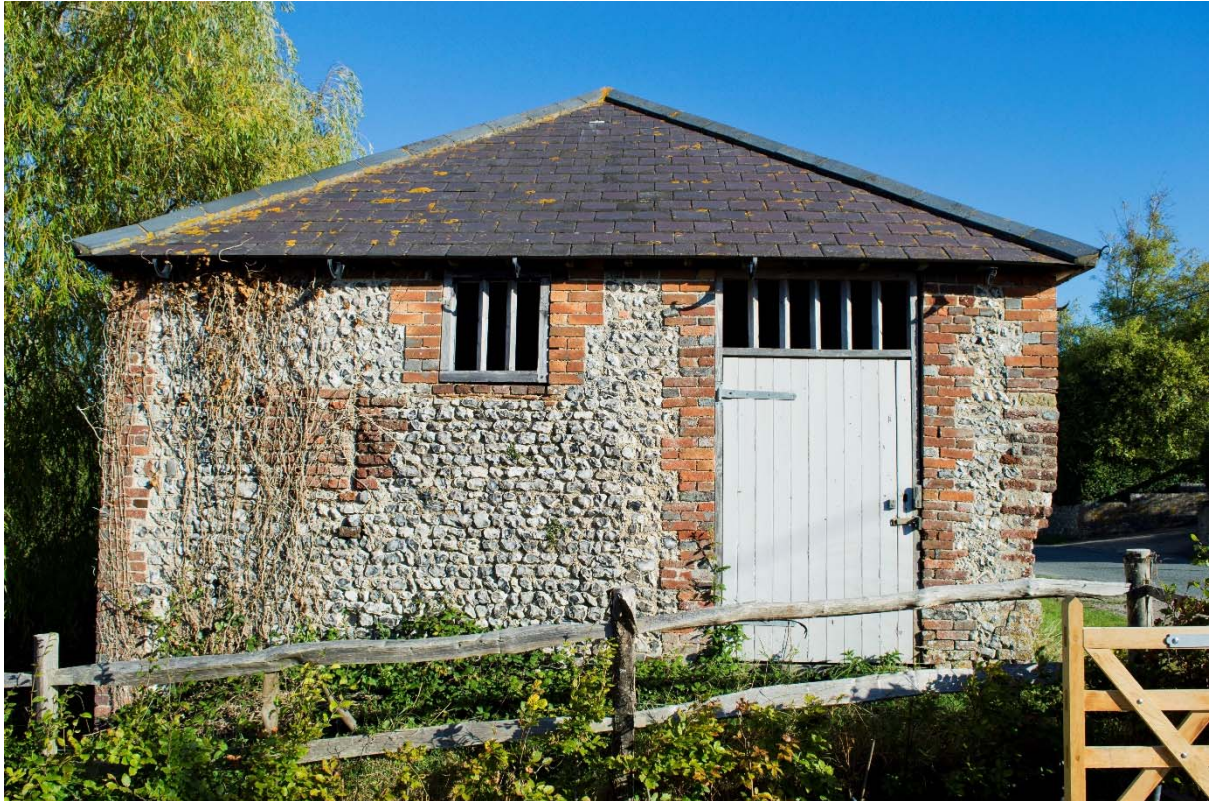
Plate 3: South elevation of the building, showing early fabric contained within the lower portion. Note the blocked window towards the left-hand side (11)

- 5.3 The early fabric extends at the same height for almost the whole width of the south elevation, indicating that the corner of a pre-existing structure was incorporated into the present building (Plate 3). The early fabric terminates just short of the south-west corner, where it seems to have been truncated since there is no original quoining surviving to indicate this was its original extent. To the east, there is a single doorway which seems to be original to the 17th century structure as its jambs are formed of early bricks at the lower level. It contains a modern boarded door which matches those elsewhere, but also contains an unglazed over-light set with diamond mullions, presumably replicating its previous form. A similar unglazed window set with modern diamond mullions is set off-centre to the west within the later fabric. Below it and to the west, the early fabric contains a slightly smaller window with chamfered brick jambs, which has been infilled with brickwork, possibly at the same time the structure was rebuilt.

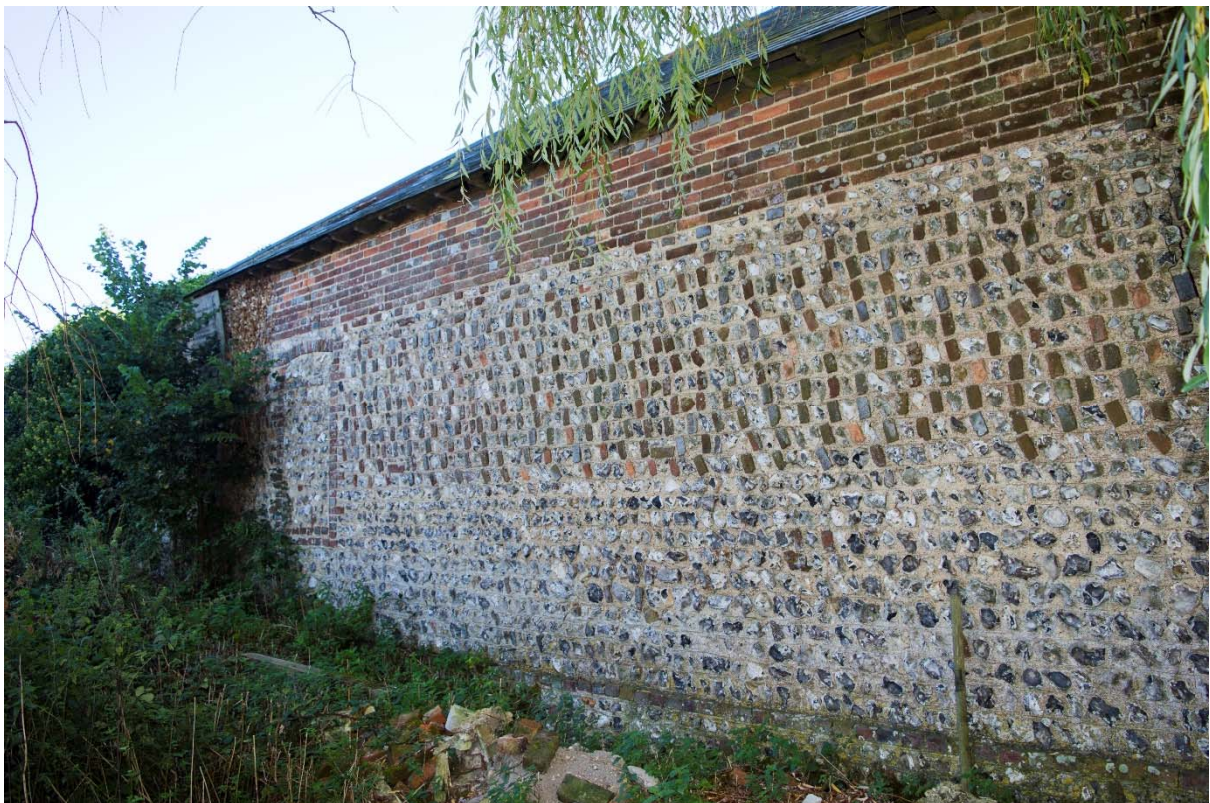
Plate 4: West elevation of the building, showing the different materials used in its construction. Note the blocked opening towards the north end (18)

- 5.4 The rear (west) wall of the building is more varied in its construction than the front (Plate 4), although there is no reason to think this has any significance in terms of phasing, more a result of utilising whatever materials happened to be at hand during construction. The lower third of the wall is of similar construction to the front, being of coursed field flints, and has a slight off-set at its base. The middle third is of a rather haphazard combination of brick and flint, a technique

known locally as 'bungaroosh'. The upper third is of brickwork laid essentially in a raking English garden wall bond. The elevation is largely featureless except at its north end, where there is an original (?) door opening whose threshold lies some distance above the present external ground level (Plate 4). Beyond this is a further full-height doorway opening which is probably a later insertion, but which could not be inspected fully at the time of the survey as it was obscured by vegetation and modern cladding. At this end of the building, the roof is pierced by a small roof-light.

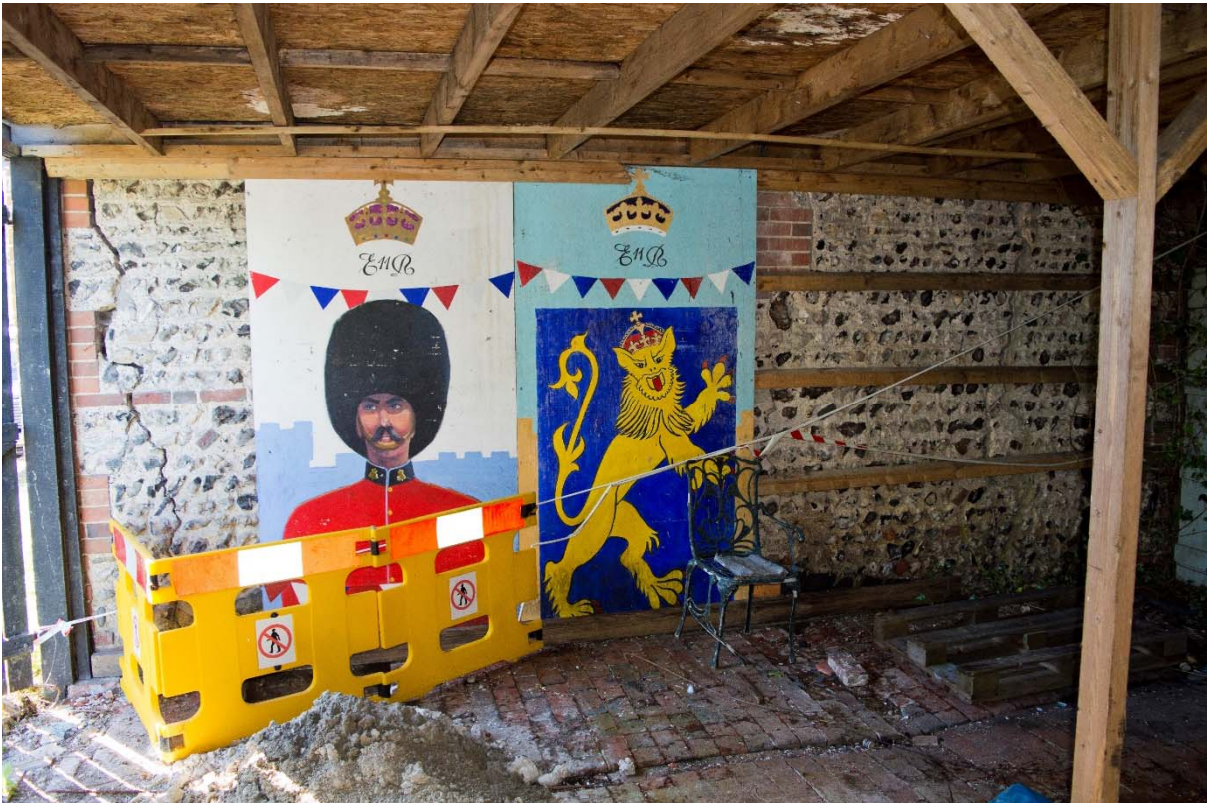
Plate 5: North elevation of the building (60)

- 5.5 The north elevation of the building is visible from within northern addition (Plate 5). It comprises coursed field flints with a brick lacing course at the mid-height. It contains a window similar to that surviving at the sound end of the building, although here it retains an early frame which has not been subject to modern repair.

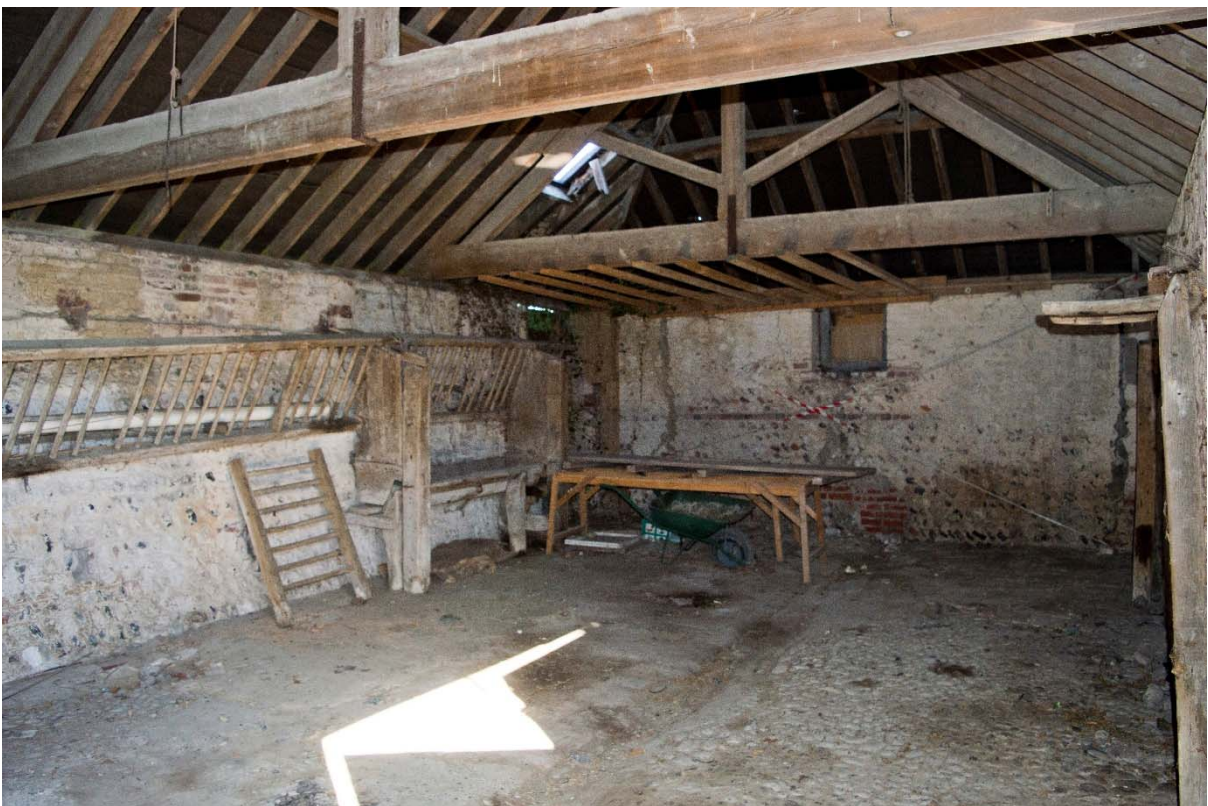
Plate 6: Interior of the building, looking north-west (24)

- 5.6 The interior forms a single space which is open to the roof (Plates 6 and 7). It has a worn, cobbled floor with a shallow drainage gully positioned just off-centre to the east, running down its length. A small, discrete area of brick pavements survives at the north-east corner of the building. The walls are generally formed of a mixture of coursed flints and bungaroosh, although at the south end, in the location of the earlier structure, the east wall contains an area of coursed sandstone and chalk/clunch blocks (Plate 8), while the south wall is formed of a less regular mixture of flint, brick and stone (Plate 9). The walls have a limewash finish, a common feature of buildings used for housing animals.

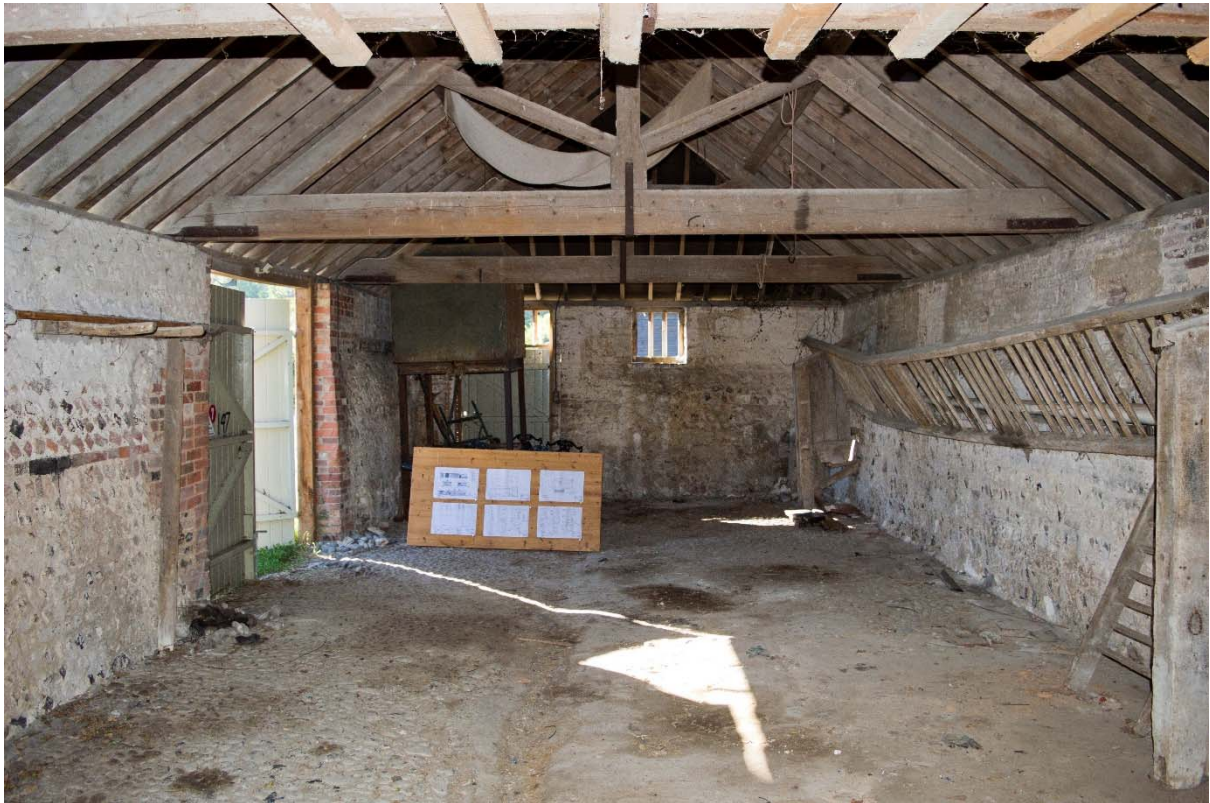
Plate 7: Interior of the building, looking south (26)

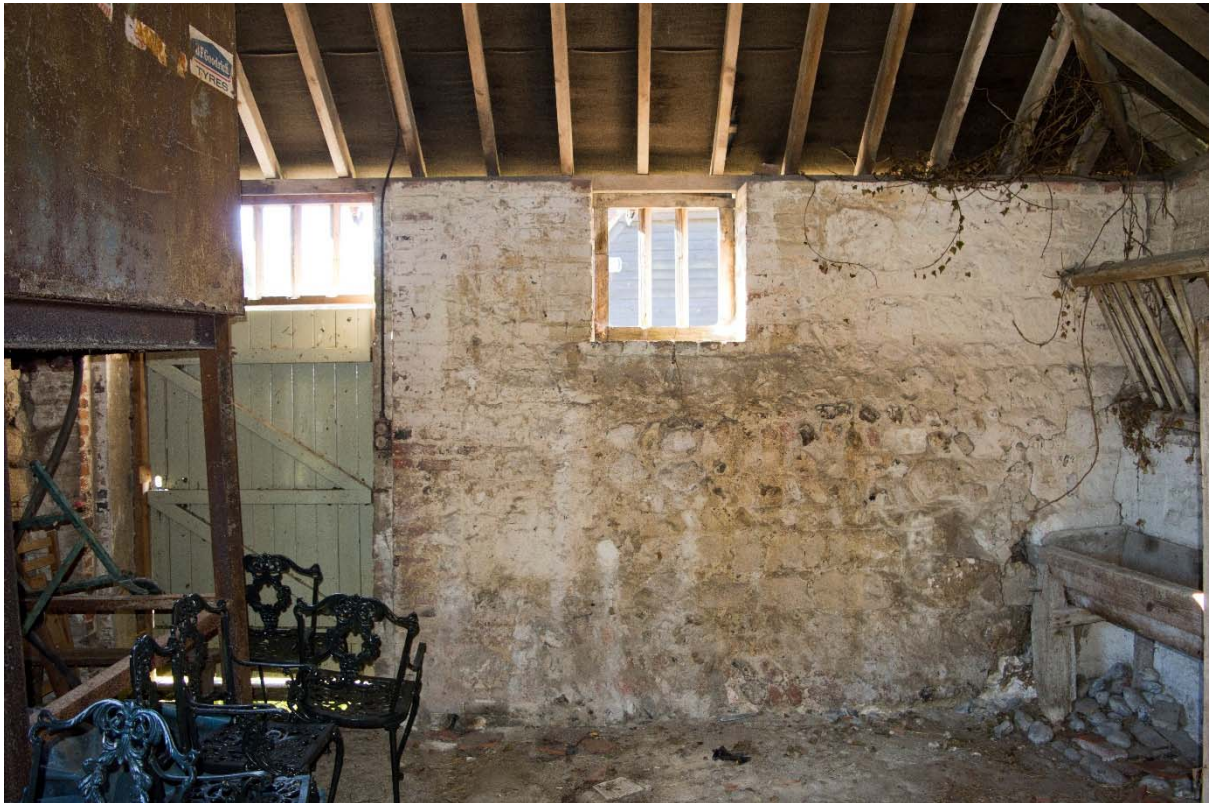
Plate 9: Walling material of the earlier structure surviving beneath the window within the south wall of the present building (28)

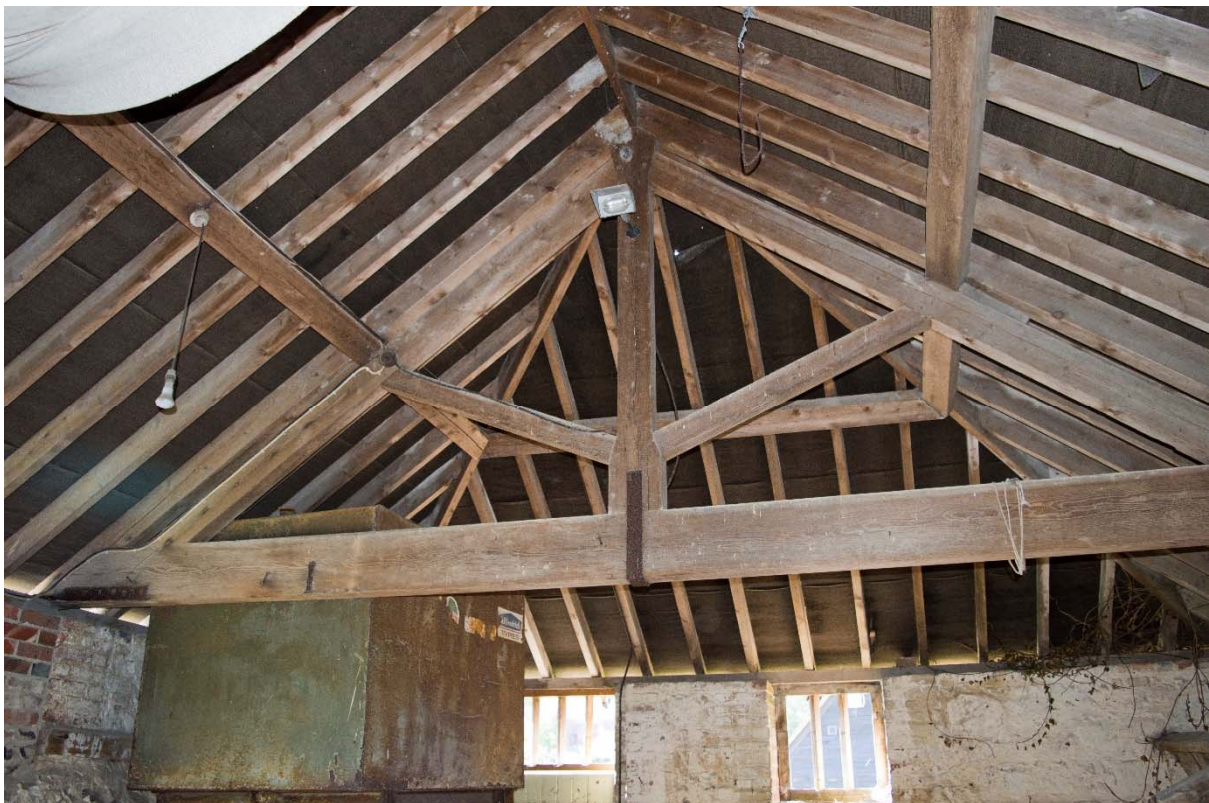
Plate 10: View of the roof, looking south (56)

- 5.7 The roof is of good quality, regular, sawn softwood. It is of double-framed type, having principal trusses carrying a common rafter roof over a single purlin in each roof pitch (Plate 10). The principal trusses, of which there are three, each comprise a straight tie-beam from which a joggled king-post supports a pair of raking struts, which in turn extend to the principal rafters. The purlins are supported over the backs of the principal rafters on cleats, and the common rafters meet at a ridge-board at the apex. The construction utilises a mixture of traditional jointing and pegging, as well as iron – in the form of bolted stirrup-straps securing the king-posts to the tie-beams, and straps attaching the tie-beams to the wall-plates. There is no obvious carpentry marking.

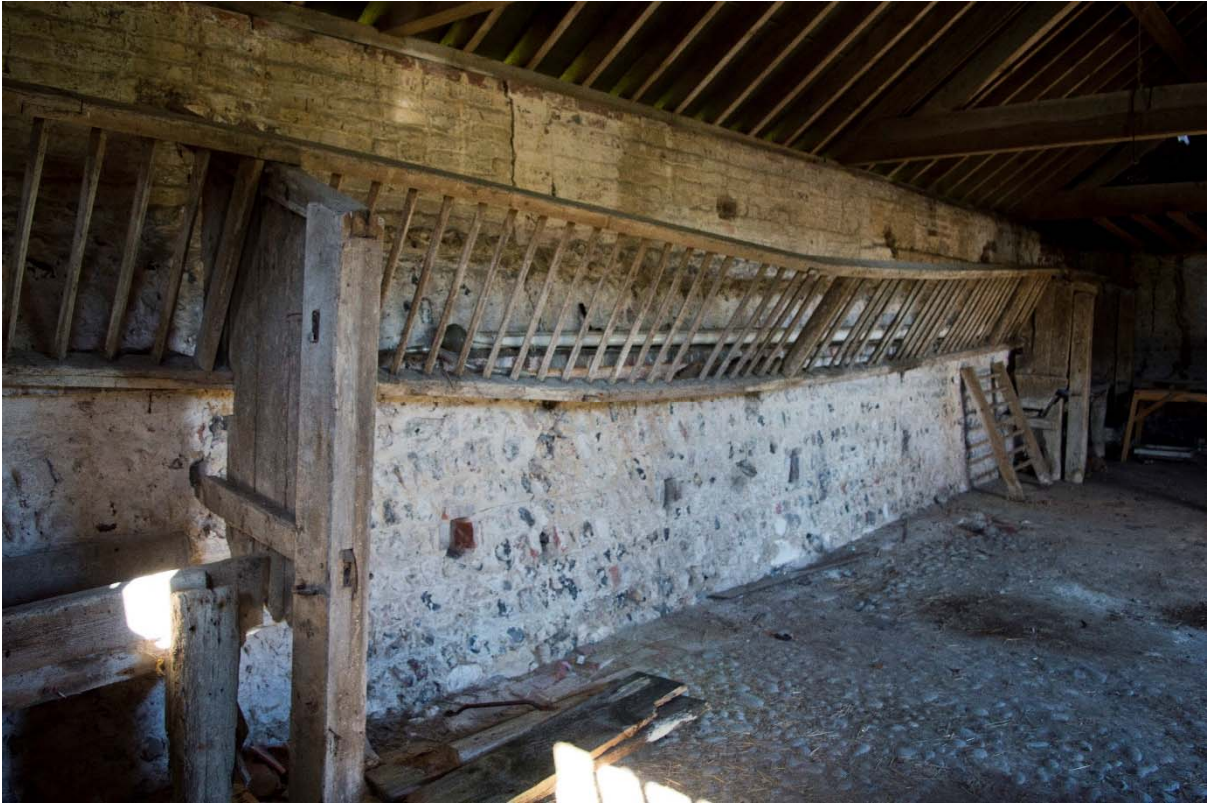
Plate 11: Hay-rack along the west side of the building. Note truncated stall-partition (44)

- 5.8 Evidence of the building's function as a cattle byre survives in the form of fragmentary timber feeding troughs and a hay-rack positioned along the west wall (Plates 6, 7, 11 and 12). The troughs and hay-rack are original features – the troughs being secured by timber supports housed within sockets in the walls, while the hay-rack is supported on a ledge formed by a course of bricks set at right angles within the wall (Plate 13). There has nevertheless been some historical modification or repositioning of these fixtures, since the surviving section of feeding trough towards the north end of the building, together with the hay-rack, block the original opening at this end (Plate 12). The surviving sections of feeding trough are accompanied by timber stall partitions; these have been truncated, although the positions of former partitions can be traced within the floor. The troughs and stall partitions also retain several iron tethering rings.

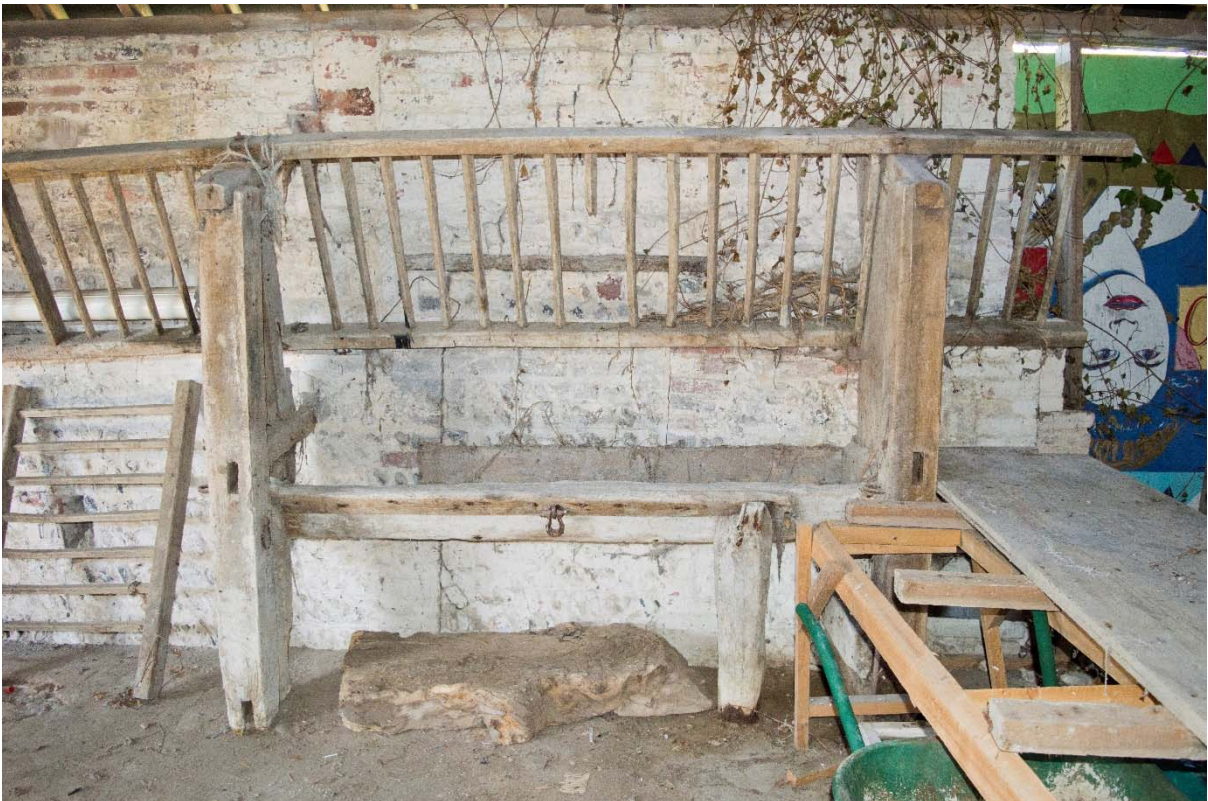
Plate 12: Detail of trough and hay-rack towards north end of the building. Note the blocked opening behind (51)

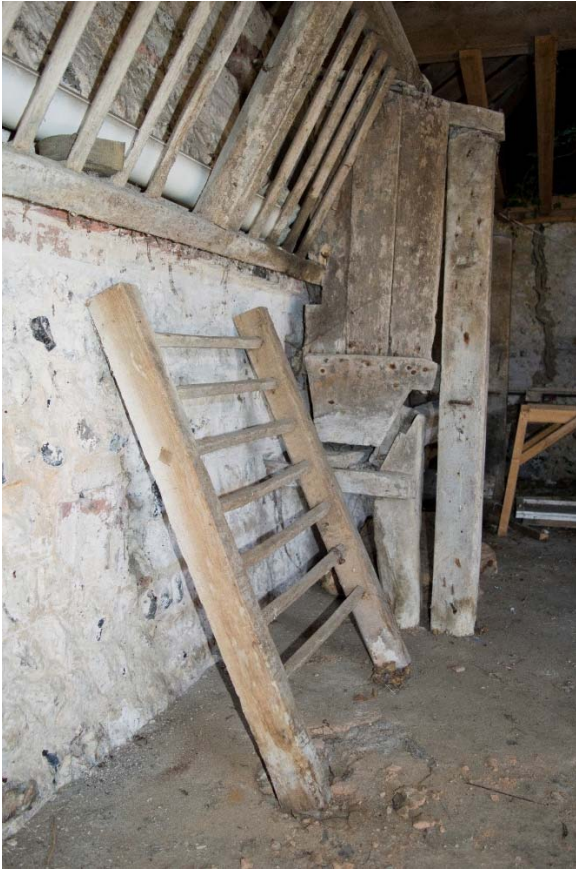
Plate 13: Detail of hay-rack. Note the brick ledge which is integral to the wall, thus indicating the hay-rack to be an original feature (49)

The hay-rack is constructed in several sections: at the join of two of the sections it is possible to see a pair of neatly-chiselled 'III' carpentry marks. No others were observed at the time of the survey. On the opposite wall, there survives a timber harness-rack which would have been used to hang the harnesses for the draught oxen (Plate 14).

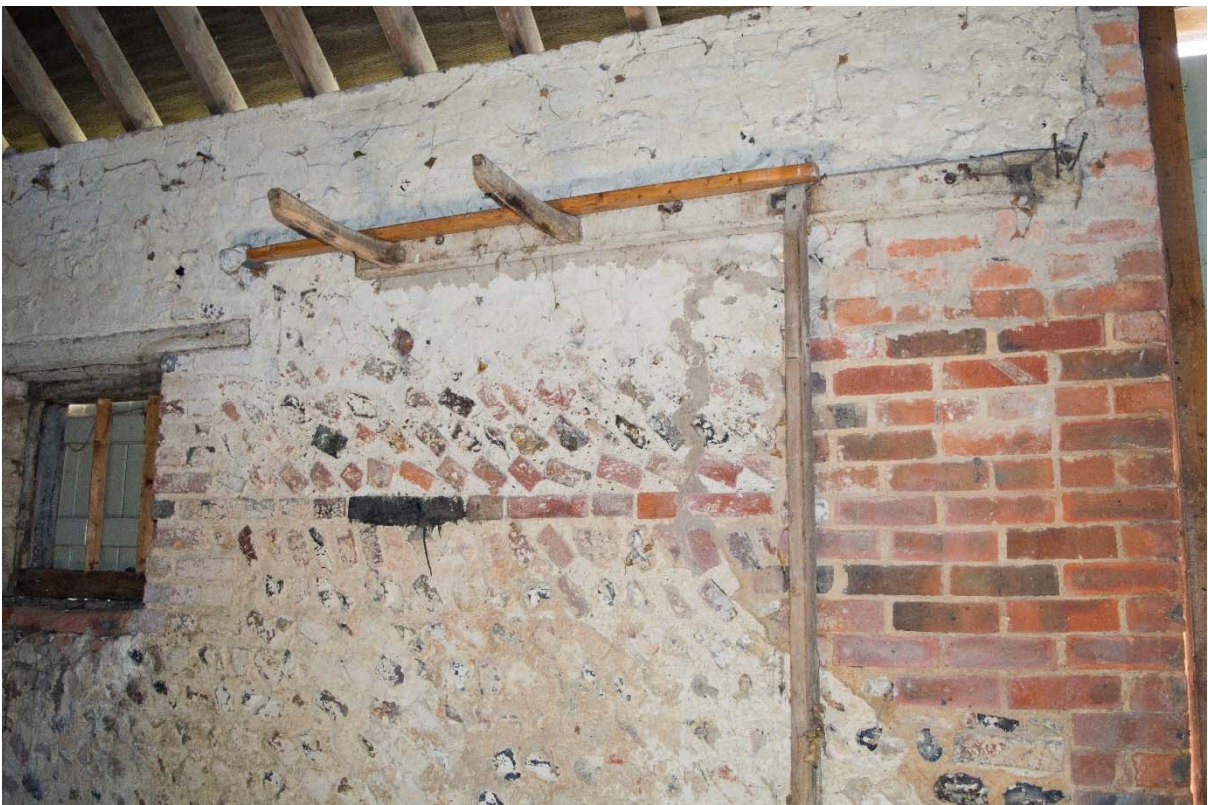
Plate 14: Harness-rack retained on east wall (38)

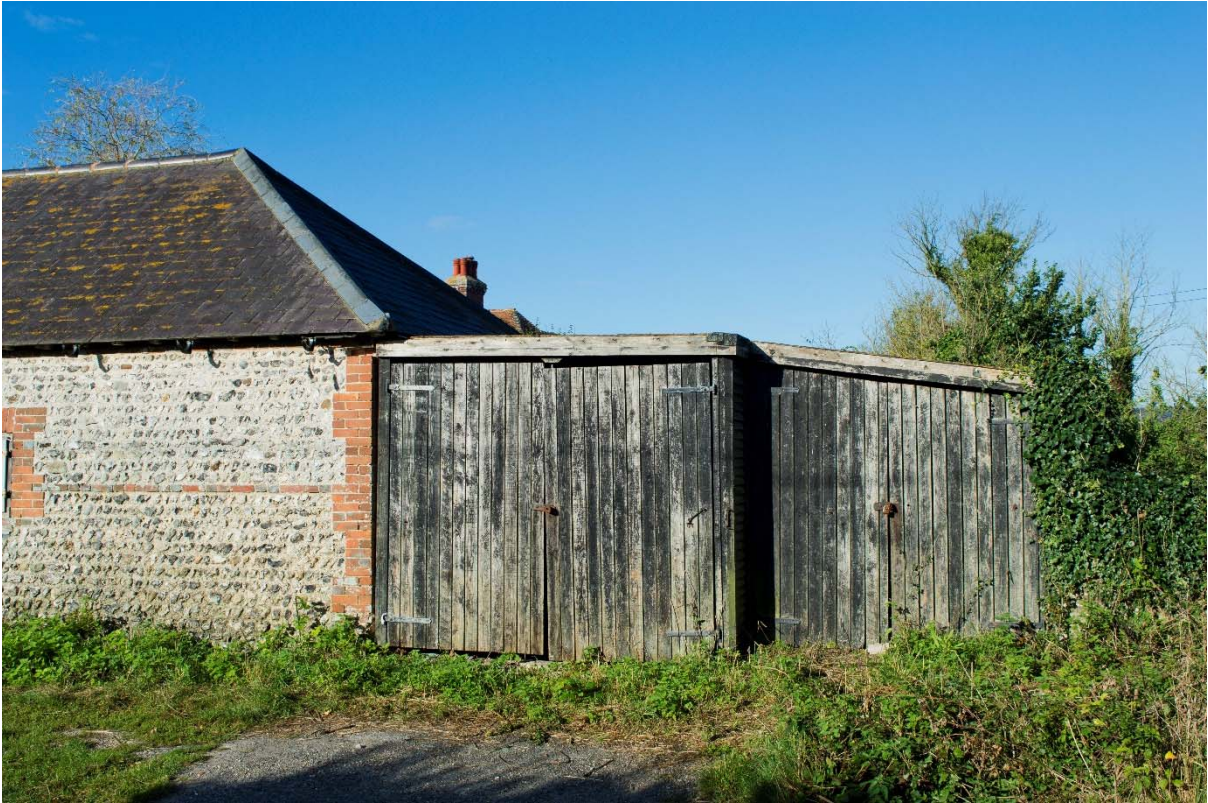
Plate 15: East elevation of northern shelter (5)

- 5.9 The enclosure at the northern end of the building is largely of modern construction. Externally, most of the structure is obscured by vegetation, with the exception of the front (east) elevation which is formed by a pair of double-width doorways which contain modern boarded doors (Plate 15). Internally, it is clear that the lower parts of the north and west walls are of a similar mixture of flint and brick construction to the main building, and survive as remnants of the enclosure noted on the early mapping (Figure 6). The north wall has been extended upwards in brickwork (Plate 16), as has the northern half of the west wall (Plate 17) – this coincides with the extent of the structure noted on the 1909 and 1928 maps (Figures 10 and 11). The remainder of the space above the west wall has been enclosed by a series of timber mullions. At the far south end, there is a doorway which retains a boarded and ledged door of early / mid-20th century type. The floor is covered with brick pavements; these seem to extend into the northern half of the structure, but this has latterly been covered with a concrete screed. The floor within the southern half has an east – west aligned drain. The roof structure is entirely modern: over the southern half it is flat, while over the northern half it is gently pitched.

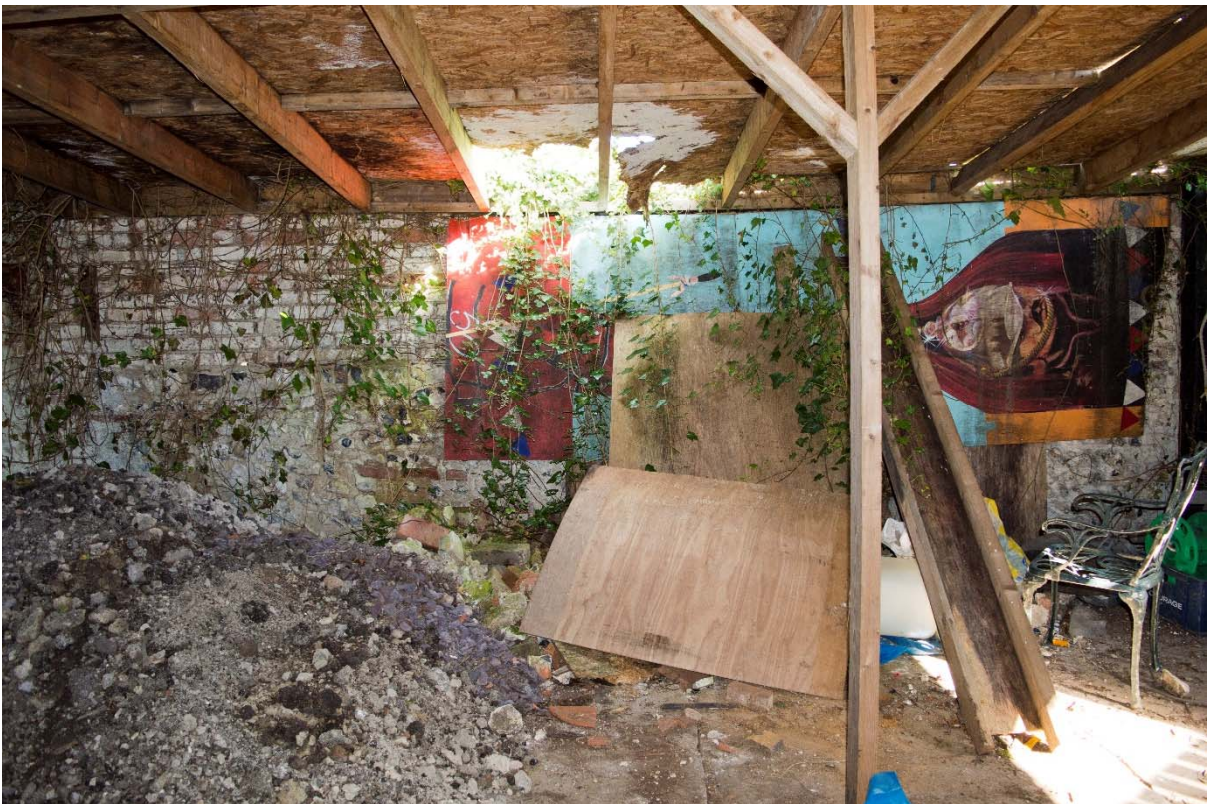
Plate 16: North wall of northern shelter, showing original enclosure walls at base, with later, probably early 20th century brickwork above (63)

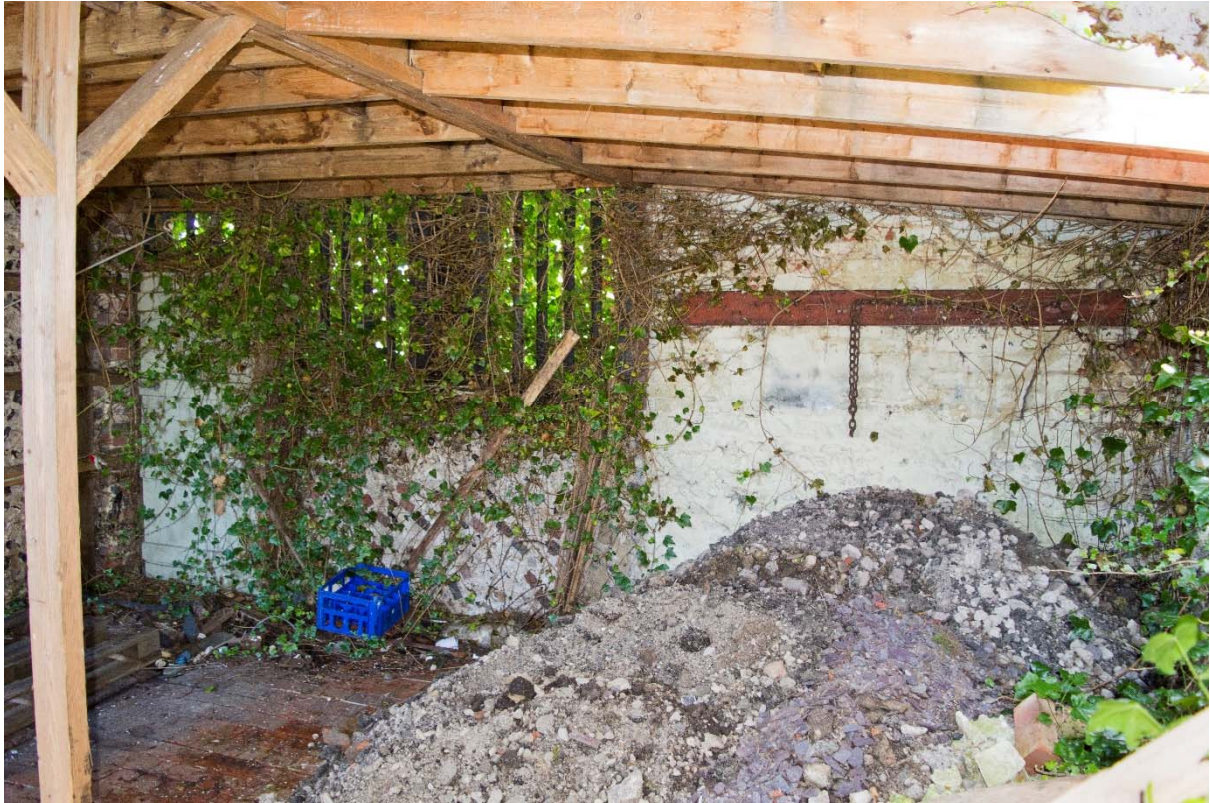
Plate 17: West wall of northern shelter, showing original enclosure walls at base, with later brickwork (right) and timber mullions (left) above. Note the early/mid-20th century door to far left (62)

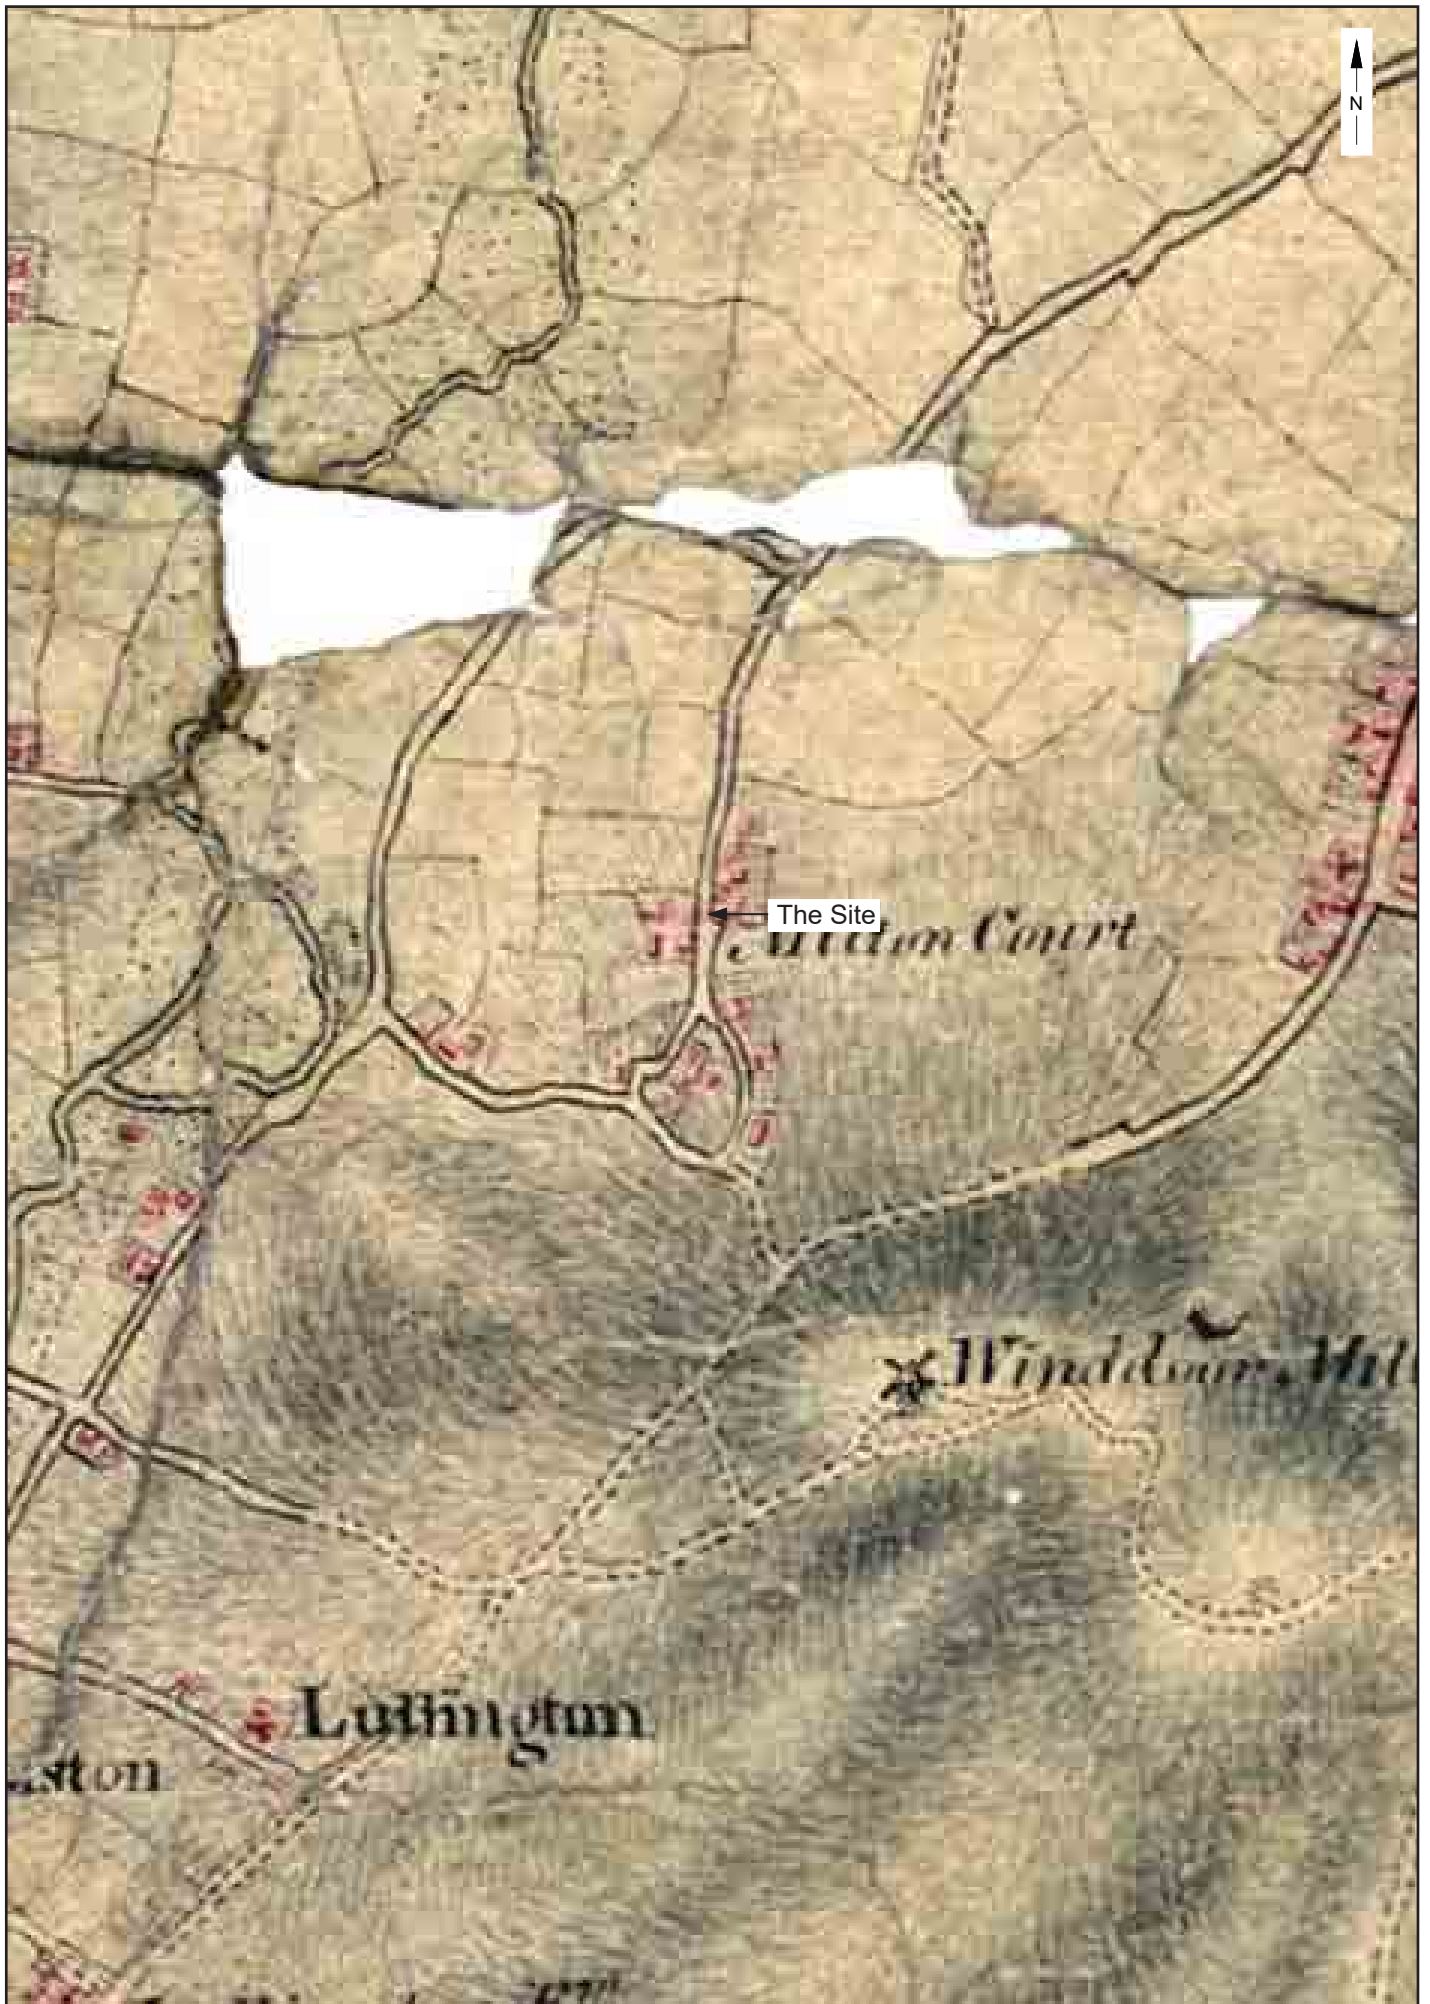
© Archaeology South-East		The Byre, Milton Street, Polegate	Fig. 4
Project Ref: 160764	October 2016	Ordnance Survey draft map, c. 1800	
Report Ref: 2016376	Drawn by: AW

- 4.3 The Ordnance Survey draft map of c. 1800 (Figure 4) represents the site at a similar scale to the previous map, but appears to show four structures, one of which is located in the approximate position of the byre.
