**THE BYRE, MILTON STREET, POLEGATE,
EAST SUSSEX, BN26 5RW**

HISTORIC BUILDING RECORD
(Historic England Level 3)

Project no: 160764

Report ref: 2016376

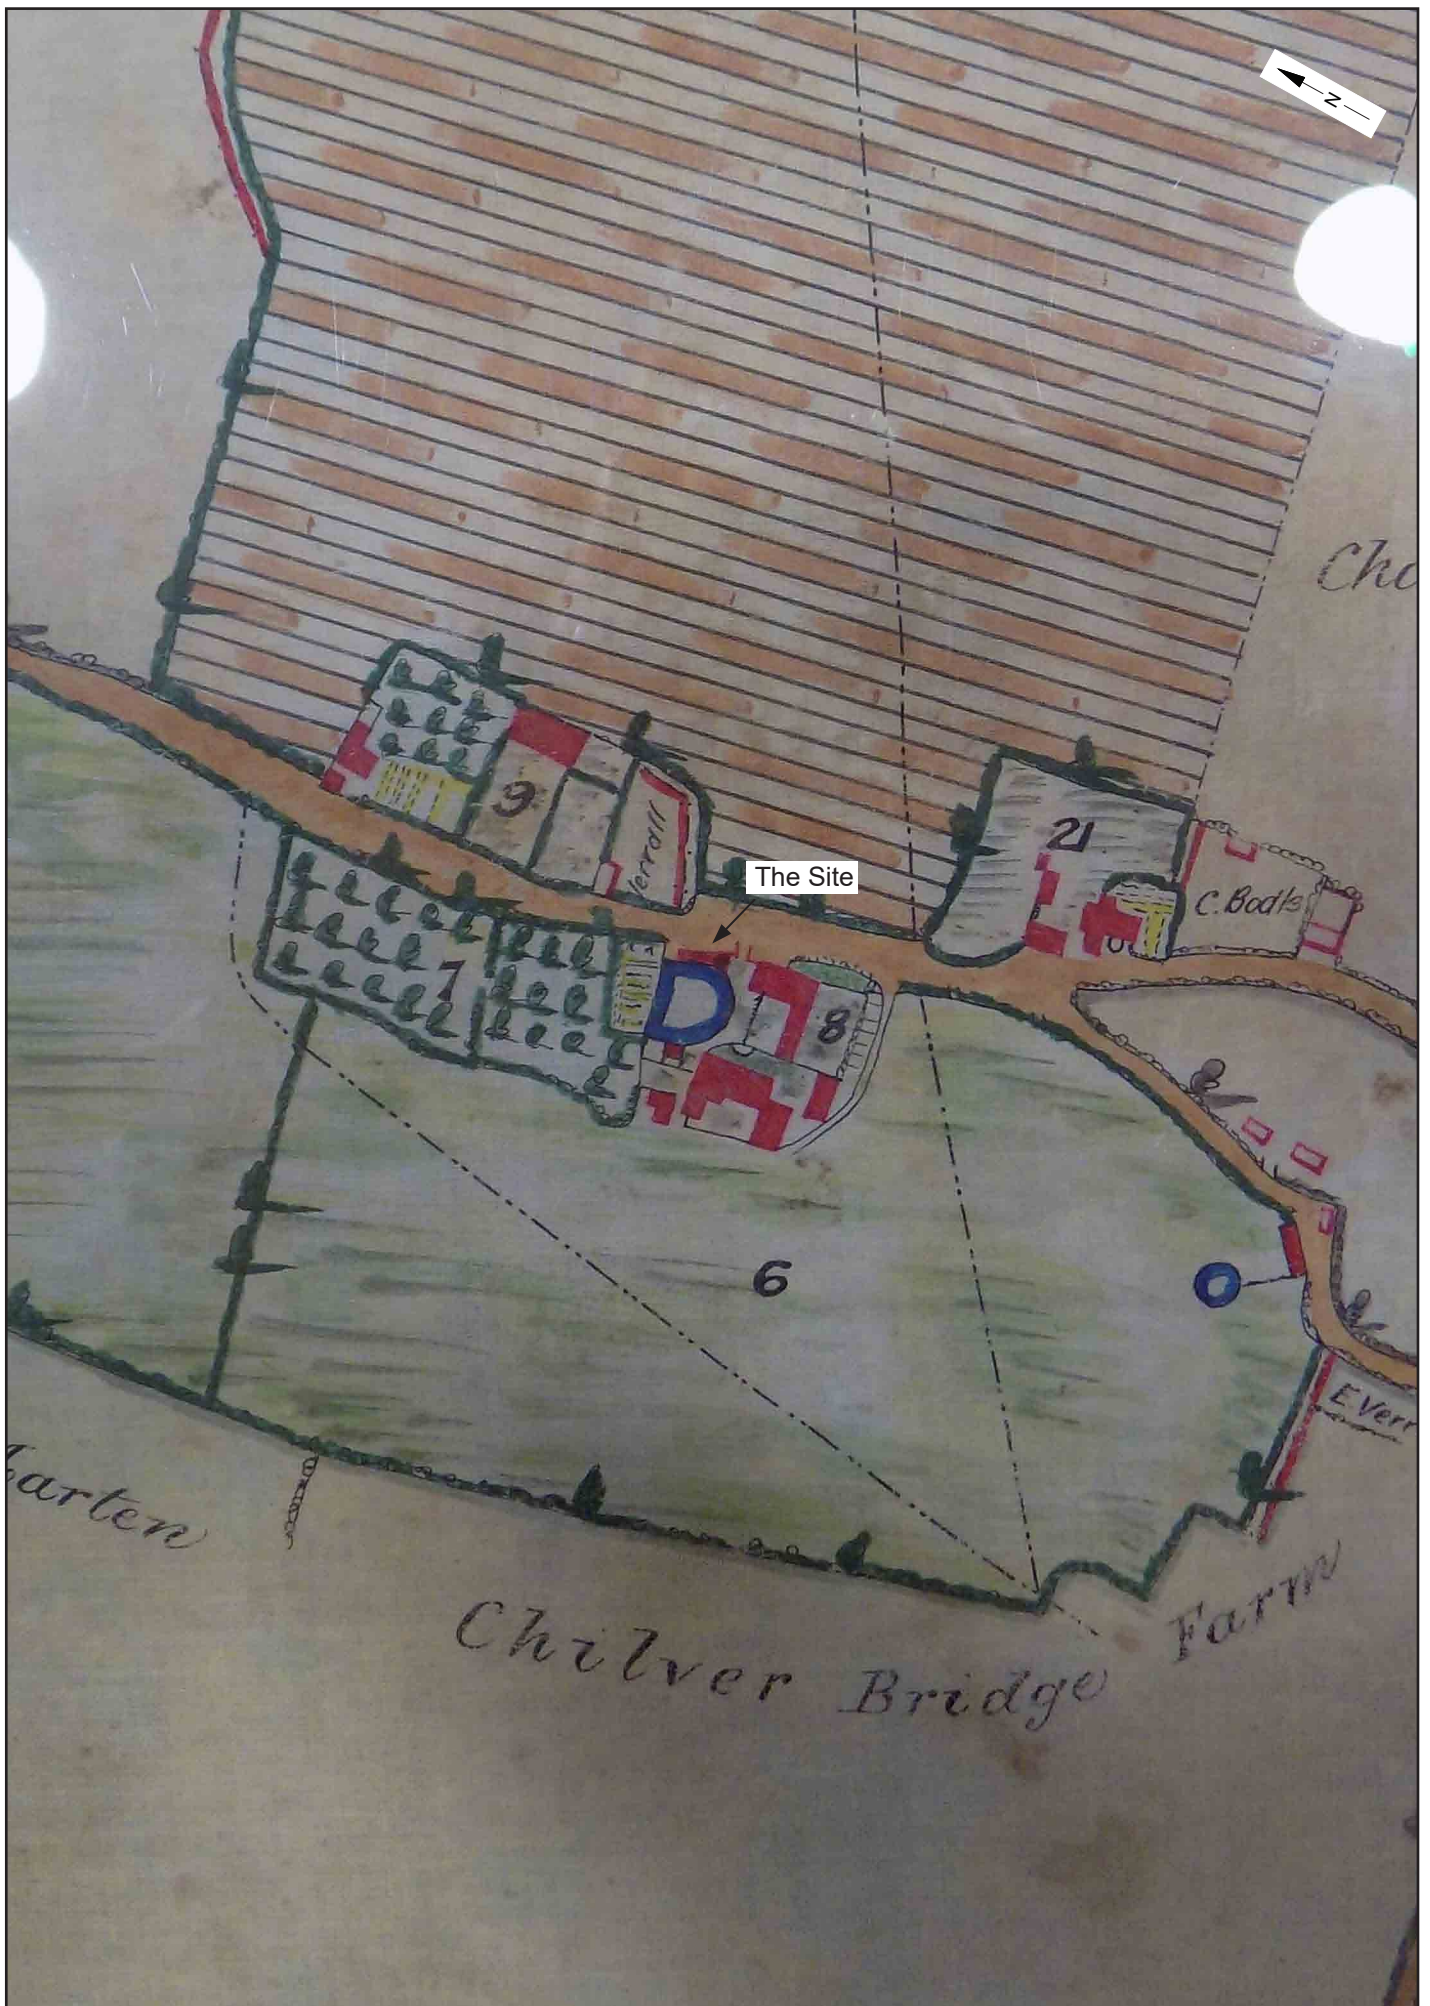
© Archaeology South-East	The Byre, Milton Street, Polegate	Fig. 5
Project Ref: 160764	October 2016	
Report Ref: 2016376	Drawn by: AW	
Estate map by William Figg, 1827

- 4.4 By 1827, when the estate was mapped by William Figg (ESRO ref. GWY 5/1/1; Figure 5), the farmstead was known as Milton Street Farm and amounted to 247 acres. The farmstead (Parcel 8) is identified as 'House Buildings Yards &c' with 'Orchards' to the north, and 'Running Field' to the west; the surrounding agricultural and pastoral fields are depicted by the use of different mapping conventions. The map shows the individual buildings in a much more useful level of detail than previous maps, including the farmhouse, dovecot and other ancillary structures. The extant barn is shown fronting the road to the south of the entrance to the farmstead, while the byre is shown to the north. To the rear of the byre there is a large pond which at that date extended right up to the building. To the north of the pond and byre is a small enclosure which is shaded differently – presumably the farmstead's kitchen garden/hop garden.

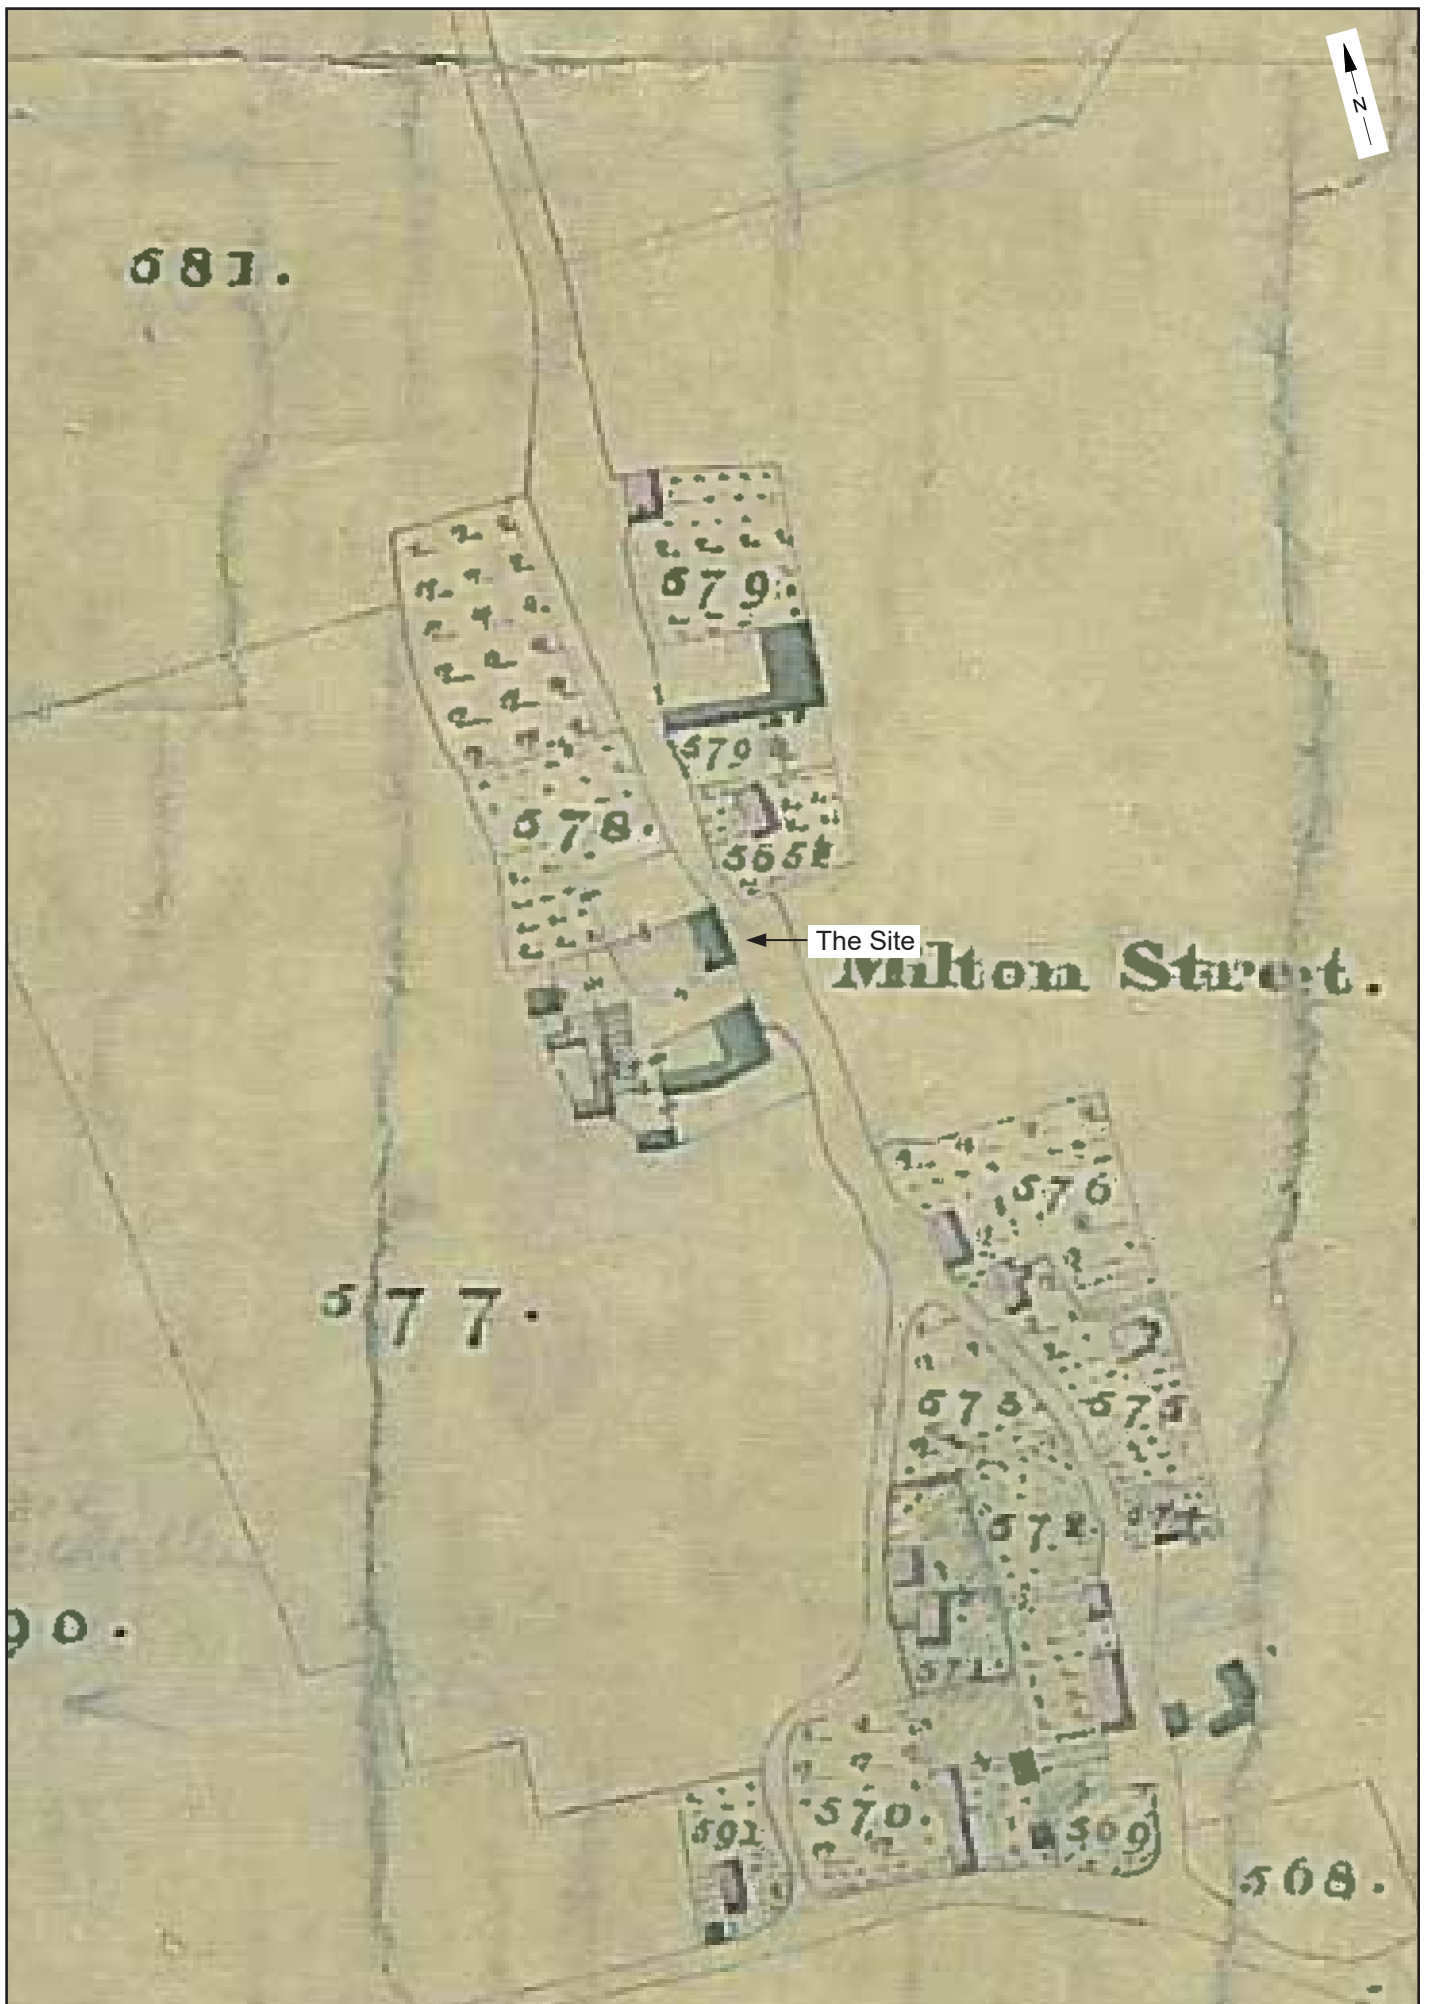
© Archaeology South-East		The Byre, Milton Street, Polegate	Fig. 7
Project Ref: 160764	October 2016	Tithe map of Arlington, c. 1843	
Report Ref: 2016376	Drawn by: AW

- 4.6 The tithe map of Arlington (ESRO ref. TD/E51; Figure 7) is undated, although the accompanying award is dated 1843. It shows the farmstead in much the same way as the two previous maps. At that date the farm was owned by Nicholas Willard and occupied by James Hallett.
