EATON'S FARM, FOOTBRIDGE, ASHURST, WEST SUSSEX

**HISTORIC BUILDING RECORD
(HISTORIC ENGLAND LEVEL 2)**

**Project no. 160804
Report ref: 2016375**

Commissioned by West Sussex County Council

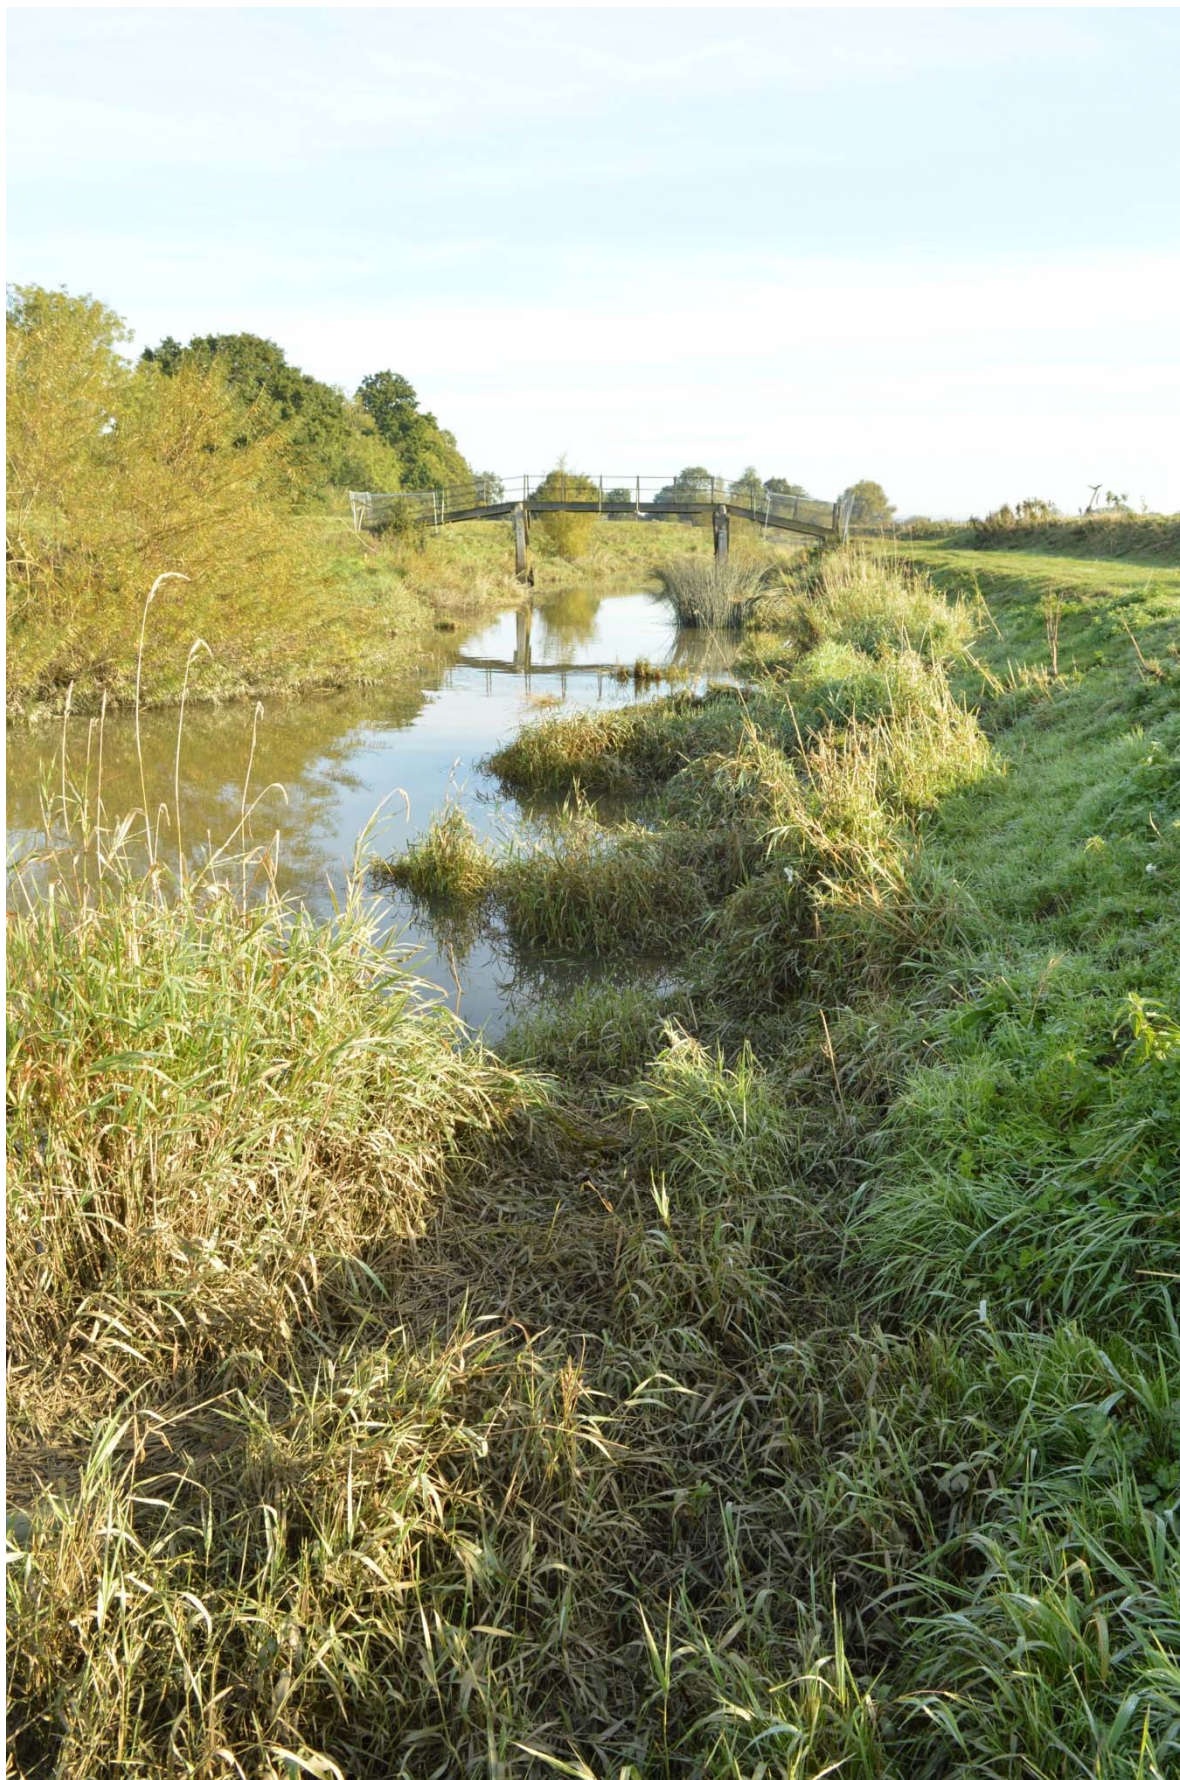
Plate 1: Looking north along the River Adur towards the bridge (#EFO16-0025)

Sussex (Plate 1). The footbridge is located at c. 4m AOD at the intersection of marked footpaths which run east – west to the north of Eaton's Farm (just to the west of the footbridge) and follow the west bank of the river (south of the footbridge) and the east bank to north and south.

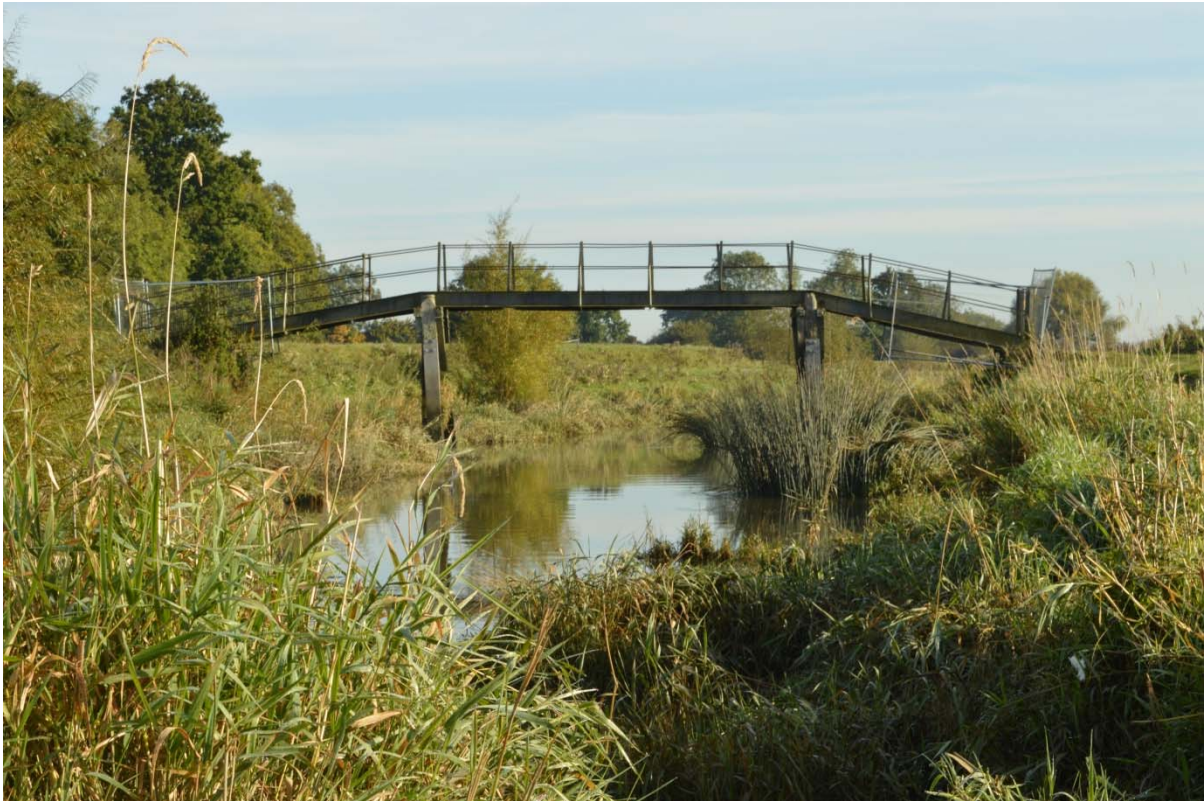
Plate 2: South elevation of the bridge (#EFO16-0026)

- 5.1 The bridge is orientated north-west – south-east across the River Adur, connecting footpaths on the opposing banks (Plates 2 and 3). With the exception of four submerged square-sectioned (presumed) piles situated

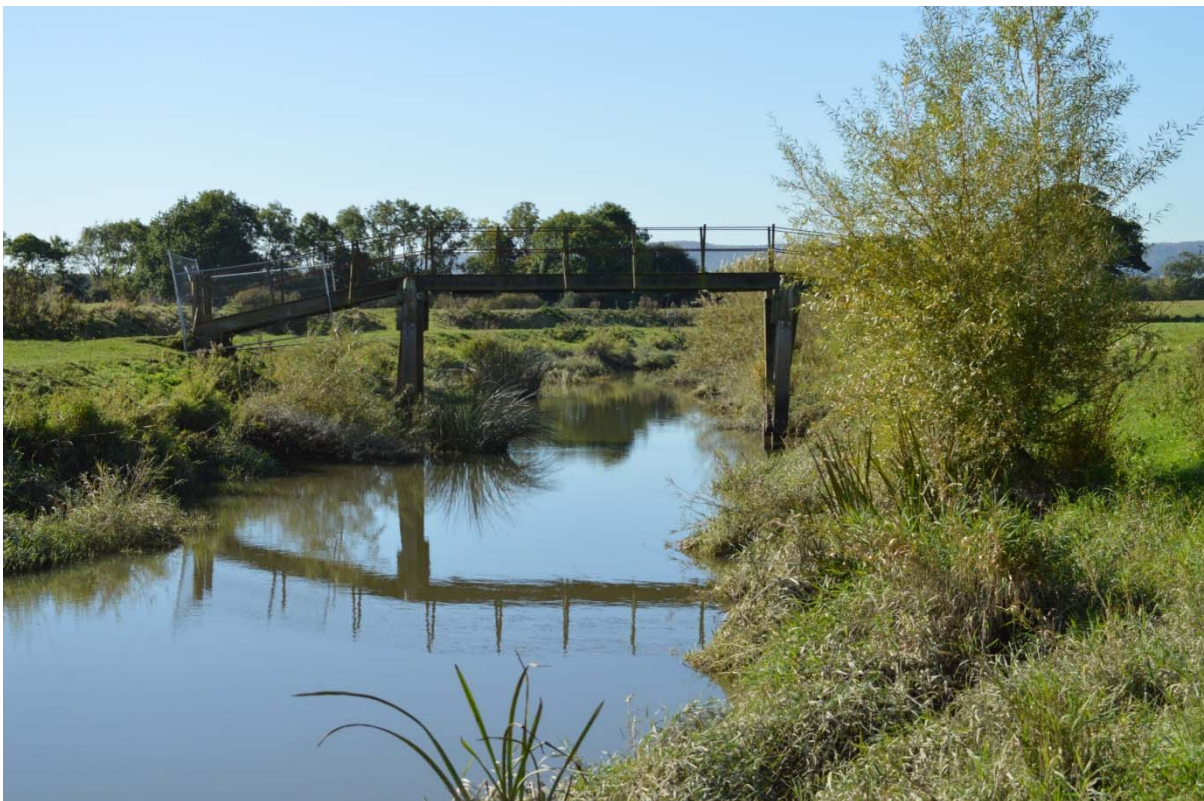
Plate 3: North elevation of the bridge (#EFO16-0054)

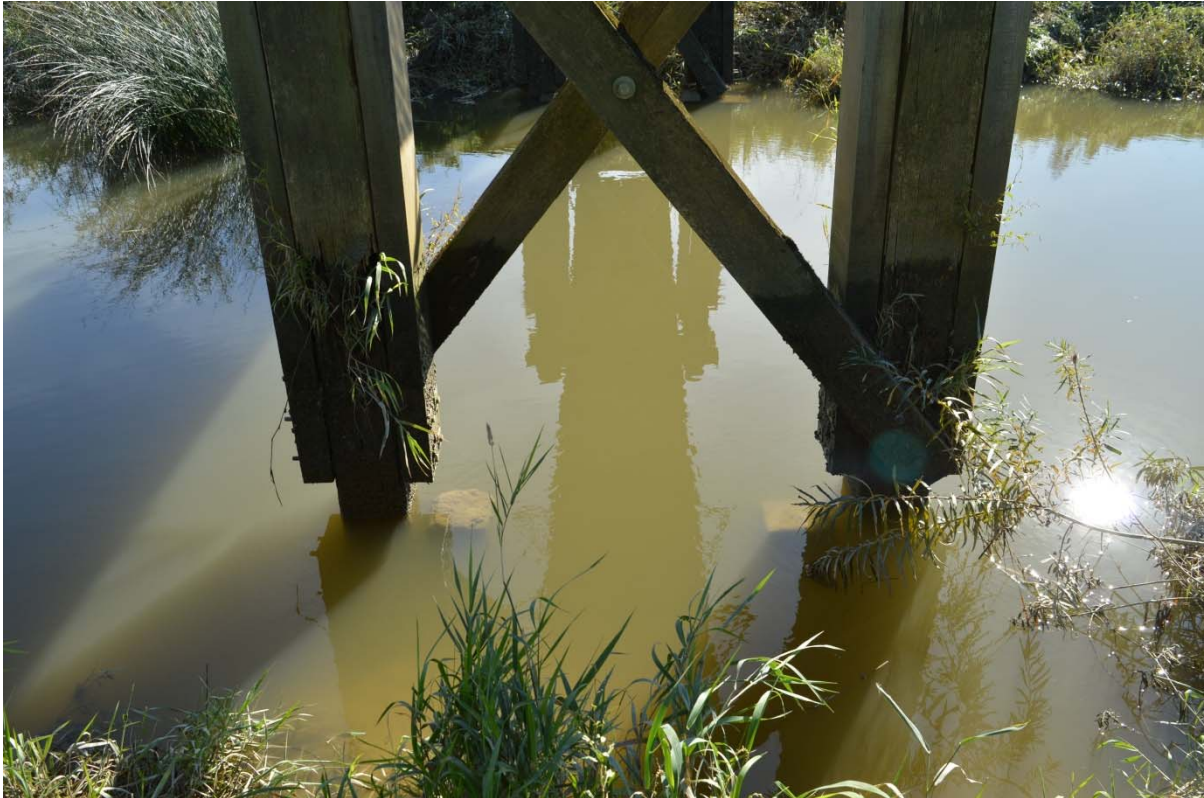
adjacent to the existing piles, no signs of an earlier bridge were observed (Plate 4). The construction of the submerged features could not be determined. It might be presumed, on the basis of the observed submerged features, that the earlier structure would have been of similar size to the present bridge. It is likely that the earlier bridge was of timber construction – as no brick, stone or relevant structural features were observed in the vicinity of the site.

Plate 4: Submerged possible former piles visible just beneath the water below the existing bridge (#EFO16-0060)

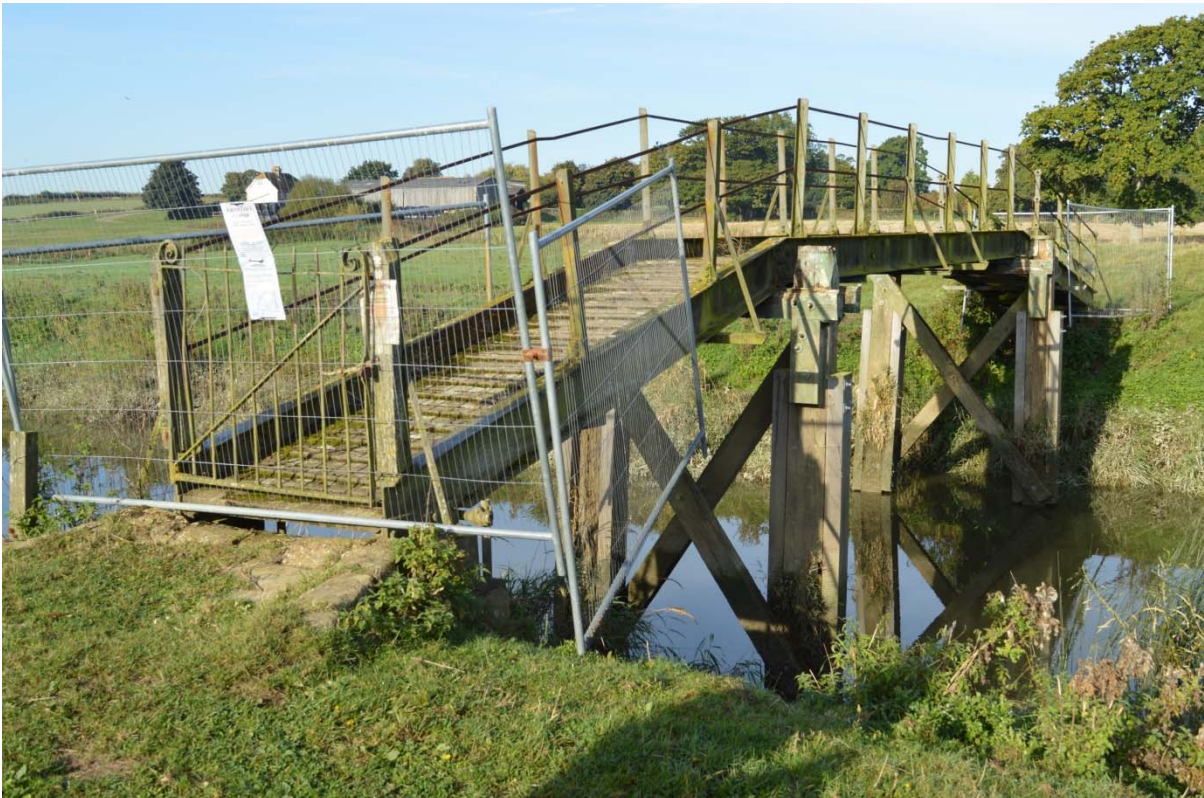
- 5.2 The existing bridge is early 20th-century in date. It is a pedestrian bridge of steel girder construction with a total span of c. 20.25m and a width of 1.38m (2.00m across the piles) (Plate 5). The bridge has a rise from low water of c. 4.04m. The bridge features cast-in-place concrete piers to either bank, reinforced at a later date with steel scaffolding on the east bank (Plate 6). Concreted sandbags form a ramp up to the east side of the bridge, likely compensating for subsidence of the river bank (Plate 7). The rise of the bridge may be to accommodate the passage of small vessels along the River Adur.

Plate 5: Oblique view of the north elevation of the bridge (#EFO16-0030)

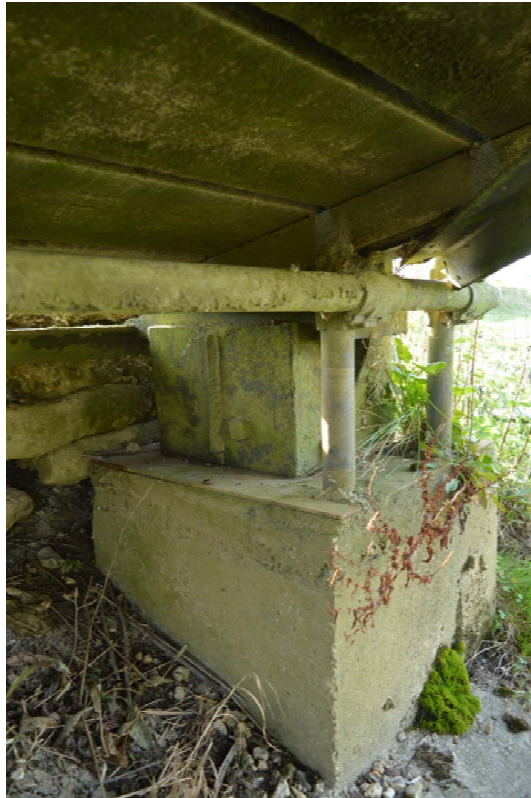
Plate 6: Concrete pier, box stanchion and inserted scaffold (#EFO16-0041)

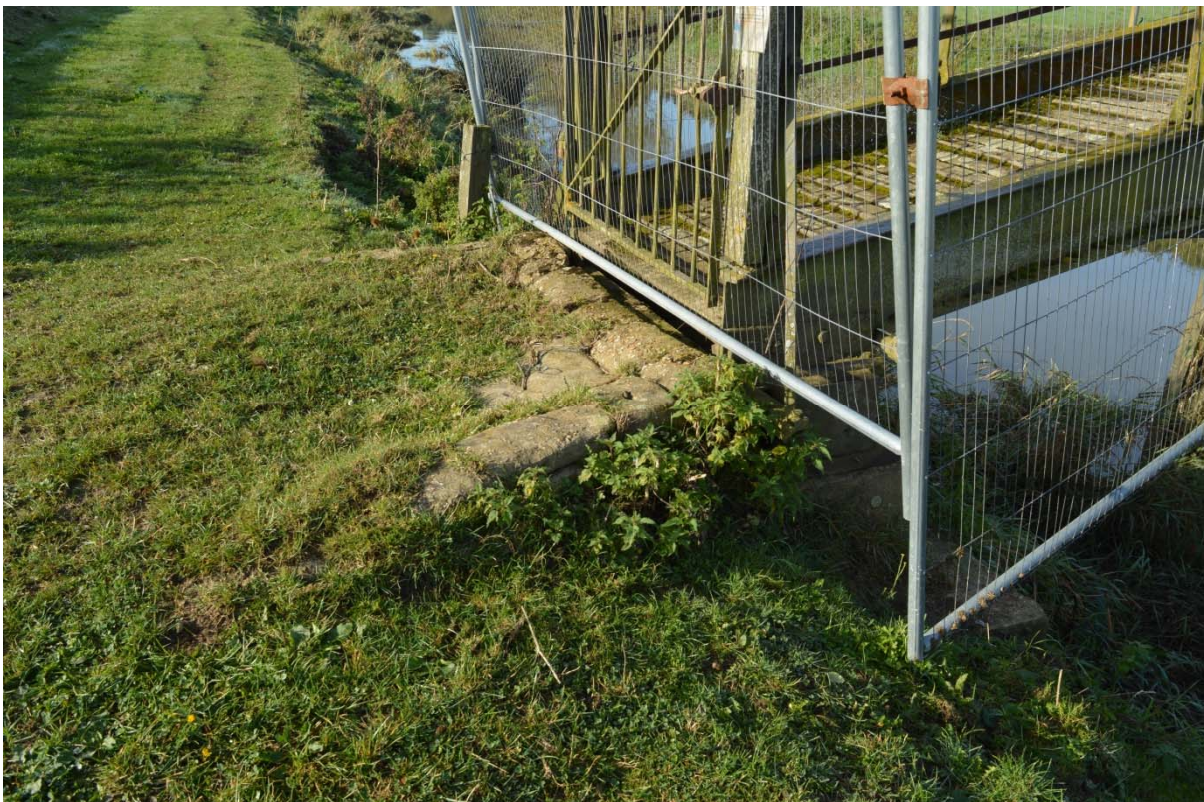
Plate 7: Concreted sandbag ramp to east side of the bridge (#EFO16-0032)

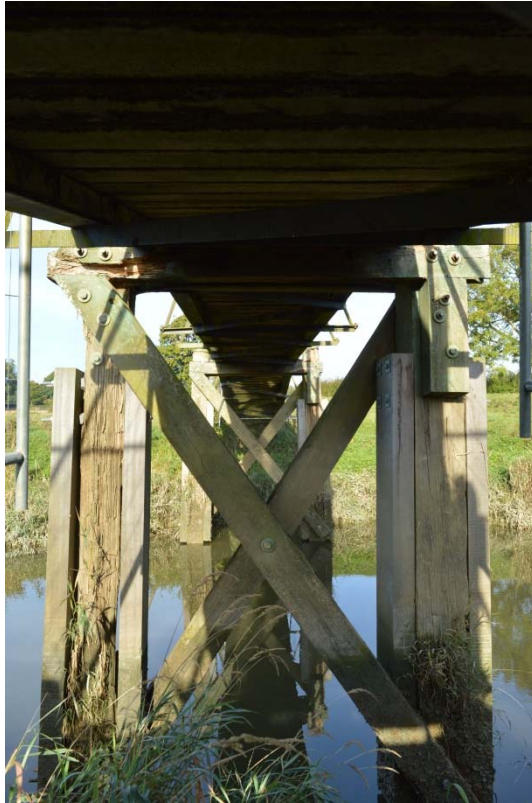
- 5.3 The bridge substructure comprises a pair of short box stanchions to either side, rising from the concrete piers, and a pair of timber piles supporting the main span of the bridge. The timber piles (Plate 8) are formed of a pair of uprights (measuring >4.04m x 0.32m x 0.32m), recently reinforced with timber splices, rising to a composite tie-beam (measuring 2.00m x 0.15m x 0.23m), and tensioned by cross bracing (measuring 3.71m x 0.15m x 0.23m). The tie-beams are of paired timber beams bolted to the east and west faces of the uprights. The uprights rise above the level of the tie-beams to deck level and, excepting where weathered away on the south-east upright, are crowned with a simple tapered finial (Plate 9).

Plate 8: Timber piles supporting the main span of the bridge (#EFO16-0037)

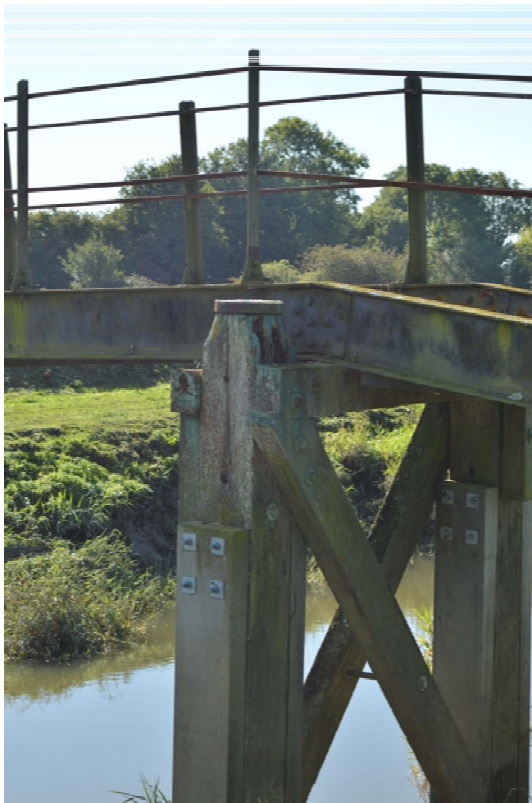
Plate 9: Timber pile finial and tie-beam detail (#EFO16-0055)

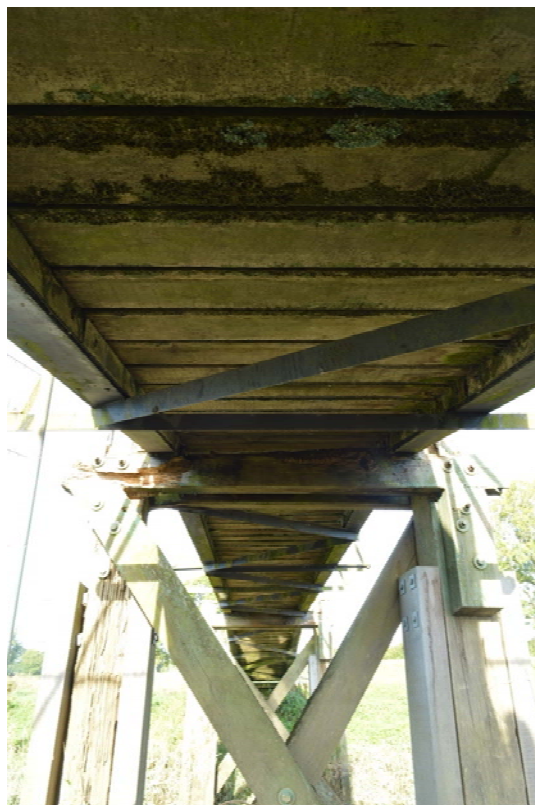
- 5.4 The superstructure is of three sections, constructed of parallel I-girders and reinforced by angle-iron bracing to the soffit (Plate 10). From the east bank the bridge's first section rises to the first pile over a distance of 4.83m, runs level between piles for 8.62m, and descends again to the west bank over 6.82m. The girders are connected to one-another with bolt-plates between sections. The girders appear to be bolted down to the timber tie-beams of the piles. In places angle-iron ties, set perpendicular to the deck, extend beyond the girders to provide a base for steel-bracing supporting handrails above.

Plate 10: Soffit of the bridge (#EFO16-0038)

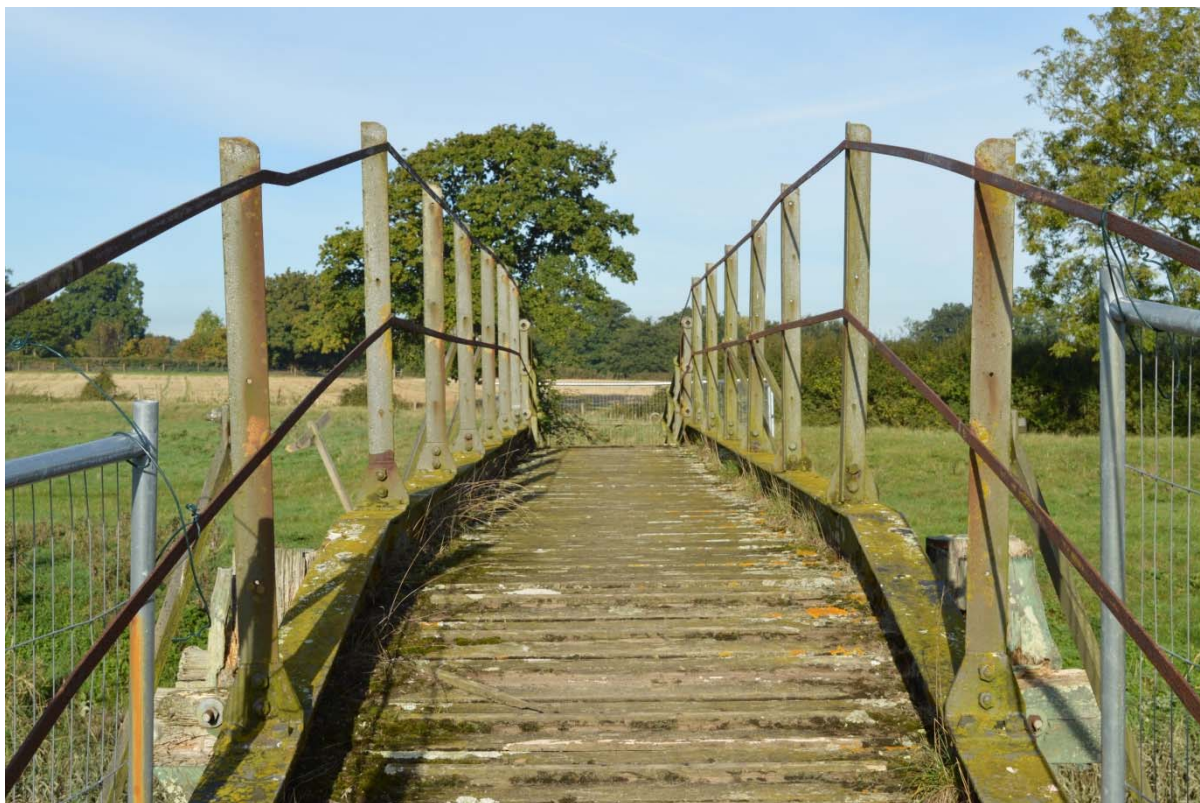
- 5.5 The deck of the bridge is of heavy-duty oak boards set between the channels of the I-girders (Plate 11). Along the rises of the bridge, regularly spaced battens atop the deck boards provide purchase for the boots of passing pedestrians.

Plate 11: View west along the bridge deck (#EFO16-0044)

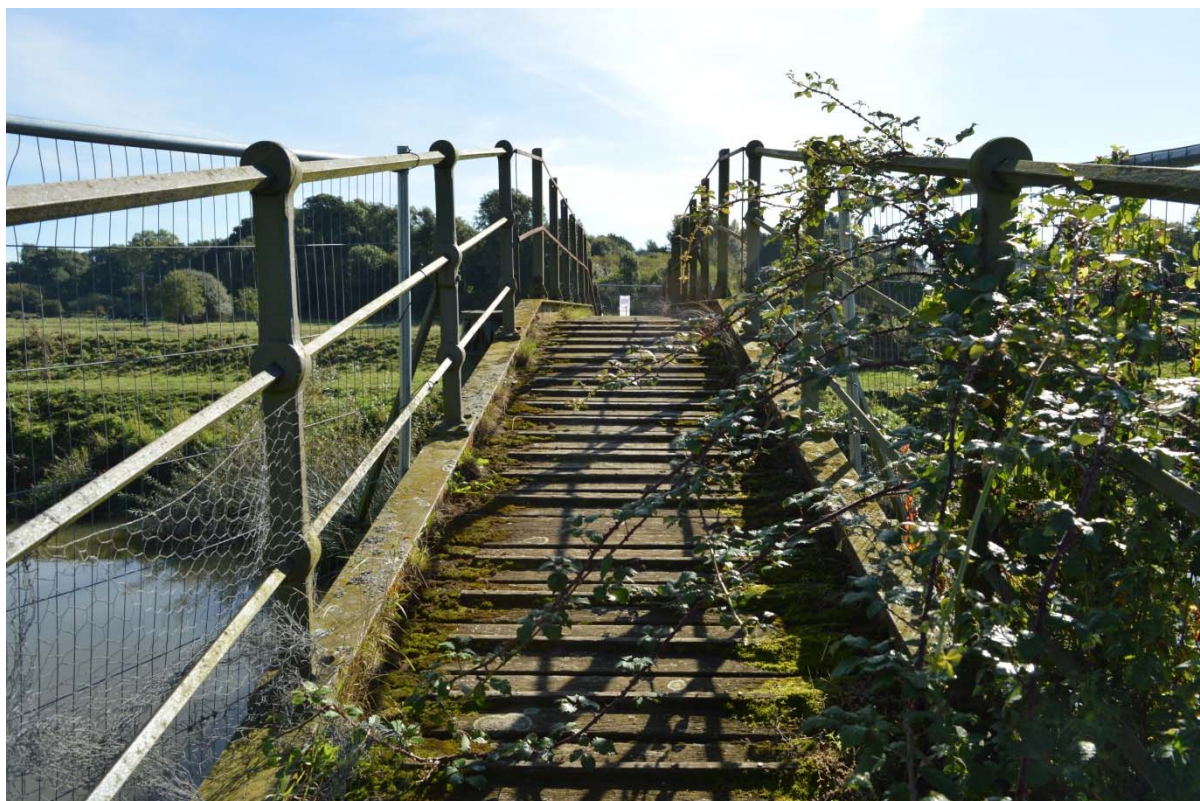
Plate 12: View east along the bridge deck – note the handrails (#EFO16-0067)

- 5.6 The bridge is protected by handrails. The handrails to the west side of the bridge appear largely original, comprising three-tiers of square-sectioned iron railings which run through ball joints within cast-iron balusters (Plates 12 and 13). The other handrail sections, later replacements, are formed of angle-iron uprights with two tiers of welded-on flat iron railings (Plate 14). Wrought iron gates allow access to either end of the bridge, and are likely original features of the bridge (Plates 15 and 16). On the west end of the bridge it can clearly be seen that the gate there is contemporaneous with the older handrails, with the end balustrades being equipped with hinges and a catch for the latch on the

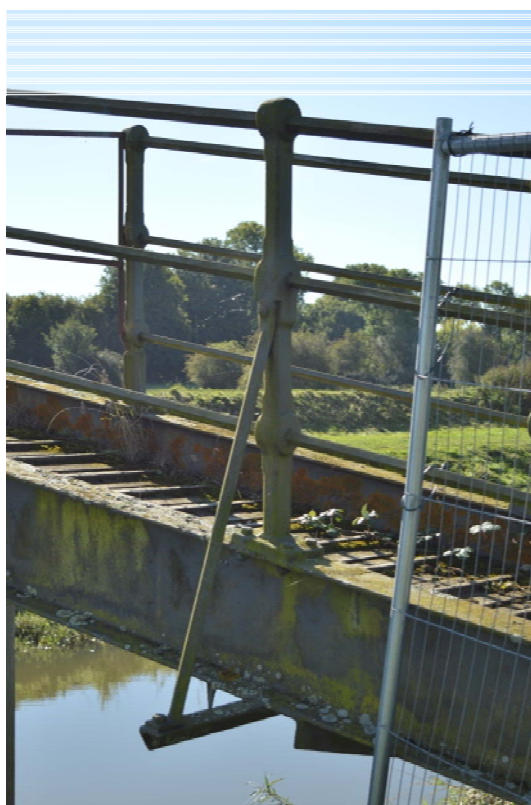
Plate 13: Bollard in original handrail, supported by angle-iron bracing (#EFO16-0056)

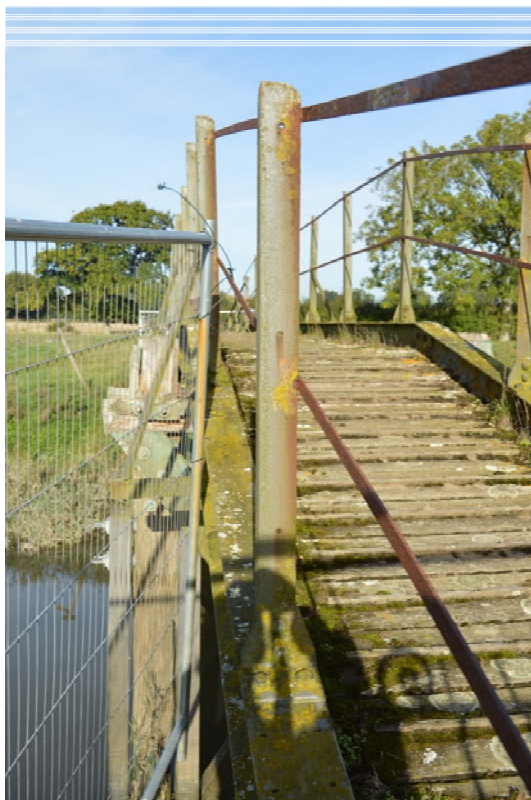
Plate 14: Replacement angle-iron and flat iron handrail (#EFO16-0042)

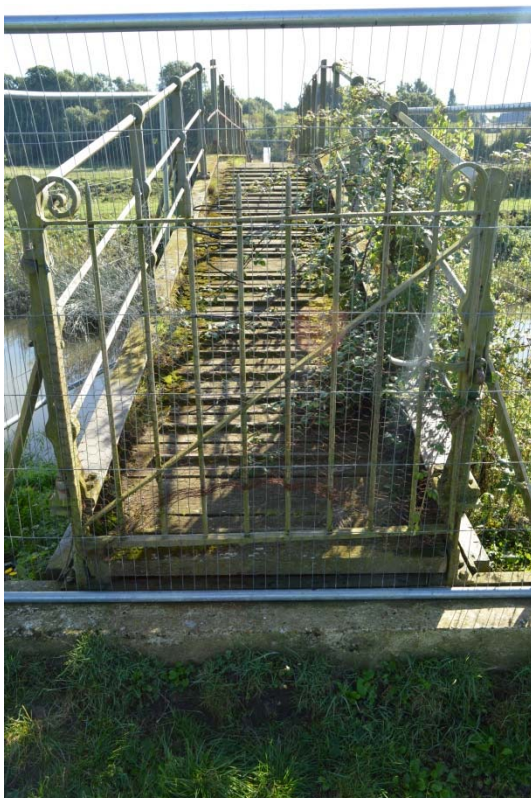
Plate 15: West gate to the bridge (#EFO16-0068)

gate. The gates and original handrails are early 20th-century in style and construction.

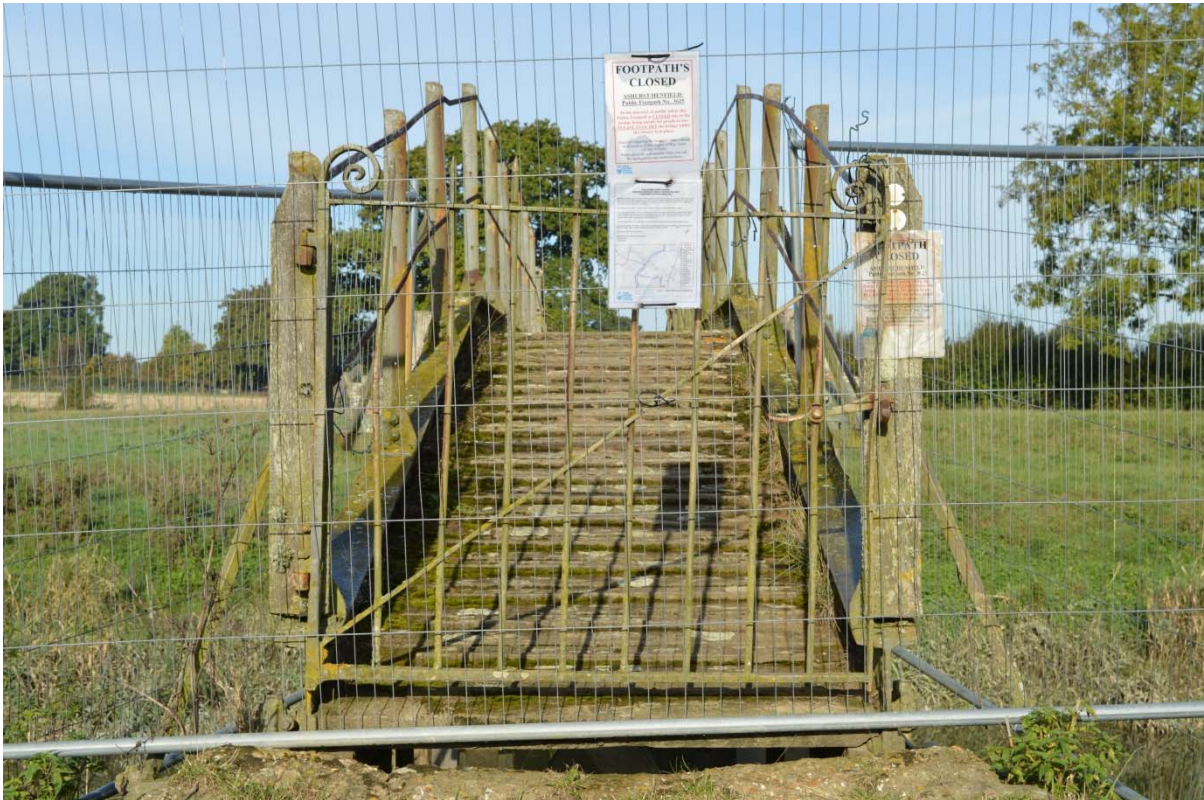
Plate 16: East gate to the bridge (#EFO16-0031)

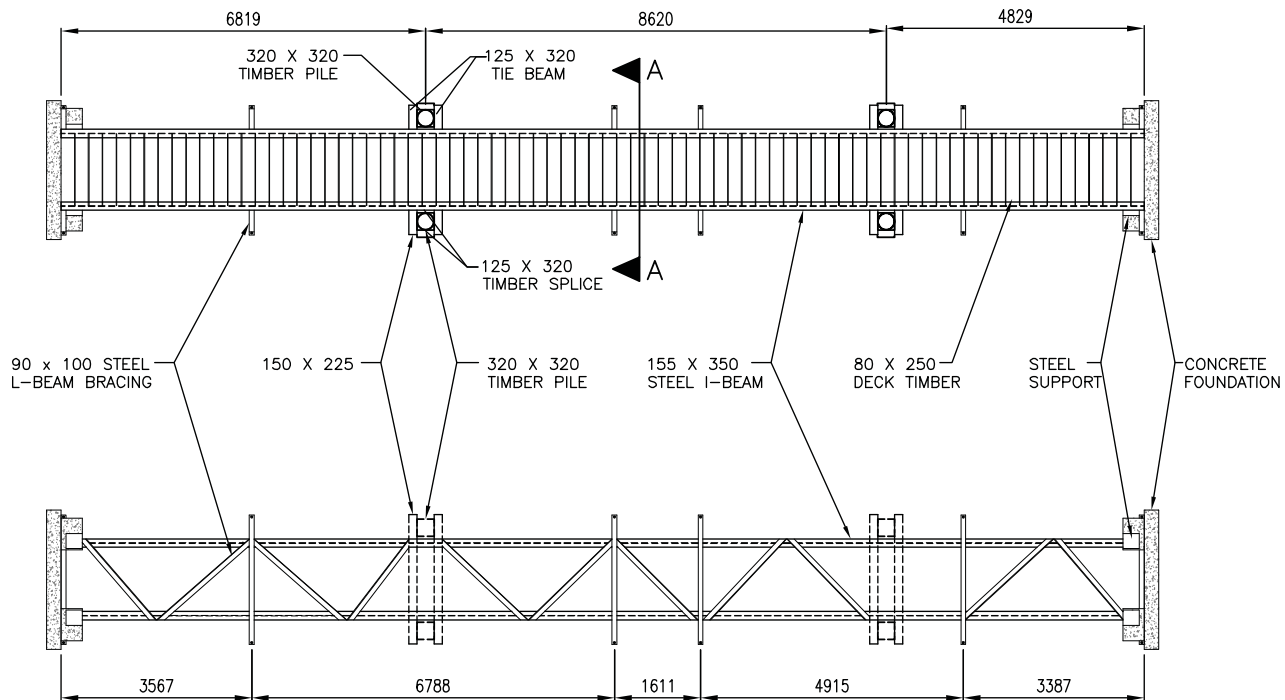
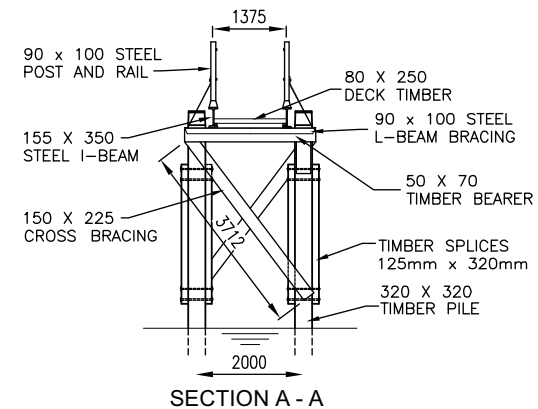
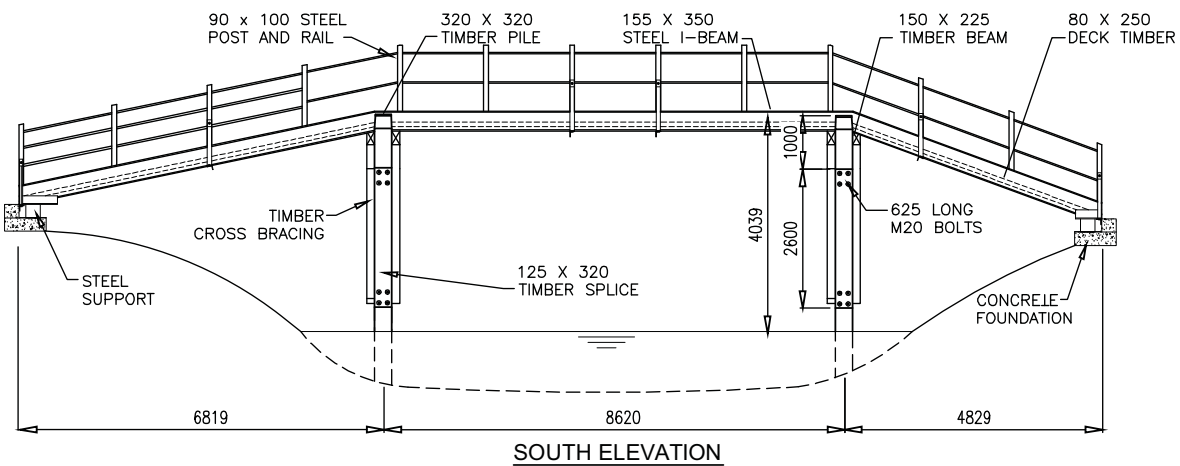
PLAN - TOP

- 2.4 The drawn record comprises a plan, elevation and section of the bridge. This is based on an existing measured drawing, which has been augmented and annotated where necessary. The resulting scaled drawing is included within the report as Figure 2.
