**Archaeological Watching Brief Report  
Stanhope Lodge, Worthing  
West Sussex**

**ASE Project No: 160322  
Site Code: SLW16  
ASE Report No: 2017008  
OASIS id: archaeol6-272724**

*Archaeology South-East was commissioned by Southern water to undertake an archaeological watching brief during works associated with the replacement of a water main at Stanhope Lodge, Worthing, West Sussex.*

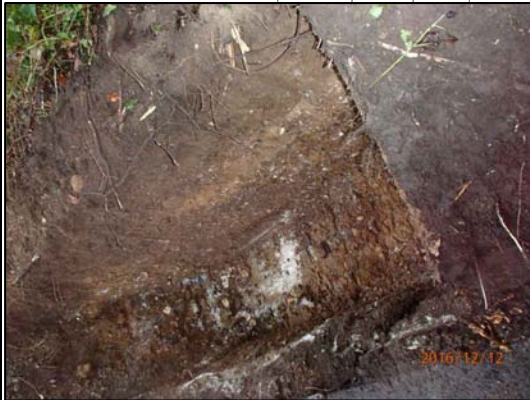
Pit 1, south-facing section

- 4.1.1 Pit 1 was situated on a grass verge to the north-east of The Coach and Horses public house. It was 1,1m wide and 3.0m long and dug to approximately 1.2m below ground level (BGL).
- 4.1.2 No archaeological finds or features were identified during the monitoring process.
- 4.1.3 The natural geology comprised a stiff yellow brown clay with flints geology [02] and was encountered at around 0.60m BGL.
- 4.1.4 The natural substrate was directly overlain by a topsoil deposit [01] made up of mid grey brown fine silt with a maximum depth of 0.60m.

Context	Type	Interpretation	Max. Length m	Max. Width m	Deposit Thickness m
01	Layer	Topsoil	Trench	Trench	0.6
02	Layer	Natural geology	Trench	Trench	NA

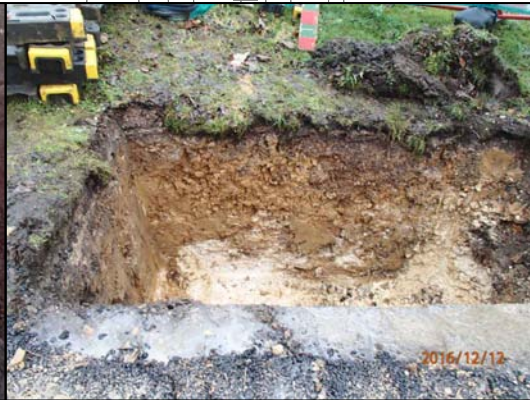
Pit 2, south-facing section

- 4.2.1 Pit 2 was situated on a grass verge to the north-west of The Coach and Horses public house. It was 1,5m wide and 3.0m long and dug to approximately 2.0m below ground level (BGL).
- 4.2.2 No archaeological finds or features were identified during the monitoring process.
- 4.2.3 The natural geology comprised a stiff yellow brown clay with flints geology and was encountered at around 0.40m BGL.
- 4.2.4 The natural substrate was directly overlain by made ground [03] made up of mid grey brown fine silt with a maximum depth of 0.40m.

Context	Type	Interpretation	Max. Length m	Max. Width m	Deposit Thickness m
03	Layer	Topsoil	Trench	Trench	0.4
02	Layer	Natural geology	Trench	Trench	NA

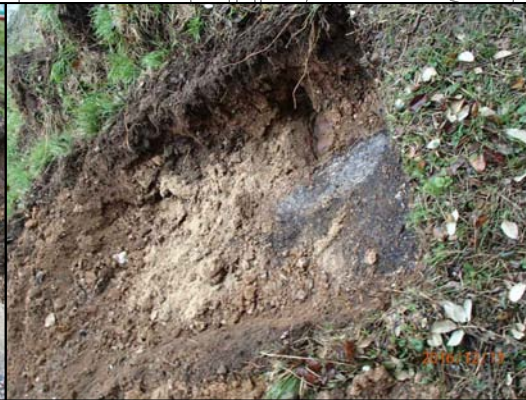
Pit 3

4.3.1 Pits 3 and 4 were situated on a grass verge between the current A27 and the public footpath in the very east of the scheme. Both pits revealed topsoil [01] and made ground [03] directly overlying tarmac of the old A27 carriageway. These deposits were as described above. In Pit 4 the tarmac and sub-base of the carriageway was removed and it was observed to sit directly over clay with flints geology with no remnant soil horizons present.

4.3.2 No archaeological finds or features were identified during the monitoring process.

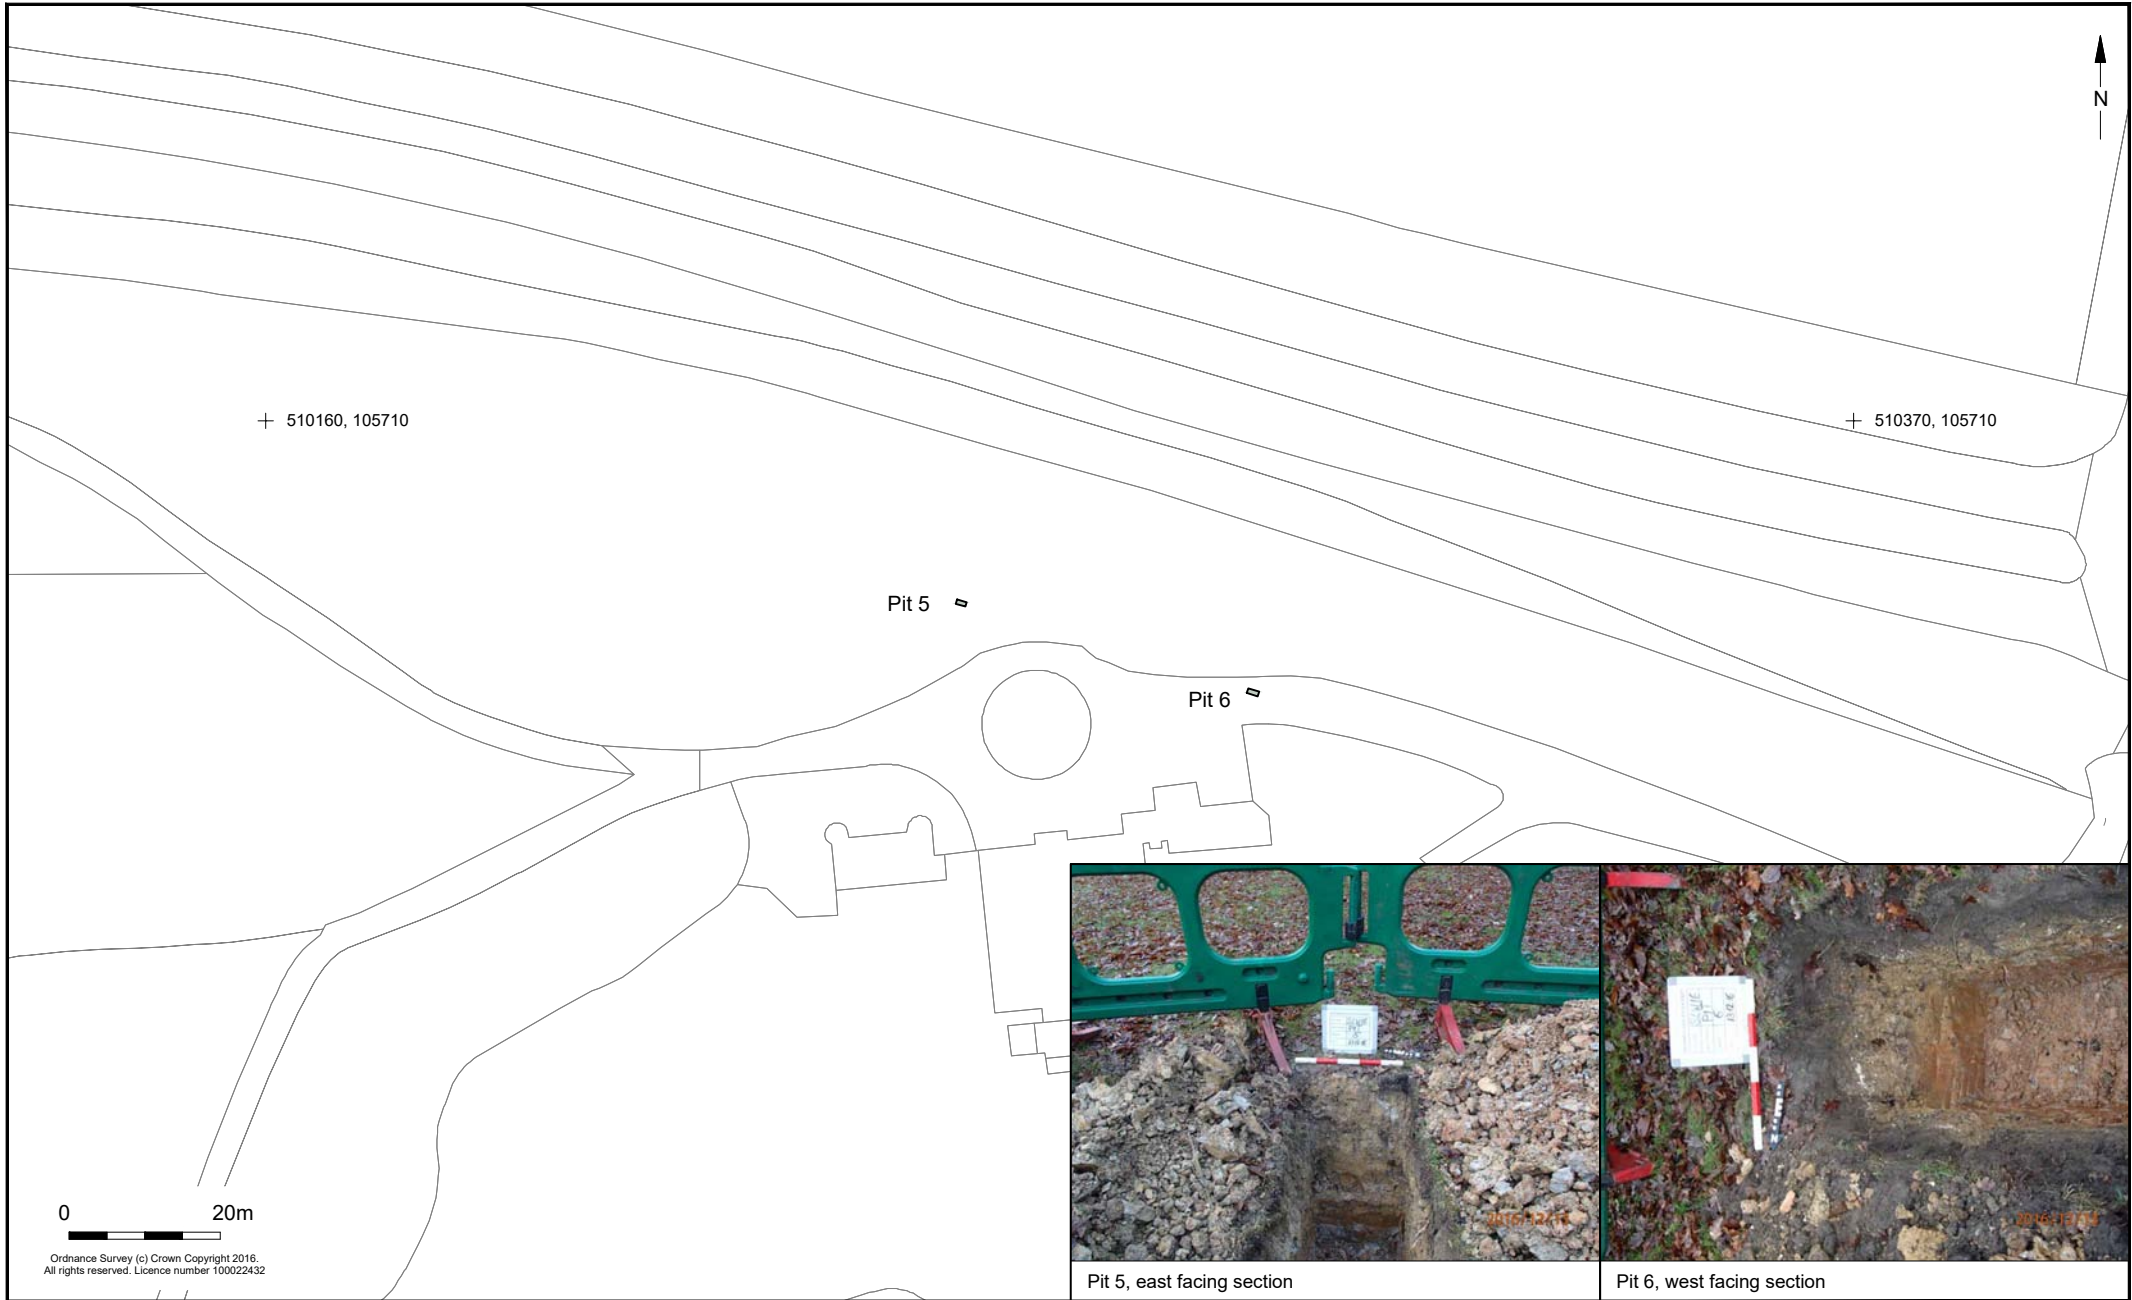
© Archaeology South-East		Stanhope Lodge, Worthing	Fig. 4
Project Ref: 160322	Jan 2017	Location of pits 5-6	
Report Ref:	Drawn by: JLR

4.4.1 Pits 5 & 6 were situated within the grounds Castle Goring in the west of the scheme. Both pits were hand dug to 0.80m BGL within the lawns to the north of the house.

4.4.2 Pit 5 was the westernmost of the pair and measured 0.60m wide by 1.3m long. Yellow clay geology [07] was encountered at 0.22m BGL. This was overlain by rooted subsoil [05] with a maximum depth of 0.15m with the sequence capped by mid grey clay silt topsoil [04] and turf which was 0.07m deep.

4.4.3 Pit 6 was dug to the south-east of Pit 5 and measured 0.65m wide by 1.50m long. Clay geology was noted at 0.45m BGL. This was overlain by re-deposited clay with flints [06] with a depth of 0.22m which was possibly deposited during the construction of the construction of the nearby drive way. The sequence was capped by topsoil and turf which was identical to that described for Pit 5 and was noted to a depth of 0.23m.

4.4.4 No archaeological finds or features were identified during the monitoring process.
