**An Archaeological Watching Brief at the site of a New
Visitor Centre, Battle Abbey,
Battle, East Sussex**

**An Archaeological Watching Brief at the site of a New
Visitor Centre, Battle Abbey,
Battle, East Sussex.**

**Project No. 2237
Oasis id: archaeol6-27297**

**by
Paul Riccoboni BA (Hons)**

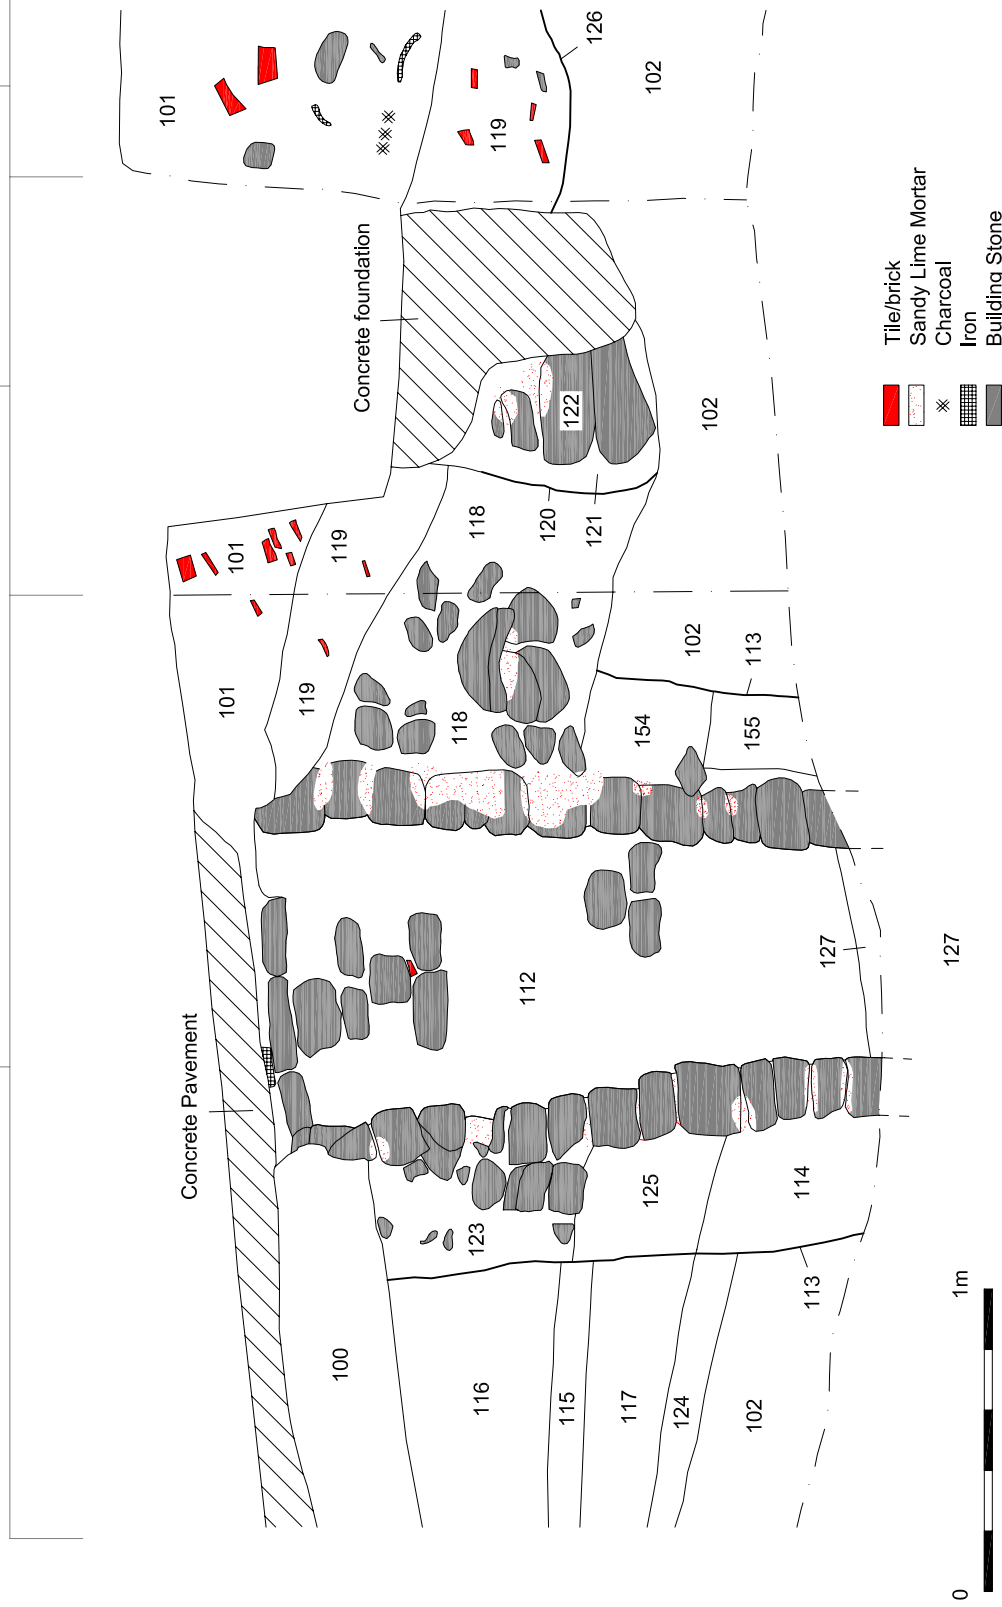
was constructed of sandstone blocks of a yellowish brown colour. The well was likely to have been constructed in the 15th-16th century (see Finds section). The blocks were roughly rectangular and were concave forming a total diameter of 1.40m. The stone blocks had a smooth finish and were rounded at the corners. The structure was constructed with regular coursing and a friable, sandy lime mortar of an orange yellow colour. It contained crushed chalk fragments between the blocks. The depth of the well reached a minimum of 3.2m from surface level.

- 4.1.6 A construction cut for the well was recorded [113]. This was located beneath [100] (described above 4.1.1) on its western side and [118] on its eastern side (Fig 7, Section 1). Context [101] was the uppermost deposit on the eastern side of the well. This deposit is described above in 4.1.1. Directly beneath [101] was [119]. This was a light-mid yellowish grey with some darker grey brown deposit mottling throughout. It had a silty clay texture and a firm consistency. This deposit contained some tile fragments (dating to the 15th-16th Century) and small angular sandstone fragments (<20-50mm). It was interpreted as a deposit of relatively recent origin. Beneath [119] was [118]. This deposit was a mid brownish grey colour and had a silty clay texture. It contained some large sandstone blocks throughout, similar to those used in the construction of the well. This deposit was interpreted as a possible floor or previous ground surface leading up to the well.

- 4.1.11 In the west facing section (Fig 7; Section 1) another cut feature was recorded. Cut [120] was c. 800mm in depth and was seen cutting through [119] and [118]. This feature had one undulating side visible in this section. It was filled by [121]. This was a dark blackish grey coloured silty clay. It contained moderate sandstone fragments and gravel (occasional chalk flecks and tile fragments). Contained within fill [121] was a possible structural feature [122]. This had a maximum width of 380mm and a depth of 170mm. It was constructed of sandstone blocks which were a roughly rectangular shape, but were poorly finished. This possible structural deposit consisted primarily of two large sandstone blocks. Another two smaller sandstone blocks were positioned above these. These blocks were probably the remains of the foundation wall footing of the previous visitors centre (1930's?). A recently laid concrete foundation trench was directly above it. This concrete cut through [119], which was the fill of [126]. The full extent of this cut is unknown, but it is at least c. 2.5m in length. This feature was interpreted as possible post-medieval terracing.

Slot excavated to total of 3.20m from top of well. Base of feature not reached.
