**LITTLE PELL, BLACKSMITH'S LANE,
WADHURST, EAST SUSSEX**

**HISTORIC BUILDINGS RECORD
(HISTORIC ENGLAND LEVEL 2)**

**LITTLE PELL FARM, BLACKSMITH'S LANE,
WADHURST, EAST SUSSEX**

**HISTORIC BUILDING RECORD
(Historic England Level 2)**

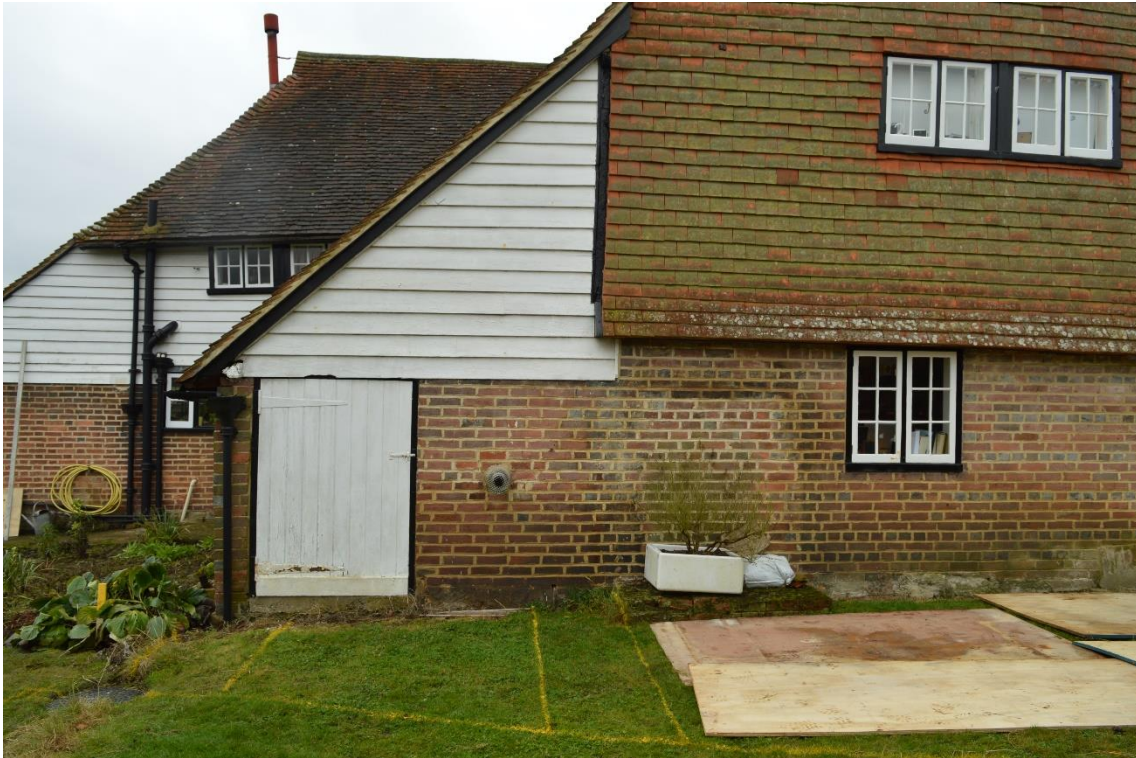
Plate 3: East elevation of farmhouse and lean-to (PEL17-0008)

- 6.3 The building currently referred to as the boiler house is a lean-to structure to the rear of the main range built, at least in part, before 1840. The structure is formed with brick walls, half a brick thick and laid in stretcher bond. Its gables are formed by timber-framing, clad with weatherboard to the east and faced with render to the west. The brickwork of the lean-to reveals some phasing and dating evidence. The east wall is constructed from the same red bricks with vitrified headers as the east wall of the main range (Plate 3). Although the bonding is different, changing from English garden wall to stretcher bond, there are no straight joints and it is likely that the walls were built as one. Above the level of the wall plate of the lean-to, the brick wall of the main range terminates with queen closers, respecting the timber-framed part of the lean-to (Plate 4). This indicates that the lean-to was either built at the same time as the underbuilding of the main range, or it was a pre-existing timber structure, underbuilt in brick at the same time. The vitrified brick headers and skintle-marks suggests a date from the late 18th or early 19th century.

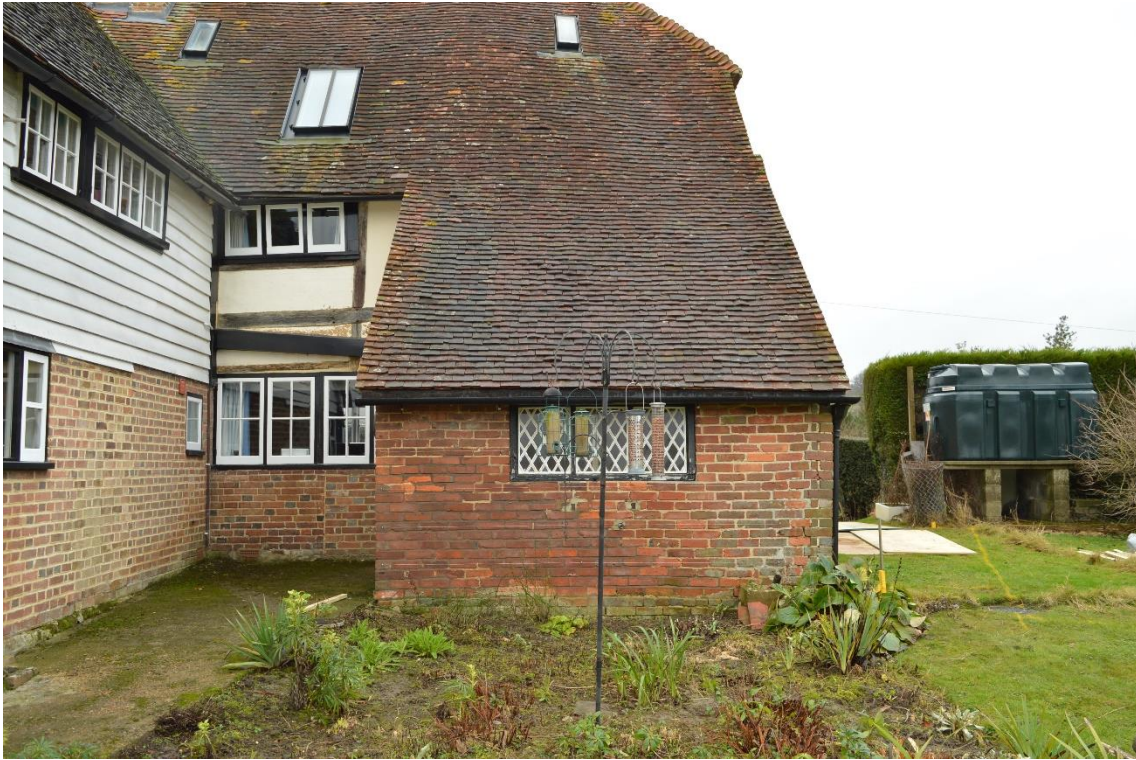
Plate 5: South elevation of lean-to (PEL17-0005)

- 6.4 The south and west walls of the lean-to are built with what appears to be later brickwork, using more uniform orange/red bricks without any vitrification (Plate 5). The brickwork includes a three-light mullion window with diamond-shaped panes which is probably contemporary with the brickwork and dates to the late 19th century.

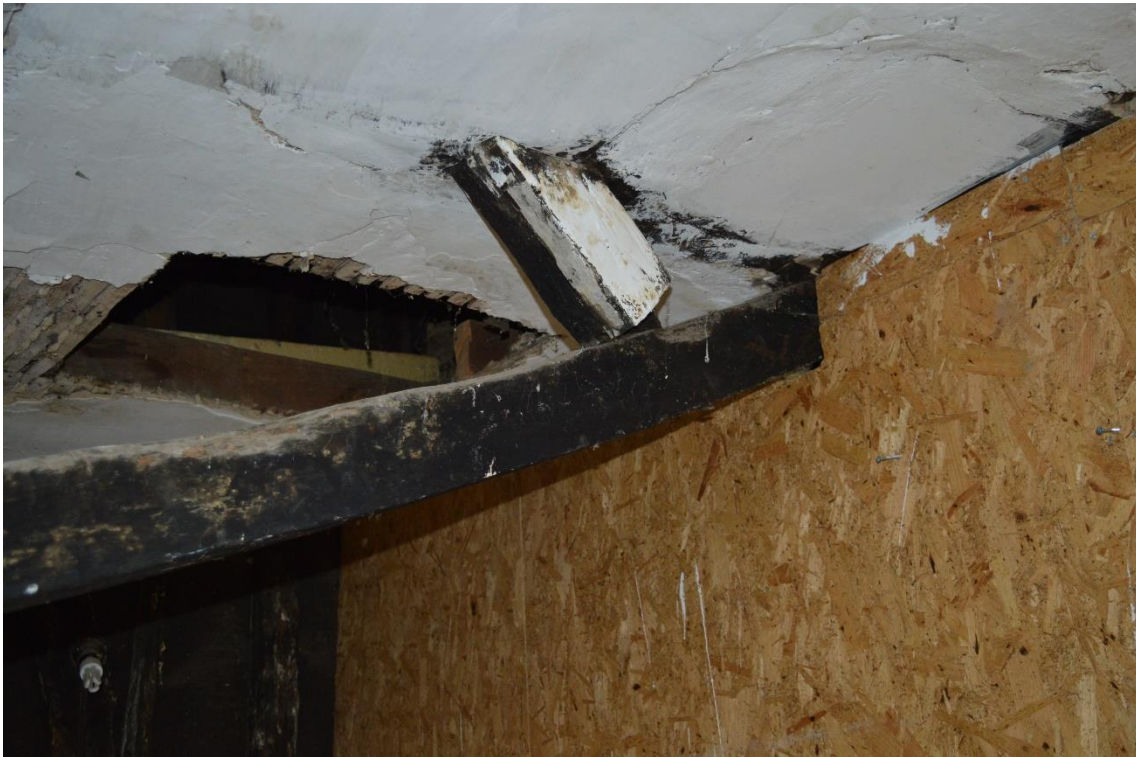
Plate 6: Lean-to tie beam and raking strut, facing west (PEL17-0019)

- 6.5 The lean-to roof extends the pitch of the main range roof, forming a catslide. It is constructed primarily from reused timbers and features a central tie with a raking strut. The roof is carried by wall plates supported by brick piers to the south-east and south-west corners of the structure. The half-brick thick walls act mostly as infill (Plates 6 & 7).

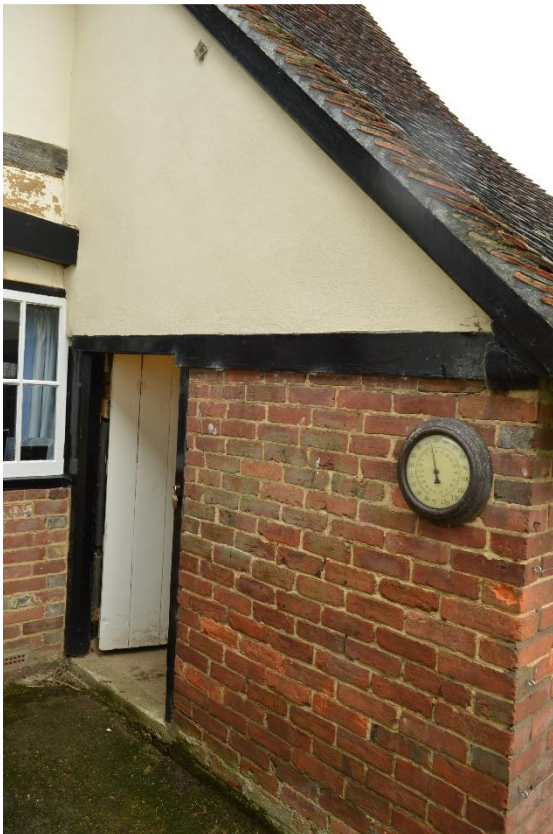
Plate 8: West elevation of lean-to (PEL17-0007)

strap hinges, which could feasibly be of 19th century date. The east doorway appears to be a later insertion, with roughly-cut brick jambs, while the west doorway appears more likely to be original, with more neatly-finished brickwork around the opening and a doorframe formed by the wall plate with jambs nailed to it (Plate 8). The lean-to was always accessed externally and never communicated directly with the house; the wall between the lean-to and the main range incorporates an original midrail, precluding any former openings (Plate 9).

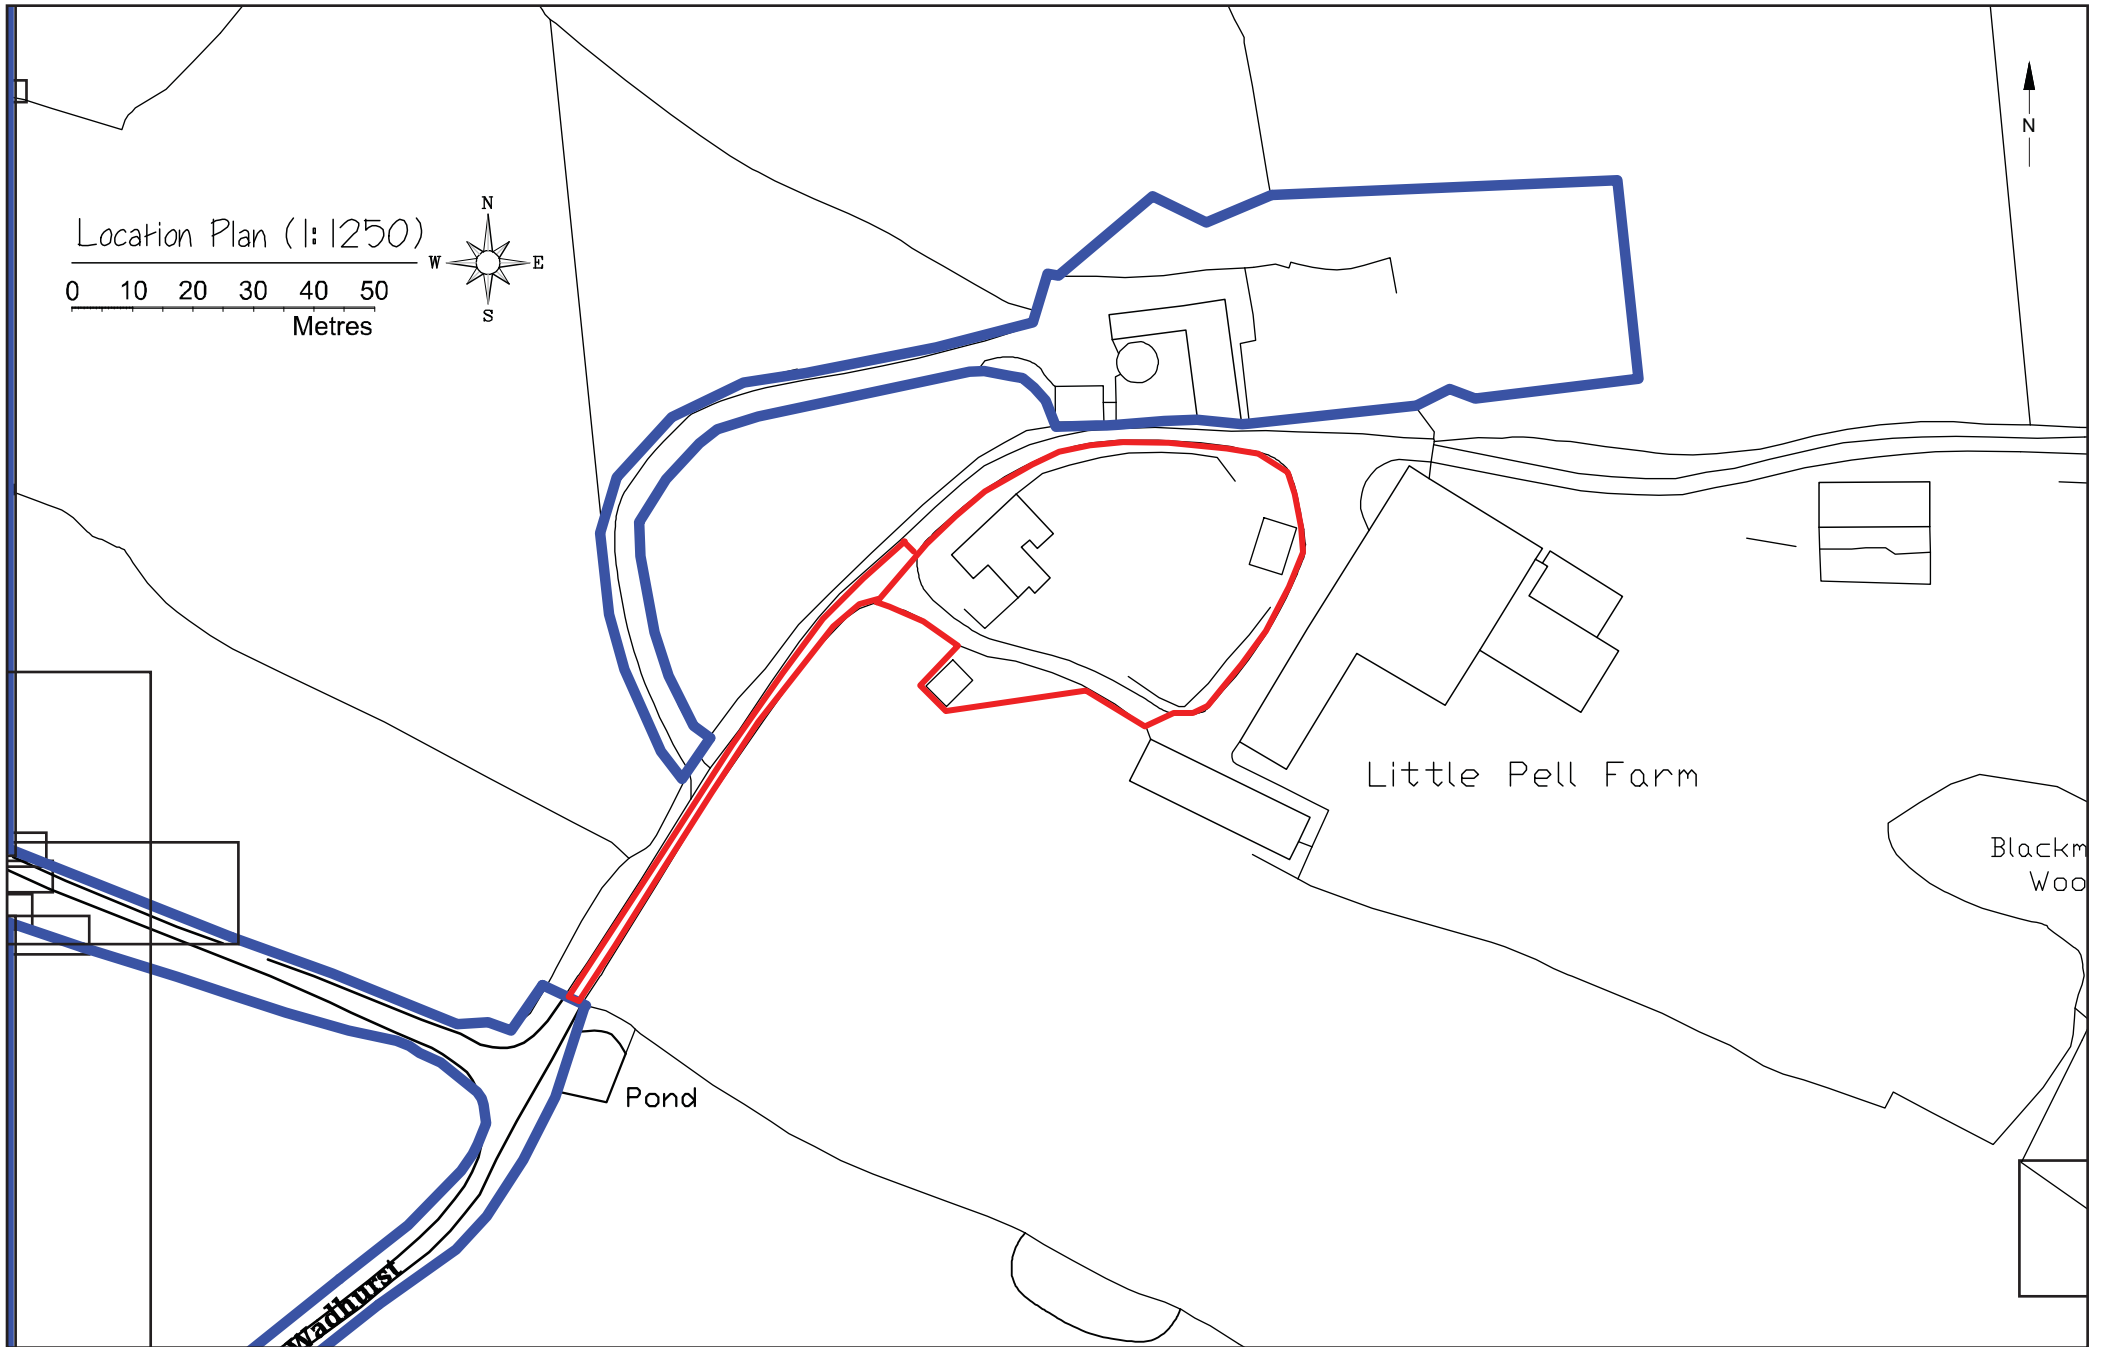
© Archaeology South-East		Little Pell Farm, Blacksmith's Lane, Wadhurst, East Sussex		Fig. 2
Project Ref: 160749	January 2017	Site Plan		
Report Ref: 2017010	Drawn by: CPC

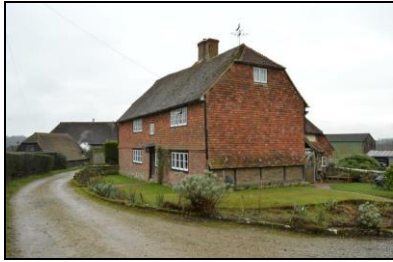
PEL17-0001

Plate 1: North and west elevations (PEL17-0001)

- 6.1 The two-storey timber-framed farmhouse comprises a three-bay main range with a cross-wing to the west, under the same roof, and a two-bay rear wing to the south. Externally, the building is clad with brick and tile-hanging and has a clay-tiled roof (Plate 1). Elements of timber-framing are visible on the rear elevation, and the upper parts of the rear wing and boiler house are clad with weatherboard (Plate 2).
- 6.2 The interior of the house is arranged around a lobby-entry plan, with an off-centred entrance leading to a lobby by the chimney stack, providing access to the principal rooms to either side.

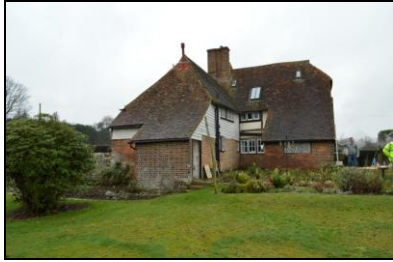
PEL17-0004

Plate 2: South elevation (PEL17-0004)

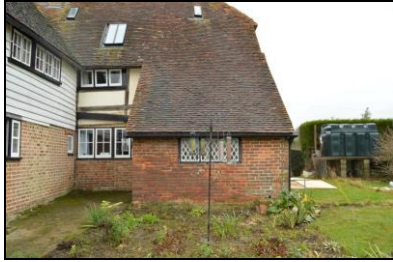
PEL17-0005

Plate 5: South elevation of lean-to (PEL17-0005)

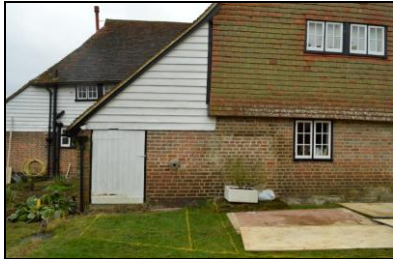
PEL17-0008

Plate 3: East elevation of farmhouse and lean-to (PEL17-0008)

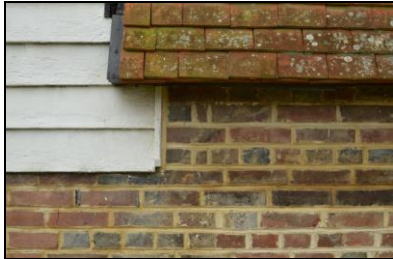
PEL17-0009

Plate 4: Queen closers at junction of east wall of farmhouse and lean-to, facing west (PEL17-0009)

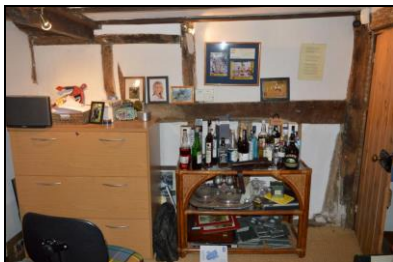
PEL17-0031

Plate 9: Wall shared between lean-to and main range, facing south (PEL17-0031)

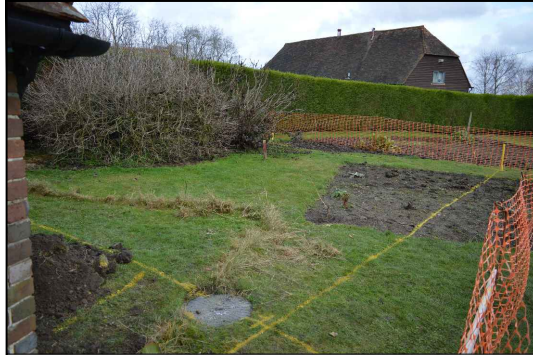
Site overview facing north-east

- 5.1 The archaeological watching-brief uncovered no notable archaeological deposits. A series of shallow, modern pits were uncovered cut into the subsoil. The development area has been used as a vegetable patch for some time, with manuring, bioturbation and turning of the soil resulting in homogenous topsoils with an admixture of late 19th- and 20th-century inclusions. The working of the land may have truncated earlier shallow archaeological deposits, the topsoil being relatively shallow, although no trace of finds predating the late-19th century was observed. It is likely the area of land has been cultivated for much of the site's history.

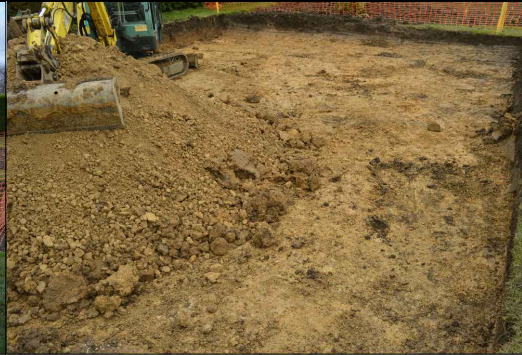
Site overview facing north-east, following reduction

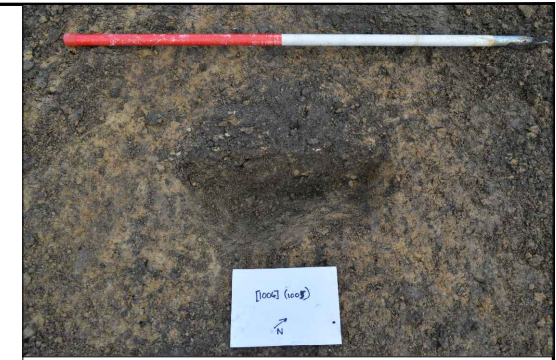
Section 1

Illustrative Modern Pit Sections

4.2.4 A number of modern pits, dug to accommodate the bodies of small mammals (likely cat), were cut through the topsoils ([1001] & [1002]) into the subsoil [1003]. In addition to degraded animal bone, the pits contained modern window glass, CBM, and pottery within a matrix of loamy sandy clay redeposited from the topsoils ([1001] and [1002]). The home owner noted that they had buried their cat in the vicinity in the last few years (pers. comm.). Three of the pits ([1004], [1006], and [1008]) were recorded for posterity, while the other features were tested and dismissed due to their modernity and insignificance. The backfill of the three recorded pits was [1005], [1007], and [1009]. All of the modern pits are depicted on the site plan (Fig. 4.2). The majority of the pits were situated beneath the vegetable patch.

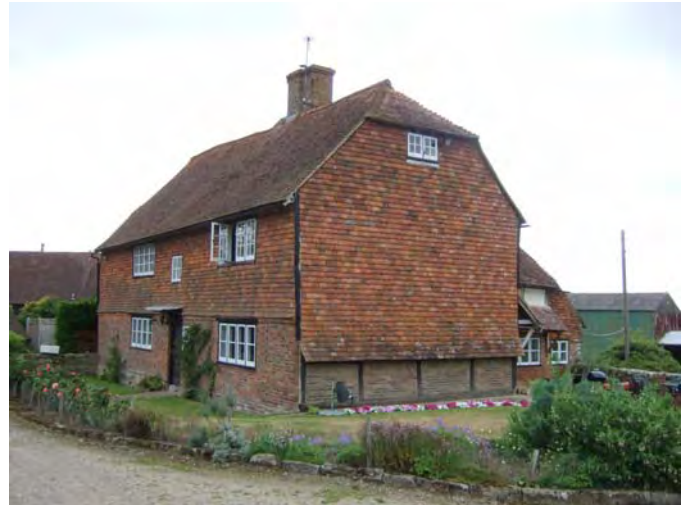
*Plate 1
Front elevation*

The modification which took place at this date had a profound effect upon the external appearance of the house (compare Plate 1 with Drawing No. 1716/8). It involved remodelling the front roof slope of the main range, and rebuilding the crosswing roof to create a continuous in-line roof over both the main range and crosswing. At the same time, the crosswing's bay window was removed. The roof over the crosswing was rebuilt spanning between trusses H-H and K-K, maintaining a similar ridge height as

that over the main range. It is of staggered butt-purlin construction, utilising timbers of small scantling: the rafters measure 80 mm x 90 mm, the purlins 90 mm x 140 mm. The new, infilled 'truss' over the western wallplate of the crosswing incorporates a collar, under which a door leads through from the attic over the main range to the space over the crosswing. A collar truss divides the two roof bays, whilst the western stub gable is of regularly-spaced studwork supporting a half-hip which is absent of high-set collar at its apex. A small window is incorporated into the stub gable.

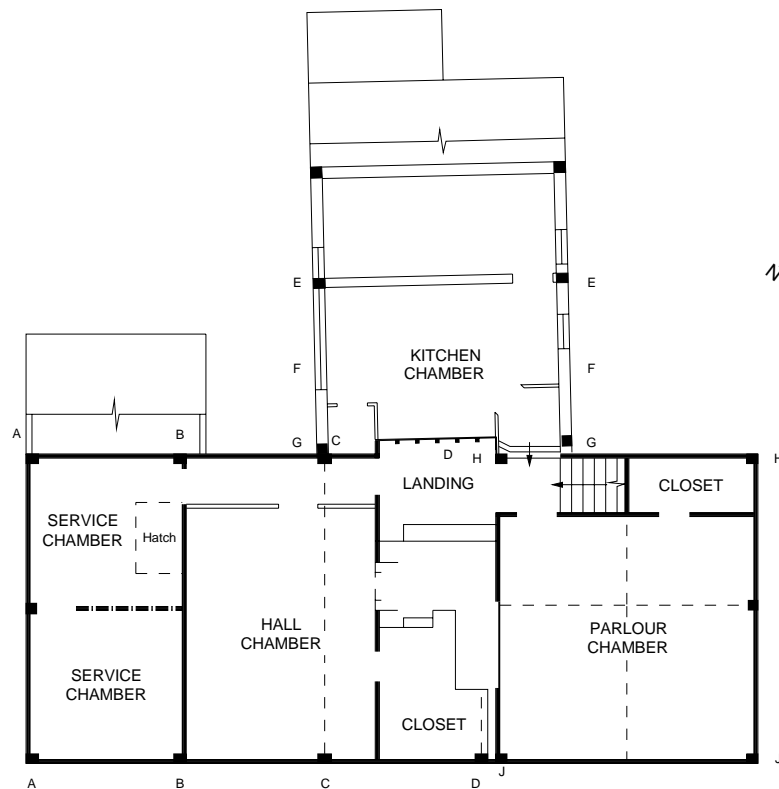
LITTLE PELL FARMHOUSE, WADHURST, EAST SUSSEX PLAN AS EXISTING, 2009				Site Ref	P104/16
				Drawing No.	1716/2
Drawn By	J Clubb	Revision No	-	Date of original survey	2009
				Date of this revision	2009

FIRST FLOOR PLAN

Around 1640 [**Period B**], the assumed-earlier structure to the west was replaced with a short crosswing, and the structure was modified to function as a lobby-entry house of more-standard plan-form. A new chimney served the hall, parlour and hall chamber, and access was cut through into the eastern bay from the hall and hall chamber. The rear range appears to have continued in service use, accessed from both the hall and parlour and housing the entrance to the cellar. The cellar lies beneath the parlour, with a separate, assumed-period-B part underneath the northern part of the rear range.

In various schemes of post-period-D work, the ground-floor external frame has been underbuilt in brick, using different styles of brickwork. The western wall has decorative nogging between the timbers, the front wall is laid in Flemish bond with burnt headers, and at a later date the western wall was laid in English-Garden-Wall bond. The rear range too was brick-underbuilt; this part of the house was extended to the south by one bay. This extension appears to be quite recent. Attached to the south-eastern corner of the rear range is a brick-built outhouse. A further extension, laid in stretcher bond, was built against the south wall of the main range. The first-floor walls of the main range and the upper part of the western ground-floor wall have been tile-hung.

Internally, the period-B stairs have been removed from the eastern room and the associated opening in the floor has been infilled. The possible period-C stair in the parlour has been replaced by a modern flight, and the enclosing partition has been removed; some studs survive against the modern stair, but these look to be of nineteenth-century date.
