**A hulk assessment on the foreshore of the River Adur, Adur
Tidal Walls Reach E2, West Sussex.**

**ASE Project No: 160031
Site Code: ATW13**

**ASE Report No: 2017055
OASIS id: 275699**

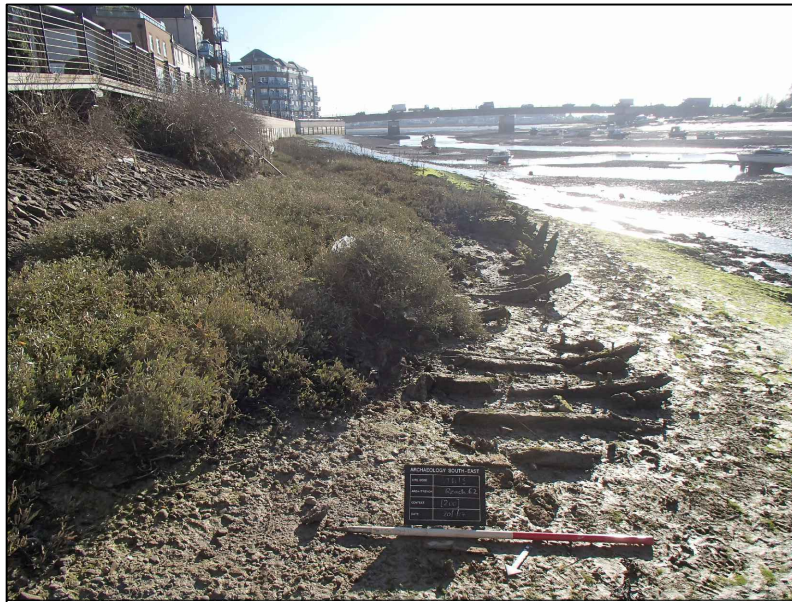
- 4.2.3 Whilst it is clear that the south east end of the hulk is partially intact and visually up-standing at least 0.8m, the north west end is flattened out, eroded and much more dismantled. Both ends have spread as the hull framing has decayed and fallen outwards. Currently it is not certain which end was the bow and which the stern, though the relatively pointed form of the south east end indicates it was probably the bow (although pointed sterns are also known in some craft).

Hulk location, looking south east

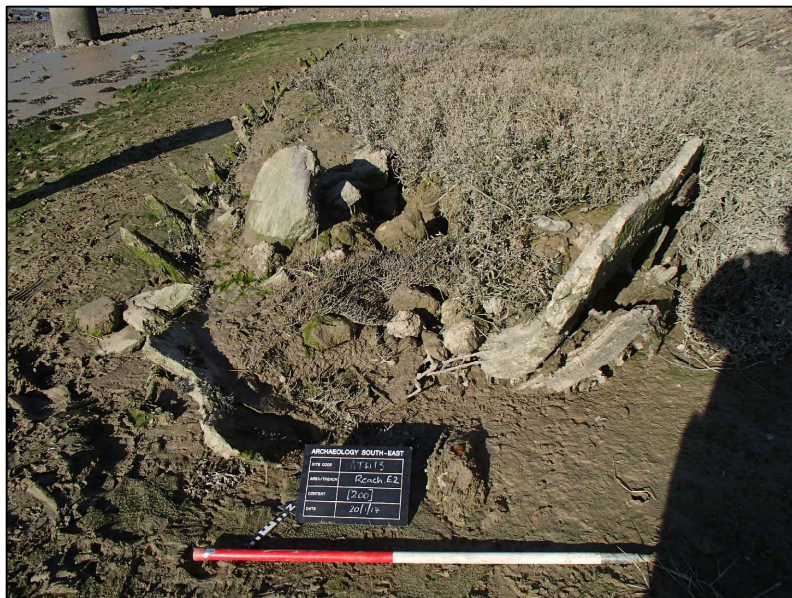
5.1.2 However, it is also important to note that there is some evidence for the use of a few, small, round-hulled barges not far to the west in Chichester harbour before the simply built, flat-bottomed tradition took over at some point in the 19th century. These craft appear to have resembled the small, round-hulled barges used in some Devon and Cornwall estuaries. It is also the case that after the 2nd World War some craft not built as barges, such as large ship's lifeboats, were used as small barges to move small amounts of building materials around the Chichester Harbour area. Finally, the local evidence of a variety of houseboats moored on the western banks of the Adur estuary shows graphically that the function a vessel was put to could vary greatly though its life with a number of craft ending their days as crudely maintained houseboats, storage hulks, or breakwaters. The crude reinforced concrete lining of the best preserved end of the vessel might just be evidence of its unintelligent reinforcement for just such a static use.

Rubble in southern end of hulk

- 5.4.1 In order to mitigate the impact of the proposed works it is recommended that more detailed recording is carried out. This is likely to involve the removal of the vegetation from the hulk, limited hand or machine excavation of the south-eastern end in order to better characterise the shape of the vessel and removal of the rubble from inside the vessel to determine the presence or absence of mast or engine fittings. It is also recommended that documentary research is undertaken, prior to fieldwork commencing, with particular reference to local collections (i.e. Marlipins museum) and aerial photography in order to determine the level of recording necessary.
- 5.4.2 The hulk is unlikely to survive intact should attempts be made to remove it and therefore preservation by record is suggested subject to approval by Historic England.

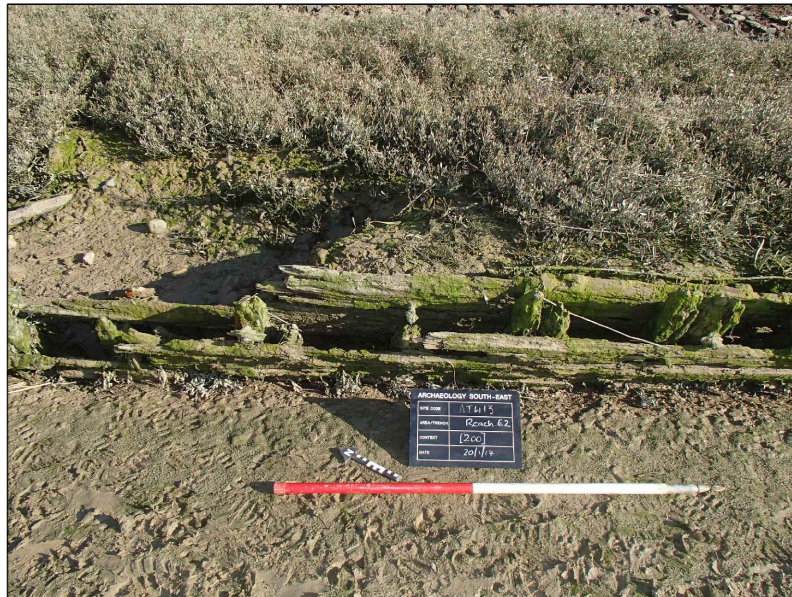
- 4.2.5 Most of the framing and planking of the vessel is heavily eroded as are the metal fastenings.
- 4.2.6 The hull is 'carvel built', that is with planking set edge to edge secured to close-fitting framing (Figure 4). The cross-wise framing is made from sawn slabs of oak fastened overlapping so as to form doubled frames. The visible bottom of the boat in the central area was relatively flat but with well-rounded bilges where the bottom turns into the sides.

- 4.2.7 The lower framing ('floor' timbers) are c. 120-140mm 'sided' (wide for and aft) and c. 120mm deep ('moulded'). The side framing or 'futtocks' overlap the floor timbers greatly to which they appear to be iron bolted. The centre of the vessel has a large conifer timber (probably American Douglas fir?) beam or 'keelson' up to c.250mm wide and 120mm deep running along its length, which is partially visible at the north west end. The external hull planking is of coniferous timber, again probably American Douglas Fir, c. 35mm thick and the plank to frame fastenings are ferrous spikes and what look like some form of bolt or clench bolt. The bolts are much corroded and it is uncertain whether they were threaded or not. Elements of a close-set lining or 'ceiling' of coniferous timber planking also survives in places of varied thickness.

Double framing of the hulk

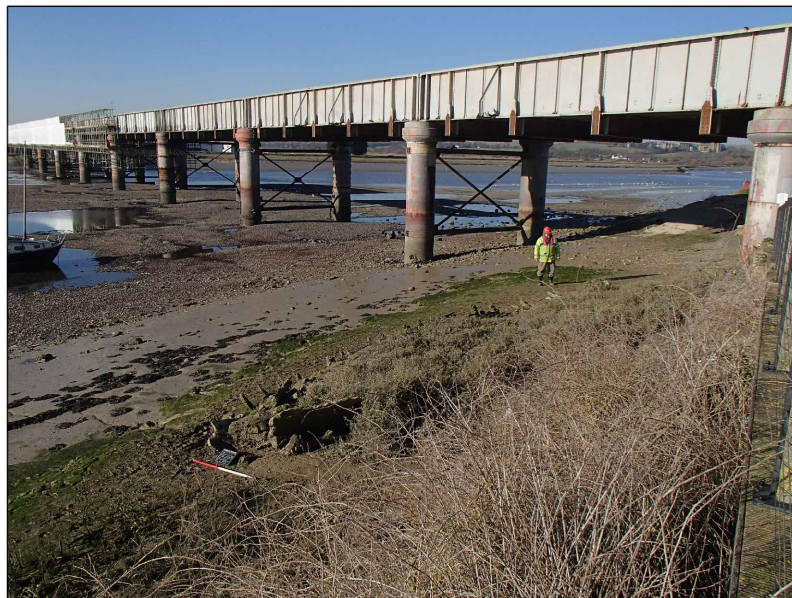
- 4.2.2 As the vessel lies only c. 2m from the base of the recently refaced seawall, adjacent to a slight indentation in its line and adjacent to crude c. mid 20th century concrete repairs, it may well be that the craft was abandoned there to reduce erosion of the wall base. English Nature placed close restrictions on the disturbance of vegetation during the fieldwork due to the presence of important flora and fauna at the site. This means that access was limited and some key structural features bearing on the function and use of the vessel were heavily obscured.

5.1.3 The vessel in its current position was probably used as a basic form of flood defence to possibly protect the area from erosion (Figure 4). This is a common practice where derelict vessels are readily available and examples of this can be seen along the south coast in areas such as the Hamble.

- 5.4.1 The hulk is in a fairly poor condition, the north western end in particular is more exposed and only the futtocks remain. The vessel is unlikely to survive attempts to move it and will certainly be heavily impacted upon during the works

Current position of the hulk looking north
