## **Archaeological Monitoring and Excavation**

**Fryerning Hall  
Blackmore Road  
Fryerning  
Essex**

**ASE Project No: 8540  
Site Code: INFH15**

**ASE Report No: 2017078**

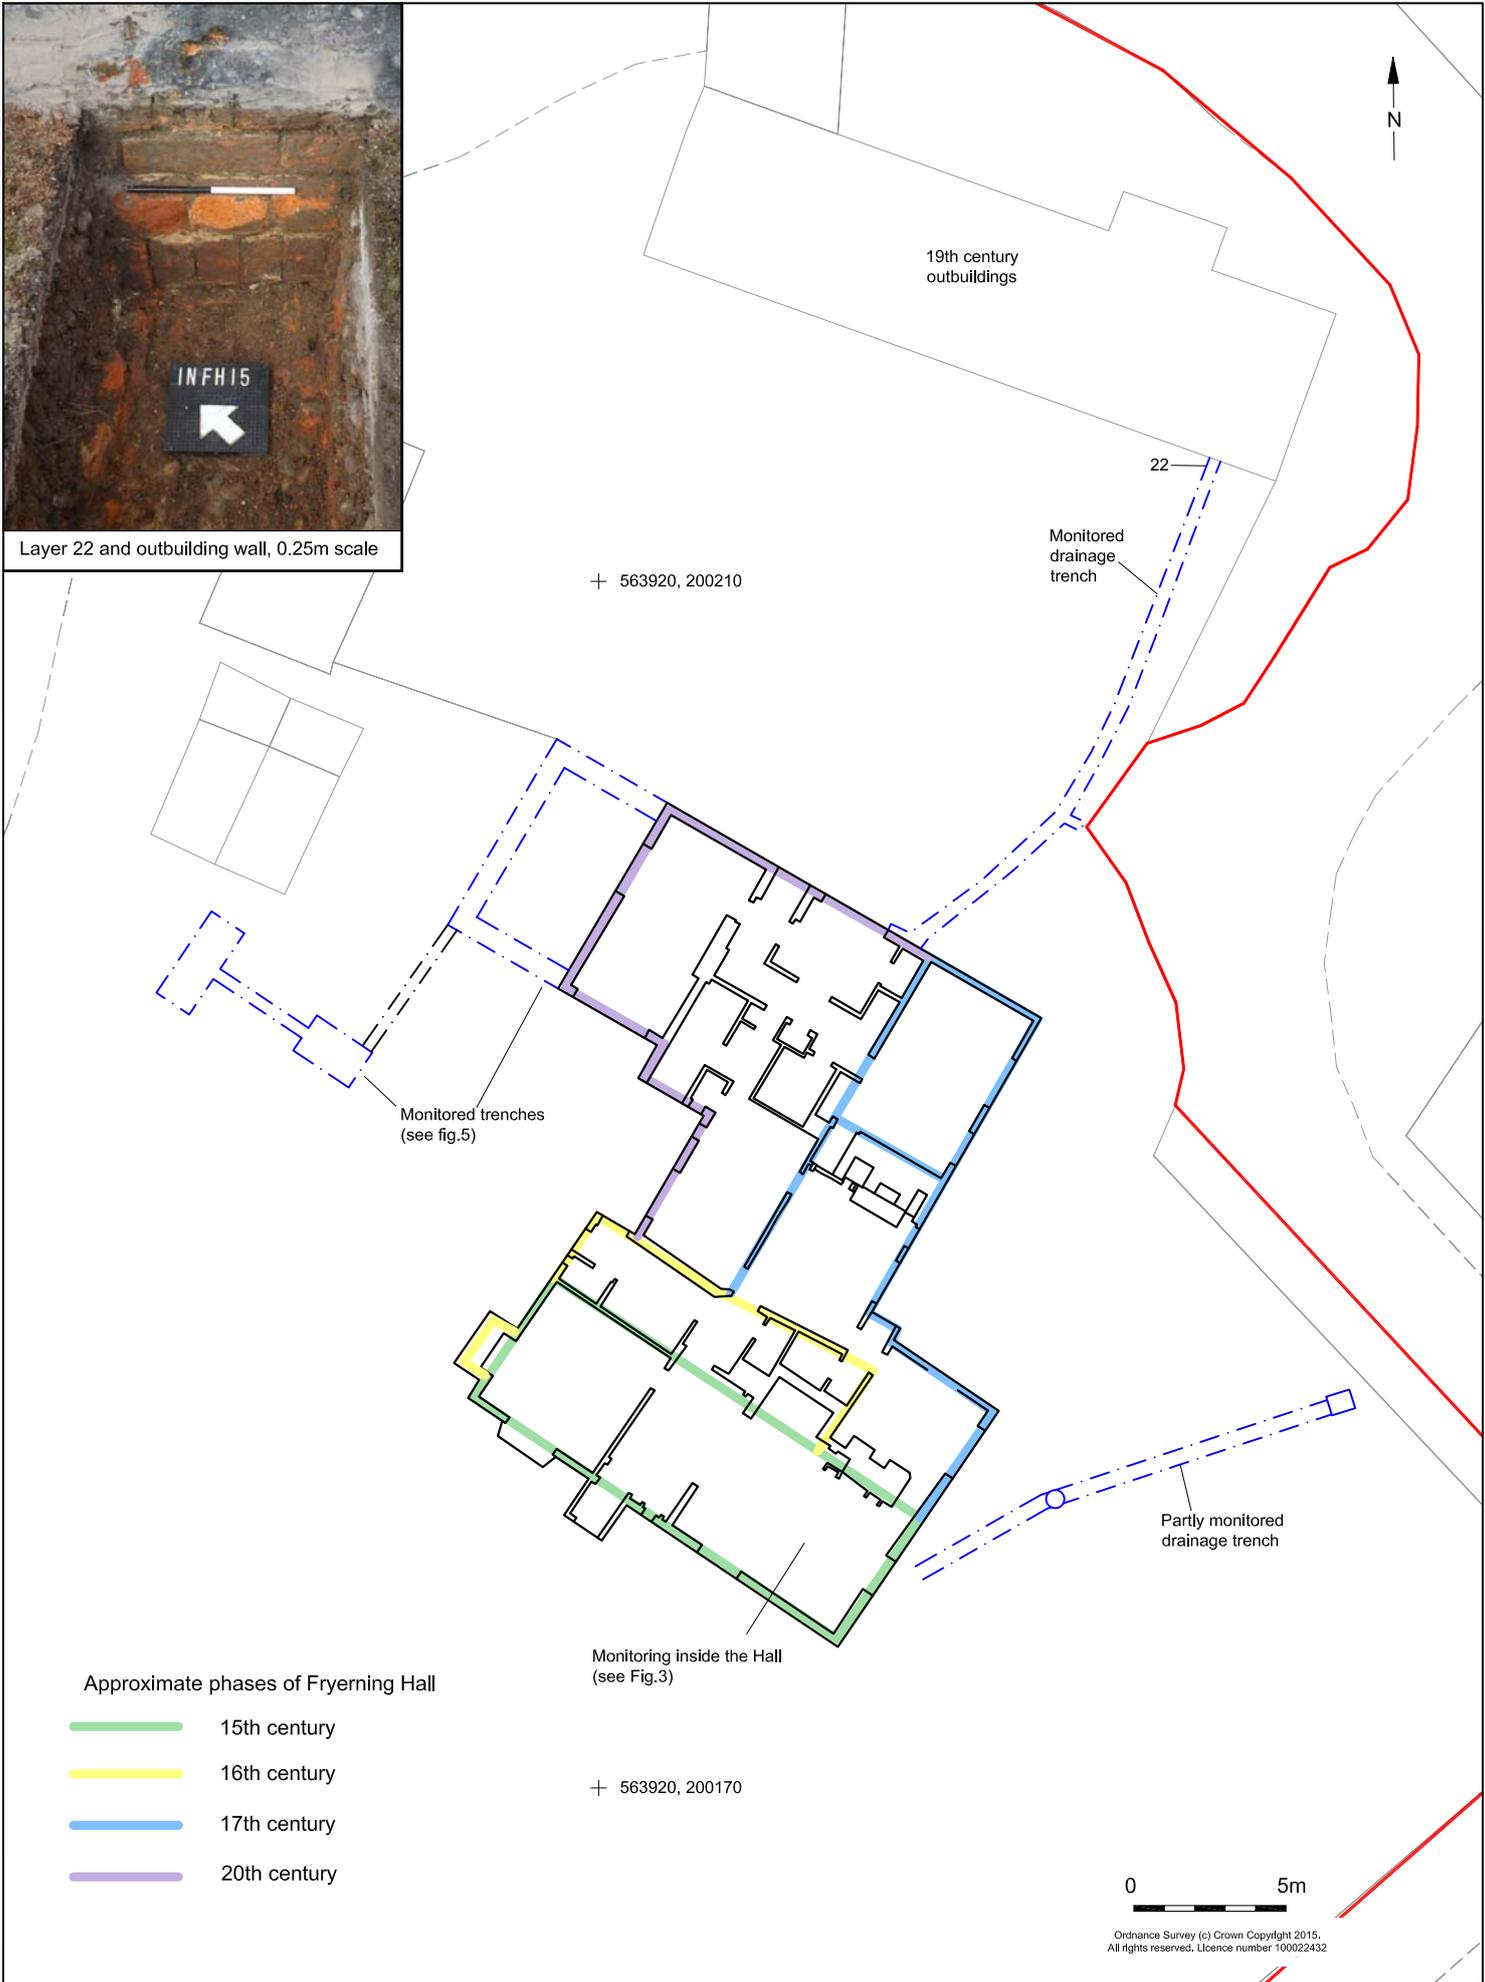
© Archaeology South-East		Fryerning Hall, Blackmore Road, Fryerning	Fig. 2
Project Ref: 8540	Feb 2017	Location of monitored areas	
Report Ref: 2017078	Drawn by: APL

### **4.2.4 *Yard (north of house) (Figure 2)***

of tarmac and orange make-up overlying 0.34m of grey gravel [23] containing occasional flecks of tile. The only archaeological feature present was a layer of brick and tile rubble [22], sealed by [23], at the north end of the trench. This extended about 0.5m from the south wall of the 19th century outbuilding and was probably part of the foundations for this structure (Figure 2 photo).

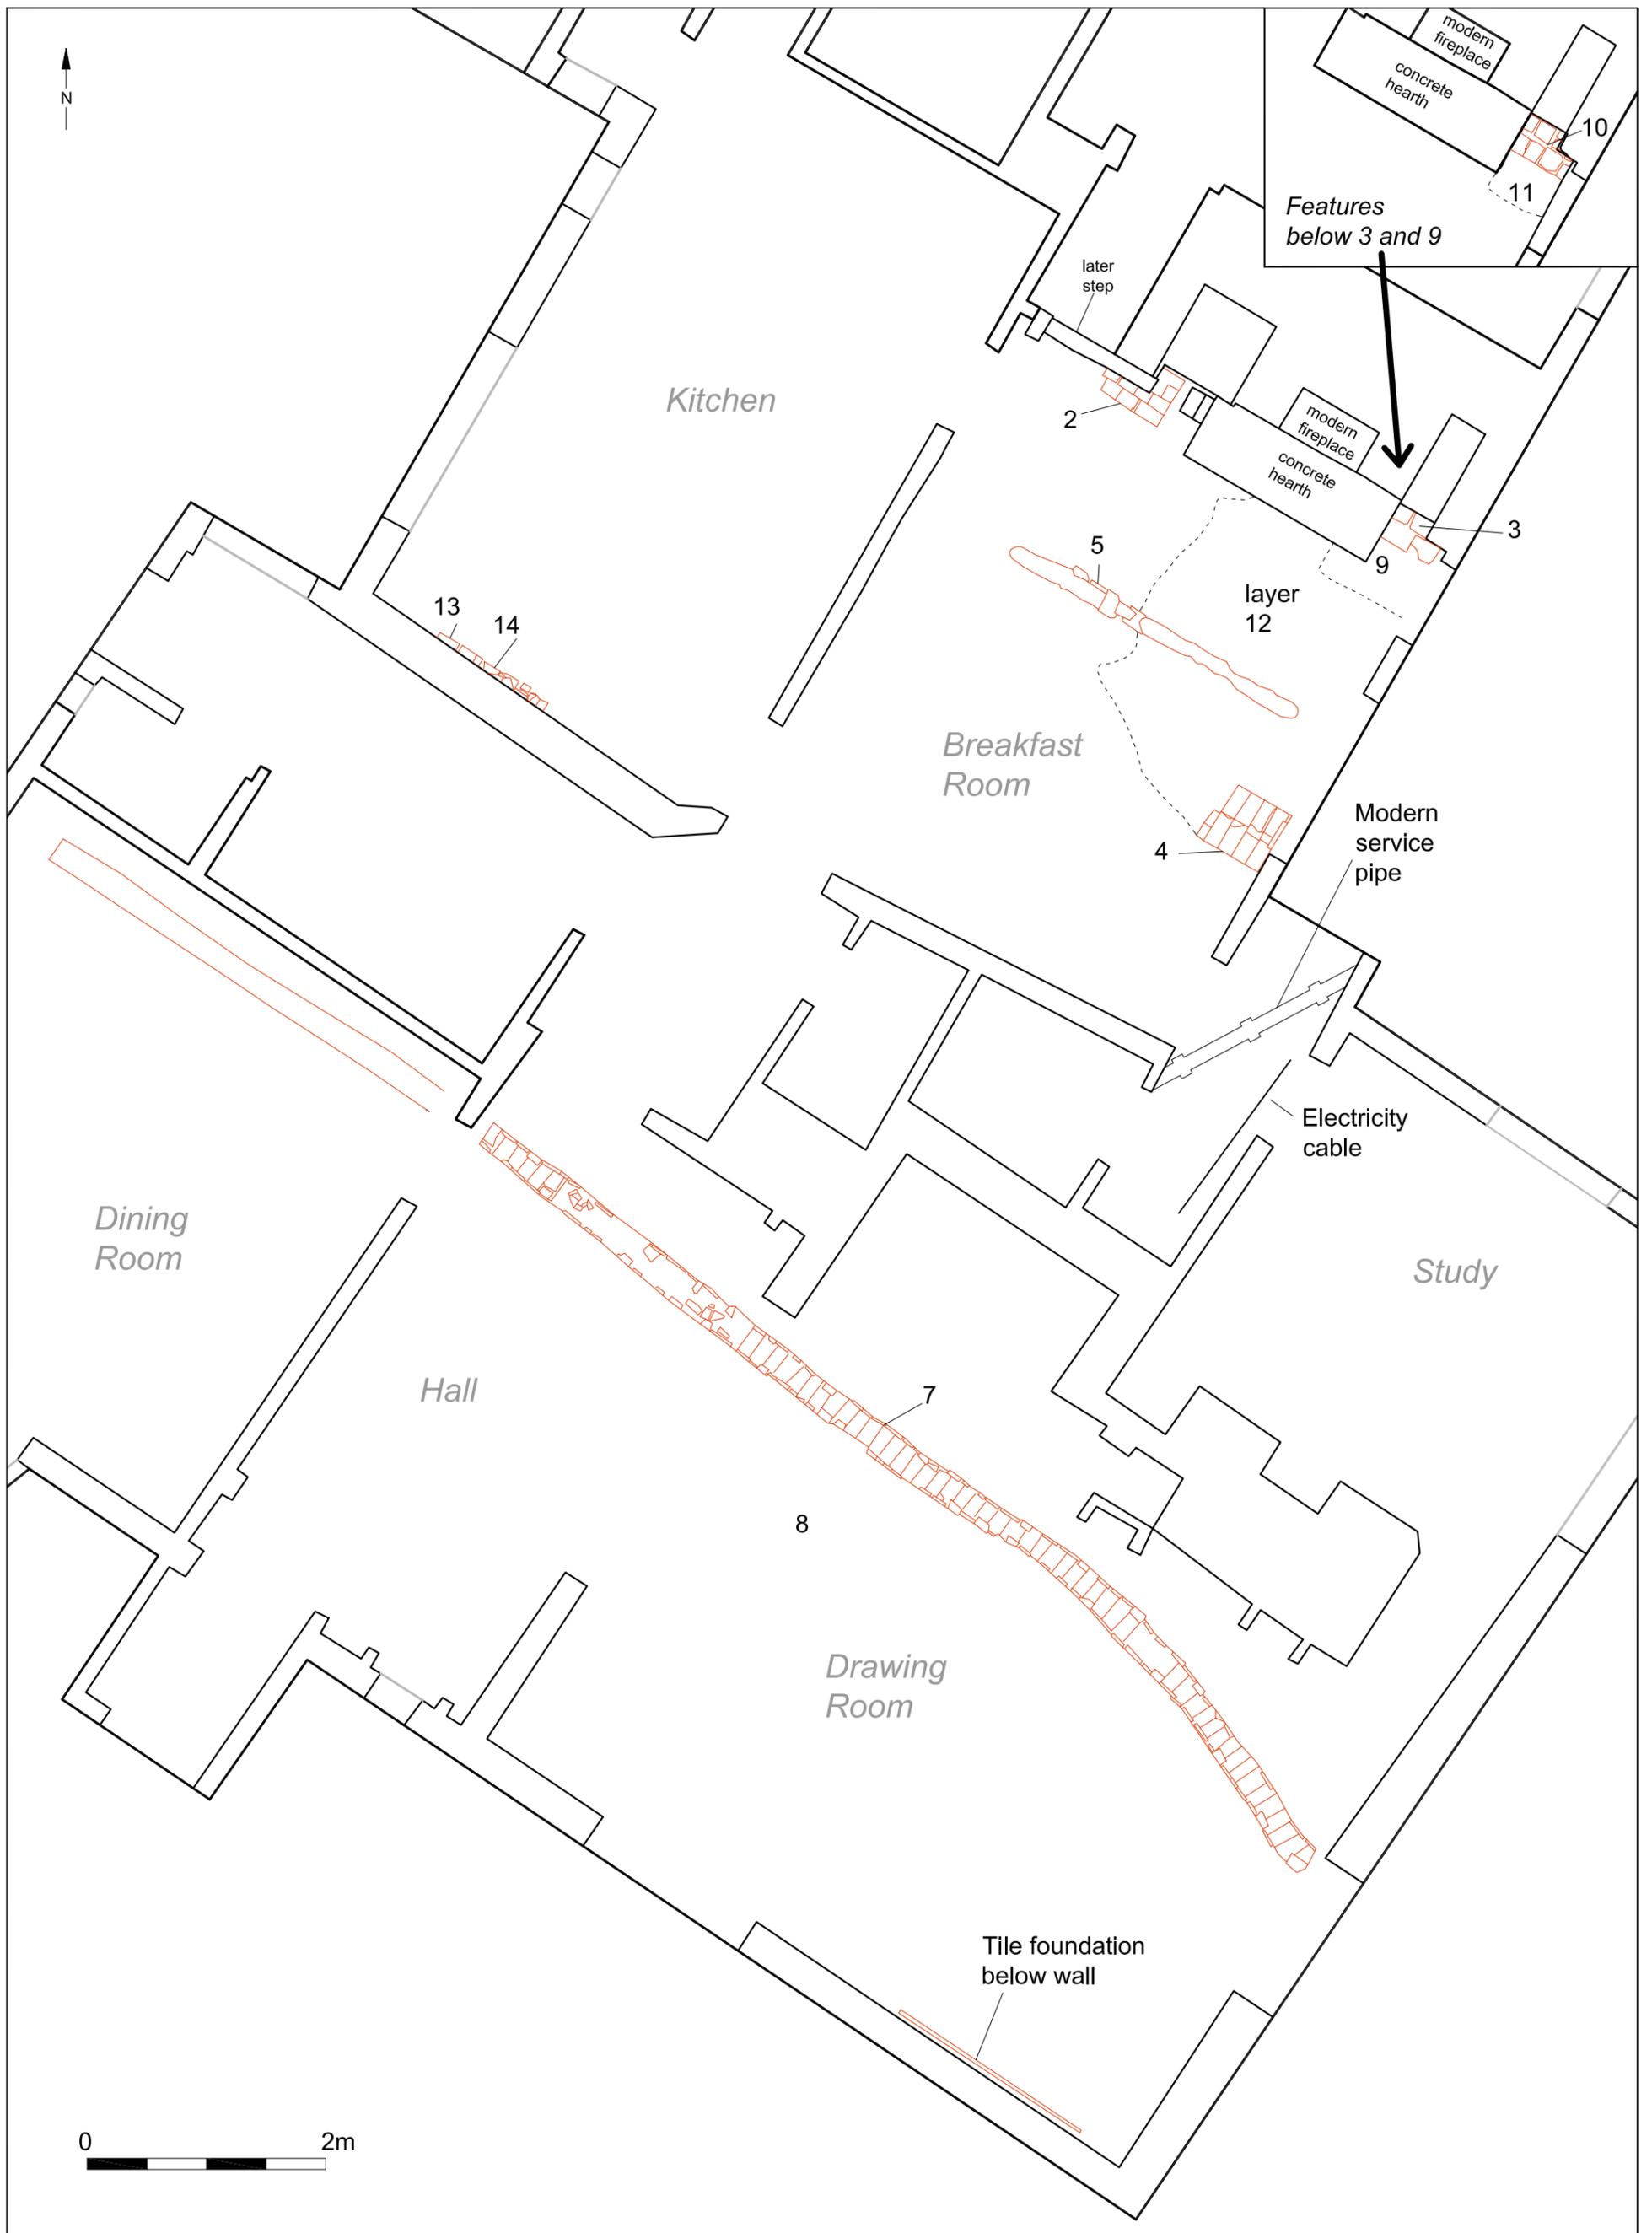
Approximately 0.2m of modern concrete flooring was removed from the Breakfast Room. Underlying this was a mixed loose deposit of mortar and clay silt [01], 0.05-0.10m thick, which upon removal revealed a number of archaeological deposits and features (Figure 3).

About 0.2m of concrete was removed from the Drawing Room and Hall interior. Concrete in the Drawing Room was grey coloured whilst that in the Hall was whiter and had been laid on plastic sheeting. Cleaning of the underlying dry pebbly surface revealed a single drainage feature [07], 9m+ long, extending through both rooms.

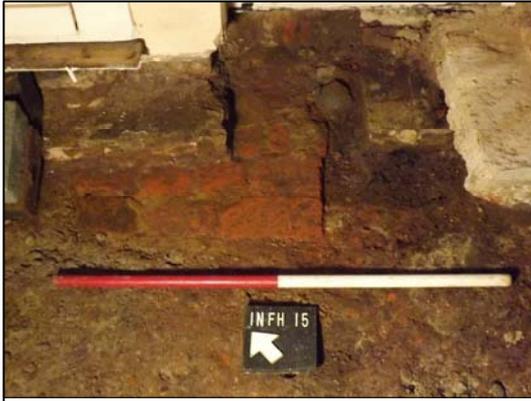
4.1.4 In the north of the room were two slightly projecting brick structural fragments, [02] and [10] (Figure 4 photos), located on either side of a modern fireplace which, although now much altered, probably originally dates to the 17th century. Structural fragment [02] to the left of the fireplace was 0.6m wide and over 0.48m long, continuing north below a later step. It was composed of whole, half and three quarter size flat (unfrogged) red bricks bonded with and partly sealed by a thin layer of brown clay. All bricks were left *in-situ*; the largest measured 240mm x 125mm. To the right of the fireplace and obscured by a concrete hearth, fragment [10], measured 0.5m+ by 0.36m+ and consisted of flat (unfrogged) red half-bricks bonded with brown clay with some buff mortar flecks. Two courses (0.11m deep) were present. Both structural fragments contained bricks of c.16th century date and are believed to be part of the original 17th century foundations for the fireplace.

Structural fragment 2, 1m scale

- 6.1.5 Within the Breakfast Room, a 17th century addition to the back of the house, the earliest remains were the two brick structural fragments [02] and [10] believed to be part of the original foundations for the fireplace. Nearby brick structure [04], of less certain use, was of similar build and appeared to be contemporary. All three contained bricks of c.16th century date, which presumably came from the latter end of this period or were, more likely, re-used given the inclusion of half, part and three quarter bricks in the build. Tile layer [03], overlying the eastern part of the fireplace foundation may be part of a later alteration. All three of the layers within the Breakfast Room almost certainly date to the post-medieval period with charcoal and coal within layer [09] derived from the adjacent fireplace. The latest feature within the room, linear deposit [05], may have supported a former flooring beam of possible 18th/19th century date.

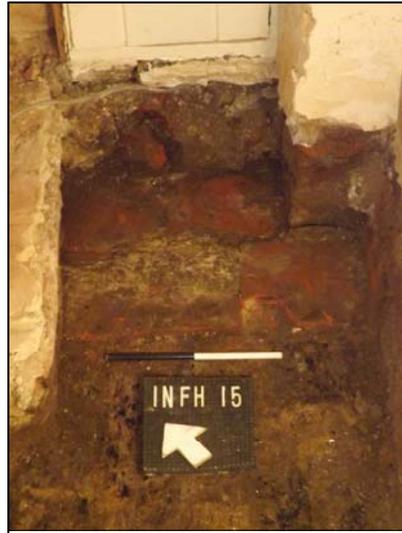
4.1.5 Overlying the bricks was a layer of flat cracked tiles [03], the largest measuring 260mm by 160mm by 12mm thick. The tiles did not extend beyond the bricks and were partly

sealed by a patch of hard cream charcoal-flecked mortar of possible 17th-18th century or later date. It is therefore possible that the tiles are part of a later alteration to the fireplace.

Tile layer 3, 0.25m scale

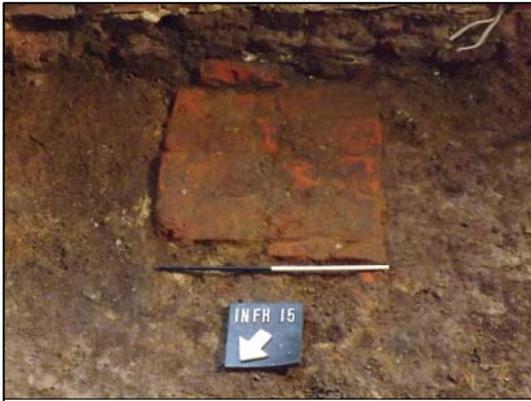
4.1.3 Adjacent to the east wall of the room were the remains of a small rectangular brick structure [04], four header bricks long by two wide with the partial remains of an additional brick to the west (Figure 4, photo). The structure was two courses (0.14m) deep and was composed of large flat (unfrogged) bricks of c.16th century date bonded with a small amount of brown clay. The structure appeared to continue below the east wall of the building and may have been truncated to the west. It is possibly part of an internal buttress base or room division associated with the original (17th century) construction for this part of the house, but its precise interpretation is unclear.

Brick structure 4, 0.5m scale

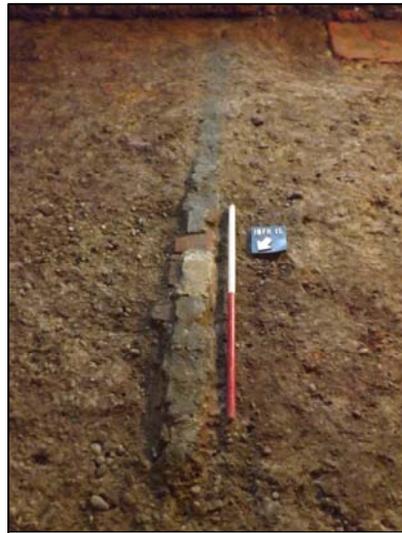
4.1.2 In the centre of the room was a narrow linear feature [05], c.2.8m long by 0.18m wide, arranged perpendicular to the east and west walls of the room. The feature consisted of a line of flat tiles (0.16m wide), sealed by creamy lime mortar, that to the east appeared to have been truncated where it survived only as a grey silty lime-flecked line (Figure 4, photo). Although positioned roughly in the centre of the room, it did not underlie a similarly-aligned substantial overhead beam and was therefore unlikely to be a former support for this structure nor the base of some form of room partition. Instead it may have constituted a sleeper wall or beam position associated with an earlier timber floor. Below the east end of feature [05], and extending across much of the north-east of the room was a shallow mixed deposit of brick-flecked brown and grey silty clay [12], up to 0.07m deep, overlying pebbly natural.

Liner feature 5, 1m scale

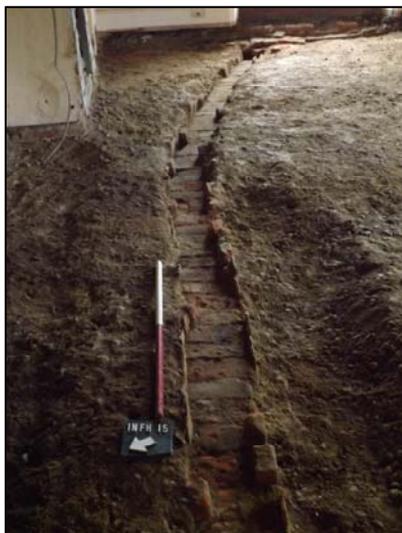
4.1.8 Under-floor drain [07] was constructed from a single line of flat header bricks with upright peg-tiles, sometimes supported by half-bricks, forming the sides (Figure 4, photo). A variety of bricks were used in its construction; all were unfrosted. Some larger examples similar to those in the Breakfast Room were likely of 16th century date whilst some smaller examples were more probably of later (c.17th/18th) date. The drainage feature dropped in height towards the east and may have originally continued beyond the building but was disturbed by more modern brickwork beneath the existing French Windows. The drain was cut into brown pebbly silt [08] of probable natural origin. The drainage feature was filled with brown clay silt [06] and contained a variety of finds including rabbit and domestic fowl bones, oyster shell, a copper alloy pin (RF<1>), two sherds of possible 16th century pottery and a fragment of clay tobacco pipe from the second half of the 17th century. Also recovered were fragments of brick and broken tile, the latter deriving from the capping for the drain. Also exposed during concrete removal within the Drawing Room were two courses of flat tiles forming part of the lower foundation for the south-west wall of this room.

Drainage feature 7, 1m scale

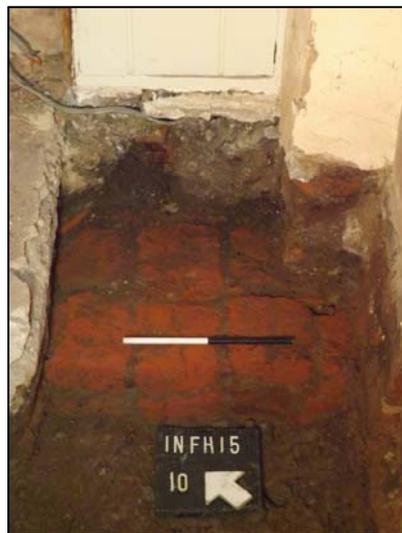
Structural fragment 10, 0.25m scale

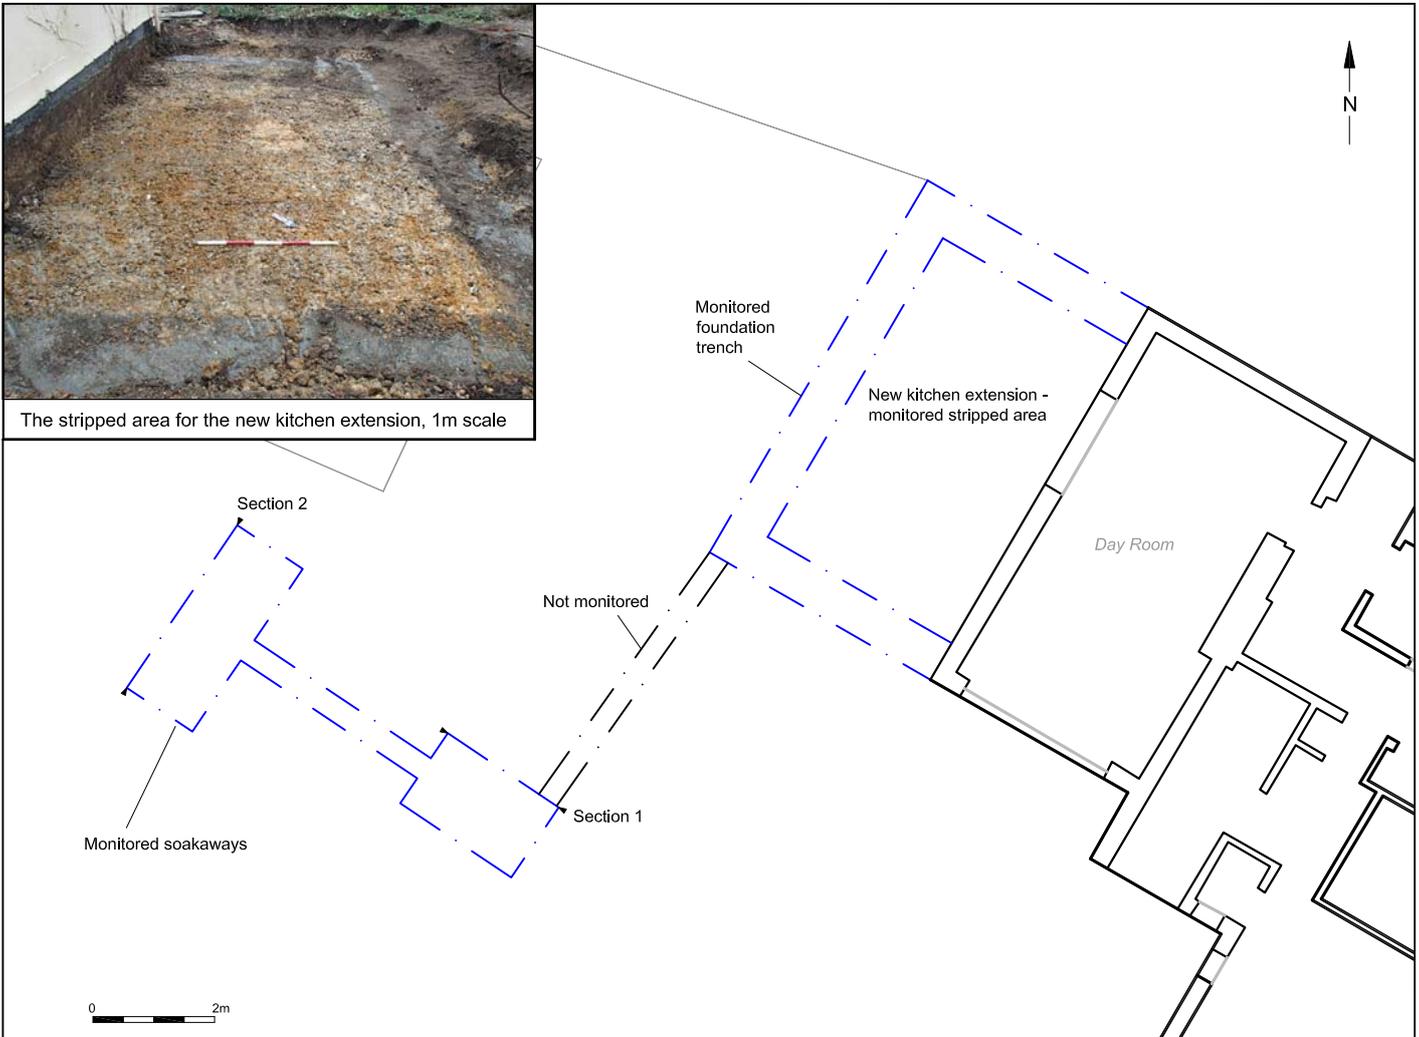
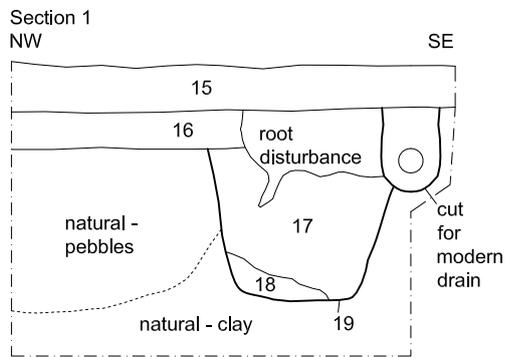
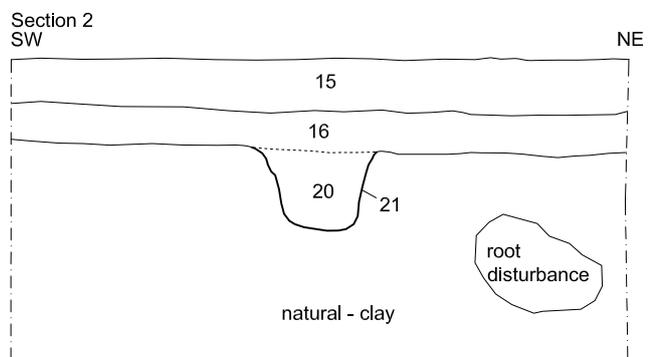
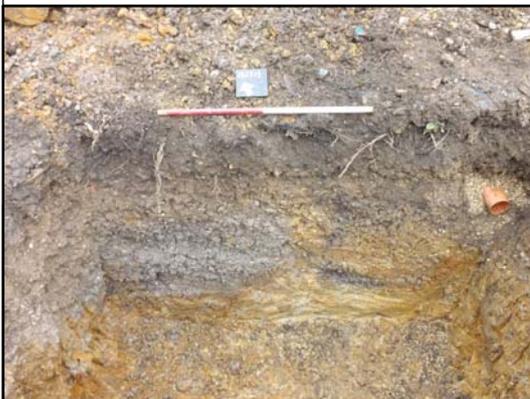
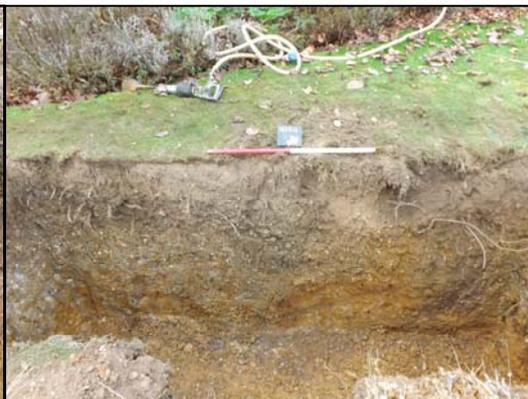
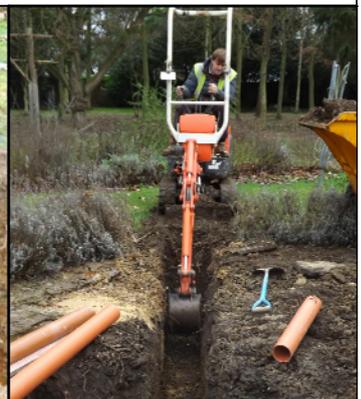
© Archaeology South-East		Fryerning Hall, Blackmore Road, Fryerning	Fig. 5
Project Ref: 8540	Feb 2017	Monitored areas west of the Hall	
Report Ref: 2017078	Drawn by: APL

The footprint of the new kitchen extension covered 28sq m. The 0.7m wide by 1.1m deep foundation trench was initially excavated under archaeological supervision. Overburden consisted of 0.4-0.5m of dark grey garden soil above natural deposits of clay and gravel. No archaeological remains were identified and the trench was subsequently filled with concrete. The interior of the extension was then stripped of its overburden to the top of the natural gravel (Figure , photo). No archaeological remains were present.

Approximately 0.45m of overburden (topsoil [15] and subsoil [16]) was removed from the area of the two soakaways. Due to the small size of the mechanical excavator, and the required significant depth of the soakaways, the underlying natural gravel could only be exposed in plan in 1-2m long segments rather than all at once. No obvious archaeological remains were observed cutting into the gravel and machine excavation continued to the required (c.1.6m) depth. After excavation the eastern soakaway was found not to be of adequate size and a further strip about 0.15m wide was removed from the northern edge of the trench. Revealed in section was a steep-sided and fairly flat-bottomed pit [19], 0.95m wide by 0.8m deep (Figure 5, Section 1 and photo). In the base of the pit was a deposit of dark grey silty clay [18] that contained a single sherd of later 15th to 16th century pottery. Above, the greater part of the pit, was filled with mixed brown pebbly clay [17]. No finds were recovered from this upper deposit which was sterile and most probably consisted of redeposited natural material. The top of the pit appeared to have suffered from root disturbance.

4.2.3 A second poorly-defined cut feature, [21], was also apparent in section in the western soakaway (Figure 5, Section 2 and photo). This measured 0.6m wide by 0.44m deep but was much vaguer, with a grey pebbly clay silt fill [20] that was hard to distinguish from the overlying subsoil. No finds were recovered. It is possible that this was a small pit of unknown date or perhaps, given its location, was possibly part of a garden feature of post-medieval to modern date. Further root disturbance was noted towards the north-eastern end of this section. No archaeological remains were identified in the shallow trench linking the two soakaways (Figure 5, photo).

- 6.1.7 Externally, archaeological remains were very scarce with one pit of possible late 15th to 16th century date identified in the eastern soakaway and a second undated and less convincing pit in the western soakaway. In the yard, the only identified feature was a rubble foundation deposit associated with the 19th century outbuilding. Archaeological remains were completely absent from the 28sq m footprint of the kitchen extension and overall, a distinct lack of earlier features suggests that this was not within the main focus of activity in the medieval period.
