**Archaeological Evaluation Report
Land at Barn Cottage, Lewes Road
Scaynes Hill, West Sussex**

**NGR: 536770 122980
(TQ 36770 22980)**

**ASE Project No: 170297
Site Code: SYE 17
ASE Report No: 2017216
OASIS id: archaeol6-285997**

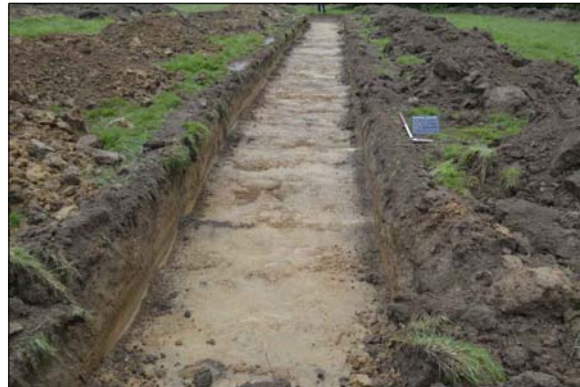
- 4.1.1 Trench 11 was located towards the south of the site and measured 30.00m x 1.80m in plan. Excavation ceased at the top of the natural Weald Clay. The trench contained a single gully.

Trench 11 looking east

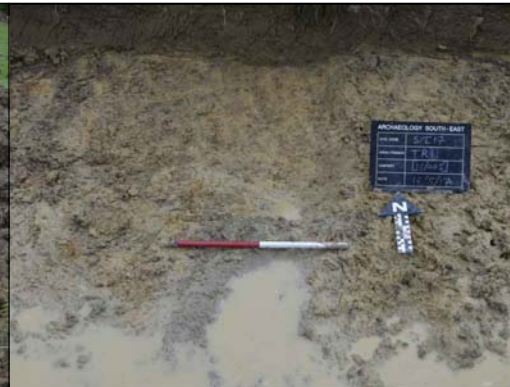
- 4.1.2 The natural yellow Weald Clay [11/003] was recorded between 67.15m and 68.03m aOD. The natural deposits were overlain by mid-brownish orange clayey silt subsoil [11/002] between 0.13m and 0.26m thick. The subsoil was cut by a north to south aligned gully [11/005]; this feature had steep sides and a flat base and measured 1.80m in visible length, 0.76m in width and 0.29m in depth. The gully fill [11/004] comprised mid greyish brown clayey silt and contained two fragments of undiagnostic CBM. This feature was also recorded in Trench 13. Given that the gully cuts the subsoil and shares a similar alignment to present-day field boundaries, it seems likely that it is of relatively recent origins, and is probably a post-medieval drainage ditch.

Feature [11/005] looking north

6.3.1 The only feature on site was the probable drainage gully in the south of the site. Given that the gully cuts the subsoil and on a similar alignment to present-day field boundaries, it seems likely that it is of relatively recent origins, and is probably a post-medieval drainage ditch.

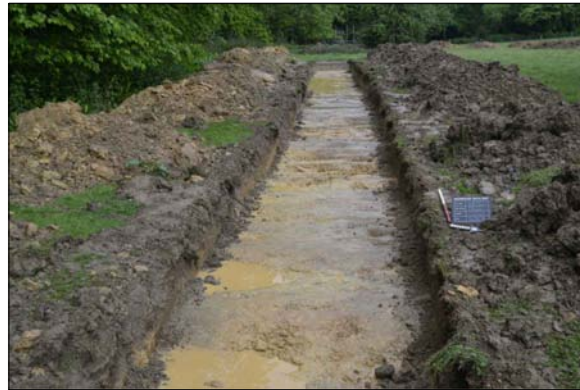
- 4.2.1 Trench 13 was located in the south of the site and measured 30.00m x 1.80m in plan. Excavation ceased at the top of the natural Weald Clay. The trench contained a single gully.

Trench 13 looking west

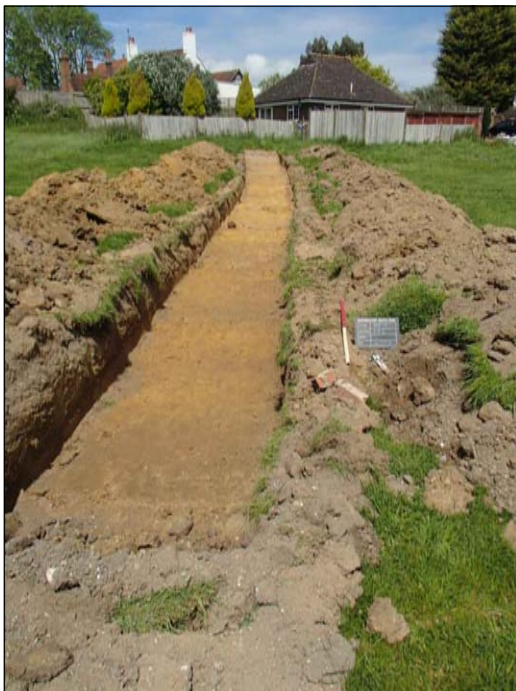
- 4.4.1 Trench 3 was located in the north-east of the site and measured 30.00m x 1.80m in plan. Excavation ceased at the top of the natural Weald Clay. The trench did not contain any archaeology.
- 4.4.2 The natural yellow Weald Clay [3/004] was recorded between 72.32m and 74.17m aOD; it was overlain by mid-brownish grey clayey silt subsoil [3/003] between 0.22m and 0.24m thick. The subsoil was overlain by a mixed dark grey and yellow rubbly clay modern made ground deposit [3/002] which measured between 0.10m and 0.40m in thickness. The made ground was sealed by dark brown grey silt topsoil [3/001] measuring between 0.28m and 0.38m in thickness. Context detail for this trench is listed in Appendix 1 at the back of this report.

Trench 3 facing north

6.2.1 The site has not been previously developed and with the exception of the landscaping the north-east, no traces of horizontal truncation were recorded. The landscaping appeared to be an attempt to terrace a small rectangular part of the site. The modern truncation recorded in Trench 5 appears to have been part of this.
